BRIDGE RE-EVALUATION SURVEY REPORT

STRUCTURE NO. 1XXX-XXX
FEDERAL STREET OVER ROUTE **US 30** AND SERVICE ROADS
CITY OF CAMDEN
CAMDEN COUNTY

SAMPLE REPORT
(FOR GUIDANCE ONLY)

12TH CYCLE

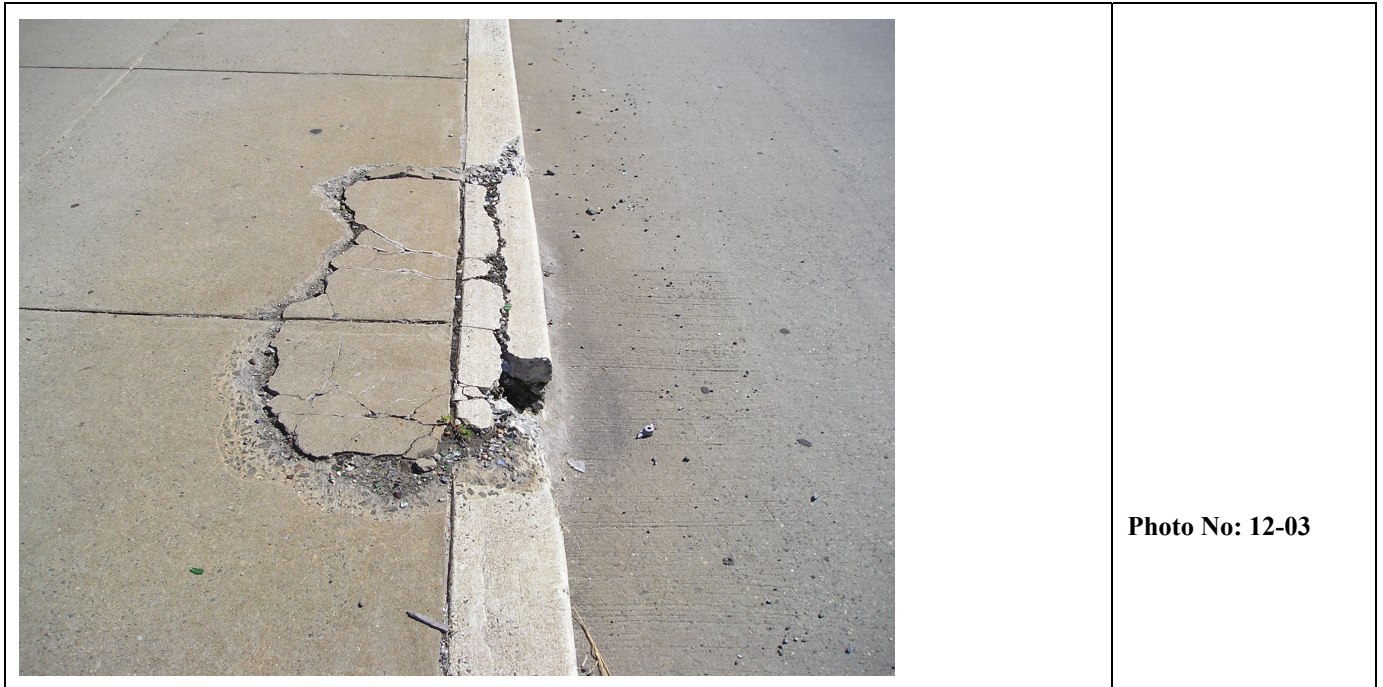
Photo No: 12-03

Location: West sidewalk and curb at 5th span from south, looking North.
Description: Large incipient spall on west sidewalk with deteriorated curb due to collision.

RATING	COMPONENT	REMARKS
6	Wearing Surface / Top of Deck (Concrete)	
6	Underside of Deck (SIP Forms)	
N	Median	None
6	Curbs (Concrete)	
4	Sidewalks / Safetywalks (Concrete)	West: An incipient spall (6 SF) at ± 20' from the South end. See Photo No. 12-03 .
7	Parapets/ Balustrades (Concrete)	
7	Railings / Fencing	
6	Deck Joints / Filler Material	
N	Drains and Scuppers	None
N	Light Stands	None
N	Utilities	None
N	Others	N/A

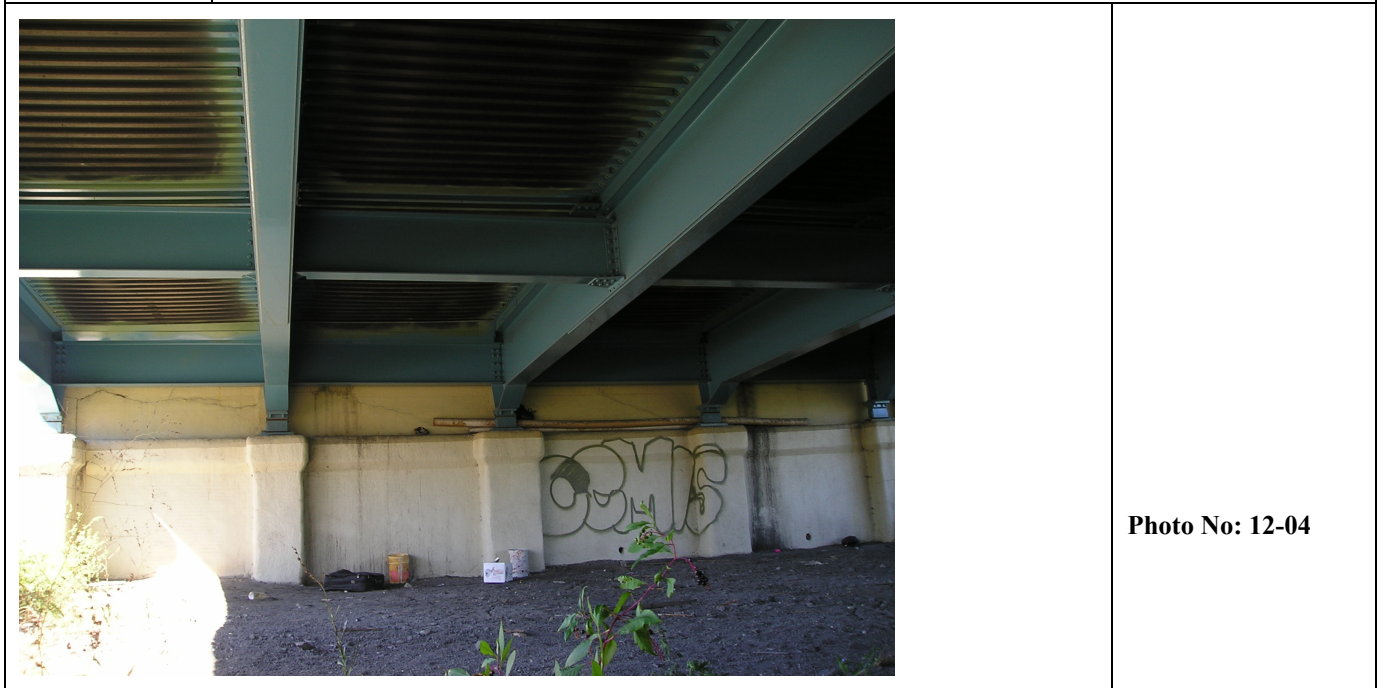
Photo No: 12-04

Location: Superstructure, looking South.
Description: General View. Typical for all spans except 4th span from South.

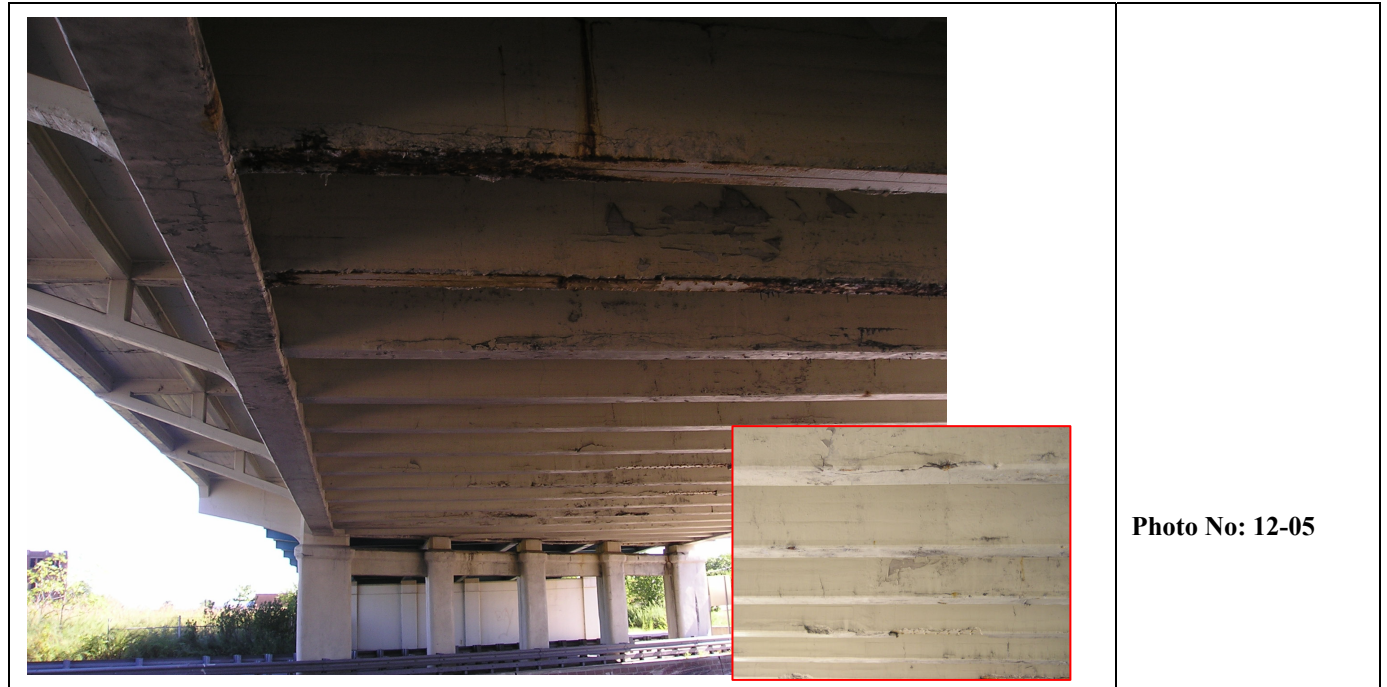
Photo No: 12-05

Location: Superstructure at 4th span from south, looking North.
Description: General View. Note: Several incipient spalls at bottom of concrete encasements.
 Insert: Close up of incipient spalls.

RATING	COMPONENT	REMARKS
6	Stringers (Steel) (5 Nos., #' d West to East)	Incipient spalls to be removed on priority 1 basis.
6	Diaphragms / Cross Frames	
6	Bearings	
	Deflection and Vibration	None noticed.
N	Others	N/A

1. Removing incipient spalls in span 4 from south ([Photo No. 12-05](#) and refer to [Priority Repair PR1_01](#) and [NJDOT Memorandum dated 10/7/2005](#)).
2. Posting for vertical underclearance on east fascia at service road (EB) since the vertical clearance is at 14'-7" at the shoulder ([Photo No. 12-07](#) and refer to [Priority Repair PR1_02](#) and [NJDOT Memorandum dated 10/10/2005](#)).

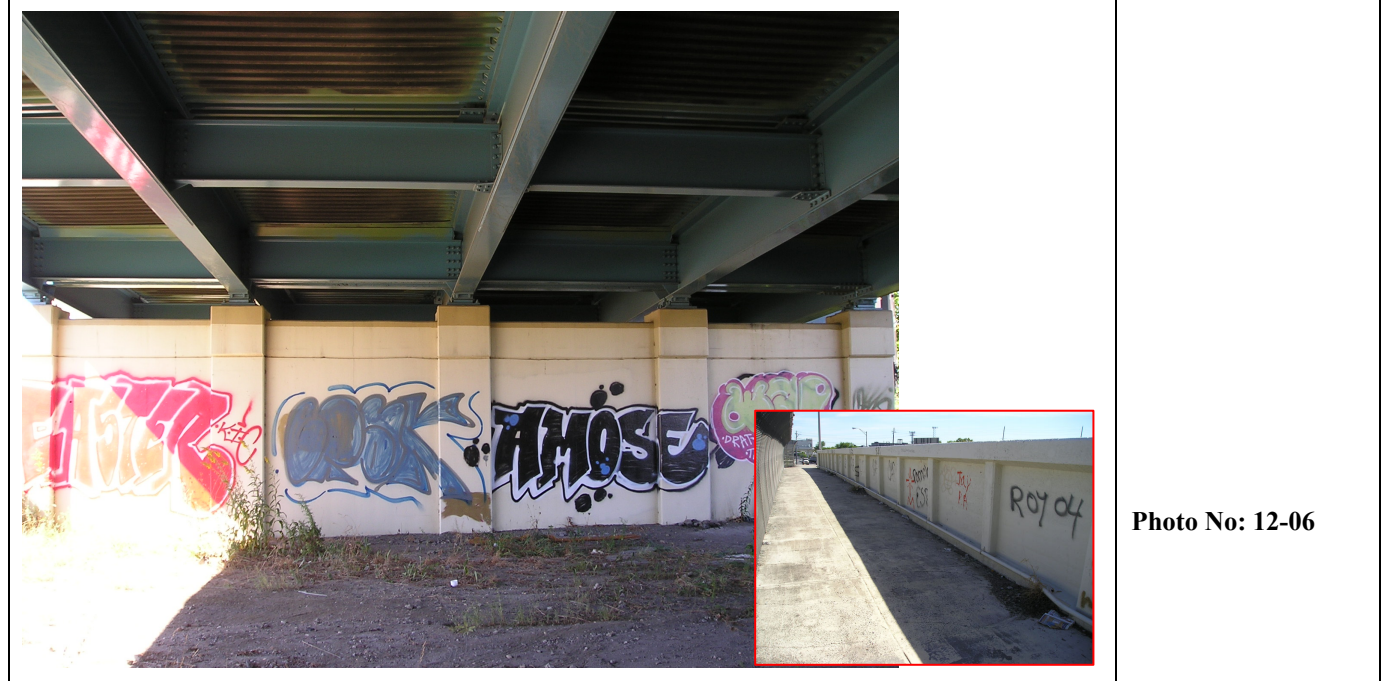
Photo No: 12-06

Location: 1st pier from South at south lane, looking North.
Description: Graffiti on pier stem wall. Typical on 2nd pier from South.
 Insert: Graffiti on west through girder.

RATING	COMPONENT	REMARKS
6	Wearing Surface / Top of Deck (Concrete)	
6	Underside of Deck (SIP Forms)	
N	Median	None
6	Curbs (Concrete)	
7	Sidewalks / Safetywalks (Concrete)	
7	Parapets/ Balustrades (Concrete)	
6	Railings / Fencing	
6	Deck Joints / Filler Material	
N	Drains and Scuppers	None
N	Light Stands	None
N	Utilities	None
N	Others	Graffiti on West through girder. See Photo No. 12-06 .

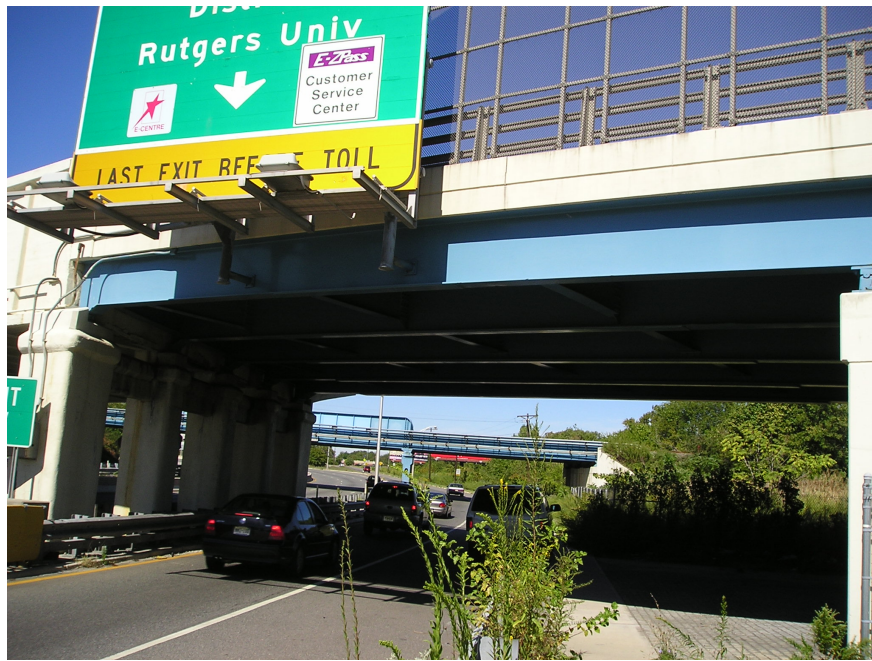
Photo No: 12-07

Location: East elevation at 5th span from south, looking West.

Description: Lack of vertical underclearance posting for Service Road westbound (Ramp under 5th span from South).

*Posting for Load / Speed / Clearance Restrictions (Include a photo)	Missing vertical posting under 5 th span from South. See Priority Repair PR1-02 . All other vertical underclearance signs posted. See Photo No. 12-09 .
--	--

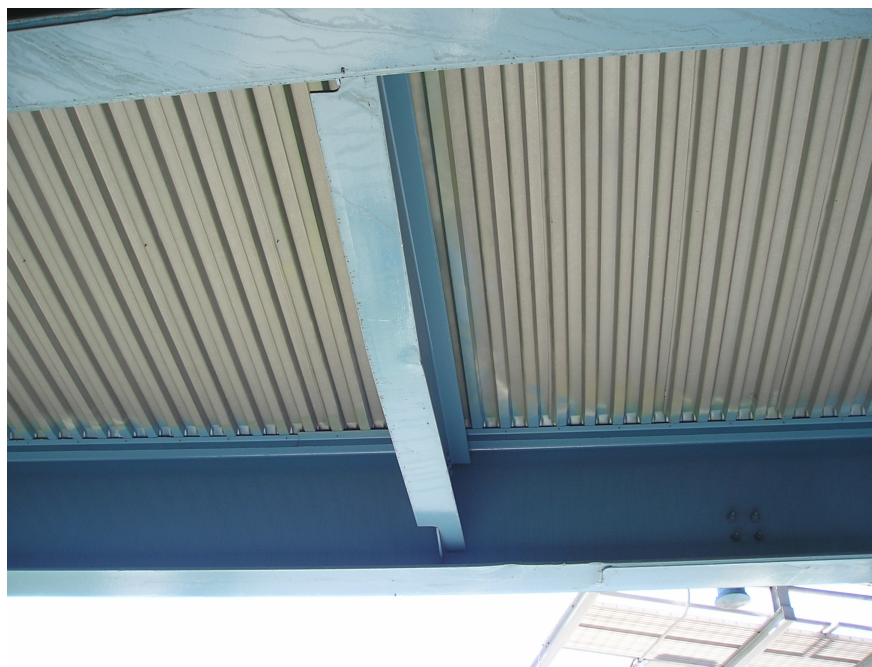
Photo No: 12-08

Location: East Bay diaphragm in 5th span from south, looking East.

Description: Bent diaphragm due to impact and low vertical underclearance.

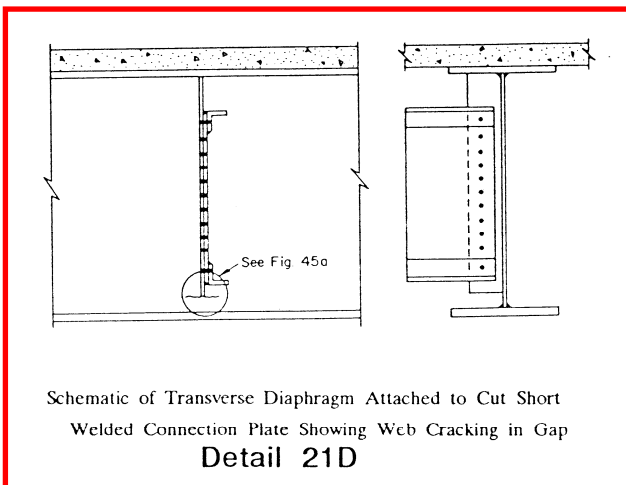
Schematic of Transverse Diaphragm Attached to Cut Short
Welded Connection Plate Showing Web Cracking in Gap
Detail 21D

Category	Detail Description and Location
E	See Detail 21D . (Transverse diaphragms attached to cut short welded connection plates).
