Neldon Brook - FIBI012

SUMMARY OF RESULTS – FIBI012

**FIBI012
NELDON BROOK
SWARTSWOOD ROAD (CR 622)
STILLWATER TWP., SUSSEX COUNTY**

FIBI012-Neldon Brook @ CR 622
Date Sampled - 6/21/2005

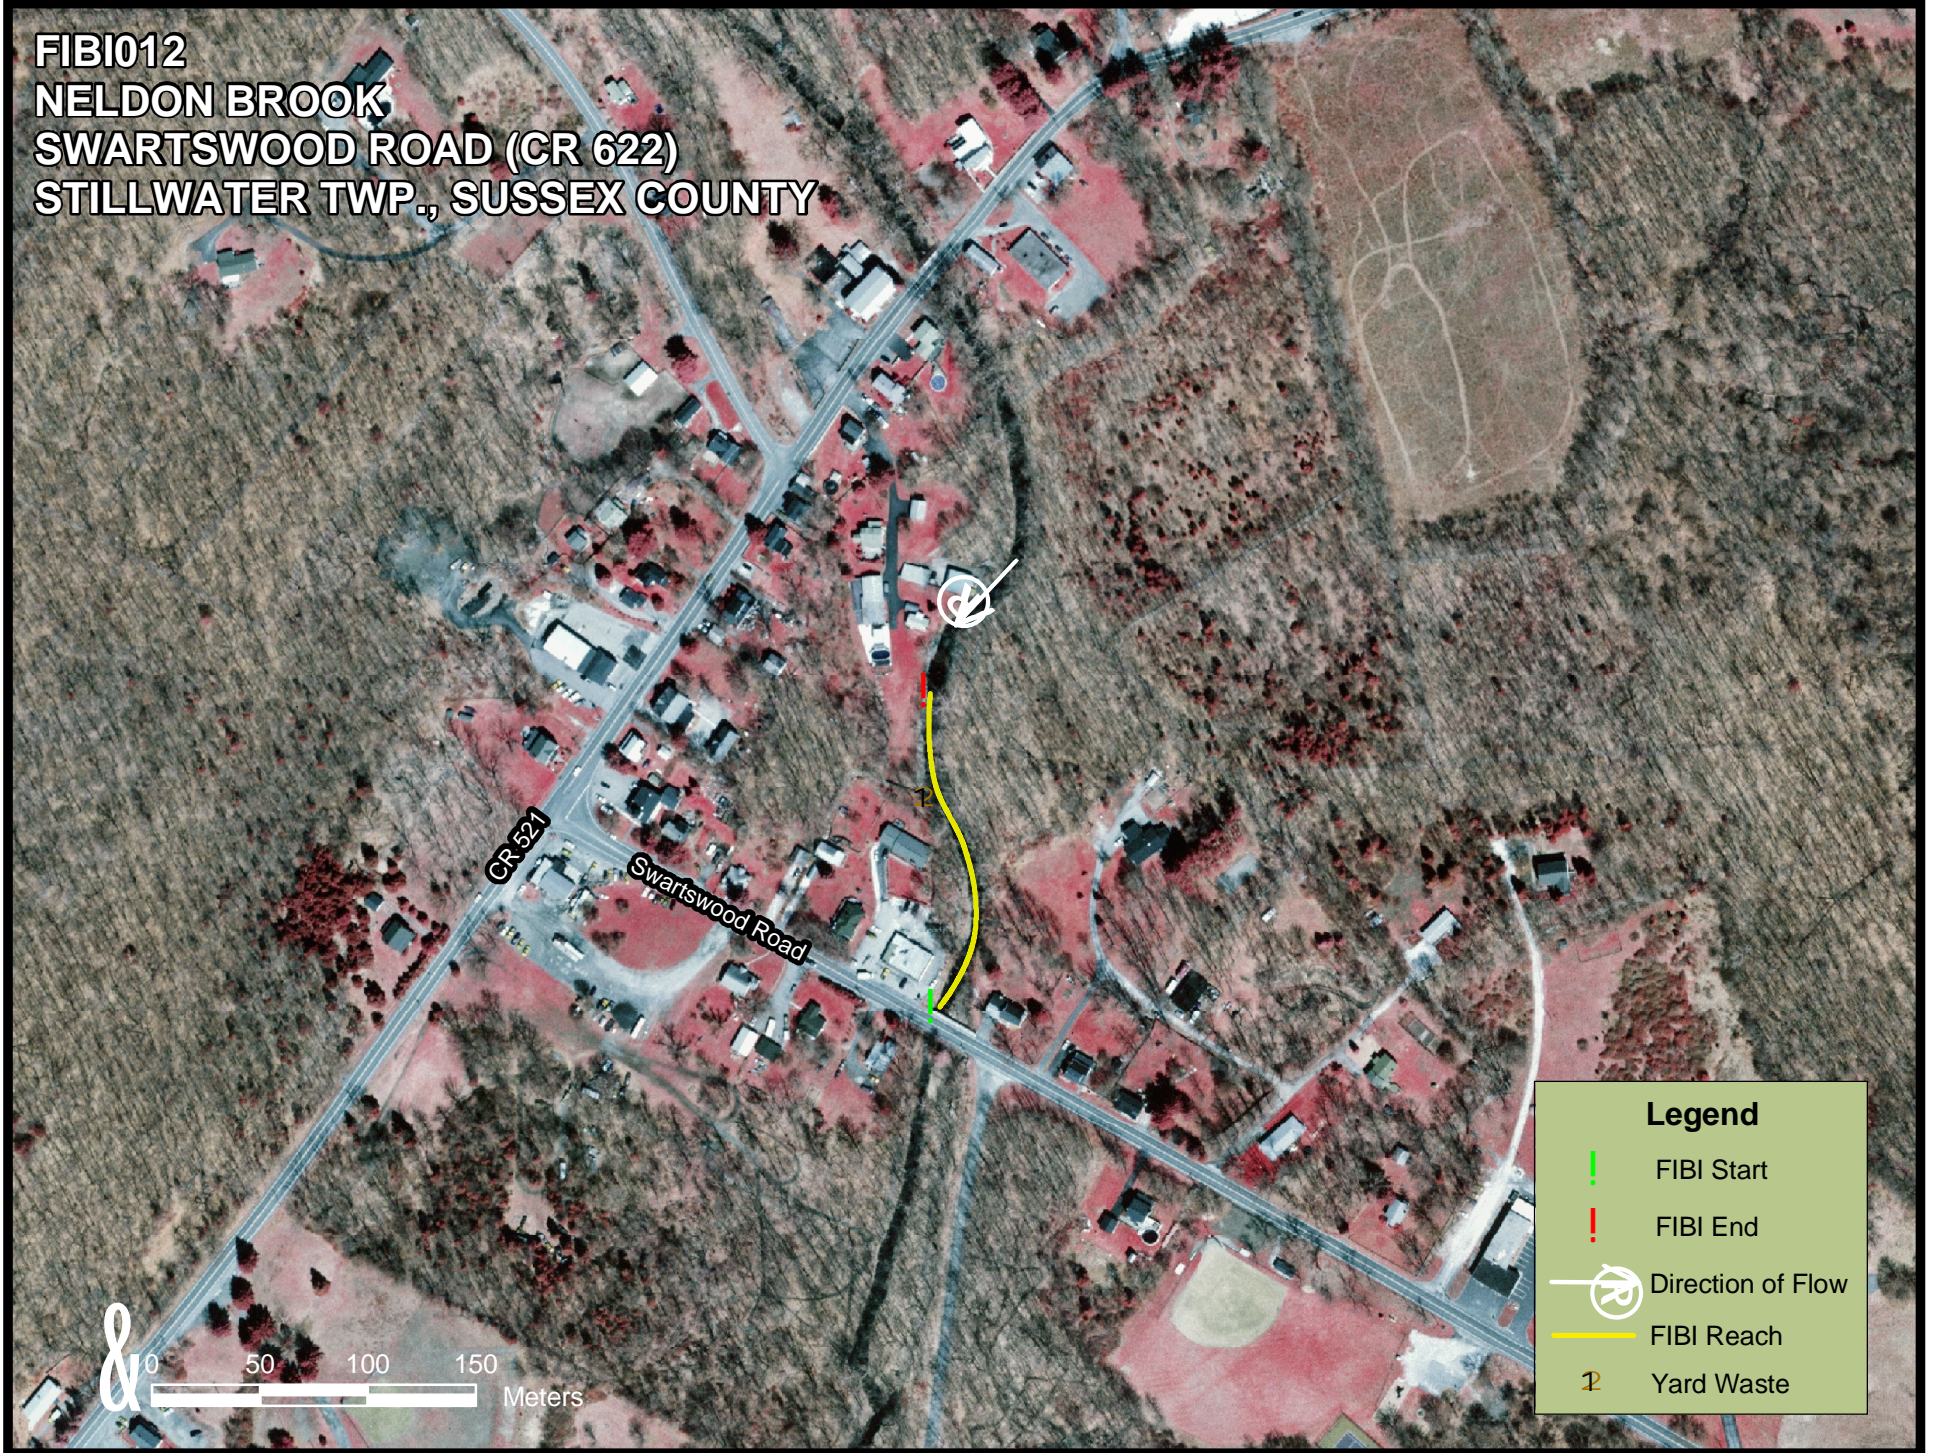
Yard Waste
