FIBI514-R1r

Peach Orchard Brook

Hussa Street

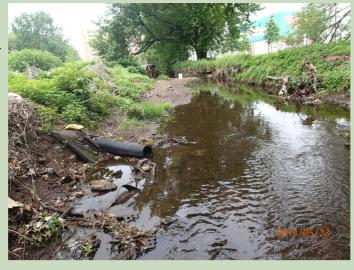
FIBI514 was rated "very poor" in 2014, and also in its previous sampling in 2013. This site contained tolerant fish and a non native crayfish. Peach Orchard Brook is located adjacent to a park and lacked suitable habitat, had poor bank stability, and had several stormwater outfalls.
