**CAMP MEETING AVENUE,
HILLSBOROUGH ROAD AND
HOMESTEAD ROAD OVER
TRENTON LINE (CSX)
SOMERSET COUNTY
BRIDGE REHABILITATION**

Wetland Identification Survey Report

WETLAND IDENTIFICATION REPORT AT HOMESTEAD ROAD, HILLSBOROUGH ROAD AND CAMP MEETING AVENUE OVER TRENTON LINE

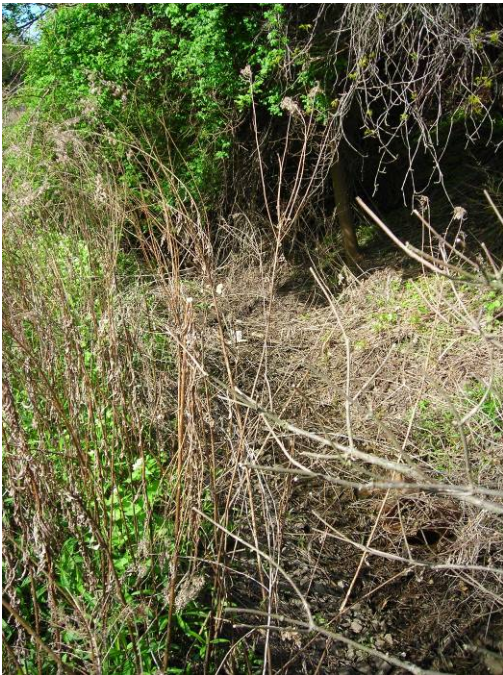
At this crossing, the two western quadrants contained a ditch that was continuous beneath the crossing. In the NW quadrant, the ditch was primarily rock-lined and largely unvegetated (lower right-hand corner of photo at left). In the SW quadrant, the ditch contained several common wetland plants, such as cattail and sensitive fern. Thus, in the SW quadrant the ditch appears to possess wetland characteristics (photo below).

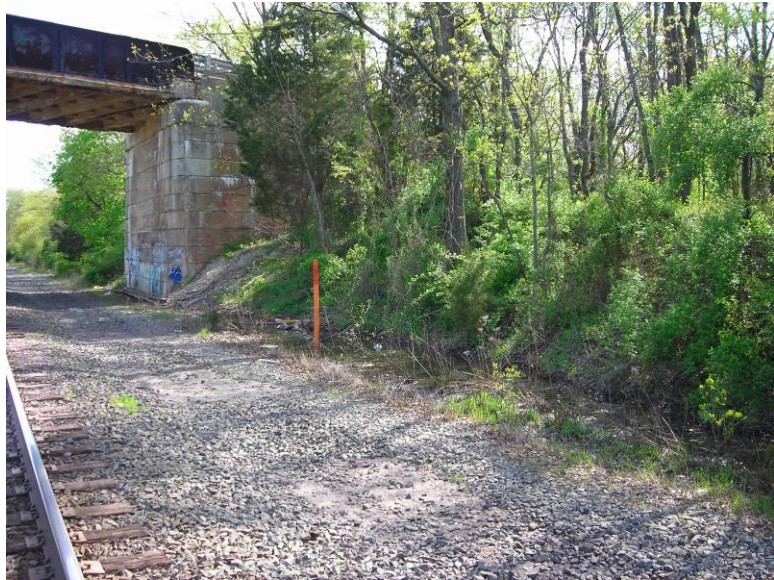
The SE quadrant contains rock fill and upland soil from the bridge support structure to approximately 25 feet south of the structure. However, beyond that distance a ditch is present adjacent to the railroad tracks. This ditch also contained several typical wetland plants, such as soft rush and green ash, and appears to possess wetland characteristics (photo at right).

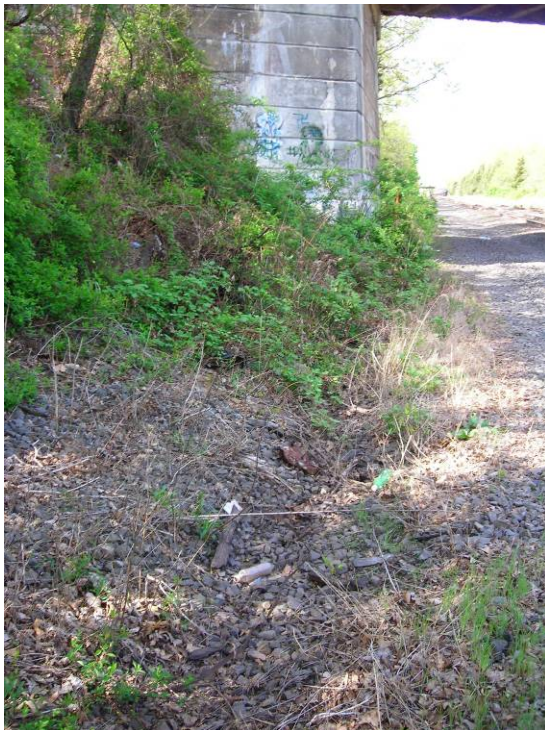
The NE quadrant contains no evidence of wetlands/waters and is basically an area of upland and rock fill (photo at left).

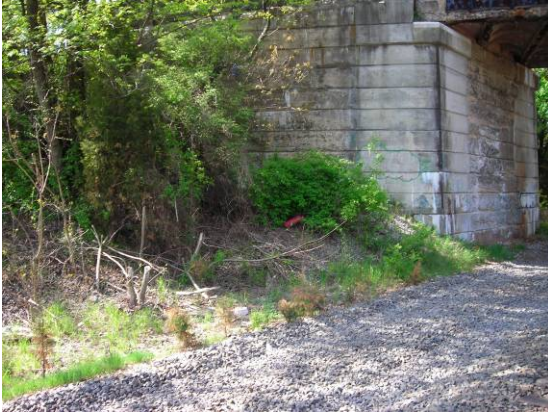
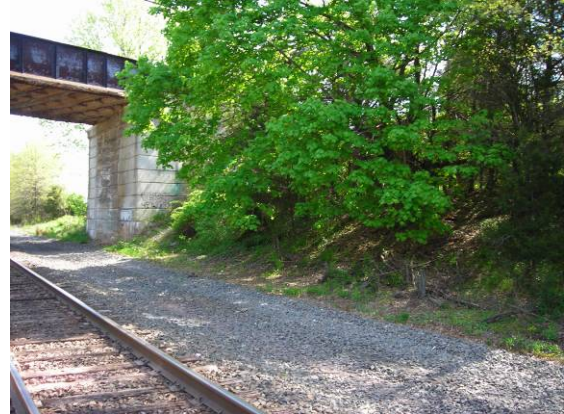
The NE (photo below-left) and SE (photo below-right) quadrants contained no ditch or depression and appeared to consist of upland only.

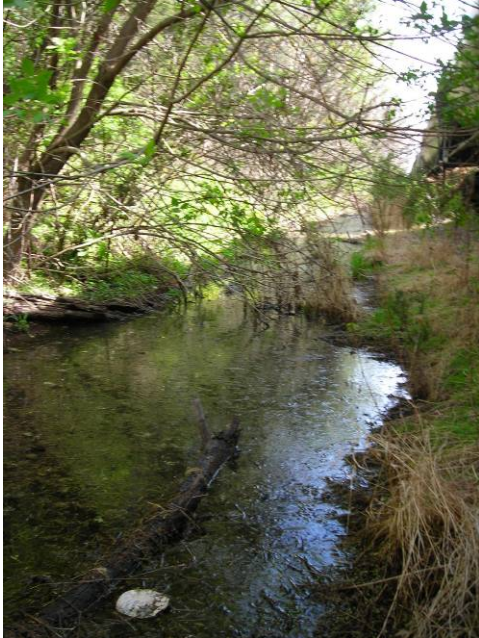
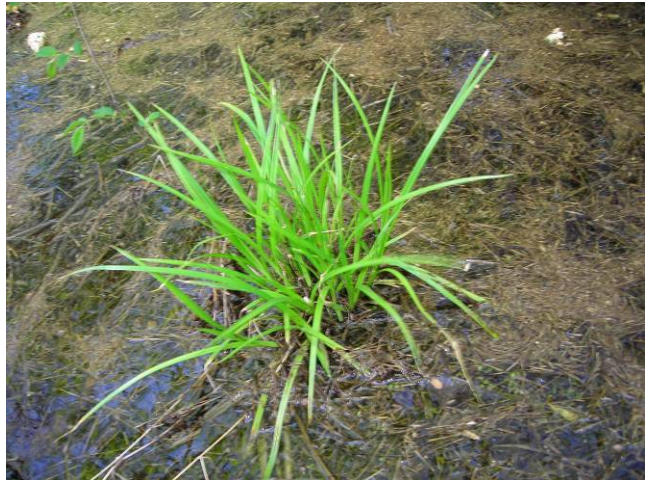
Both the NW and SW quadrants contained ditches, but the ditches were not continuous beneath the road crossing. Both ditches contained few emergent wetland plants, but both contained algae and an unidentified aquatic plant. In the NW quadrant, the ditch had several ashleaf maples along its banks, and it contained several sedges emerging from the water (photos below). This ditch appears to possess wetland characteristics.

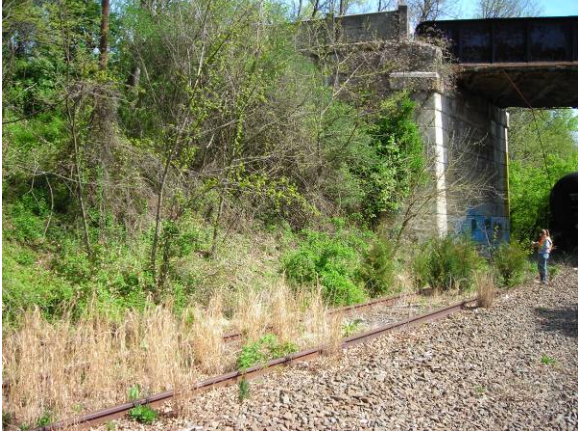
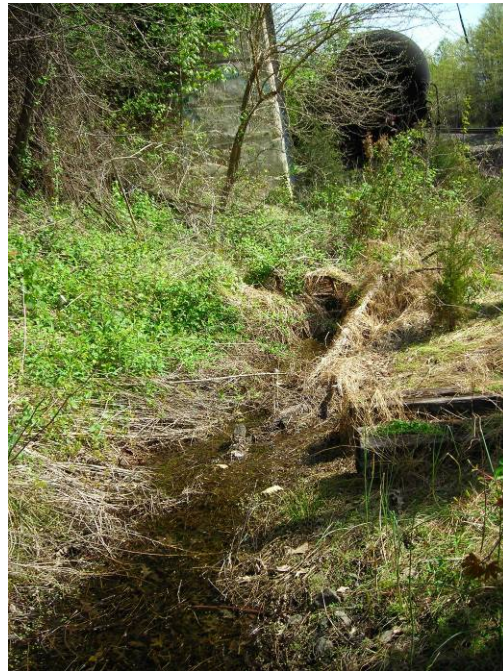
Emergent vegetation was not observed in the SW quadrant ditch (photo at right). Plants along its banks included poison ivy and red cedar (photo below). Lacking wetland plants, this ditch may not be considered a wetland.

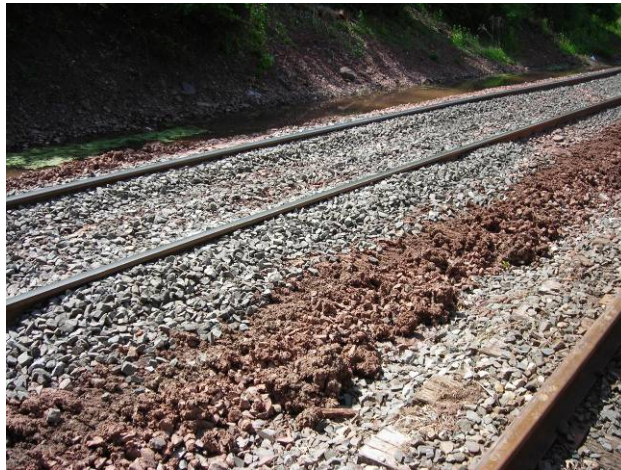
Most the quadrants at this crossing showed evidence of recent ditch dredging or modification. What appeared to be dredge spoil had been placed between the railroad tracks (photo at right).

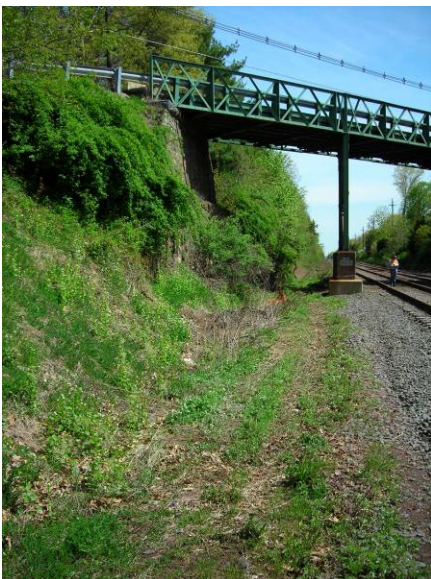
The SW quadrant is the only quadrant that did not contain a ditch. It appears to consist of upland (photo below).

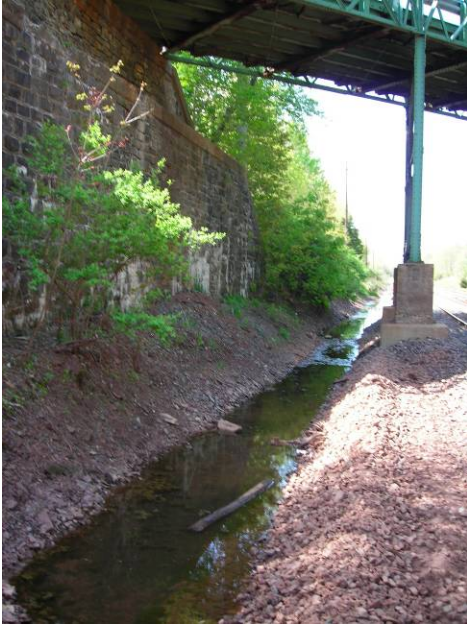
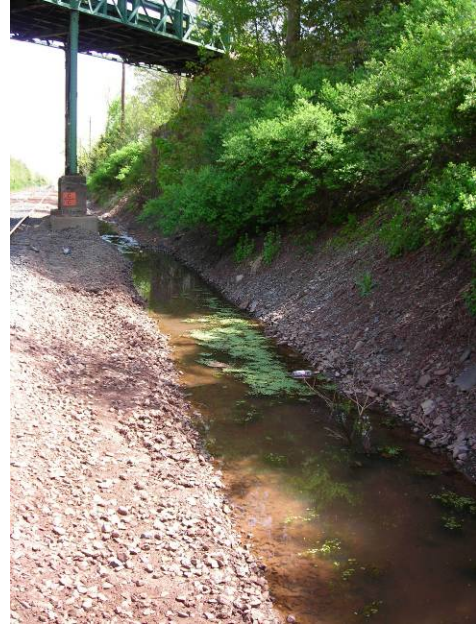
The NE (photo below-left) and SE (photo below-right) quadrants contained a continuous ditch that gradually flowed to the north. The ditch contained no emergent plants but did contain algae and aquatic plants. The ditch had evidently been excavated, dredged, or deepened in the recent past, as mud was still adjacent to the ditch and in the center of the railroad tracks. This ditch does not possess wetland characteristics but appears to constitute state open water.

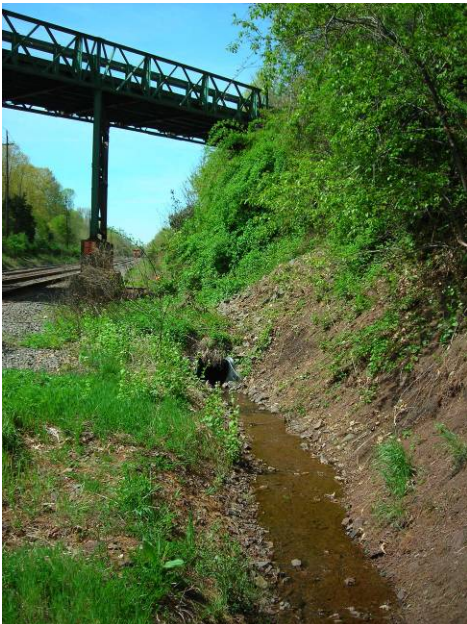
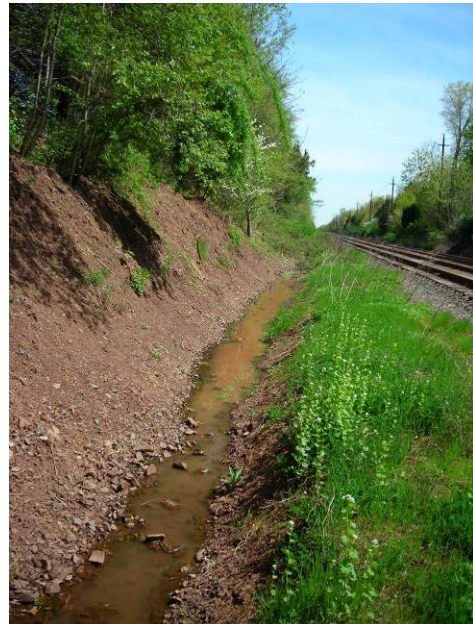
The NW quadrant contained a ditch with steady flow to the south. The ditch flowed into a plastic culvert approximately 20 feet north of the bridge support structure. The outflow of this culvert could not be located in the vicinity. This ditch contained no vegetation and also appeared to have been recently altered (both photos below: right is toward crossing and left is upstream/north). This ditch does not possess wetland characteristics but appears to constitute state open water.
