U-POST INVESTIGATION

NJ DOT PROJECT 7758

Bureau of Operations Research  
Division of Research and Development  
New Jersey Department of Transportation

July 1973

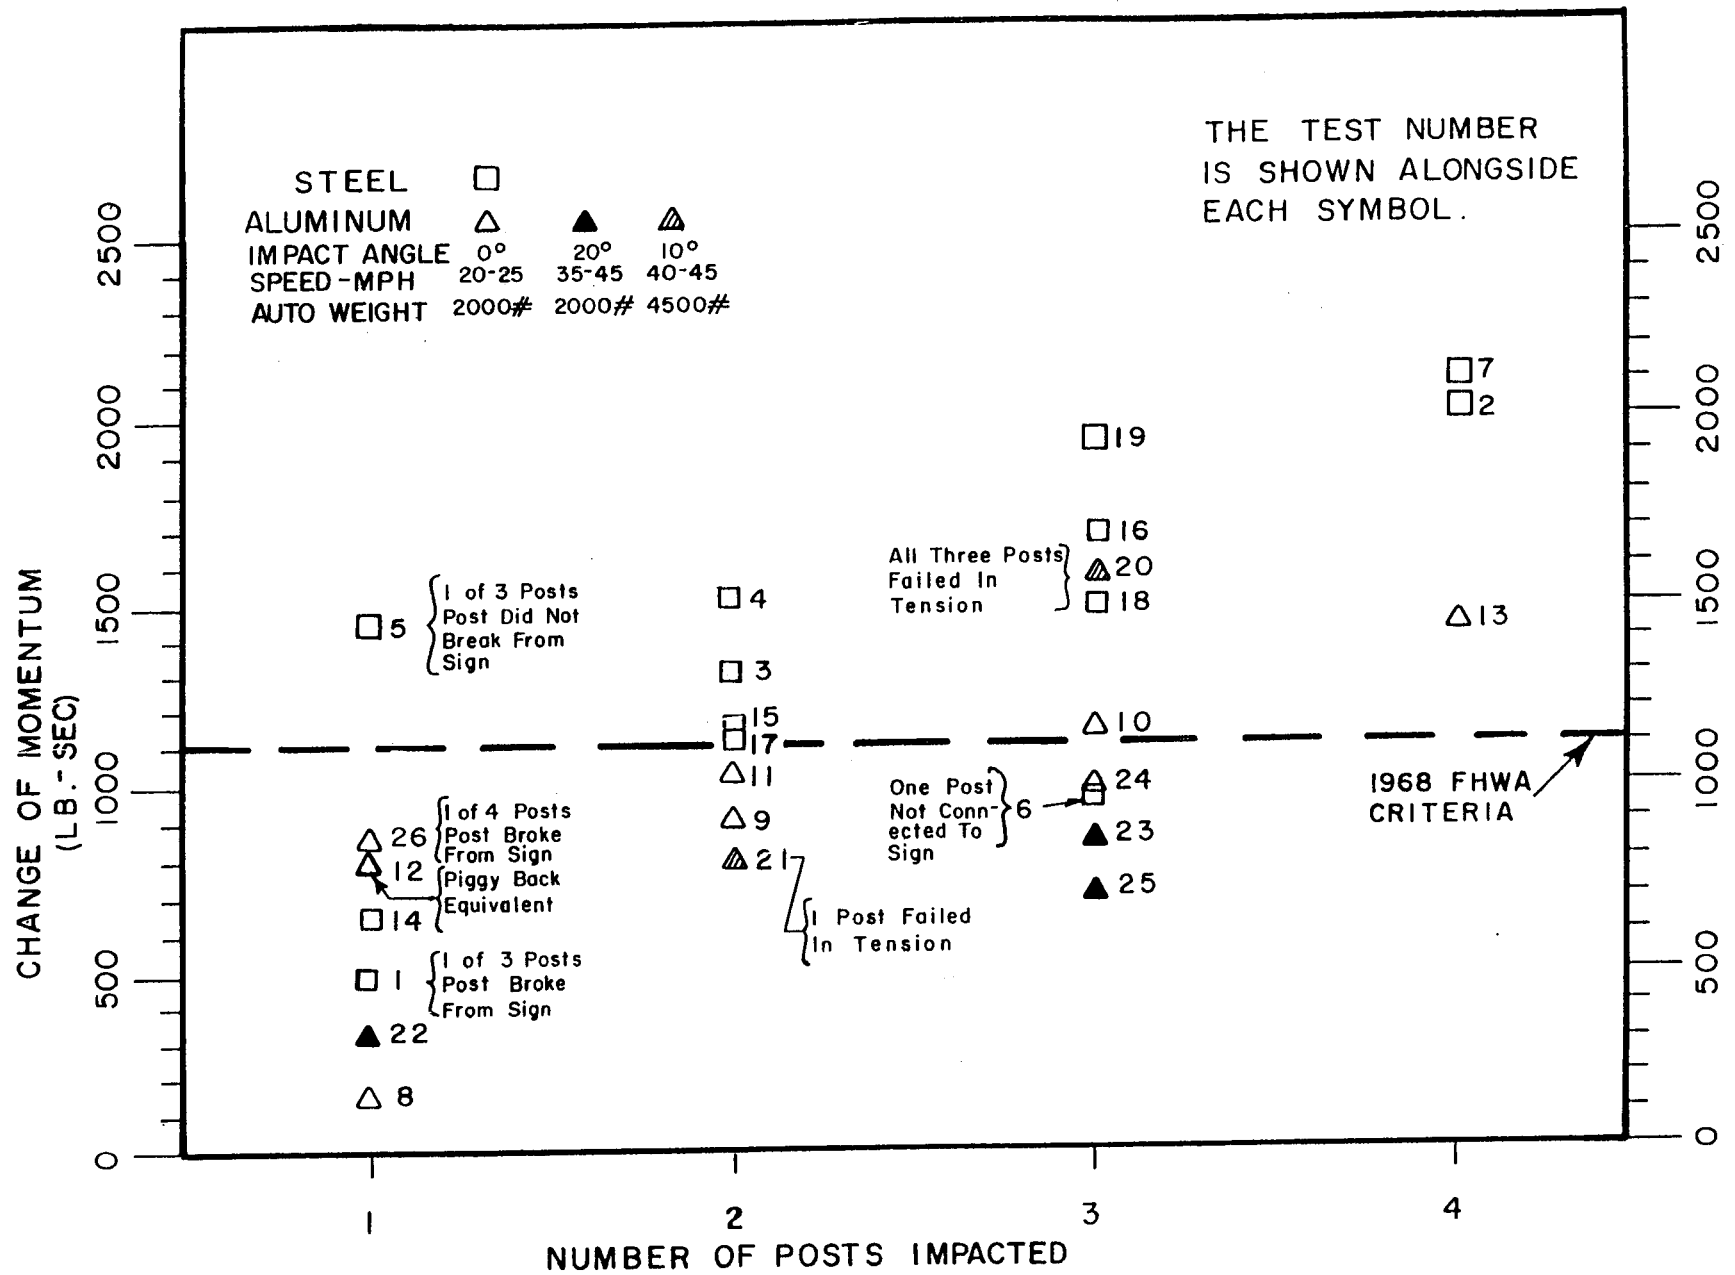
FIGURE 5

Figure 5 shows the momentum change as computed for each test, post type and the number of posts impacted.

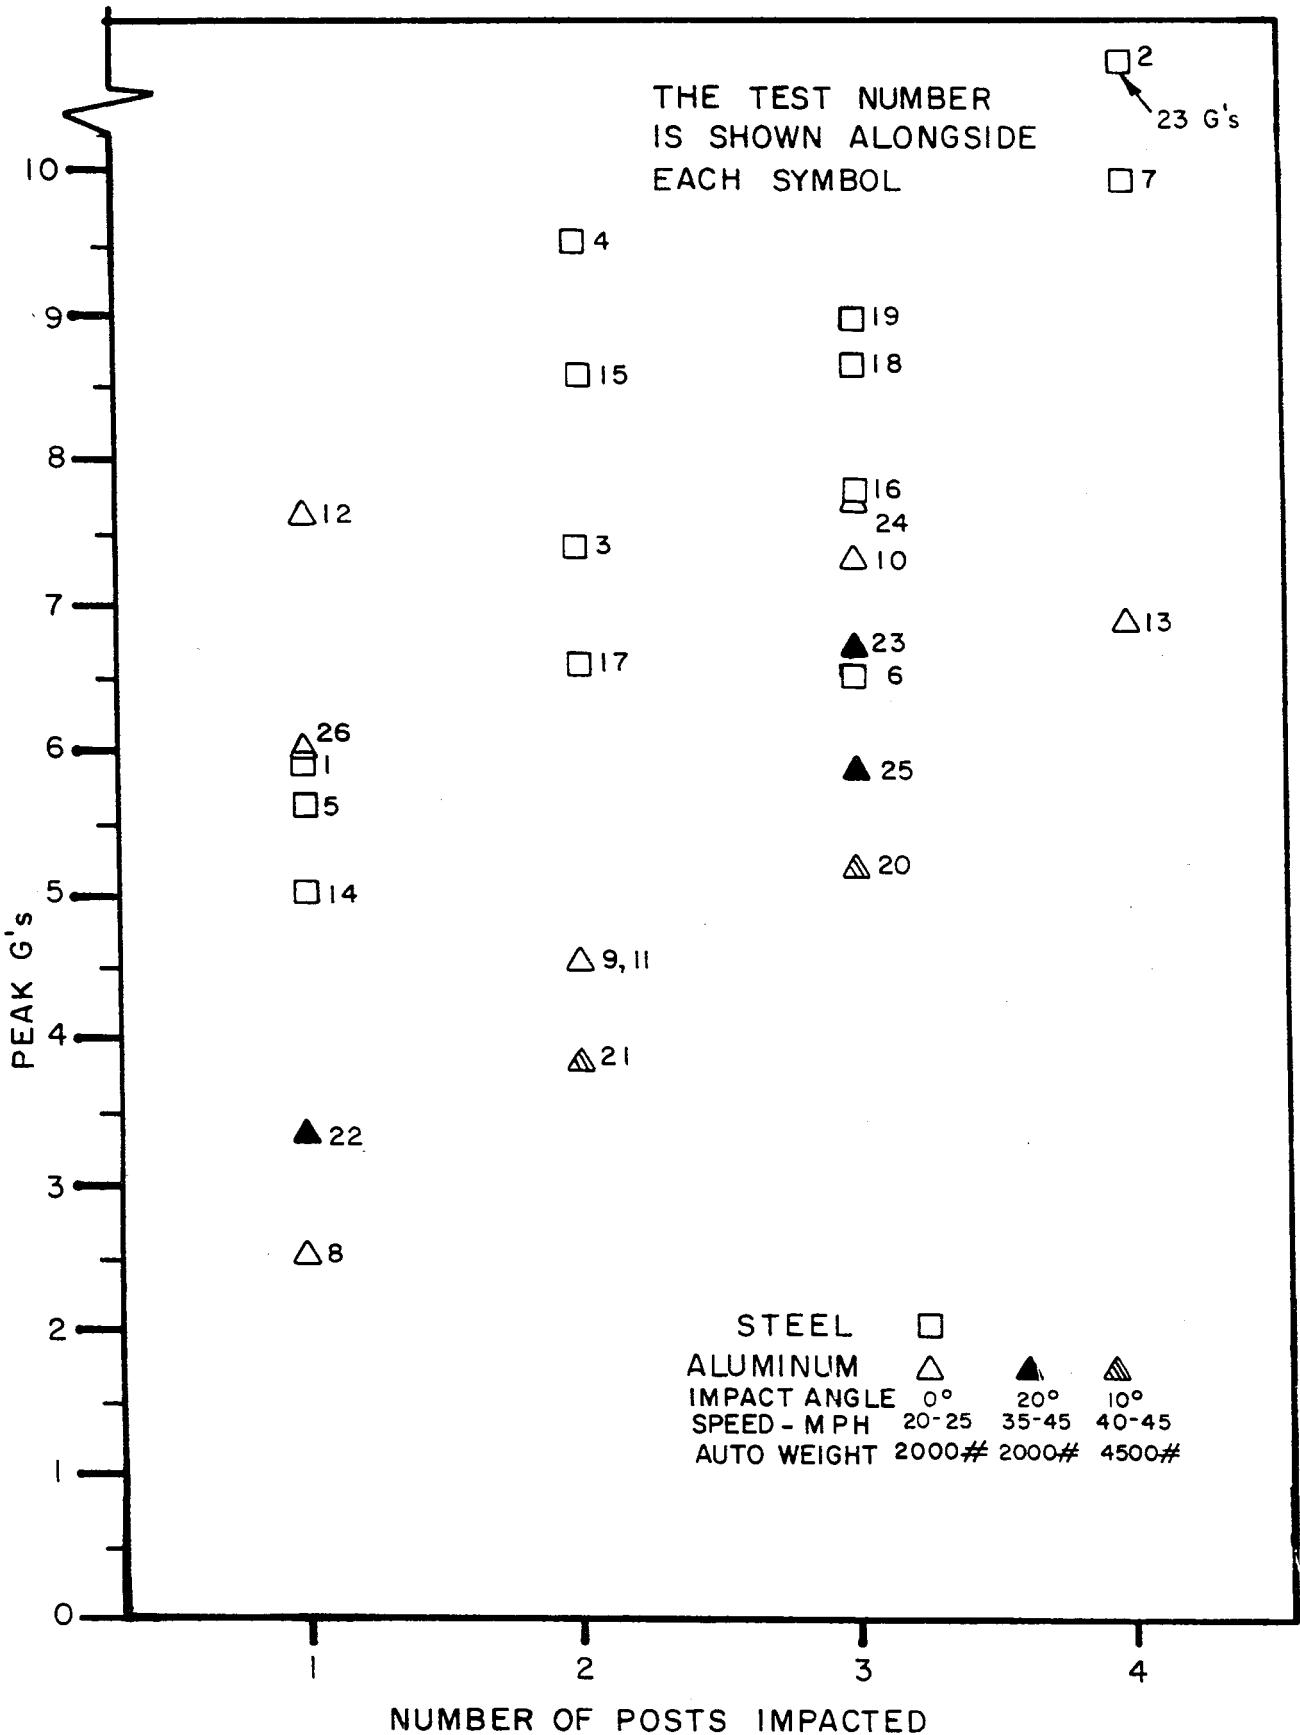
FIGURE 6

Figure 6 shows the peak G's recorded for the various tests and post types.

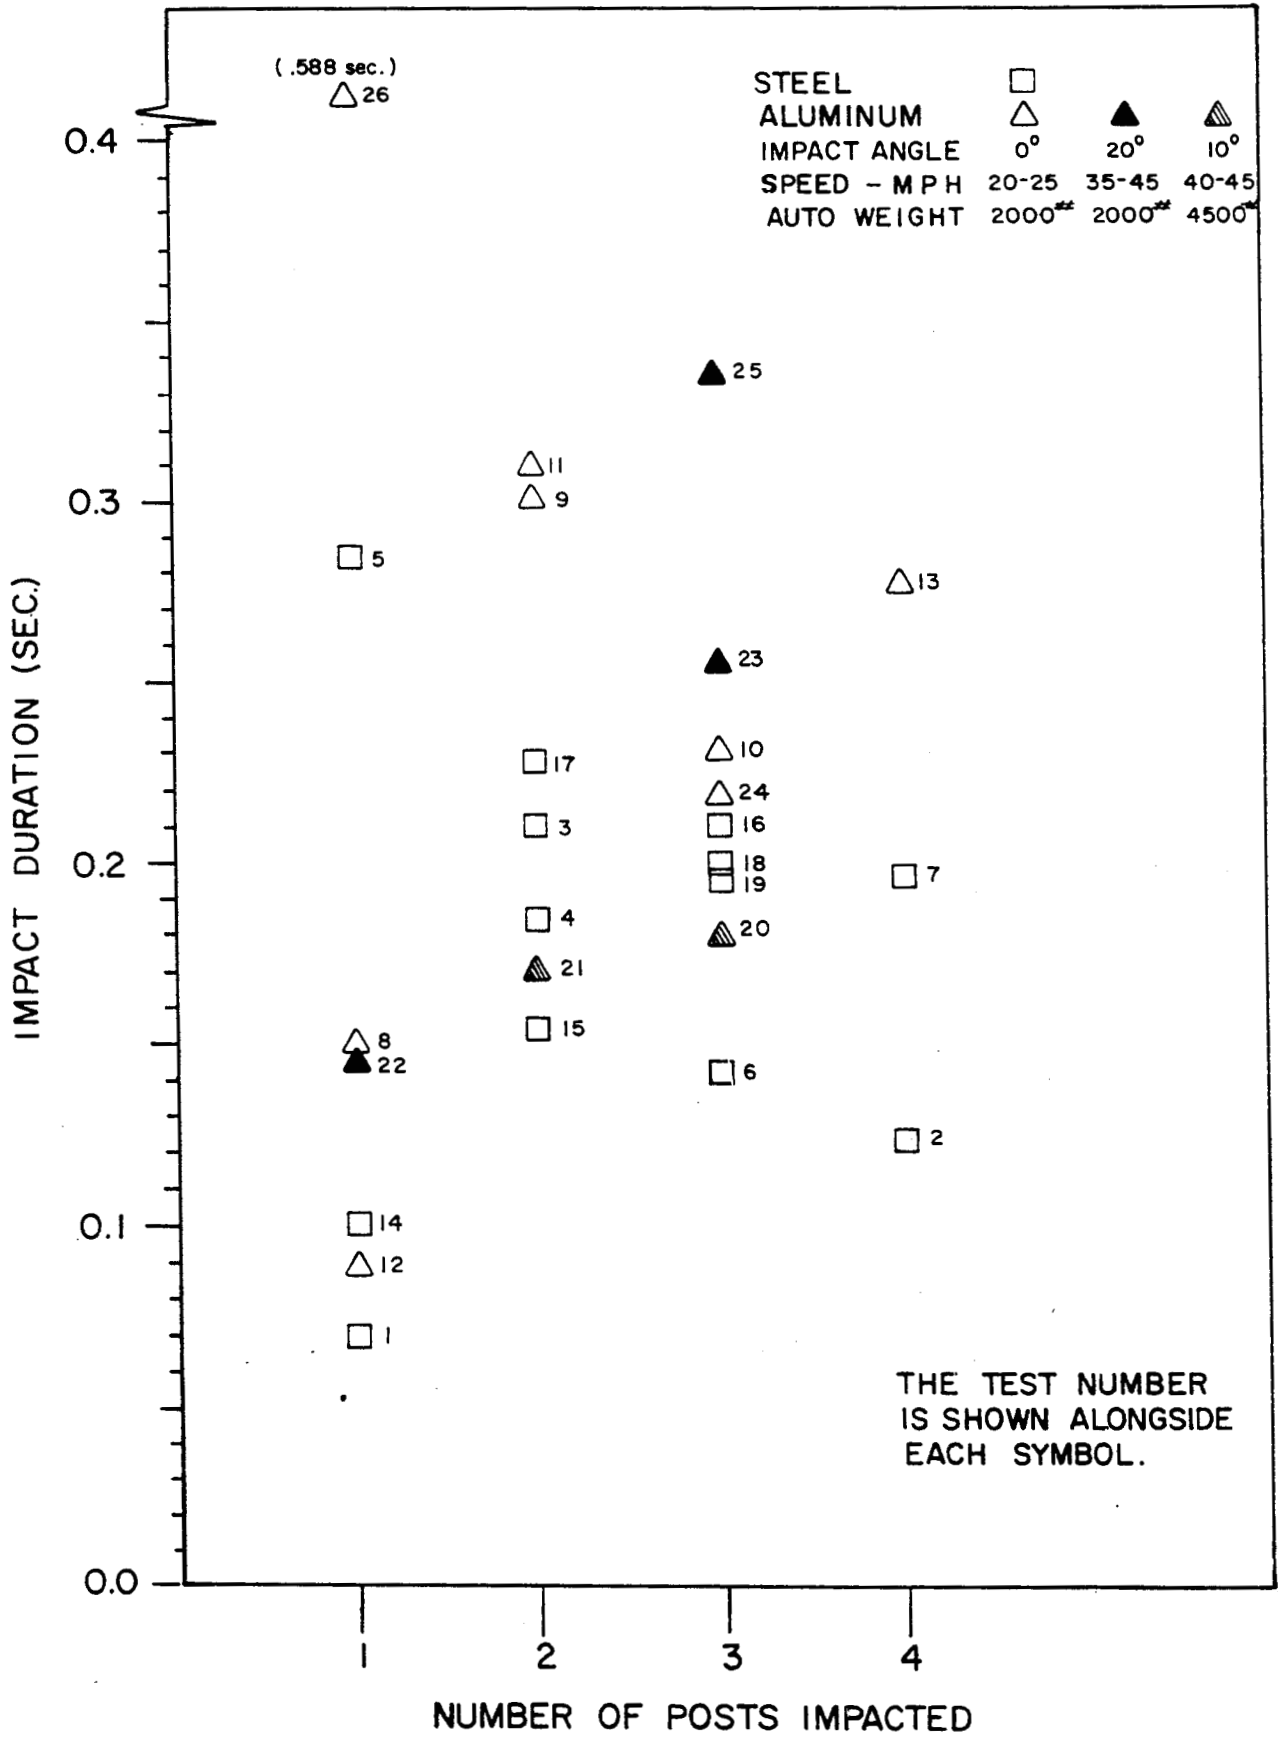
FIGURE 7

Figure 7 shows the relationship of impact duration to the materials and number of posts impacted.

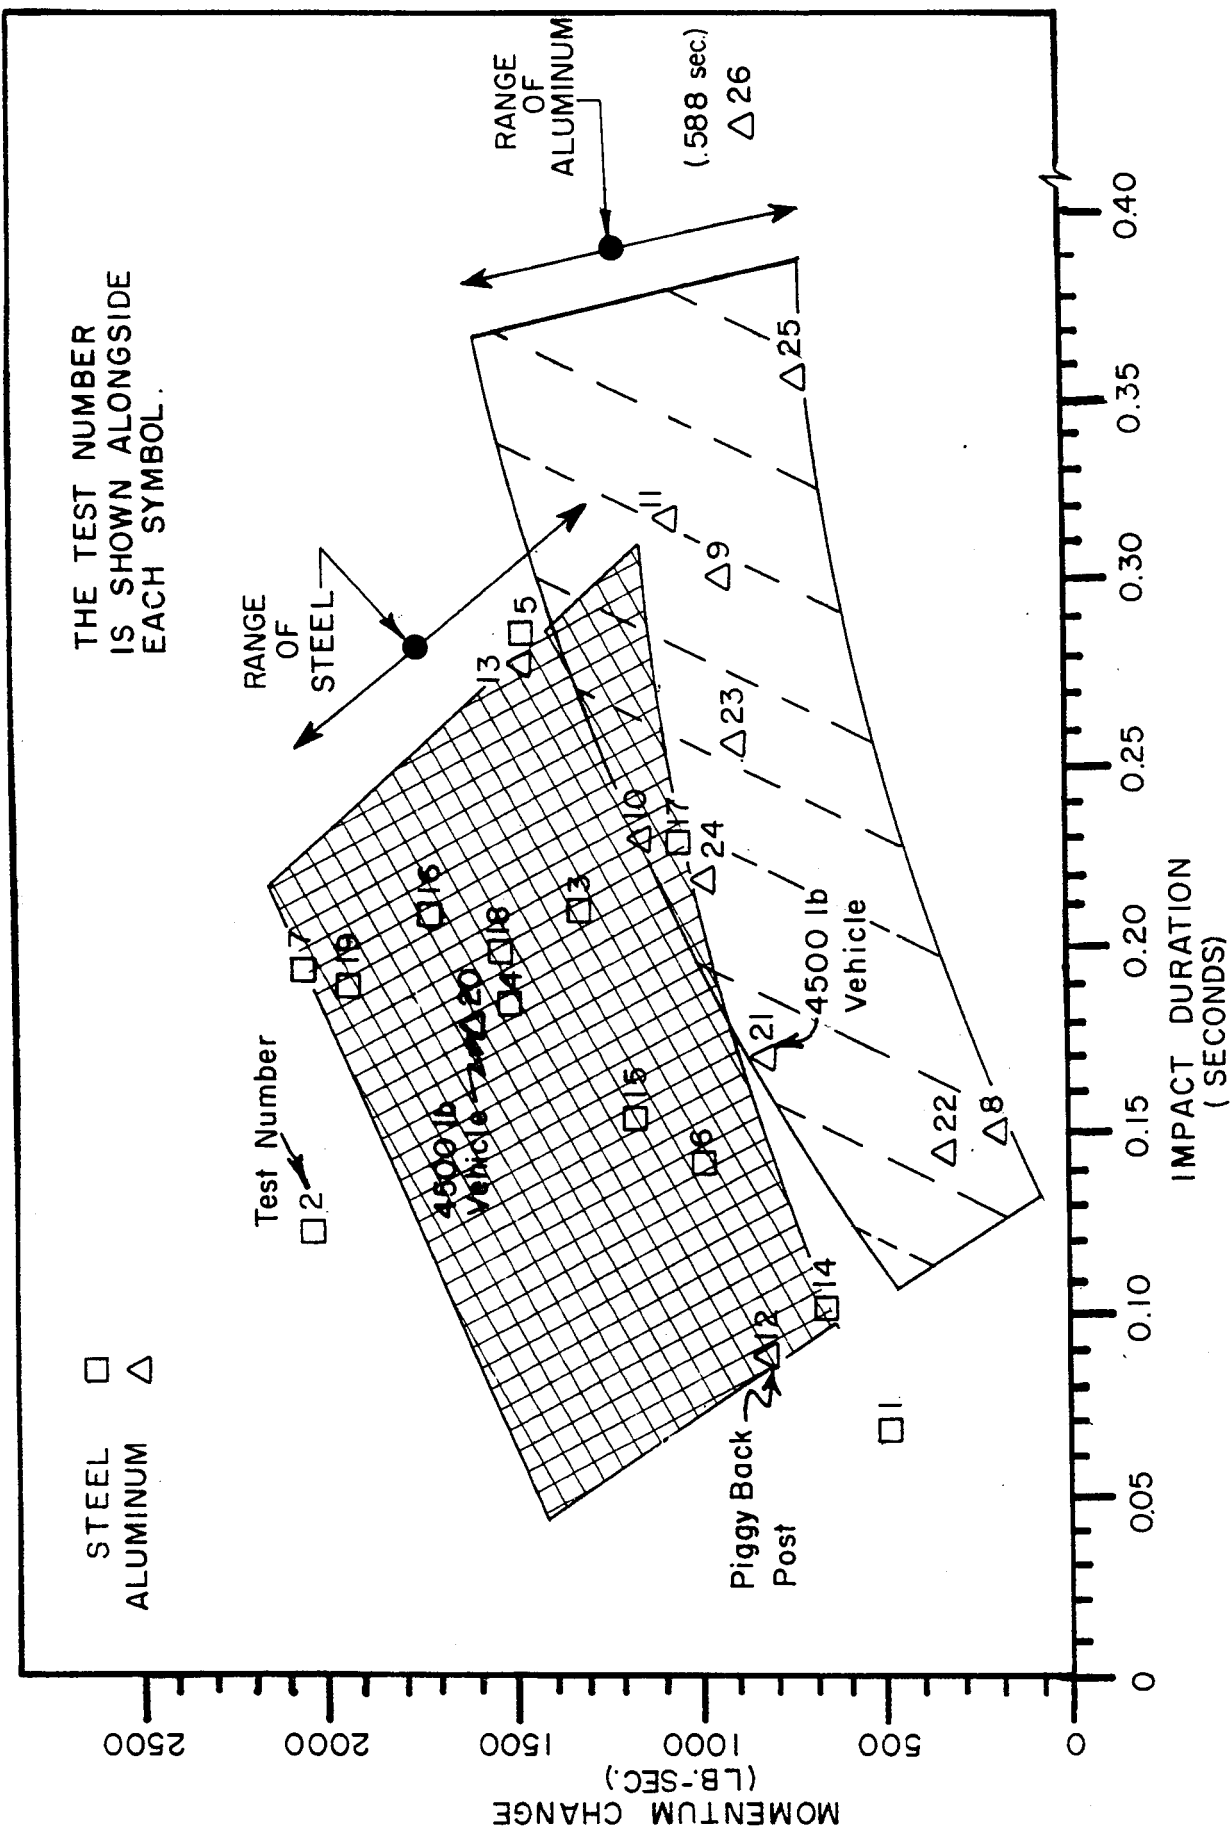
FIGURE 8

Of the posts tested, there appears to be two distinct regions for the ranges of momentum change. Although this is not obvious from Figure 5, Figure 8 highlights this feature in a plot of momentum change and duration of impact. The variation of momentum change in Figure 8 (for each material type) is mainly a function of the number of posts simultaneously impacted, while the variation in the duration of impact is mainly a function of the conditions of impact (e.g., an impact of a partial number of posts of an installation, or an angle impact).

Most of the data samples of Figure 8 are for the 2,000 pound vehicle. The 4,500 pound vehicle was only used to satisfy the Federal Highway Administration test conditions, since it was hazardous towing this vehicle at 45 mph. Hence, only the comparison of Tests 20 and 21 can be made for the heavier vehicle. Although Test 20 yielded a very high momentum change, the low "peak G" and speed change puts this test in the acceptable region (less than 8.5 G's) of the other impacts of three aluminum posts.
