State Channel Maintenance Capacity

FINAL REPORT

January 2015

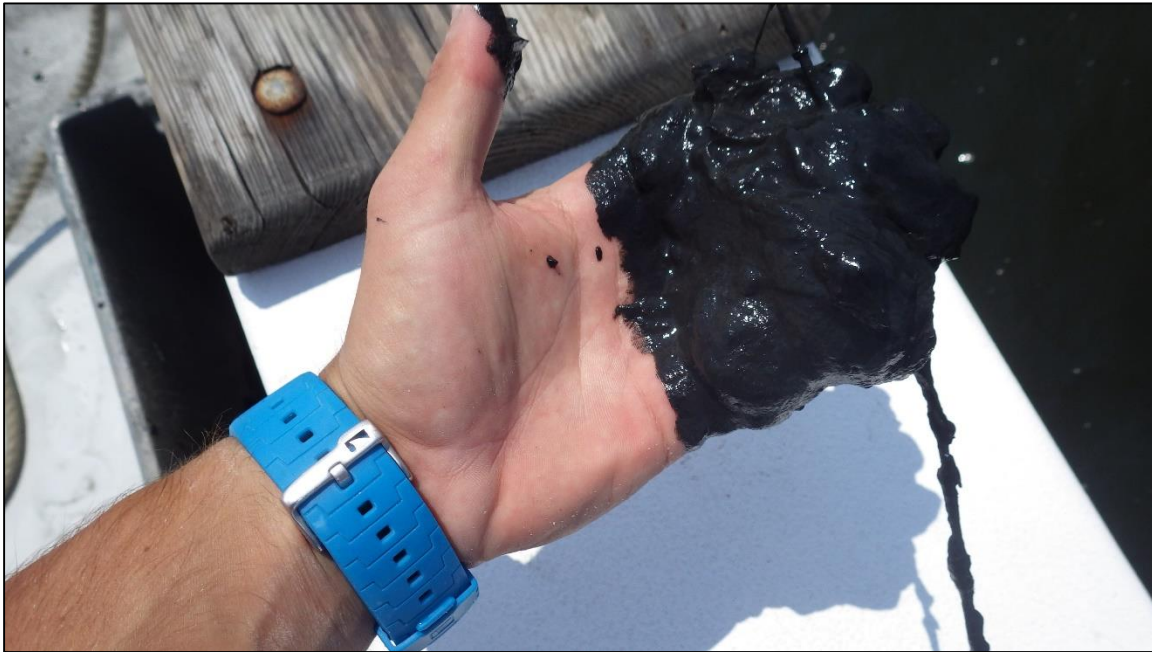
Figure 10, The grab sample from the deepest sampling location in the center of Dredged Hole 25 consisted of black mud and plant debris.

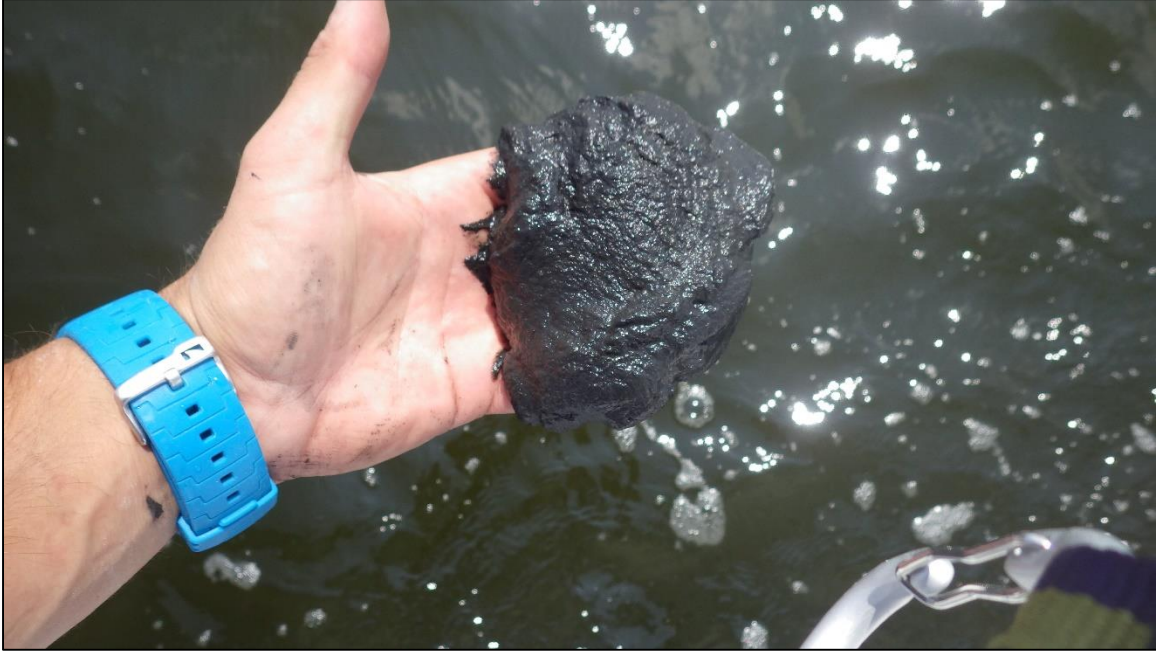
Figure 11, Fine grey sand with plant debris, shell fragments, and a few small pebbles were found at the shallow control sample near Dredged Hole 25.

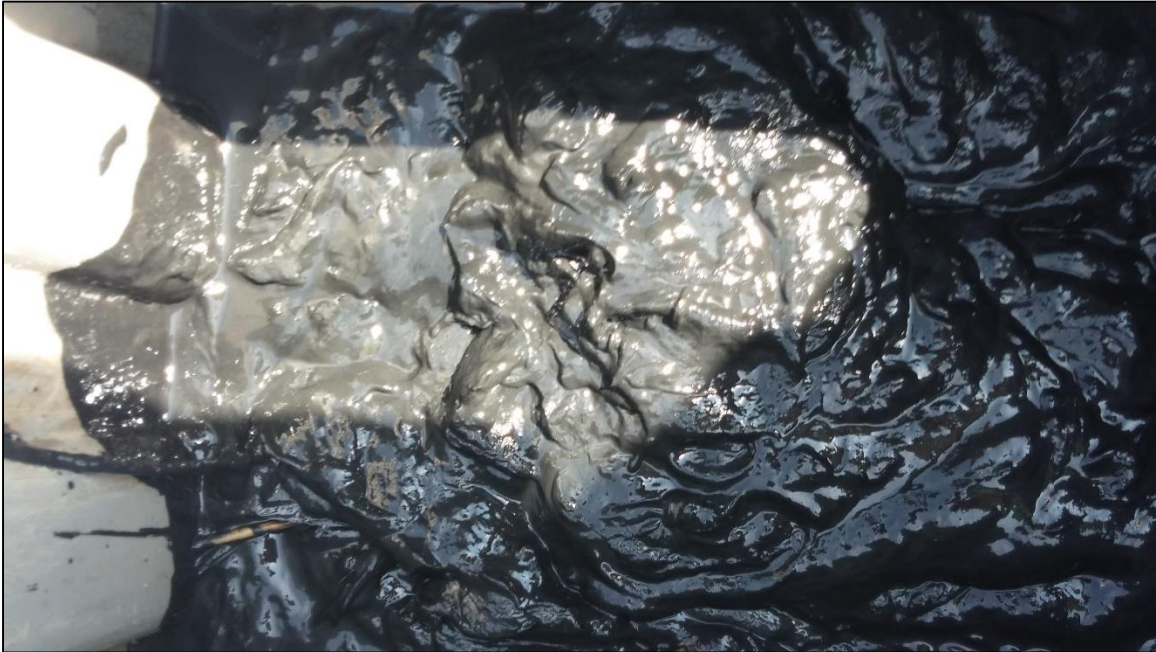
All three benthic grab samples from Dredged Hole 78 had consistent findings during an August 11, 2014 field visit. Samples within the feature were azoic and consisted of dark grey silt with some black stained detritus and had a distinct sulfur odor. The grab sample at the control location differed from samples within the dredged hole. The control sample contained grey sandy silt with some shell fragments and contained the macroalgae, (*false agardhiella*).

Figure 15, The northern grab sample within Dredged Hole 78 consisted of dark grey silt and detritus which can be seen in the bottom left of the image.

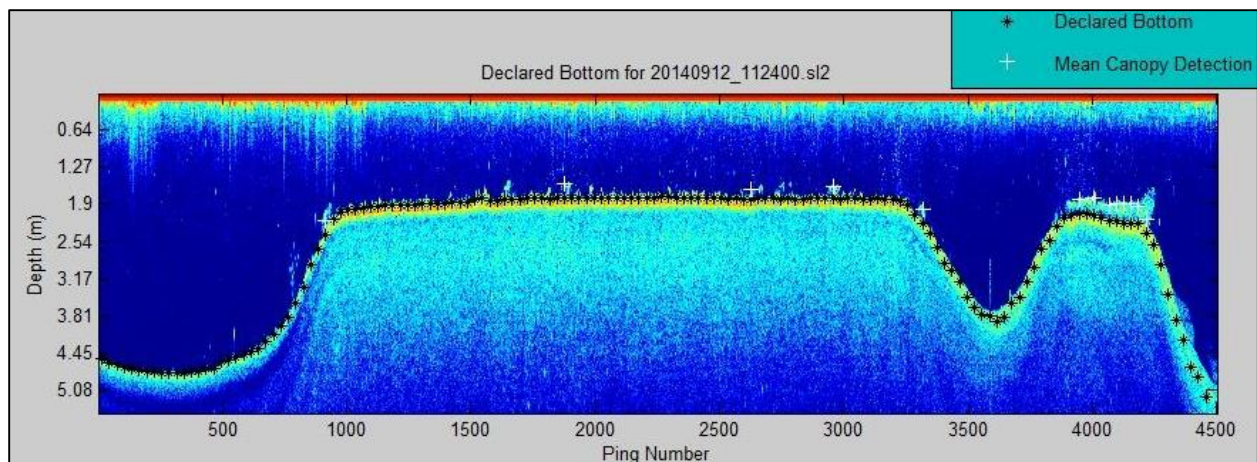
A survey to map SAV was conducted using SAVEWS Jr. on September 12, 2014 which found an absence of SAV within 328ft (100m) of Dredged Hole 78. Large areas were covered by macroalgae which were below the 0.5ft (0.15m) canopy height threshold set for the detection of SAV. There were several instances where SAV were falsely detected due to canopy heights of macroalgae greater than 0.5ft (0.15cm). These occurrences of SAV we deemed false by visual inspection of the echogram and analysis of drop camera video in the vicinity of the readings. Analyzing the echogram, the false SAV occurrences exhibited weaker acoustic reflectivity (indicated by light blue) and in most instances lacked a continuous vertical echo return between the bottom and canopy (Figure 17 and Figure 18). When compared to echograms of known SAV at the control site

Figure 17, In the above echogram in vicinity of Dredged Hole 78 acoustic reflectivity symbolized with the warmer red and yellow colors indicating stronger acoustic reflectivity and cooler blue colors indicating weaker acoustic reflectivity. Bottom declarations

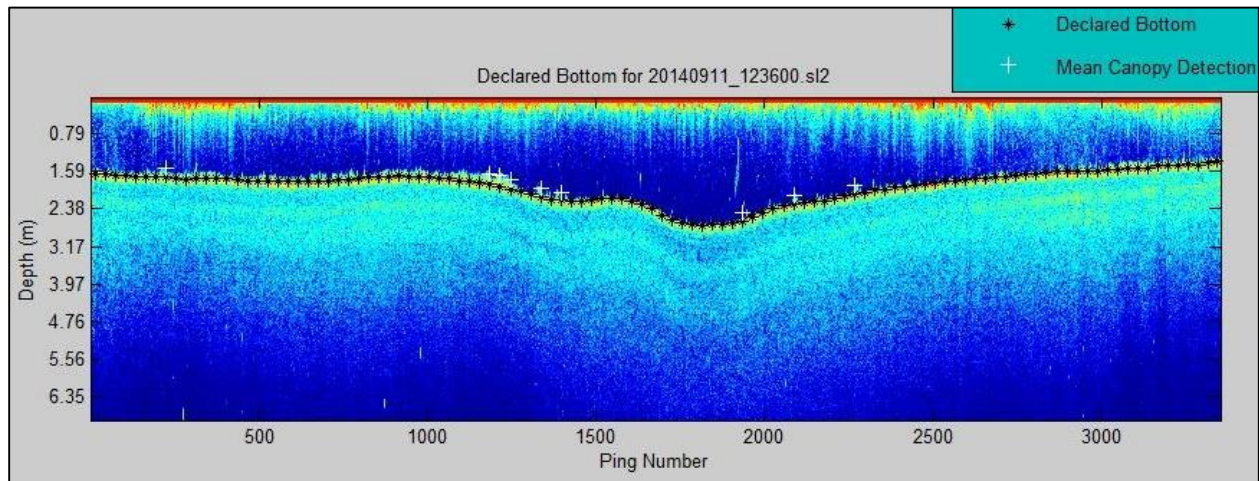
A September 11, 2014 survey using SAVEWS Jr. found no SAV present in the vicinity of Dredged Hole 86. The bay floor in the vicinity of Dredged Hole 86 was mostly bare or covered by macroalgae. The automated processing of SAVEWS Jr. did produce some false occurrences of SAV that were predominantly due to false bottom tracking near relief in bathymetry or due to dense macroalgae (Figure 25).

Figure 25, In the above echogram in the vicinity of Dredged Hole 86, acoustic reflectivity symbolized by the warmer red and yellow colors indicating stronger acoustic reflectivity and cooler blue colors indicating weaker acoustic reflectivity. Bottom surface declarations are symbolized by black asterisks and canopy detections are indicated by white crosses. There are a few false SAV canopy detections due to dense macroalgae.

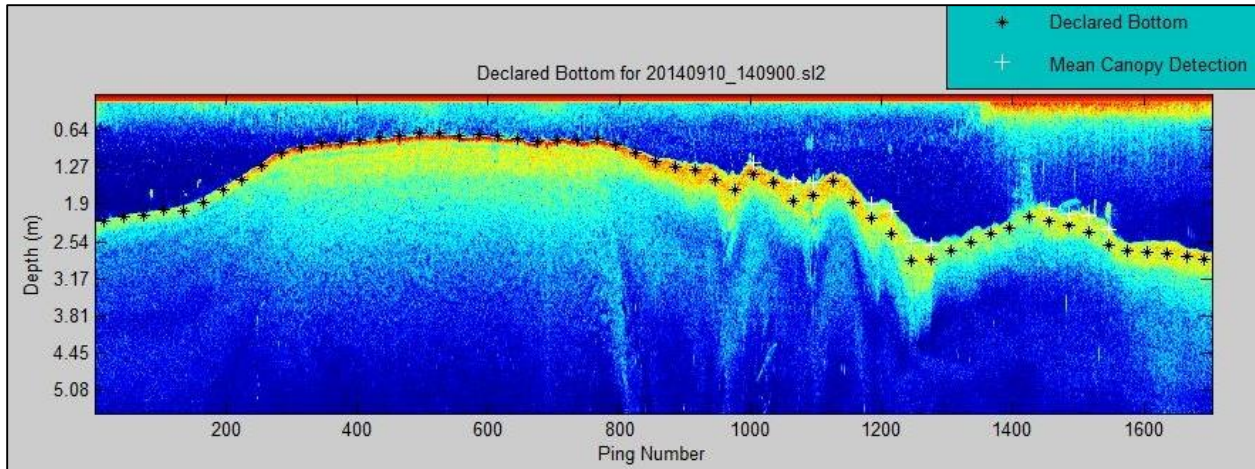
The area around Dredged Hole 93 was nearly completely barren and lacking of SAV, as well as macroalgae during a September 10, 2014 survey utilizing SAVEWS Jr. There were only two instances where SAVEWS falsely identified SAV due to improper bottom tracking where the bay floor was highly irregular. These occurrences of SAV were clearly false when visually inspecting the echograms (Figure 32).

Figure 32, Transect 27 from SAV mapping efforts on Sept. 10, 2014. False identification of SAV occurred in several instances between pings 1000 and 1500 due to poor bottom tracing of irregular bay floor resulting in SAVEWS incorrectly detecting canopy heights greater than 15cm. The barren area between pings 0 through 1000 represent the typical bay floor in the vicinity of Dredged Hole 93.

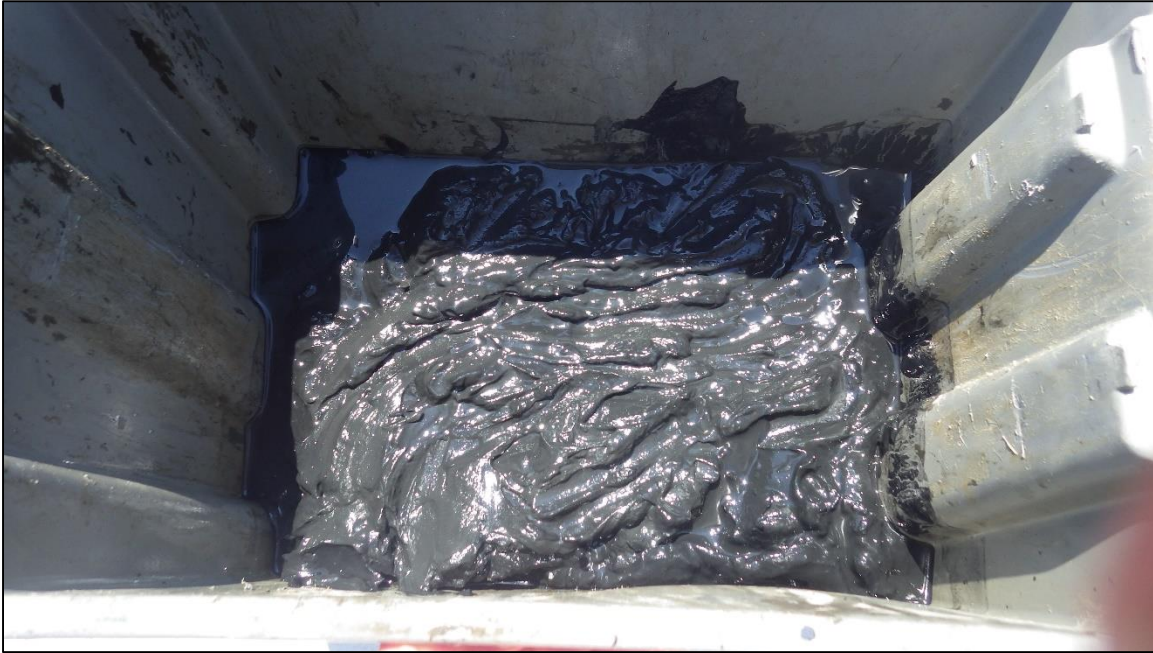
dissolved oxygen measured 5.08 mg/l at the bottom of the hole. A benthic grab sample taken along with the July water quality reading revealed sediment in the dredged hole contained black silt and black stained plant debris without any living organisms.

Figure 37, A benthic grab sample from Dredged Hole 54 contained black silt and black stained plant debris without any living organisms.
