BUILDING ECOLOGICAL SOLUTIONS TO COASTAL COMMUNITY HAZARDS (BESCCH)

Coastal Vulnerability Assessment Island Beach State Park Ocean County NJ

May 2017

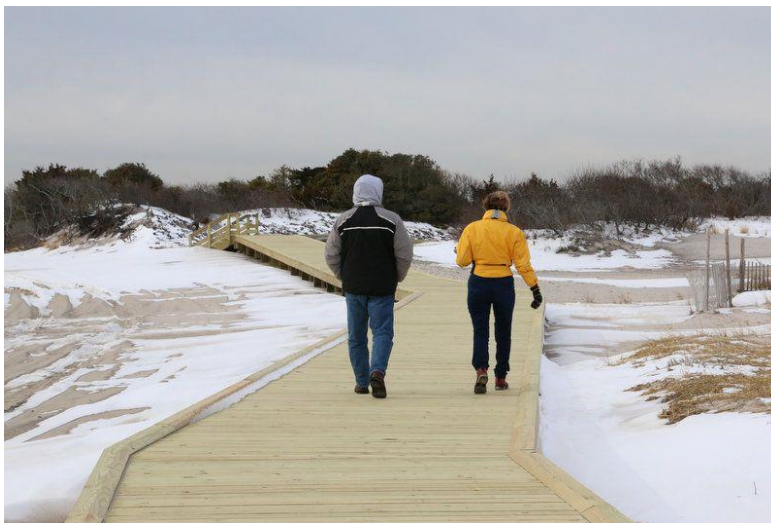
Image 2: The rebuilt Fisherman's Walkway (nj.com)

IBSP experienced some damage from Superstorm Sandy in 2012 and was closed to the public until March 2013. Impacts included dune breaches (with a century-old shipwreck exposed at one of the breaches), damage to Fisherman's walkway, and 7 feet of sand in the roadway.

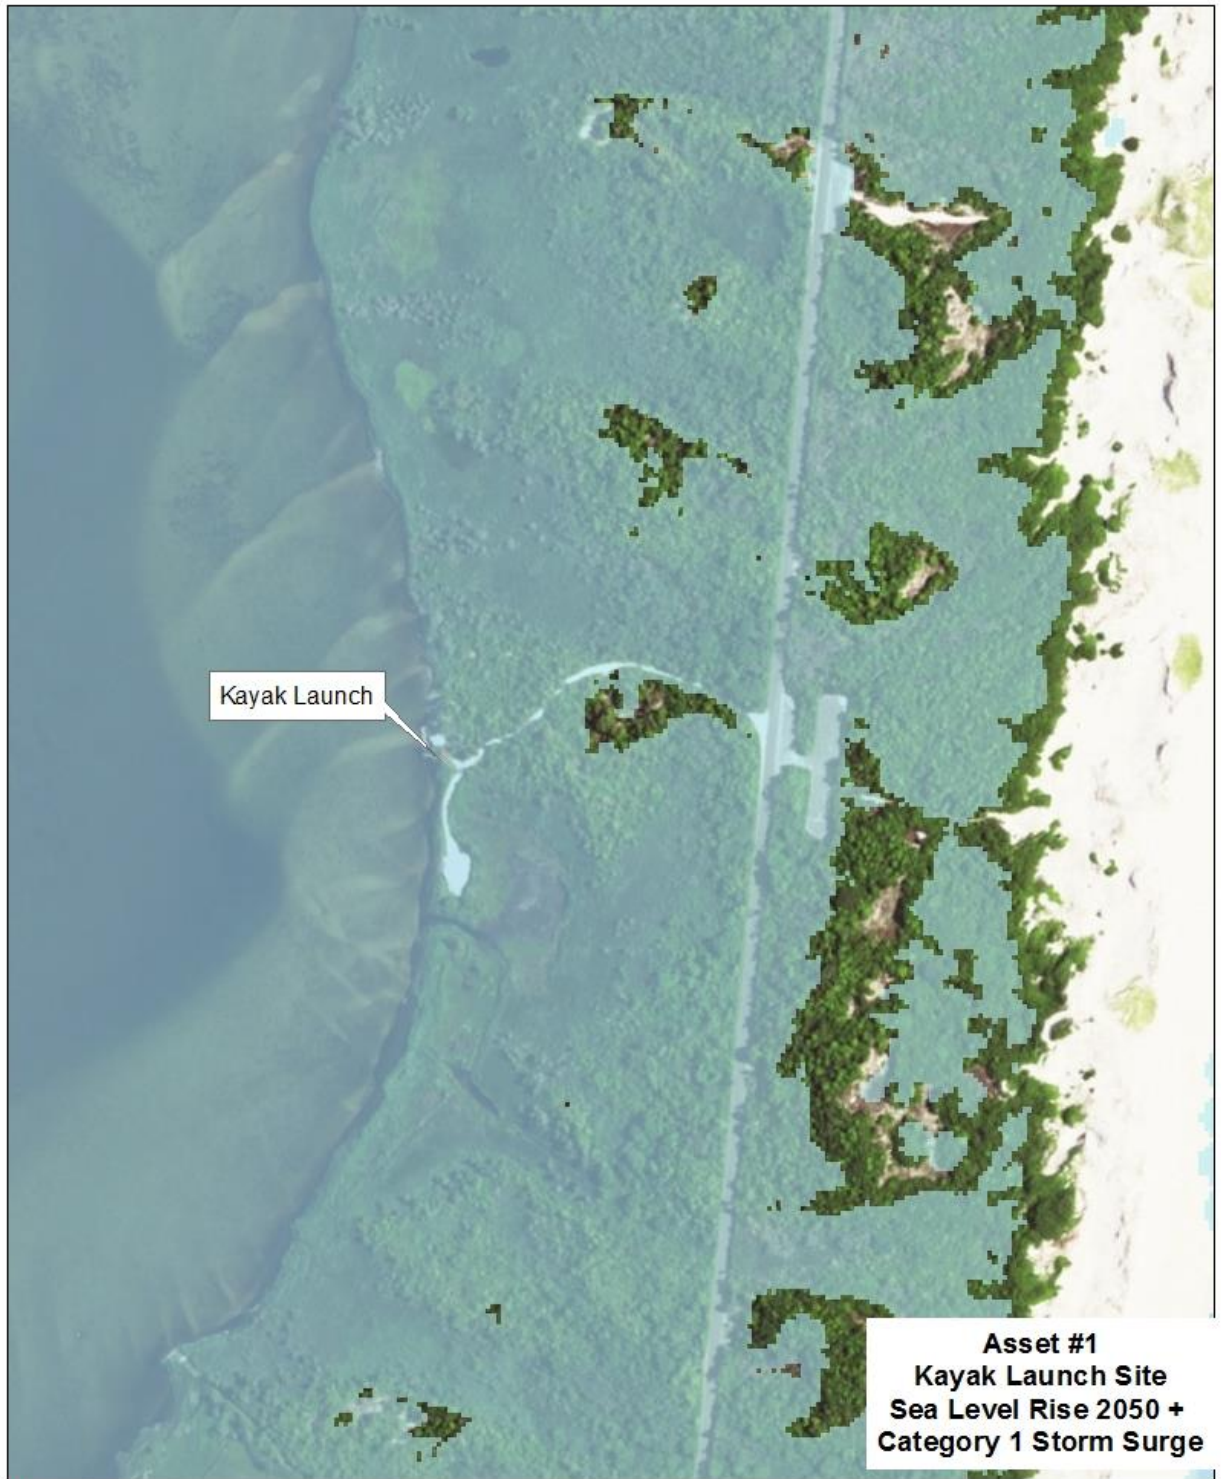
Map 3: Asset #1 - Kayak Launch Site

Asset #1: Kayak launch site A-15 is one of two heavily utilized launch sites at the park, the other being site A21 located further south before the Barnegat Inlet. The park supervisor noted that there is erosion occurring at the site and there is barely any wetland fringe remaining. Park personnel attempted to address the issue by filling the eroded area with clam bags but it did not work. Due to the popularity of kayaking at the park, stabilizing the shoreline at this site is a top priority for the park.

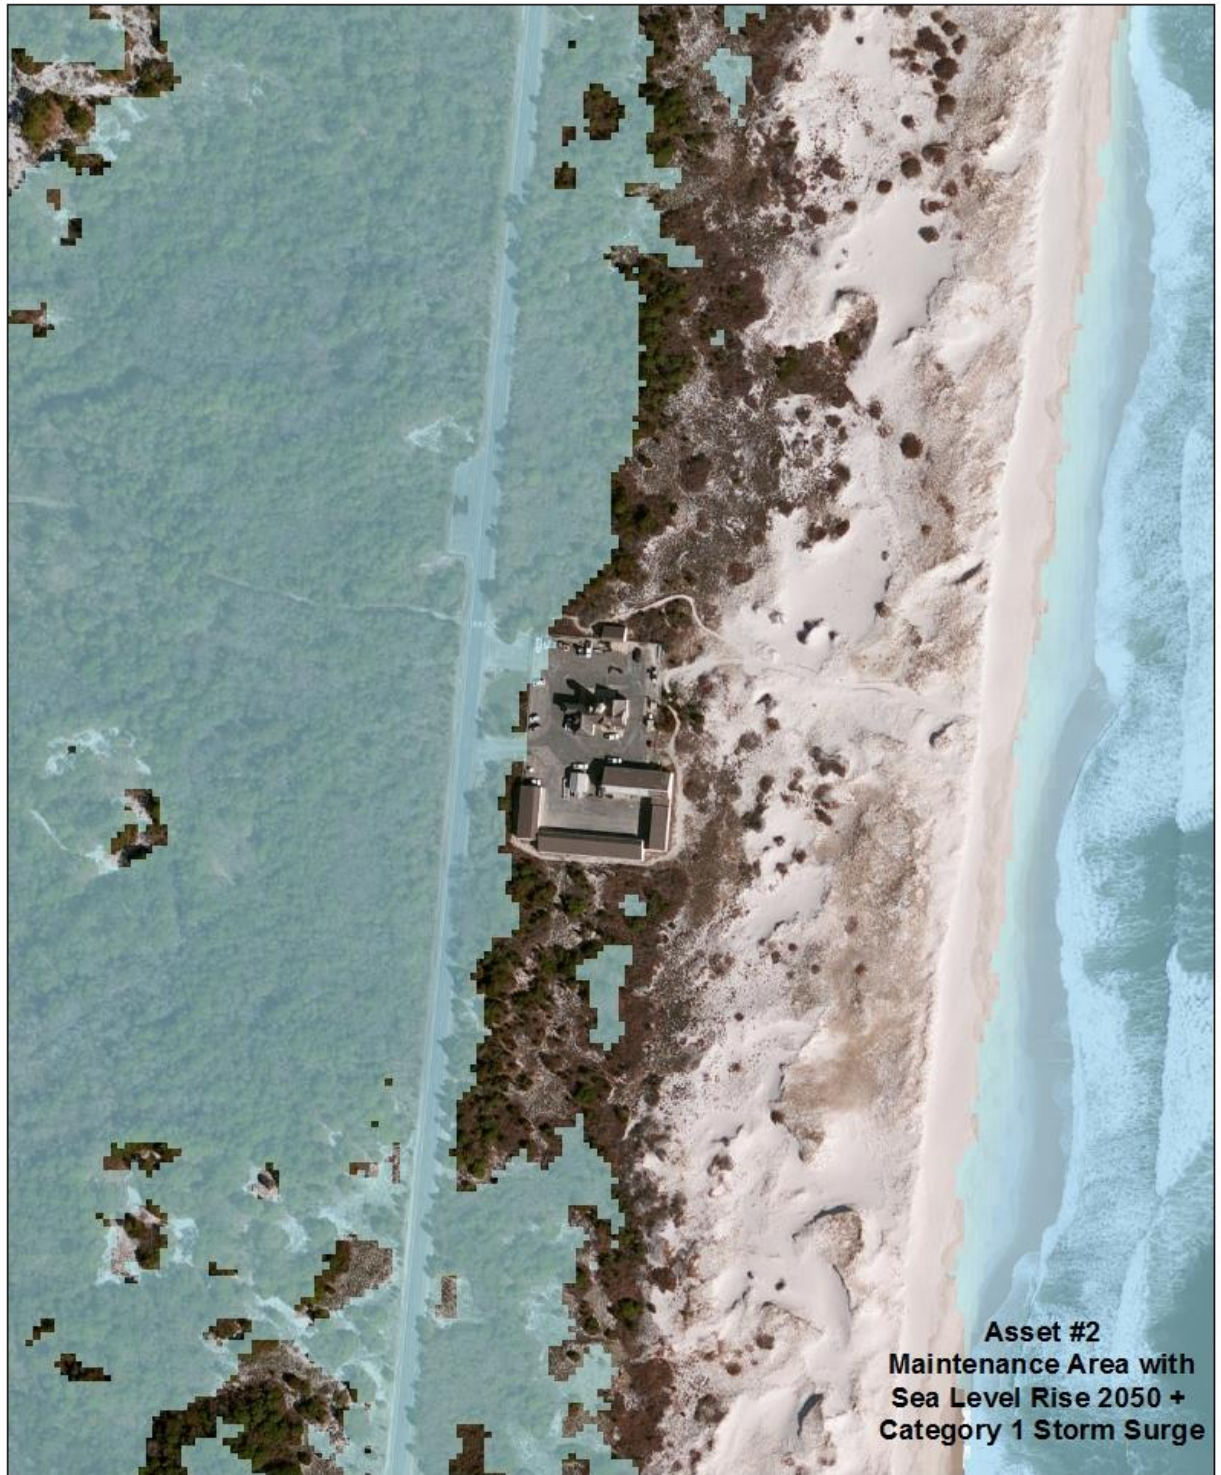
Map 4: Asset #2 – Maintenance Area

Asset #2: The park maintenance area holds the park service vehicles and machinery and there are 7 separate buildings located on the site. The area is currently protected on the ocean-side by a secondary and primary dune. Future projected inundation shows flood impacts coming from the bay-side, most immediately impacting access to and from the lot. A buffer will need to be created to keep flood water from inundating the lot from the bay-side. Other than the machinery located here, there is currently no sewer infrastructure located on the island beyond the entrance gate. The park is, however, scheduled to be fully sewered in the future.

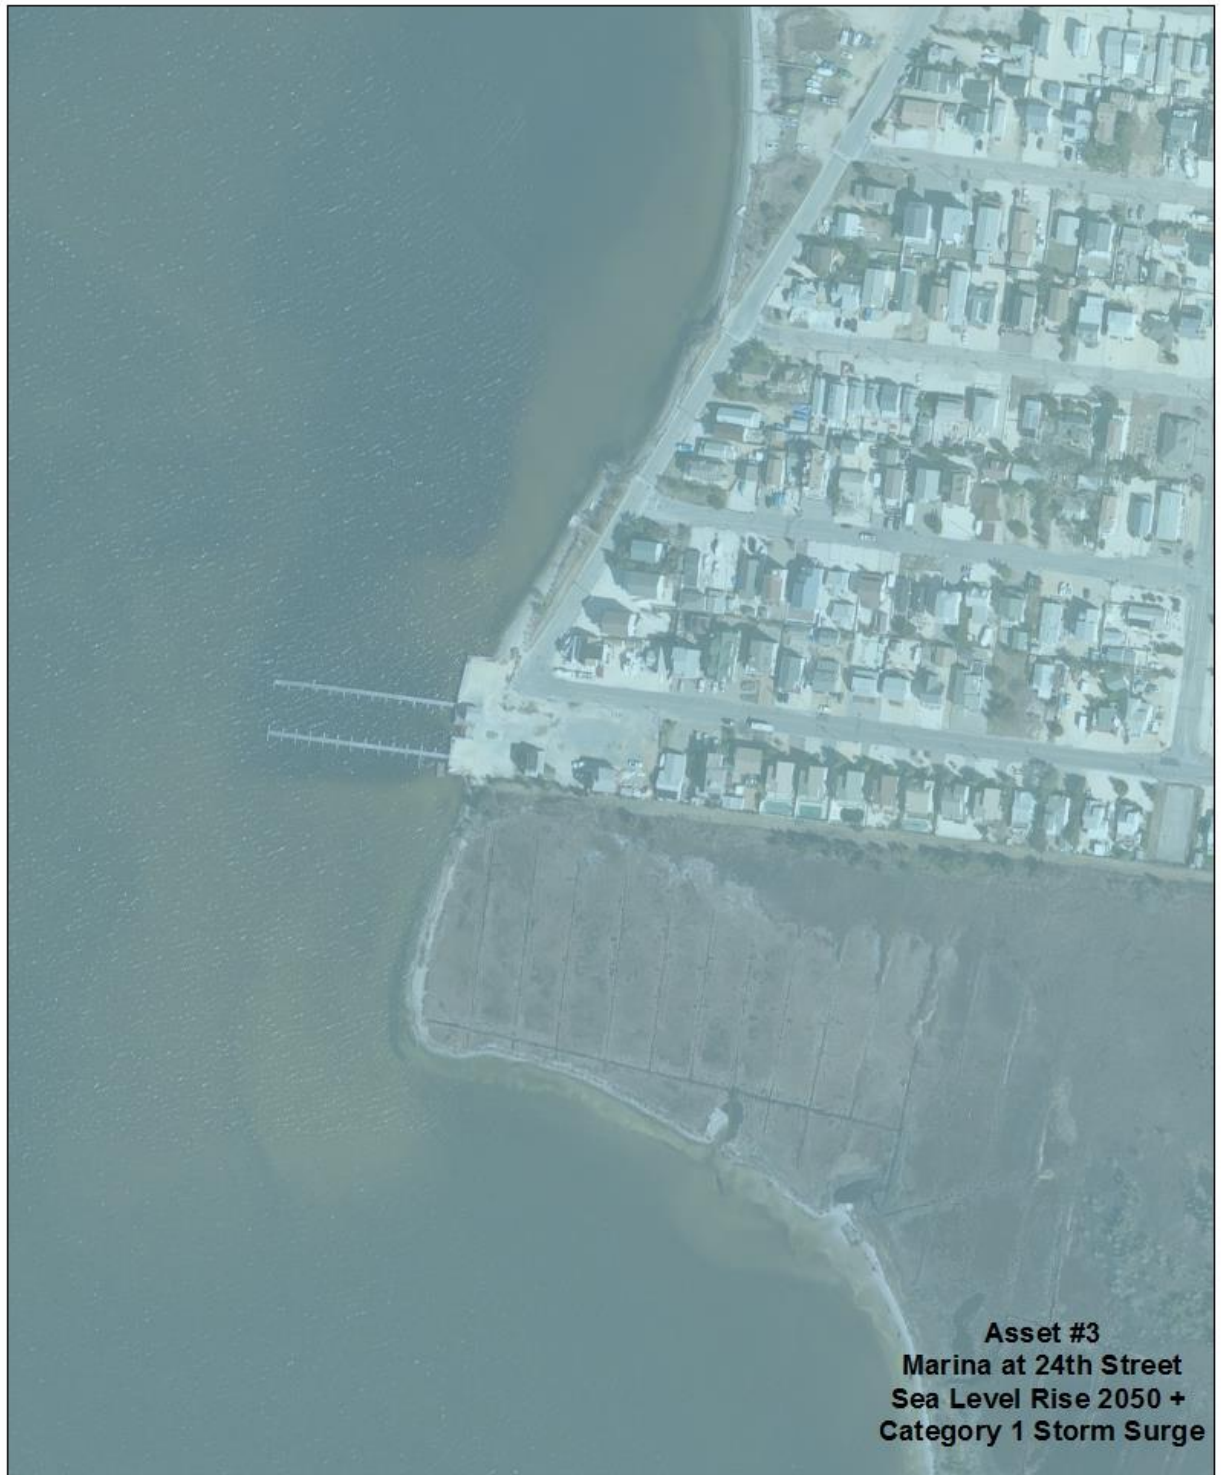
Map 5: Asset #3 - Marina

Asset #3: The marina is located on 24th Street just before the park entrance. It is owned and operated by IBSP. It currently holds 40 slips but does not have infrastructure such as an office or bathrooms. The land immediately adjacent to the marina is only about 25 feet wide from the water to the roadside. This area could benefit from a living shoreline to stabilize this area and therefore protect the parking and access to the site from storm surge and wave action.

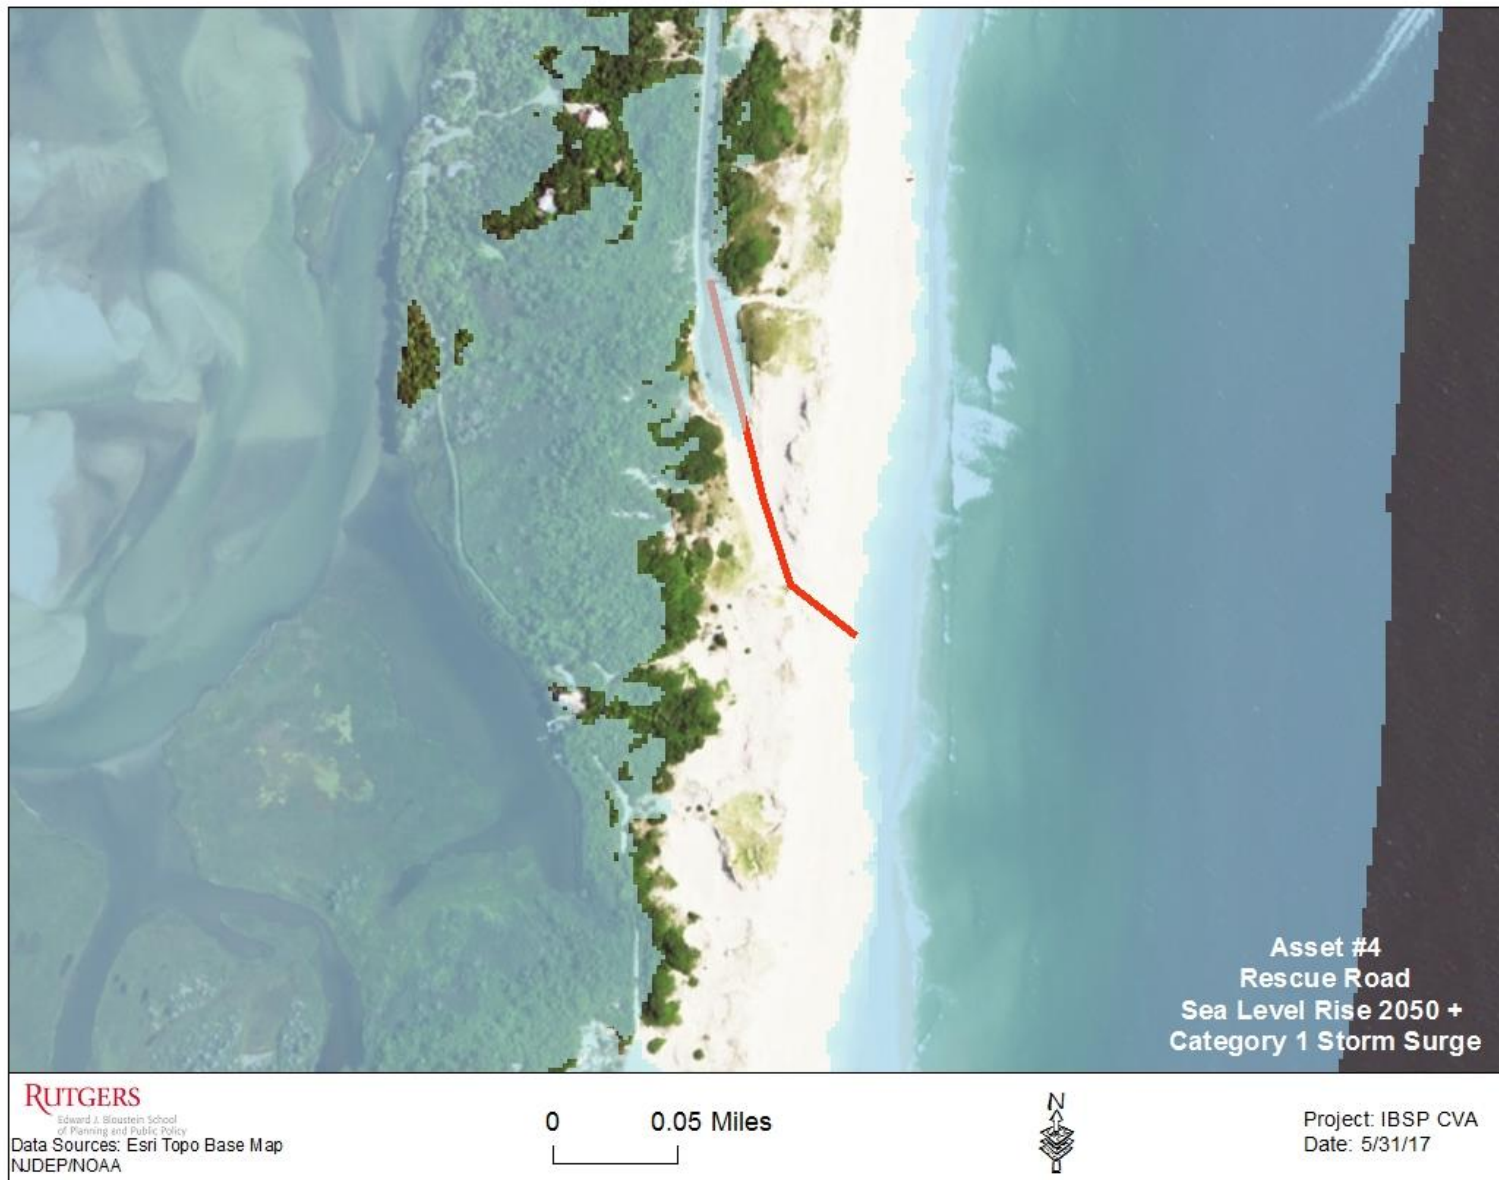
Map 6: Asset #4 – Rescue Road

Asset #4: Rescue Road is a sand road located at the terminus of Shore Road at the southern end of the park. It offers access to a mobile sport fishing site and is the only access to the Barnegat Inlet. Maintaining access to the inlet via this sand road is important in case an emergency should occur with sport fishermen utilizing the site. The inundation is coming from the bay-side and therefore a buffer should be considered to maintain this access route.

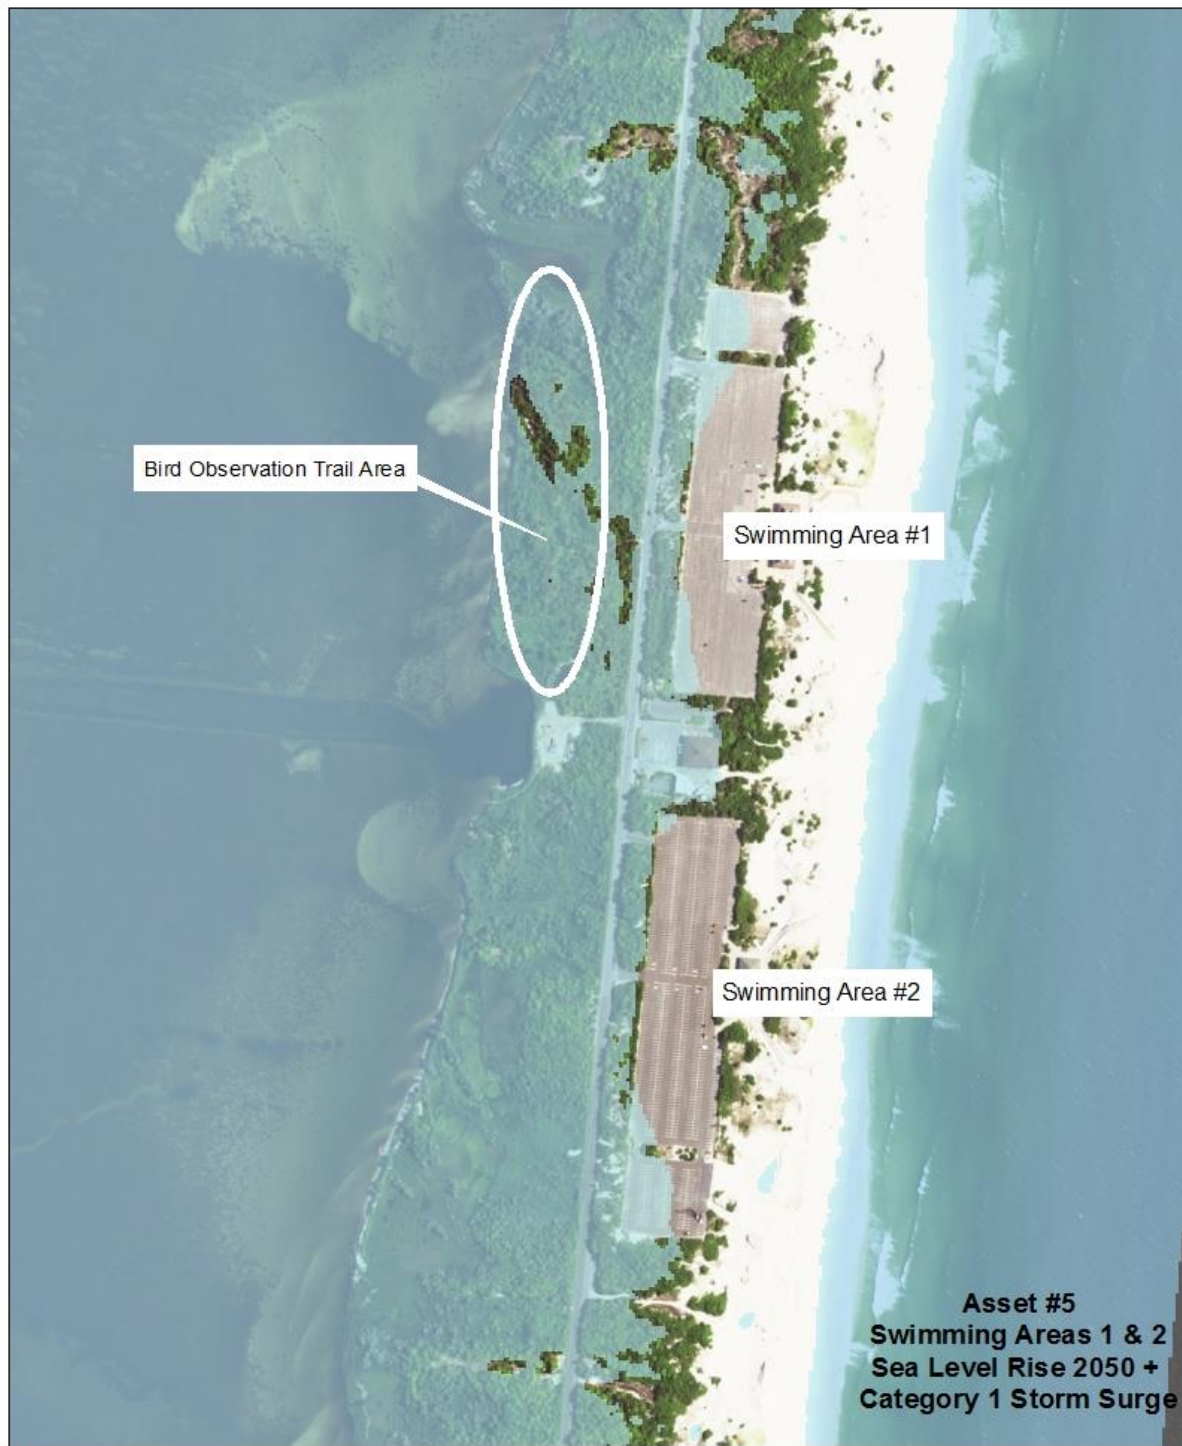
Map 7: Asset #5 – Swimming Areas

Asset #5: There are 24 auxillary beach access sites in total on the island. Access to the only 2 official swimming areas in the recreation section are projected to be inundated by flood water

coming from the bay-side, as the parking lots and paths to the ocean are dune protected. Funds permitting, the park service would consider constructing raised pathways over the dunes. Shoreline restoration at the bay-side site would protect access to the two swimming areas as well as preserve the use of the bird observation trail located on the bay-side.
