# FIBI514-R1

## Peach Orchard Brook

Hussa Street

Sample Date: 6/28/2013

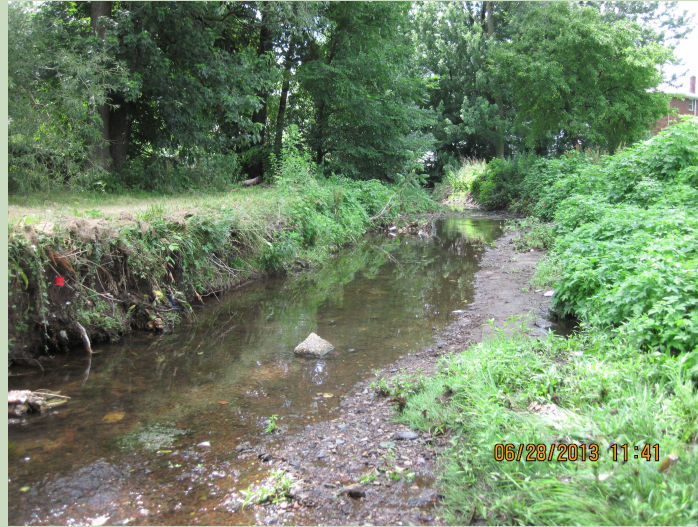
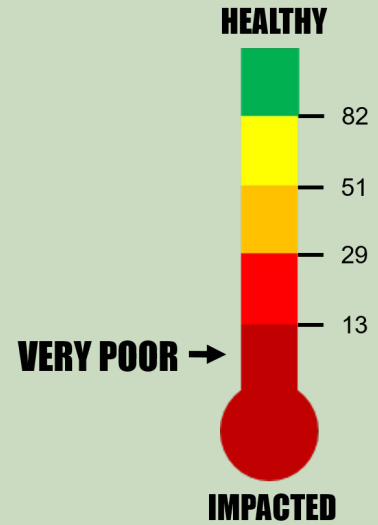
**Summary:** FIBI514 was rated "very poor" in 2013. This site contained tolerant fish and a non native crayfish. Peach Orchard Brook is located adjacent to a park and lacked suitable habitat, had poor bank stability, and had several stormwater outfalls.
