Silver Brook Watershed Restoration Plan

7th Annual Water Monitoring and Education Summit

November 18 and 19, 2009
Rutgers EcoComplex, Bordentown, NJ

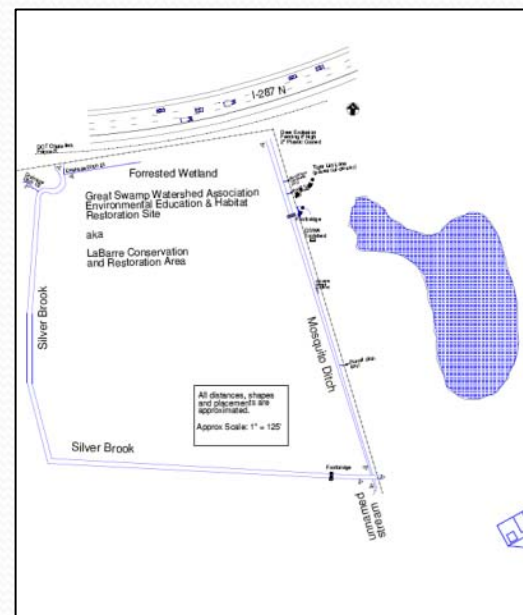
10. Sediment on Stream Bottom	4 1. None 2. Light 3. Moderate 4. Heavy
11. Bank Stability	Right Bank: 1. Stable: evidence of erosion or bank failure absent or minimal; 10% of bank affected 2. Moderately stable: small areas of erosion; mostly heaved over; 10 - 50% of bank in erosion 3. Moderately unstable: 51 - 80% of bank in erosion; high erosion; significant bank sloughing 4. Unstable: major erosion; bank failure frequent; obvious bank sloughing; 80% or more of bank in erosion Left Bank: 1. 0 - 25% 2. 26 - 50% 3. 51 - 75% 4. 76 - 100%

17. Algae Location	1 1. None 2. On streambed 3. On rocks 4. Bank
18. Algae Color	1 1. Light green 2. Dark green 3. Black 4. Other
19. Channel Alteration	4 1. Stream with normal pattern 2. Some manmade or natural causes in areas of erosion, etc. 3. Channelization evident 4. 50% or more of stream bank 4. Channel flow lines stream channelized, point bars and/or oxbow lakes and/or other channel features

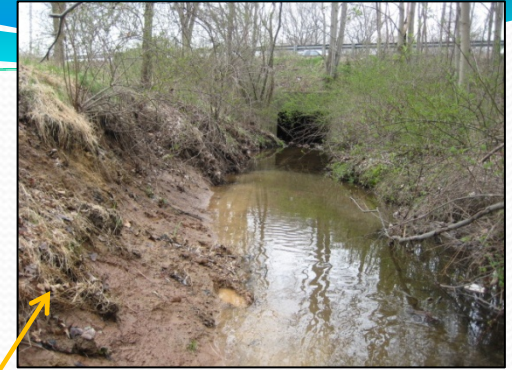
Upstream I287

- Residential and undeveloped in good condition
- Segmented by roads
- Instability and active incision
 - Upstream of I-287
 - Downstream of commercial basins
- Lack of woody debris
- Main stem downstream of I-287
 - Historically channelized
 - Sediment aggradation from upstream incision
