# **SCOPE OF WORK**

## **New Roof Replacement**

New Jersey State Museum  
Trenton, Mercer, NJ

**Project No. A1430-00**

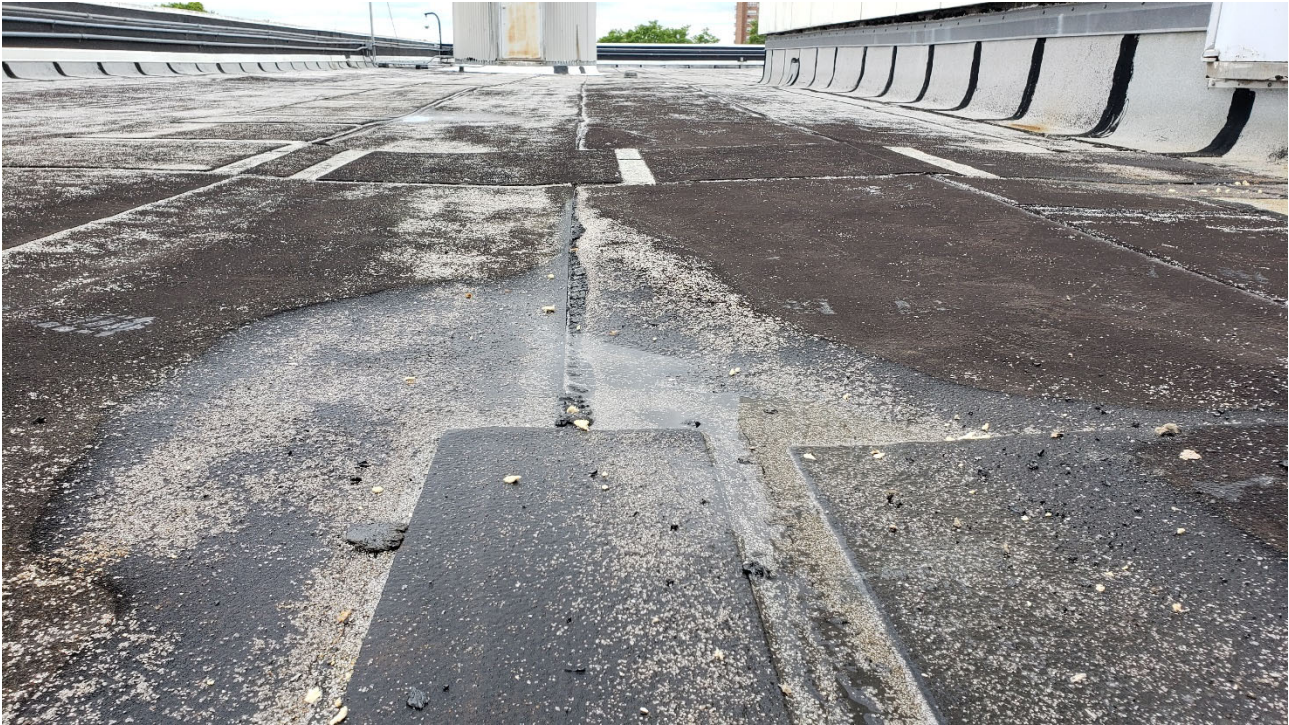
The existing modified bitumen built-up roofing throughout the building is in fair to poor condition. There are signs of wear and deterioration, including loss of granules from the cap sheet surface, blisters, bubbles, soft spots, exposed roofing plies, fishmouths, alligatoring, and split-open blisters.

**Main Roof South Side.**

**Standing Water, Loss of Surface Granules, and Bubbles in Roofing Observed**

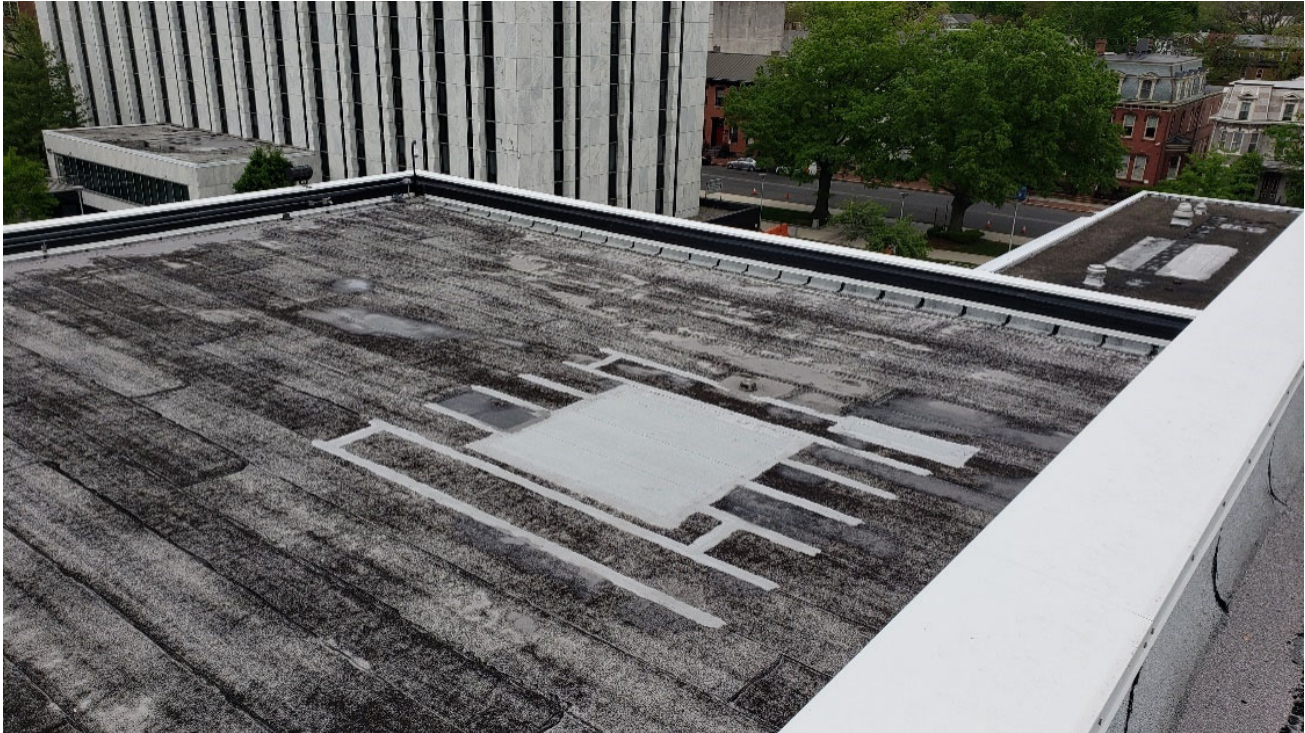
A patch is present at a previous leak location on the west side of the Main Roof.

**Main Roof West Side. Previous Patch**

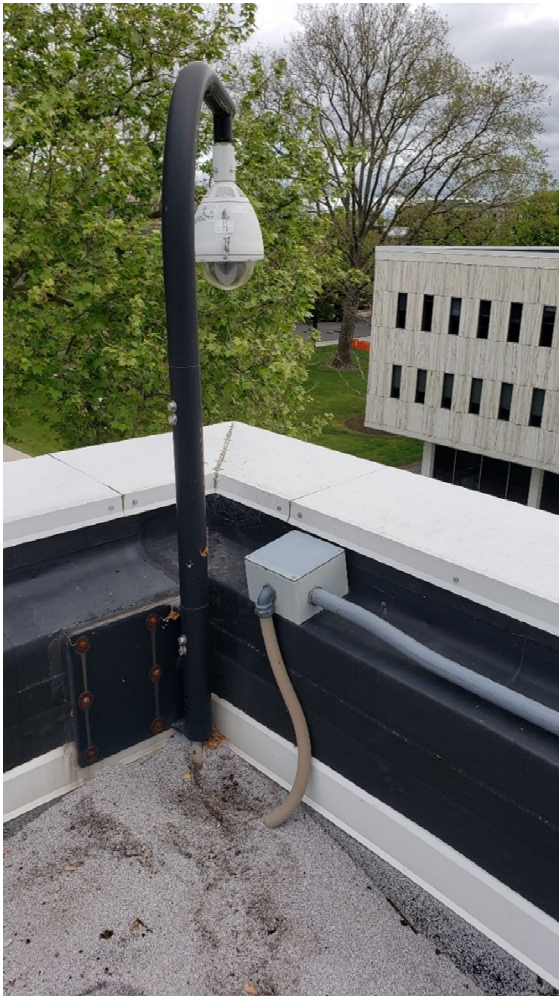
Piles of built-up loose granules from the roofing cap sheet are located in low spots throughout the roof. These granules can potentially end up in roof drains causing clogs and backups. They also impede the flow of water across the roof surface.

**Existing Camera, Coping, Junction Box, and Conduit at Northeast Corner of Main Roof.  
Note Build-up of Dislodged Cap Sheet Granules and Inner Shelf at Parapet Wall Covered with EPDM Membrane**

- Existing conduits, junction boxes, cameras, etc. that are mounted on and along the interior of the Main roof parapet walls will need to be removed and reset as part of the roof replacement work by a New Jersey licensed electrician.

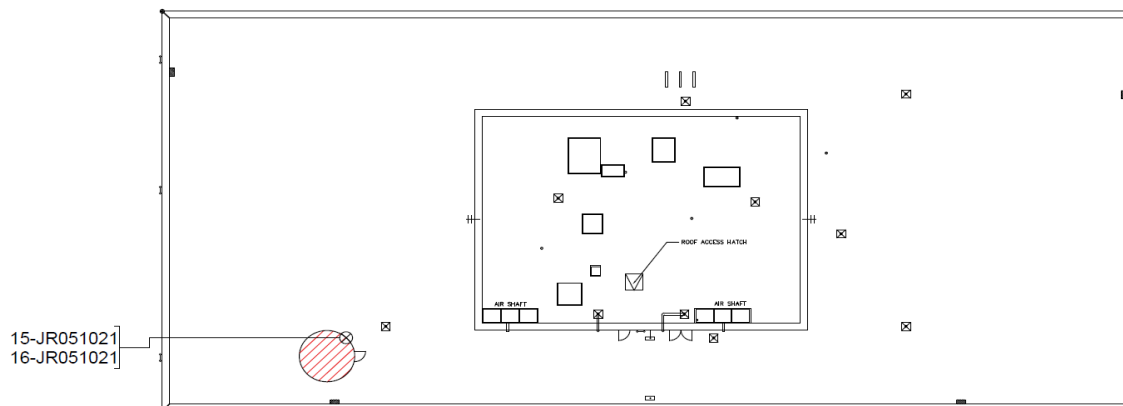
**Asbestos:** As part of this Study, Environmental Connection, Inc. performed a limited Hazardous Materials Survey of the roofing and related joint sealant materials on the main and penthouse roofs of the New Jersey State Museum. Roof cuts were conducted and samples of roofing, flashings, sealants, and roofing asphalt, materials were taken and tested for asbestos content. No samples of the roofing were positive for asbestos content. One (1) sample of joint sealant was positive for asbestos content; the sealant associated with the rooftop observatory telescope.

CONFIRMED ASBESTOS CONTAINING CAULK MATERIAL

**Hazardous Materials Sample Location Plan Showing Location of ACM Sealant**

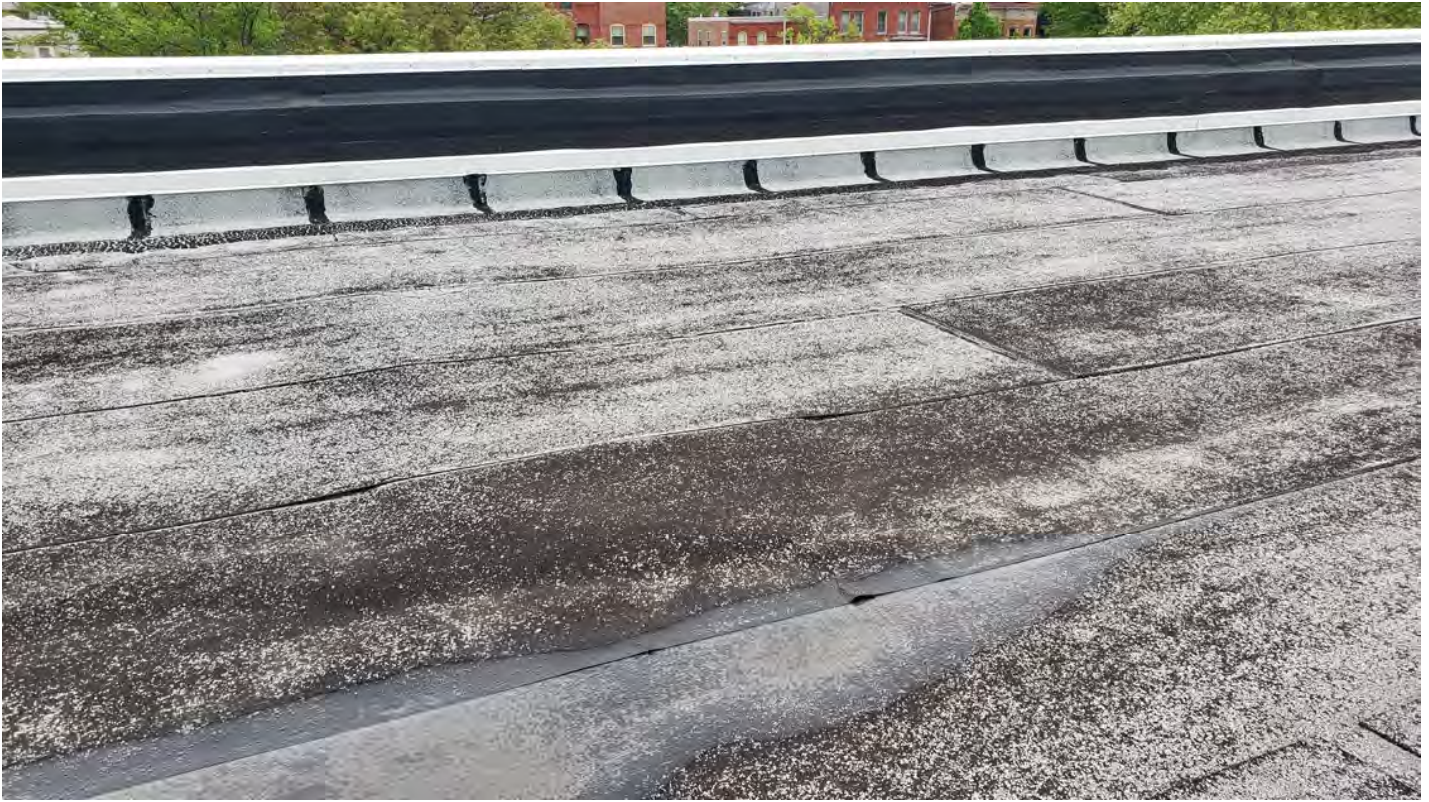
**Standing Water, Fishmouthed Ply Edge, Loss of Surface, and Bubble**

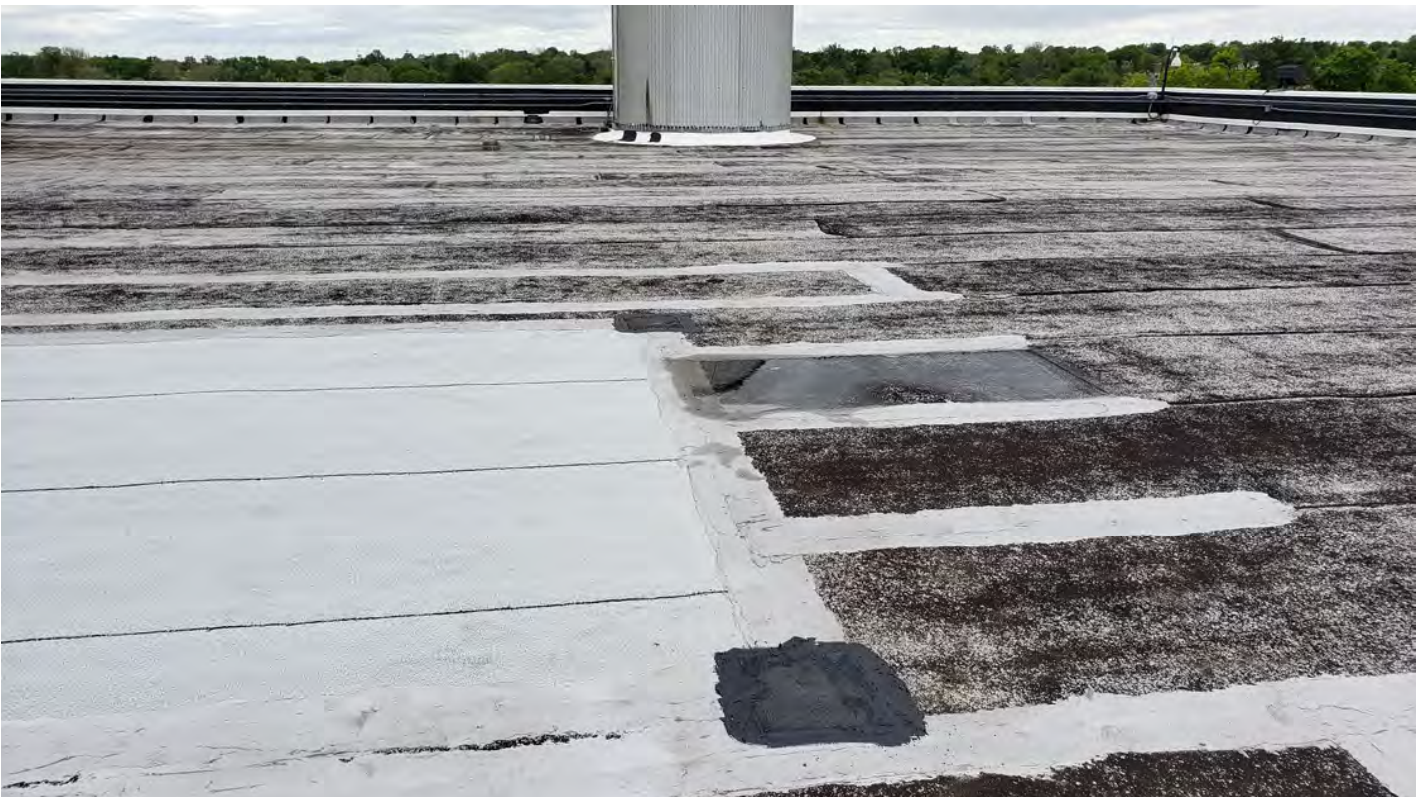
**Field of Main Roof, West Side, at Previous Patch**

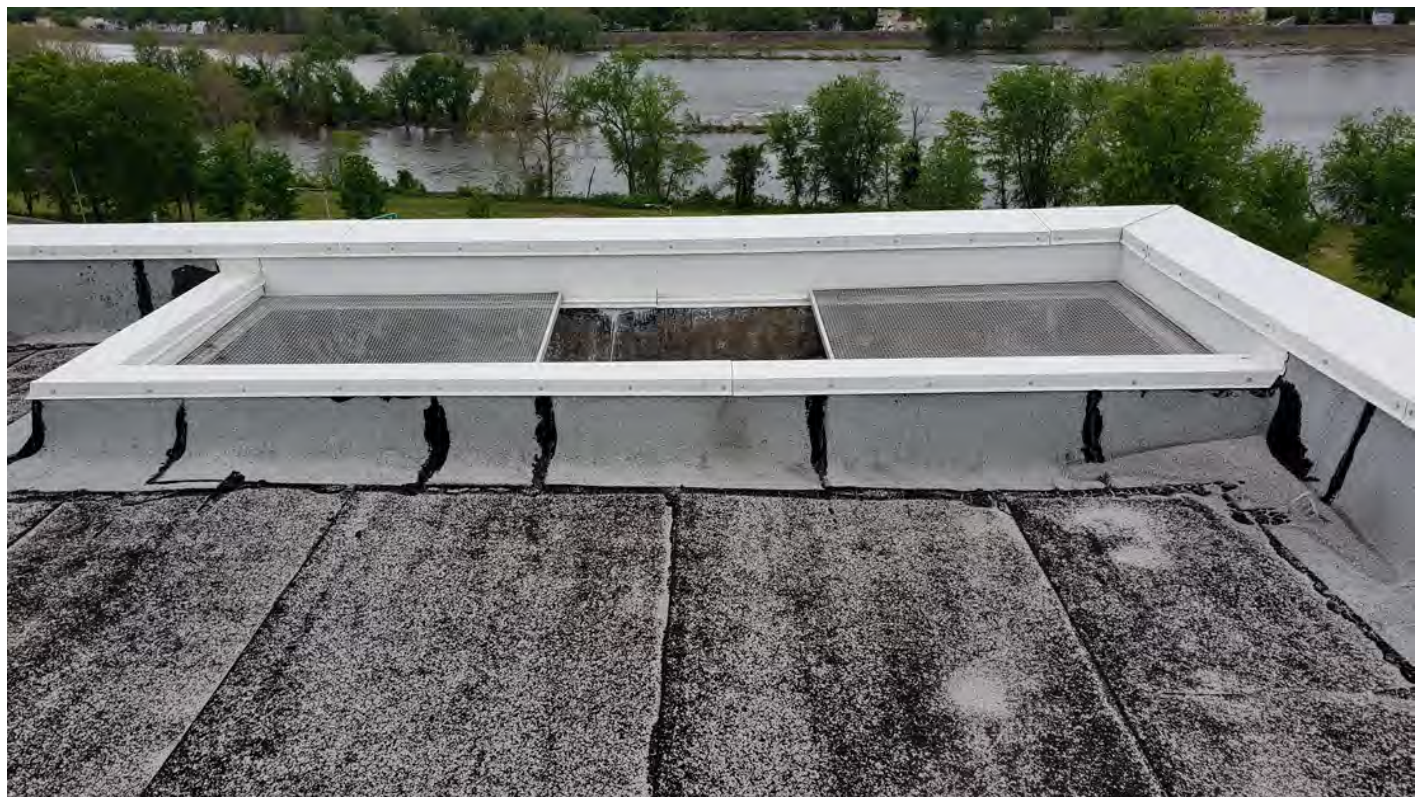
There are several intake and exhaust vents located on the Penthouse Roof. Other penetrations at the penthouse roof include the roof hatch, pipe vents, and the raised curbs surrounding the air shafts. It is noted that the screen cover for one of the shafts is no longer in place and was located loose at the bottom of the air shaft.

Top of Air Shaft at Penthouse Roof

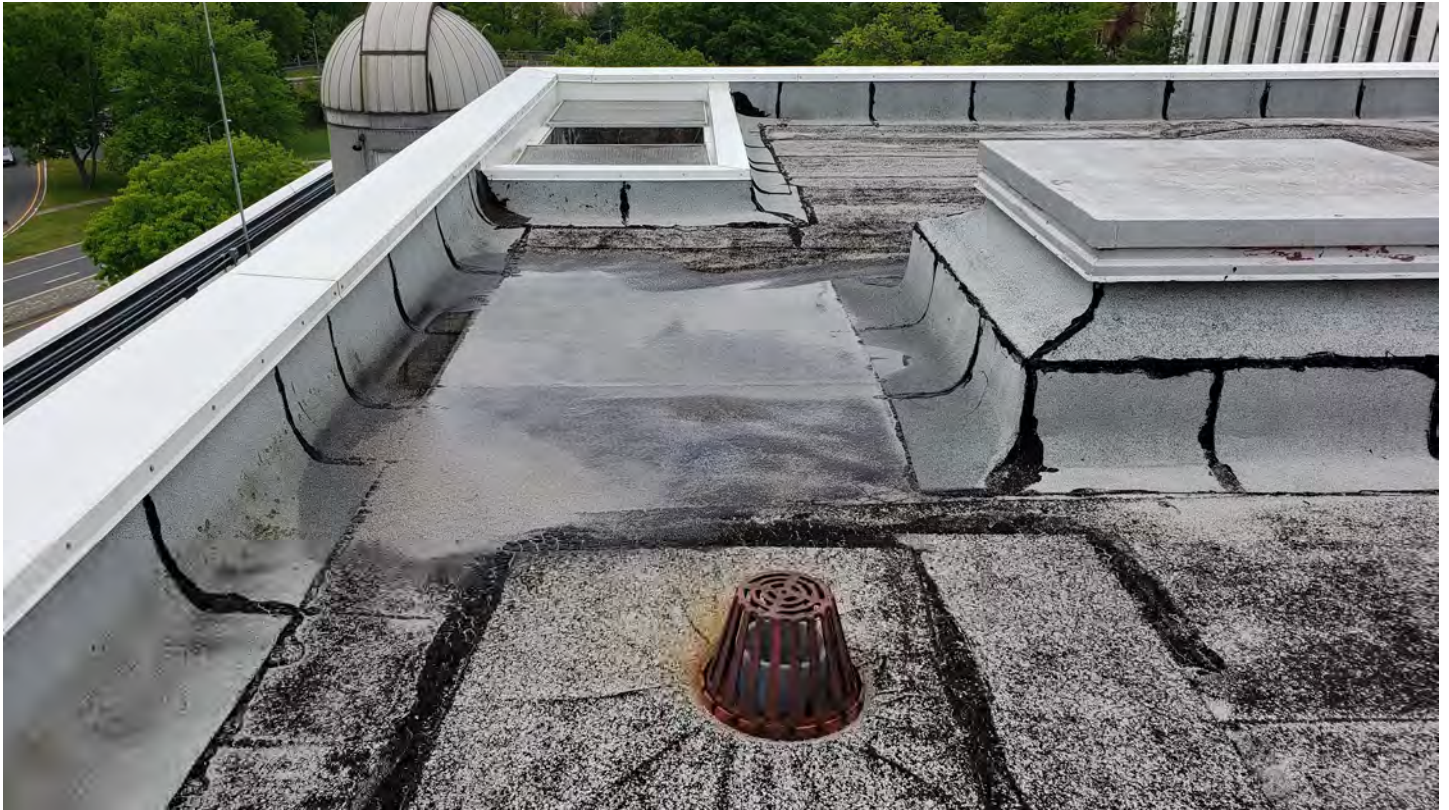
**Standing Water and Overflow Roof Drain at Penthouse Roof**
