## ***Firefighter Fatality and Serious Injury Report Series***

### **Career Firefighter Severely Burned While Operating at a Structure Fire**

**Asbury Park, New Jersey  
January 10, 2011**

***Report Issued:***  
**February 1, 2014**

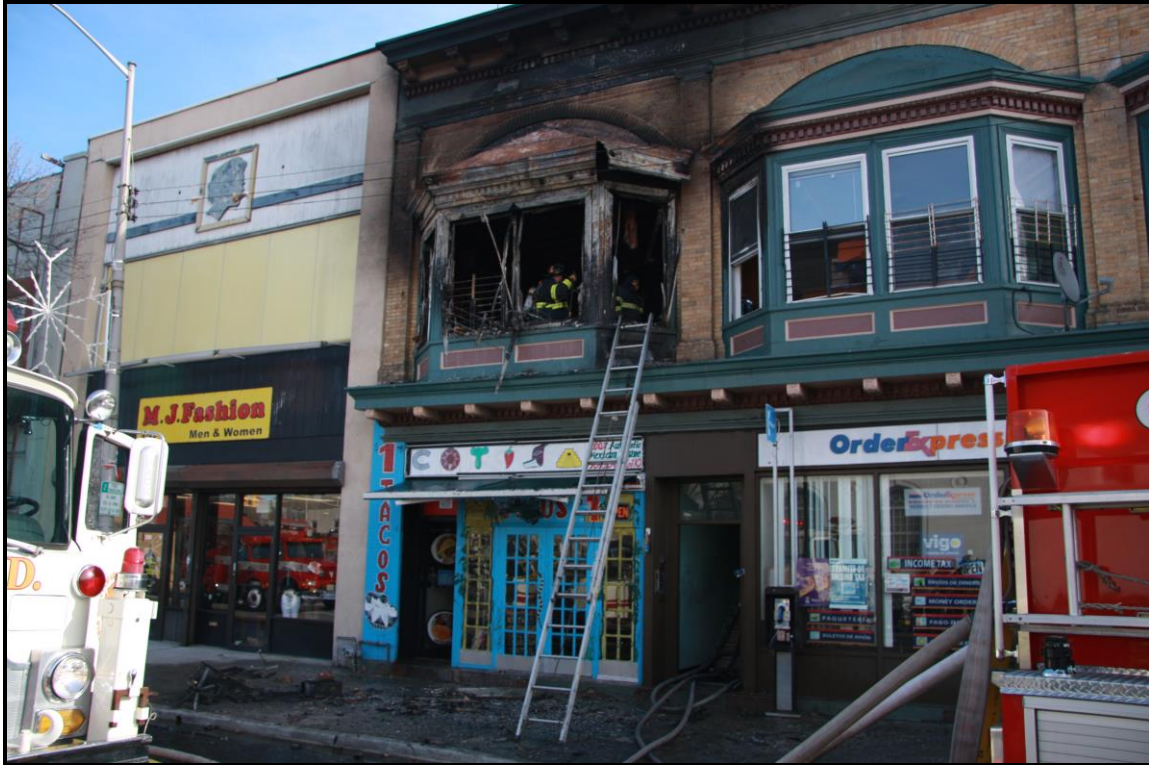
**Figure 1 – Side A view of structure after fire was extinguished.**

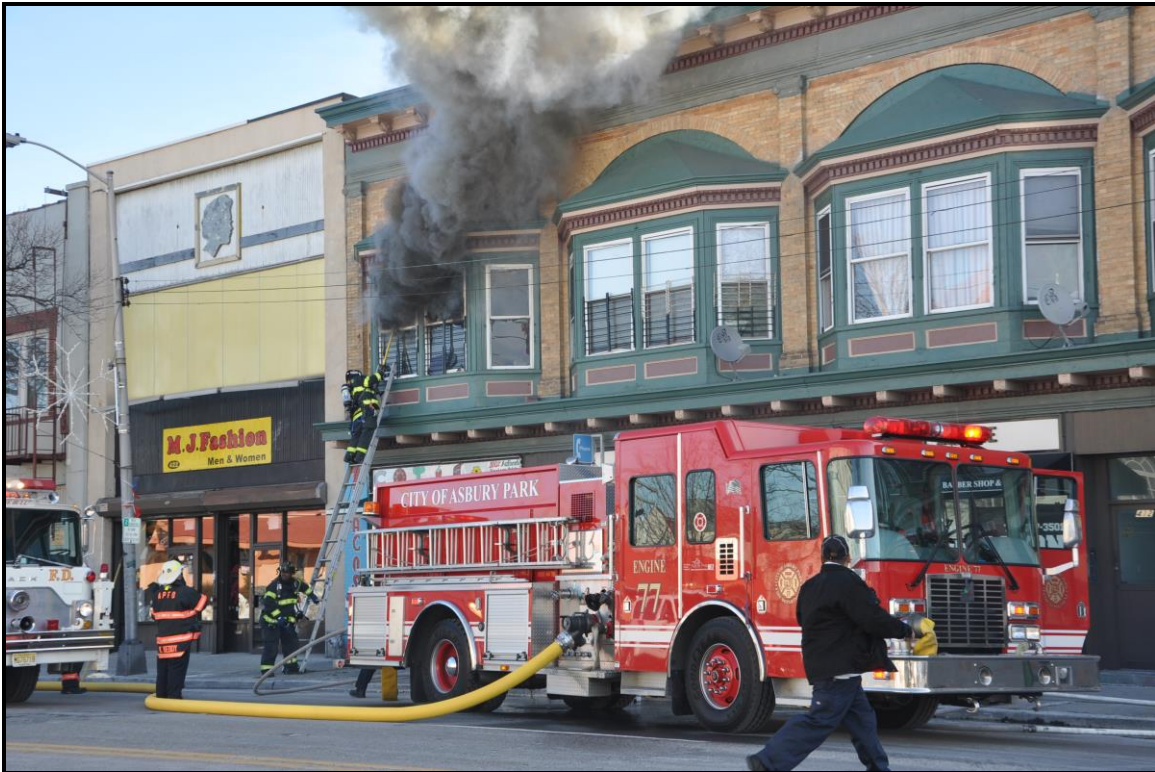
**Figure 2 – Photo shows exterior ventilation operations being initiated on side A and worsening smoke conditions as the building is opened up.**

While the interior operations were underway, FFs on the exterior were directed to horizontally ventilate the structure by removing windows on the Division A side of the second floor. A ground ladder was deployed by FFs to accomplish this task. However, there was no communication to the interior crews that ventilation was being performed. This action greatly intensified fire conditions in the room of origin where FF Fazio was searching. The room, with an ample supply of oxygen

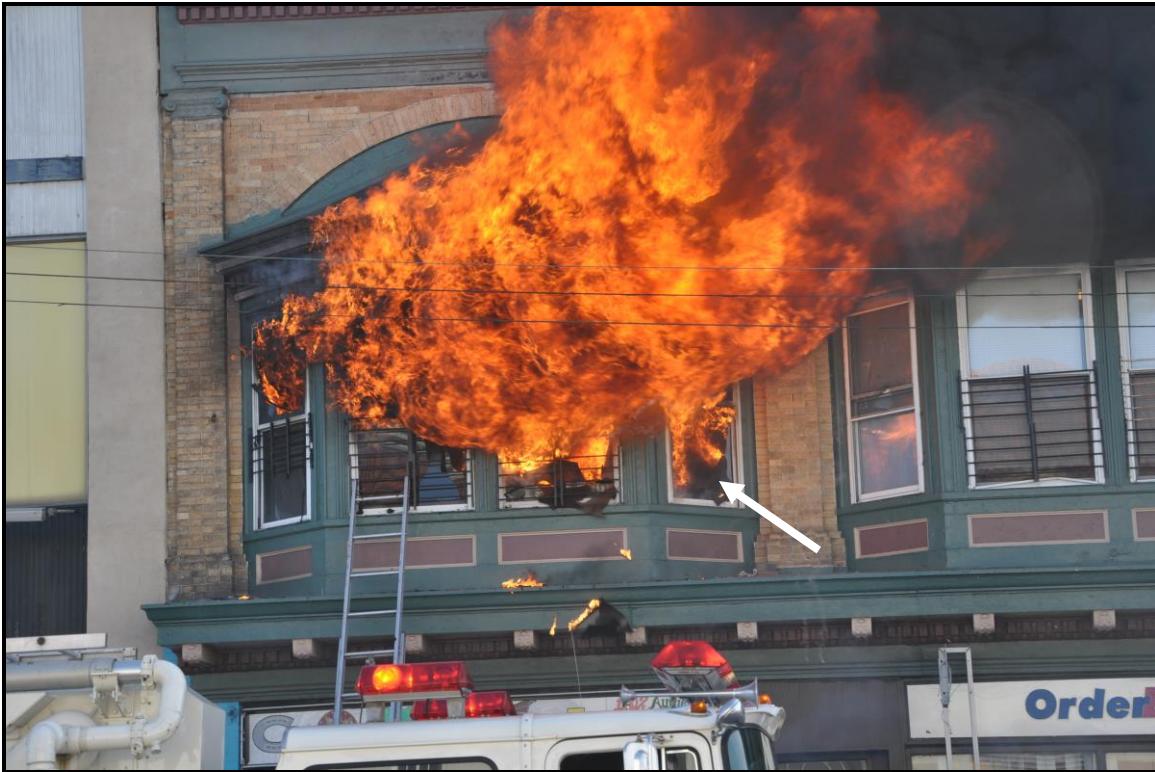
**Figure 3 – Photo shows the flashover conditions after ventilation was completed. FF Fazio was still inside the flashover room at this time. He was able to escape by diving out the right side window of the room where flames were emanating (the only one without window guards; see arrow above).**

What was not known by personnel was that FF Fazio was still inside the front bedroom that was ablaze at this time, and was now being severely burned by the fire. FF Fazio later reported that he began praying and went into “survival mode.” He searched around the cluttered room for an escape, locating a window and breaking it out with a tool he was carrying. He did not have time to issue a “Mayday” message or to deploy a personal “bail-out” system with which he was equipped. He just dove through the broken window, and fell to the sidewalk below with his turnout gear melting and burning off of him.

quickly reached flashover causing Fazio to be exposed to untenable conditions. The hose crew was not in an ideal position to control the sudden increase in the volume of fire, which now enveloped FF Fazio, forcing him to dive out the window.

One such similarity is flashover. In fires where there are extreme heat conditions coupled with superheated flammable gases produced by the fire, an influx of fresh air from ventilation will nearly always lead to flashover if an adequate supply of water is not applied quickly. In this incident, ventilation, suppression and search and rescue operations were not well coordinated and the direct result was flashover and the severe injuries sustained by FF Fazio.
