# BOROUGH OF MOONACHIE NEW JERSEY STRATEGIC RECOVERY PLANNING REPORT

Post Sandy Planning Assistance Grant Program

**PRELIMINARY DRAFT**  
March 2015

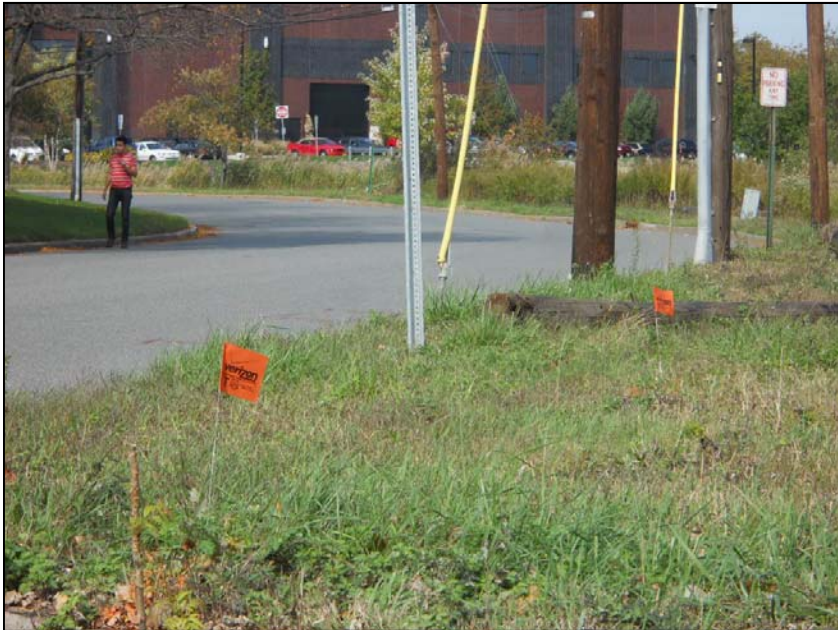
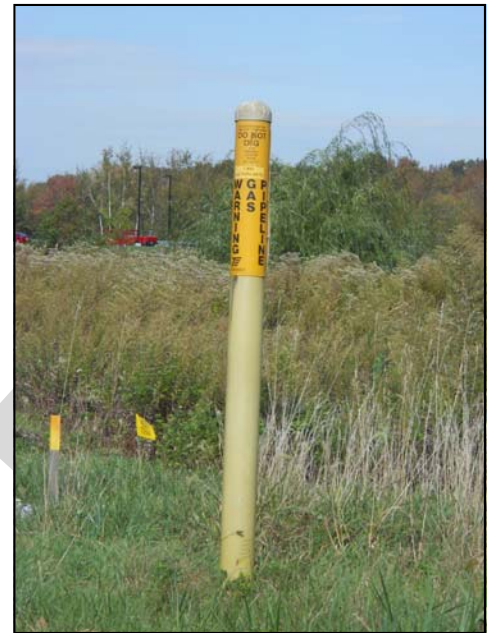
### **Water and sewer lines, gas mains and communications arrays and cables for much of Bergen County crisscross Moonachie, posing potential challenges during major weather and flooding events like Superstorm**

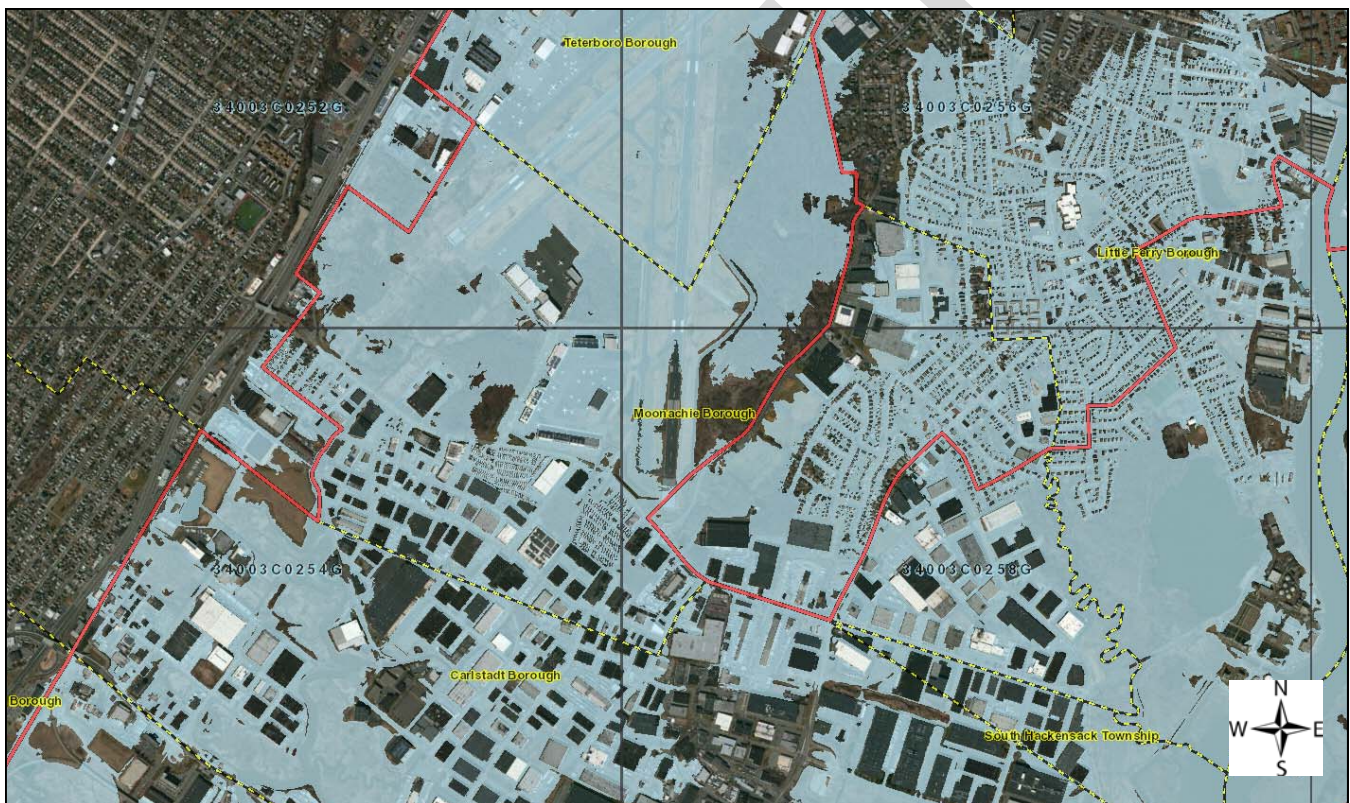
**Extent of Tidal Flooding from Superstorm Sandy in Moonachie, New Jersey and Surrounding Communities (shown in light blue)**

A recent autumn rainfall of two inches flooded critical areas of the Borough. Events which vary in magnitude and duration will continue to occur, causing interim flooding and related damage. Sandy's sea surge averaged between 8.5 and 9.5 feet above mean sea level in the Meadowlands, overwhelming the existing network of earthen berms and other flood controls. [Figures 4-9] Tide gates designed by the Army Corp of Engineers at 7.5 feet above mean sea level were breached by more than two feet of water.

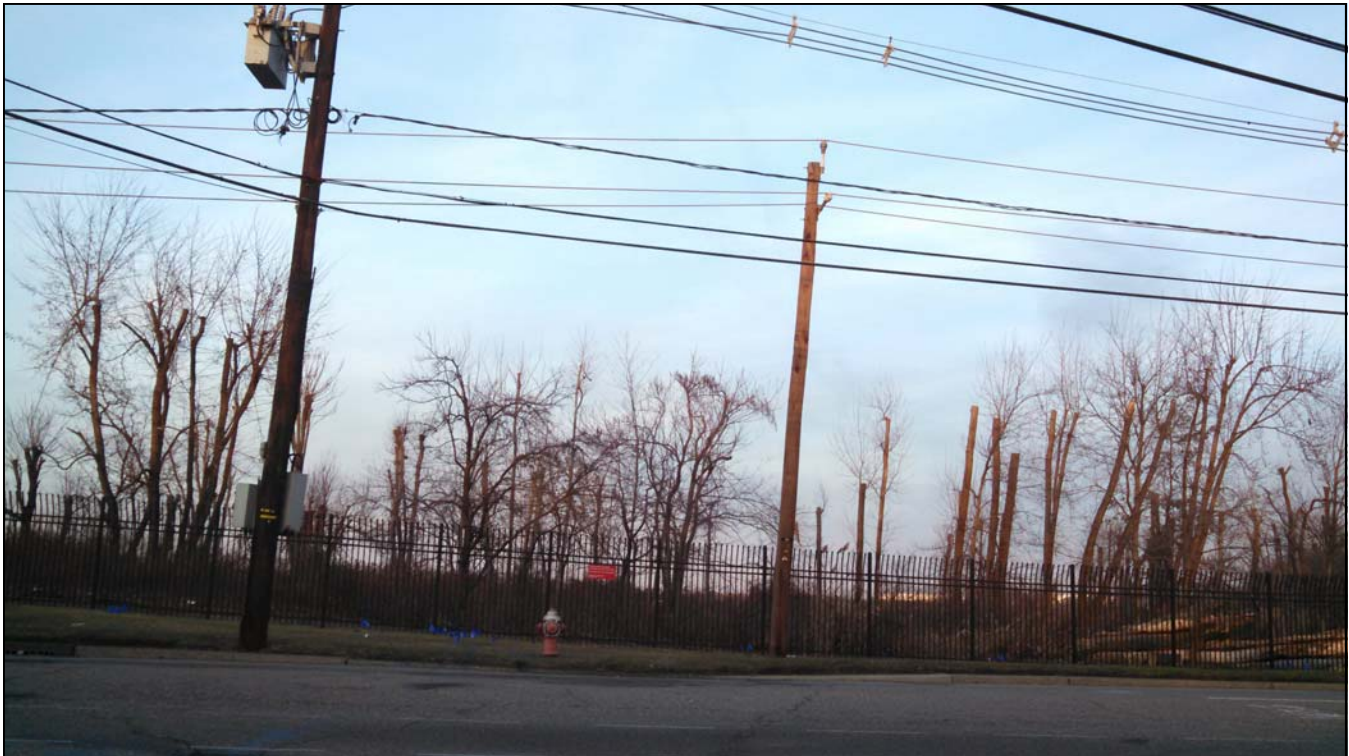
**Mature trees were recently “topped” on land controlled by the Port Authority of New York and New Jersey in Moonachie.**

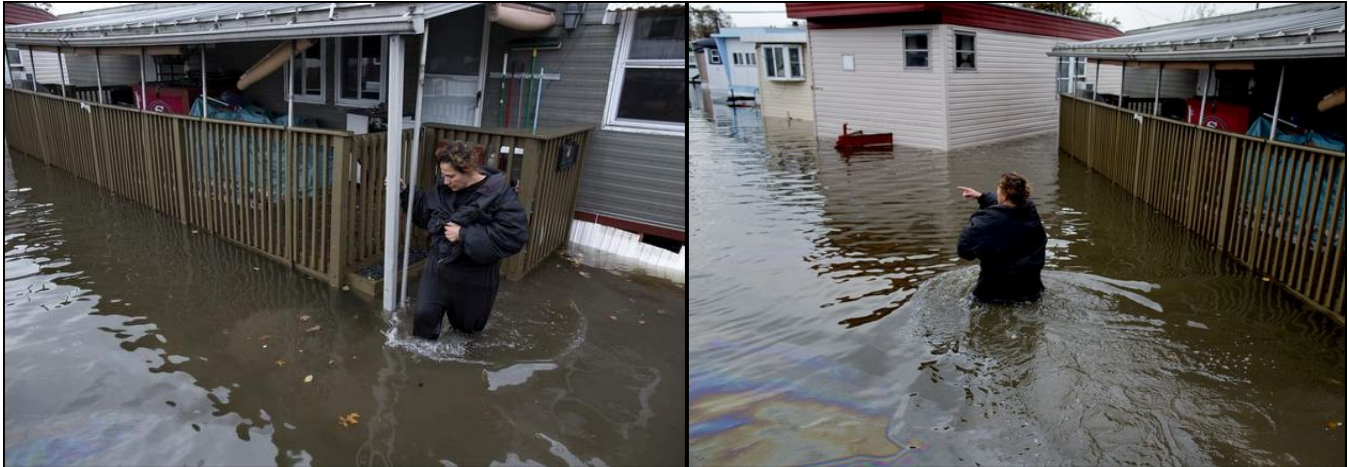
**Mobile home parks in Moonachie south of Teterboro Airport were devastated after the Superstorm Sandy tidal surge.**

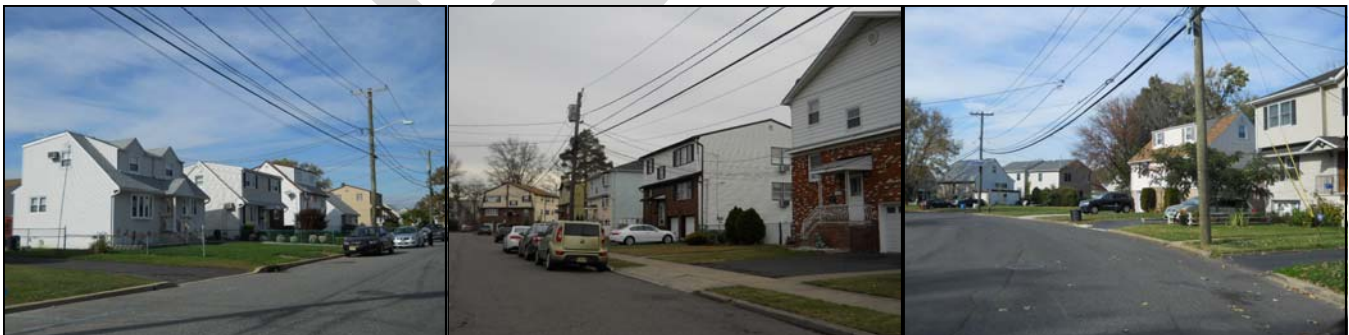
**The residential sections of Moonachie are primarily made up of detached single and two-family houses. Throughout the Borough, the worst damage caused by Superstorm Sandy was generally confined to the first floor.**

According to the respondents, much of the damage was limited to the basement and first floor. However, the scope of damage varied widely, from minor flooding to complete damage of garages and cars to total destruction of entire first floors and all of the contents therein.

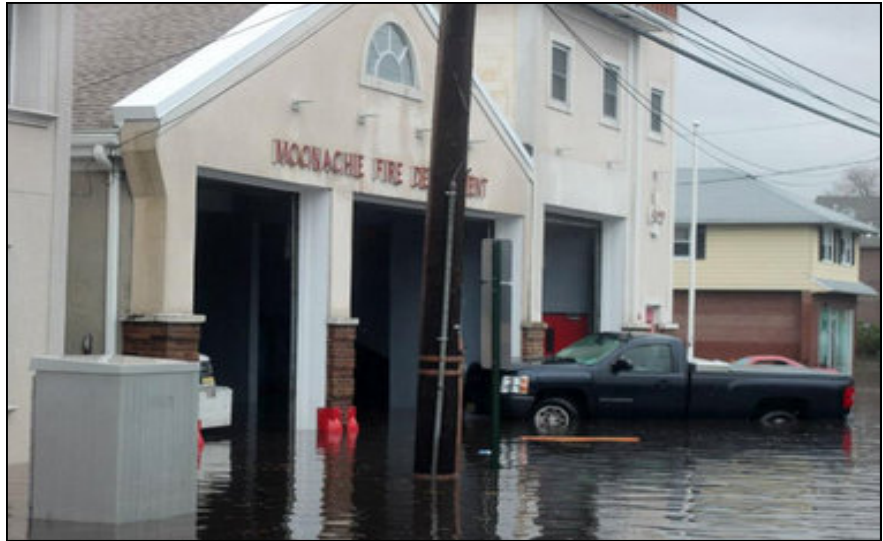
**The Fire Department building has been partially renovated since flood damage during Sandy.**

The **Firehouse** had its garage floor renovated by the Borough. The cascade system has not yet been replaced although a grant has been procured by the Fire Department, with replacement anticipated soon. They have received foundation, private and other funds for the replacement of personal and firefighting equipment. In conjunction with bid jobs for improvements, private donations may subsidize the all volunteer organization's efforts to make their building as flood resilient as possible.

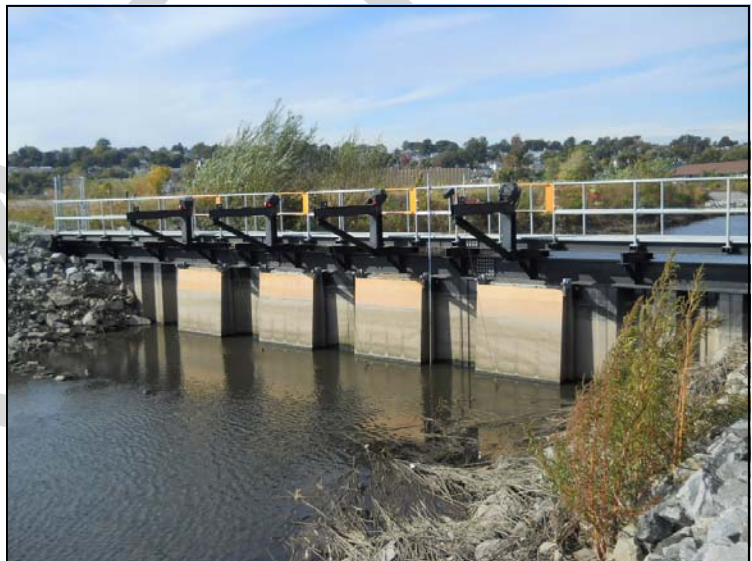
**The Berry's Creek Tidal Gate has been repaired and upgraded to protect Teterboro Airport from daily tidal flood-**

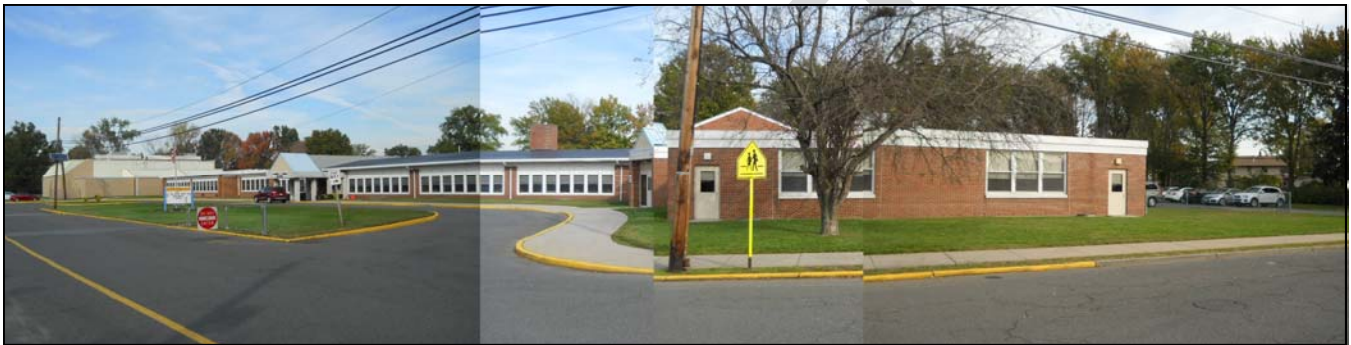
**The Robert L. Craig Elementary School was closed for months after extensive flooding and damage from Superstorm Sandy. Future proposals call for an elevated structure which can also be used as emergency shelter.**
