The Impact of Storm-water Runoff in the Toms River

The effects of storm drains located in Beachwood Beach in Beachwood Township, N.J., and West Beach in Pine Beach, N.J. on the Toms River

August 12, 2011

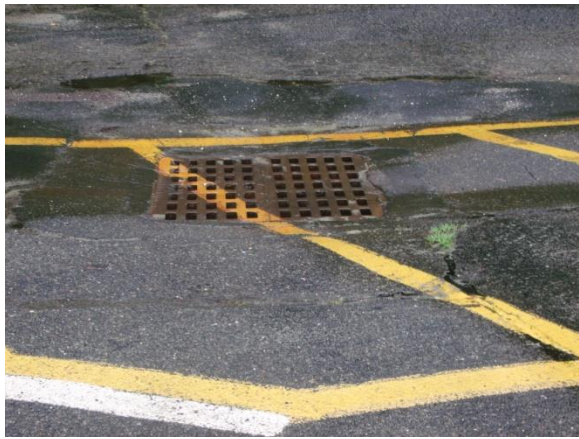
Figure 1: Storm drain located in the Beachwood Beach parking lot.

can collect a wide variety of data that can be used for comparisons. It is also important for samplers to conduct sampling at several locations because human structures can influence the water quality of an area. One such structure, for example, is a storm drain (Figure 1). During a rainfall event, storm

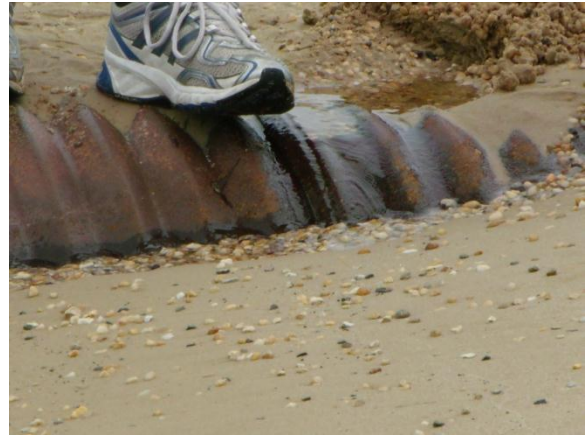
Figure 2: Storm drain with slight infrastructure problem. Water is leaking out of a crack in the drain.

bacteria recorded during the first flush, the assumption can be made that there is a fault with the storm drain. The storm drain may need cleaning; however, the storm drain could also have an infrastructure problem (Figure 2). While it is likely that a rainfall

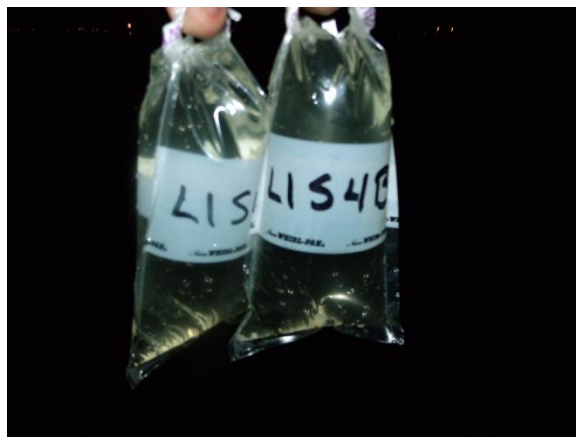
Figure 4: Thiosulfate treated sampling Whirl-paks.

the sampling locations (Figure 4). A cooler with ice packs was also used to keep samples cool. Waders were required to enter the water to collect samples, and nitrile gloves were used both in the field and in the laboratory. A Turner Designs Aquaflour was used to test for optical brighteners and turbidity in sample water. To properly calibrate the Aquaflour, the NJDEP issued a 5 percent detergent solution to calibrate the optical brightener channel to a 50 on the relative optical brightener scale. The NJDEP also issued 100 NTU turbidity fluid to calibrate the turbidity channel of the Aquaflour. Plastic cuvettes were used to run samples through the Aquaflour. Plastic 1 milliliter pipettes were used to move small amounts of sample water from the Whirl-Paks to other locations. A graduated cylinder was used to measure liquid

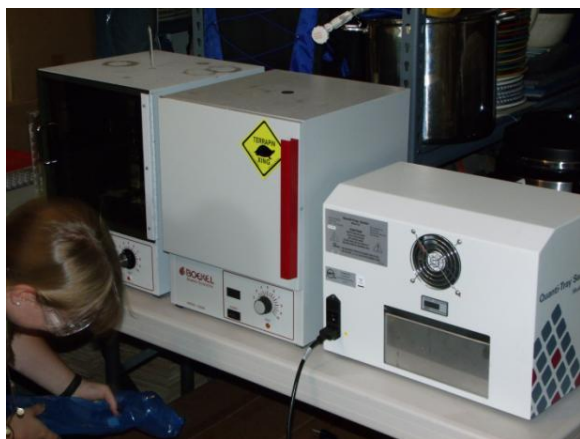
Figure 5: Incubators and the IDEXX sealer at the lab in Dr. Wnek's garage. From left to right: incubator, incubator, sealer.

volumes. A YSI-85 meter was used to check water quality parameters such as dissolved oxygen, percent saturation, conductivity, salinity, and temperature. An Oakton Handheld pH Meter was used to assess pH of sample water. The YSI-85 was calibrated for dissolved oxygen by comparison to a Winkler Titration. The YSI-85 was also calibrated to NJDEP issued conductivity calibration fluid. To check the calibrations, instruments were also given a blank sample of deionized water. Due to sterilization techniques and calibrations, a large carboy of deionized water was utilized. Please note that the carboy had to be refilled on several occasions. To conduct the bacteriological assessments, two incubators were used (Figure 5). One incubator was constantly set to 35 degrees Celsius for the incubation of Coliscan plates. The other incubator was constantly set to 41 degrees Celsius for the IDEXX Enterolert Quanti-Trays. Coliscan Easygel media and petri dishes were used to assess *E. coli* in the samples. An IDEXX sealer (Figure 5) as well as IDEXX Enterolert media was used to assess

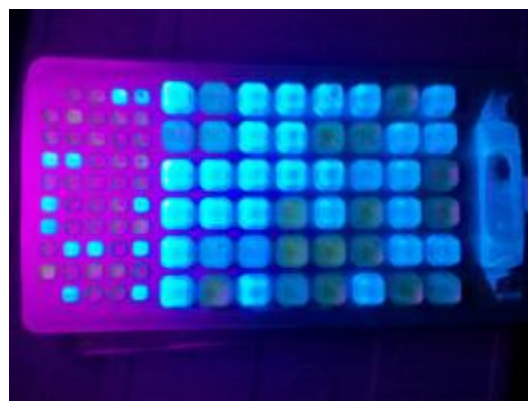
Figure 6: Fluorescent Quanti-Tray/2000 being viewed under a black light.

used to house the sample water and media solutions for incubation. To analyze the results of the Enterolert test, a black light was utilized to count fluorescent wells on the Quanti-Trays (Figure 6). Journals and preformatted data sheets were utilized to record all data and observations made throughout the project.

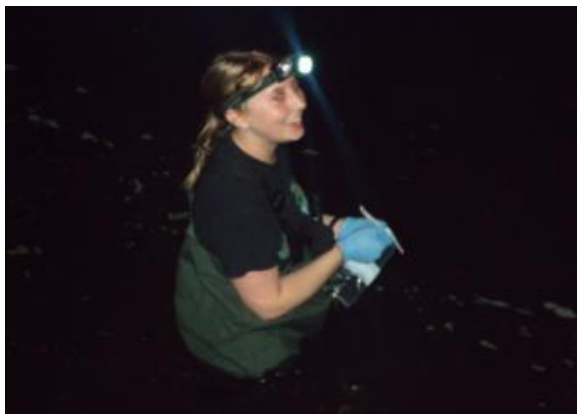
Figure 7: Sampler Danielle Clancy collecting samples wearing gloves according to the quality assurance plan.

calibrated to NJDEP meters for further accuracy. For each sampling session—or approximately every twenty samples should several sessions exist in one day—a duplicate sample was collected to compare to original results. A blank sample was run on the same basis in order to conduct a handling check. In order to assure sterility, nitrile gloves were worn when collecting or handling samples (Figure 7). Storm sampling generally required a 0.10 inch rainfall before sampling the first and second flush was possible. This plan for quality assurance was submitted to the NJDEP and was approved at the Tier B level.

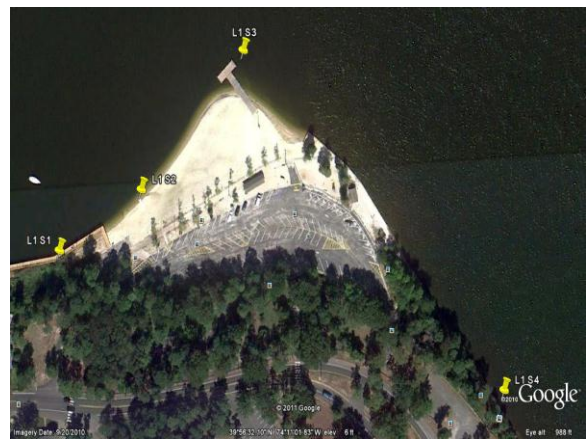
Figure 8: Aerial view of Beachwood Beach in Beachwood Township, New Jersey. Sampling locations are labeled next to yellow pegs. Image courtesy of Google Earth.

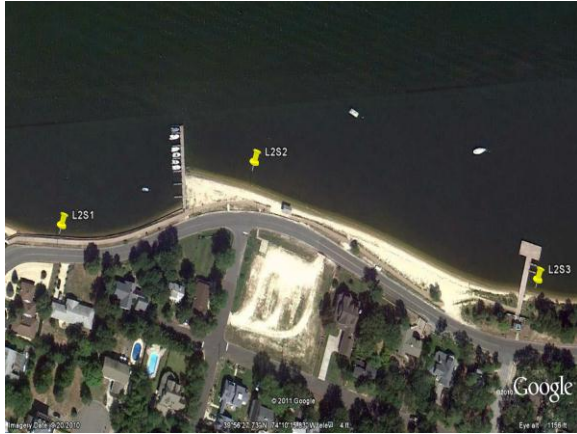
Figure 9: Aerial view of West Beach in Pine Beach, New Jersey. Sampling locations are labeled by yellow pegs. Image courtesy of Google Earth.

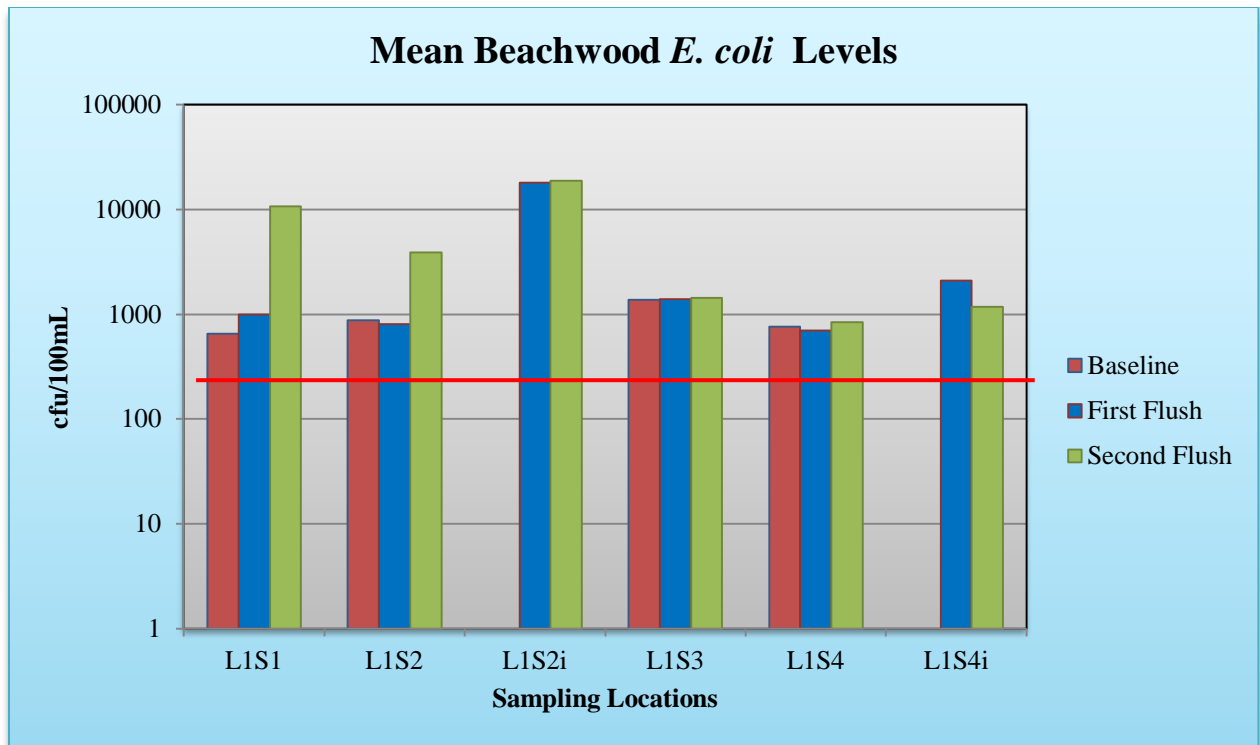
Figure 11: Visual display of mean *E. coli* levels at Beachwood Beach for baseline, first flush, and second flush time periods. The red bar illustrates the recommended safe swimming level for freshwater bathing beaches.

Throughout the project, several spikes in both *E. coli* and *Enterococcus* bacteria were seen throughout rainfall events. It can be seen in Figures 11 and 12 that the levels of *E. coli* in the water were abnormally high for baseline, first flush, and second flush sampling sessions. While *E. coli* may not be a great indicator for bacteriological activity in marine water, studying *Enterococcus* bacteria is an

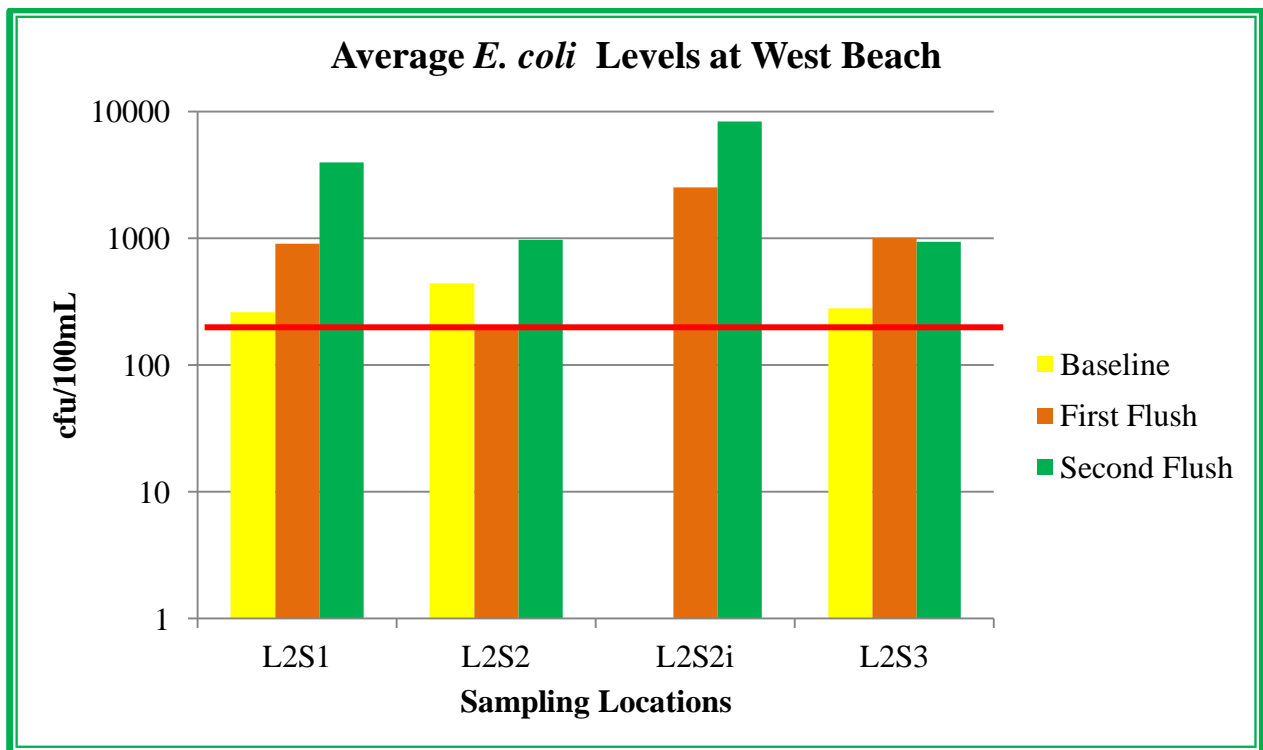
Figure 12: Average *E. coli* levels at West Beach for baseline, first flush, and second flush events. The red bar annotates the recommended freshwater safe swimming level of *E. coli*.

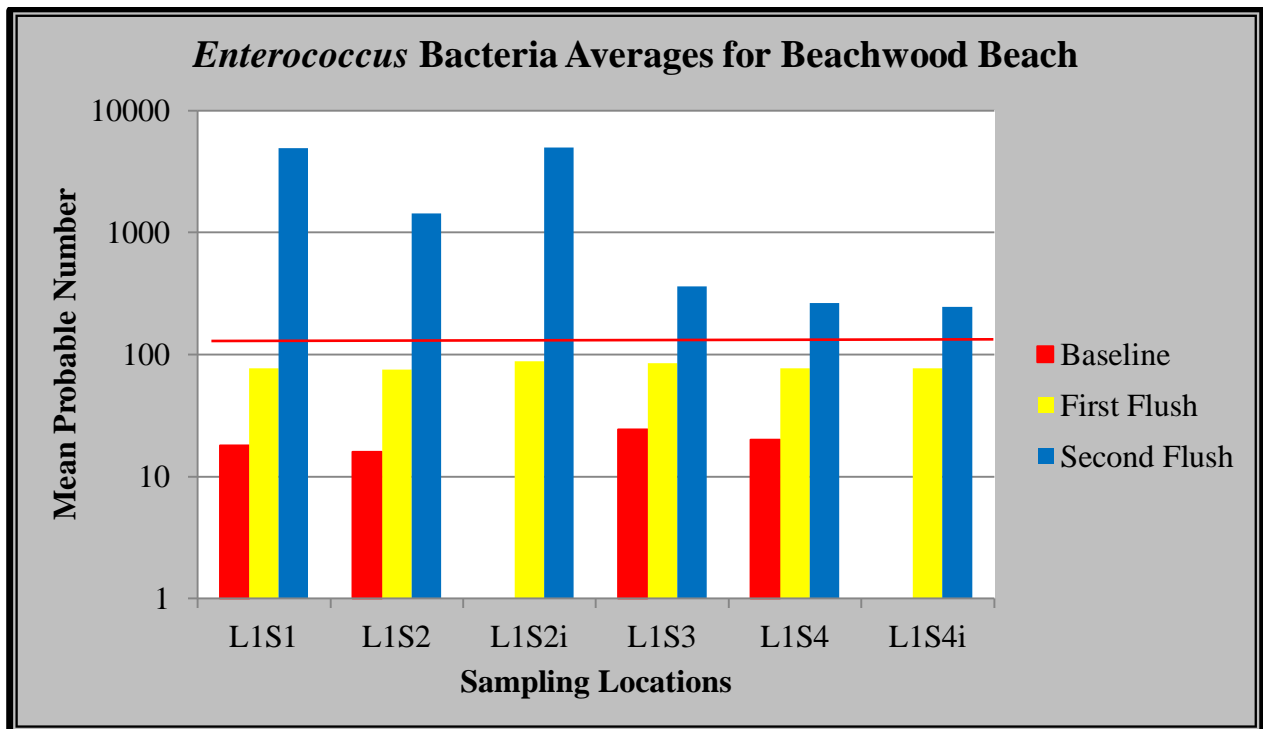
Figure 14: Average *Enterococcus* bacteria levels at Beachwood Beach during baseline, first flush, and second flush sampling. The red bar represents the recommended 104 CFU/100mL standard for marine bathing beaches.

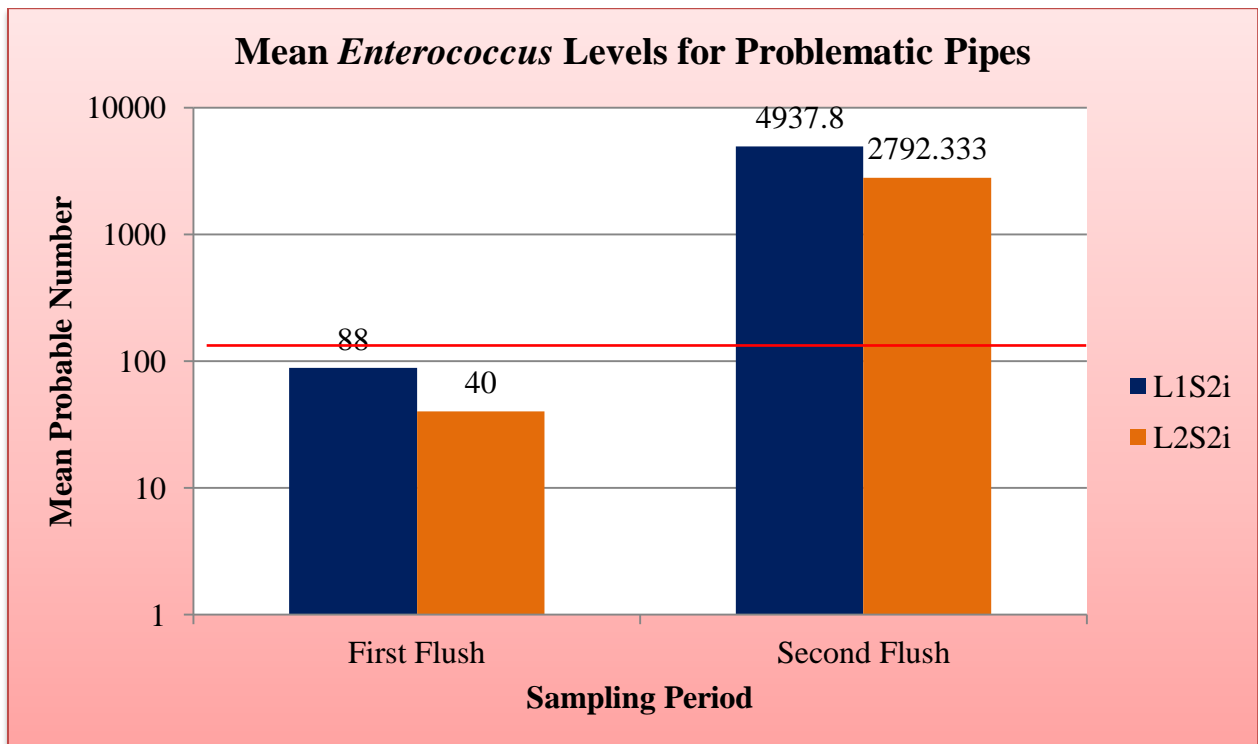
Figure 16: Mean *Enterococcus* levels for suspected problematic pipes at Beachwood Beach and West Beach. The red bar indicates the NRDC safe marine bathing beach standard.

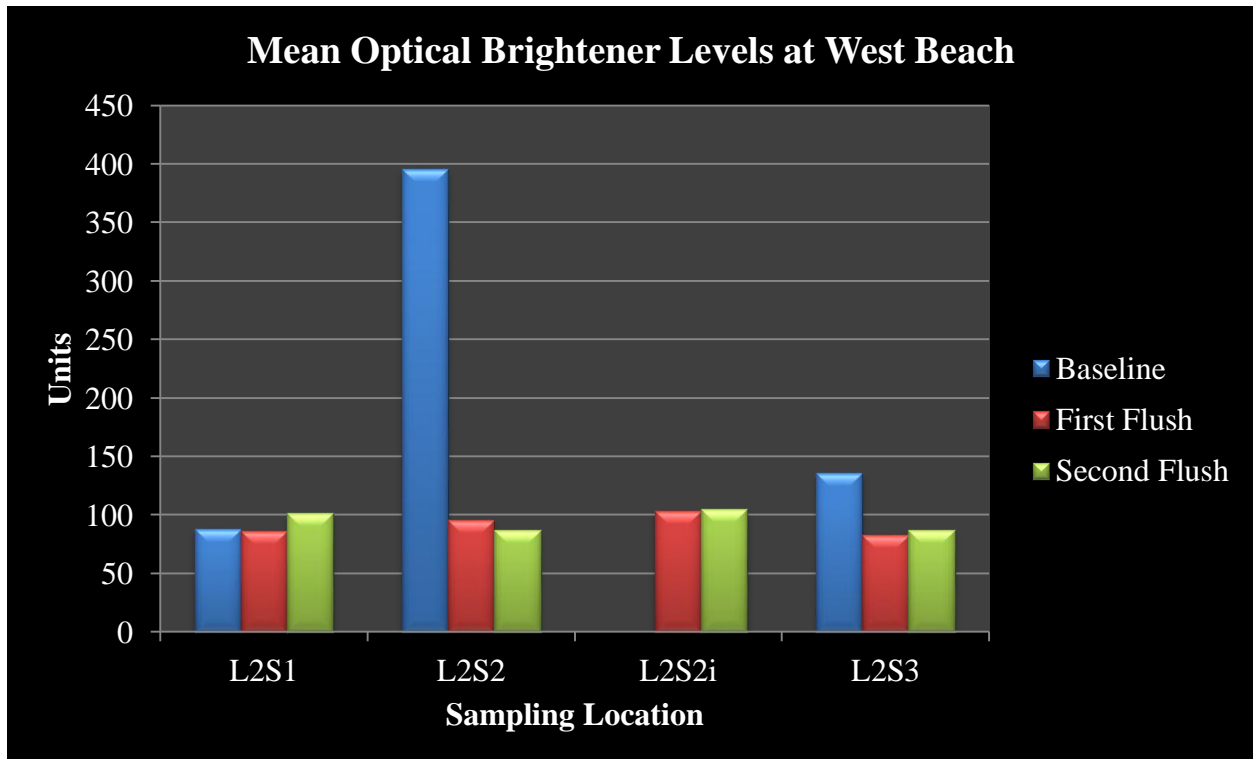
Figure 18: Mean optical brightener levels at West Beach during baseline, first flush, and second flush sampling events.

Figures 17 and 18; however, there appears to be no set pattern to the levels. Figure 19 displays *Enterococcus* bacteria levels plotted against optical brightener levels, and Figure 20 shows *Enterococcus* bacteria levels plotted against rainfall levels. Table 4 displays data received throughout the project as well as data received by the Ocean County Health Department. Table 5 displays data received throughout the project as well as data received by the Leed's Point Lab Staff.

The optical brightener averages throughout the study proved to be of little use for the overall assessment of the area. The average optical brightener levels for each sampling site can be viewed in Figures 17 and 18. On these figures, it can be seen that there is no strong trend or pattern in the optical brightener levels. This may be due to interference from salt water conditions or possibly due to tannins in the water which may also affect the optical brighteners. When viewing Figure 19, one can see *Enterococci* values plotted against optical brightener levels on the relative scale. The R^2 value for this comparison is 0.0009. This number represents very little, if any, correlation. As previously stated, optical brightener levels may be a great indicator of human influence in an area; however, with so many variable affecting the experiment, it cannot be definitively stated that they have a correlation with any of our pertinent data. This test may have significance in a freshwater system; however, in a marine water body the fluctuations are too great to truly quantify.

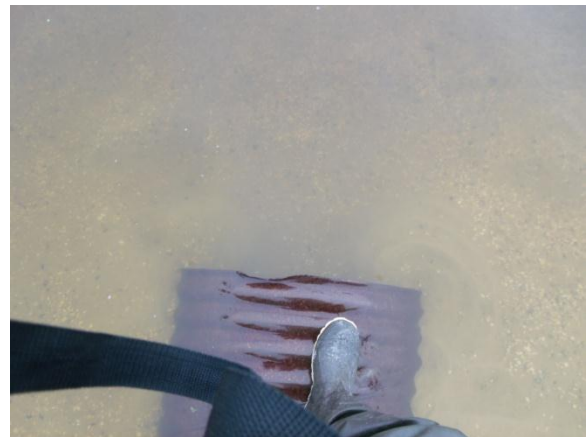
Figure 21: Gray cloud discharge coming from L1S2i on July 8th, 2011.

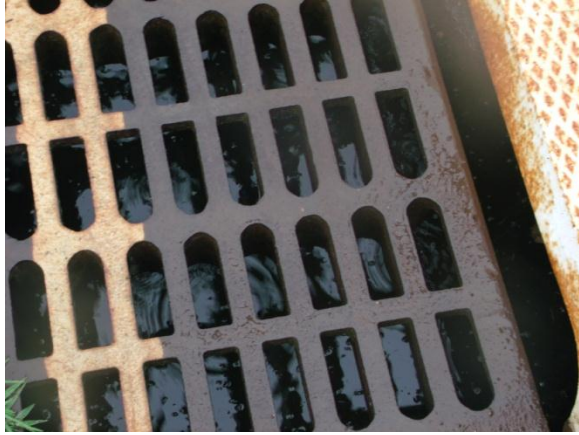
Figure 22: Sludge composition at the bottom of a Pine Beach storm drain.

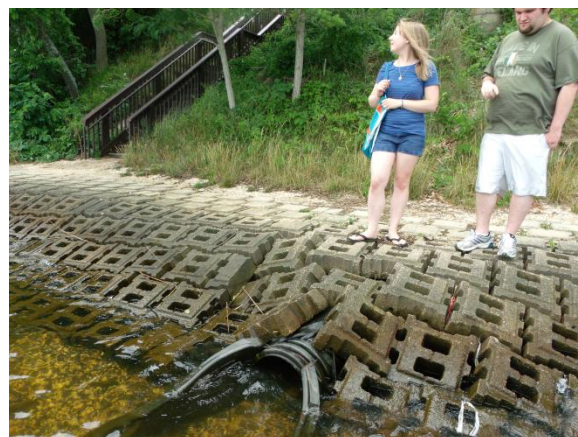
Figure 23: Location 1 Site 4 storm drain pictured with researchers Danielle Clancy and Kevin Dillon.

One observed storm drain did not experience intense changes in bacterial levels. The storm drain located at L1S4i (Figure 23) appeared to have changes in bacterial levels during storms; however, the significance of the changes is not well understood. L1S4i seemed to have small

variations in bacteria levels which could mean one of two things. The pipe could either be blocked and any flush resulting from the pipe was merely a result of its submersion; or, the pipe could be clean and

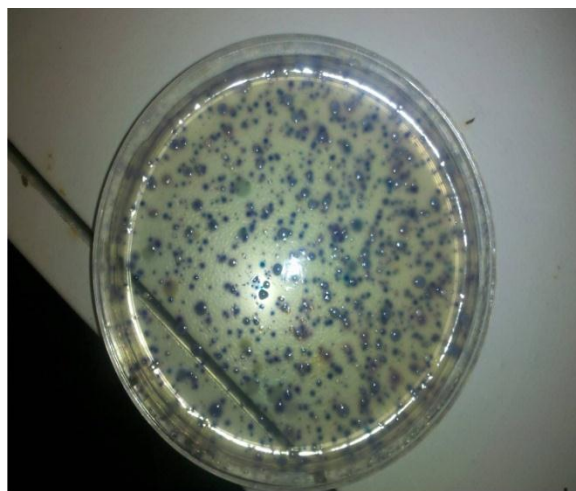
Figure 24: Coliscan petri dish after culturing. The plate represents 41,900 CFUs/100mL from L1S2i.
