NEW JERSEY OFFICE OF CULTURAL AND ENVIRONMENTAL SERVICES
HISTORIC PRESERVATION SECTION
INDIVIDUAL STRUCTURE SURVEY FORM

HISTORIC SITES INVENTORY NO. 1514-1

HISTORIC NAME: Larrabee Store
LOCATION: 11 Union Ave. & Locust St.

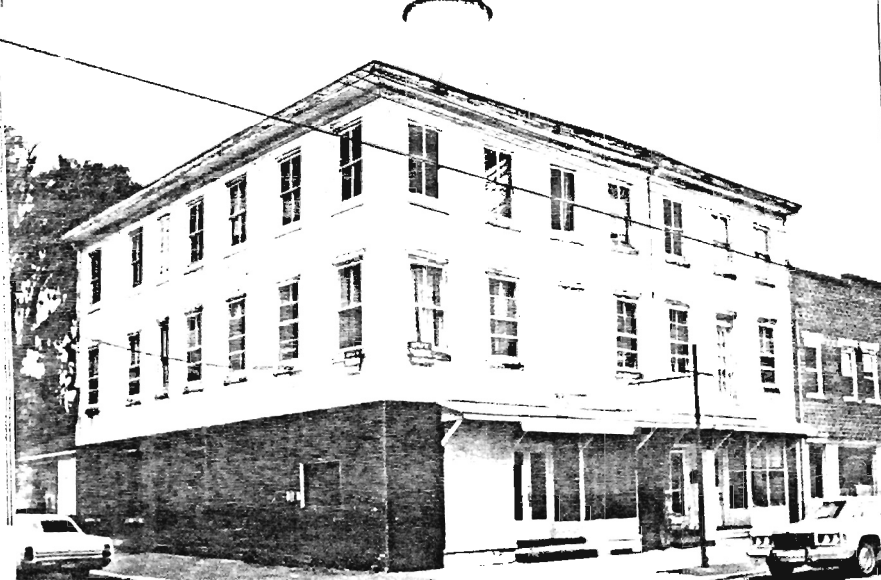
Negative File No. 1514-1

Three irregularly spaced doorways penetrate the facade of this structure; the major entrance is recessed and has double doors and a transom. A pent eave extends across the facade above the first floor. Limestone lintels and sills frame each window.

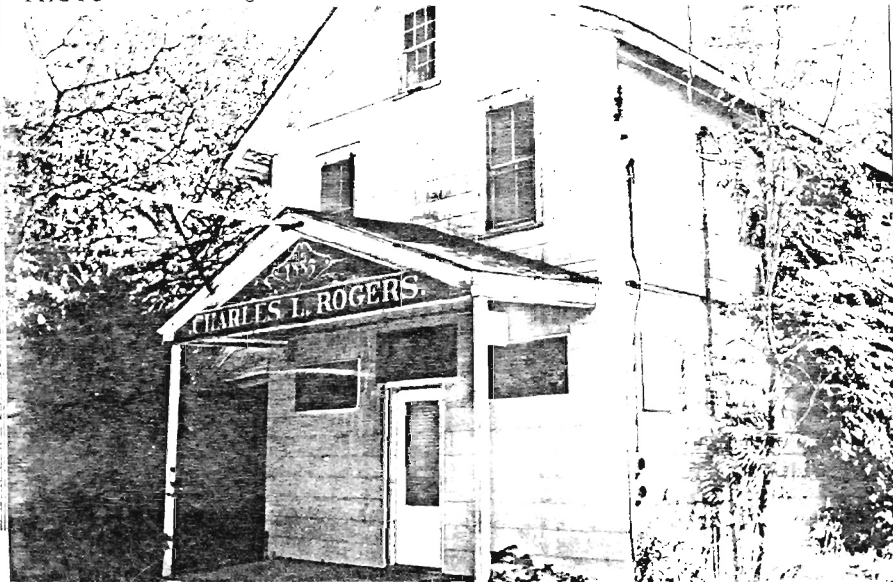
Negative File No. 1514-2

The structure is distinguished by its signboard (probably original) which reads, "Charles L. Rogers - 1885." The sign is mounted to fill the upper portico area above the center door. The gabled portico is supported on wooden piers and there is a plank porch floor. First floor windows have been boarded but the massing of the entrance area is typical of the Torrey workmen's cottages.

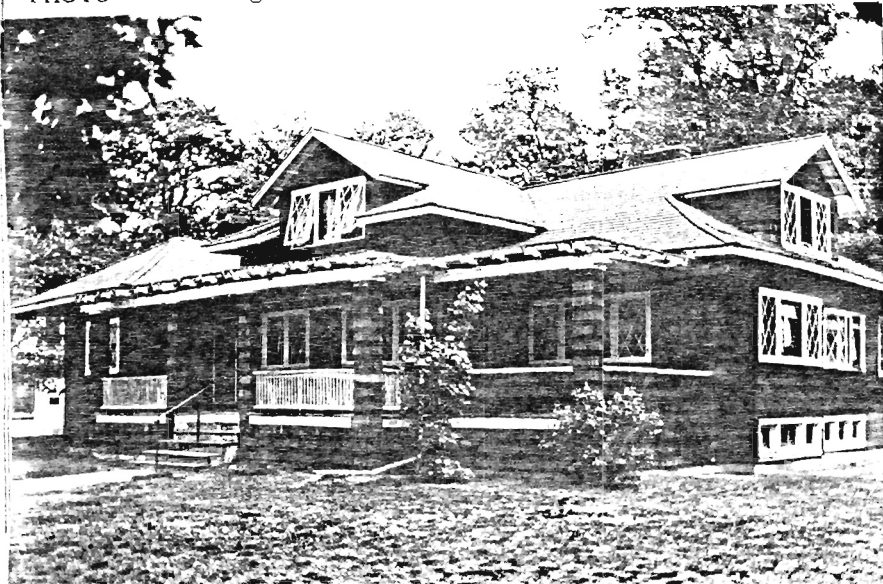
PHOTO Negative File No. 1514-5

Although this structure presents an informal, rambling appearance, it is in fact highly organized around a center door. A secondary door to the south leads to an office area. The spacious front porch has shingled posts and long shaped rafter tails, which form an open trellis area extending beyond the porch eaves.

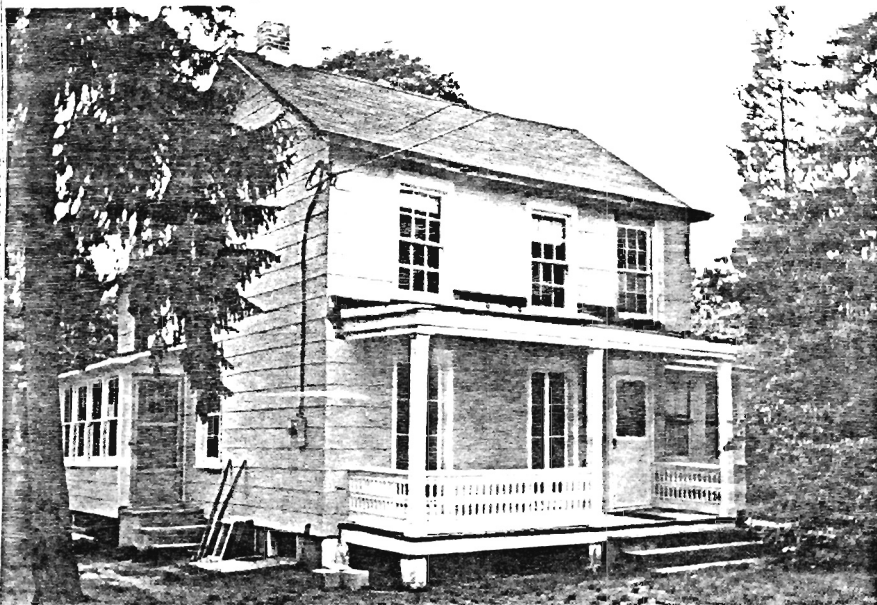
PHOTO Negative File No. 1514-6

There is an asymmetrically located door, and French doors on the first floor. An open porch with square piers and sawn rails (no brackets) projects front, and there is a shed open rear porch and an enclosed shed porch with continuous fenestration to the south. A one story addition extends north. Purlins are visible beneath the eaves of the main element.

This structure is noted on the 1872 Beers Map and seems to be among the oldest surviving area residences. Its sawn porch trim is intact and is outstanding, contrasting sharply with the more sophisticated, integrated Queen Anne residences to the north and south.

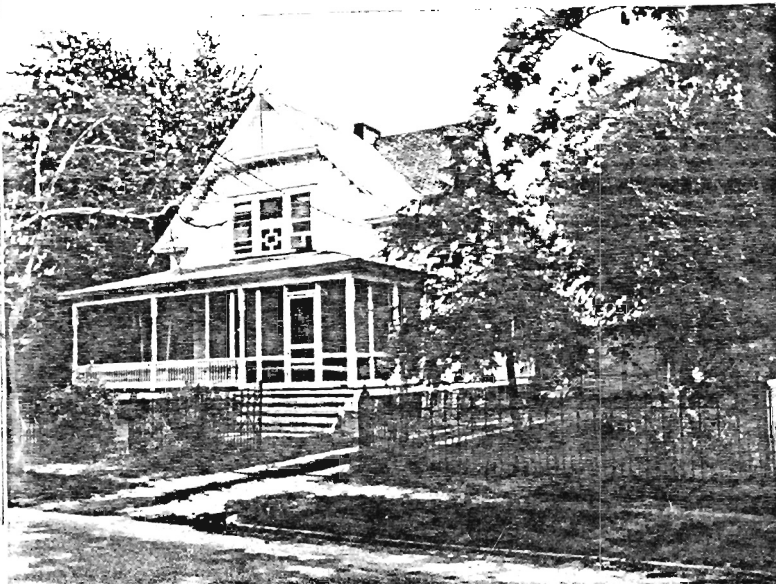
PHOTO Negative File No. 1514-9

There is a screened shed front porch with turned posts and decorative rails. Brackets line all roof areas. There is a central second floor window group which is elaborated by molding forming a geometric design.

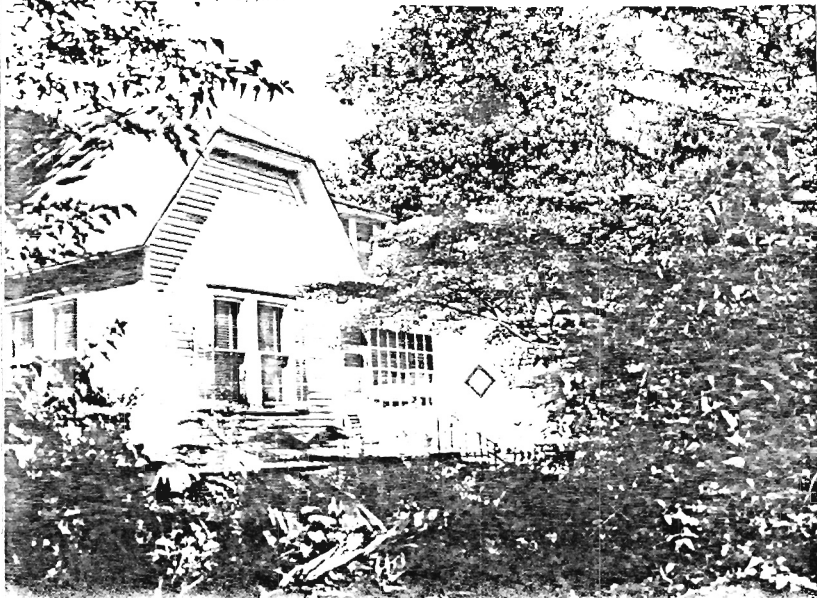
PHOTO Negative File No. 1514-10

This symmetrical structure emphasizes a center door and a wide open elevated terrace between the end projections. Two 28 light windows stretch from the doorway to the pavilions. There is a shed dormer.

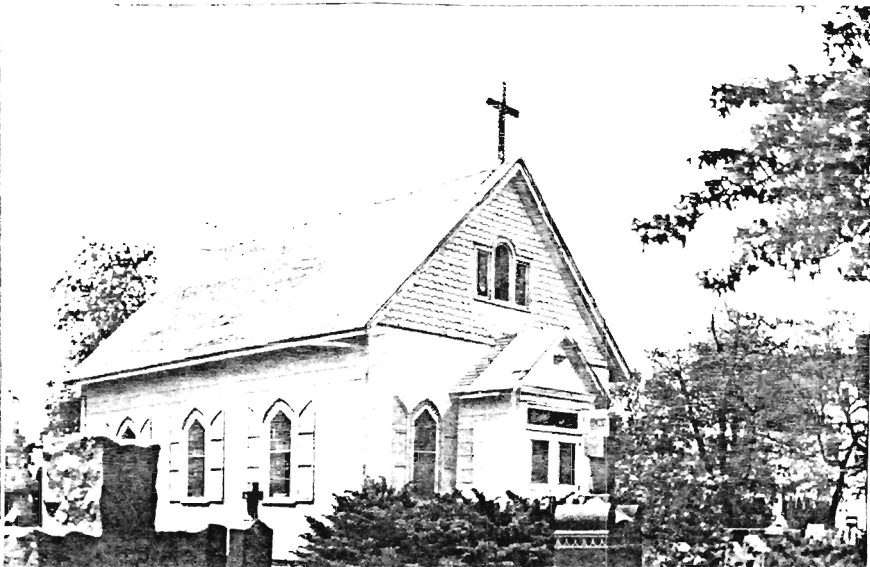
PHOTO Negative File No. 1514-12

There is an enclosed entrance portico with double leaf doors and a palladian type window above, with a pictorial stained glass window above. The nave windows are pointed arch shaped and they are set into traditional Roman arch frames. Each window has shutters. There is a one story rear projection, and a side entrance.

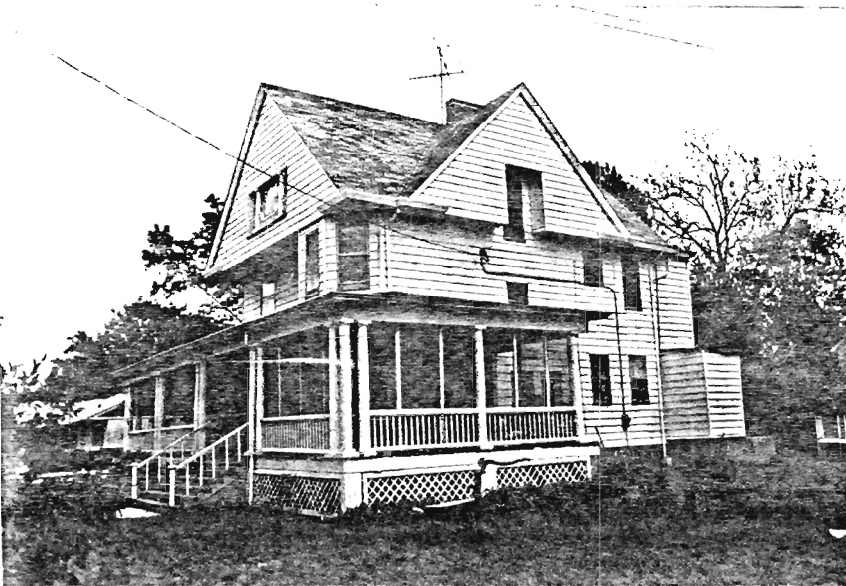
Negative File No. 1514-14

The Laurel Cottage is on the south side of Union Avenue; opposite the elementary school. There are neighboring residences of comparable scale to either side.

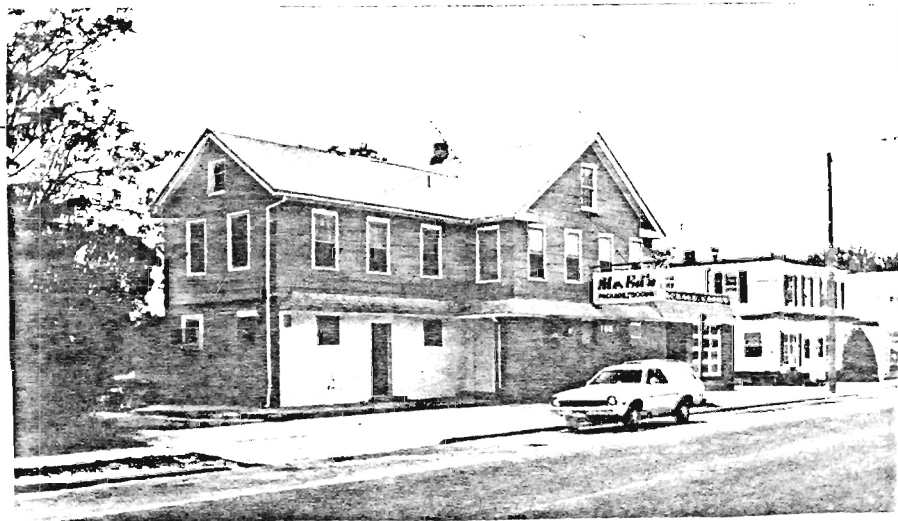
MAP: 1514-5
SLIDES: Union Avenue
REFERENCES: Lakehurst
View: South

There are two structures of pivotal importance: The Larrabee Store (# 1514-1) and Charlie Rogers Hotel (# 1514-2.) Along Railroad Street, small outbuildings to the rear may be survivors of the railroad repair industry here, or remnants of the Manchester Hotel.

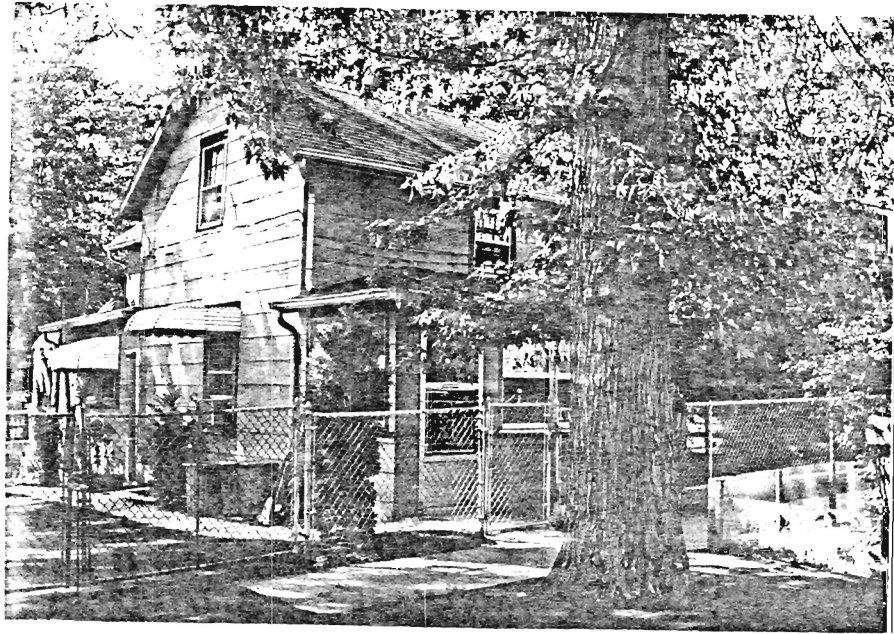
1514-L1

2½ story, 3 bay, asbestos sided structure with 6/6 windows and an enclosed hipped roof front porch, c. 1860

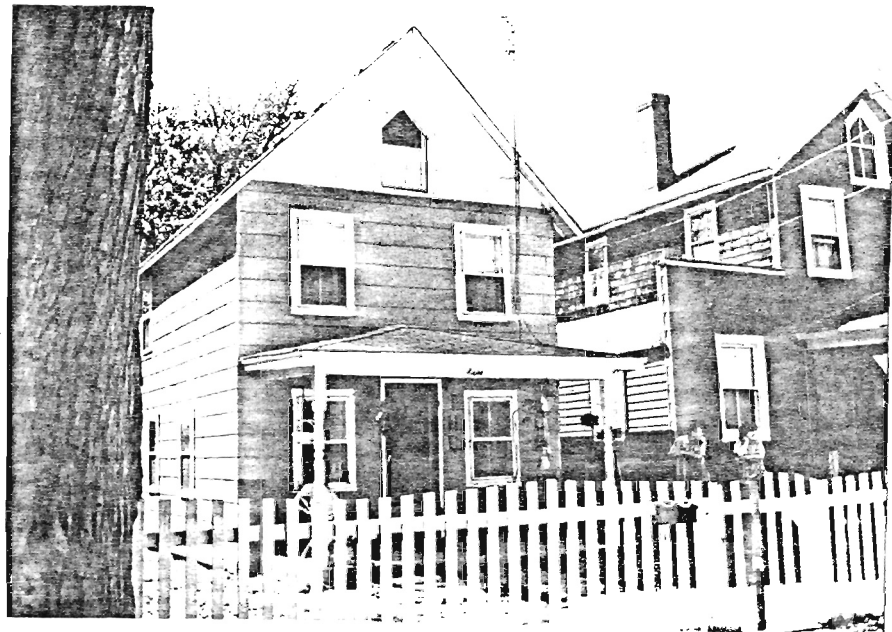
1514-L2

2½ story, vernacular Gothic structure c. 1880 with asbestos shingle and staggered butt shingle siding, 2/2 windows and pointed arch windows in the attic area. The gable roof is oriented to the street and there is a hipped front porch with turned posts.

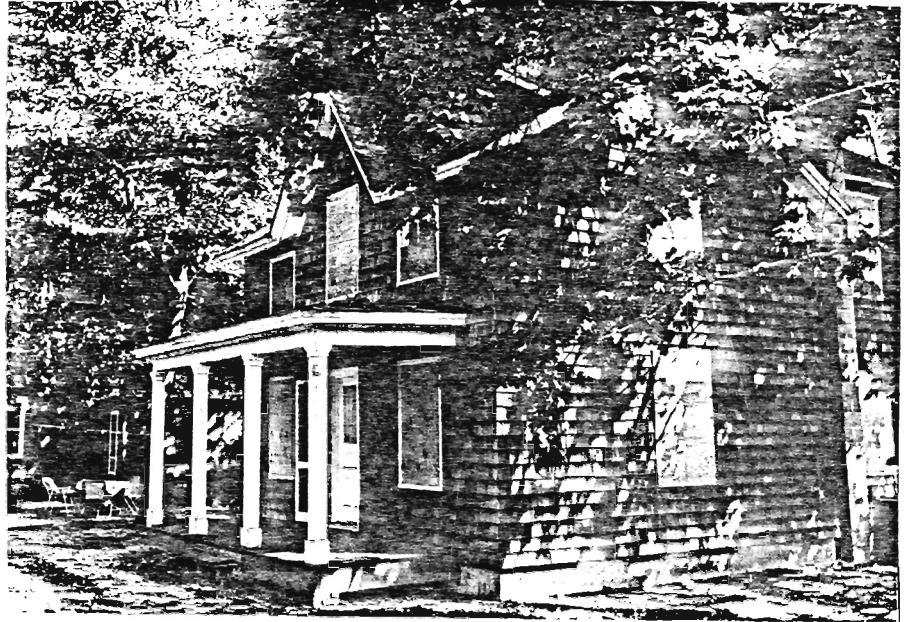
1514-L3

1½ story, 3 bay, center cross gable vernacular Gothic cottage, natural shingle siding, c. 1860. There is a center door and an open hipped front porch with square piers. This house is marked on the 1872 map and is oriented to Union Avenue, although it is deeply back from the road. A 20th century cottage has been constructed in front.

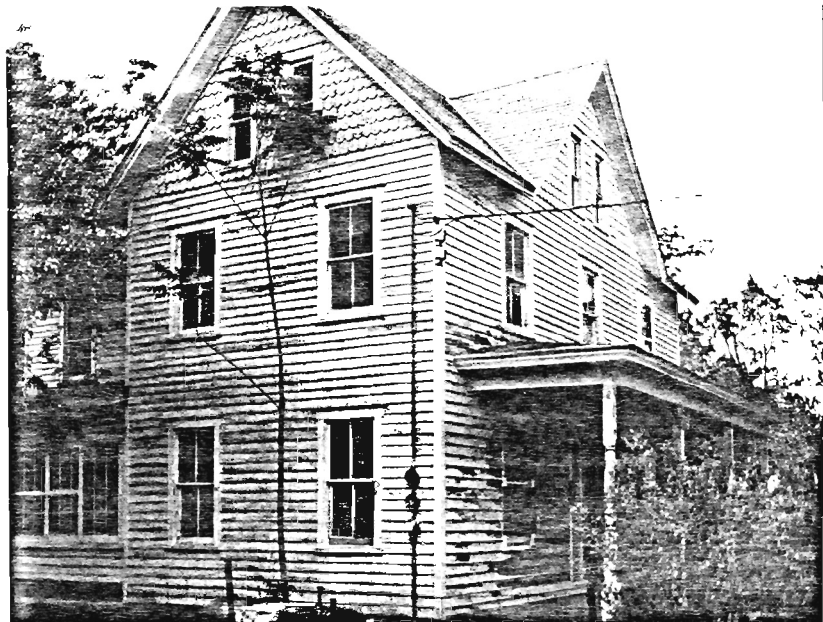
1514-L4

2½ story, 3 bay, T-plan center cross gable vernacular Gothic house, clapboard siding with octagonal shingle in the gable peaks, c. 1870. There is a center door with sidelights, 2/2 windows, and an open shed porch with turned posts. (Deteriorated.)

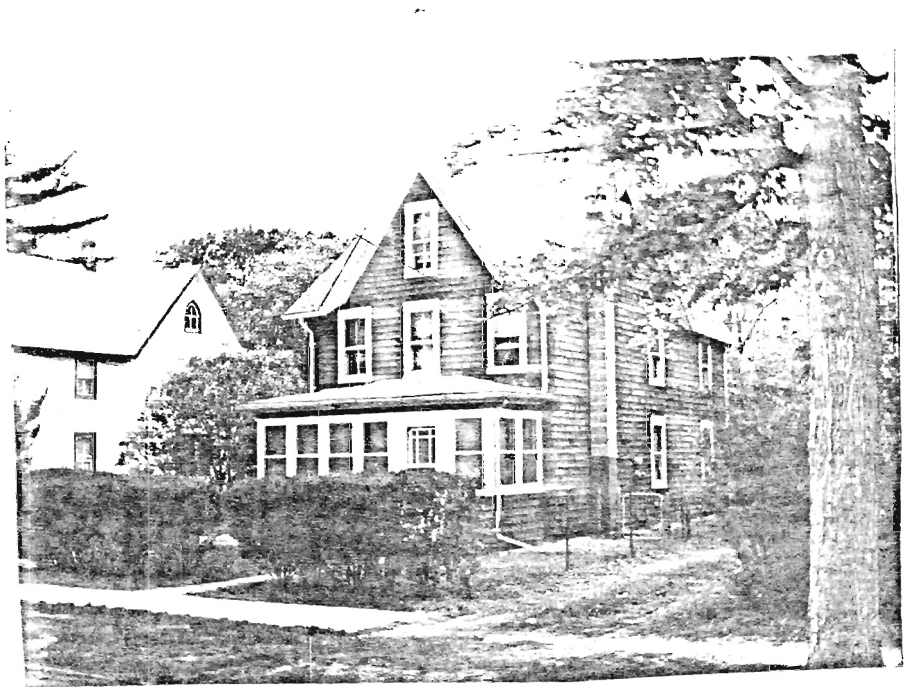
1514-L5

A narrow 2½ story, 3 bay, vernacular Gothic structure with central cross gable, c. 1870. The siding is painted shingle, and the windows are 1/1 and 2/2. There is an enclosed front porch with continuous fenestration.

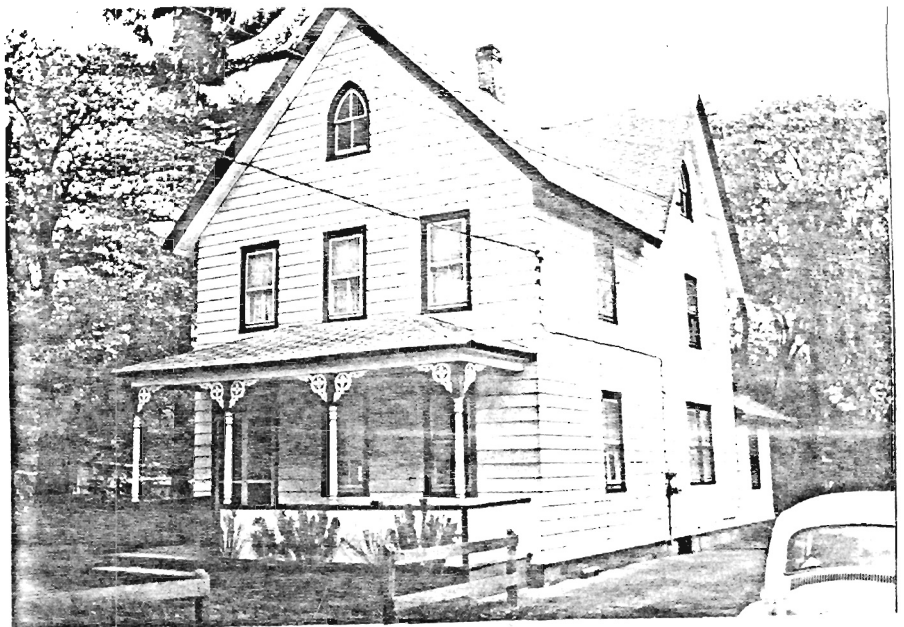
1514-L6

2½ story, 3 bay, vernacular Gothic cottage with gable roof to street and cross gables, c. 1870. Aluminum siding. details include an asymmetrical double leaf entrance with transom; turned porch posts and sawn brackets and arched windows in the attic areas.

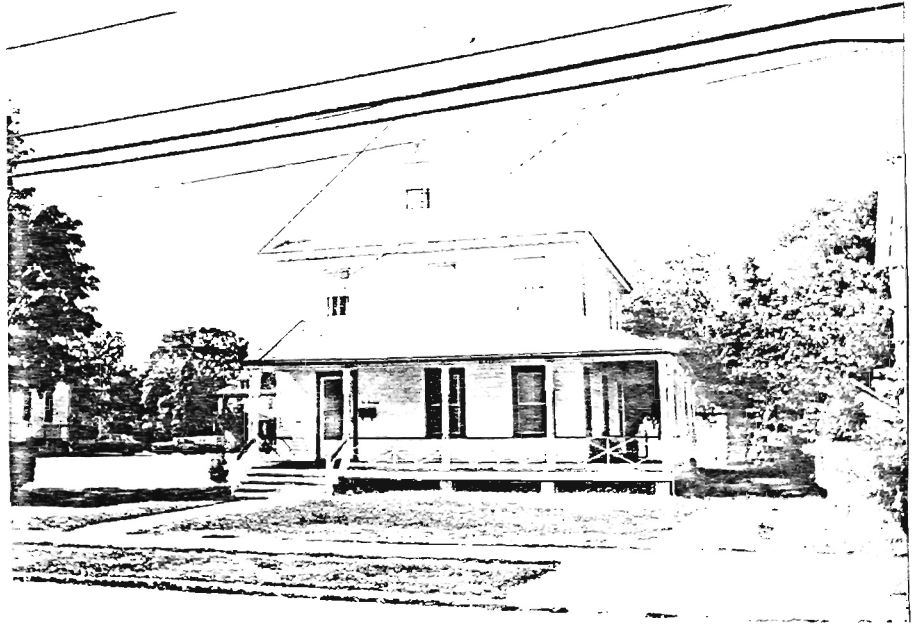
1514-L7

2½ story, 3 bay, vernacular Queen Anne structure with Colonial Revival elements; aluminum siding, gable roof to street. There is an open front porch with turned posts and diamond patterned rails. A false pediment marks the entrance.

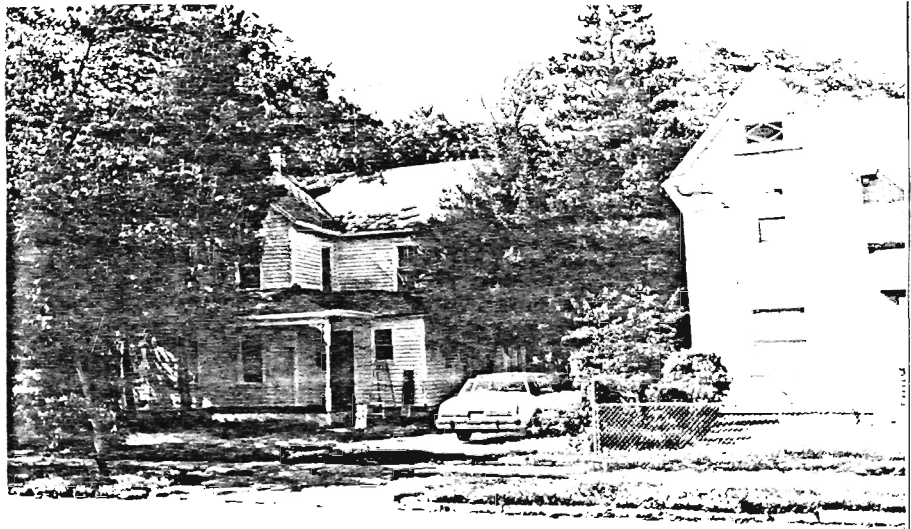
1514-L8

2½ story, L-plan, vernacular Gothic cottage sided with clapboard and scalloped shingle, 2/2 and 1/1 windows. There is an open front porch with turned posts and sawn brackets and two interior corbelled chimneys.

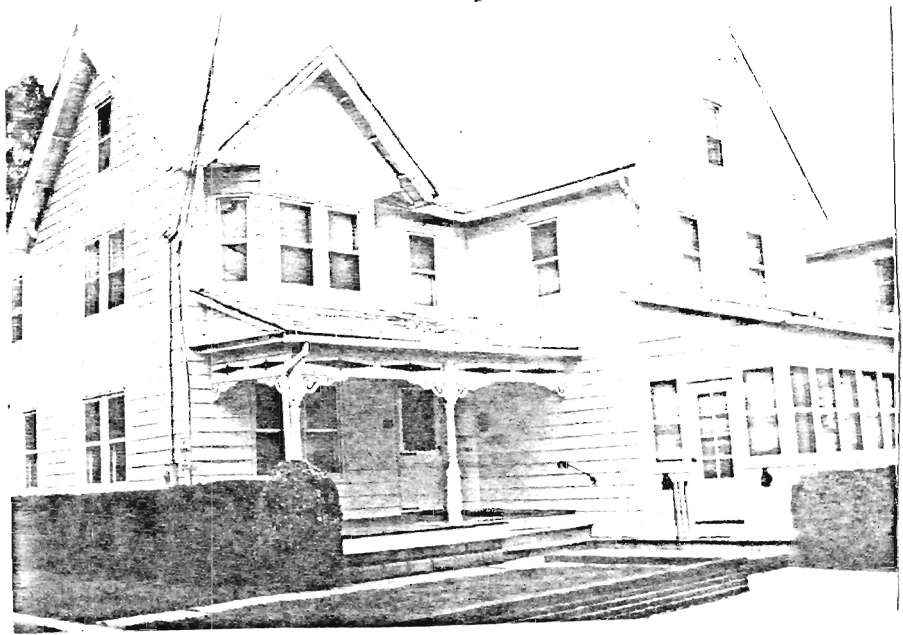
1514-L9

This structure is composed of two joined residences, both c. 1885, with gable roofs intersecting in an ell. Each portion is 2 bays wide and the windows are 1/1. The siding is aluminum. A partial open front porch extends to the west, with sawn trim and turned posts.

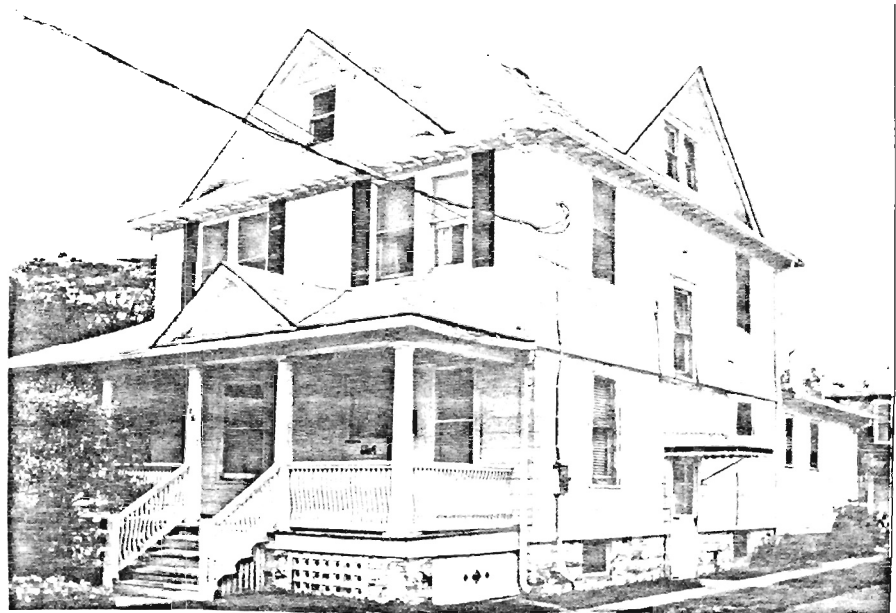
1514-L10

3 story, asbestos sided, square plan contractor's Georgian structure, c. 1910. There is a first floor oriel, an open porch to the front and west with Doric columns and a false pediment marking the entrance. There are brackets supporting the eaves.

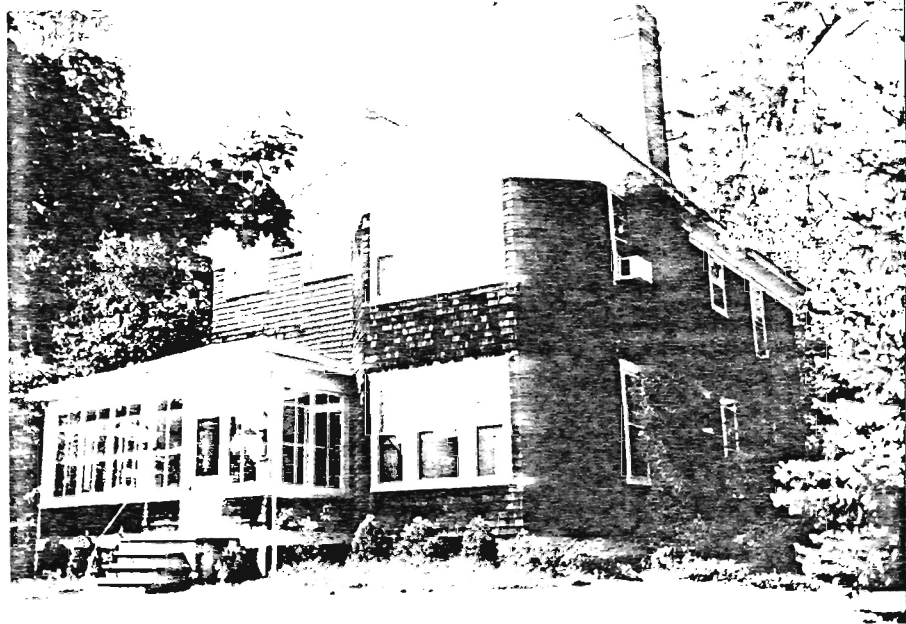
1514-L11

2½ story, natural shingle structure with high mansard roof and two exterior corbelled brick chimneys. There is an oriel in the southwest corner and multiple dormers with multiple window groups. A hipped enclosed front porch curves at the southeast to accommodate the corner location; it has continuous fenestration.

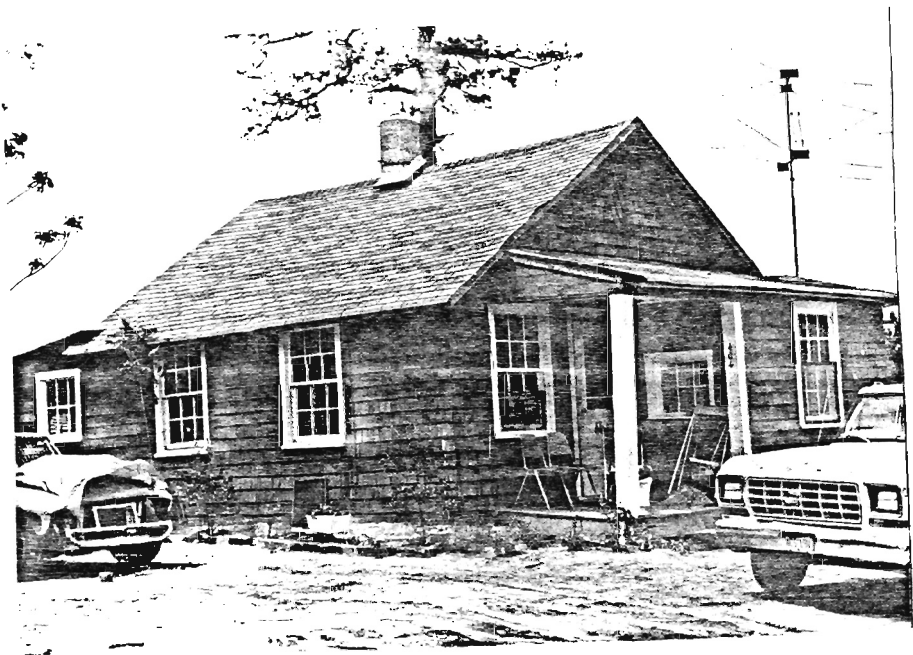
1514-L12

1½ story, 2 bay, painted shingle structure with gable roof and 6/1 windows. There is an enclosed shed porch to the south and a saltbox addition.

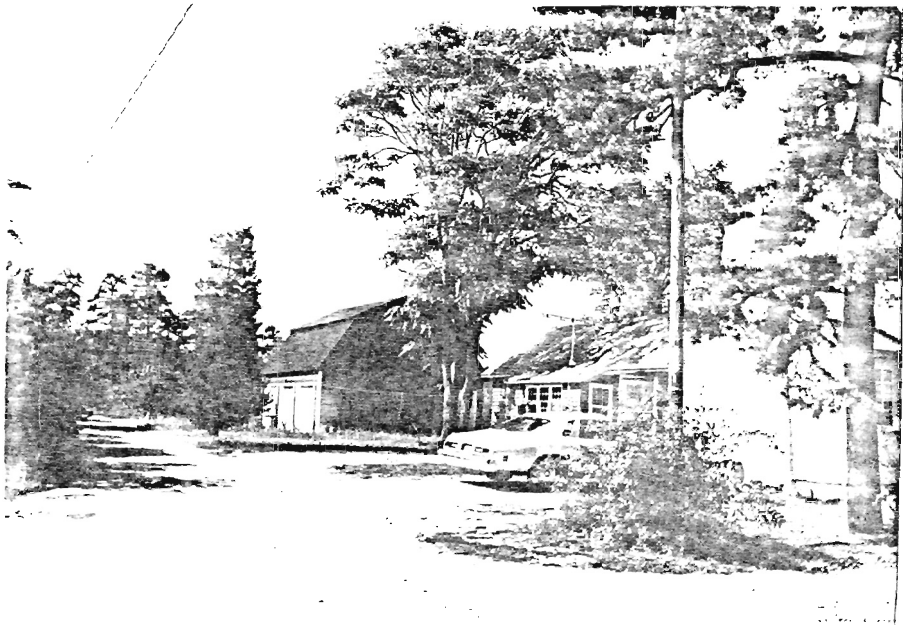
1514-L13

2 story structure sided with vertical board, with a Dutch gambrel roof.

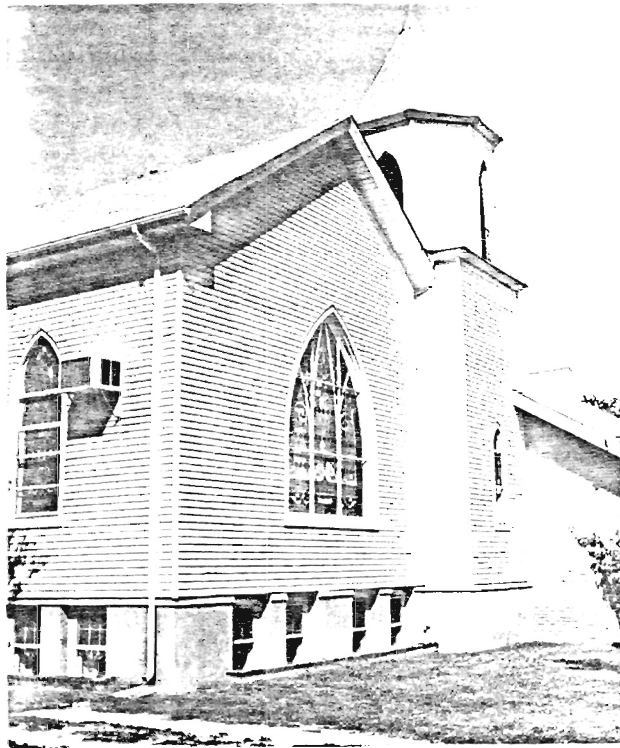
1514-L14

A large gable roof structure with aluminum siding and a square tower pierced by lancet windows; octagonal belfry with open pointed arches. The south elevation has large arched windows with lancet muntins, infilled with non-pictorial stained glass. A 5 bay, 1 story, modern (1964) brick addition extends to the east. This structure was built in 1899; in 1906 it was moved to its present location from Brown Street and it was rebuilt in 1943.

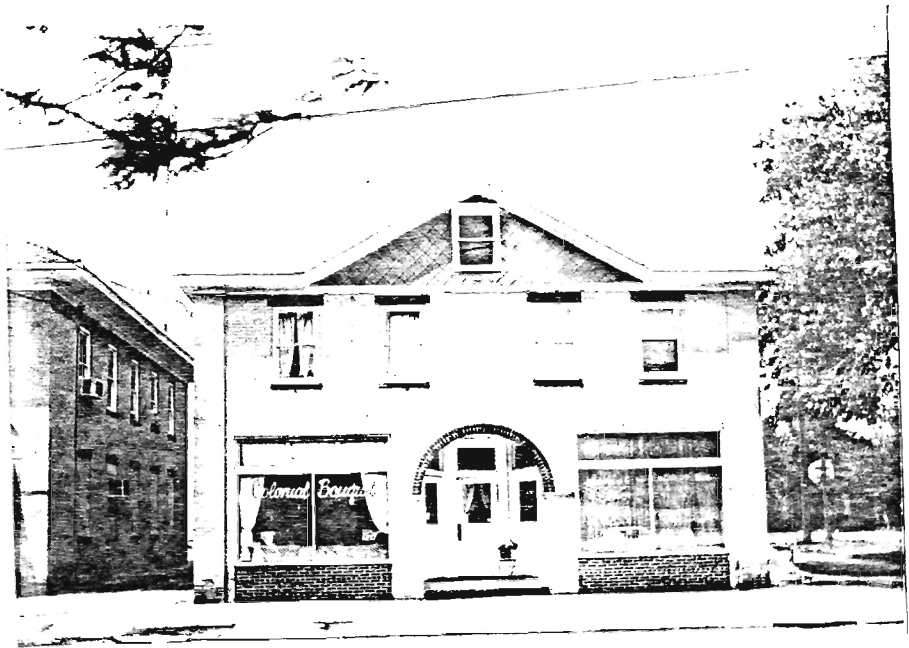
1514-L15

2½ story, 5 bay, pressed brick structure with hipped roof and center cross gable, commercial building with modified neo-colonial overtones, c.1910. There are angled triple doors within a recessed arch area with marked spring-line and flanking shop windows on the first floor; 4-1/1 windows punctuate the second floor and there are limestone lintels and sills. There is an emphasized soffit area and corner piers.

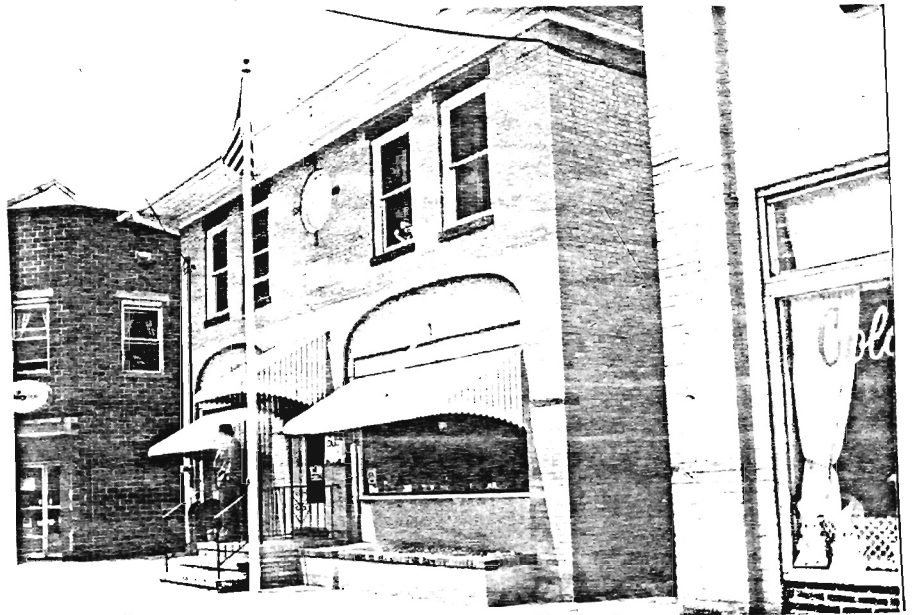
1514-L16

2½ story, 5 bay, pressed brick structure with hipped roof, municipal Georgian Revival style. There is a small center doorway and relieving arches on either side, infilled with plate glass and a secondary entrance. The windows are 1/1 with limestone sills and lintels; there is an infilled oculus with keystones and a central datestone. Aluminum awnings decorate the first floor.

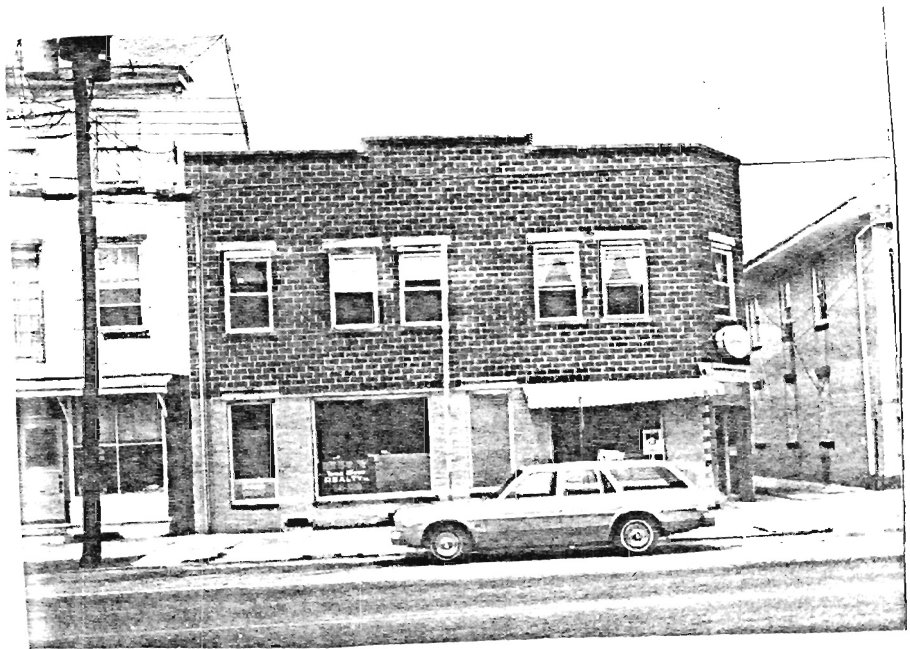
1514-L17

2 story, 6 bay, commercial building with low stepped gable roof and diagonal southwest corner, large "art" brick material, c. 1930. Commercial first floor; 1/1 windows with stone sills and lintels on the second story.
