TUCKERTON

NEW JERSEY OFFICE OF HISTORIC PRESERVATION HISTORIC SITES INVENTORY NO.: 1533-1
STREETSCAPE SURVEY FORM

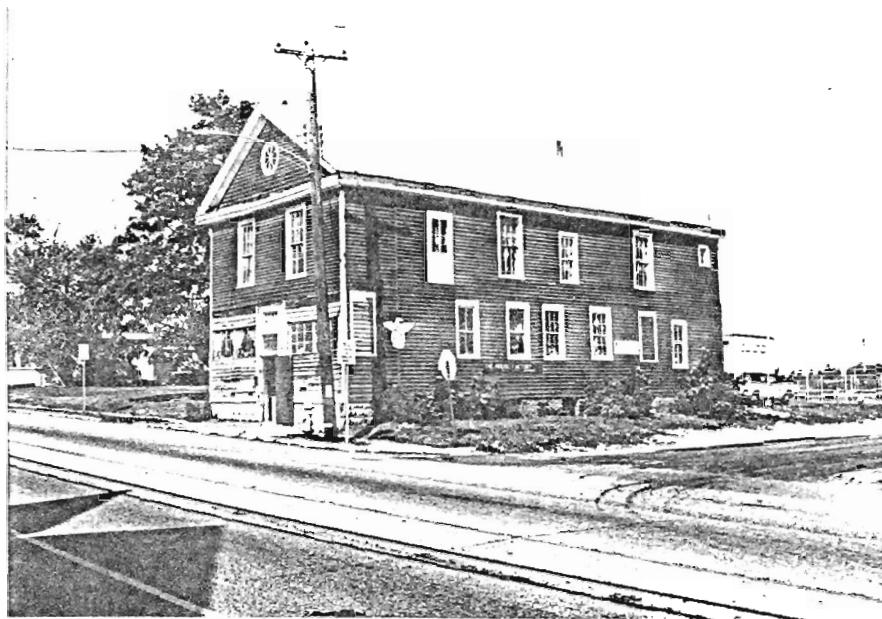
1533-1
West Main Street
Tuckerton
April 1981
View: Southwest

A number of late 18th and 19th century structures are found along West Main Street, originally the New Gretna Town Road. Today these structures are masked behind modern store fronts and enclosed porches. The buildings are located near the roadway and are scattered along both sides of the street. The buildings were originally residential and farm-houses. In the late 19th century, a sewing machine factory was built at #137. Early in the 20th century, other commercial structures could be found along the road including a small art deco gas station at the corner of Center Street. Through the years the road has remained a major route leading to and from Tuckerton.

A map of 1879 shows many of the existing structures, however other 19th century structures have been built along the northern section. Early structures usually have 2 stories, 2, 3 or 5 bays, gabled roofs and 6/6 windows or 2/2 and 1/1 replacements. Late 19th century buildings contain more decorative elements including towers, cross gabled roofs and verge-boards. Many of the buildings have been extensively altered. In the early 20th century the road became the major route to popular South Jersey resorts such as Atlantic City and Cape May.

PHYSICAL CONDITION OF BUILDINGS: Excellent % Good 50 % Fair 50 % Poor %

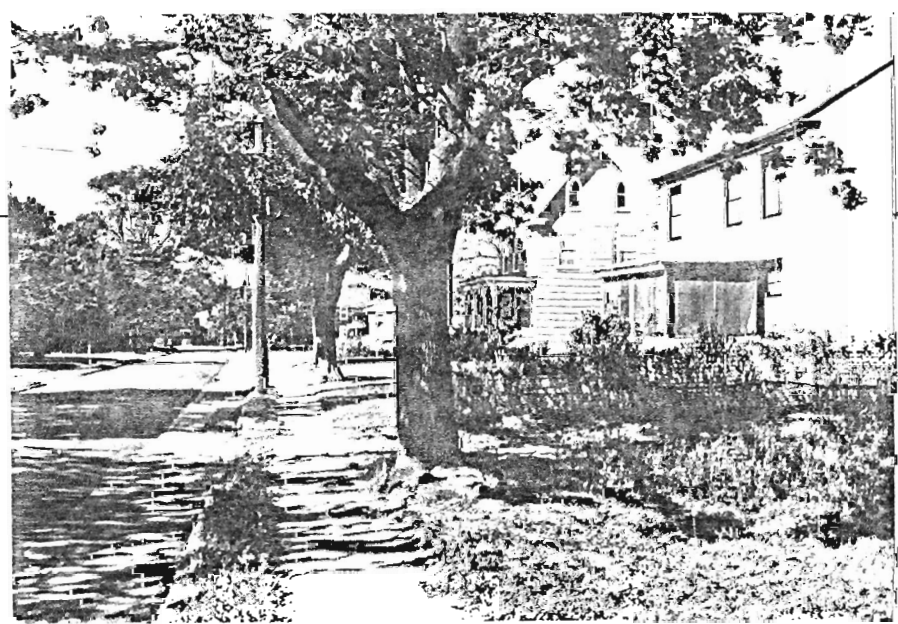
1533-2
Center Street
Tuckerton
March 1981
View: South

APPROXIMATE NUMBER OF BUILDINGS: 12
PHYSICAL CONDITION OF BUILDINGS: Excellent ___ % Good 75 % Fair 25 % Poor ___ %
REGISTER ELIGIBILITY: Yes ___ Possible ___ No ___ Part of Larger District X
THREATS TO STREET: Roads ___ Development ___ Zoning ___ Deterioration ___ No Threat X Other ___
COMMENTS:

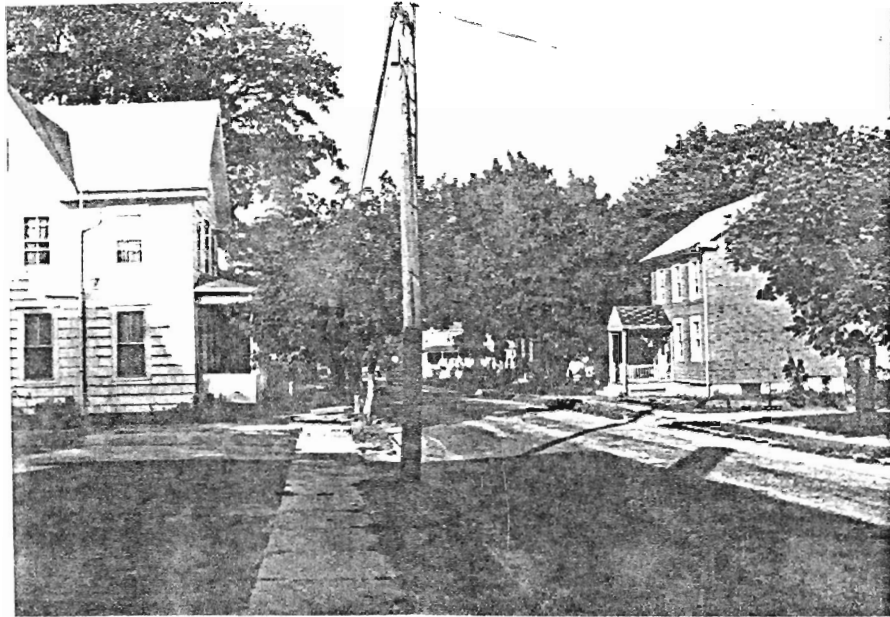
1533-5
Church Street
Tuckerton
March 1981
View: South

This small street runs one block between North Green and Wood Streets. Small structures built close to the road's edge line the street. A graveyard, which dates from the late 18th century is at the southwest corner of the street. Various building types can be seen. One of the earliest buildings is #119 which is 2 stories, 3 bays with a stone foundation, gabled roof with returns, 6/6 windows, and door with transom. Later structures such as #120, circa 1880, has a cross gable roof, and paired Roman arched attic windows. #129 contains a gambrel roof and open porch with turned posts, sawn brackets and a standard railing. Many of the buildings have been altered by the replacement of clapboard and cedar shingles with aluminum and asbestos and by the enclosing of porches. According to the 1878 map, a schoolhouse and other buildings existed on the block.

APPROXIMATE NUMBER OF BUILDINGS: 6
PHYSICAL CONDITION OF BUILDINGS: Excellent ___ % Good 50 % Fair 50 % Poor ___ %
REGISTER ELIGIBILITY: Yes ___ Possible ___ No ___ Part of Larger District X
THREATS TO STREET: Roads ___ Development ___ Zoning ___ Deterioration ___ No Threat X Other ___
COMMENTS:

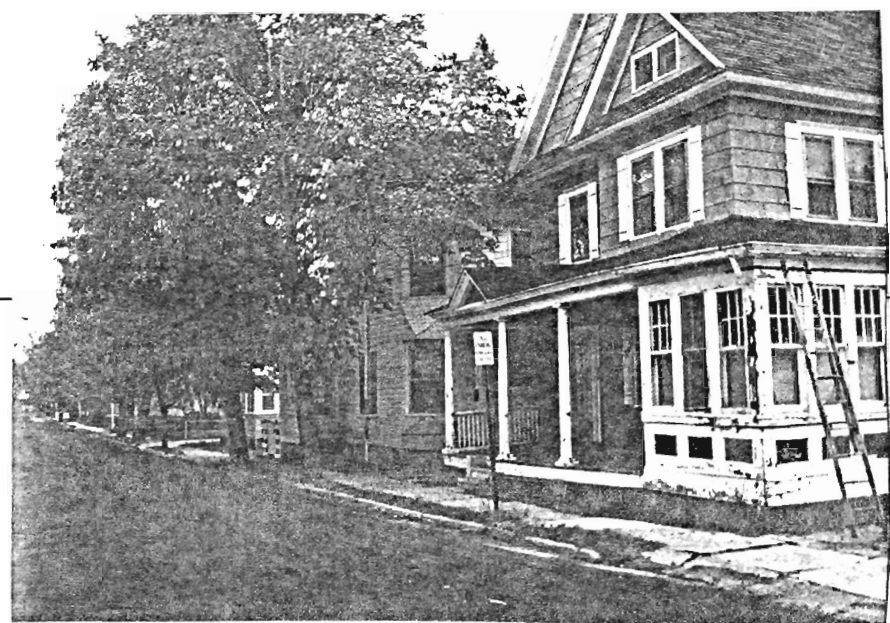
1533-6
Wood Street
Tuckerton
Fall 1981
View: West

APPROXIMATE NUMBER OF BUILDINGS: 31
PHYSICAL CONDITION OF BUILDINGS: Excellent ___ % Good 60 % Fair 20 % Poor 20 %
REGISTER ELIGIBILITY: Yes ___ Possible ___ No ___ Part of Larger District X
THREATS TO STREET: Roads ___ Development ___ Zoning ___ Deterioration ___ No Threat X Other ___

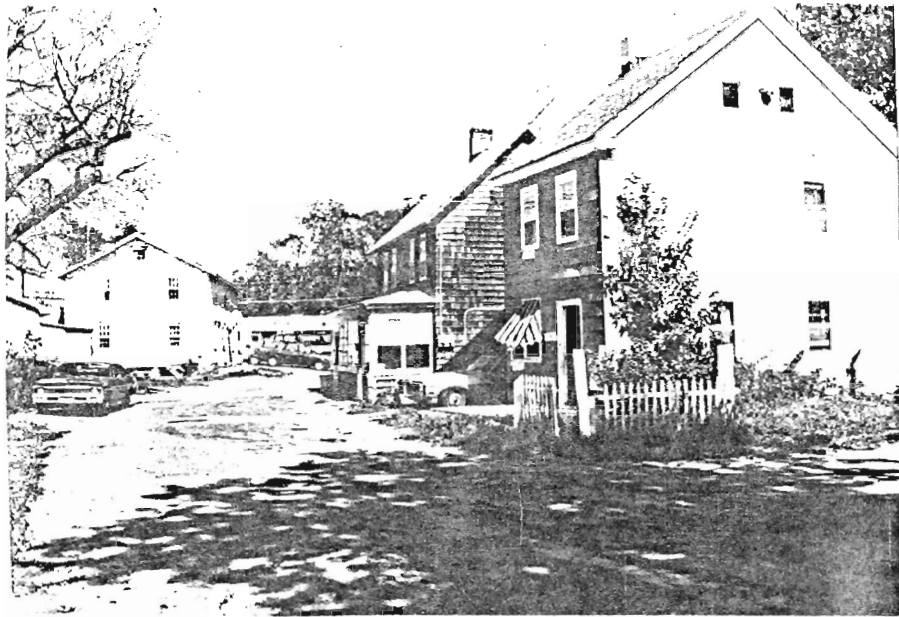
1533-7
Water Street
Tuckerton
March 1981
View: West

The structures are located close together at the road's edge. Water Street is a narrow road which curves along Tuckerton's waterfront (Tuckerton Creek) for one block. Modern structures have been built along the south side of the street, however, all of the 19th century structures except one are found on the north side. All of the buildings are simple gabled roof houses which have been altered over the years. The typical structure is 2-2½ stories, 2-4 bays wide, asbestos sided with 2/2 windows. The mill, located at the western end of the street has been the site of saw mills since 1704. The present mill, now the towns waterworks was constructed in the 19th century. The Water Street area is one of the oldest settled places in Tuckerton and was one of the major commercial areas of town during the 18th and early 19th century when shipping and boat-building were Tuckerton's major activities. The 1878 map of Tuckerton shows all of the buildings along the northside of the street, however, no road existed at that time.

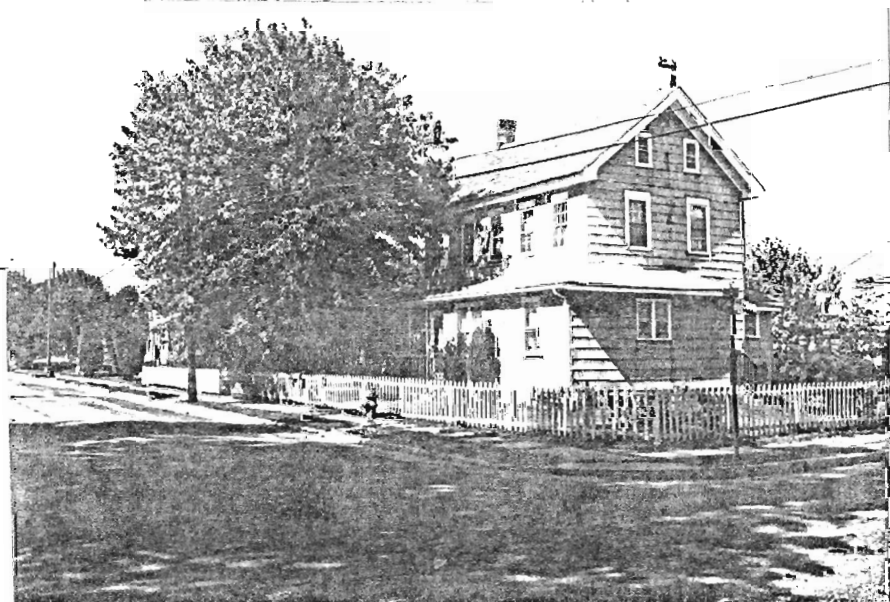
1533-8
Clay Street
Tuckerton
March 1981
View: Southwest
MAP:
SLIDES:
REFERENCES:

APPROXIMATE NUMBER OF BUILDINGS: 21
PHYSICAL CONDITION OF BUILDINGS: Excellent % Good 75 % Fair 20 % Poor 5 %
REGISTER ELIGIBILITY: Yes Possible No Part of Larger District X
THREATS TO STREET: Roads Development Zoning Deterioration No Threat X Other
COMMENTS:

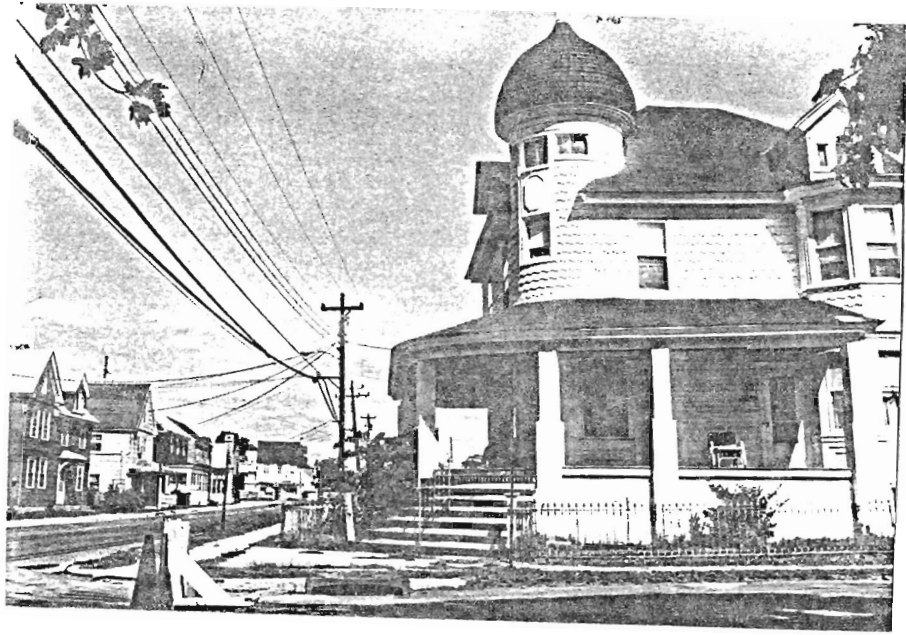
1533-9
Green Street
Tuckerton
March 1981
View: West

Green Street contains a number of structures built during the second half of the 19th century. The northern end of the street contains later structures with Queen Anne elements. These structures often have open porches, cross gabled roofs and irregular plans. Large empty lots in this block mark where buildings have been demolished or destroyed by fire. One Tudor style structure with half-timbering in its gabled peak is found in this area. The southern block has older buildings which are smaller in scale and have few decorative elements. These buildings have been altered over the years (windows and exterior materials have been replaced.) A large Queen Anne building with an onion dome dominated the southern section of the street. Like the northern end of the street, large empty lots exist. The street, however, shows the various architectural types existing in the Borough, including the Queen Anne, Greek Revival, Italianate and Second Empire. Many of the structures appear on the 1878 and 1898 maps of Tuckerton.

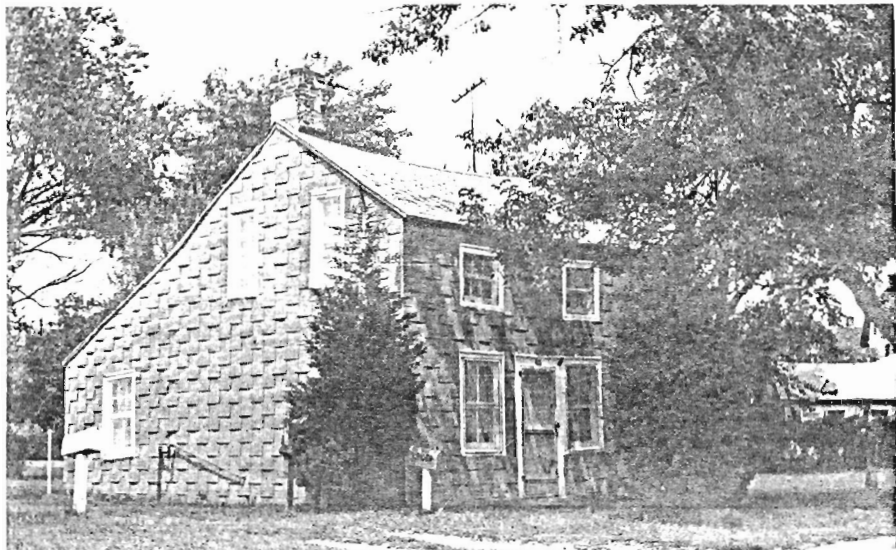
Negative File No. 1533-10

Foundation: low, covered by asphalt

A six-panelled center door is flanked by 2/2 windows. Narrow eyebrow 3/3 windows are found on the second floor.

The structure is one of the oldest structures in the Tuckerton area. Only a handful of buildings dating from the 18th century can be found in the region. Although altered by asphalt siding, the structure remains much as it did when constructed.

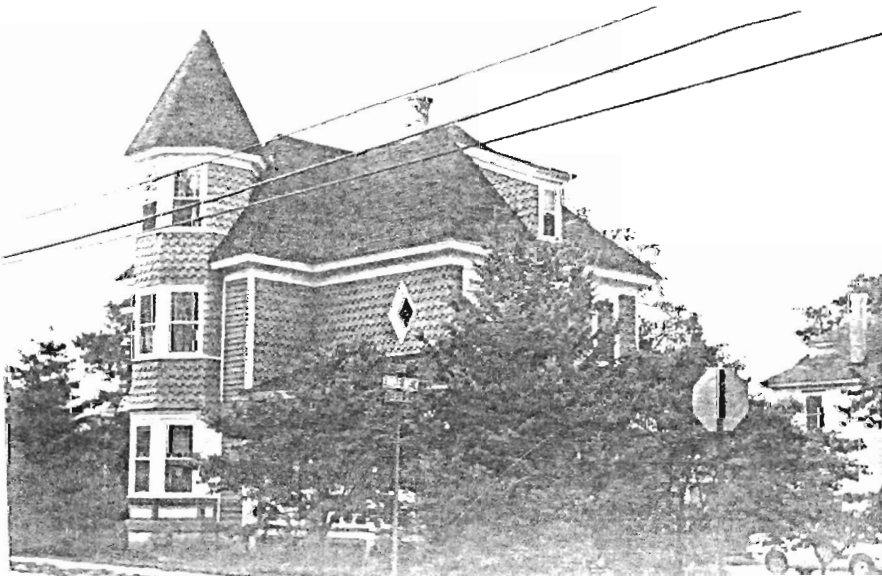
PHOTO Negative File No. 1533-11

Construction Date: c. 1849
remodelled 1893
Architect:
Style: vernacular / Queen Anne
Number of Stories: 2½
Foundation: low, poss. brick
Exterior Wall Fabric: clapboard, staggered butt shingle
Fenestration: 3 bay
Roof/Chimneys: hipped
Additional Architectural Description:

A 3 story turret with octagonal roof is found in the corner. Windows are Queen Anne sash. Shed dormers and elongated first floor windows with shoulders are found. An open porch contains turned posts, a valence rail and balustrade. A double leaf door with transom is located on the facade.

The structure is located on a corner lot in a densely settled area. Smaller structures with less decorative elements are found in the area.

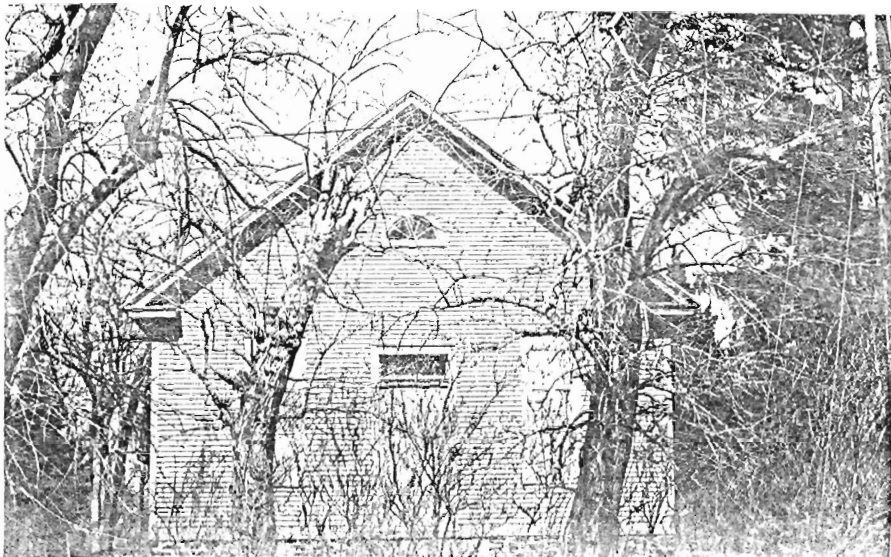
Negative File No. 1533-12

Foundation: stone, low

A lunette is found in the facade gable end. A large double-leaf center door contains a transom and simple molded surrounds. A three-step platform leads to the entrance. Large elongated windows flank the doorway. The windows have shutters which are closed.

The Friends Meeting was the first religious organization established in the area in 1704. By 1708 a meeting-house was built and graveyard plotted. In 1863 that structure was replaced by the present meetinghouse. It remains one of the few reminders of the early Quaker settlement.

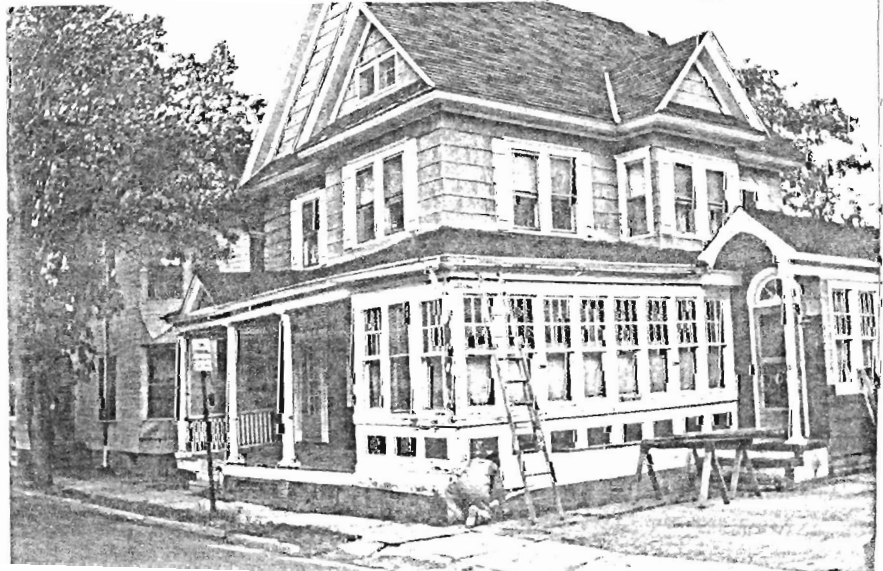
PHOTO Negative File No. 1533-13

DESCRIPTION
Construction Date: c. 1890
Architect:
Style: Victorian Queen Anne
Number of Stories: 2½
Foundation: low, stone
Exterior Wall Fabric: shingle, asbestos 1st floor on wing
Penetration: 4 bay
Roof/Chimneys: double gable
Source of Date: style
Builder:
Form/Plan Type: duplex, rectangular
Additional Architectural Description:

These semi-detached buildings contain decorative shingles and Queen Anne and 2/2 windows. Angled windows are found at the corner and contain drops and flaring walls. Diamond windows are located in the gable peaks. Incised boards and vergeboard are also found in the gable ends.

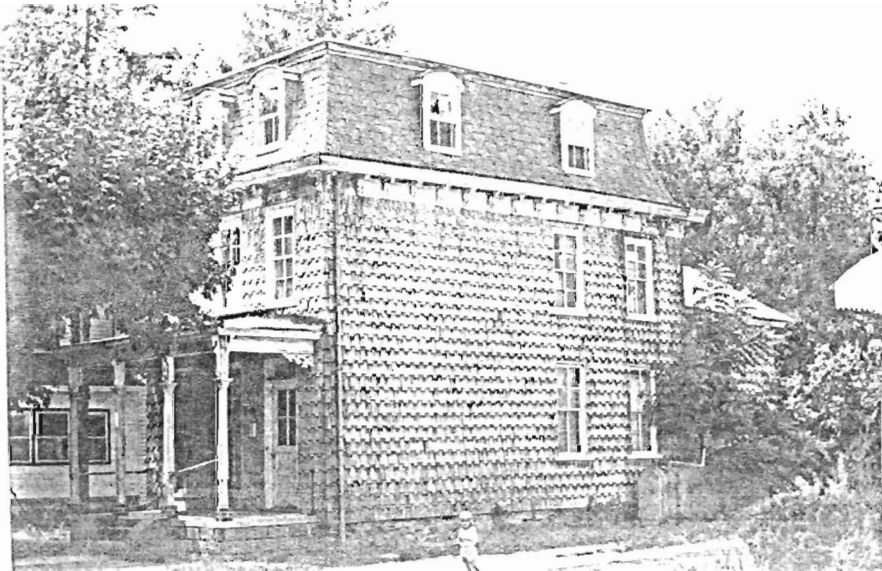
Negative File No. 1533-15

Construction Date: pre 1878
Architect:
Style: vernacular / Second Empire
Number of Stories: 2½
Foundation: low
Exterior Wall Fabric: natural wood shingle, staggered butt
Fenestration: 3 bays
Roof/Chimneys: mansard / 1 chimney
Additional Architectural Description:

The structure is found at a bend in the road and is surrounded by small houses on narrow lots. A structure across the street contains similar elements, but has been altered.

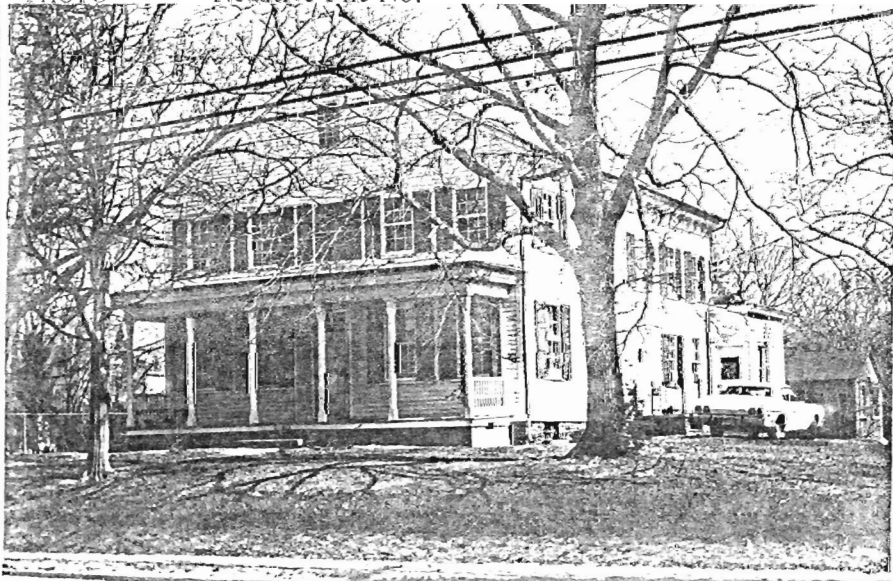
PHOTO Negative File No. 1533-19

This large structure has a steep gable roof that faces the street. 5/6 windows with louvered or panelled shutters are employed. A center door contains a transom. An open porch with chamfered posts runs across the facade. Corner posts are found at each end. A scroll bracketed cornice runs along the perimeter of the building.

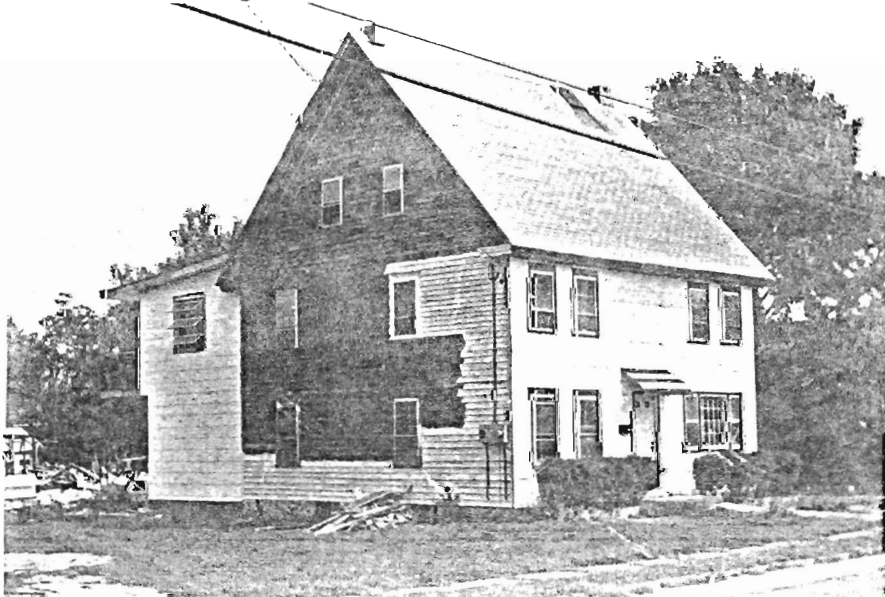
Negative File No. 1533-24

The structure is one of the most unusual houses in town since its scale is larger than those found in the area. (The building's scale is similar to houses found in New England.) The structure has been altered, but still has unpainted clapboard sides, steep gable roof, and a lean-to rear. The size of the building indicates that it originally may have been used for commercial purposes.

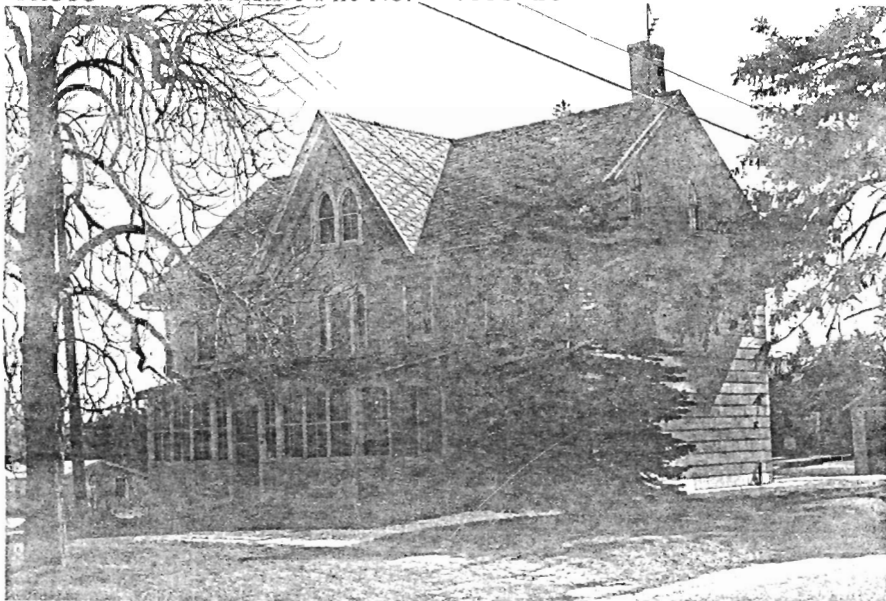
PHOTO Negative File No. 1533-25

Windows are 2/2. A palladian window is found on the second floor and pointed arch windows in the gable peaks. An enclosed porch is located on the facade.

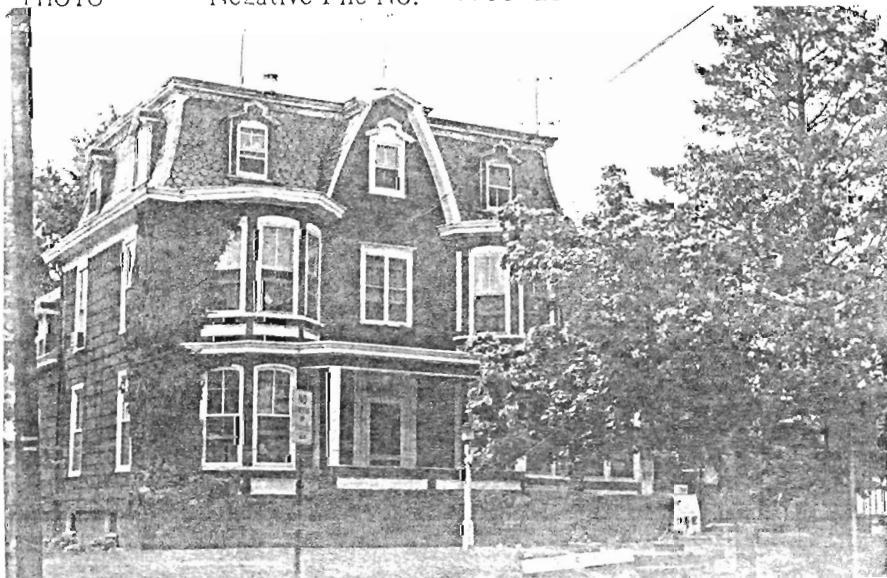
Negative File No. 1533-23

Windows are 2/2. Dormers with decorative surrounds are found on the mansard roof. A 1 story rear ell was built about the same time since similar elements are employed. An enclosed porch is located on the south end. A center door has a transom and is flanked by 2 story bay windows.

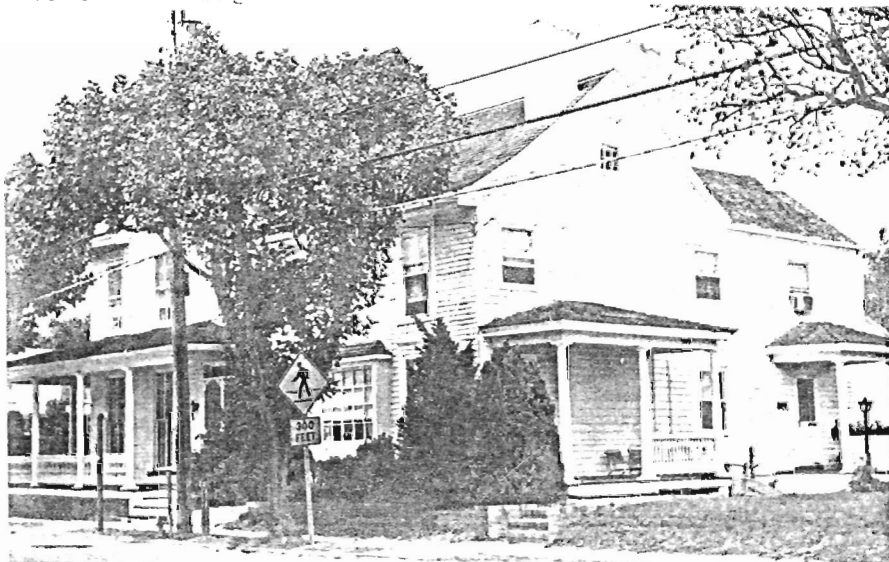
PHOTO Negative File No. 1533-29

The structure is two separate buildings which were joined together. The northern section is 2 bays with a clapboard exterior, 12/12 windows and a gable roof. The south end is newer. 2/2 windows are employed. The first floor windows are elongated. An open porch contains Doric columns and turned railing. A double center door has a transom. Paired pointed arch windows are found in the cross gable end.

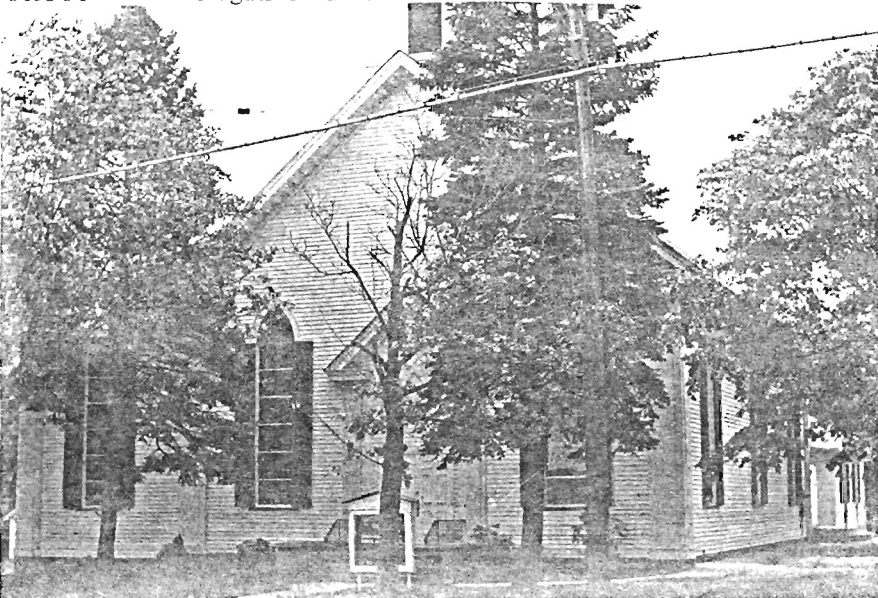
PHOTO Negative File No. 1533-30

A center door with pointed arch transom and pediment surround is flanked by large pointed arch stained glass windows. All windows contain louvered shutters. Colossal end pilasters are found on the facade. A heavy modillion cornice runs along the perimeter of the church and the gable roof has returns. There is a cupola with four pointed arch openings. A one story north wing contains a false front with similar elements. A large rear addition is modern.

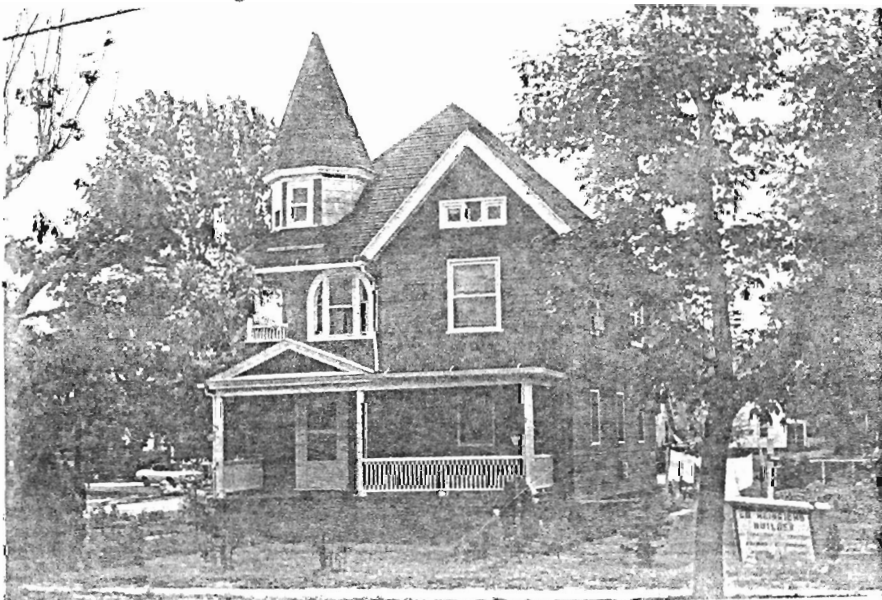
Negative File No. 1533-31

An open porch contains a two-course dentilled cornice, standard railing, and Doric columns. A balcony is found on the second floor, cut into the main house. Windows are 1/1. A tripartite arched window is located on the second floor. The second floor also contains a turret with dentil cornice and octagonal roof. Exposed rafter tails can be found on the north elevation.

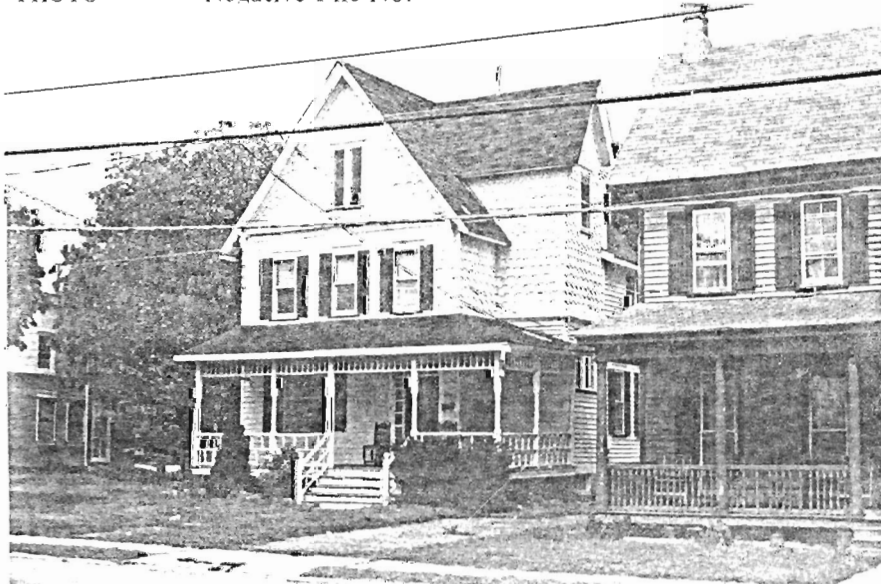
PHOTO Negative File No. 1533-32

An open porch has turned posts and valence and a standard railing.
All windows are 1/1. A south bay window has scroll brackets and a shed
roof. Exposed rafter tails and scroll brackets are found at the roofline.

The structure is typical of late 19th century vernacular / Gothic Revival architecture. Common elements of this style found in this building are the cross gable roof, open porch with turned elements, and decorative shingled peaks.

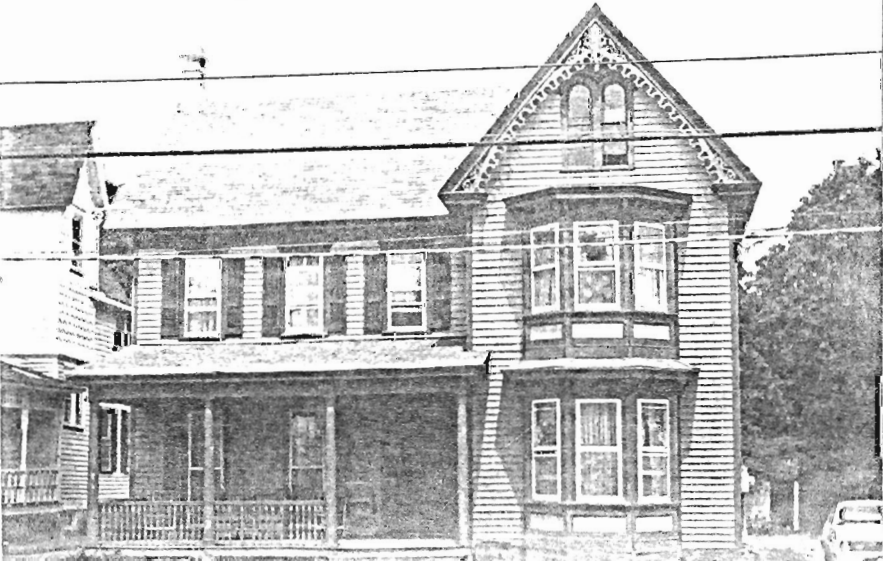
PHOTO Negative File No. 1533-33

An open porch contains Doric columns and a turned balustrade. 2/2 windows with louvered shutters are employed. The first floor facade windows are elongated. A two story bay window is found on the ell. Paired Roman arch attic windows are located in the facade gable end. The gable roof contains returns and vergeboards.

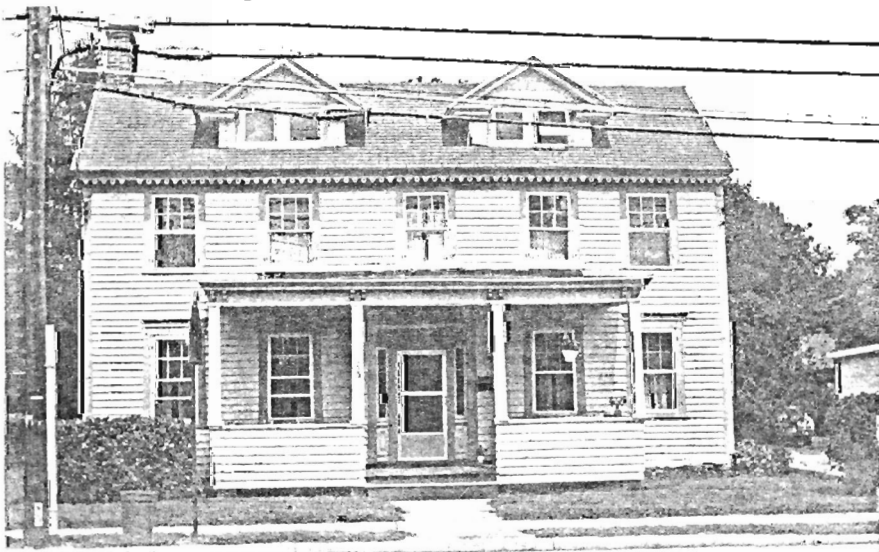
Negative File No. 1533-34

A small porch partially extends over the facade and contains a blind balustrade, piers, and paired brackets. A center door has sidelights and a transom. 6/1 windows with molded surrounds are employed on the first and second floors. Two 20th century dormers with returns are found on the roof. A carved scalloped board runs along the roofline.

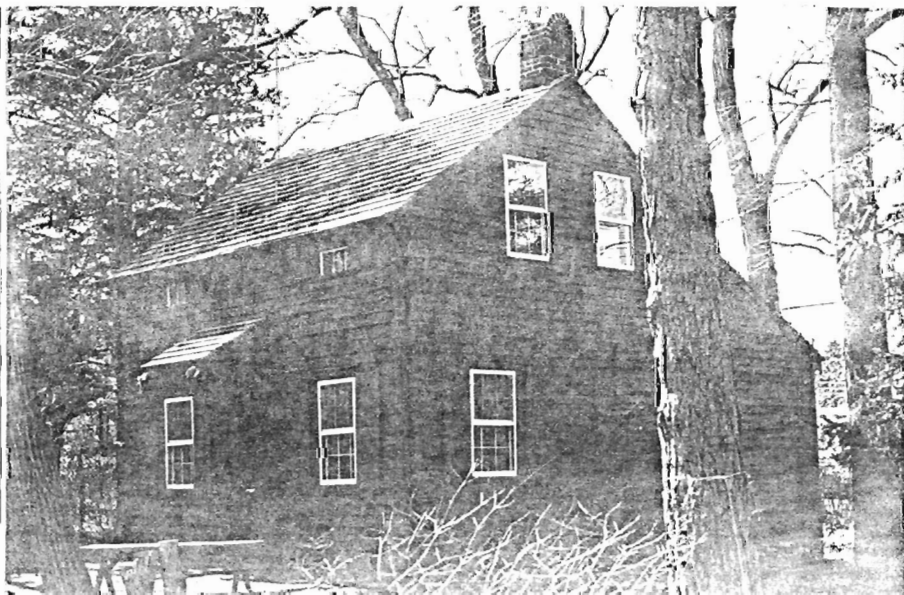
Negative File No. 1533-35

6/6 windows with panelled shutters are found on the first floor. Small 3 paned / single sash windows and shed dormers are located on the upper floor. A lean-to addition is found to the west. The door is centered and contains a hood. Corner posts are found at each end.

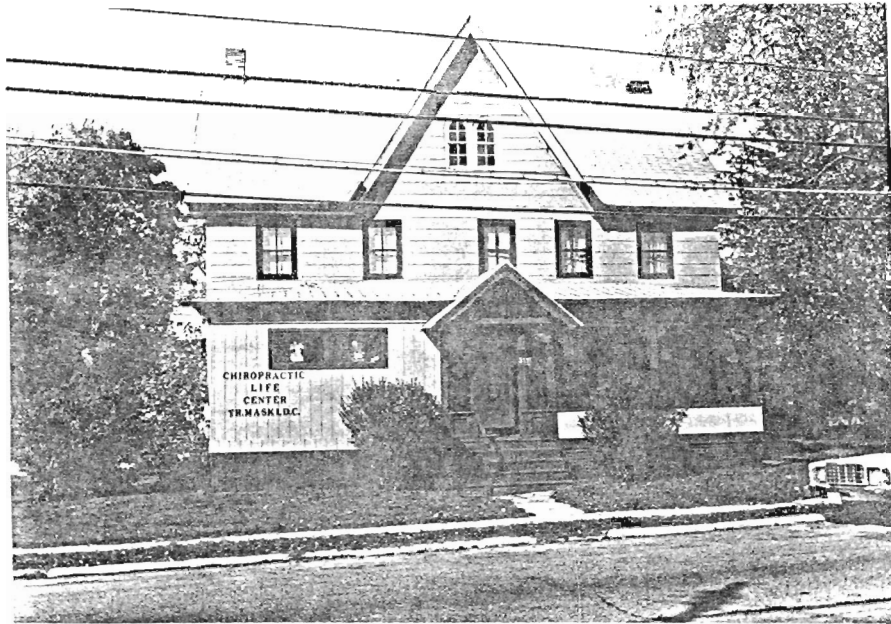
1533-L3

Austin House / 317 Main Street

2½ story, 5 bay, asbestos siding, cross gable roof. A partially enclosed porch with turned posts runs across the facade. Paired Roman-arched attic windows are found in the gable peaks. The structure was the home of Frank Austin, Tuckerton's first mayor, after it became a Borough in 1901.

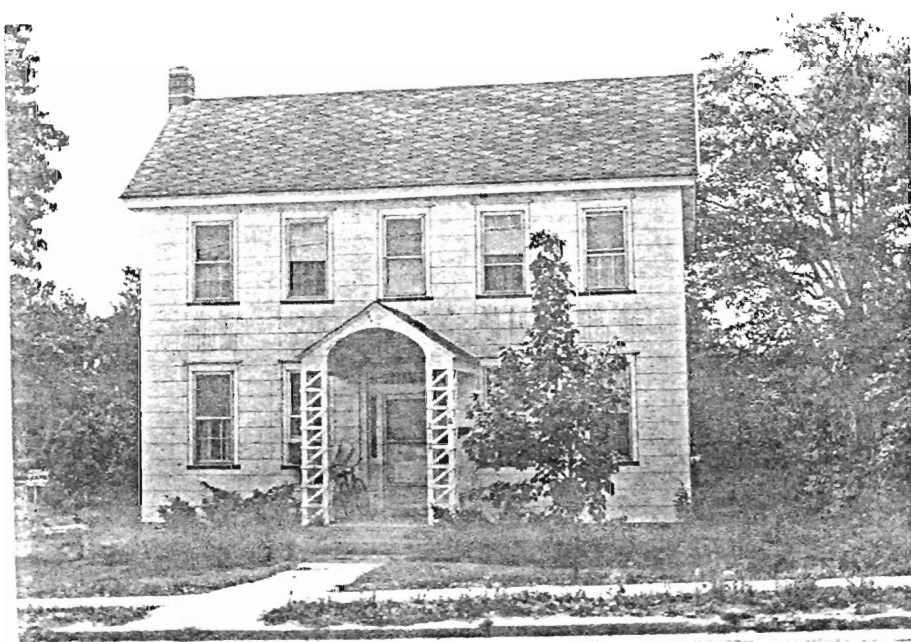
1533-L4

Presbyterian Manse / Main Street

2½ story, 5 bay, asbestos siding, gable roof with returns, c.1860. 6/6 windows with molded surrounds, a center door containing a transom and sidelights, and an open portico are found on the facade. The structure has been altered by the use of asbestos siding and a modern portico.

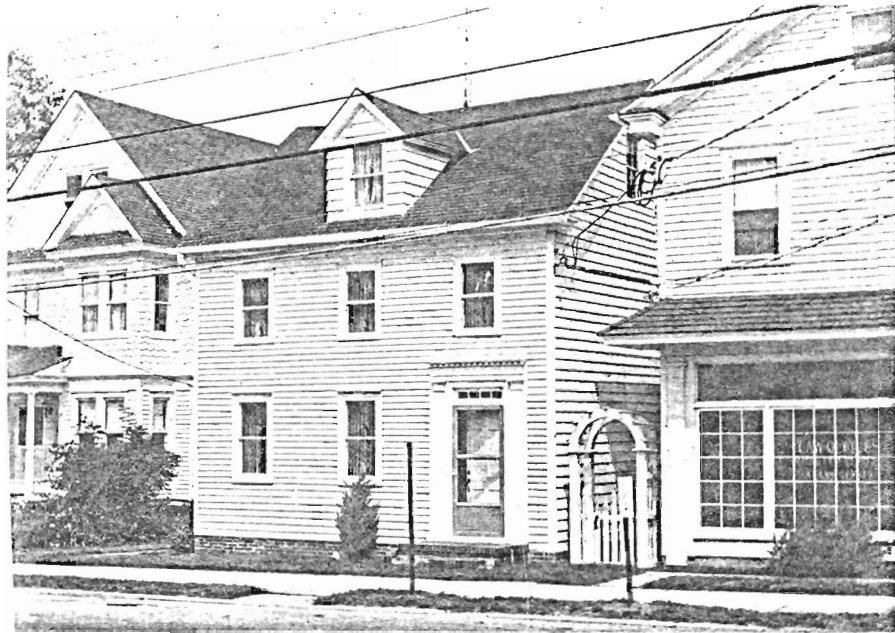
1533-L5

Main Street

2½ story, 3 bay, clapboard exterior, gable roof with returns, c.1860. This small structure still retains its door with dentiled cornice and pilaster. Modern 1/1 windows and a gabled dormer are employed. The structure has a brick foundation.

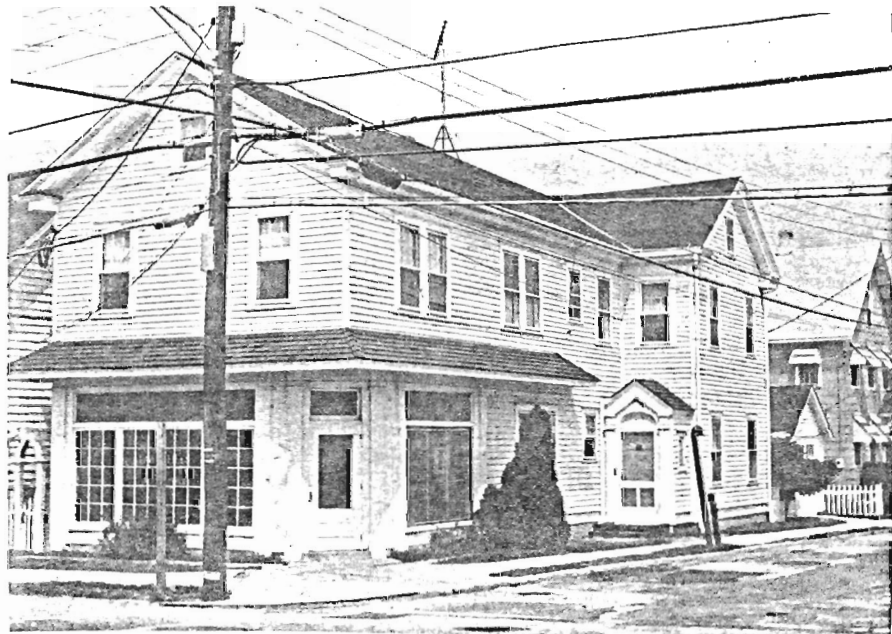
1533-L6

S.W. corner of Main and Wood

2½ story, 2 bay, clapboard exterior, gable roof with returns, built after 1878. A structure on this site is shown on the 1878 map of Tuckerton as the townhall. Windows are 6/1. The first floor contains multi-paned transoms over the door and windows.

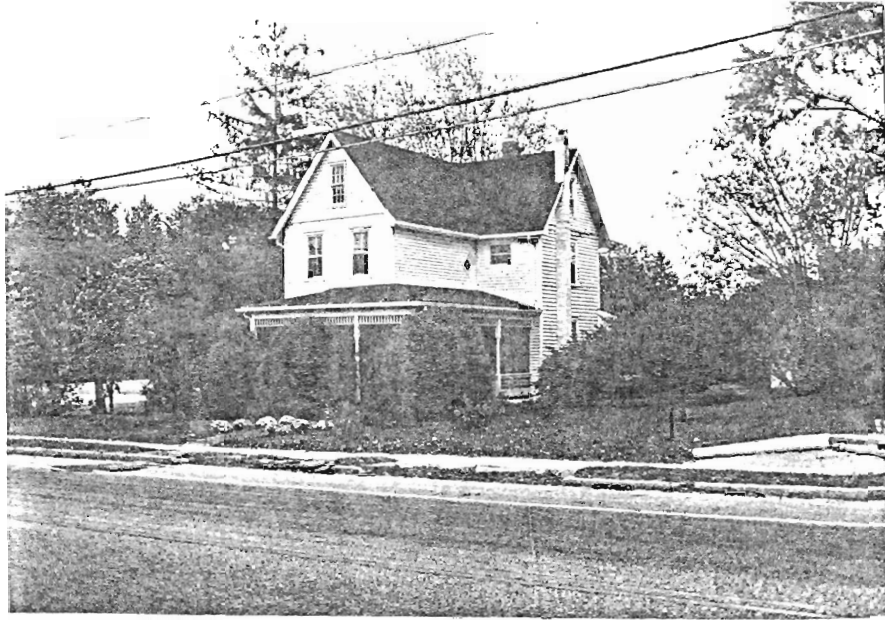
1533-L7

West Main Street

2½ story, 2 bay, clapboard, gable roof. This late 19th century L-plan residential structure has 2/2 and 6/6 windows and an open porch with turned posts, railing and valence.

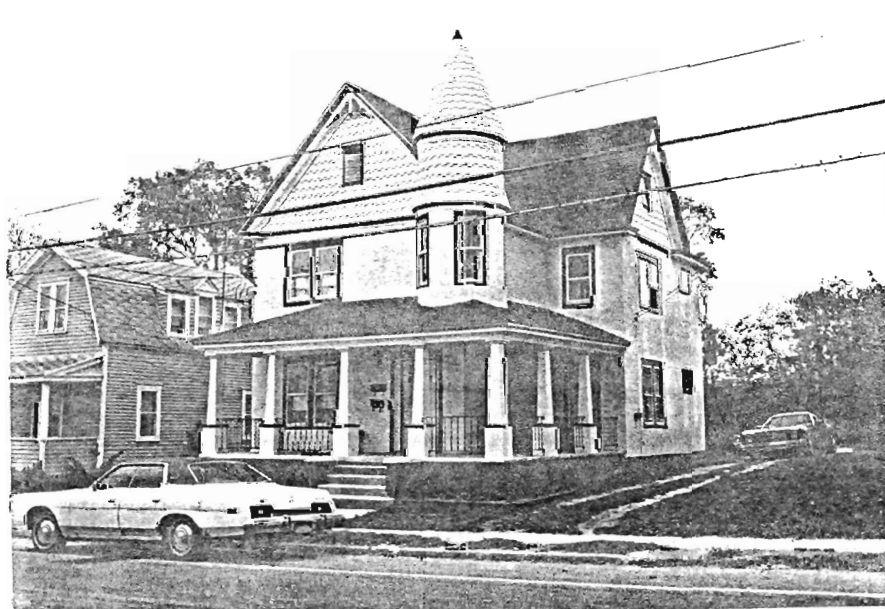
1533-L8

130 Main Street

2½ story, 2 bay, stucco with staggered-butts peaks, gable roof. A turret is located in the southeast corner. The structure is an unusual example of Victorian Queen Anne architecture. Its exterior has been extremely altered.

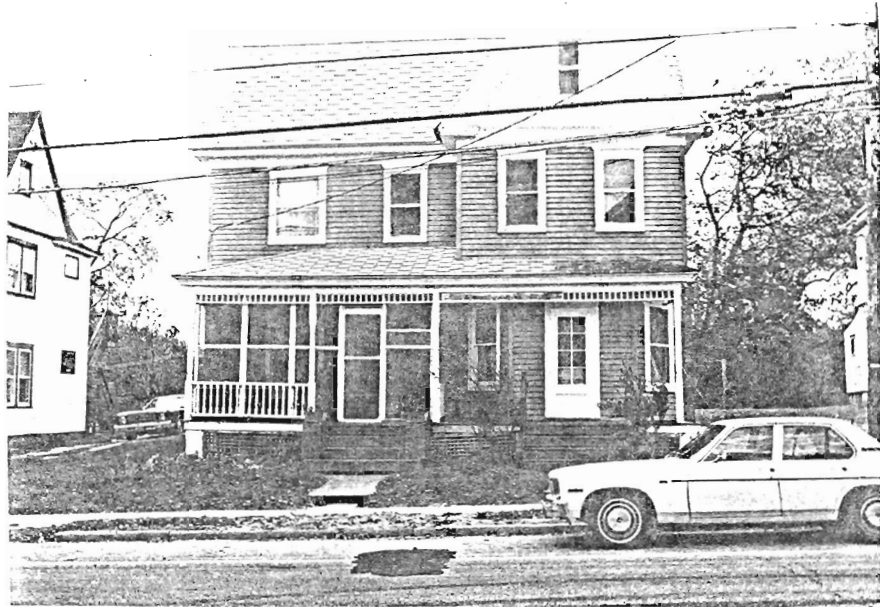
1533-L9

136 Main Street

2½ story, 4 bay, clapboard and staggered-butt shingle peaks, cross gable roof with returns. An open porch contains turned posts, balustrades and a valence. Windows are 1/1 throughout. The structure's first floor has been extensively altered.

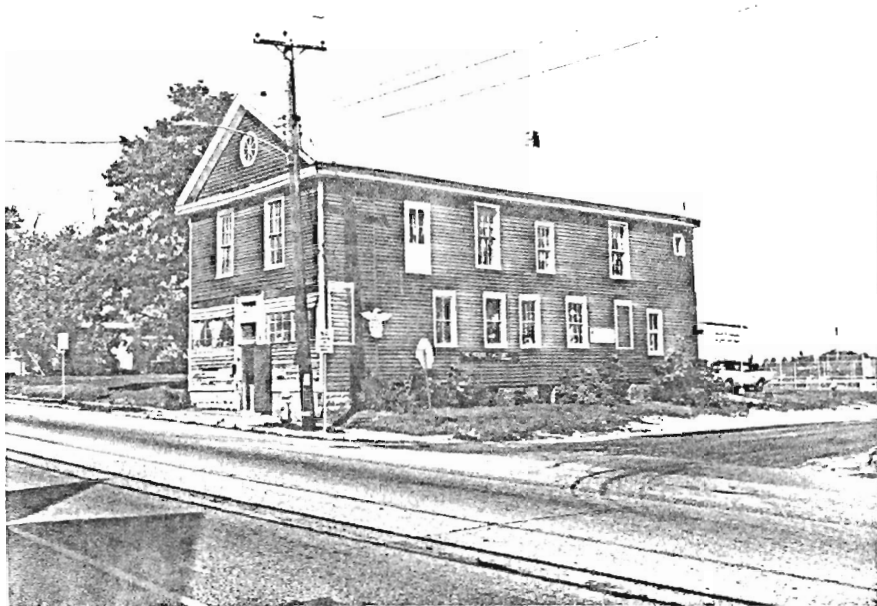
1533-L10

137 West Main Street

2½ story, 2 X 4 bay, clapboard, gable roof with full return. The gable peak faces the road and contains a bull's eye in its attic level. 6/6 windows are found on the second floor. The first floor has been altered for commercial purposes. The foundation is brick.

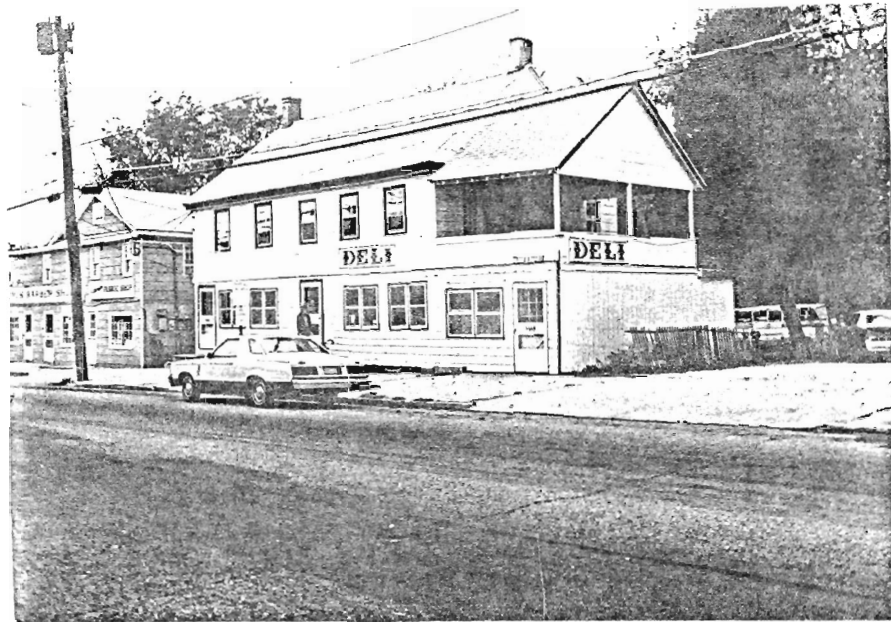
1533-L11

Delicatessen / Main Street

2½ story, 5 bay, asbestos and shingle exterior, gable roof. Two end interior chimneys. 2/2 windows are employed throughout. This structure has been a commercial building for many years. In the early 1900s it was the Blackman's Ice Cream Shop. It is also believed to be the site of the first post office in Burlington County in 1714.

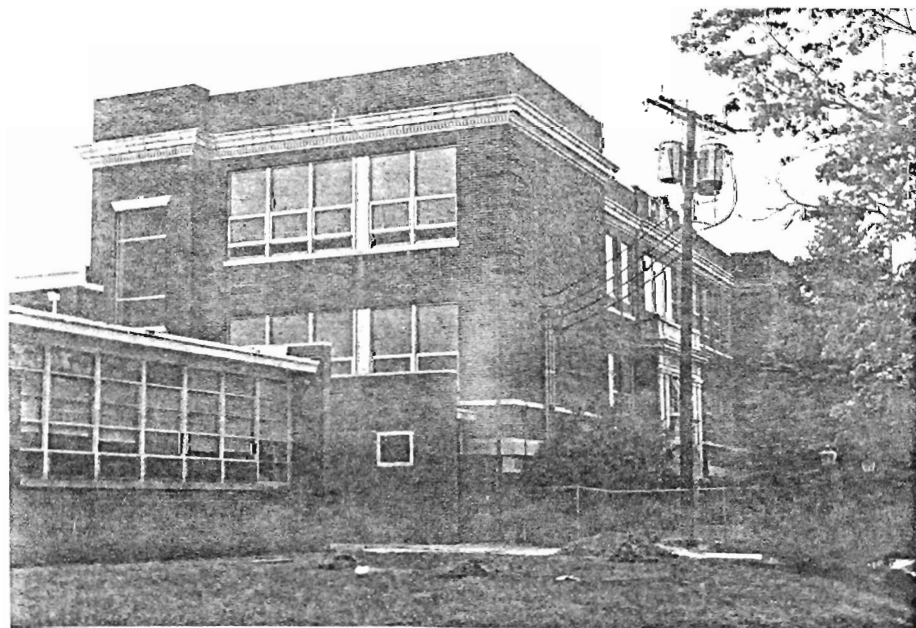
1533-L12

Tuckerton High School / Marine Street

2½ story, 11 bay, brick exterior, parapet roof, circa 1926. A modern wing is located to the west. The original school has a center doorway with limestone pilasters, dentil cornice and consoles. Limestone bands are also found at the cornice and watertable levels. A cartouche is located at the top of the center portion. Large continuous windows are employed.

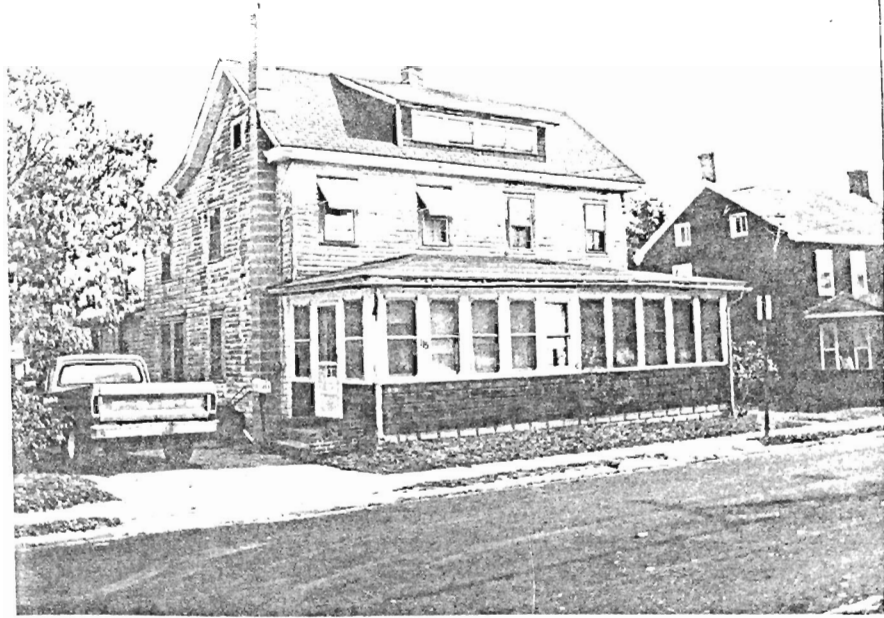
1533-L13

115 Marine Street

2½ story, 4 bay, clapboard exterior, gable roof with large slope to rear. An enclosed porch runs across the facade. A group of 4 shed dormers and 1/1 windows is also found on the facade.
