TUCKERTON

NEW JERSEY OFFICE OF HISTORIC PRESERVATION HISTORIC SITES INVENTORY NO.: 1533-1
STREETSCAPE SURVEY FORM

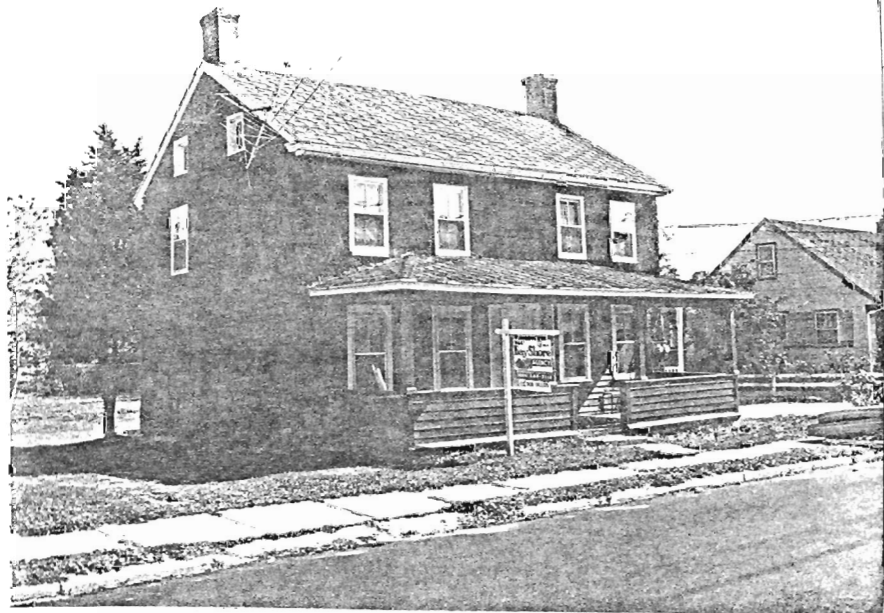
1533-L14

121 Marine Street

2½ story, 4 bay, natural wood shingle exterior, gable roof. A center door is flanked by 4/4 windows. Two interior chimneys can be found at either end of the main roof. A large lean-to addition is located in the rear. An open porch runs across the facade containing square posts and blind balustrade.

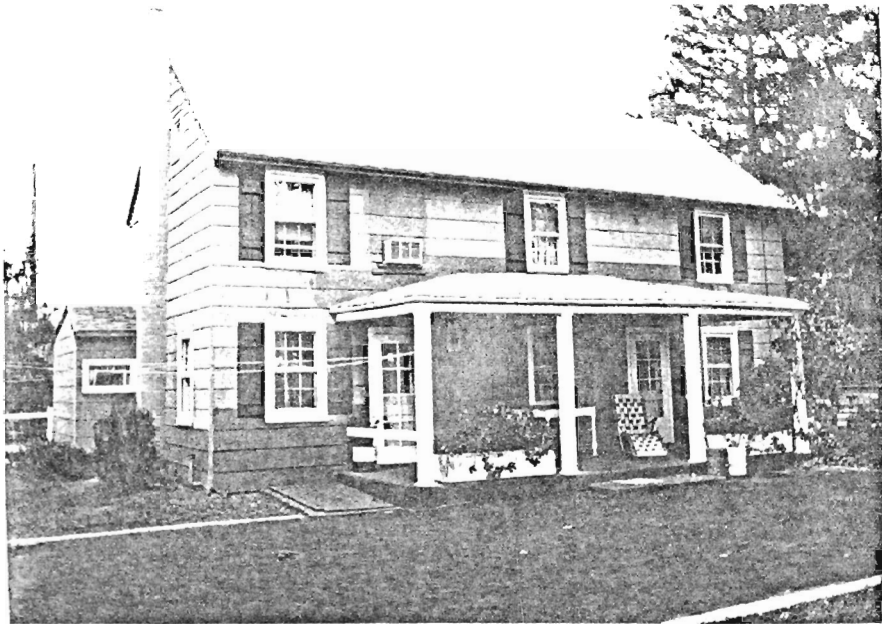
1533-L15

Rockhill / 350 Marine Street

2½ story, 3 bay, asbestos siding, gable roof. Built before 1878. The structure had 6/6 windows and two doors on its east elevation. The building is situated perpendicular to the road.

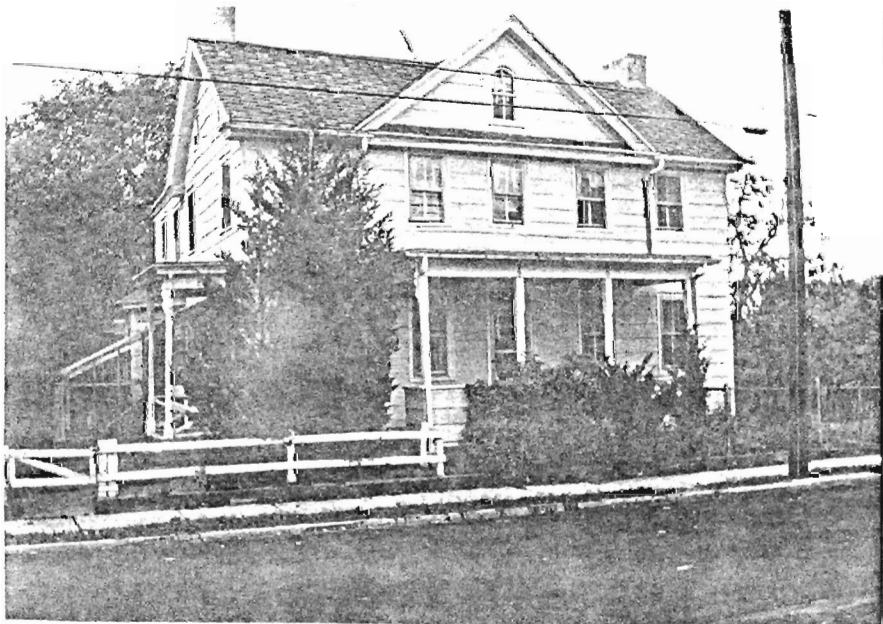
1533-L16

Wood Street

2½ story, 5 bay, asbestos siding, cross gable roof with returns. Windows are 2/2 and round arched with labels in the gable peaks. A center door has a transom. The structure appears on the 1878 map.

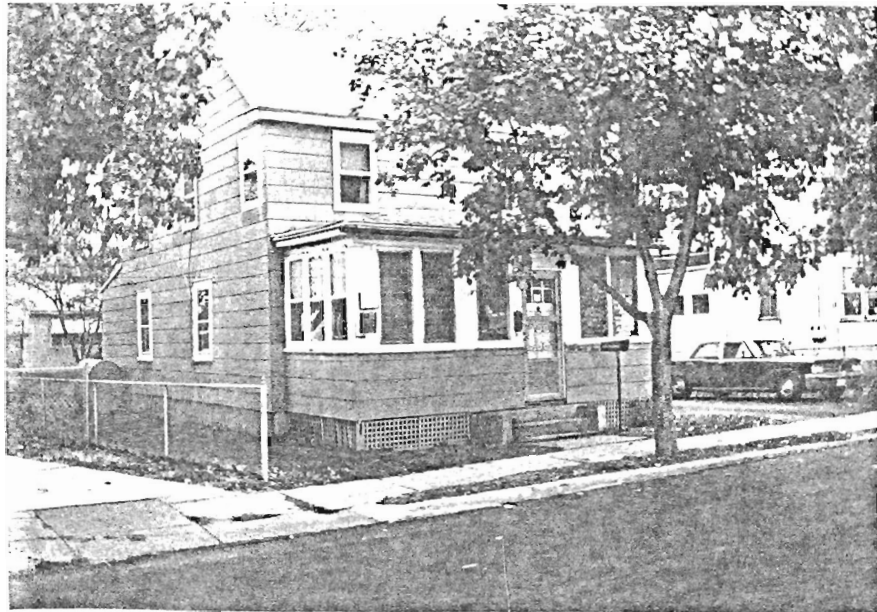
123 Wood Street

2 story, 2 bay, asbestos siding, gable roof. The structure is one of the earliest buildings on the street. The exterior has been extremely altered. An enclosed porch now runs across the facade.

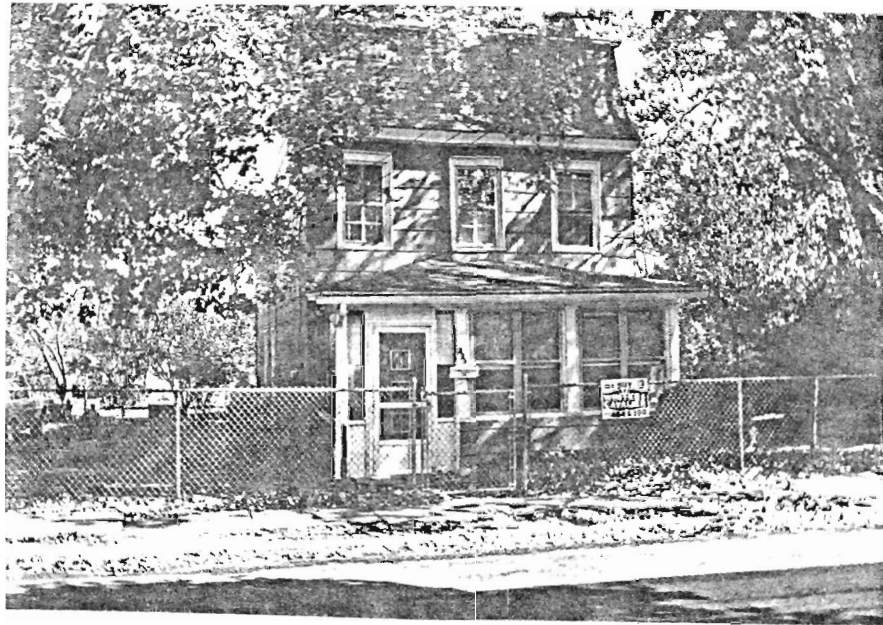
221 Wood Street

2½ story, 3 bay, asbestos siding, mansard roof. The structure is similar to #220 Wood Street, however, the building has been altered by the addition of an enclosed front porch. The structure is one of the few Second Empire style homes still standing.

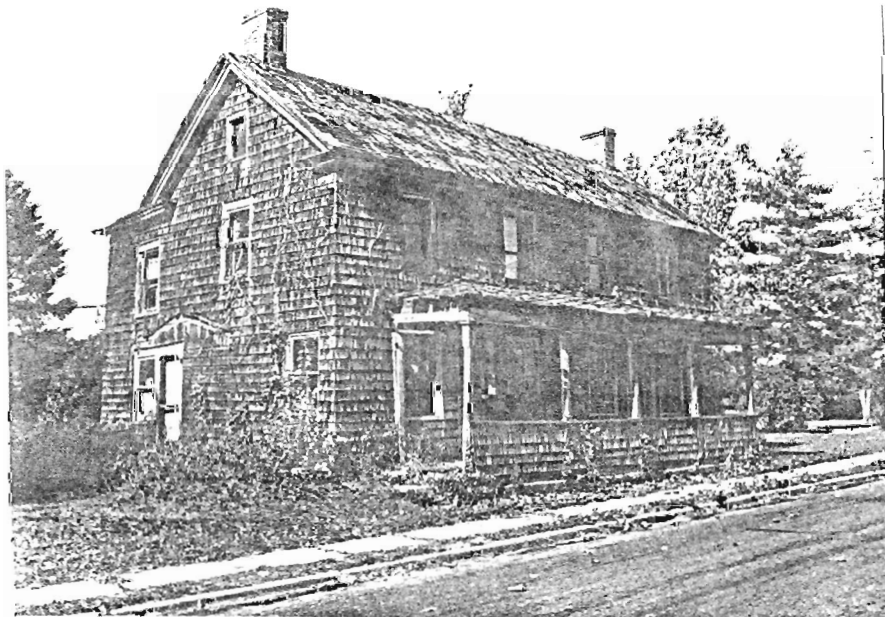
Wood Street

2½ story, 4 bay, natural wood shingle, gable roof with returns. An open porch with blind balustrade and square posts runs across the facade. Windows are 2/2. The building is typical of mid-late 19th century vernacular construction in the Tuckerton area.

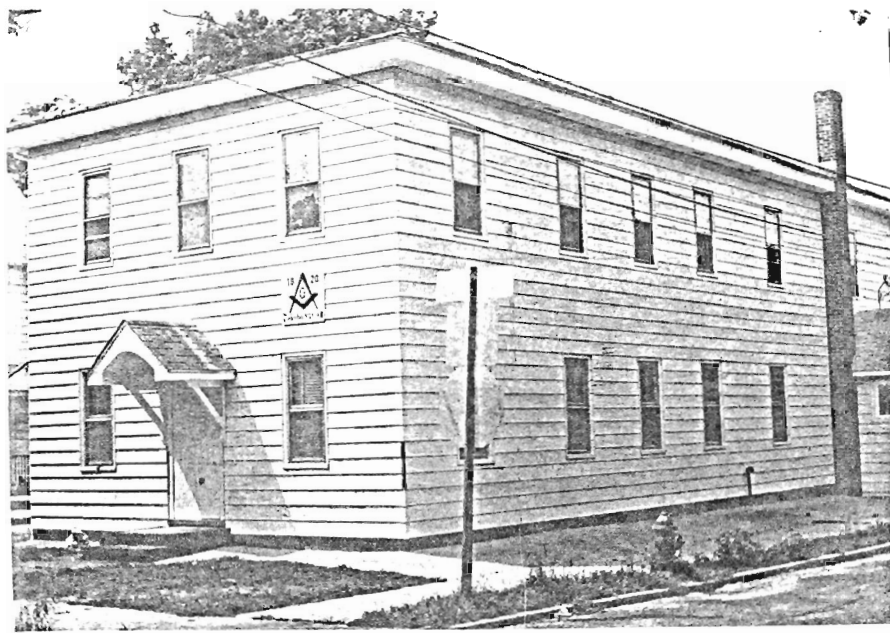
Masonic Hall / Wood and Church Streets

2 story, 3 bay, aluminum siding, gable roof. Although extensively altered the building is one of the earliest Masonic Halls in the state and appears on the 1878 map of Tuckerton.

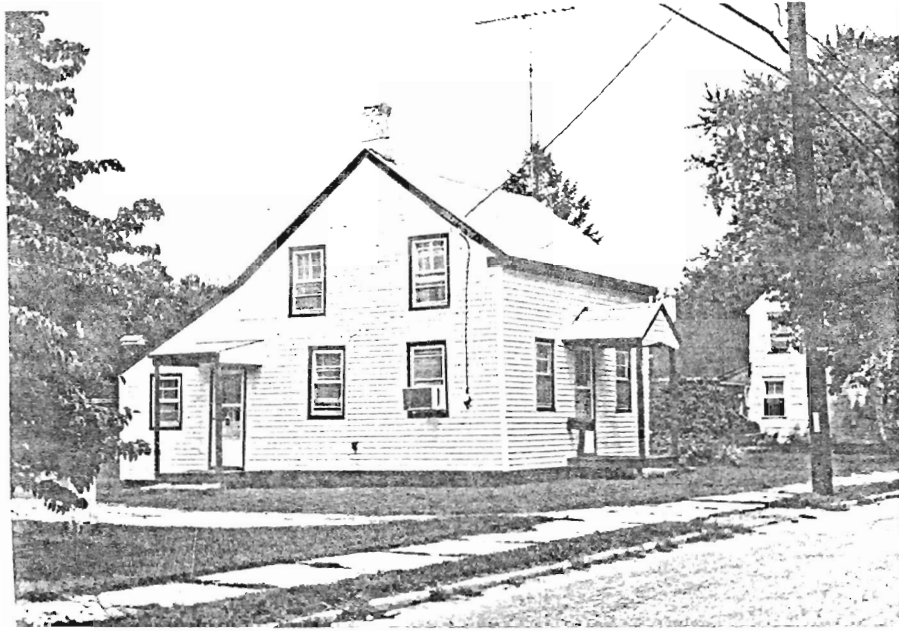
224 Western

1½ story, 3 bay, clapboard exterior, gable roof. This building is similar to #-10 since it has a center door and similar scale and shape. It has been altered slightly.
