# Sediment Decontamination Demonstration Program: Cement-Lock<sup>®</sup> Technology Phase I Pilot Test

## FINAL REPORT

August 2006

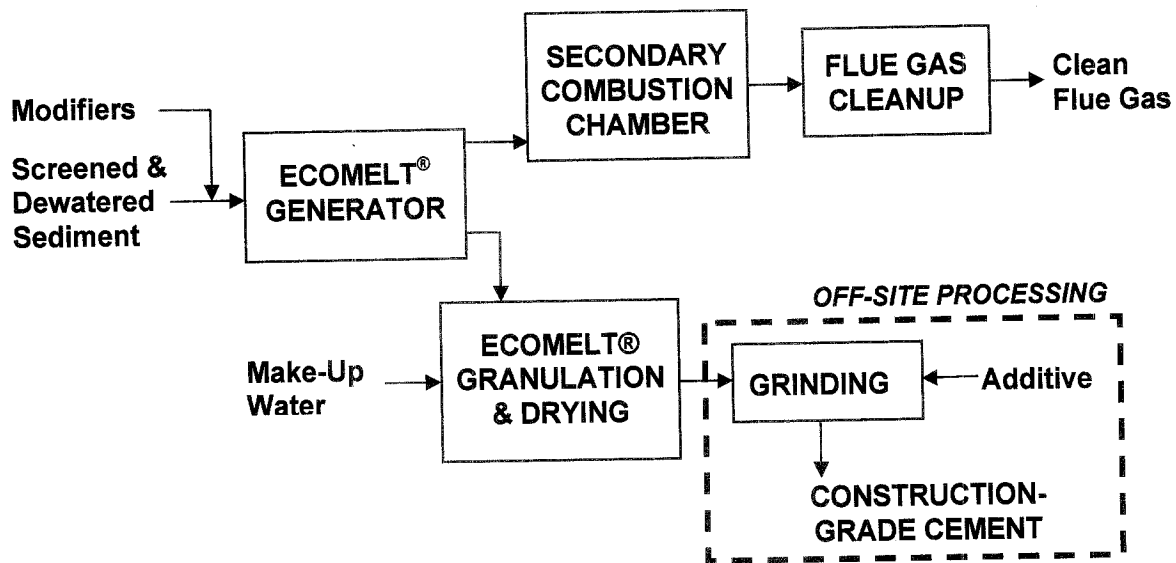
Figure 1. Process Flow Diagram for Cement-Lock Demonstration Plant

In the Cement-Lock process, the mixture of sediment and modifiers is charged to a rotary kiln melter (Ecomelt<sup>®</sup> Generator). The Ecomelt Generator is maintained at a temperature in the range of 2400° to 2600°F by combustion of natural gas or other fuels with air. This temperature yields a melt with a manageable viscosity and causes the minerals in the sediment and modifier mixture

to react together. During processing, the sediment-modifier mixture is thermo-chemically transformed from the recognizable feed materials to a homogeneous melt. All nonvolatile heavy metals originally present in the sediment are incorporated into the melt matrix via an ionic replacement mechanism. The melt flows slowly through the Ecomelt Generator like lava as the kiln rotates. The melt then falls by gravity through a plenum and into water, which immediately quenches and granulates the melt. The quenched and granulated material, called Ecomelt<sup>®</sup>, is removed from the quench granulator by a drag conveyor, which also partially dewateres it.

Flue gas from the Ecomelt Generator flows into the Secondary Combustion Chamber (SCC), which provides an additional 2 seconds of residence time at a minimum temperature of 2200°F to ensure complete destruction of any organic compounds that survive the severe thermal conditions in the Ecomelt Generator. Flue gas exiting the SCC is rapidly cooled via direct water injection to prevent the formation or recombination of dioxin or furan precursors. In a commercial application, the thermal energy of the flue gas could be used to raise steam in a heat recovery steam generator.

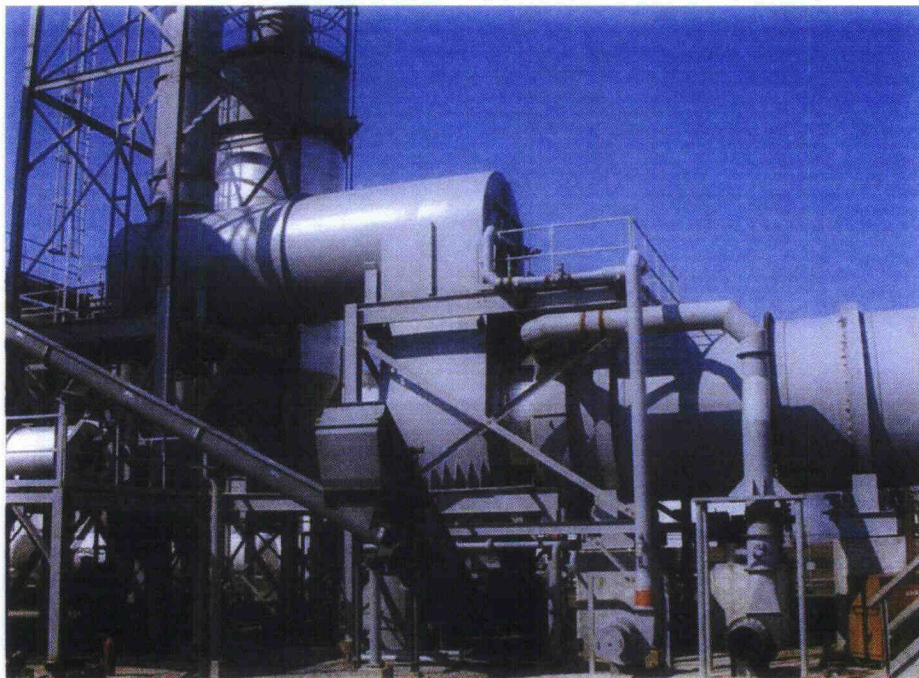
Figure 2. The Cement-Lock Demonstration Plant from the South

Figure 2 shows the Ecomelt Generator and Secondary Combustion Chamber (SCC) from the South. The Ecomelt Generator is a 30-foot long by 10-foot diameter rotary kiln at right. The kiln is connected to the SCC at left via the drop-out box. The drop-out box and Ecomelt Granulator are at center. Visible at the back left is the Flue Gas Quencher.

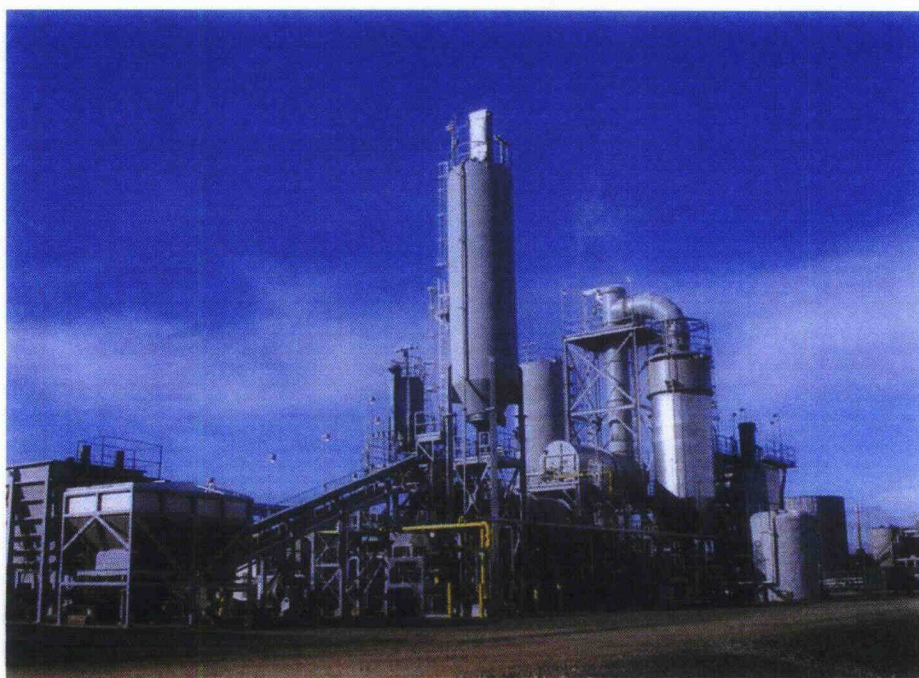
Figure 3. The Cement-Lock Demonstration Plant from the Northeast

Figure 3 shows the overall Cement-Lock demo plant from the Northeast. At far left is the 100-yd<sup>3</sup> sediment storage hopper. To the right of the sediment storage hopper is the 25-yd<sup>3</sup> alternate feed hopper. An inclined screw conveyor connects the feed hoppers to the charging deck. The large vessel at center is the Modifier 1 hopper. The much smaller Modifier 2 hopper is immediately to the left of the Modifier 1 hopper. The Flue Gas Quencher and the quench water storage tank are also shown at the right.

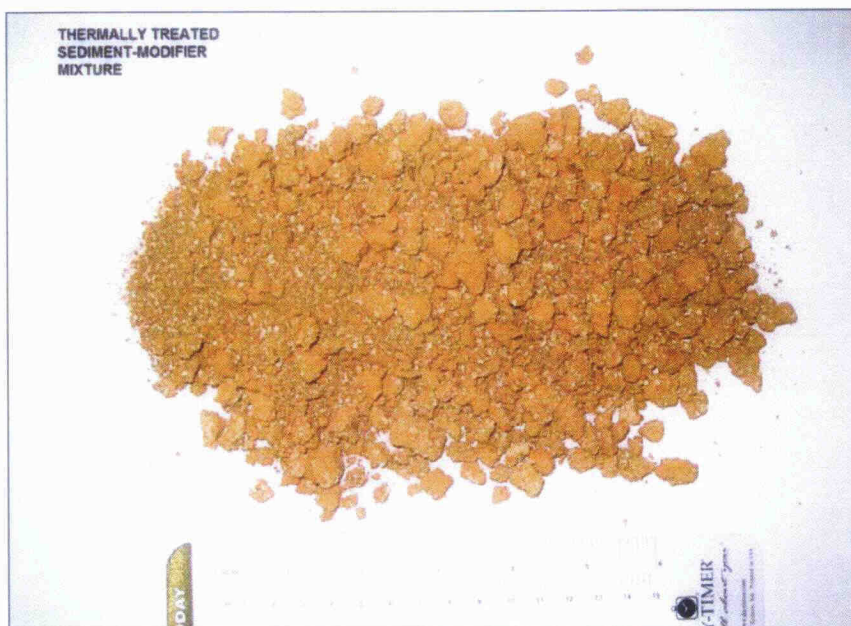
As shown in Figure 4 (below), the thermally treated material from the laboratory-scale test had a uniformly rusty (reddish) color, probably from iron oxide. Also visible in the clumps were inclusions of limestone ( $\text{CaCO}_3$ ), most of which had calcined to lime ( $\text{CaO}$ ) during treatment.

Upon breaking, the exposed fresh surface of the clumps had the same color as the external surface indicating that treatment was uniform.

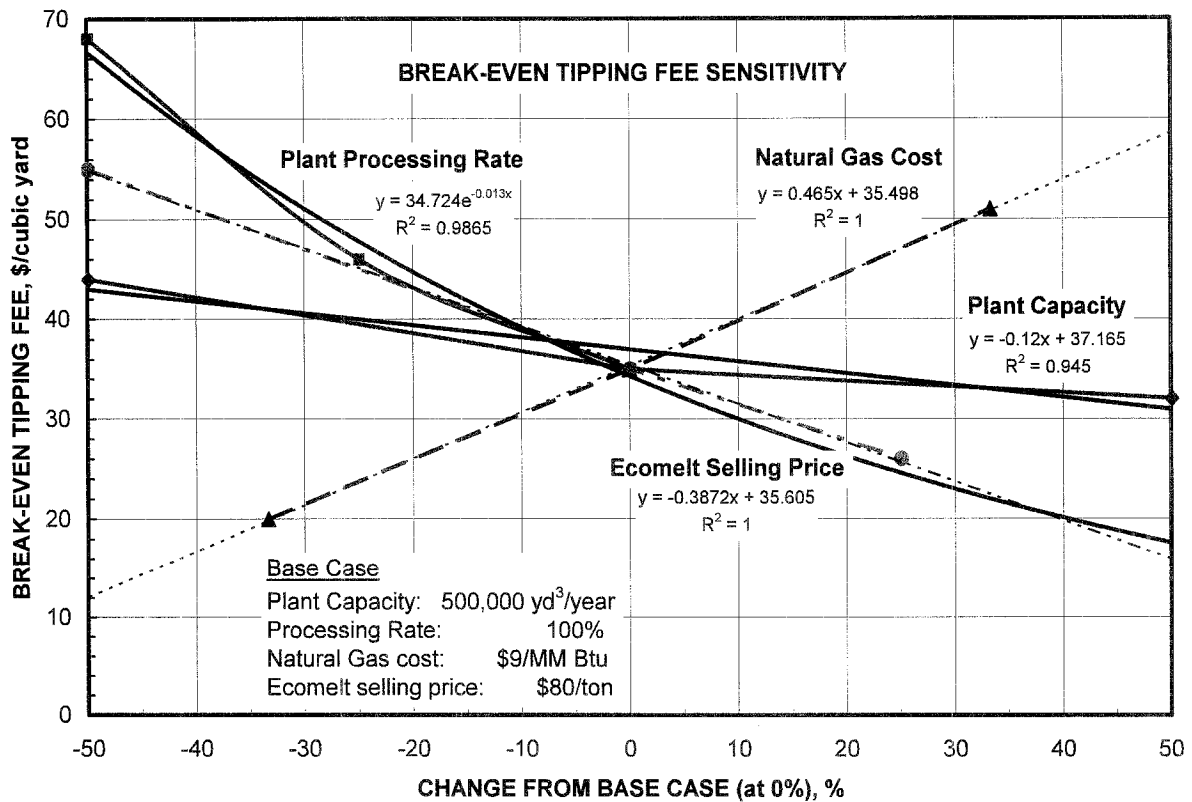
Figure 8. Sensitivity of Required Break-Even Tipping Fee to Process Economic Parameters for a Commercial-Scale Cement-Lock Plant

To understand Figure 8, consider the case in which the value of Ecomelt were to increase by 25 percent (from \$80 to \$100/ton). Follow the green curve for “Ecomelt Selling Price) from the Base Case (\$34.97/yd<sup>3</sup>) to the 25 percent value on the abscissa. The break-even tipping for that case would decrease to \$26/yd<sup>3</sup>. If, on the other hand, the value of Ecomelt were to decrease by 25 percent (from \$80 to \$60/ton), the break-even tipping fee would increase to \$46/yd<sup>3</sup>. As another example, if the cost of natural gas were to increase by 33 percent (from \$9 to \$12/million Btu), the break-even tipping fee would increase to \$51/yd<sup>3</sup>.

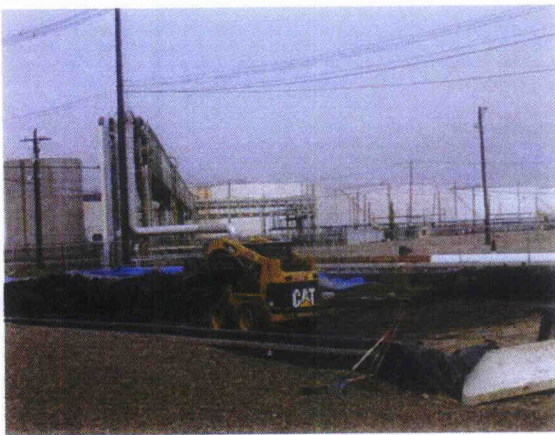
Figure A-10. Oversize Debris Being Separated from Sediment in Storage Area

During the shakedown and commissioning activities, the RPMS operators systematically combed through the sediment in storage using a bobcat-type front-end loader and shovels to remove the

polyethylene liners and any other oversized material (Figure A-10). This debris was discarded in an ordinary landfill.

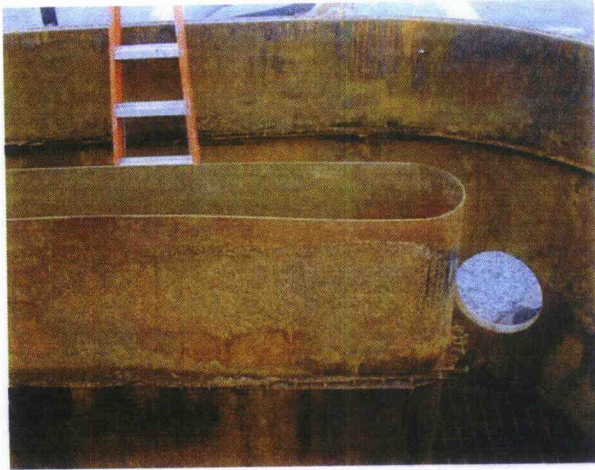
Proceeding with the mechanical repairs, the mechanical subcontractor first removed the 36-inch diameter duct connecting the I.D. fan inlet to the AC bed outlet. Then they removed the conical upper portion of the AC bed to expose the damaged upper carbon support screen and grating. The damaged screen and grating supports were removed. Both upper and lower damaged fire suppression systems were removed. The lower support grating sustained little damage and was

retained in place (Figure A-15). A new layer of #10 mesh steel screen was installed on top of the steel grating in the lower bed.

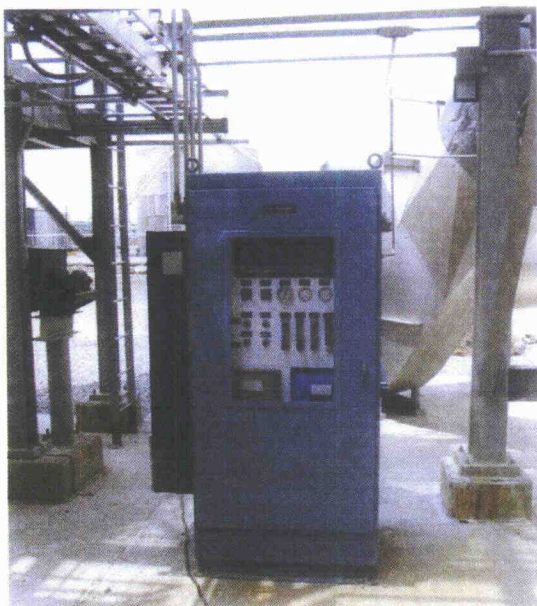
The Continuous Emissions Monitor System (CEMS, Figure A-16) is capable of measuring the oxygen (O<sub>2</sub>) and carbon monoxide (CO) contents of the flue gas as well as opacity. All three of

these parameters are required to be measured and recorded as stipulated by the Air Quality permit issued by the NJ-DEP.

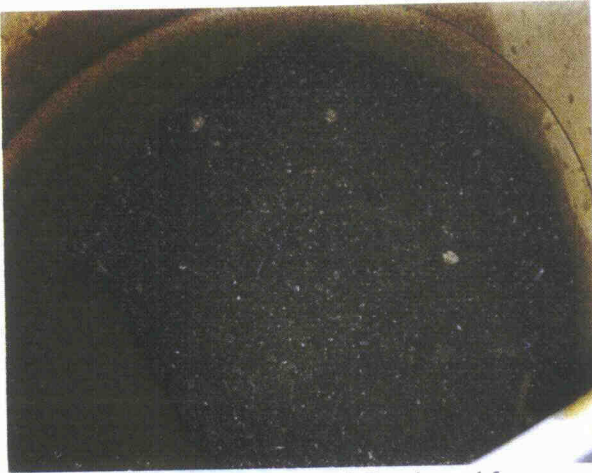
Figure A-19. Initial Ecomelt Produced from Stratus Petroleum Sediment – Collected December 10, 2003.

At 3:10 p.m., the first sample of Ecomelt from Stratus Petroleum sediment was conveyed out of the granulator (Figure A-19). Samples were taken for visual and microscopic examination. Under cross-polarized light, the desired non-crystalline (glassy) phases appear dark (Figure A-20). The undesired crystalline phases appear as bright spots. The estimated desired glassy composition of the Ecomelt sample was over 90 percent.

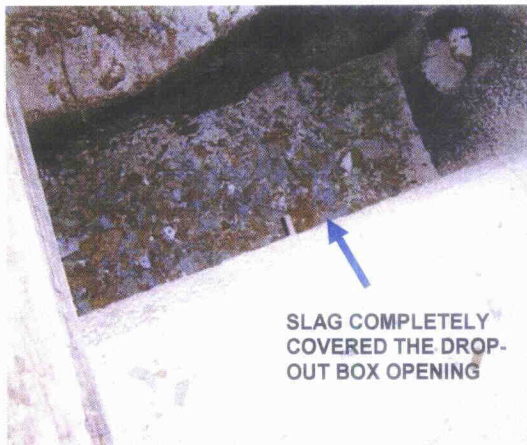
On July 20, the system had cooled sufficiently for personnel to enter and make a photographic record of the slag accumulation in the drop-out box. The photo (above left) shows that the top level of the slag was uniformly flat. It had completely covered over the granulator opening just below the new Hot Spot melt burners. The photo (above right) shows slag had begun to fill the nozzle of the Hot Spot burner under the new refractory “lip”. As mentioned above, the drop-out box had been heated by the melt burners overnight at about 2600°F and the slag had flowed to a uniformly flat level. Thin layers of slag also flaked from the walls and kiln as shown in the photo.

Operating staff entered the drop-out box with a jackhammer and began chipping away at the slag. Within two hours, the slag had been completely broken up. Shards of slag were removed from the granulator through the sample port at the entrance to the C-205 conveyor. Later, to facilitate removal of any oversize slag in future tests, FMW installed an access/clean out port on the upper end of the C-203 conveyor. Figure A-23 shows the time-temperature history of Test No. 2 of the Cement-Lock demo plant from July 16 to 17, 2004 with retrofits and enhancements in place.

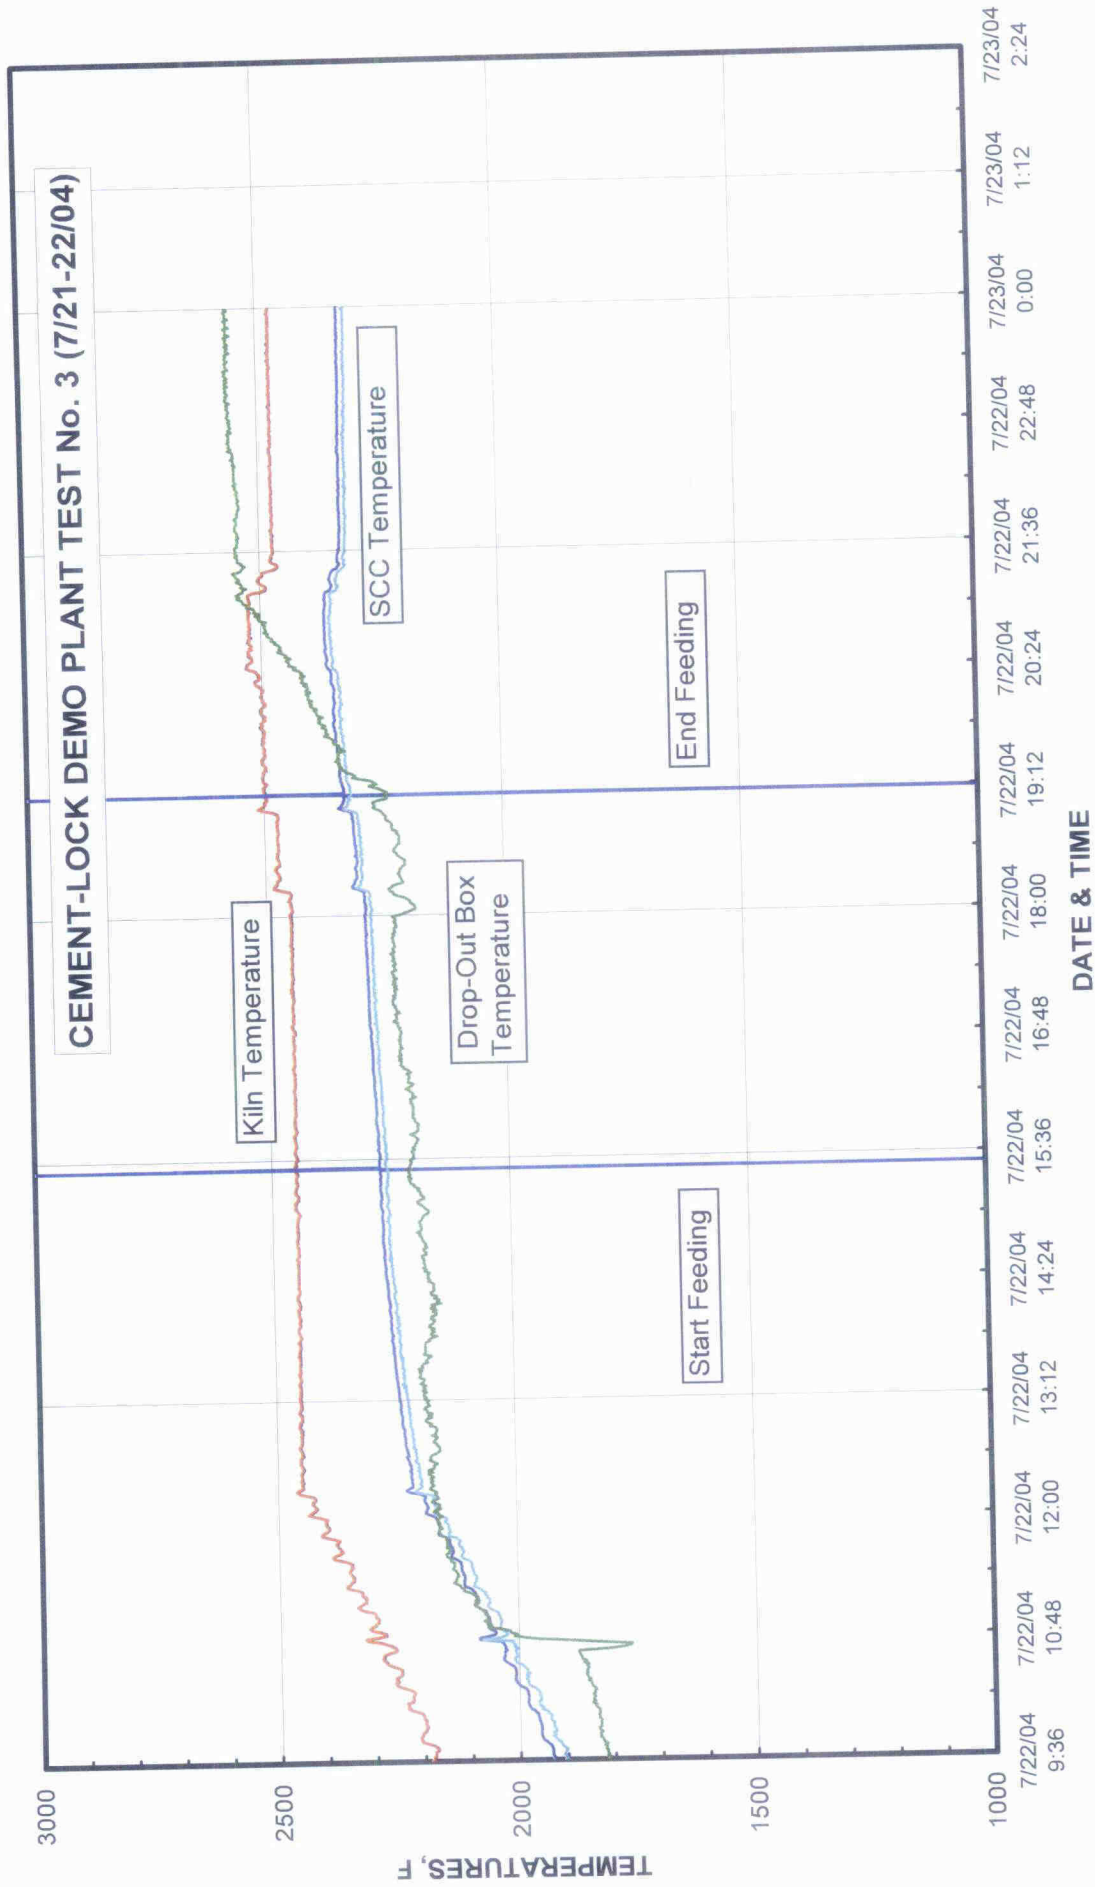
Figure A-24. Time-Temperature History of Cement-Lock Demo Plant Test No. 3 with Retrofits and Enhancements (July 21-22, 2004)

Slag "rain" was also observed to fall from the ceiling of the kiln as it rotated during this test. Figure A-24 shows the time-temperature history of Test No. 3 of the Cement-Lock demo plant from July 21 to 22, 2004 with retrofits and enhancements in place.

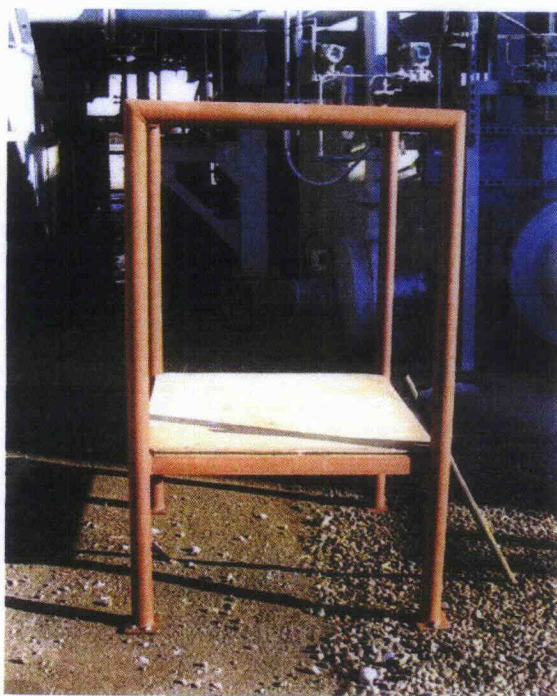
**EcoAggMat Collection:** We designed and FMW fabricated two stands to collect EcoAggMat as it was discharged from the inclined drag conveyor (C-203) discharge chute. Having two stands

enabled us to recycle the first stand while the other was collecting EcoAggMat. When the Super sack was filled, the drag conveyor would be momentarily shut down. The photo above left shows one stand as built. The photo above right shows the stand with Super sack in place in position under the C-203 discharge chute. The Super Sacks were 39 inches by 39 inches by 36

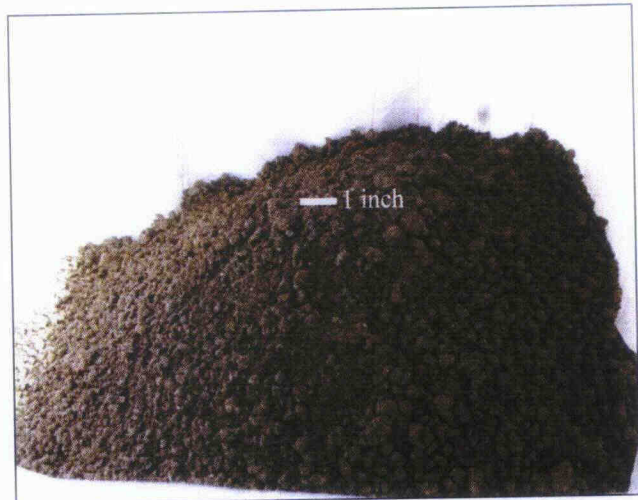
The size ranged from sand to about 1 inch in size (Photo at right shows EcoAggMat collected in a Super Sack). On several occasions, material tumbling in the kiln agglomerated into larger chunks that resemble logs or pancakes. These were described as being typical of non-slugging kiln operation by Dr. Paul Queneau (consultant). One log about 4 feet long and 8 inches in diameter

successfully passed through the kiln and broke up as it dropped into the granulator. On another occasion, a pancake about 2½ feet in diameter and 8 inches thick dropped into the granulator and caused the drag conveyor to jam. Fortunately, the pancake was accessible from the back of the granulator and it readily broke up when manipulated with a poker. Pieces of the pancake were withdrawn from the granulator by the drag conveyor.
