# ***WRECK POND BROOK WATERSHED RESTORATION PLAN FOR IMPAIRED WATERS***

**NAJARIAN ASSOCIATES**

**JANUARY 2015**

**An ADDENDUM to the  
WRECK POND BROOK REGIONAL STORMWATER  
MANAGEMENT PLAN**

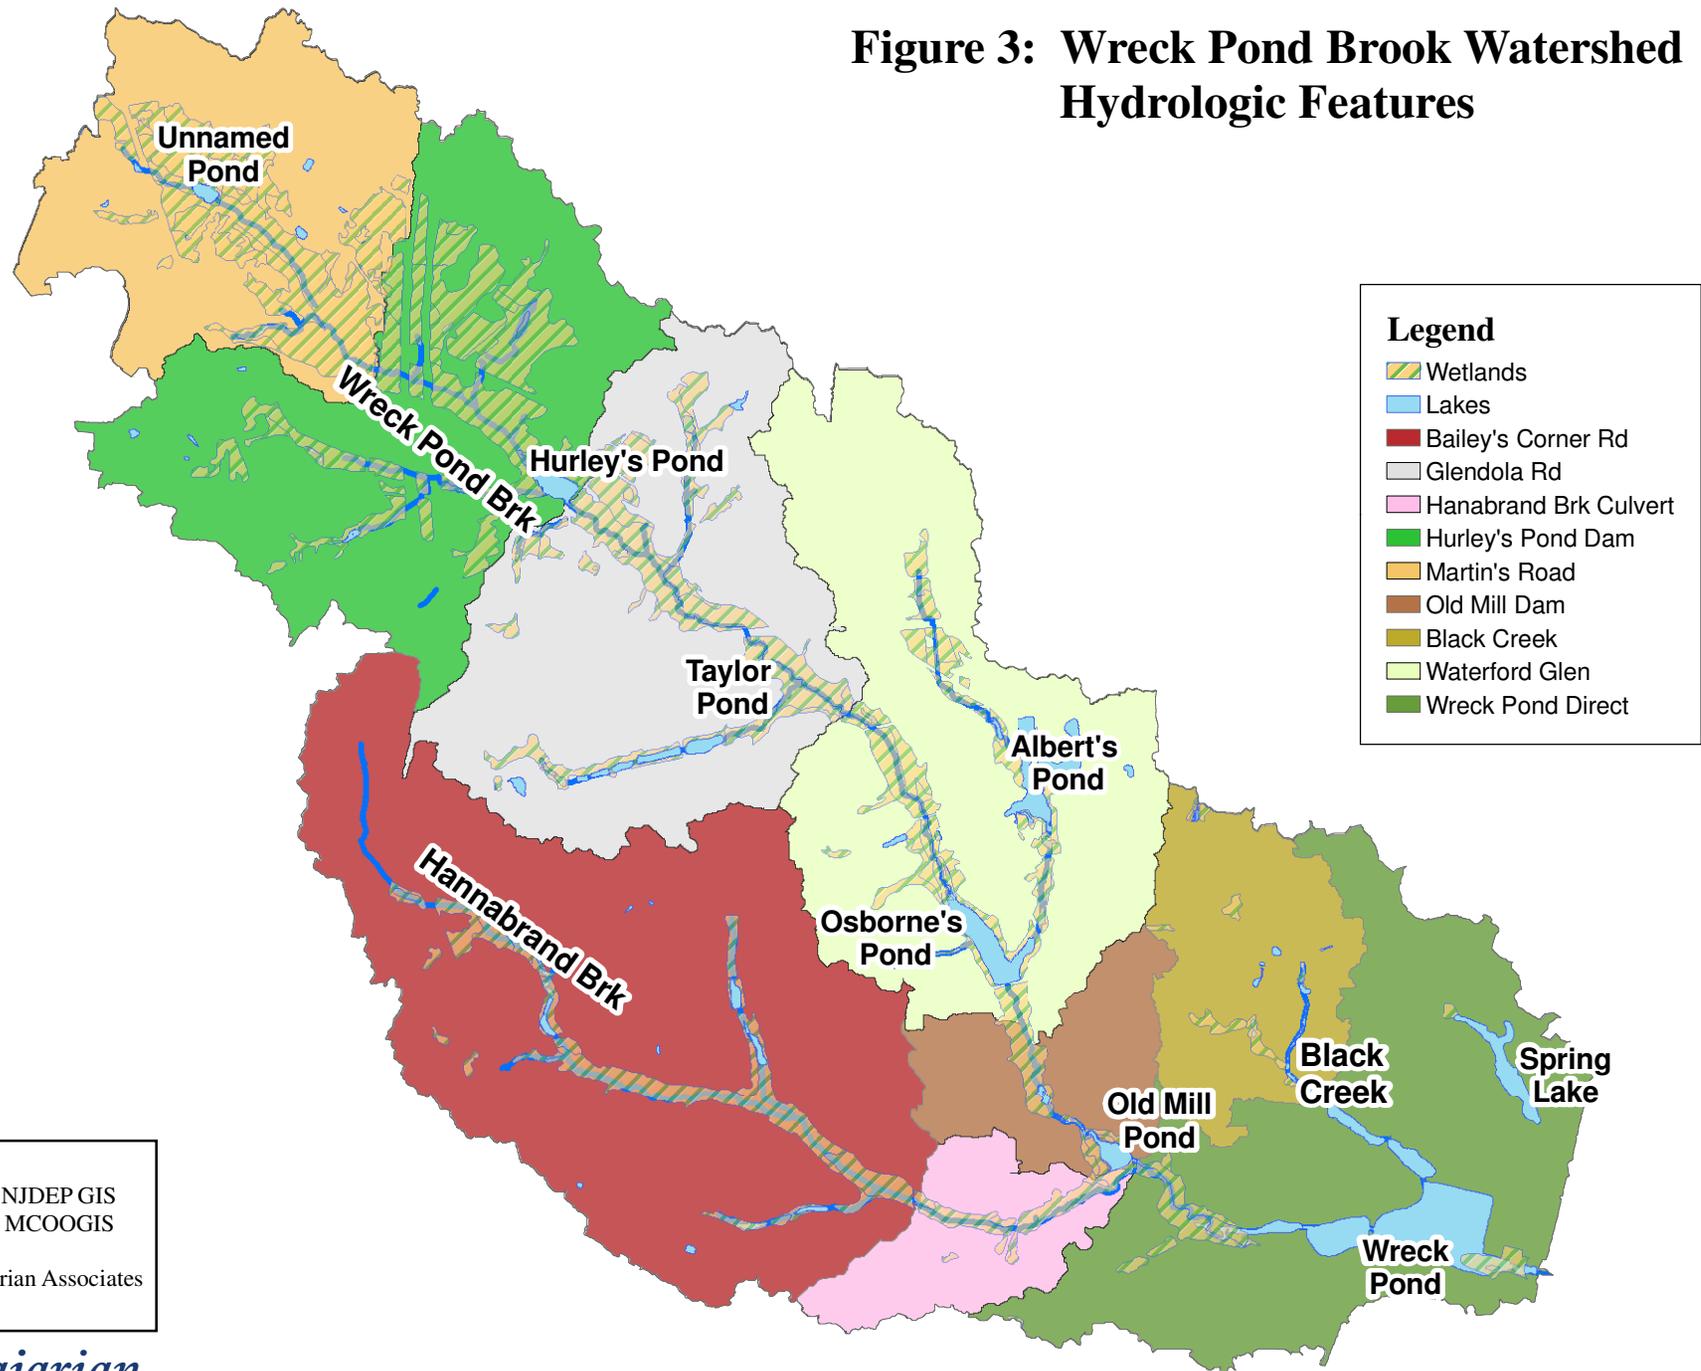
**Figure 3: Wreck Pond Brook Watershed Hydrologic Features**

The other hydrologic features of the watershed are numerous lakes and ponds. These are generally human made structures. Figure 3 shows the ponds within the watershed, which are summarized in Table 2. Other unnamed small ponds are also found throughout the watershed, including some impounded areas along the streams.

Of the approximately 1,100 acres of wetlands, about 800 acres (72%) are wooded deciduous wetlands classified as either deciduous wooded wetlands or mixed forested wetlands (deciduous dominant). Only very small areas of freshwater ( $\pm 4.81$  acres) and saline ( $\pm 9.98$  acres) tidal marsh is noted. Wetlands are shown on Figure 3.

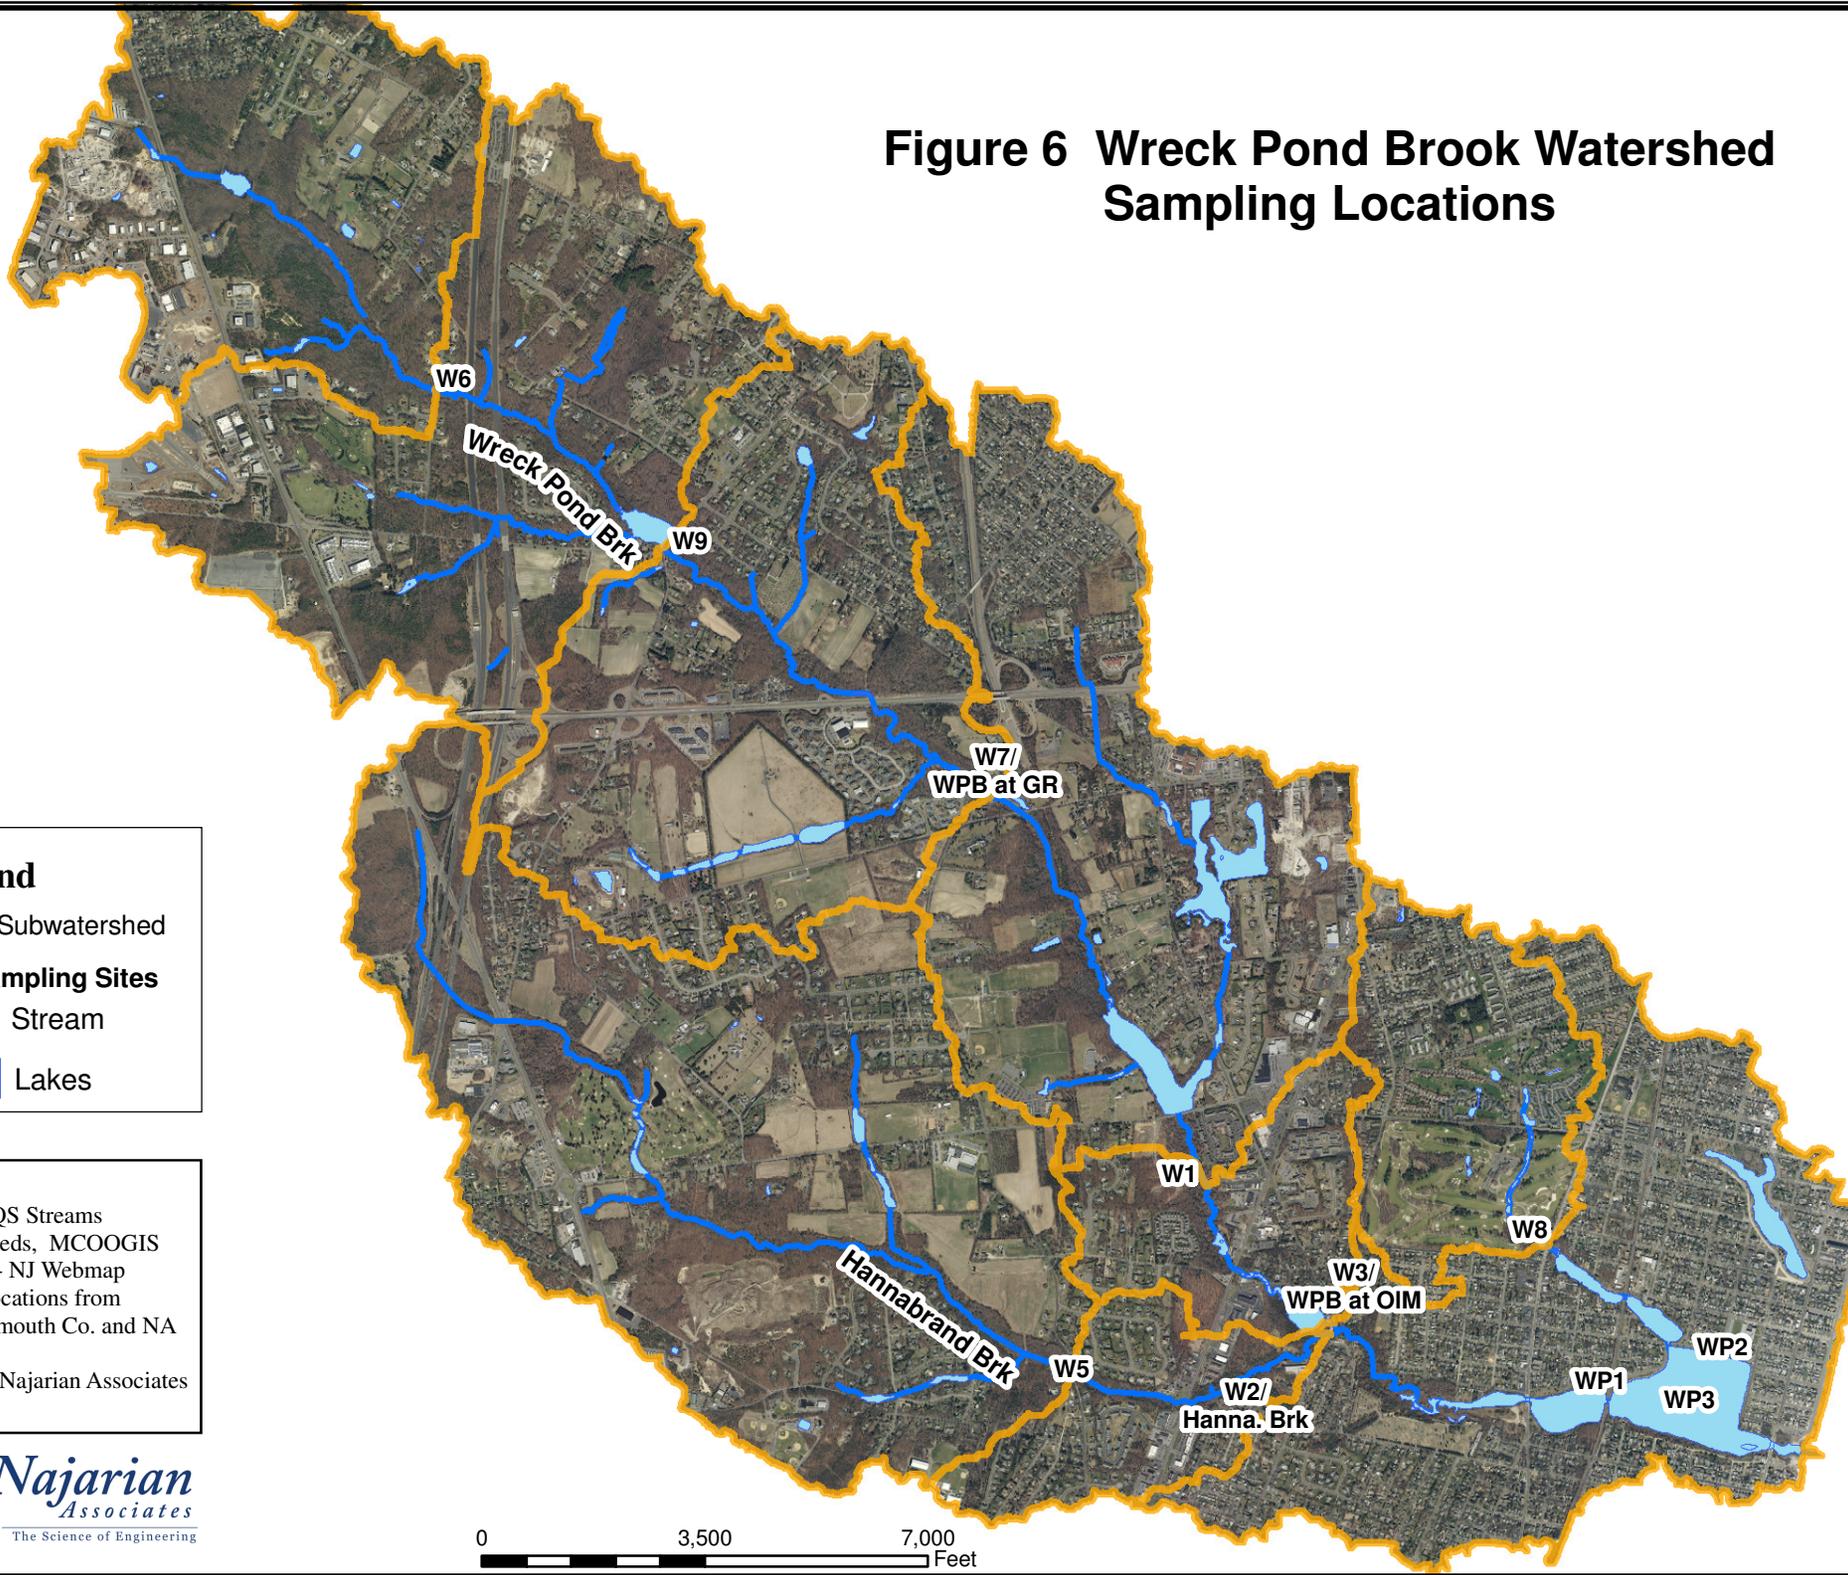
Figure 6 shows the monitoring locations and subwatersheds referenced in the following sections. The points labeled as "W1-W9" are the County water quality sampling locations and also the NJDA water depth stations. These stations are also noted as Wreck 1 – Wreck 9. W2 and W3 are also the locations at which Najarian Associates sampled for the Borough Study at the locations labeled as Hannabrand Brook and Wreck Pond Brook, respectively, both at Old Mill Road. The WP1-WP3 points are the ambient locations in the Pond where NA sampled for the Borough Study.

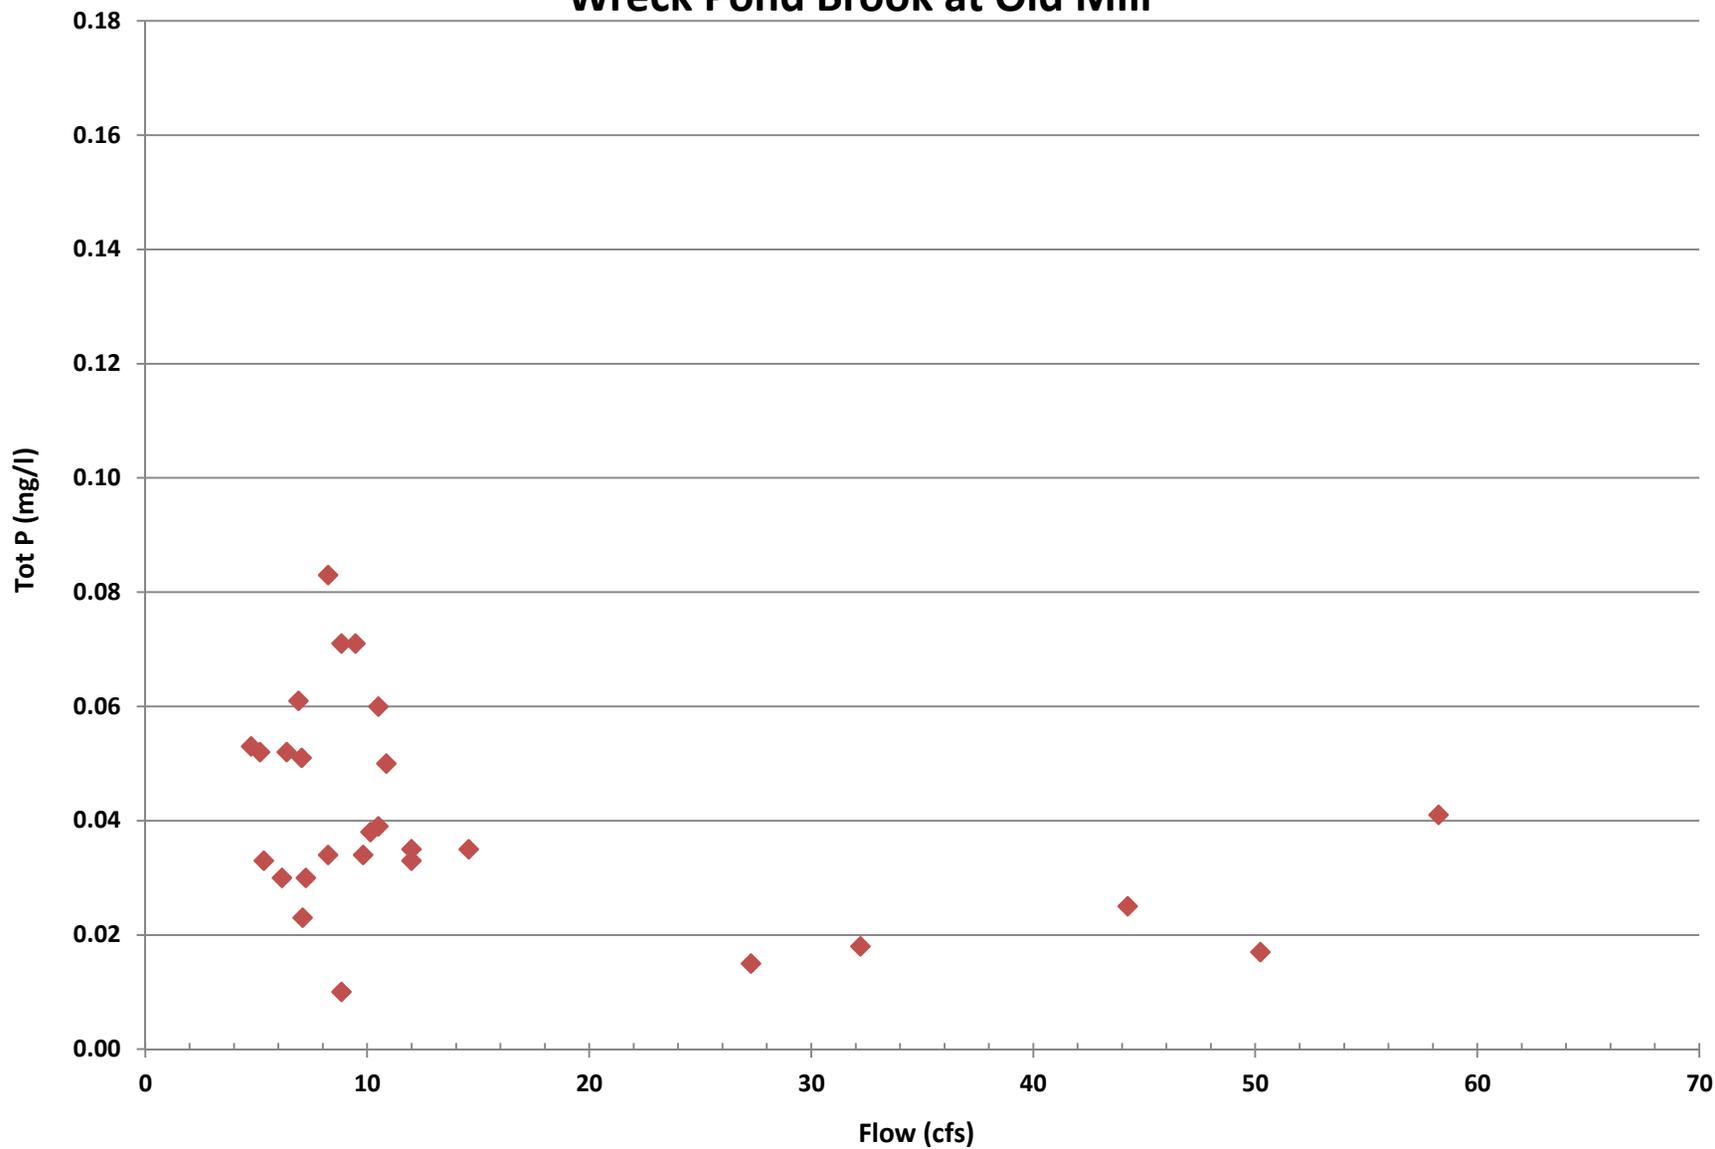
**Figure 8: Total Phosphorus vs Flow  
Wreck Pond Brook at Old Mill**

This pattern was evaluated during the storm event sampling as discussed in the RSWMP. The anticipated increase in concentrations of stormwater-related parameters, found at Hannabrand Brook and at the upstream station on Wreck Pond Brook at Glendola Road, was not apparent at this station (see Section 3.2.3 of the RSWMP). This was attributed, at least in part, to the presence of Old Mill Pond just upstream of this station. The lake may trap sediment and associated pollutants.

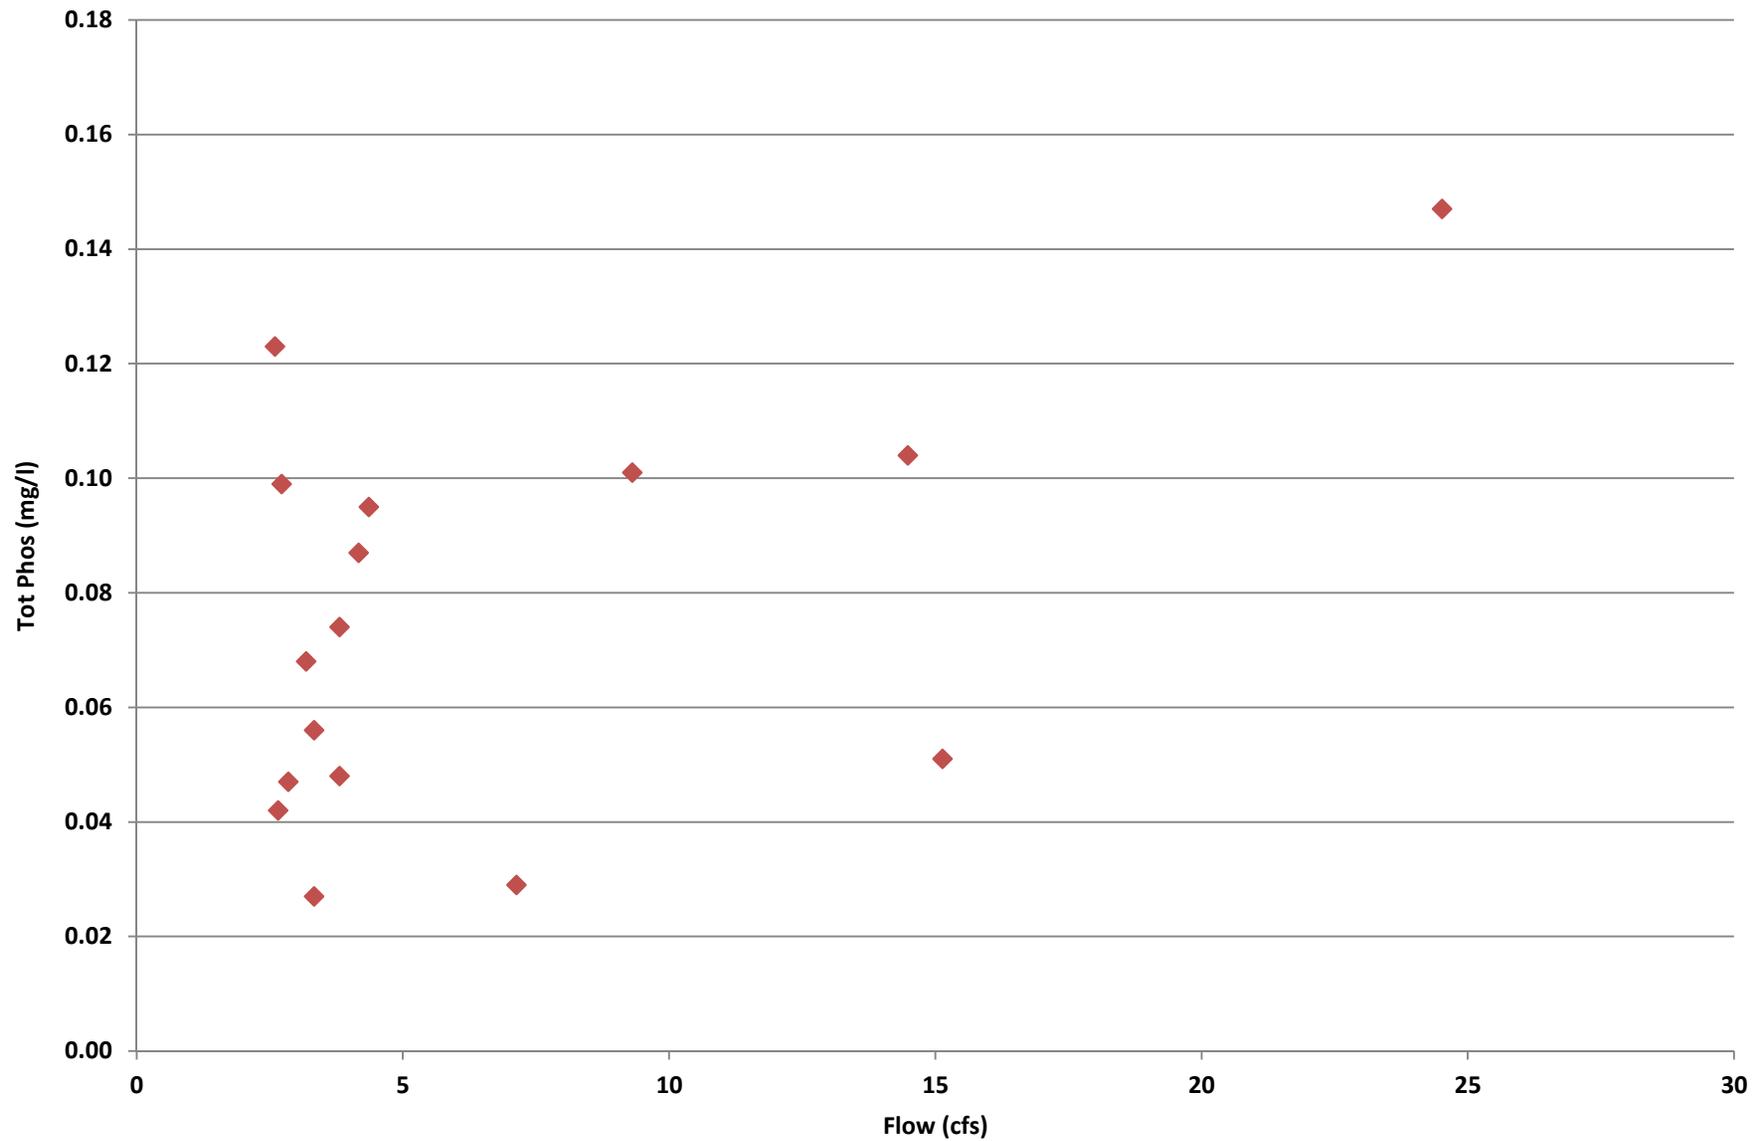
**Figure 9: Total Phosphorus vs Flow  
Wreck Pond Brook at Glendola Road**

Figure 9 plots the TP concentration versus flow for this station for both storms. Some increase is noted with flow.

As discussed above, only storm sampling was available for this station. Figure 9 graphs the total phosphorus concentration vs flow for this station. Also as discussed above, the NJDA flow rating curve did not provide appropriate results. Therefore, the flows were determined from the SWMM results and NA rating curves. The phosphorus concentrations are somewhat related to flow. Figure 13 provides the regression lines as calculated according to the method noted above. Table 34 provides the slopes using the FIRE analysis.

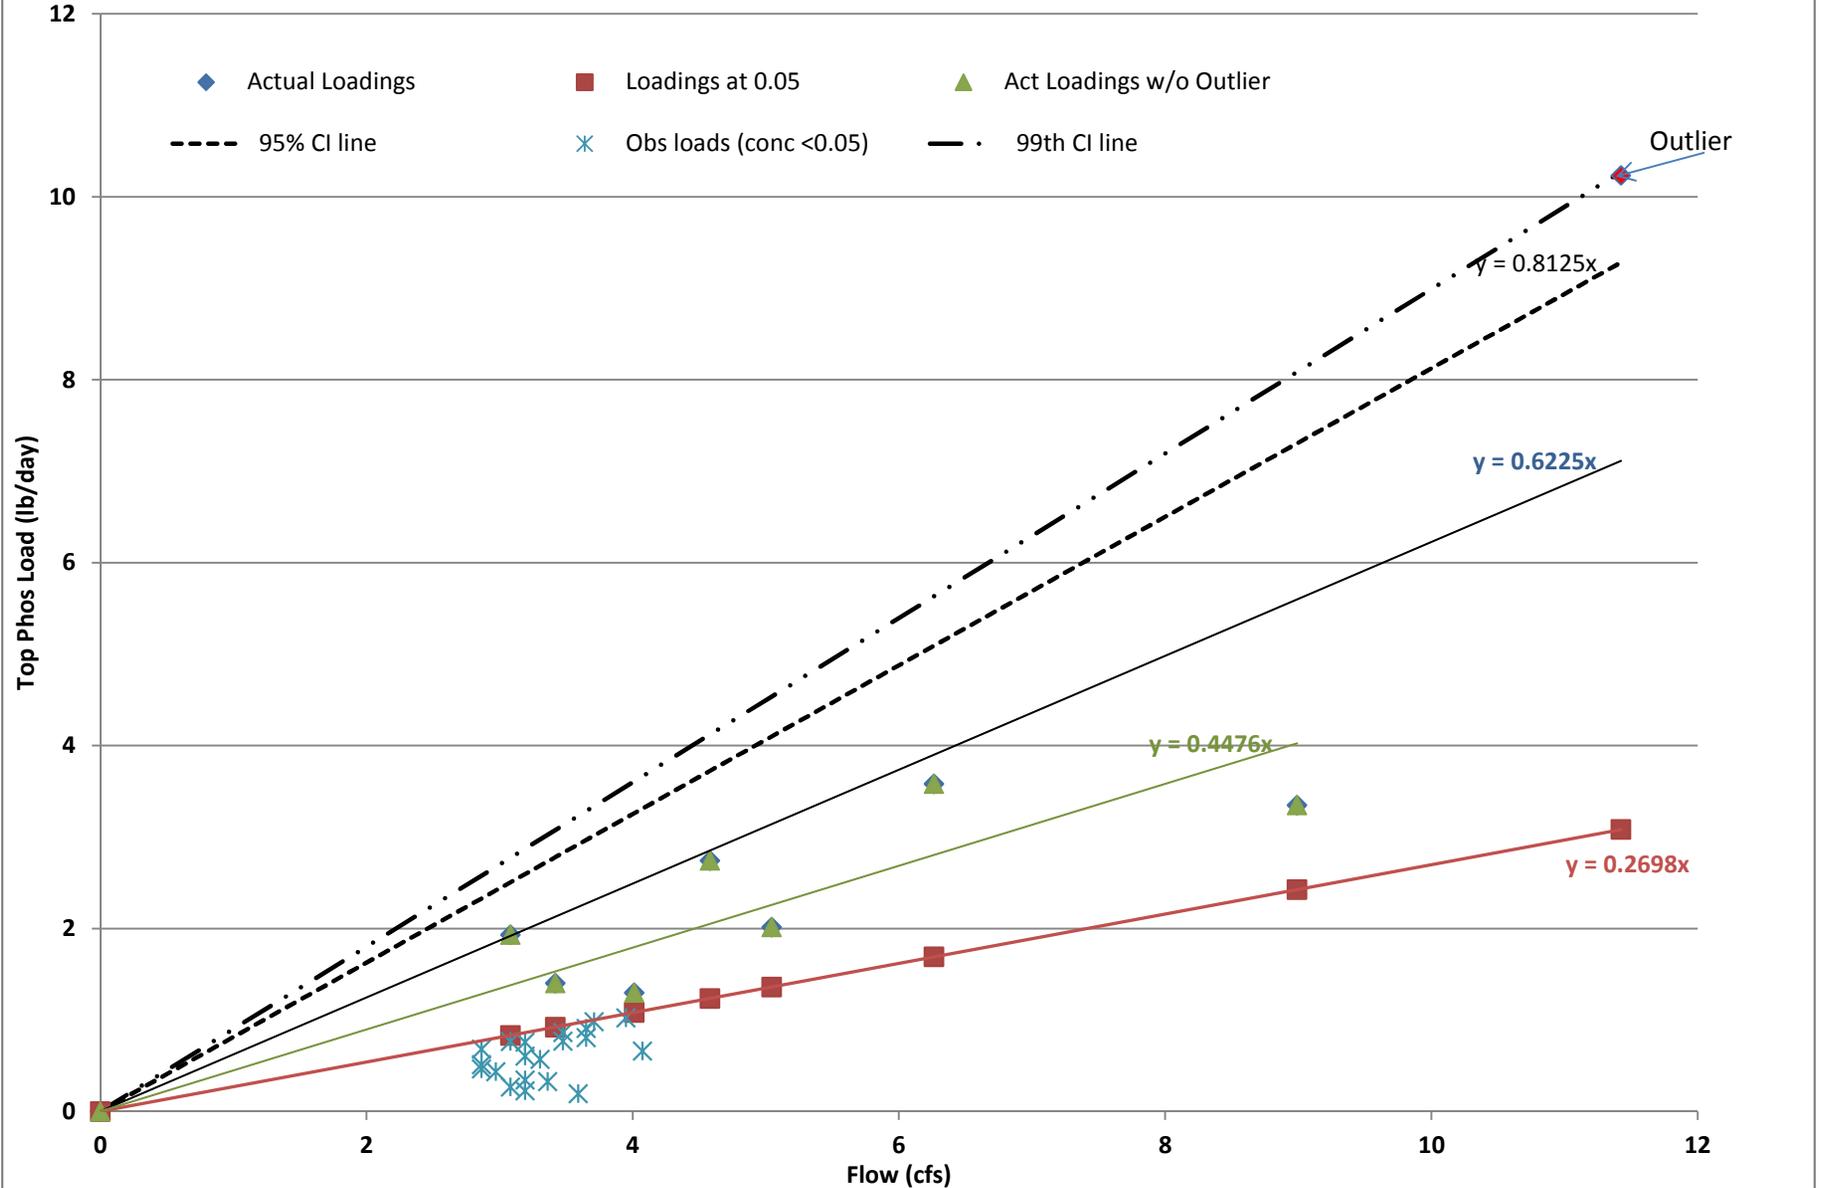
**Figure 10: Phosphorus Loading Analysis FIRE**  
**Hannabrand Brook at Old Mill Road**

$$\text{Percent Reduction} = 1 - \frac{0.2698}{0.4476} * 100\% = 1 - 60.3\% = 39.7\%$$

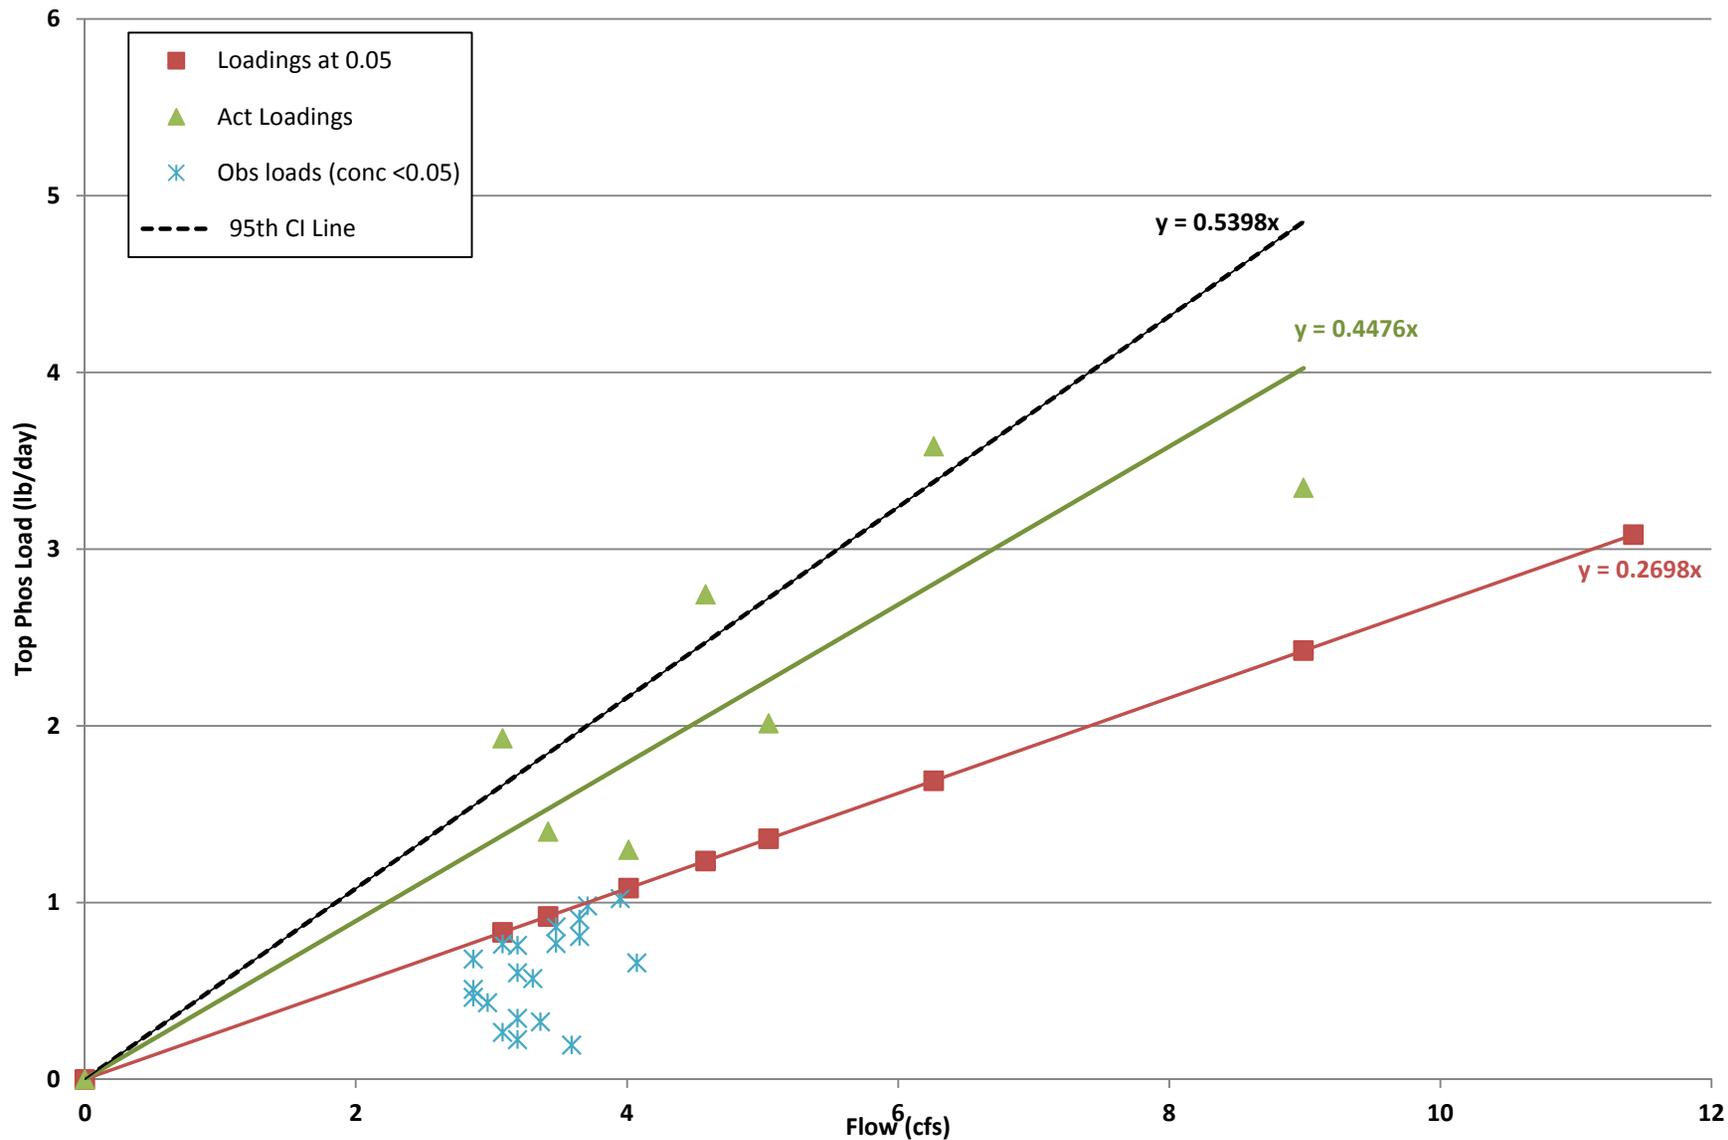
**Figure 11: Phosphorus Loading Analysis FIRE without Outlier**  
Hannabrand Brook at Ole Mill Road  
(Outlier Load Removed)

<b>Table 32: Load Reduction Analysis from FIRE Regression Line Phosphorus – Hannabrand Brook (without outlier)</b>	
Target Loading Slope	0.2698
Exceedance Regression Slope	0.4476
Upper 95% Confidence Limit of Slope	0.5398
Overall Percent Load Reduction	50% using the 95 <sup>th</sup> CI Slope

The margin of safety (MOS) reduction is calculated using the upper 95<sup>th</sup> Percent confidence interval on the slope as follows:

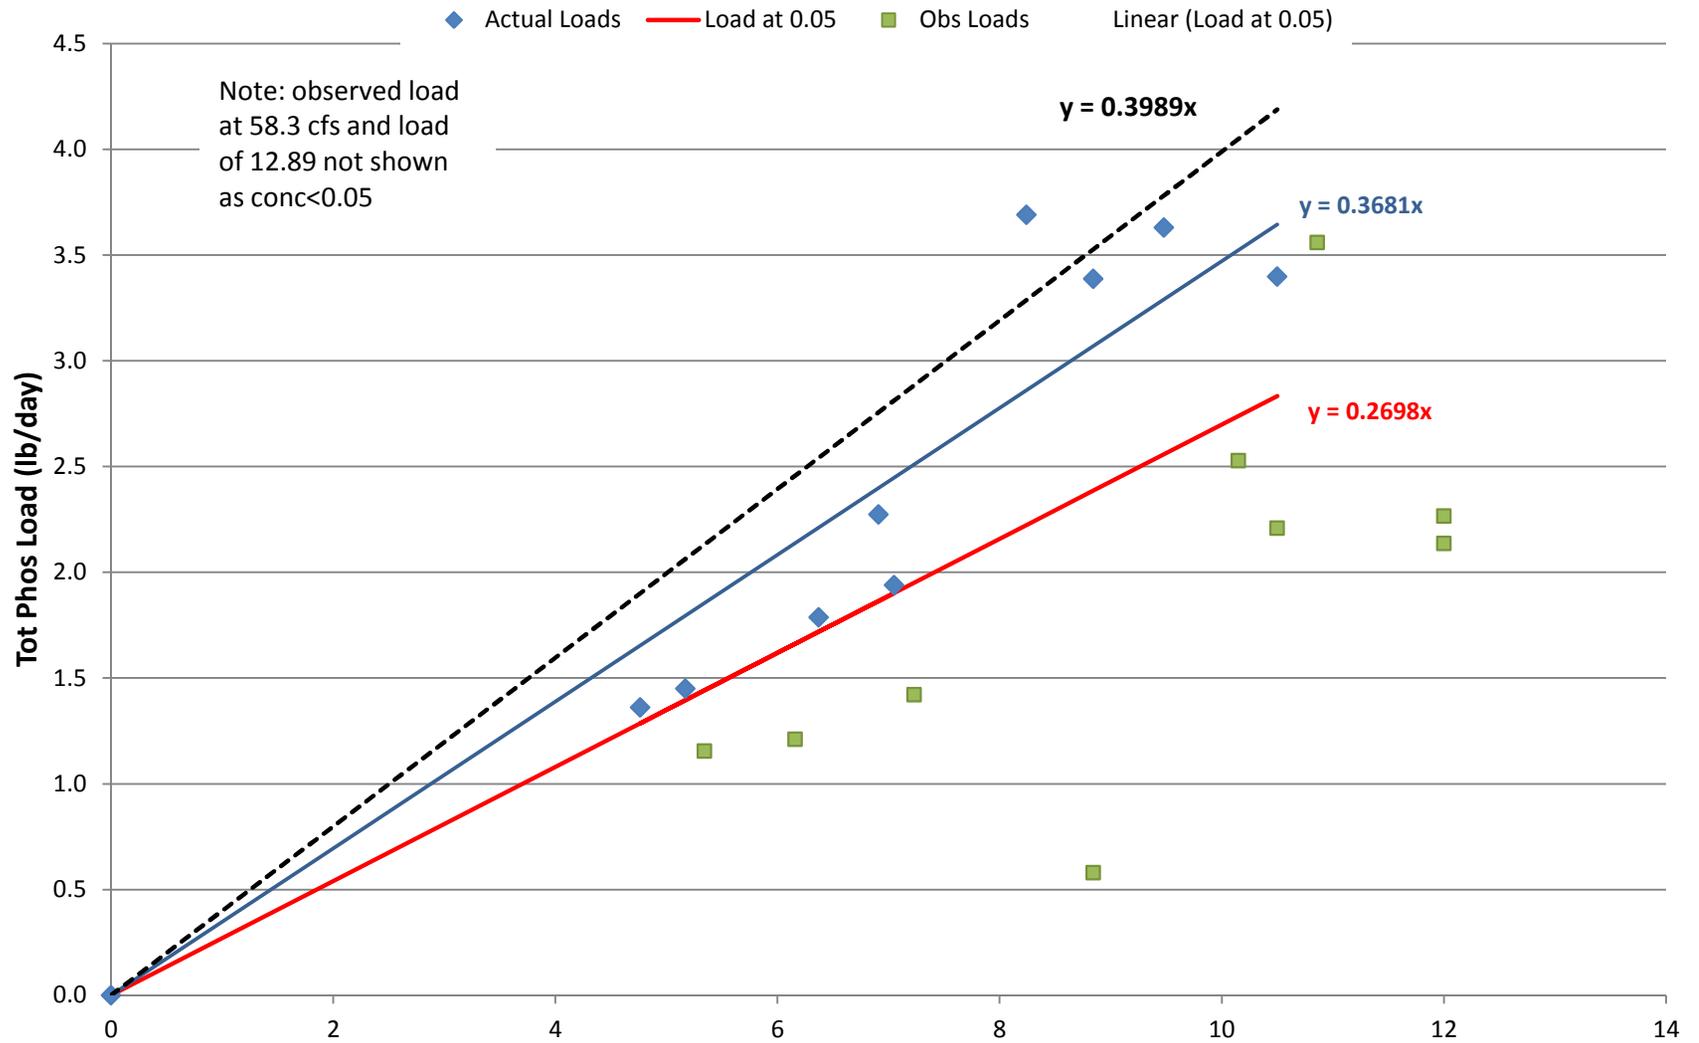
**Figure 12: Phosphorus Loading Analysis FIRE -  
Wreck Pond Brook at Old Mill Road**

As expected, the percent reduction required to meet standards is lower at this station than at Hannabrand Brook. As noted above, the storm event sampling did not show increased total phosphorus concentrations at this station. Few samples exceeded the 0.05 mg/l concentration.

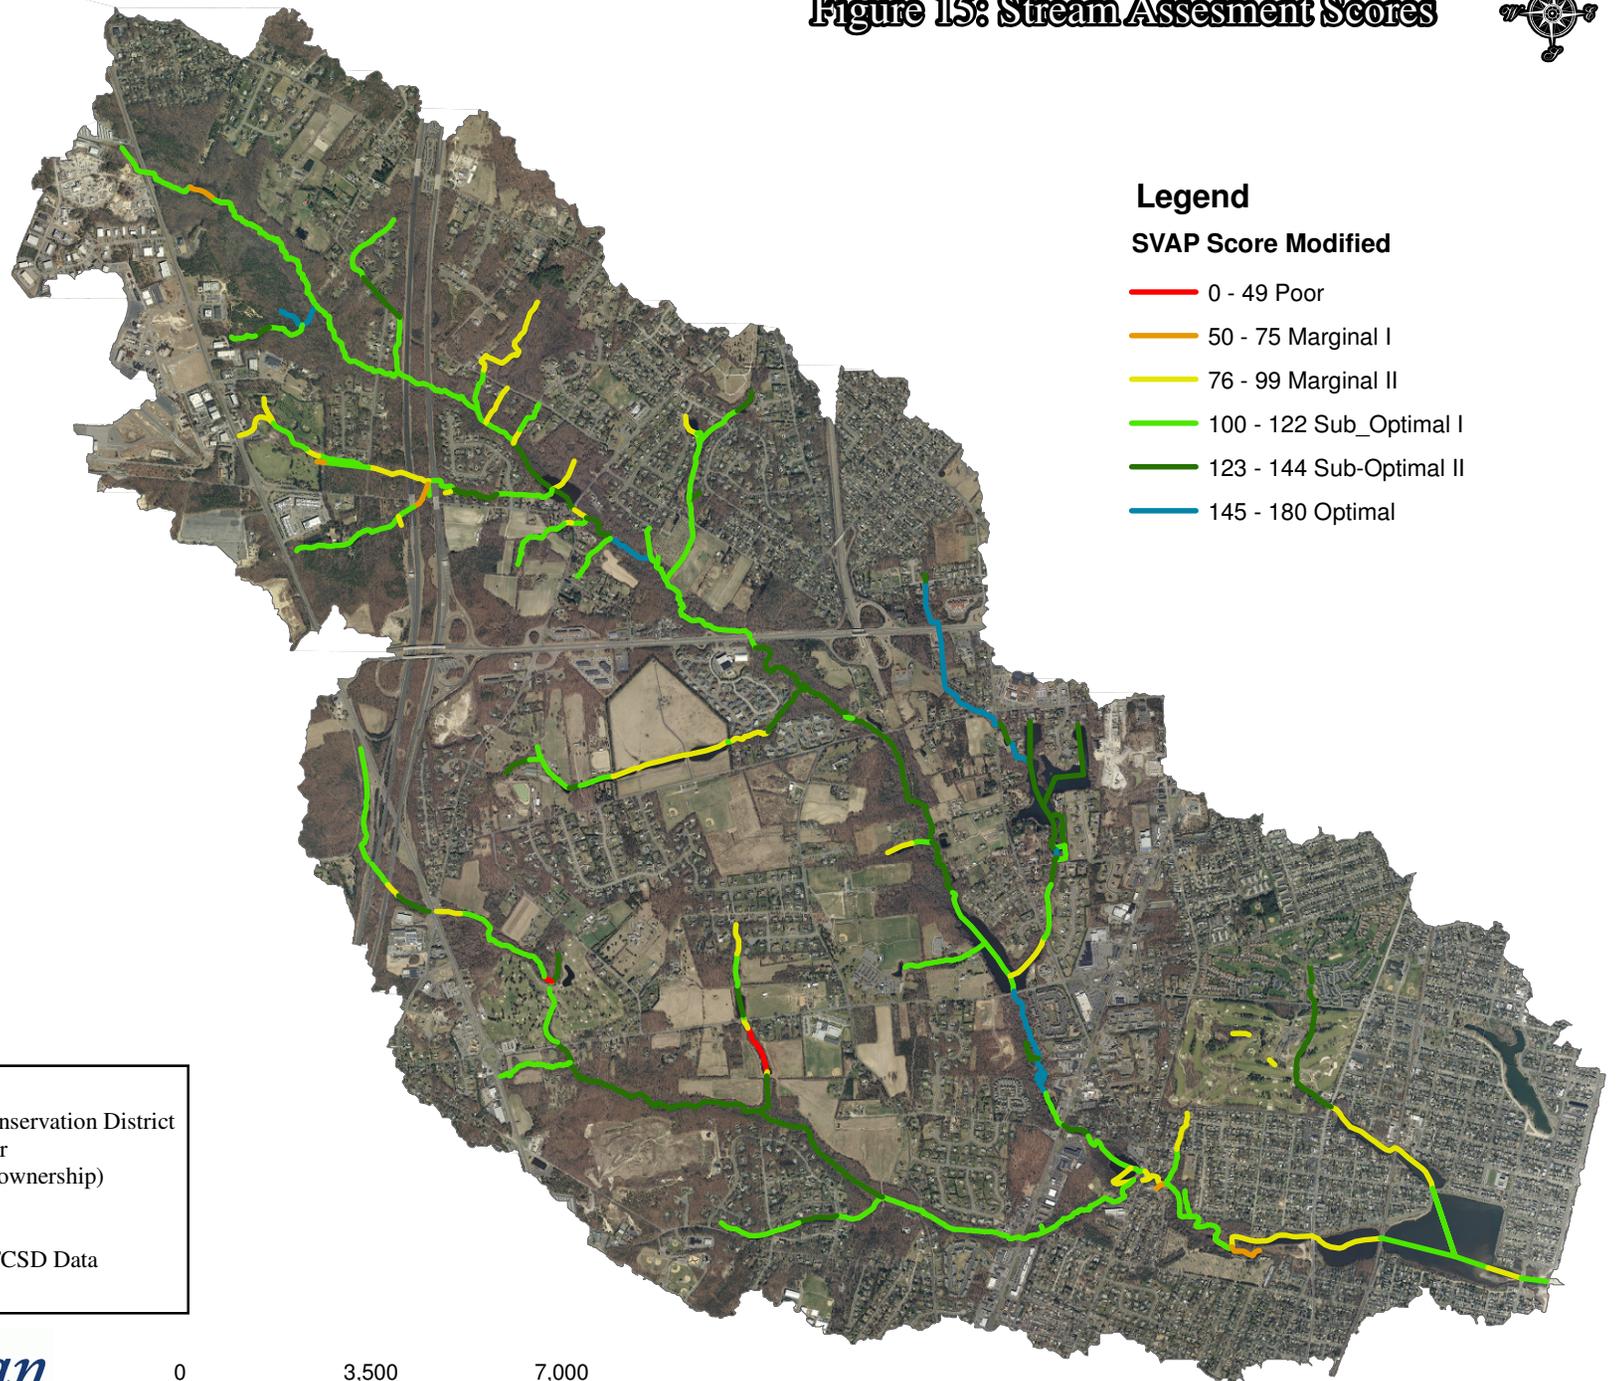
Figure 15: Stream Assessment Scores

Streams in the watershed were generally ranked as sub-optimal in the field-based stream study conducted by Freehold soils. Details on this study are given in RSWMP. However, certain segments were found to have highly eroded banks and other features that require remediation. This is discussed later herein.

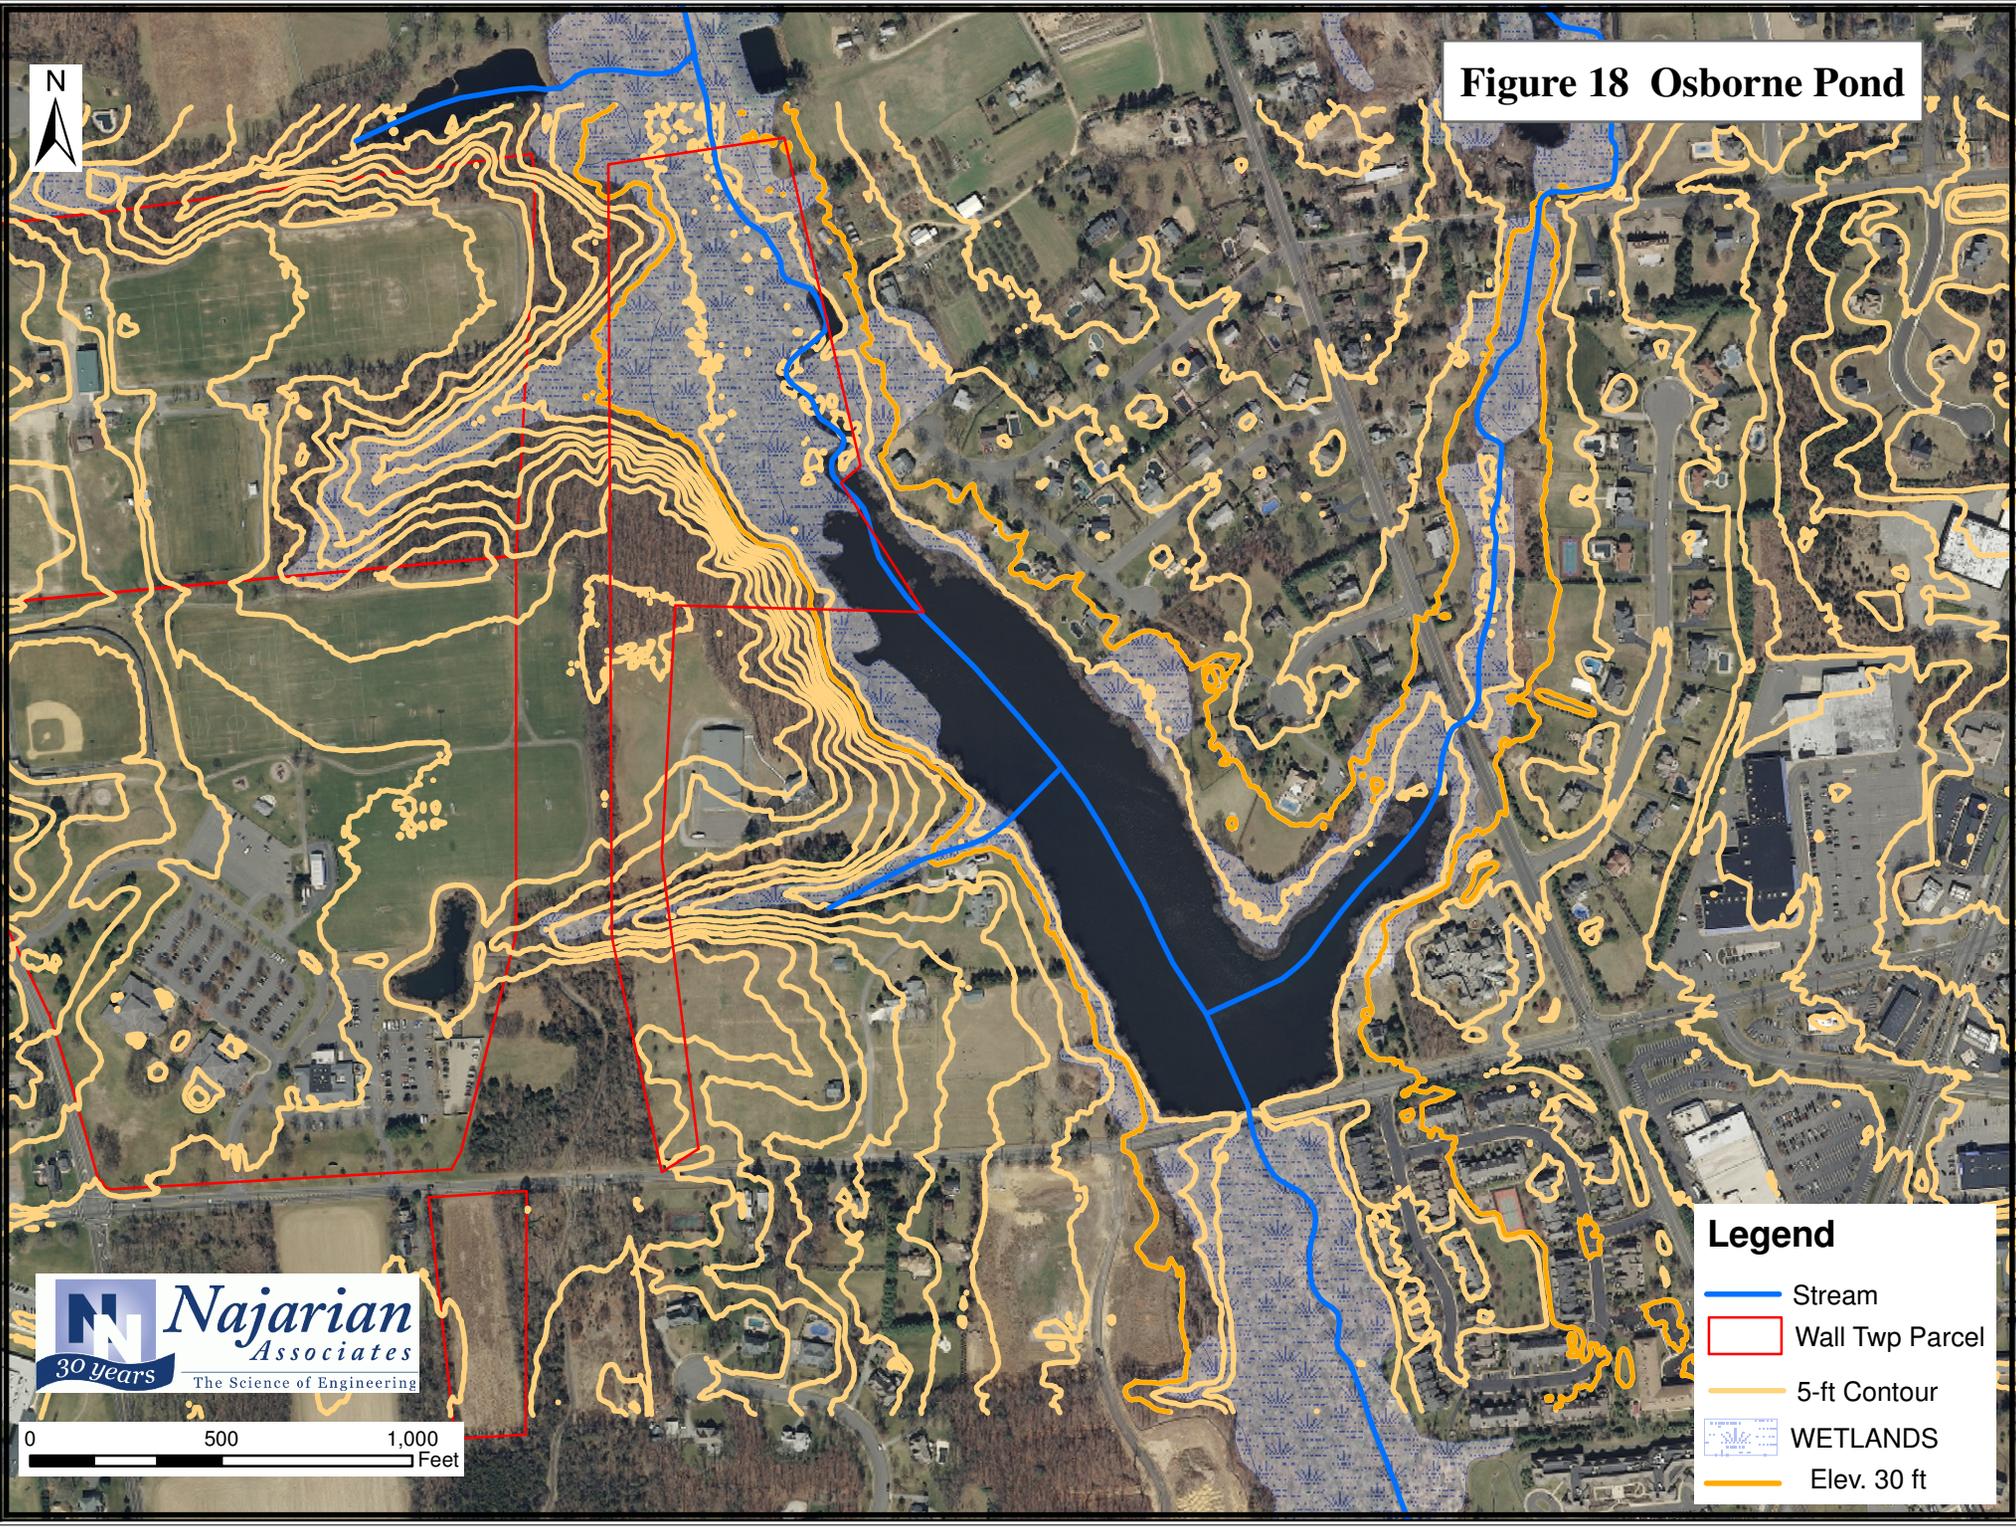
Figure 18 Osborne Pond

The other upland ponds are also degraded. The ponded portion of Black Creek appears highly eutrophic and subject to algal blooms. It is very mucky with much sediment in the bottom. The Osborne Pond's dam structure is non-functional and in need of repair. This repair could also enhance the pond's environment.

The report noted the bulkhead damage as well as downstream slope erosion, partly from road drainage. Further, the low flow outlet appeared to not be operable. A verbal
