INVESTIGATION REPORT

Fatality Assessment & Control Evaluation Project

FACE 07-NJ-044 March 13, 2009

23-Year-Old Hispanic Road Maintenance Worker Struck by Wheel that Separated from the Trailer Axle of a Tractor-Trailer Truck

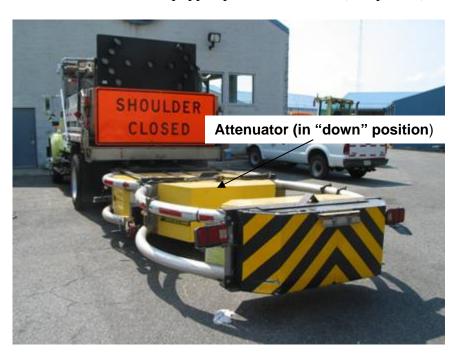
Figure 1: Truck-mounted attenuator-equipped protection vehicle (bump truck)

The incident occurred near a grassy area along the shoulder of the southbound side of a major highway in New Jersey. Two workers were assigned to trim the grass around poles and delineators. A truck with a rear-mounted attenuator (bump truck) was stationed approximately 25 feet north of the incident site (see Figure 1), a lead truck (cover truck) between the attenuator and the site (see Figure 2), as well as two advanced warning signs. While the workers were trimming grass, two rear tandem wheels separated from the axle of a flatbed trailer being pulled by a tractor-trailer truck traveling southbound on the highway adjacent to the incident site. One wheel rolled onto the center median. The other wheel rolled past the attenuator-equipped truck and struck the victim. The coworker witnessed the wheel rolling along the roadway and immediately radioed the victim, but received no response. The coworker walked back toward the incident scene and saw that the victim was lying on the ground. The worker called 911, and police and rescue workers arrived at the scene within minutes. The responders did not find any vital signs, and the victim was pronounced dead at the scene via telemetry.

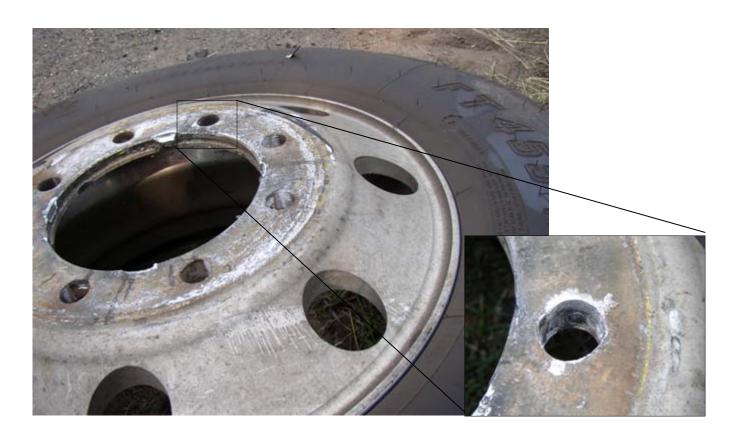
Figure 3: Wheel that was involved in the incident

According to the employer, the wheel and tire assemblies completely separated from the axle of the moving truck trailer because the lug nut studs sheared off from the wheel hub. Figures 3 and 4 show the wheel involved in the incident and the axle from which it separated, respectively. When the tire struck the victim, the victim was apparently thrown against an adjacent bridge abutment, landing approximately 30 feet from the initial point of impact with the wheel. Figure 5 shows an overview of the incident site.
