**Comments on New Jersey Highlands Water Protection and Planning Council  
Draft RMP Amendment: Plan Conformance Procedures**

# Stone Arch Bridge Inventory, Phase II Hunterdon County, New Jersey

The Stone Arch Bridge Inventory, Phase II, is a study of 92 stone arch bridges in Hunterdon County, New Jersey. The purpose of the study is to provide the County with recommendations regarding the preservation and future modifications to the bridges in view of their historical significance and current and future traffic patterns. The Stone Arch Bridge Inventory, Phase II, is a sequel to Phase I, prepared by A.G. Lichtenstein & Associates, Inc, dated November, 1995, which is a similar study of 14 stone arch bridges. The bridges in both of these phases have less than a 20 foot span and were therefore excluded from the NJ Department of Transportation's statewide study of bridges, NJ Historic Bridge Survey, 1994. Both of the Stone Arch Bridge Inventories were funded by an Intermodal Surface Transportation Enhancement Act (ISTEA) grant to the County.

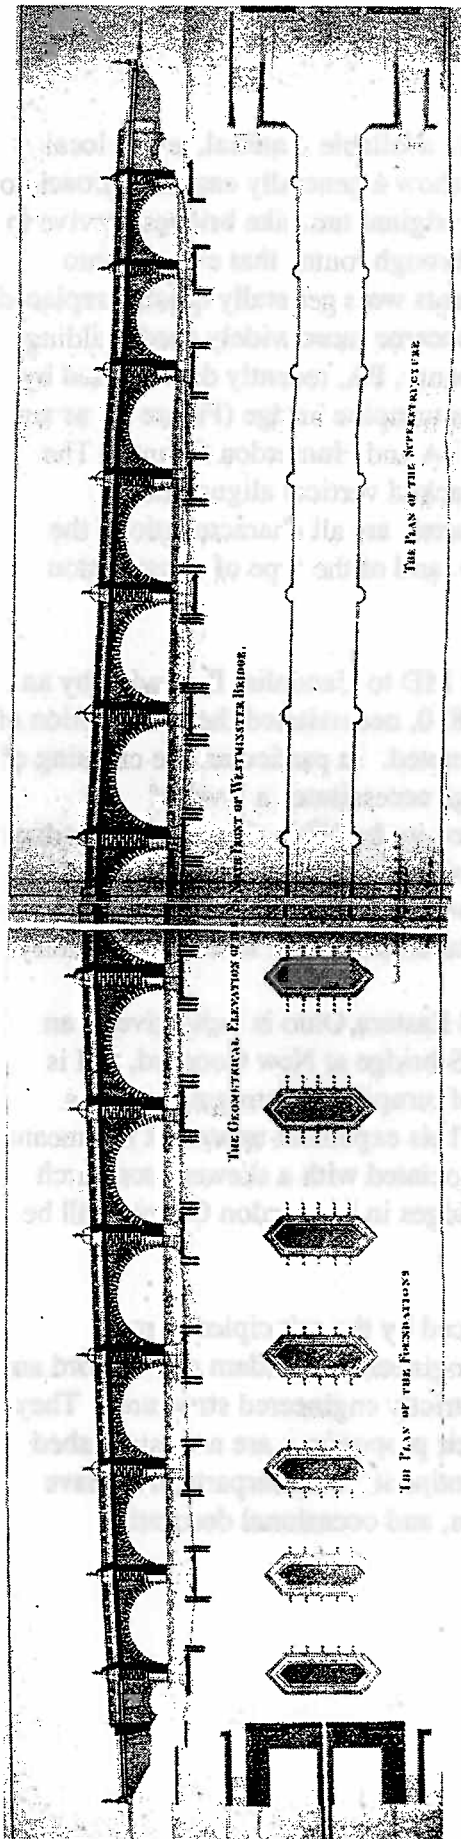
Figure 1  
New Westminster Bridge, London 1740 (Ruddock 1979)

To illustrate this contrast, Figure 1 shows the careful execution of design details for the Westminster Bridge, designed 1738-9, and built 1740-4. It is quite typical of the monumental structures of its time, having multiple spans of about 50 feet. The piers are wide enough to support the thrust of each of the arches without the counteracting thrust from the adjacent arch. The ring is rusticated stone of narrow width, with a backing, or secondary arch tapering from 2 1/2 feet thick at the crown to the full half-width of the pier at the springline. The thrust in the arch was calculated by the relatively new methods published by Philippe de la Hire. In summary, this is a monumental structure showing the influence of a millennium old craft, combined with new information allowing the mathematical analysis of arches, and reflecting a sophisticated and unified formal treatment of the structure and all its details. In fact, the European and British traditions had, by the turn of the nineteenth century, advanced the construction of stone bridges to a high state of sophistication, both in the advanced engineering design and construction techniques, and in the sophisticated treatment of bridge form and detailing (Ruddock 1979)

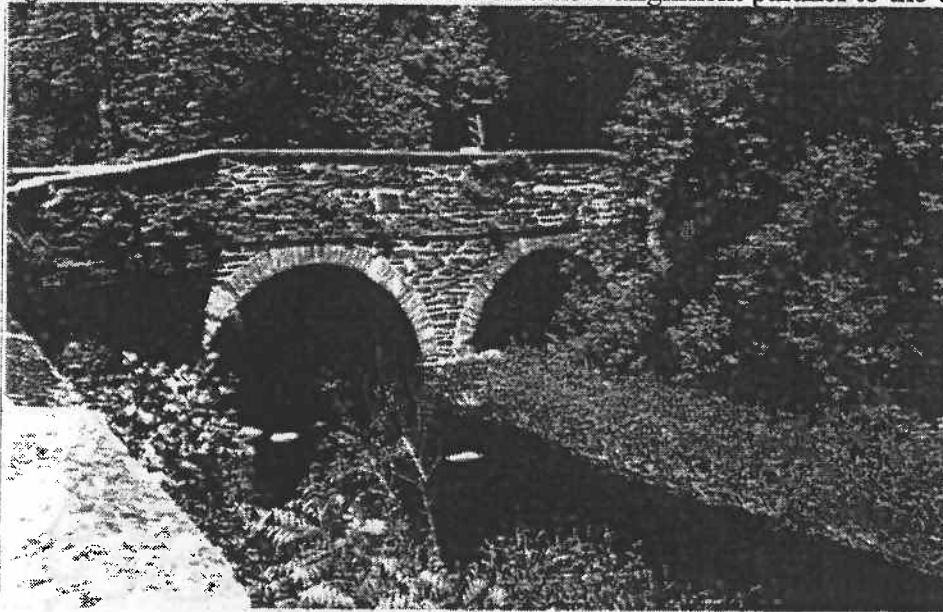
Figure 12. Bucks County Bridge No. 223 (1826)

This structure bears many of the hallmarks of the somewhat later Hunterdon County Bridges. The inset treatment of the arch and spandrel walls, clearly shown in Figure 11, up to the level of the extrados at the crown is a feature often associated with bridges in Hunterdon County, which is discussed in detail later in this report. The alignment of the ring stones, apparent in Figure 12(a), follows a pattern that will be discussed in the section below. The use of rough cobbles in the arch ring, past the facing stones, is shown in Figure 12(b), and is a universal feature of the

bridges in Hunterdon County. The ring is built of sandstone, apparently quarried at some distance from the bridge site, and the spandrel and parapet are built of altered shale freely available in the stream bed.

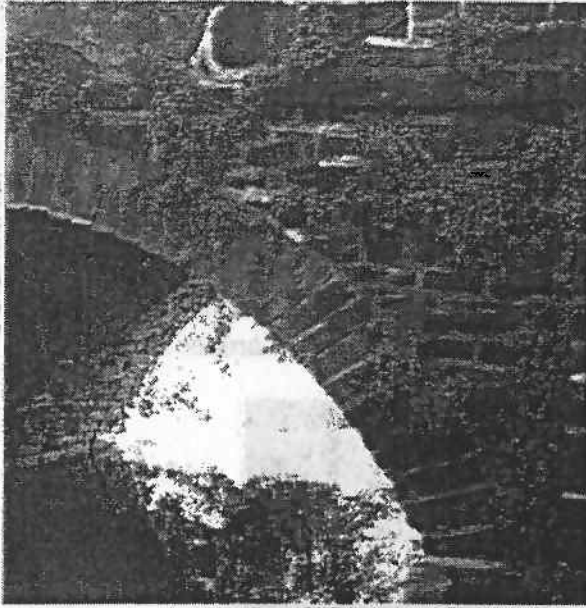
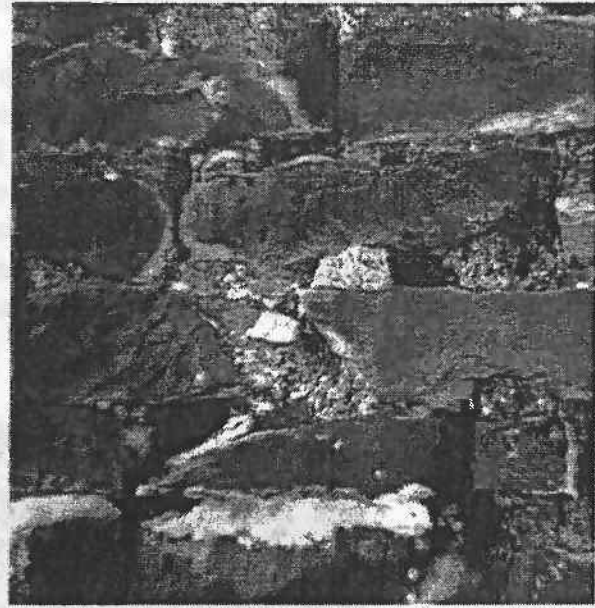
Figure 13. Bucks County Bridge No. 223. Details.

(a) detail of ring

(b) detail of barrel

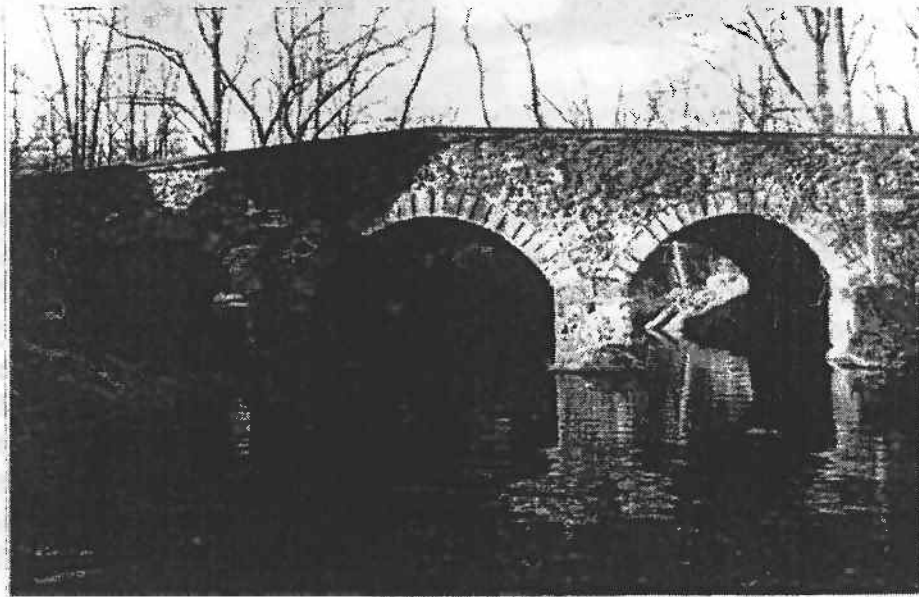
Figure 14. Bucks County Bridge No. 305 (1873)

c. 1900, in the use of hard portland cement mortar in the forming and construction of the arch barrel. The bridge is also characteristic of most of the structures found in Hunterdon County in the construction of the arch barrel, and the provisions made for the skew angle of approximately 70 degrees.

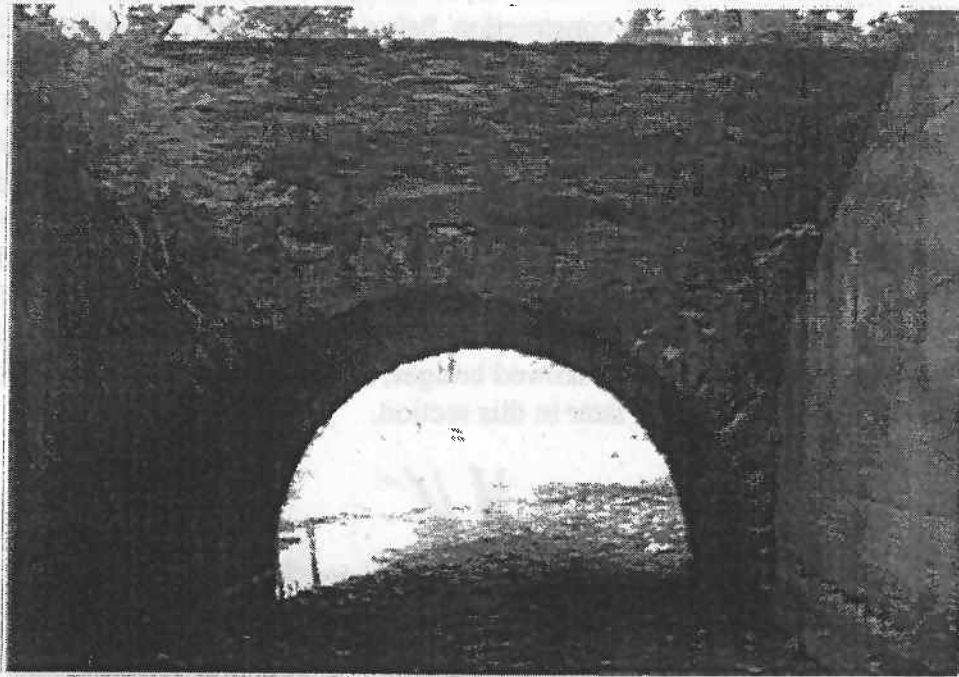
Figure 16. Bridge P-160. *This structure incorporates monumental features, such as the high semicircular opening, the formal treatment of the ring, and the high spandrel walls.*

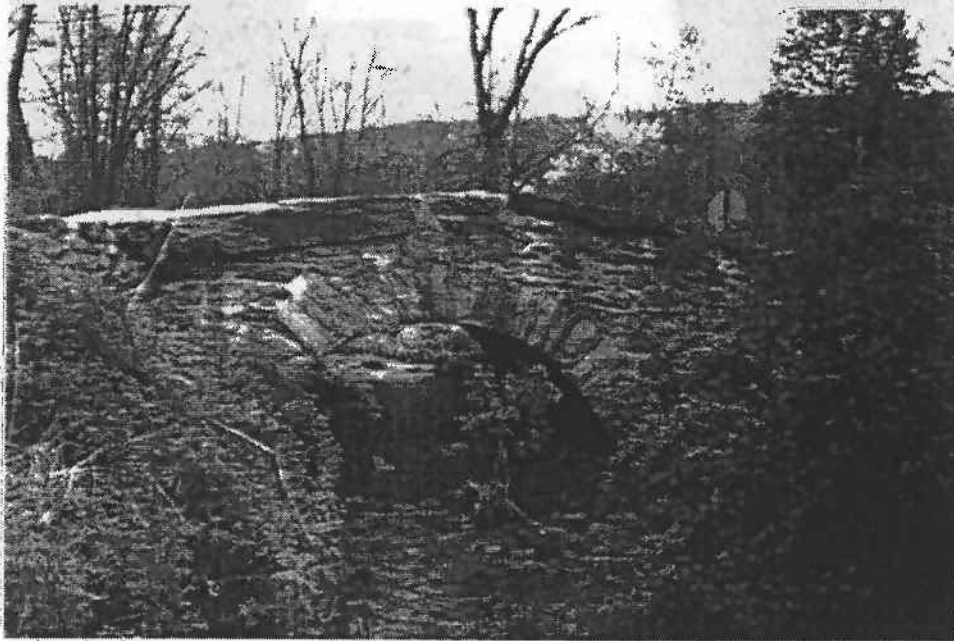
Figure 17. Bridge T-8 *Typical of Northern bridges: low profile, low segmental opening, large rough random unshaped voussoirs, and random size coping stones.*

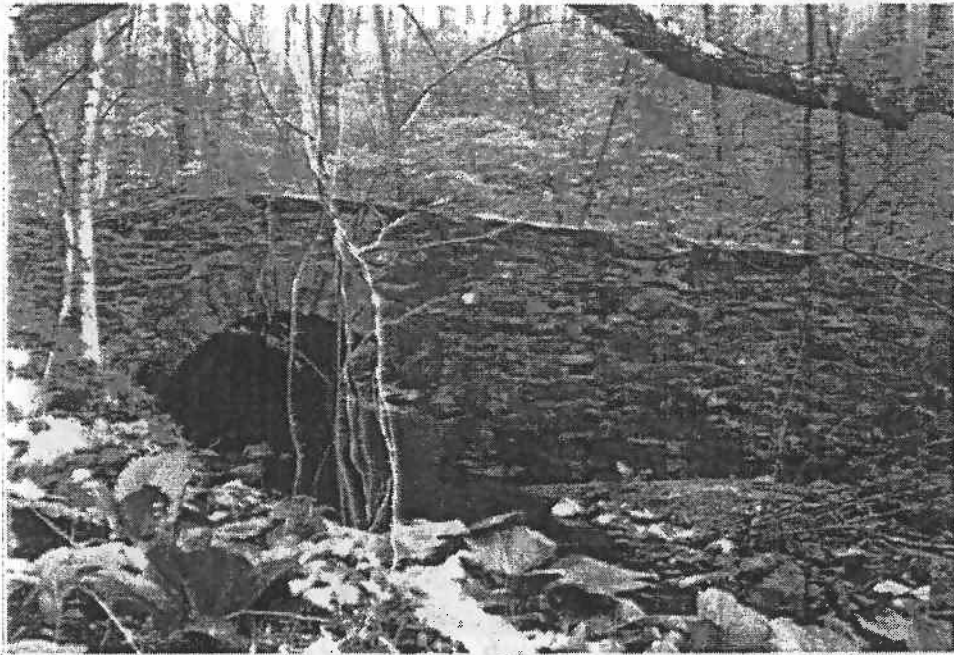
Figure 20. Bridge T-9. *Northern bridge: although a little more organized than its counterpart T-8, this structure displays a low profile opening, irregularly shaped stones, and random copings*

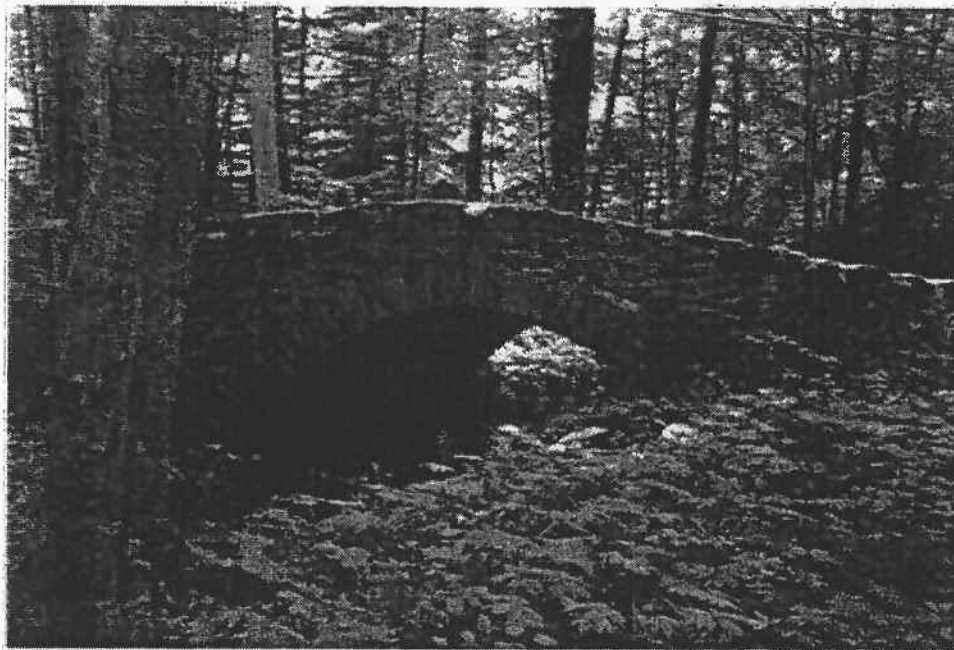
Figure 21. Bridge T-89. *Low profile, irregular shaped stones, segmental opening, and rough random uncoursed spandrel stones are hallmarks of the Northern style.*

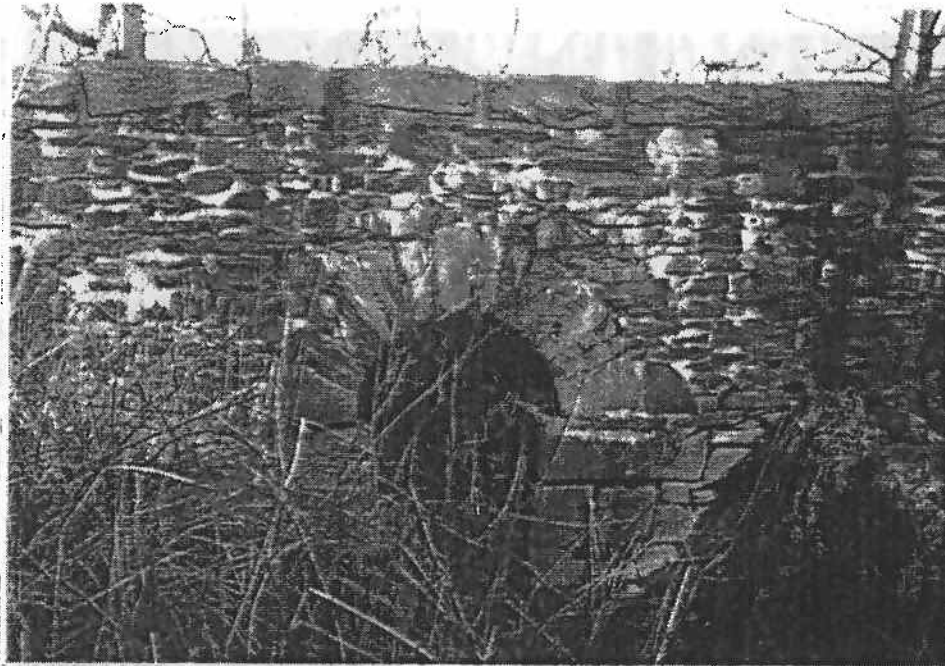
Figure 22. Bridge E-249. *Careful squaring of the abutments and a light shaping of the intrados at the opening, and choice of matching coping stones are some of the refinements visible in this structure.*

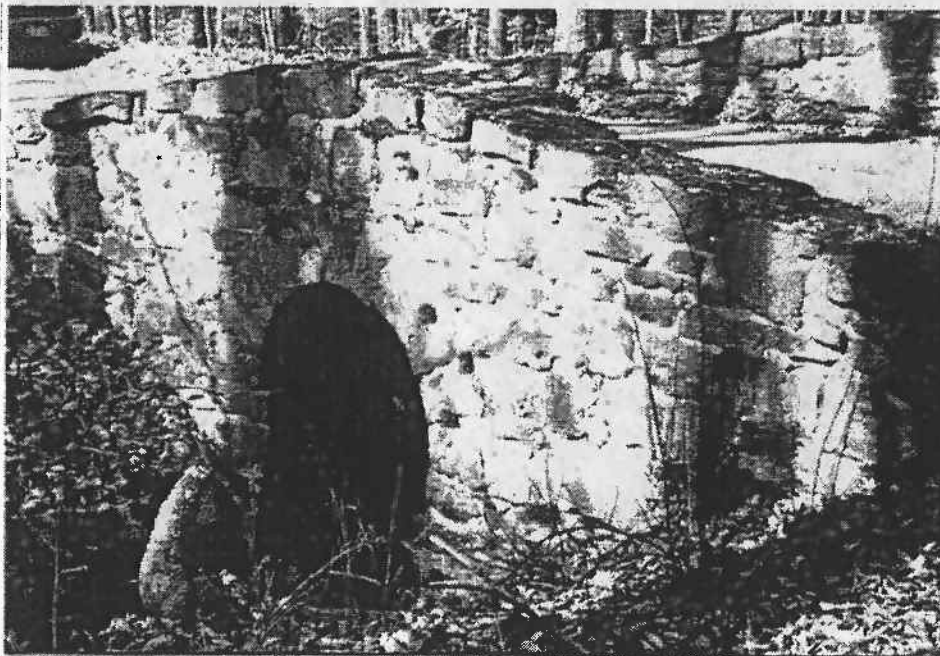
Figure 23. Bridge D-449. *Shaped regular voussoirs and a distinct curved cut of the intrados are evident in this structure.*

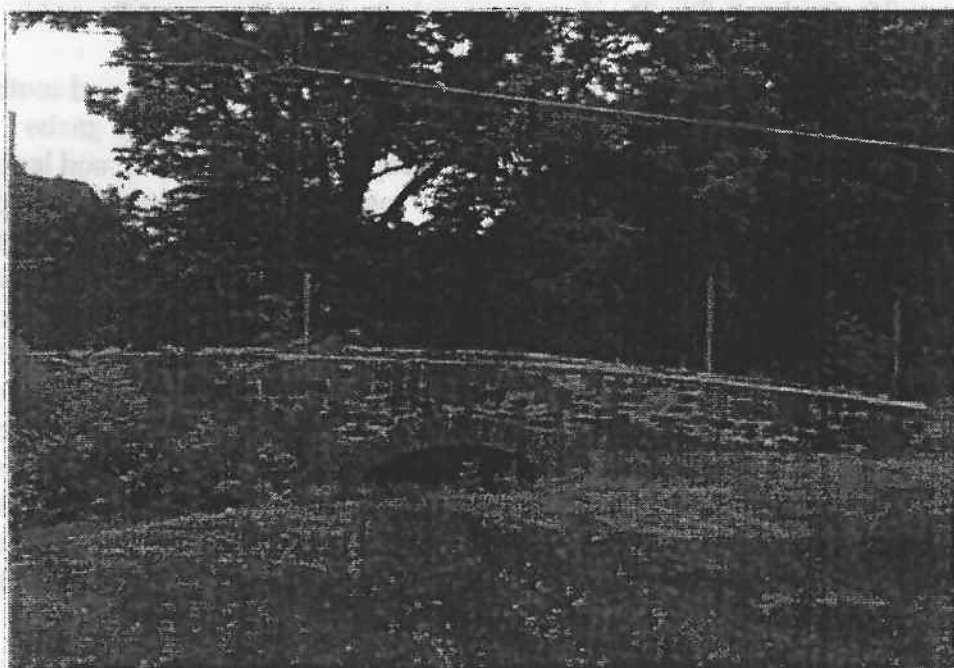
Figure 24. Bridge D-368. *A refined and gracious example of the Southern style, with carefully cut and matched voussoir stones, a graceful low vertical curve, carefully placed parapets, and inset spandrel and ring.*

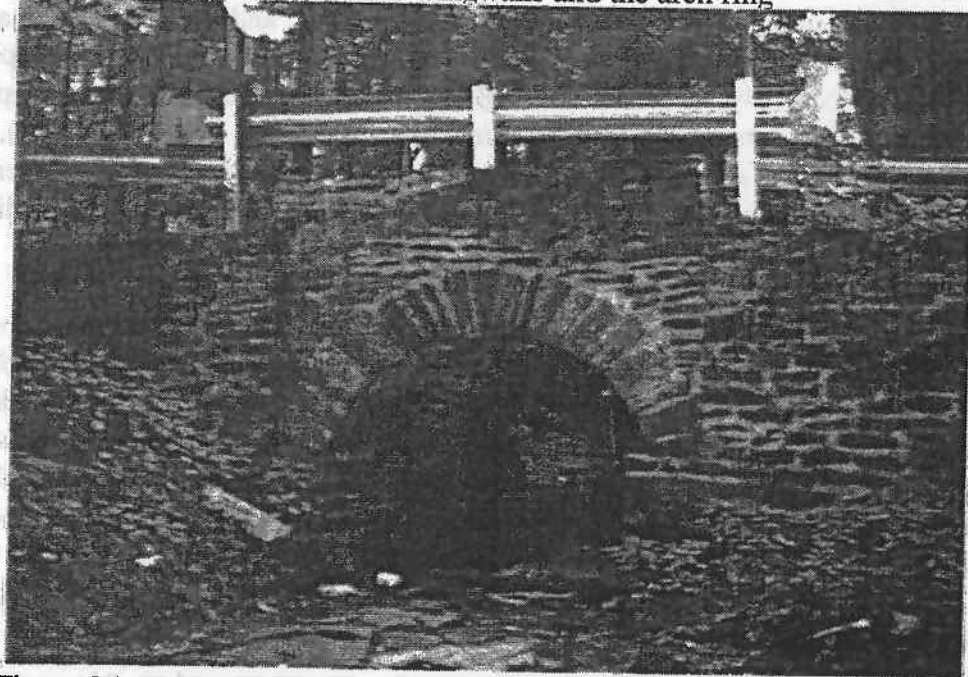
Figure 25. Bridge K-78. *The deep inset style found in Kingwood Township*

variation, including a deep inset, a parapet over the semicircular arch ring only, and the use of squared flat stones for construction of the wingwalls and the arch ring

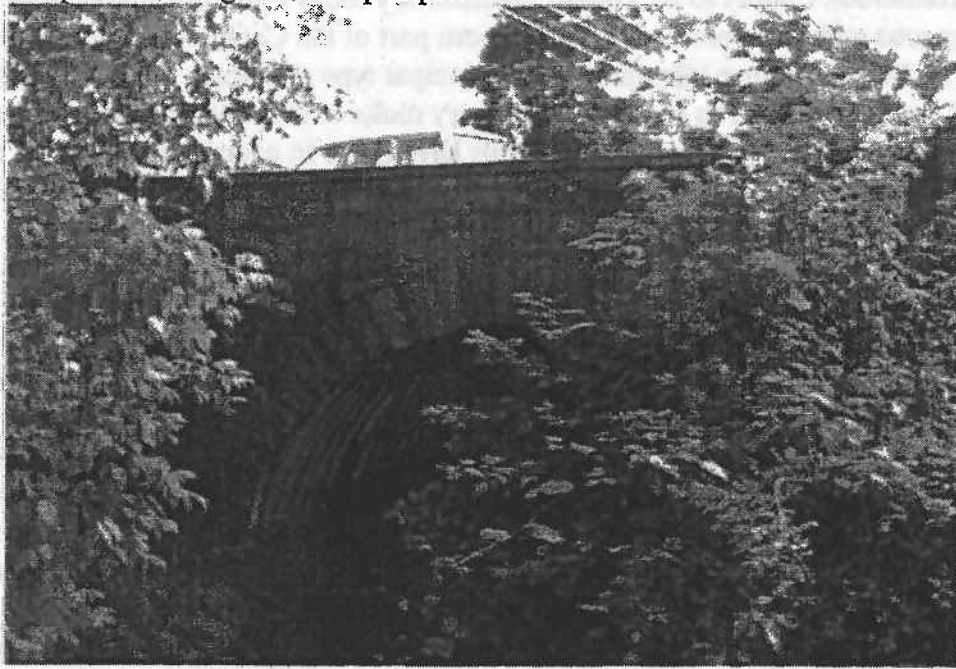
Figure 26. Bridge E-237. A 1940 structure built in a distinct WPA style.

237, a corrugated steel plate arch is used as stay in place centering. An arch ring, though not necessary for the structure, is placed on the outside of the centering, and spandrel walls are constructed of semi-coursed cut stone. This method has other precedents in the 1930's, for example among the stone bridges built by the WPA in Eastern Colorado. The other method, which is visible in widening projects throughout Hunterdon County, is to build a formed concrete arch for the widened part of the bridge. The arch is usually faced, as it is in Bridge U-21, located on Strotz Road in Union Township (Figure 27) with a cut stone arch ring and a carefully built spandrel, wingwall, and parapet.

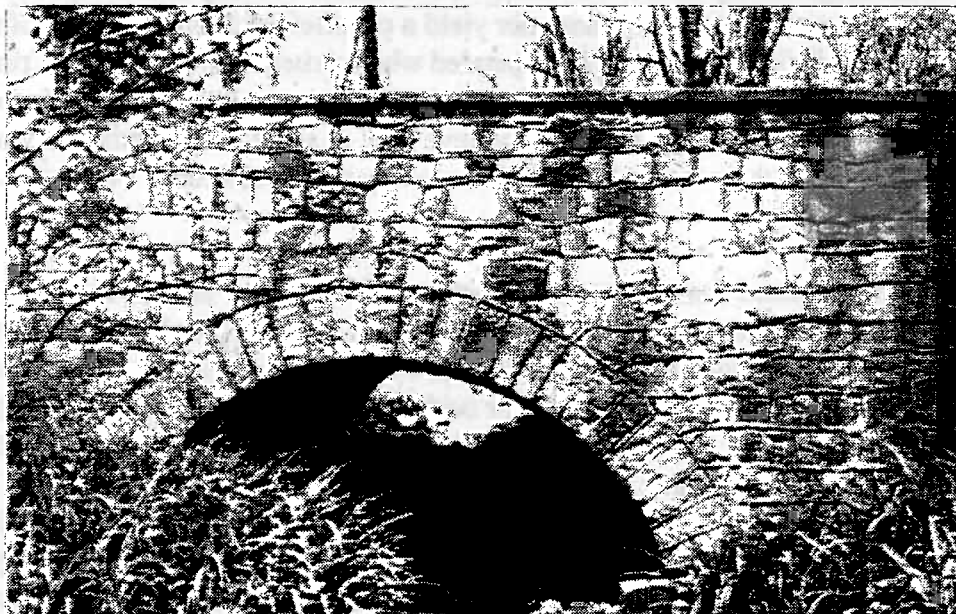
Figure 27. Bridge U-21. This bridge was widened to both sides in a 1930's style.

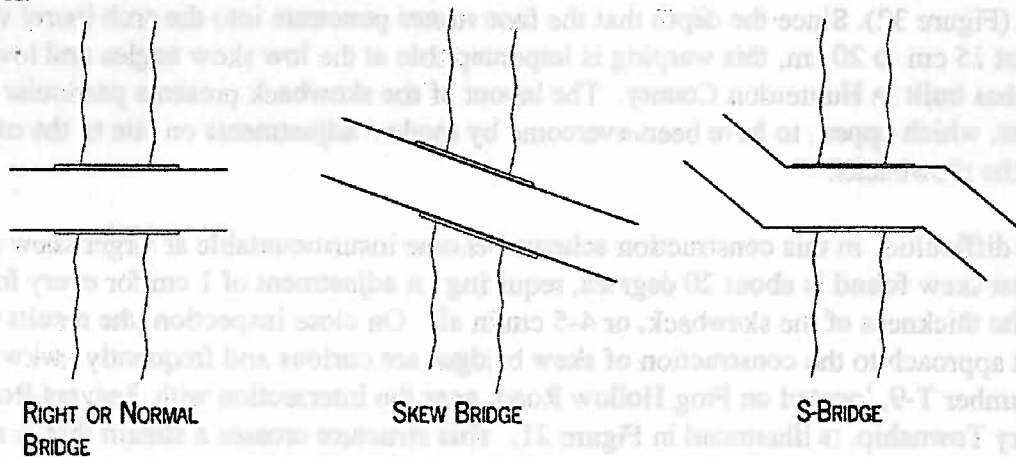
Figure 29. Types of stream crossings

Four basic strategies were generally adopted for the construction of skew crossings. The S-bridge, previously described in Section I, is a response to the challenges of building a skew crossing, in which the alignment is simply kinked to allow a right bridge to be built instead of a skew bridge. In the false skew scheme, a cylindrical arch barrel is simply cut off parallel to the road centerline, and the coursing joints in the arch barrel run parallel to the abutments. In the US, builders of rail bridges often built skew bridges as a series of narrow offset right arches, called ribbed arches. The most refined type of skew arch bridge structure is the skew arch, of which a bridge in Reading, PA (Figures 6 and 7) furnishes an example. In this scheme, the joints twist around the intrados at an angle related to the skew angle of the structure. Although the angle at which the facing stones are cut is different for each stone, they are nearly normal to the face of the arch. The interior stones in the arch barrel are identical and present a rectangular face on the intrados, although their sides have to twist slightly to accommodate the curve of the arch barrel.

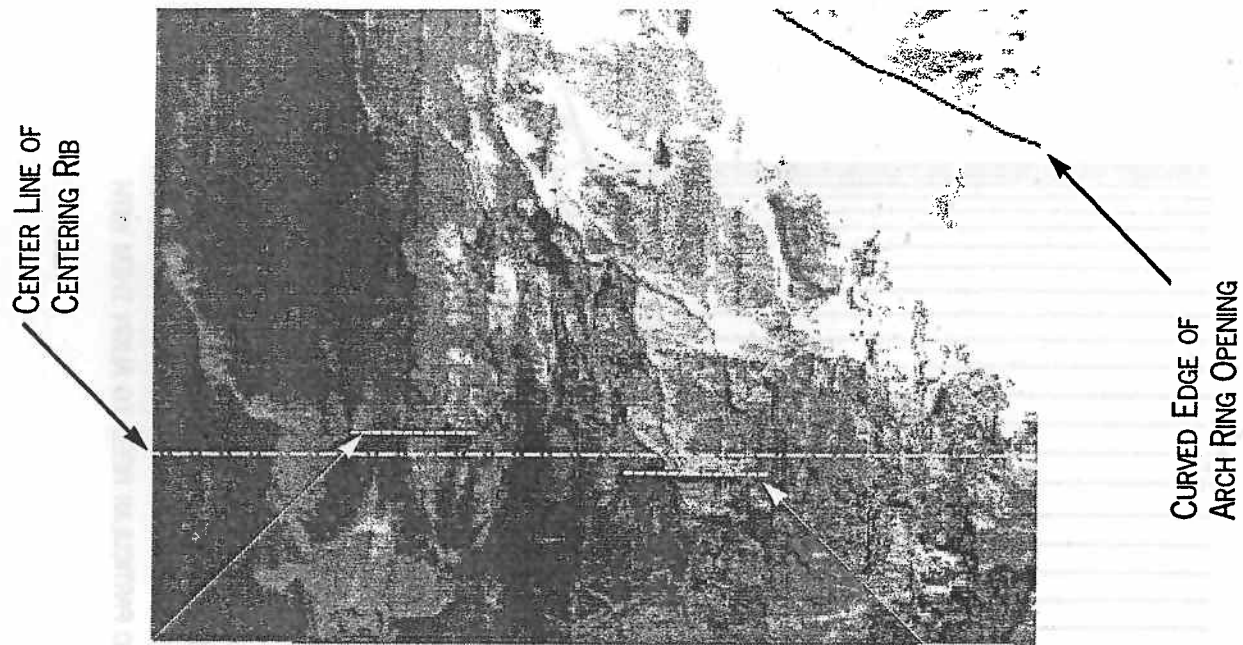
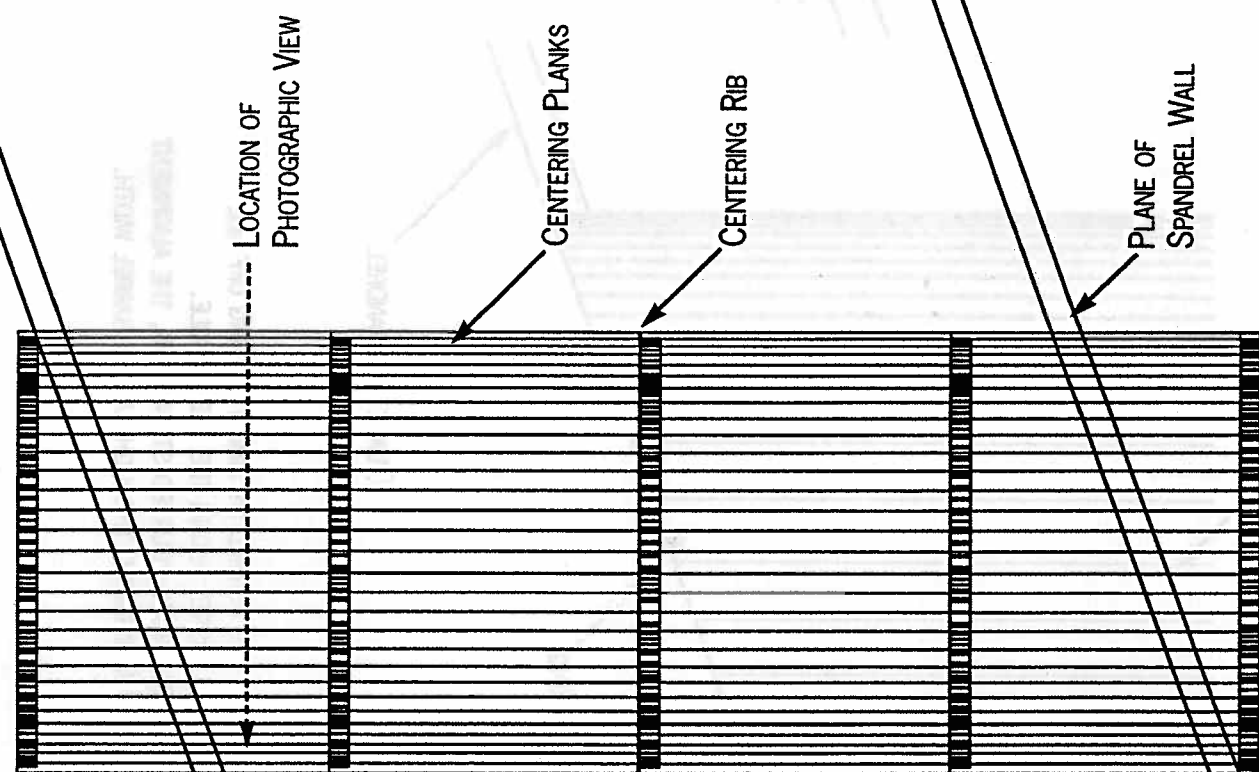
FIGURE 30 CENTERING USED FOR THE CONSTRUCTION OF SKEW BRIDGES SIMILAR TO T-42

Of the bridges in the Phase II survey, a surprisingly large proportion, over  $1/3$ , are built with a detectable skew alignment of the arch barrel. As previously described, the bridges in Hunterdon County universally have cut stones on the arch faces only, and the barrels are filled with elongated random rubble stones, roughly parallel to the abutments, and filled with loose mortar apparently placed after all the stones are in place on the centering. In adapting this construction process to a skew bridge, the builders would have to decide whether to make the opening follow a circular arc at the face and an elliptical curvature at the interior or *vice versa*. In every case the builders elected to use cylindrical centering, with a resulting elliptical curvatures at the face of

INTERIOR OF THE BARREL OF T-42

Since the difficulties in this construction scheme become insurmountable at larger skew angles, the greatest skew found is about 20 degrees, requiring an adjustment of 1 cm for every four through the thickness of the skewback, or 4-5 cm in all. On close inspection, the results of this expedient approach to the construction of skew bridges are curious and frequently awkward. Bridge number T-9, located on Frog Hollow Road, near the intersection with Beavers Road in Tewksbury Township, is illustrated in Figure 21. This structure crosses a stream that is almost parallel to the road alignment, calling for a very large skew angle, however the structure is built with a skew angle of no more than 20 degrees. Bridge T-97, located on Philhower Road, shown in Figure 33, presents the curiosity of being a combination S-bridge and being built on a skew. The alignment of the approaches to these bridges is distinctly kinked and the barrel of the arch is skewed with respect to the faces of the spandrels. Both of these effects work together to overcome a skew angle of approximately 30-35 degrees between the roadway and the stream crossing.

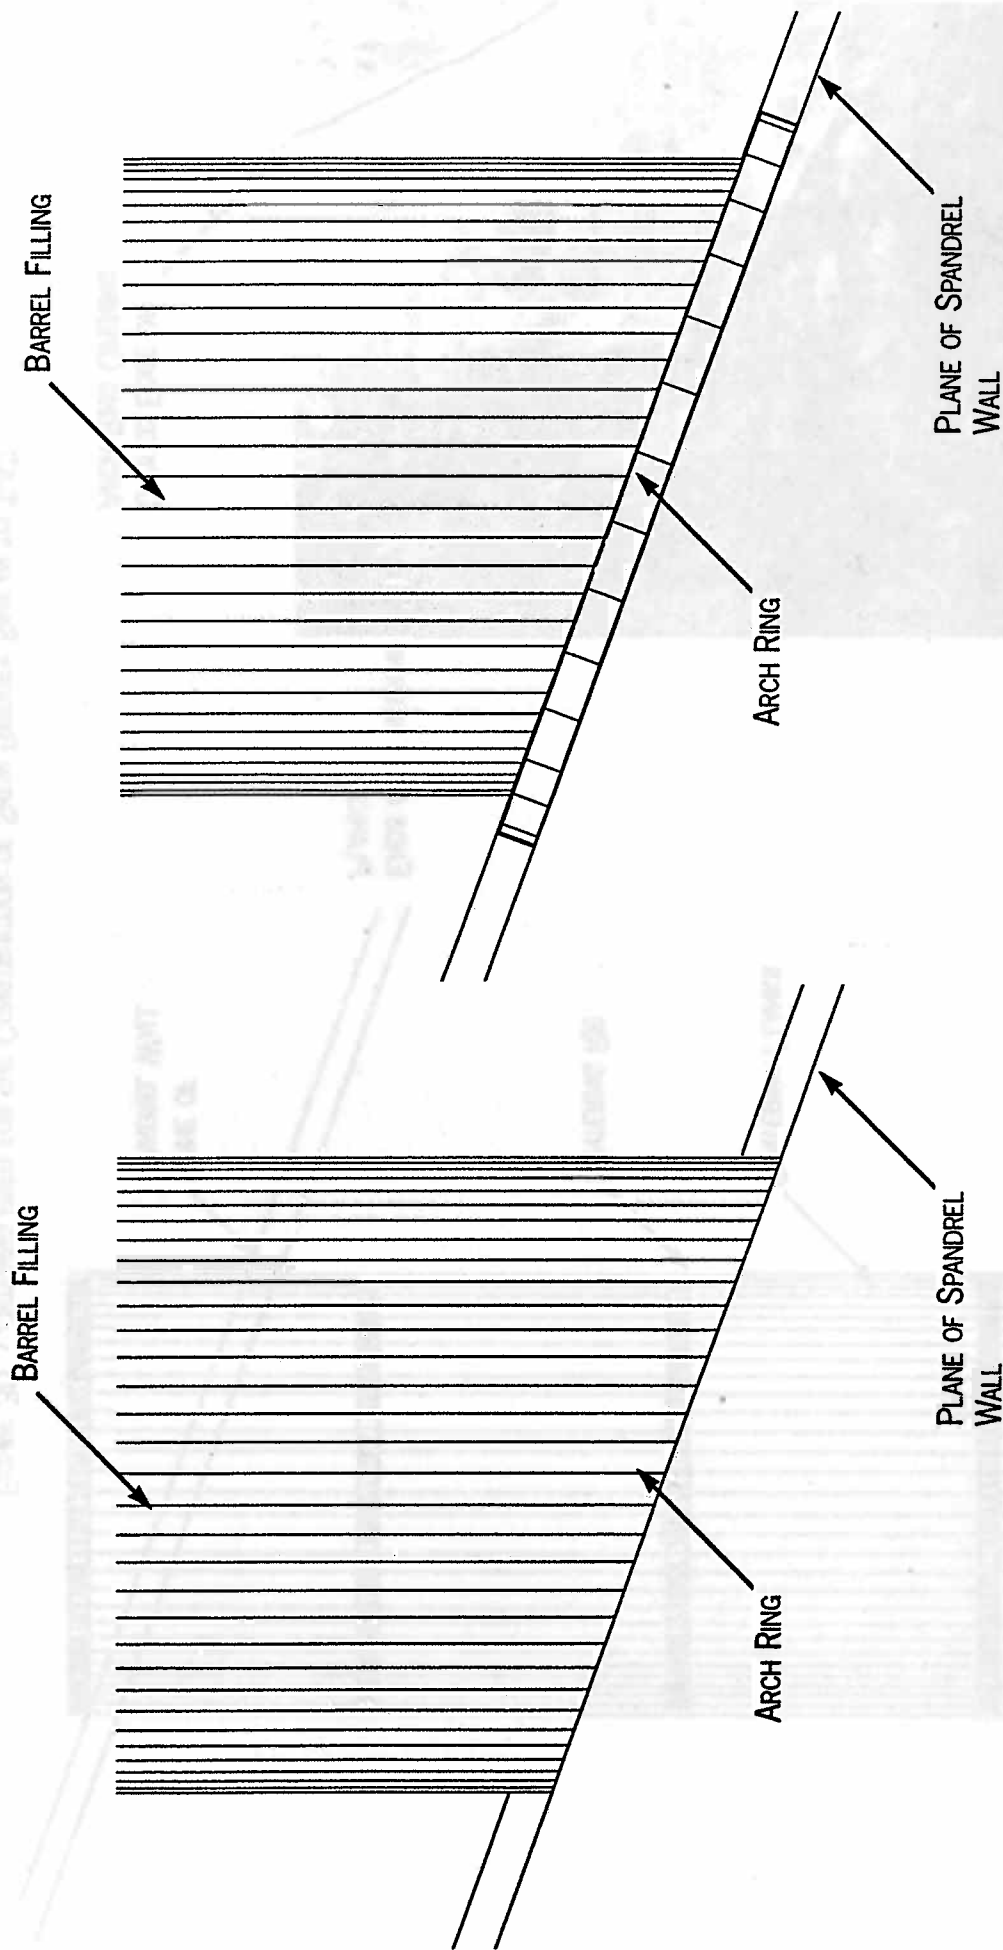
FIGURE 31 FALSE SKEW ARCH AND HUNTERDON COUNTY SKEW ARCH

THE RING STONES ARE FORMED BY SIMPLY CUTTING OFF THE CYLINDRICAL ARCH BARREL ALONG THE SKEW ANGLE. AS THE BARREL FILLING IS COURSED STONWORK, THE ALIGNMENT OF THE JOINTS IS MAINTAINED THROUGHOUT THE BARREL WIDTH.

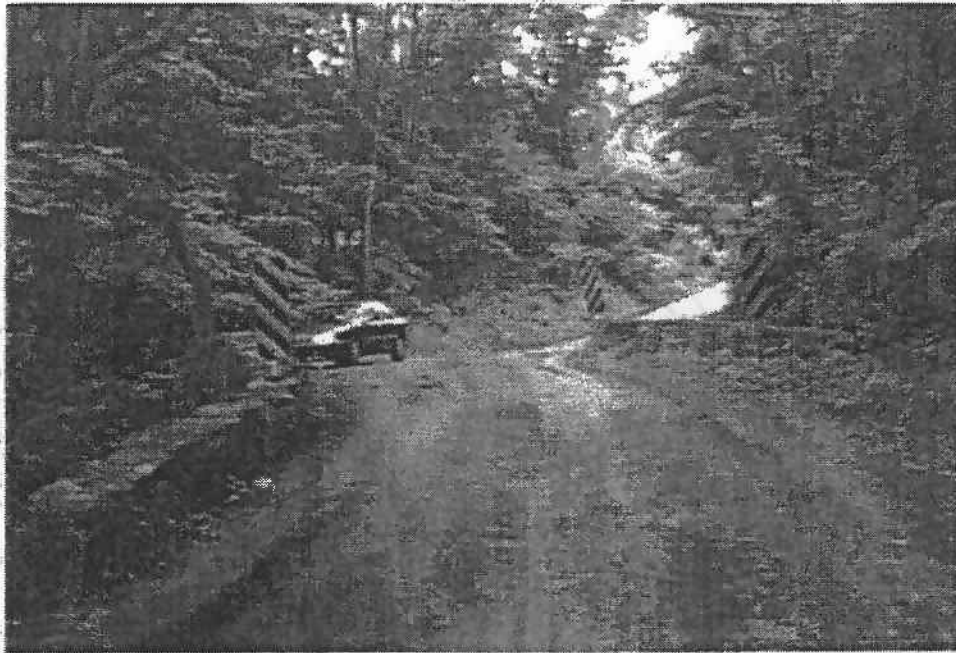
Figure 33. Bridge T-97. *This structure is identifiable as an S-bridge, in spite of the skew of the arch barrel.*

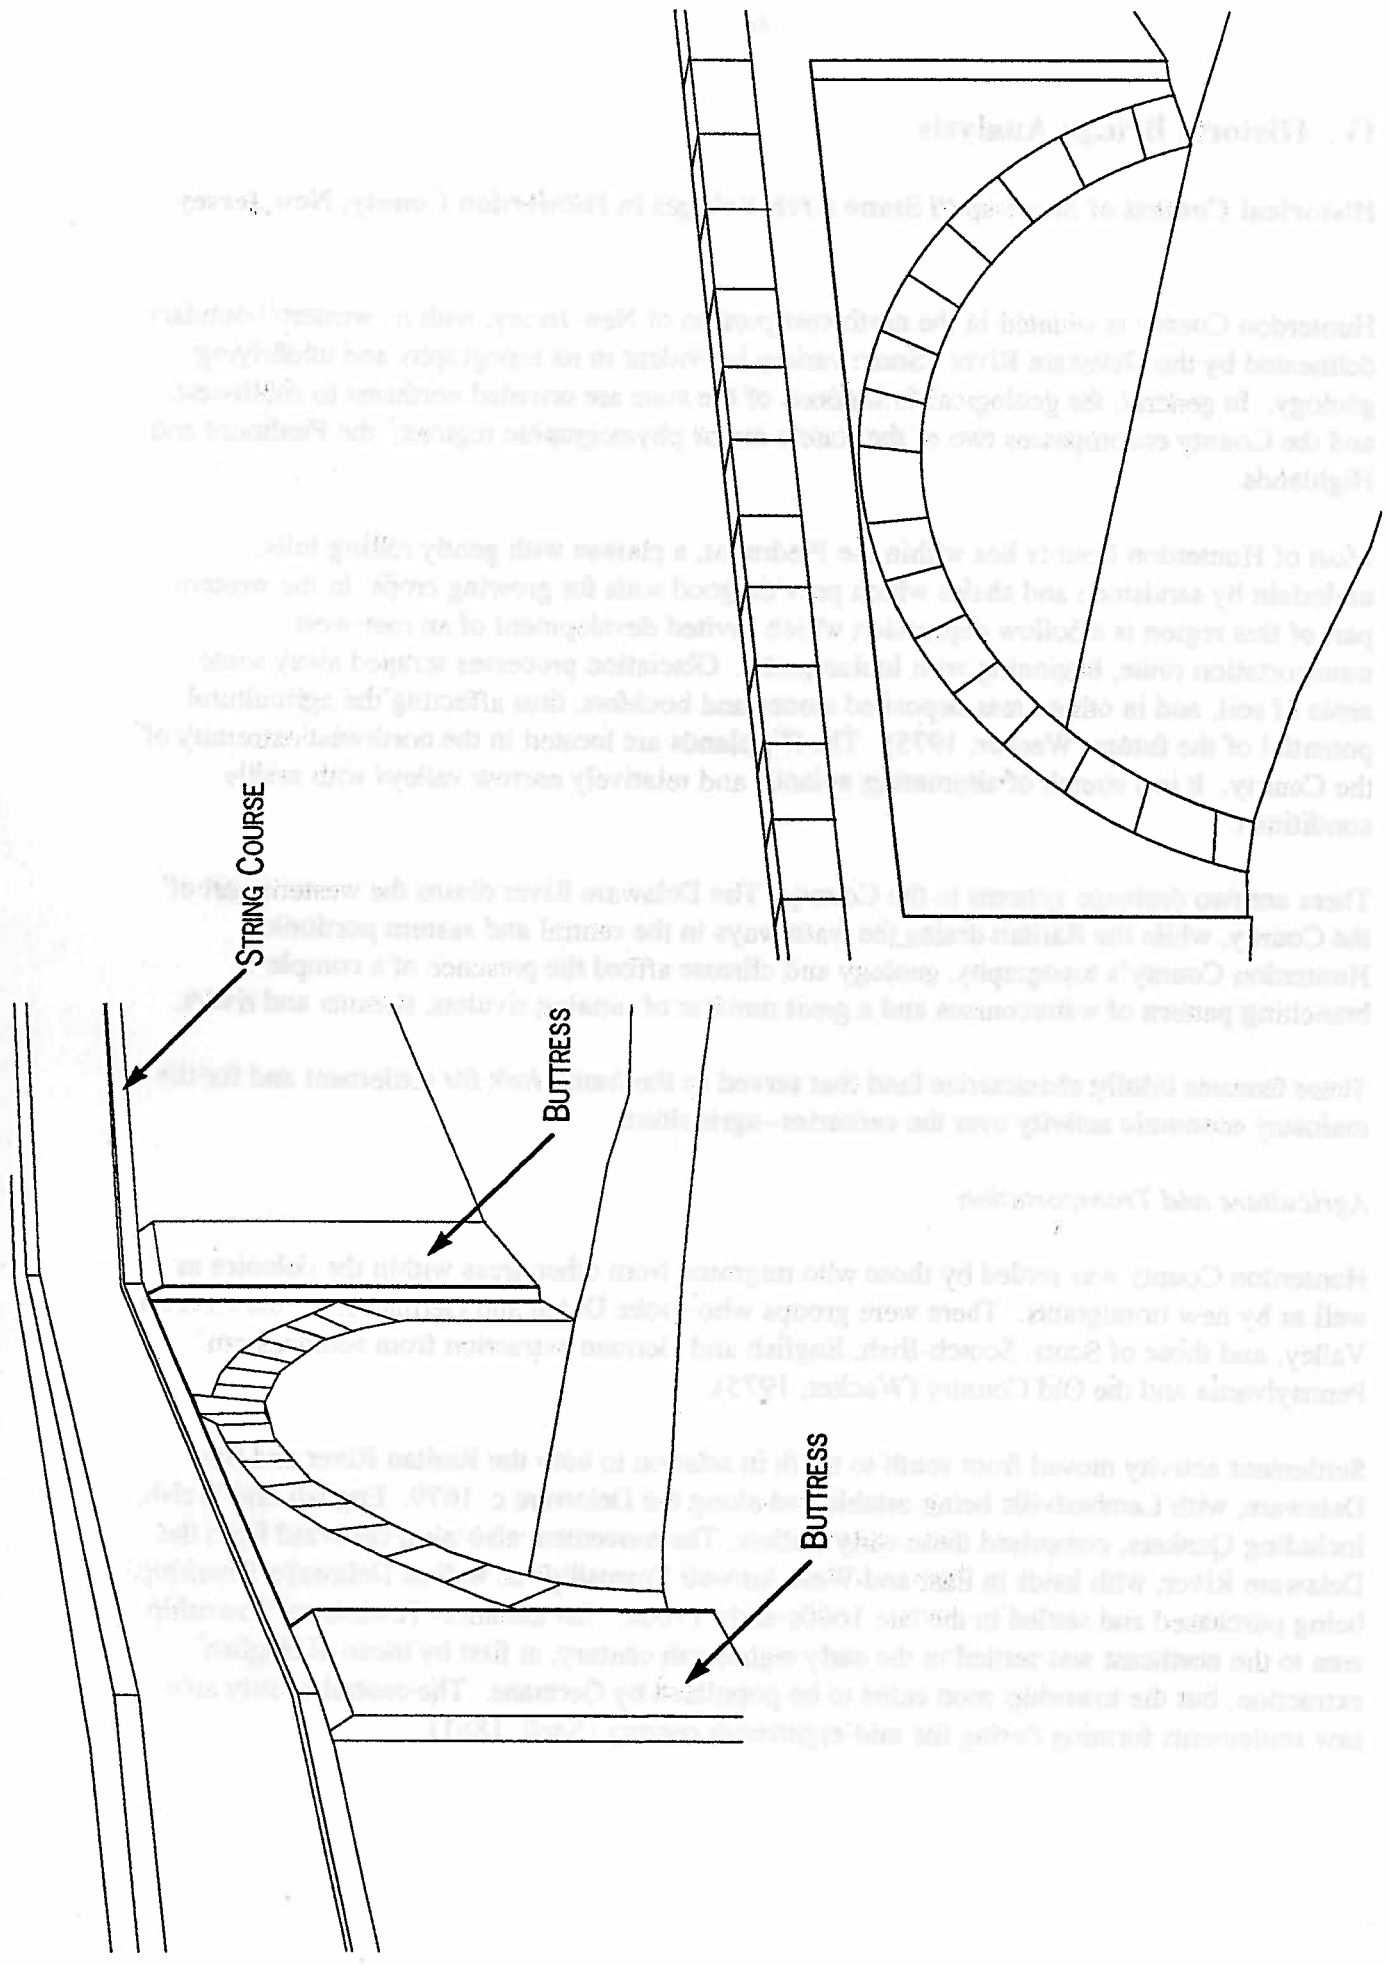
FIGURE 34 INSET ARCH RING AND SPANDREL

The inset arch ring/spandrel wall is a feature that appears on 17 of the structures in this survey. The structures exhibiting this feature are located in Delaware, East Amwell, Franklin, Kingwood, and Holland Townships, and it has been described previously as a feature primarily identified with the more refined structures from the southern portions of the county. This treatment is not unique to Hunterdon County, but can be found in various forms in structures in other regions. It is also identified with some of the structures surveyed in Bucks County, PA, such as Bridge No. 223, previously illustrated in Figure 11. Features of the S-bridges along the National Road in Ohio are also suggestive of the inset, including the string course at the bottom of the parapet, and the enlarged buttresses often observed in line with the abutment, at the deepest part of the wingwall. In most cases where this treatment is observed in Hunterdon County bridges, the wingwalls are at a slight angle to the parapet. It is thought that this feature is a way to make a visible transition between the arch and the associated spandrel wall, and the curved, battered, or flared wingwalls, without involving the builder in complicated stone cutting. It is well known from carpentry that a quirk is much easier to build and more satisfying to the eye than a difficult or poorly executed attempt to effect a smooth transition between the two planes. It is likely that the arch ring and the spandrel wall were constructed first, followed by construction of the wingwalls and the parapets. In this case, building the wingwalls and parapet on a different plane than the arch ring eases the task of completing the transition. It is quite conceivable, then, that this feature evolved from the combination of a buttress and a string course (Figure 33).

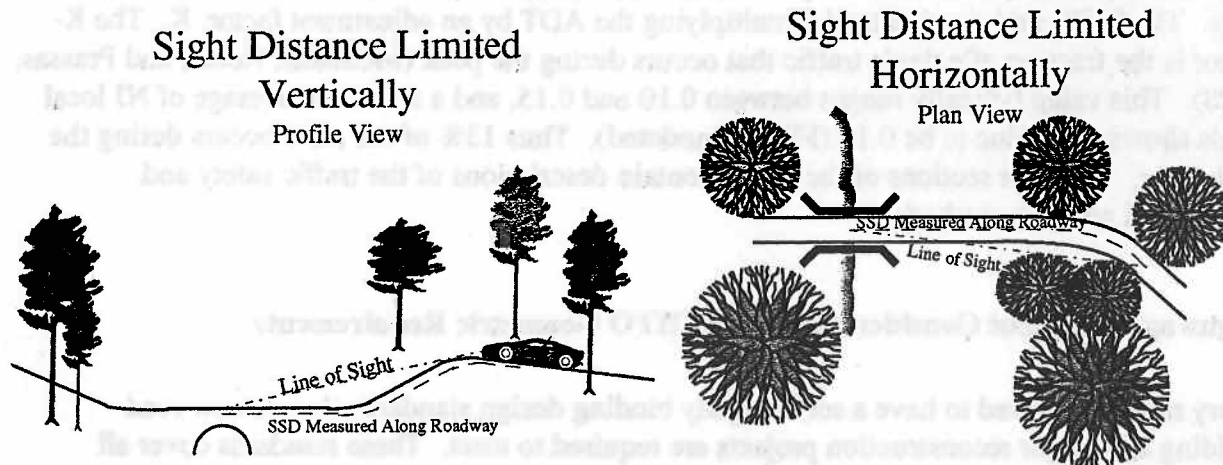
Figure 34. Sight Distance

should be noted that the sight distance for the bridges in this study was measured from each approach to the center of the bridge. Sight distance from one side of the bridge to the other was *not* measured for this project; it was determined to be not as important in this study as the visibility to the bridge structure itself.

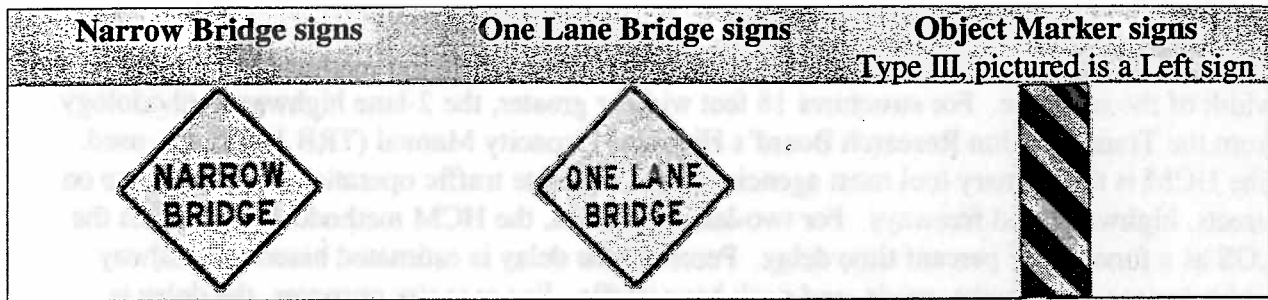
Figure 36. Traffic Control Devices

Recommendations were formulated for each bridge based on the comparison to AASHTO minimum design requirements, the Bridge Safety Index calculations and the LOS estimation. A brief narrative of the traffic conditions for each bridge is then presented. A set of needs for Signing, Marking, Parapet/Guiderail, Horizontal, and Vertical improvements was compiled. These needs are based strictly on design criteria and field conditions; they are not based on traffic volumes. Specific recommendations were given, to quickly show the most common recommendations for the bridges in the study, such as signing improvements and guiderail changes. The reference for the signing recommendations was the Manual of Uniform Traffic Control Devices (FHWA 1988). Specific sign recommendations include the following signs:
