**Comments on New Jersey Highlands Water Protection and Planning Council  
Draft RMP Amendment: Plan Conformance Procedures**

# Stone Arch Bridge Inventory, Phase II Hunterdon County, New Jersey

The Stone Arch Bridge Inventory, Phase II, is a study of 92 stone arch bridges in Hunterdon County, New Jersey. The purpose of the study is to provide the County with recommendations regarding the preservation and future modifications to the bridges in view of their historical significance and current and future traffic patterns. The Stone Arch Bridge Inventory, Phase II, is a sequel to Phase I, prepared by A.G. Lichtenstein & Associates, Inc, dated November, 1995, which is a similar study of 14 stone arch bridges. The bridges in both of these phases have less than a 20 foot span and were therefore excluded from the NJ Department of Transportation's statewide study of bridges, NJ Historic Bridge Survey, 1994. Both of the Stone Arch Bridge Inventories were funded by an Intermodal Surface Transportation Enhancement Act (ISTEA) grant to the County.

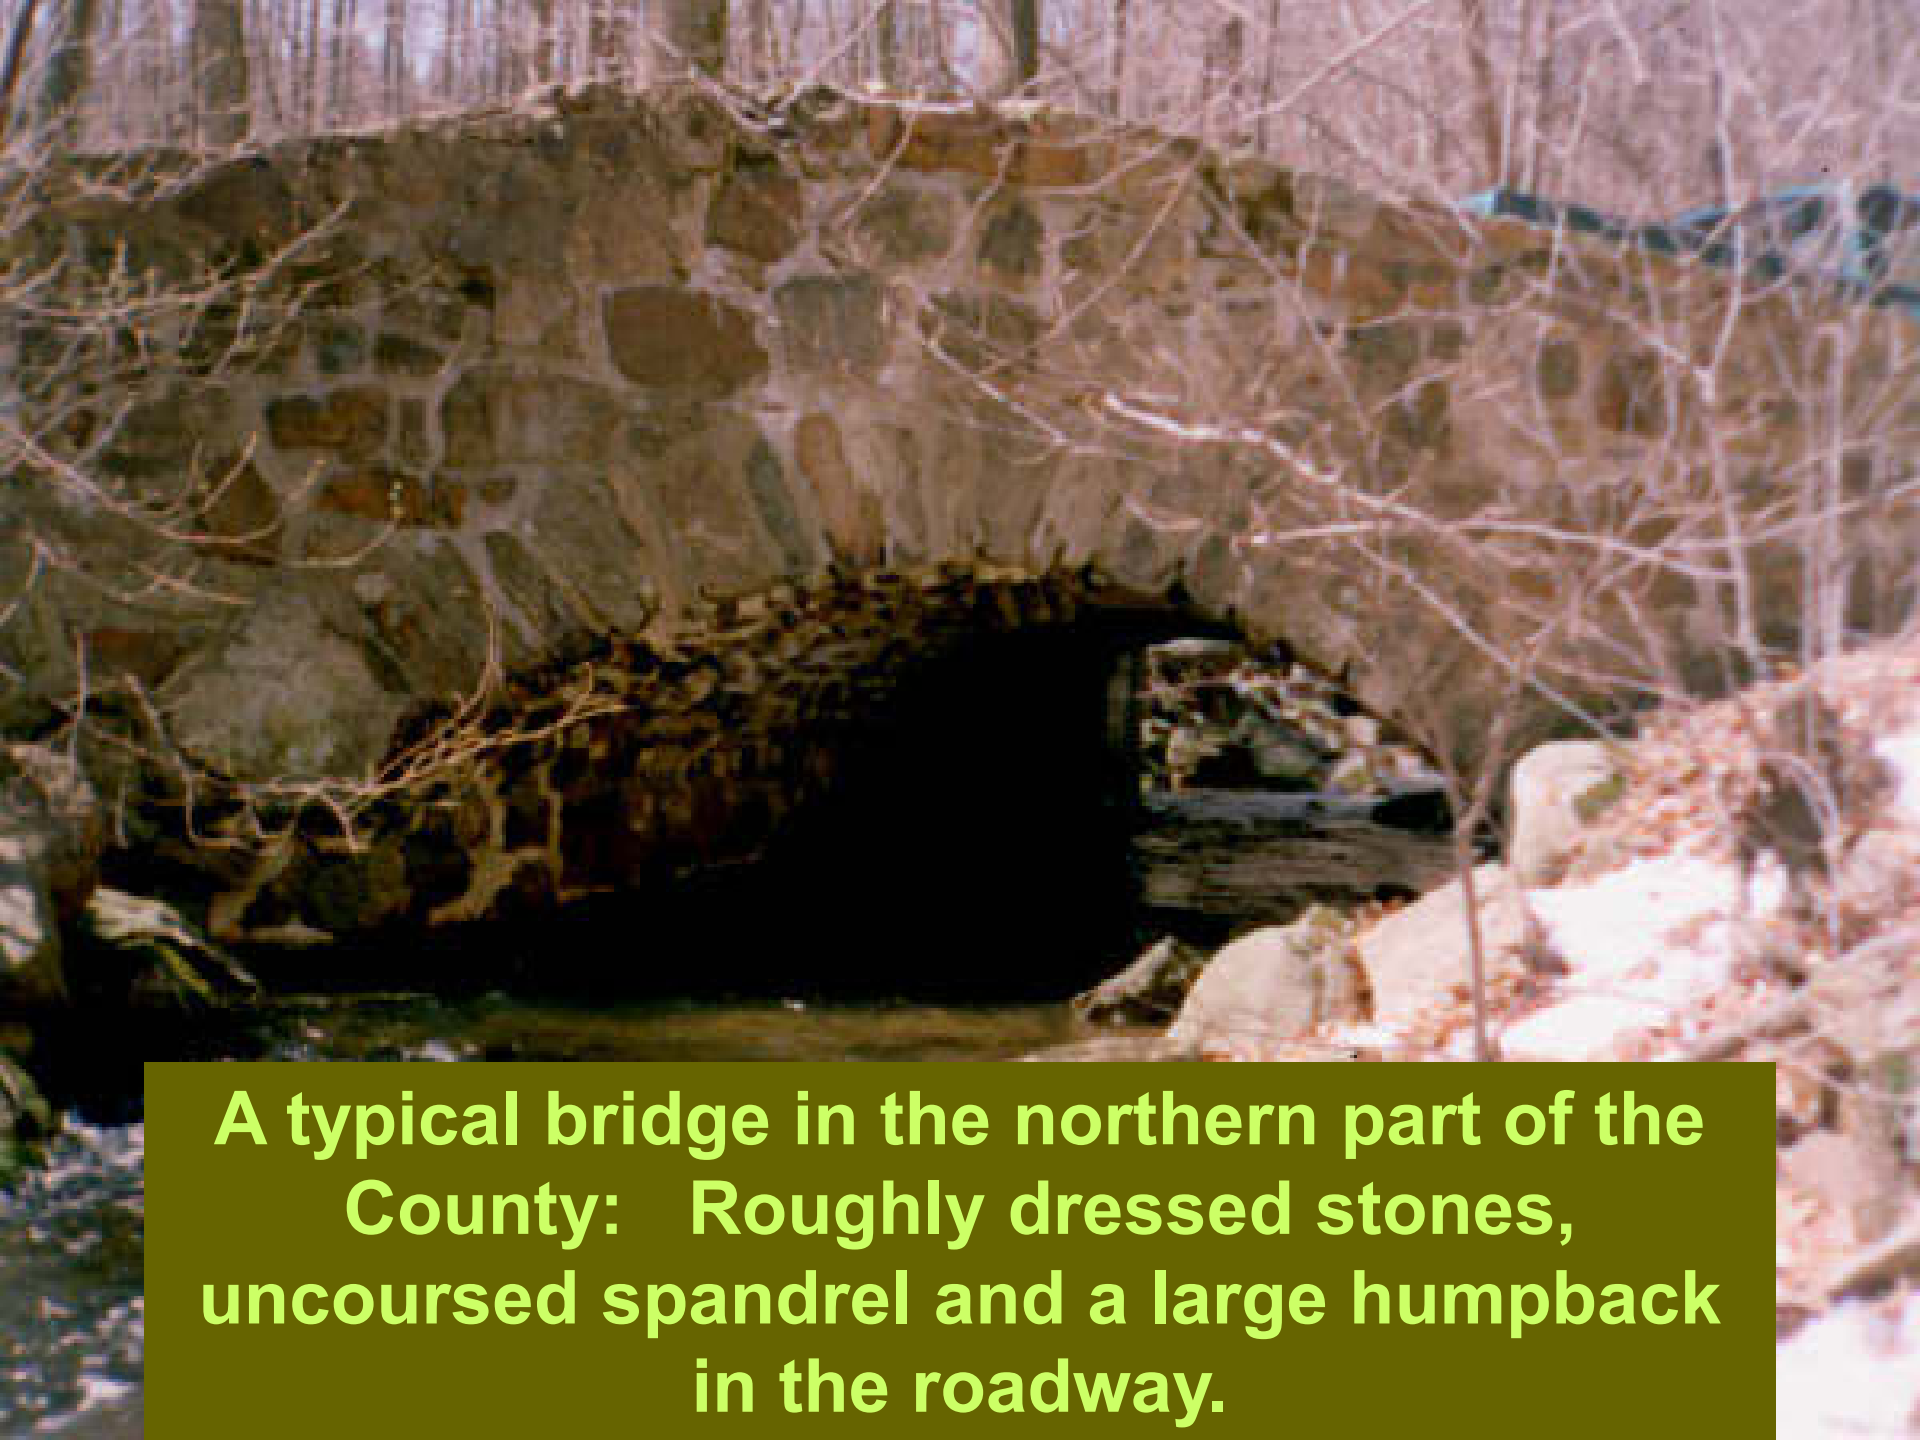
**A typical bridge in the northern part of the County: Roughly dressed stones, uncoursed spandrel and a large humpback in the roadway.**

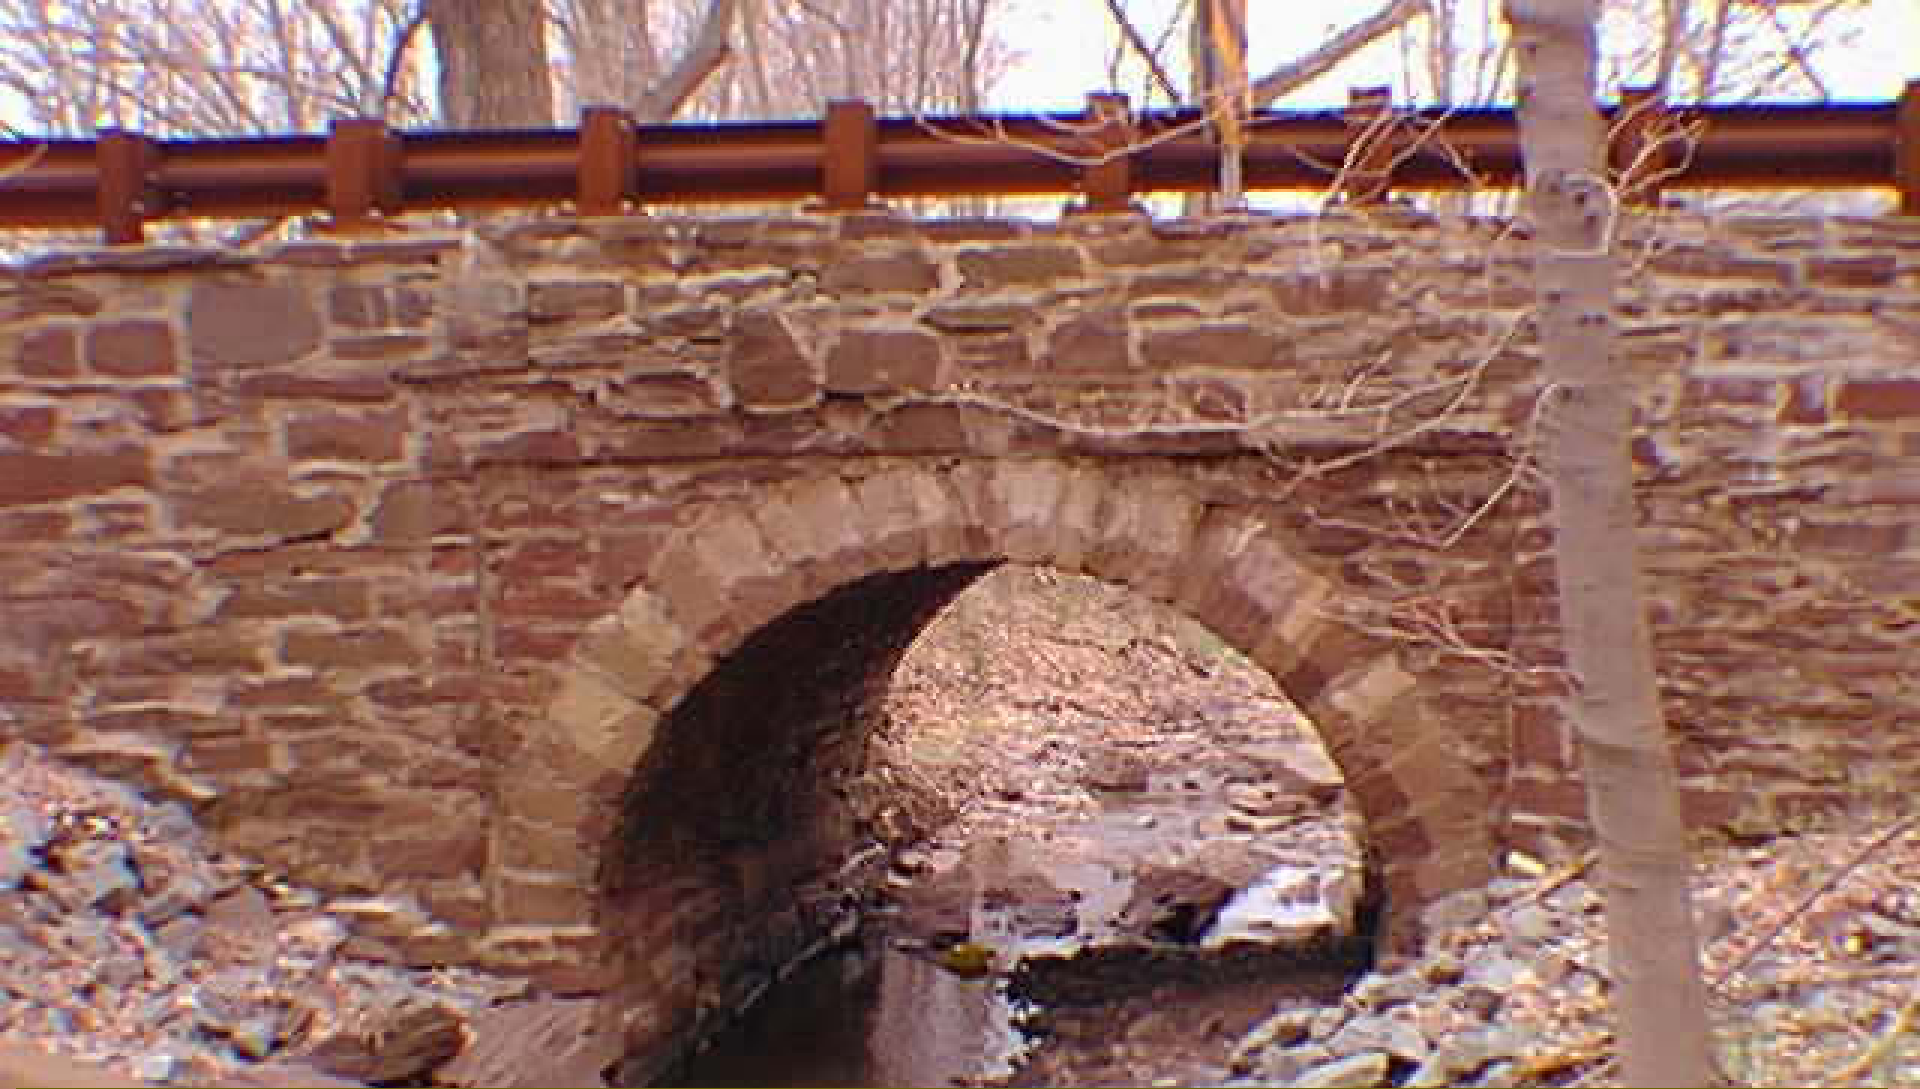
**A typical bridge in the southern part of the County:  
Dressed and shaped stones, smaller humpback in  
roadway, coursed spandrel, radial voussoir joints,  
arch ring inset.**
