PASSAIC COUNTY HISTORIC PRESERVATION ELEMENT

FOR THE PARK, RECREATION AND OPEN SPACE MASTER PLAN

OCTOBER 2022

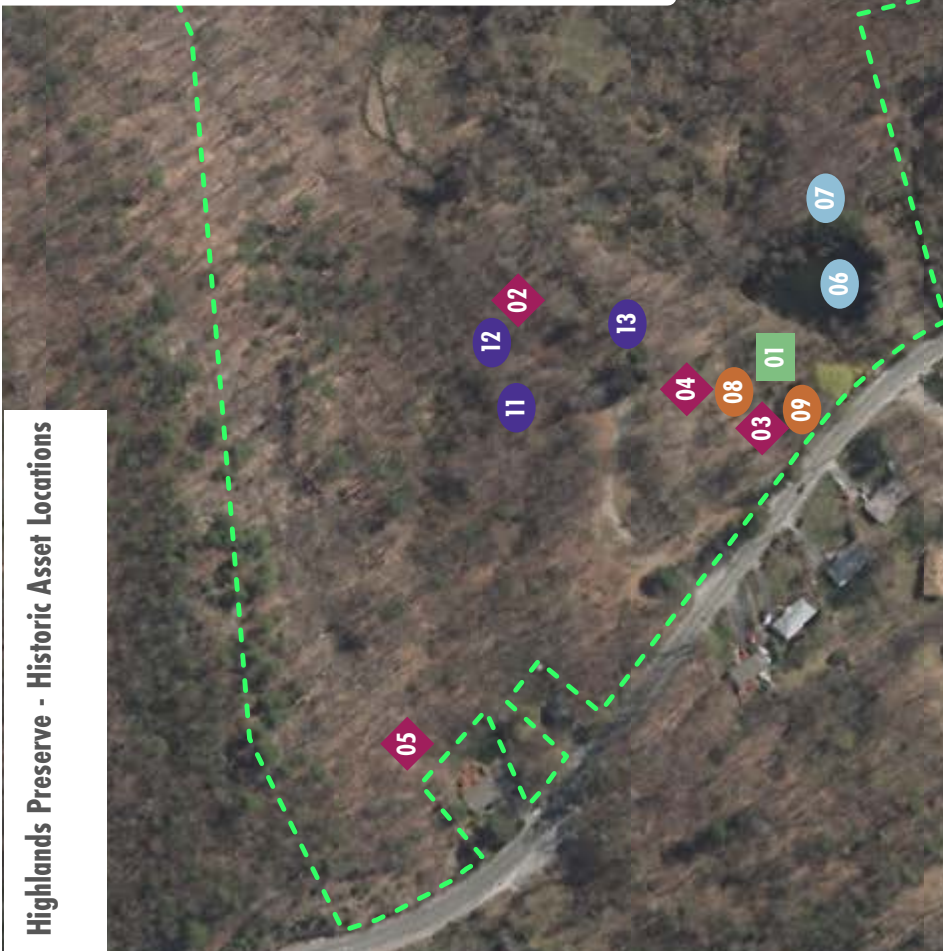
TICHENOR/MCDONALD HARDSCAPES

Over 200 linear feet of wet laid stone masonry wall are present along the crest east of the house site. Although age is unknown, these features appear to be 20th century. A long elevated farm lane is also present within a low-lying section of the property east of the house site.

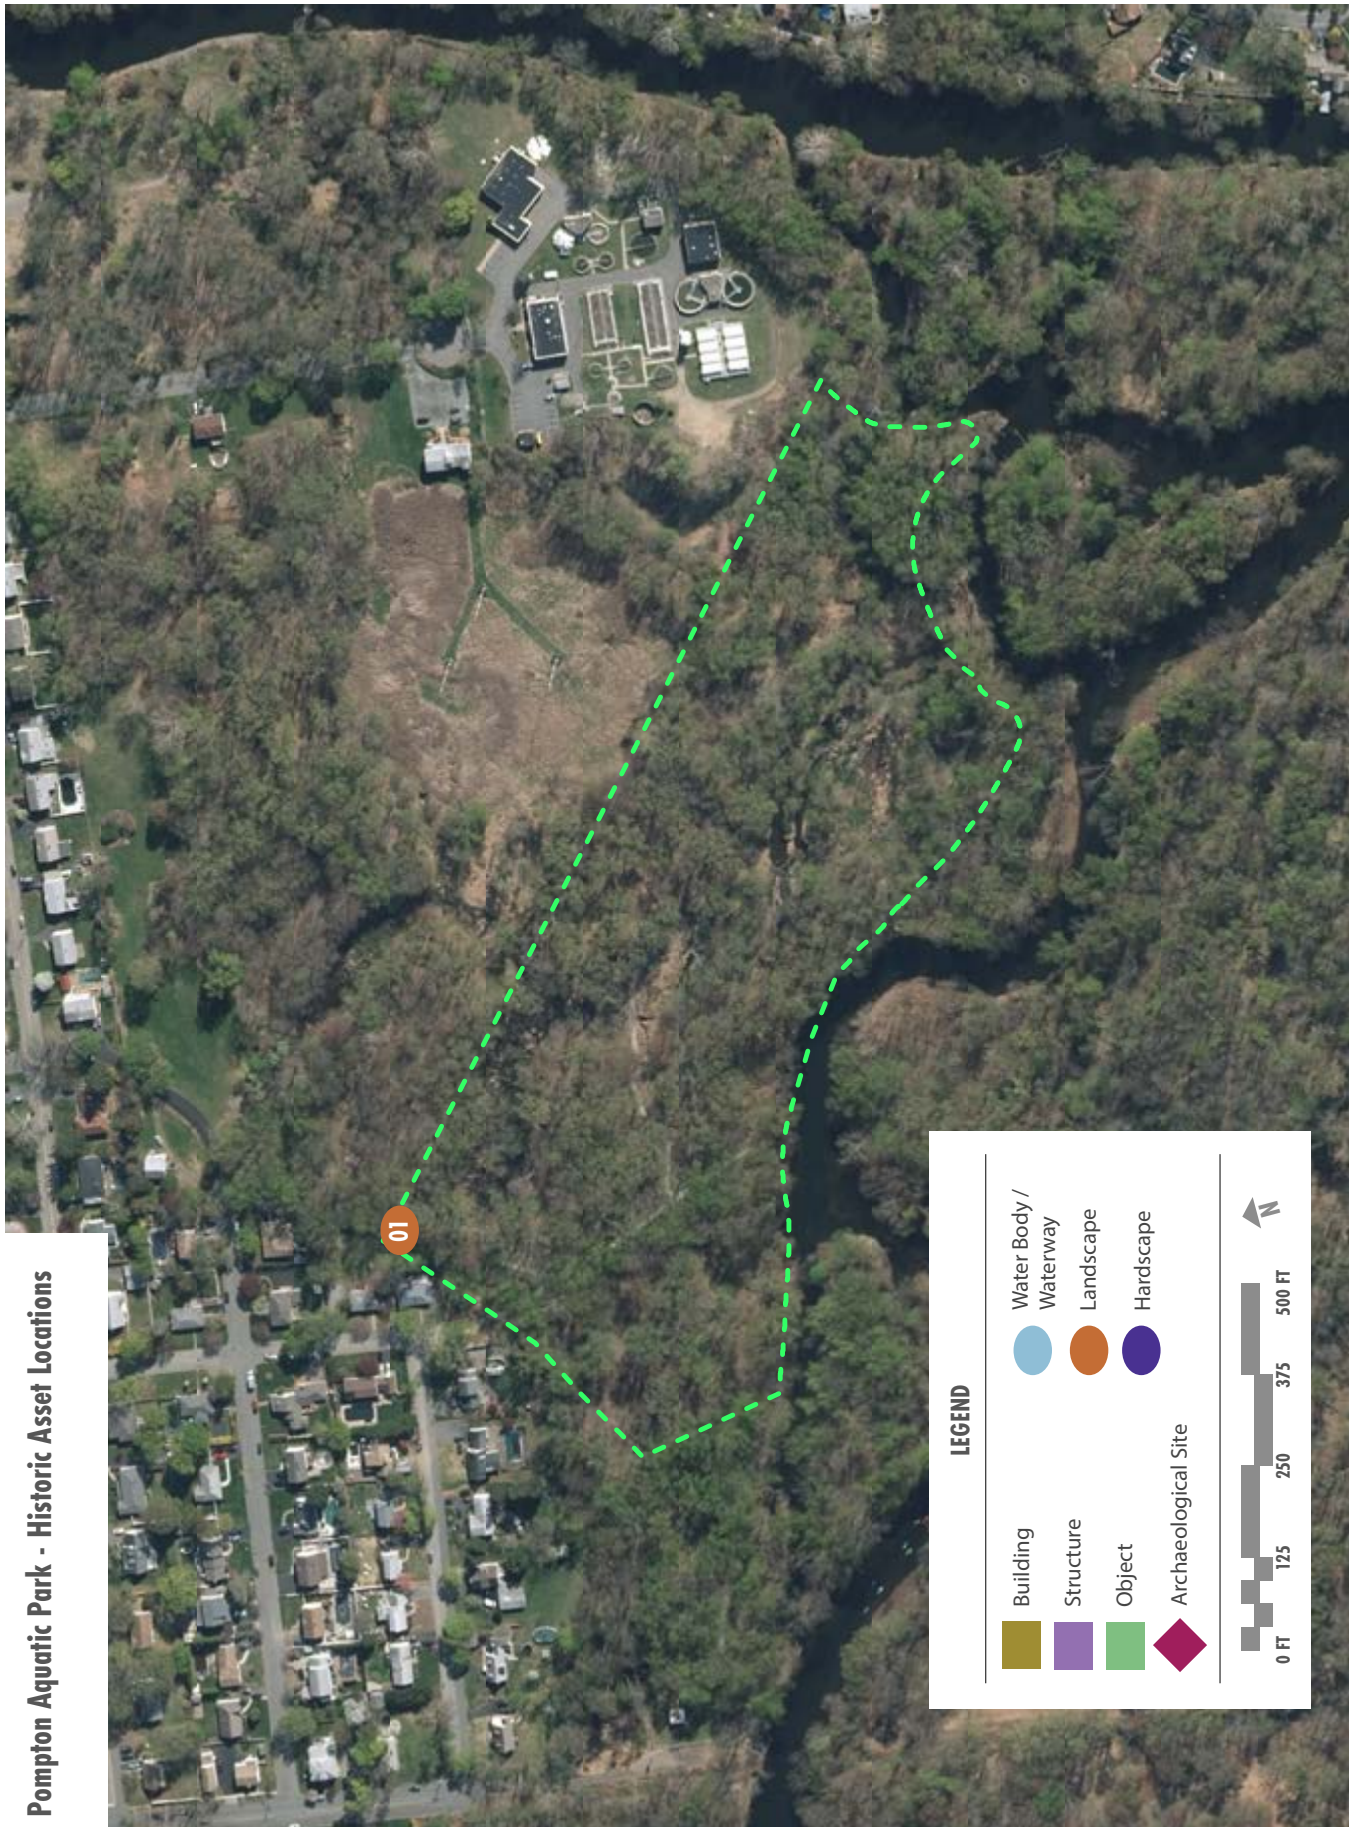
Pompton Aquatic Park - Historic Asset Locations

No potential historic sites were identified in a review of historic maps and 20th-century aerial photographs. Portions of the property appears to have been farmed in the early 20th century, however no buildings associated with the activity have been identified within the park.
