DIAGRAMMATIC SIGN STUDY
PHASE I REPORT

Bureau of Safety and Traffic
Division of Research and Evaluation
New Jersey Department of Transportation

August 1970

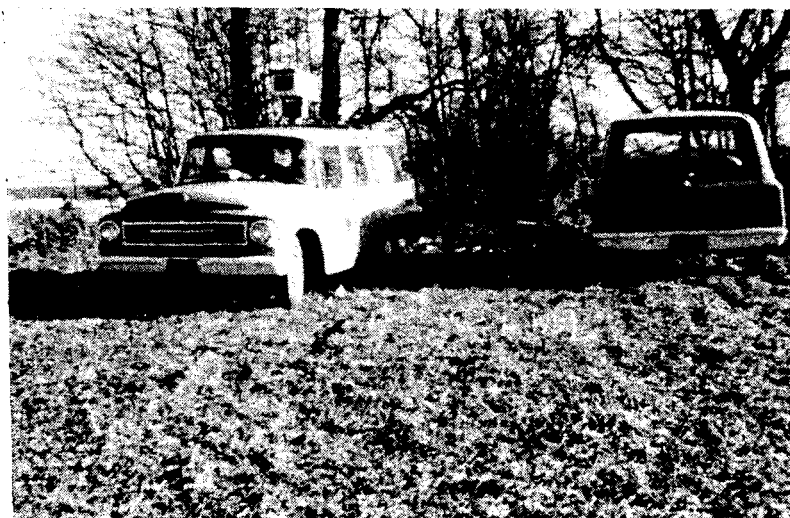
Fig. 2. Mobile TV Surveillance Unit

1. Electric power (115 volts) was provided in the median for our Mobile TV Surveillance Unit.

Two Mobile TV Surveillance Unit operators recorded the traffic approaching the exit gore on video tapes. The camera was adjusted to record all lanes from 400 ft upstream to points beyond the physical gore.

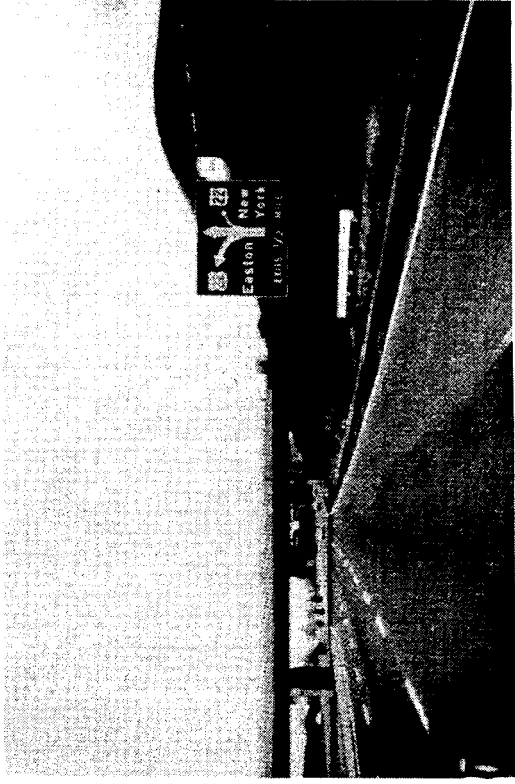
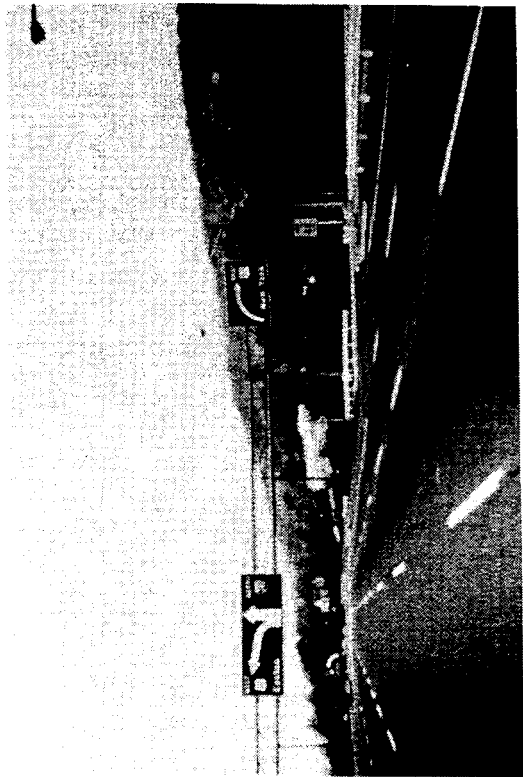
SIGN LOCATIONS: PHASE I - SIGNS
AFTER - DIAGRAMMATIC

The specific changes made on the signs were (a) the exchange of diagrammatic with conventional arrows and subsequent repositioning of messages, and (b) the addition of one US Route 22 shield on the first sign (refer to Appendix I).

2. The number of lanes for a movement are communicated at the most advanced point. This is done by displaying different arrow stem thicknesses.

4. The relative position of the sign within the interchange is more adequately communicated. Arrow stem connections and lengths show the choices left to the motorist at the sign locations.

1. The sign at location No. 3 was not referenced on the lane line that divides exit from through movements. A more ideal placement -- 8 ft to the left and at a more advanced point -- was not possible because of the overhead structures' wind-load capacity and its constructed position.

2. In the mind of the motorist the sign at location No. 5 does not entirely eliminate the possibility that its exit ramp may be farther down the highway. The sign may have been better placed over the exit ramp on a cantilever structure with its support on the outside of the ramp.
