PREMATURE DETERIORATION
OF
WHITE CONCRETE CURB

FINAL REPORT

New Jersey Department of Transportation
Task Force on Concrete Durability

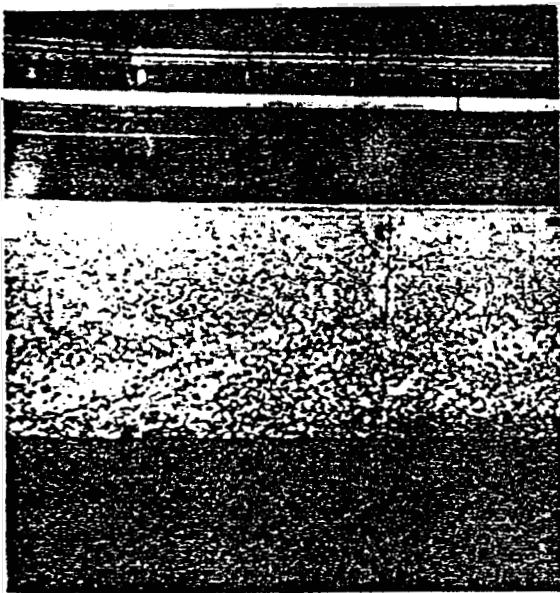
Approximately 5 years after construction (Project A)

1B. Scaled (northwest) curb face.

confined to the north curb face, with almost the entire length of curb being affected. This differential performance is attributed to the fact that the shaded (north) curb face would not be expected to receive the beneficial heating and drying effects of the sun to the same degree as the south face. Thus, the former might retain more freezable water and/or be subjected to freezing cycles of longer duration. Similar, but less pronounced, differences in durability between curb faces were also observed on another study project.

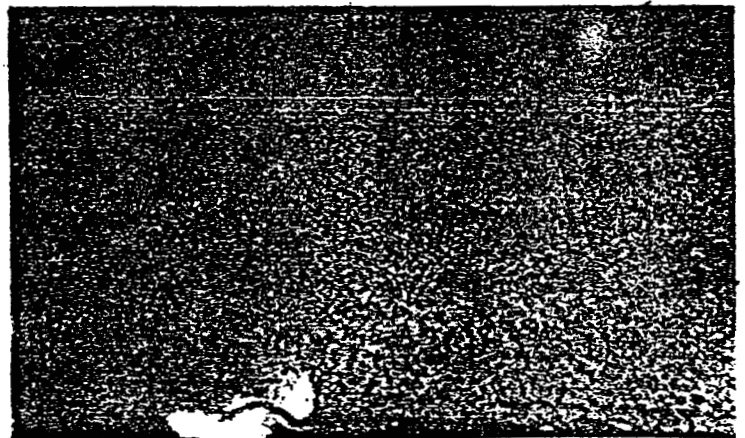
1C. Close-up of scaled (northwest) curb face.

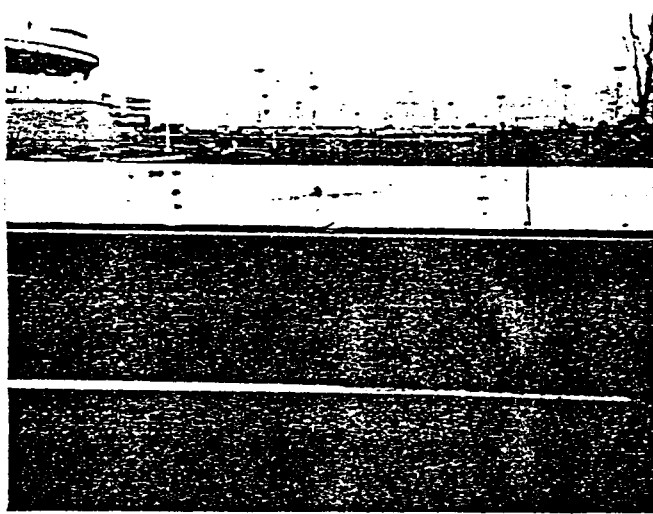
FIGURE 2. WHITE CONCRETE BARRIER CURB

Approximately 7 years after construction (Project B)

2A. Unscaled (south) curb face.

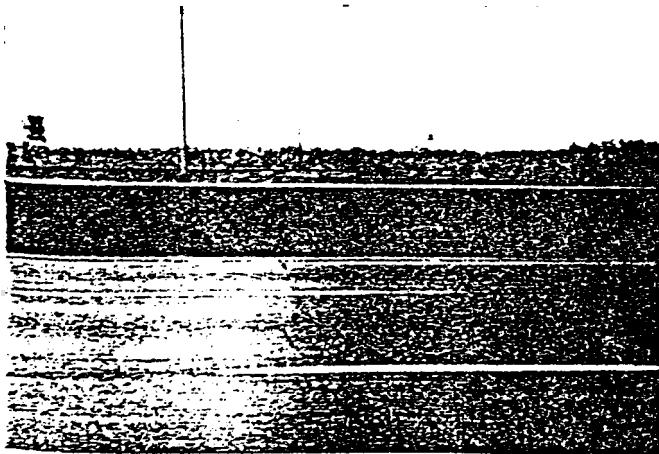
2B. Scaled (north) curb face.

As indicated in Table 2, 95% or essentially the entire 5,100 feet of north curb face exhibited some degree of scaling with the largest amount (45%) being in the moderate category (see Figure 5). In marked contrast, the raters indicated no significant deterioration for the south curb face.

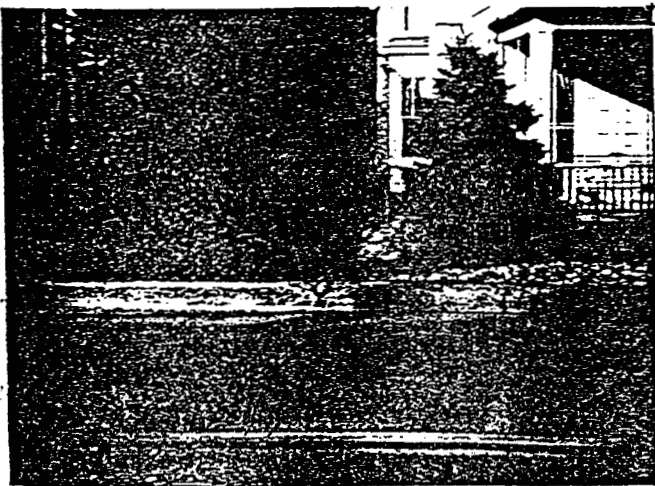
3B. Scaled curb.

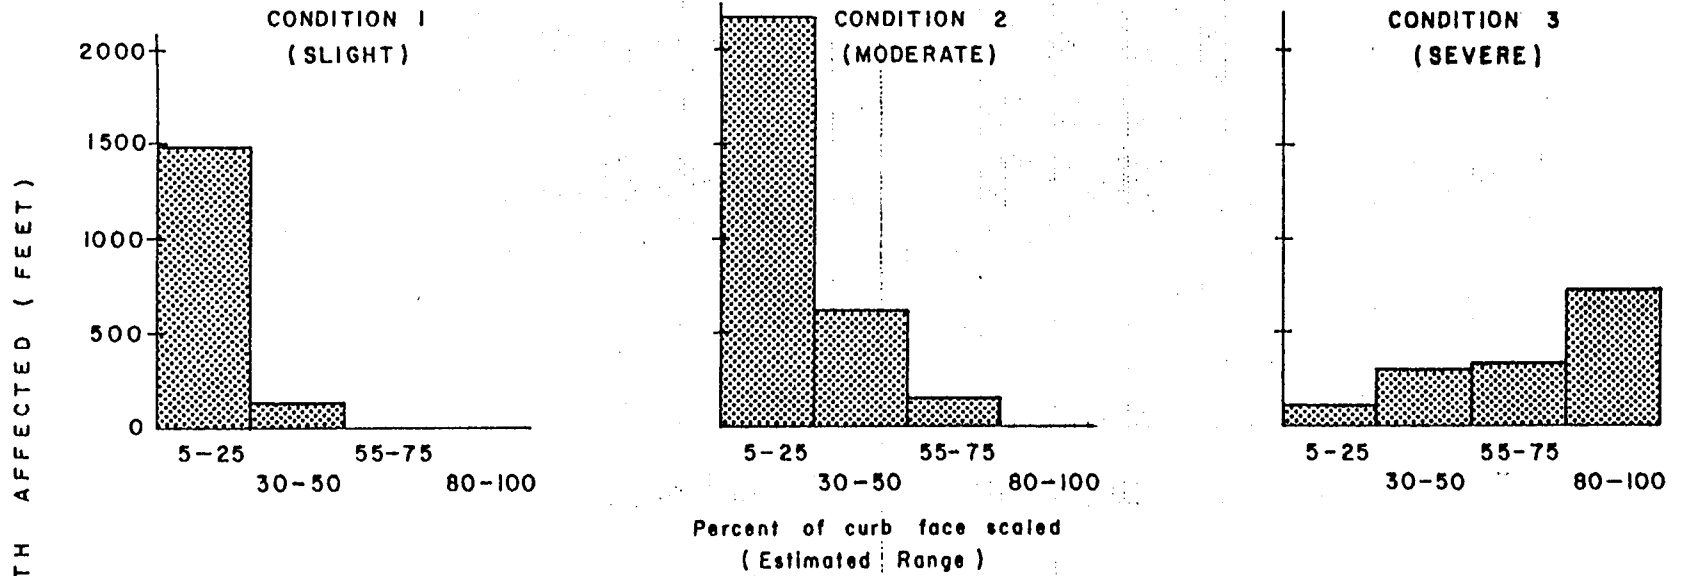
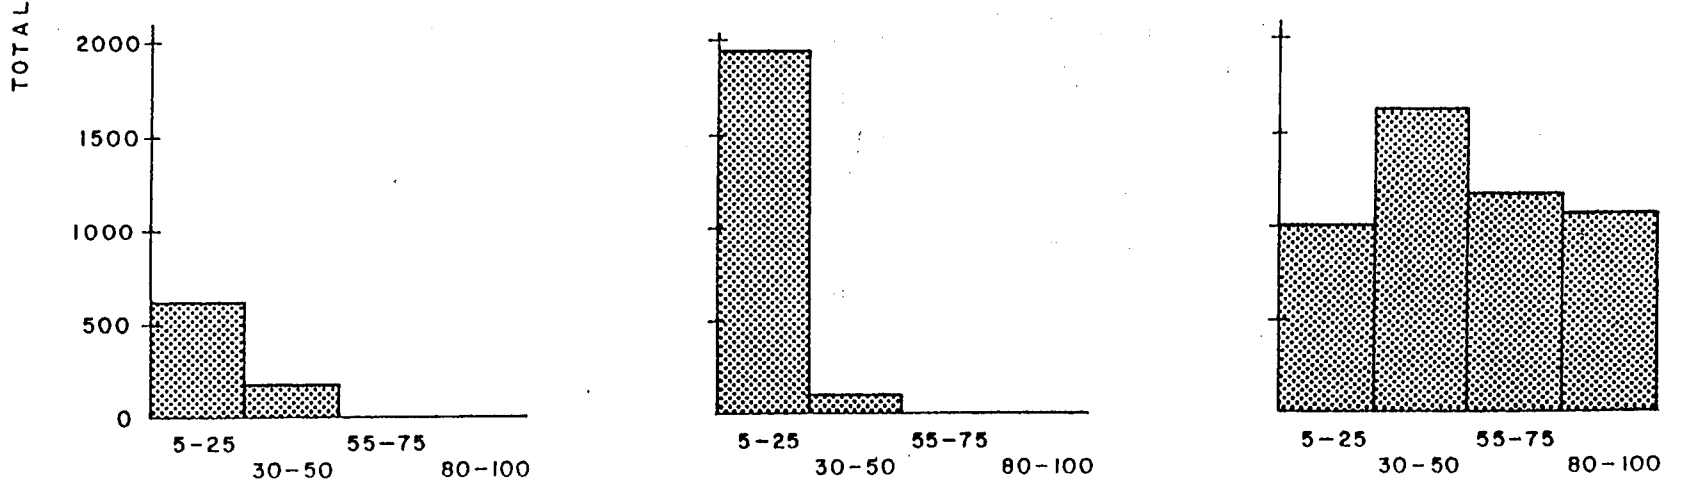
Figure 4. PERCENTAGE OF CURB FACE AFFECTED BY VARIOUS DEGREES OF SCALING (PROJECT A).

Figure 4 shows the extent of scaling within each category -- that is, the total amount of curb surface affected with a given degree of distress. This data presentation further underscores the relatively greater extent of distress for the northwest curb. Where severe scaling occurred (i.e., condition 3), on the northwest curb face it covered more than twice the area of the similarly distressed curb on the southwest face.

NORTHBOUND ROADWAY (SOUTH EAST CURB FACE)

SOUTHBOUND ROADWAY (NORTH WEST CURB FACE)

Table 1 shows the total length and overall percentage of each curb face displaying scaling of a given severity. As indicated, both sides of the project curbing displayed at least some distress; 63 and 82%, respectively for the southeast and northwest curb faces. The deterioration exhibited by the northwest curb face is considerably more severe than observed for the southwest face. Specifically, more than half of the northwest face was severely scaled, compared to only 15% for the southwest face.

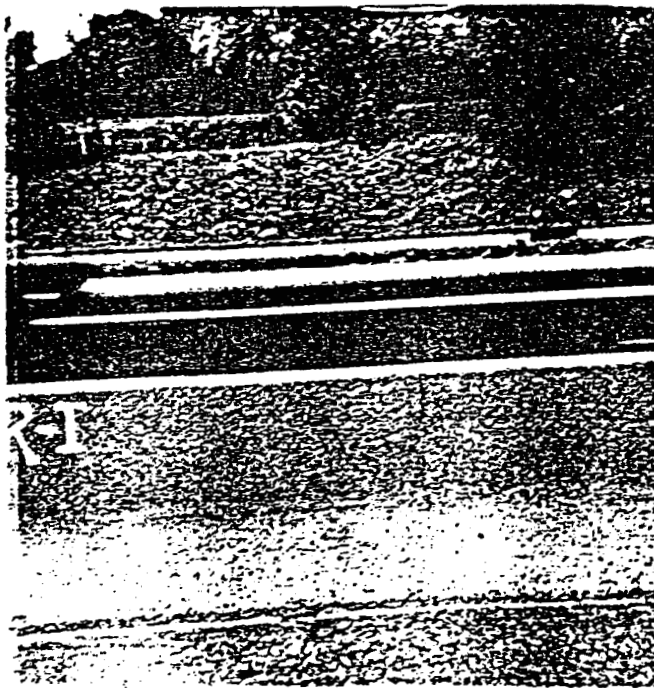
9B. Project E - Grey Barrier Curb.
