CONSTRUCTION ZONE SAFETY AND DELINEATION STUDY

THOMAS D. DAVIS
Senior Engineer

FEBRUARY 1983

Prepared By
New Jersey Department of Transportation
Division of Research and Demonstration
In Cooperation With
U.S. Department of Transportation
Federal Highway Administration

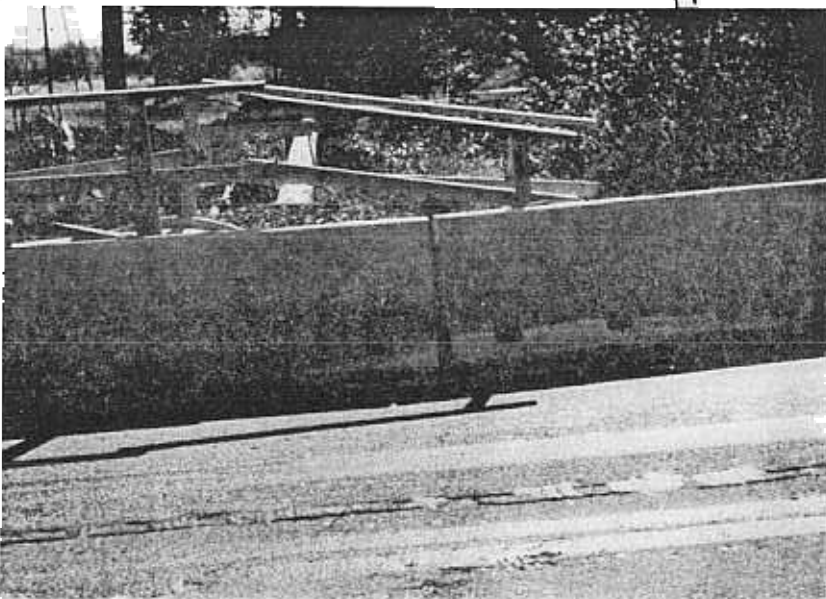
FIGURE #2 - VAN VEGHTEN BRIDGE SCHEMATIC

INSET - TIRE MARKS ON BARRIER

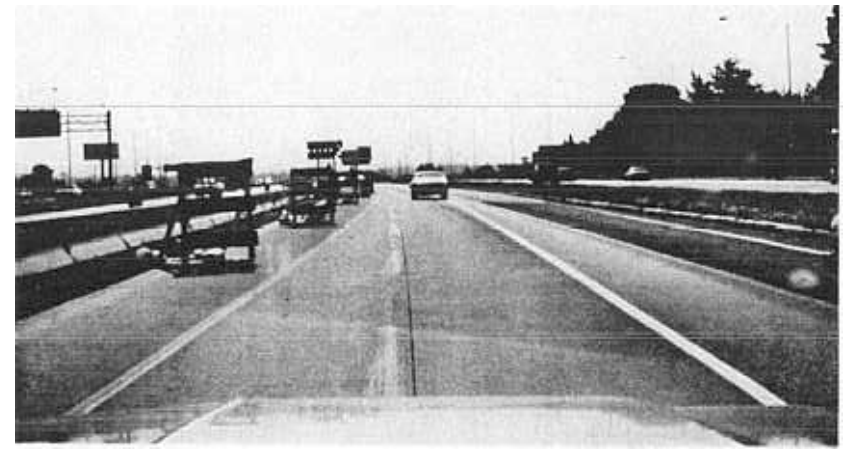
FIGURE #5 - I-80 SCHEMATIC

I-80 (FIGURE 5) - The left lane in both directions was closed with Type III barricades mounted with steady burn lights, concrete barrier curb, and flashing arrow board. The shoulder was used as a lane to maintain two lanes of traffic. In the transition the old striping was removed and new striping applied. However, vehicles were observed still following the old alignment especially where there was a contrast between pavement and shoulder

INSET-PAVEMENT-SHOULDER CONTRAST DELINEATION CONFLICTING WITH TRANSITION STRIPES.

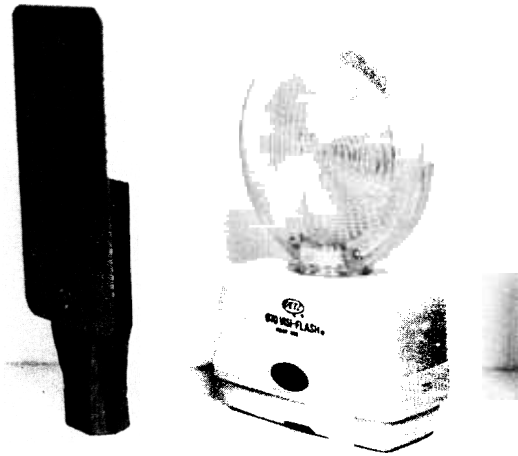
Figure#6 - STEADY LIGHT AND 5" x 10" REFLECTOR

Yellow steady burn lights (12 units at 180 ft. spacing) were studied in the before condition, and 5" x 10" yellow high intensity retroreflective sheeting panels (24 units at 90 ft. spacing) were studied in the after condition (Figure 6). A control site was used to account for changes in traffic performance due to factors other than the steady burn-reflector change.

- 1 5" x 10" yellow retroreflective sheet reflectors were less expensive initially and less expensive to maintain and more dependable as delineators compared to steady burn lights during the study period. Yet vehicle mean speeds and speed variances did not change nor was there a change in the proportion of vehicles using the lane adjacent to the reflectors. Also, the reflectors could be seen from an adequate distance based on the MUTCD

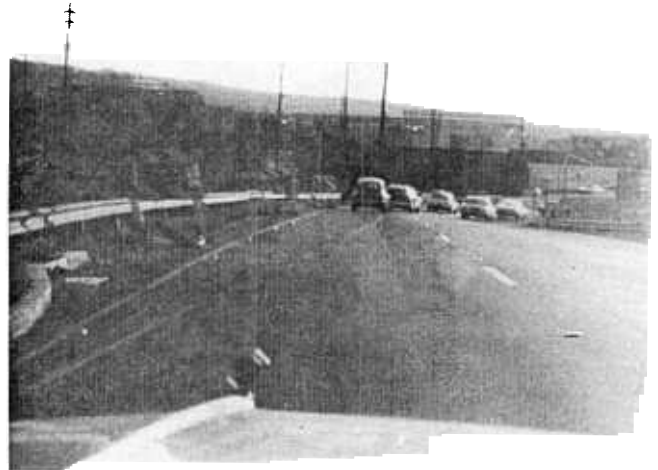
Figure#7 - FOURTH BARRICADE BLOCKED FROM VIEW

along the right lane edge line. Placed in that manner there was no deceleration area or storage for disabled vehicles. In order to enter a restaurant on the right, drivers had to decelerate in the right hand lane and pull into an entrance gore between the barricades for a turn into the parking lot. Drivers were observed stopping between the barricades with part of their vehicle still in the lane. They must stop because they have to look up an exit ramp which they have to cross to get into the restaurant's parking lot. Drivers coming down the exit ramp onto Route 46 had to look between these barricades for an appropriate place to merge into the flow of traffic. It was further observed that each barricade was only partially visible because it was blocked by the barricade in front.

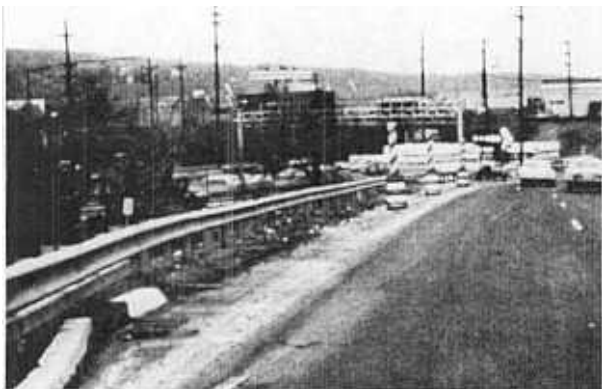
Figure#8 - FOURTH PANEL VISIBLE OVER TOP OF CAR

A seven foot high, eight inch wide vertical panel to replace Type III barricades was developed (FIGURE 8). The panel was made up of two 4 foot long plastic glare foils bolted together and faced with microscopic vinyl corner diagonal striping. The panels were held upright in plastic barrels weighted with sandbags. A hole in the shape of the panel cross-section was cut on top of the barrel to accommodate the panel. The panels:

1. took up less space horizontally,
2. could be seen over the tops of lead vehicles (Figure 8),
3. could be used in narrow median shoulders to close off a left lane,
4. on impact offer no more hazard than Type III barricades since all components were made of plastic, and
5. were stackable after the panel was easily removed from the barrel.

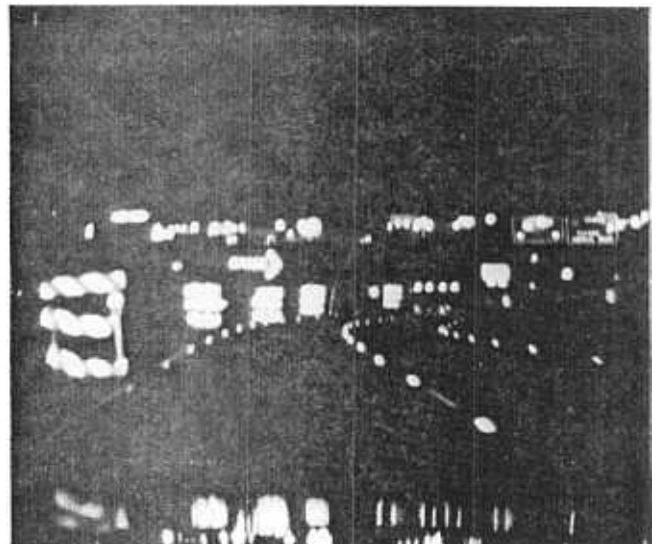
Figure#9 - DIVERSION VISIBILITY WITH RAISED PAVEMENT MARKERS

Stimsonite 911-SS markers were installed on an asphalt surface prepared with a liquid primer in a two-lane (U.S. 46) diversion as a paint supplement. In addition to the primer, vehicle pressure was necessary. Failure to follow these steps could lead to marker loss. In the day, the markers were barely visible, and at night, they increased the diversion visibility (Figure 9).

4. Raised pavement markers as a paint supplement increased diversion visibility compared to ordinary paint alone. To install the markers, a primer had to be used and vehicle pressure had to be applied. Failure to fully follow installation procedures could lead to marker failure. The markers resulted in a decrease in lane changes and lane encroachments. When not needed, the markers were easily removed.

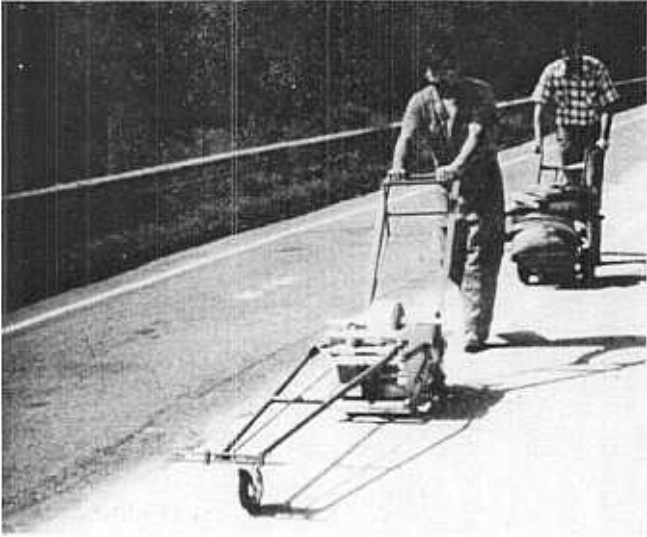
Figure #10- REMOVABLE TAPE
INSTALLATION

To test the long term performance of the tape, samples of tape were placed across the right lane of a state highway. Six thousand vehicles ran over the tape every day, and 12 percent of the vehicles were trucks. After 96 days, the tape still pulled up intact with no pavement damage.

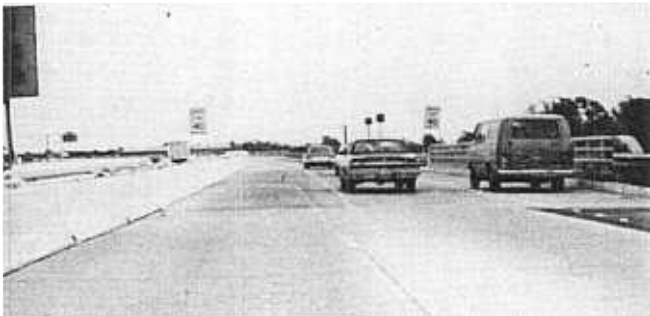
Figure #12- DAY VISIBILITY OF
CERAMIC MARKERS

5. Raised ceramic markers were day visible and were used to replace paint. Being raised and reflective, the markers also provided and wet pavement lane delineation superior to that provided by paint. To install the markers, a primer had to be used and vehicle pressure had to be applied. Failure to fully follow installation procedures could lead to marker failure. A large number of markers were lost while under traffic. The markers resulted in a decrease in lane changes and night lane encroachments. When no longer needed the markers were easy to remove with shovels.

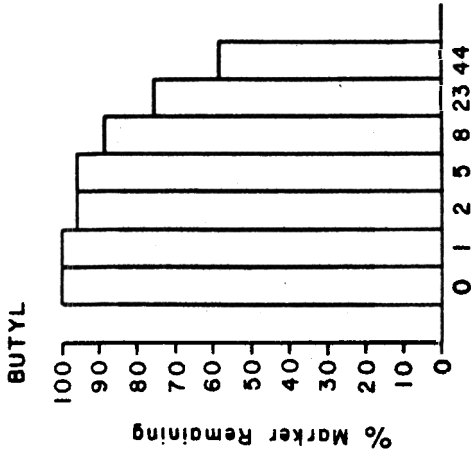
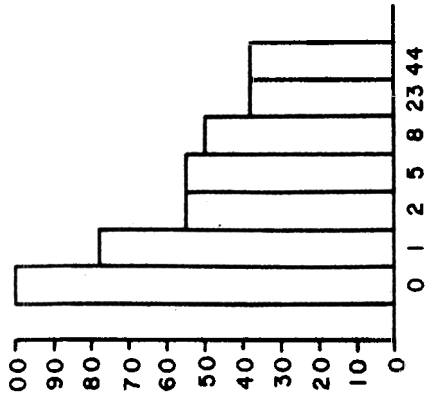
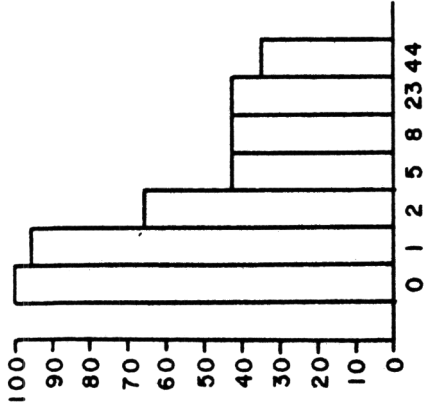
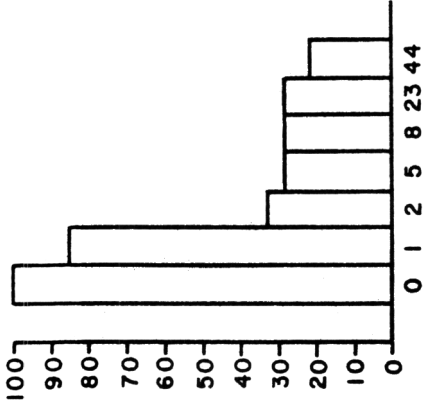
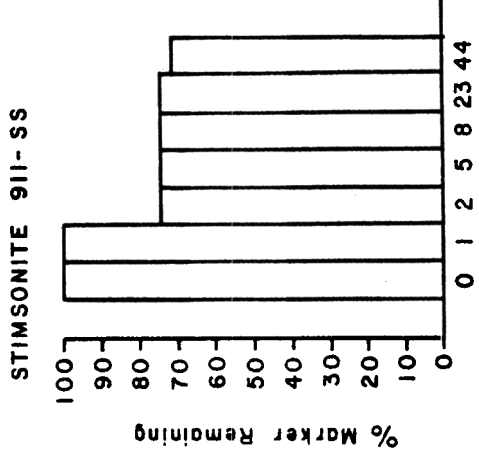
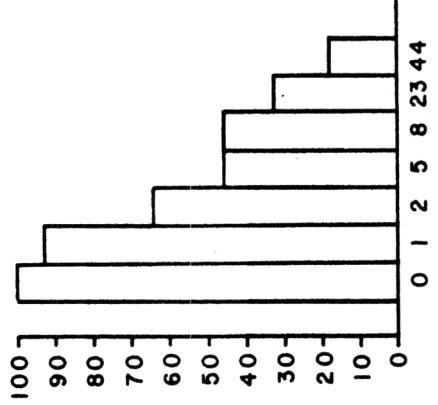
FIGURE #15 MARKER - ADHESIVE DURATION

Figure 15 shows the endurance of four adhesive systems after 44 days of exposure to traffic. The following trends can be noted:

1. The butyl pad proved to be the most durable adhesive with a 42 percent failure rate, though when used with the Stimsonite 911-SS butyl experienced no failures at all.
2. The H. B. Fuller adhesive had a 62 percent failure rate, though when used with the Stimsonite 911, H. B. Fuller experienced a 25 percent failure rate.
3. The PL-400 adhesive had a 65 percent failure rate
4. Liquid Nail 601 had a 79 percent failure rate.

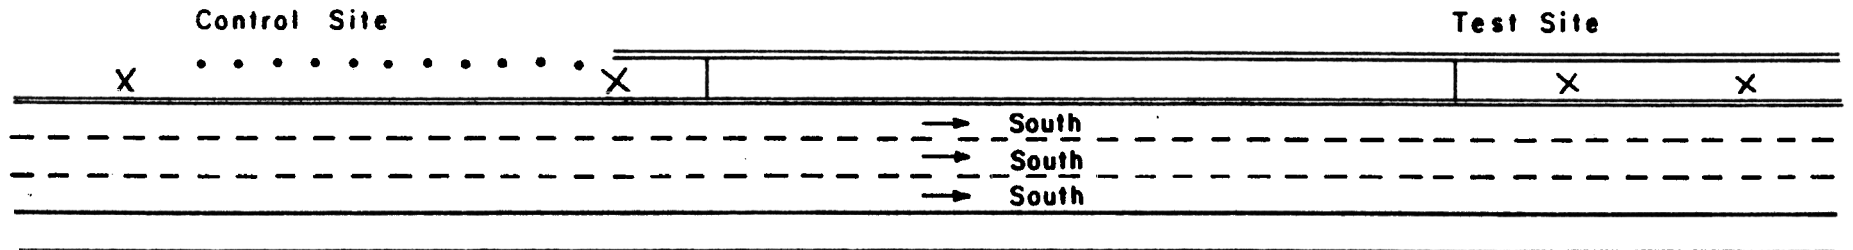
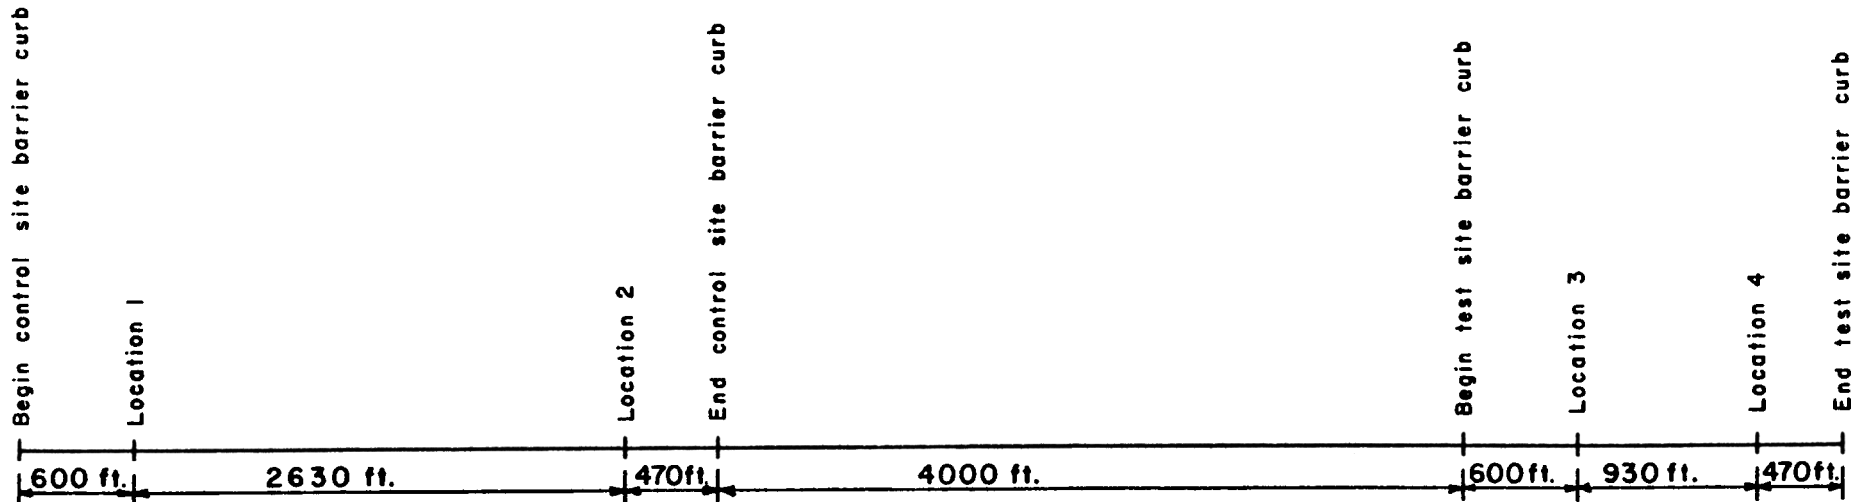
FIGURE #16 REFLECTOR - STEADY BURN SITE SCHEMATIC

- Plastic barrel
- Concrete barrier curb
- X Observation location

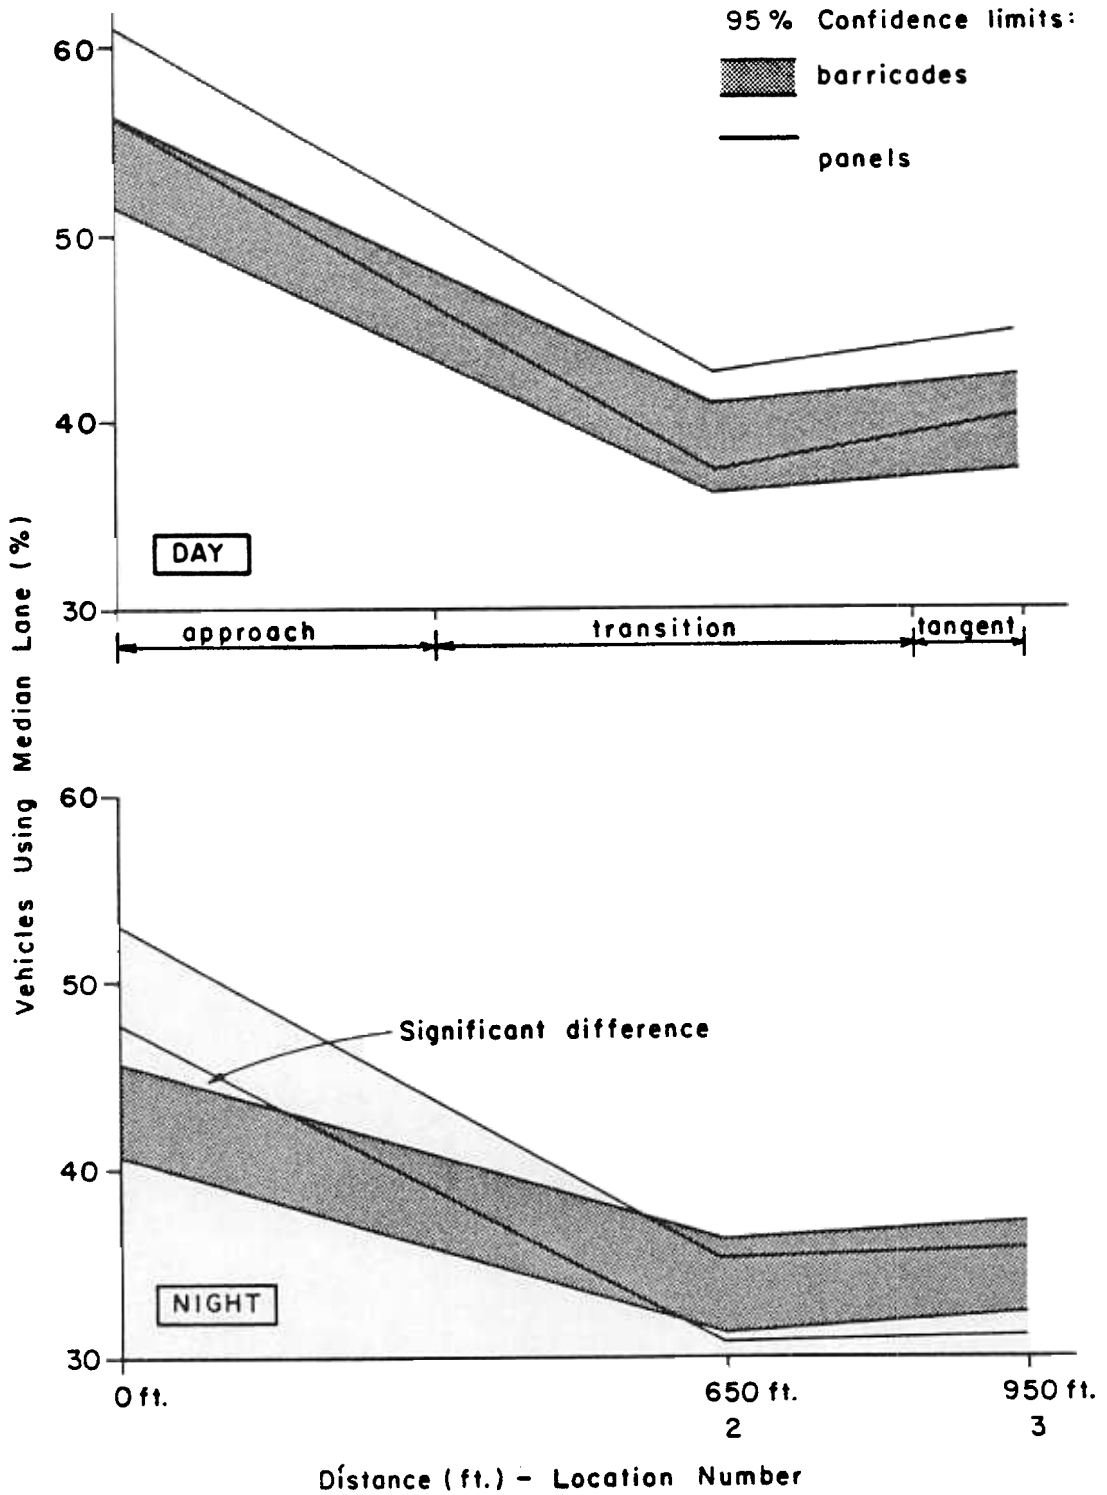
FIGURE#20 PANEL -BARRICADE LANE DISTRIBUTIONS

The confidence limits are plotted in Figure 21, the upper plot for day and the lower plot for night. If the treatment envelope (panels) falls outside the base treatment envelope (barricades), then the difference is statistically significant. There were no significant differences.

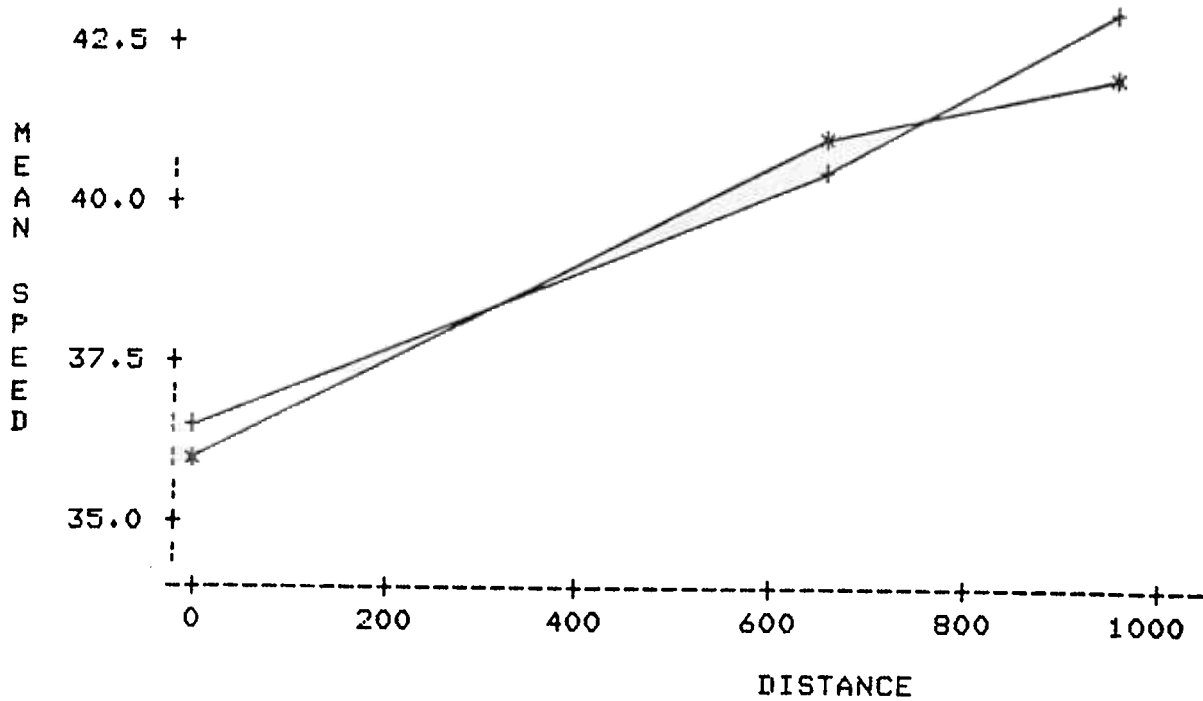
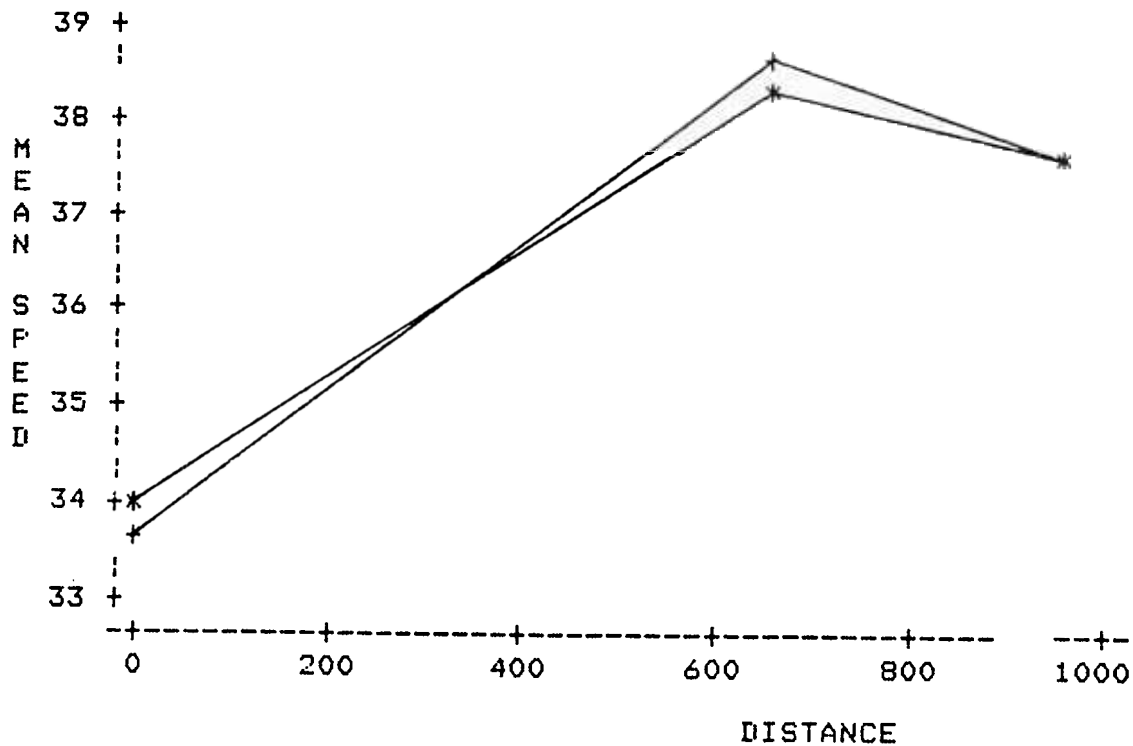
FIGURE 22 BARRICADE (BEFORE) - PANEL (AFTER)
LEFT LANE MEAN SPEEDS

Speeds - Forty-five minutes of speed data was collected in 15 minute increments under various conditions -- left and right lanes, day and night, barricades and panels, and three locations. An analysis of variance performed to determine how much variability in traffic speeds could be attributed to each of the various conditions. If a factor accounts little or no variability, then one is led to the conclusion that the true average traffic speed is constant over the different levels of that factor. If a factor accounts for a significant amount of the total variability, then one concludes that there are at least two different average traffic speeds associated with that factor's levels.

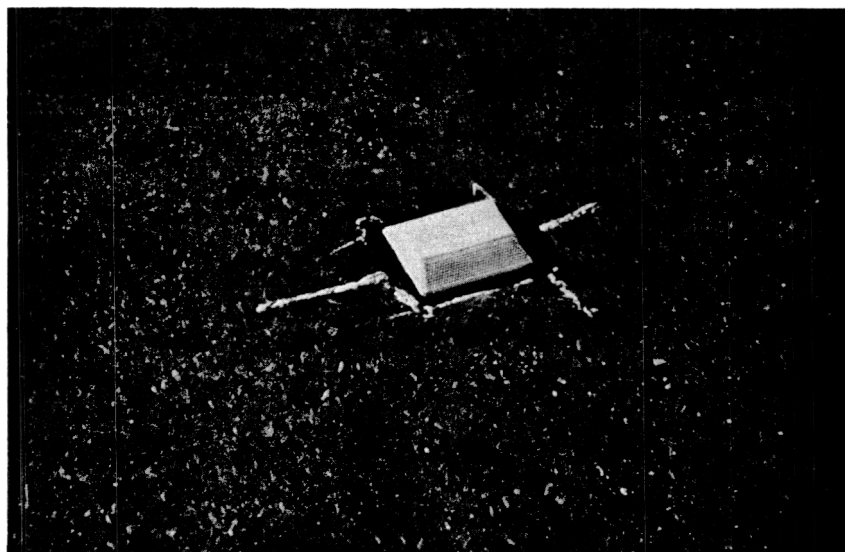
FIGURE 24
Stimsonite 911-SS

No markers were lost during the 23 days of the study even though traffic was heavy and there was lane changing through the transition. On December 19, 1979, two-thirds of the markers were removed in snowplow operations. The remaining one-third were either missed or damaged by the plow blade.

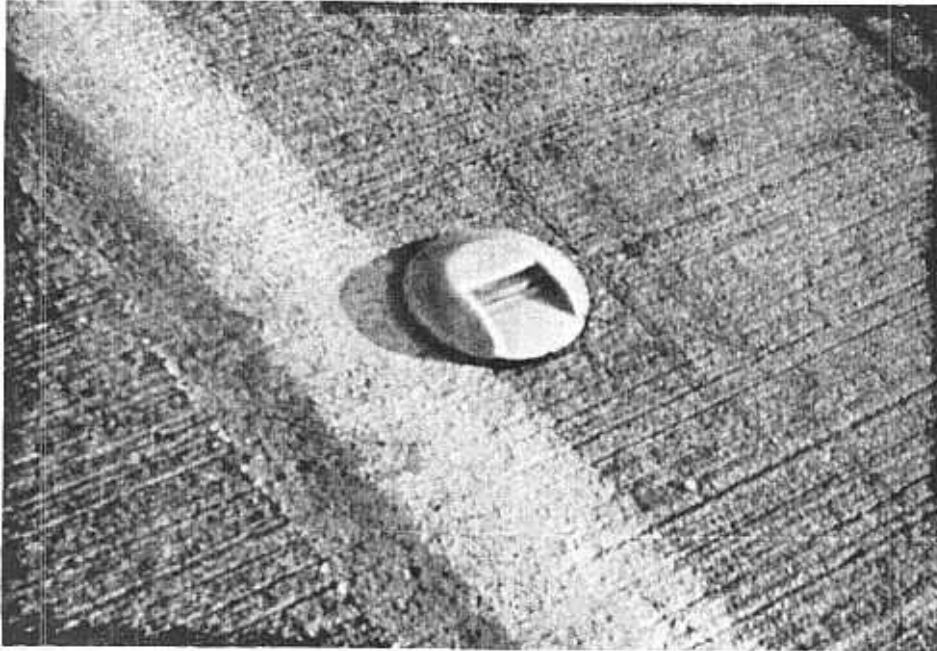
FIGURE 30
CERAMIC MARKER

The markers were installed on a clear day with a minimum temperature of (75° F). The marker spacing was layed out with a yard stick. The surface prepared with a liquid primer to provide a smooth surface for the marker to adhere to. Since the butyl pad was pressure sensitive a truck ran over each marker, resting on the marker for one minute. The project engineer provided training, instruction, and advice during the installa-
since the contractor had no experience with markers. The markers were a contract item and the contractor charged \$2.90/marker to cover the cost of the markers, installation, and removal

During the six days the diversion was in effect virtually no markers were damaged or lost in the transition. However, 310 out of 1,236 or 25 percent of the total markers were lost or damaged, the majority of the losses occurring in the approach. These losses could have been due to heavy traffic weaving in the vicinity of a major exit and less supervision of the workers during installation of the markers in this area.

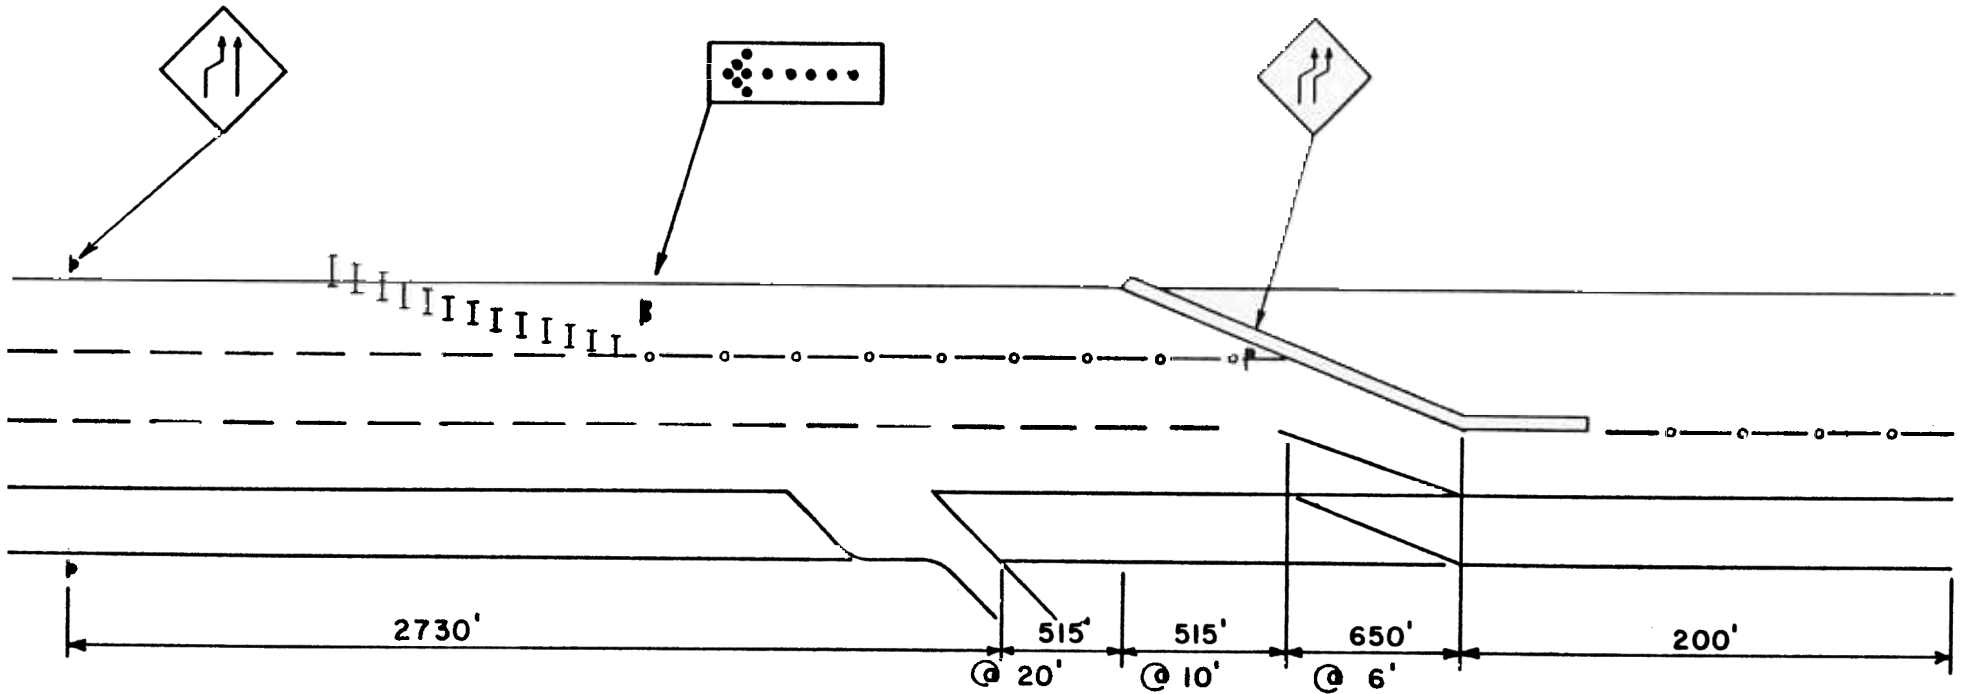
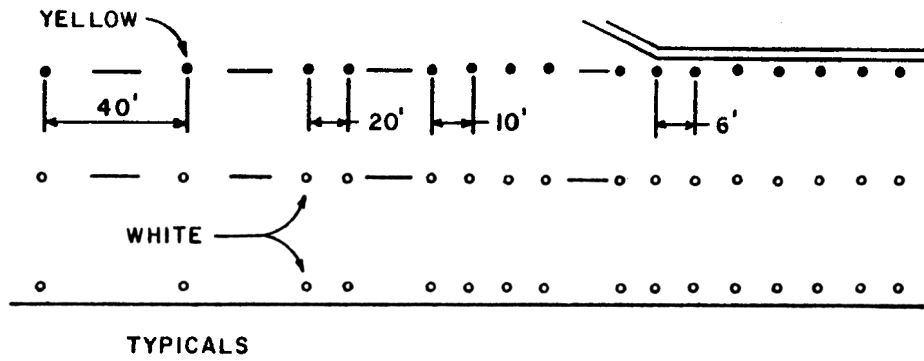
Figure # 32 MARKER - PAINT REPLACEMENT MARKER LAYOUT

Installation and Removal On October 17 and 20, 1980, a total of 1,236 markers were installed as shown in Figure 32. The approach consisted of markers supplementing paint at a spacing that went from 40 feet to 10 feet. Markers in the approach were felt to be necessary since at night the driver would be faced with an abrupt change from paint to reflective markers. markers were spaced at 6 feet in the transition where they replaced paint.

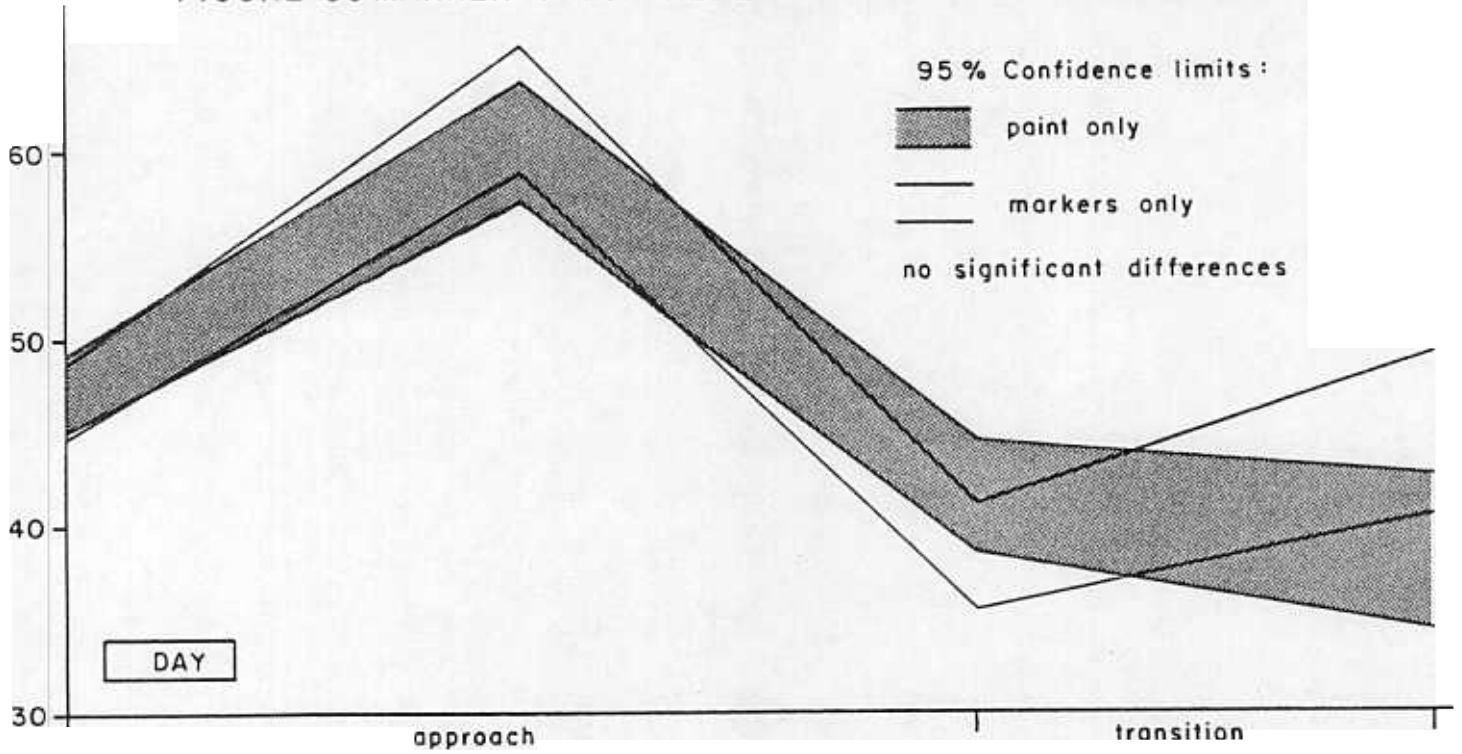
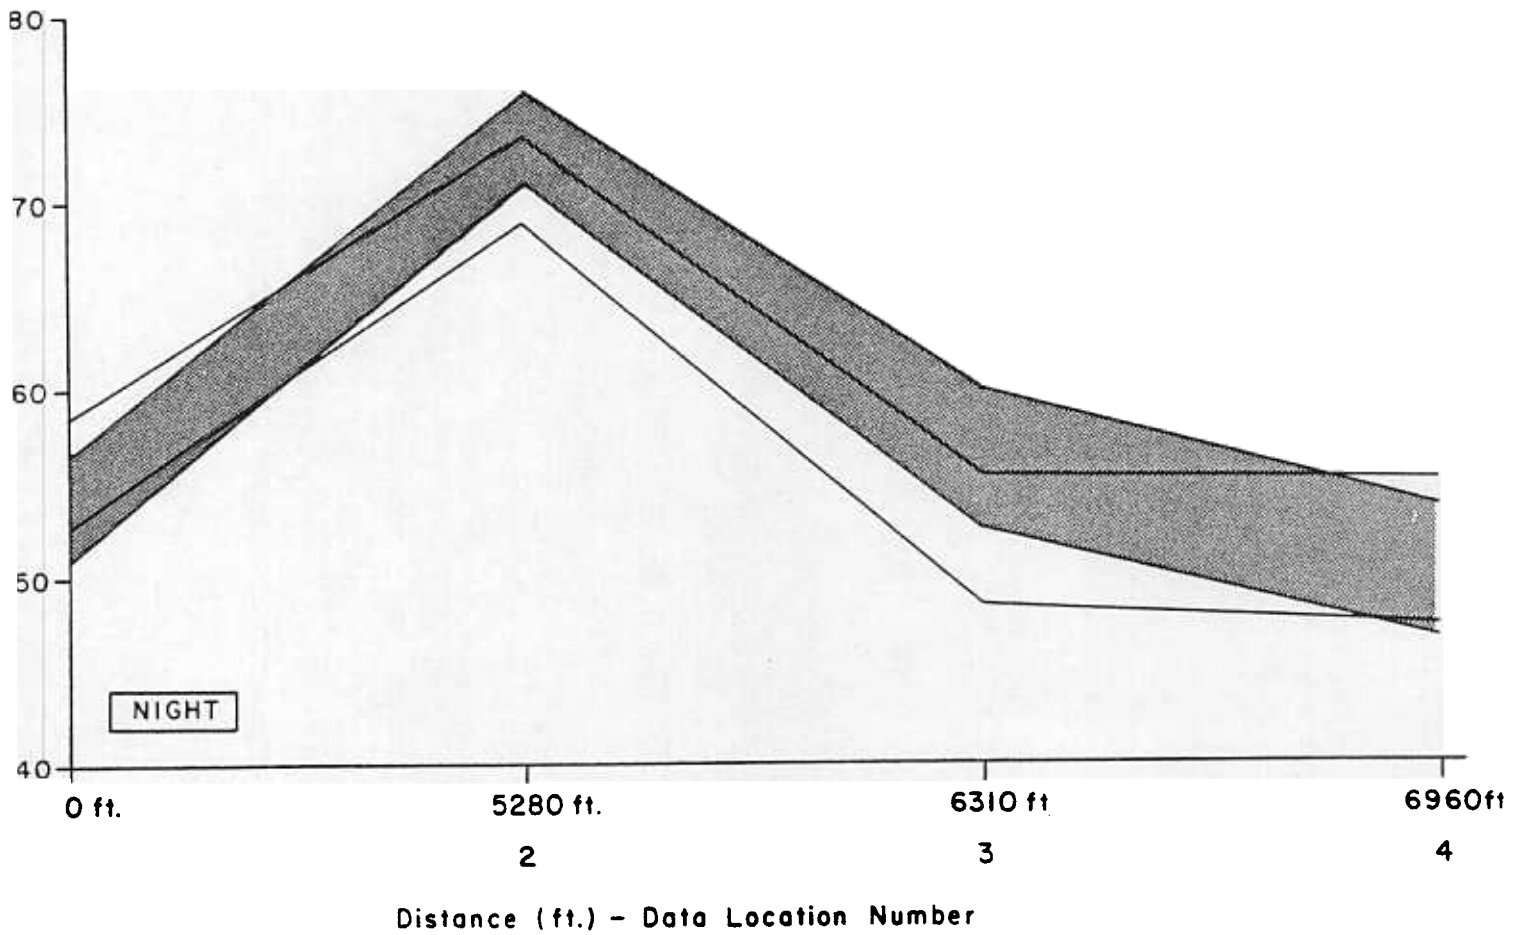
FIGURE #33 MARKER-PAINT REPLACEMENT LANE DISTRIBUTIONS

<u>Location</u>	<u>Time</u>	<u>Left Lane Volume</u>	<u>Right Lane Volume</u>	<u>Total Volume</u>	<u>95% Confidence Limits</u>	
					<u>P</u>	<u>+/-</u>
D	Before	1120	998	2118	.471	.021
	After	1244	1080	2324	.465	.020
A	2 Before	346	528	874	.604	.032
	After	309	509	818	.622	.033
Y	3 Before	644	455	1099	.414	.029
	After	727	453	1180	.384	.028
N	4 Before	330	205	535	.383	.041
	After	271	221	492	.449	.044
I	1 Before	573	663	1236	.536	.028
	After	535	669	1204	.556	.028
G	2 Before	362	1002	1364	.735	.023
	After	358	891	1249	.713	.025
H	3 Before	329	420	749	.561	.036
	After	394	426	820	.520	.034
T	4 Before	374	377	751	.502	.036
	After	333	349	682	.512	.038
