EFFECT OF WIDTH  
ON  
EDGELINE LIFE

FINAL REPORT

BUREAU OF TRANSPORTATION SYSTEMS RESEARCH  
DIVISION OF RESEARCH AND DEMONSTRATION  
NEW JERSEY DEPARTMENT OF TRANSPORTATION

HPR STUDY NO. 7728

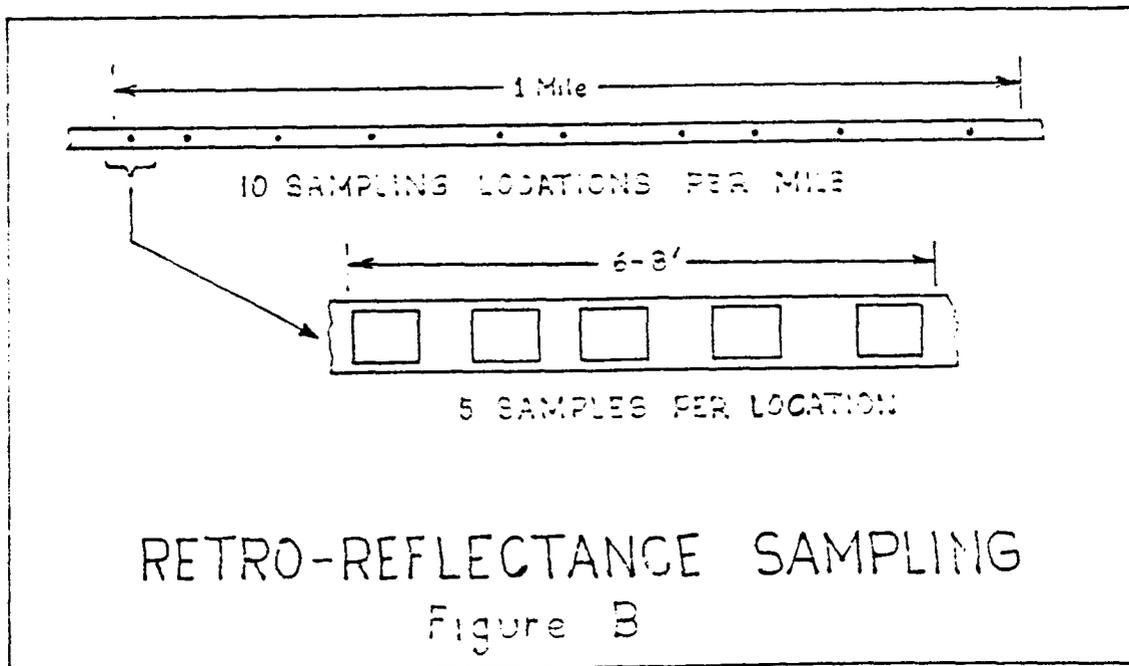
The retro-reflectance of each of the 10 locations was based on the average of 5 samples taken within a 6 to 8 foot section of the line. (fig. B) The retro-reflectance of each one mile section of test line was thus the average of 50 samples.

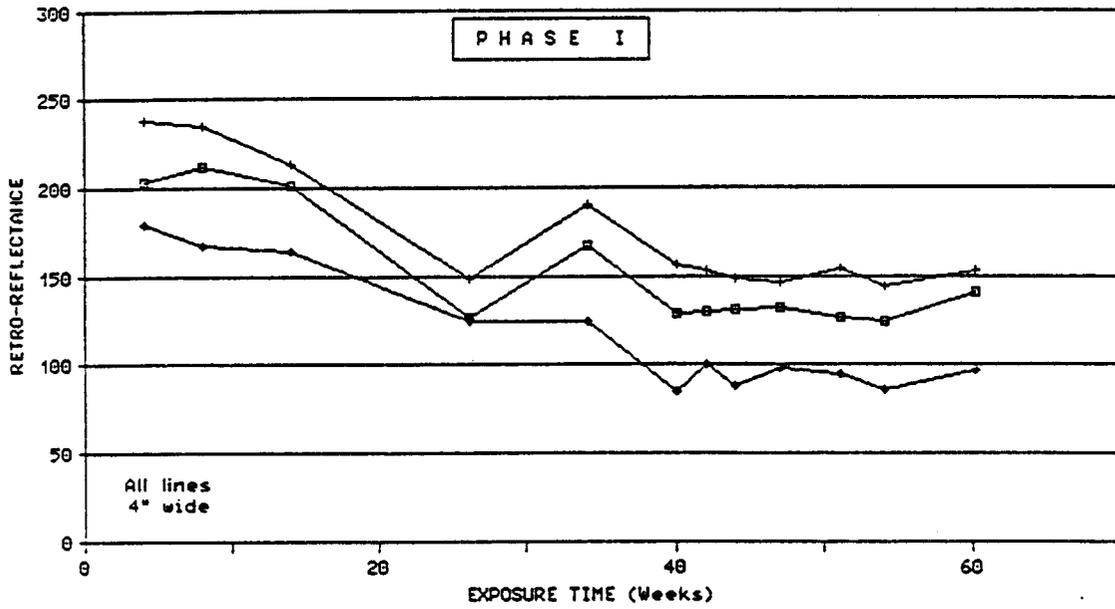
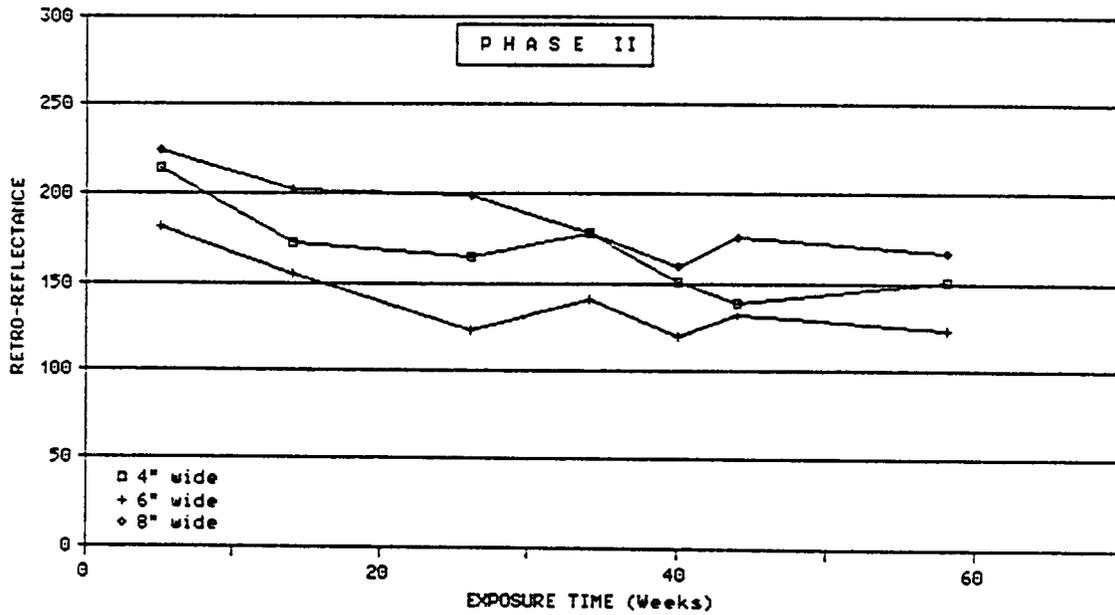
Figure 2

Rt. 31 SB - Hopewell Twp.

The rate of change in retro-reflectance between the 4, 6, and 8 inch wide lines remained practically the same at each test site. (Figs. 1 to 10) It was anticipated prior to the start of the study that the wider lines would wear at a slower rate. This was based on the premise that the wider lines would command more attention thus causing drivers to drive more centrally in the lane and hence reduce line wear from tire abrasion. This expectation, however, did not materialize as all lines seemed to wear at identical rates even at sites such as Route 22 in Union where both the 4" and 8" lines were completely worn down within 6 months. It was also anticipated that the right side of a wide edgeline would not be worn as much as the left side of the line which is closest to the traffic. A comparison of the retro-reflectance data of the right side vs. the left side of 8 inch wide lines (Figs. 11a to 11d) did not demonstrate any practical differences in retro-reflectance.

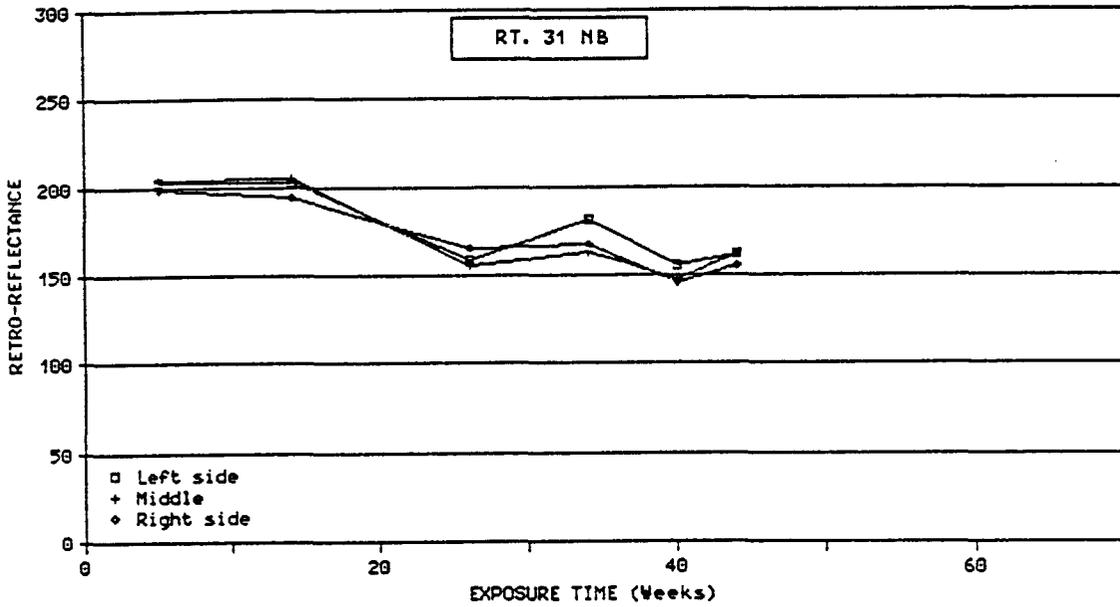
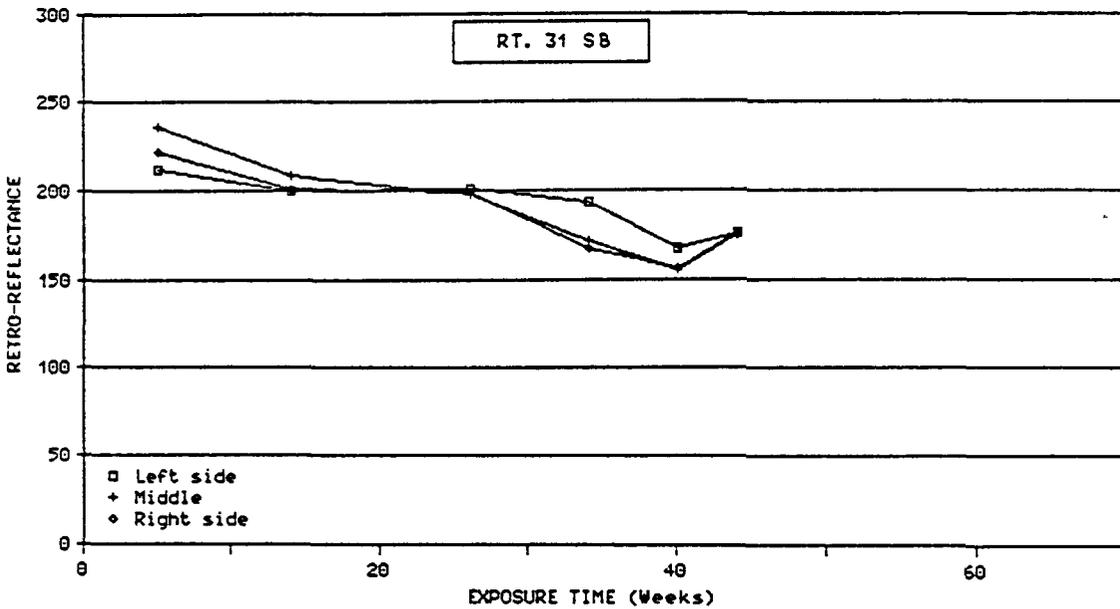
Figure 11a  
Wear Pattern of 8" Wide Lines

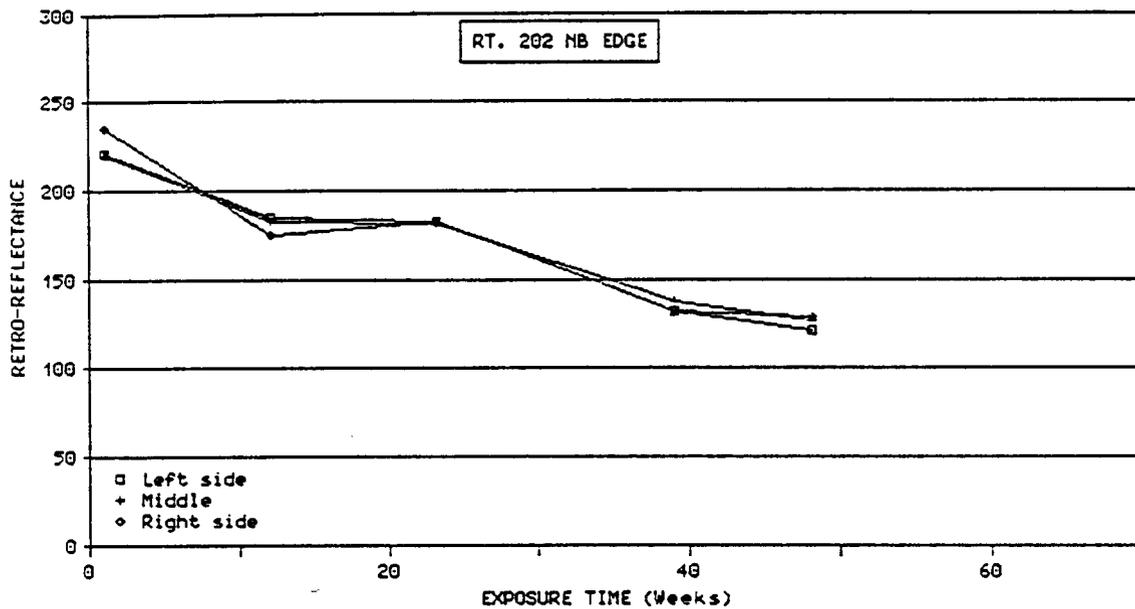
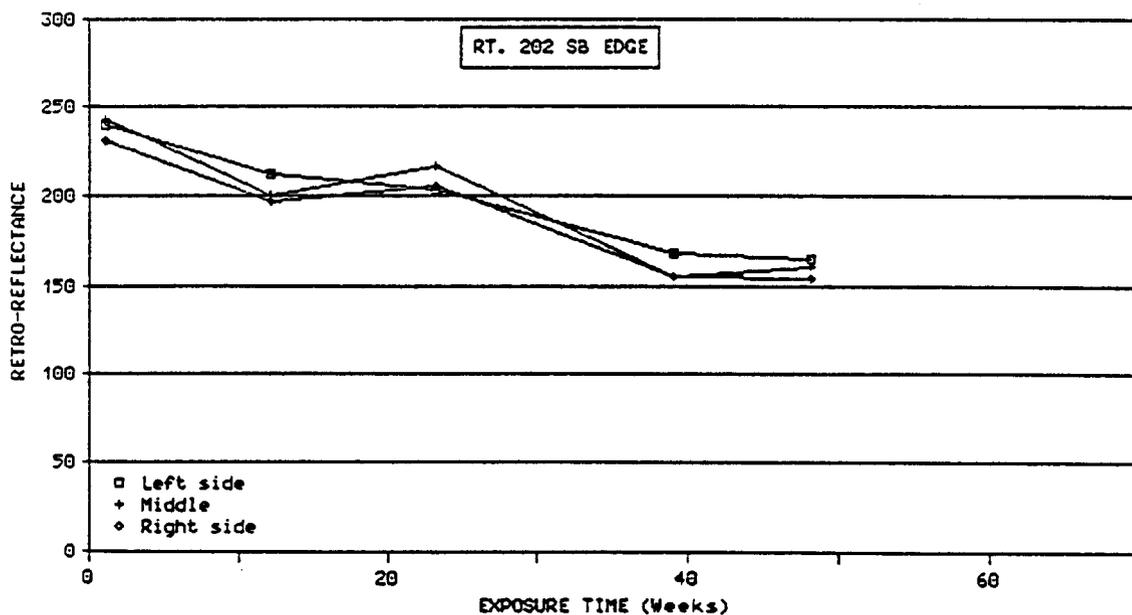
Figure 11b  
Wear Pattern of 8" wide lines

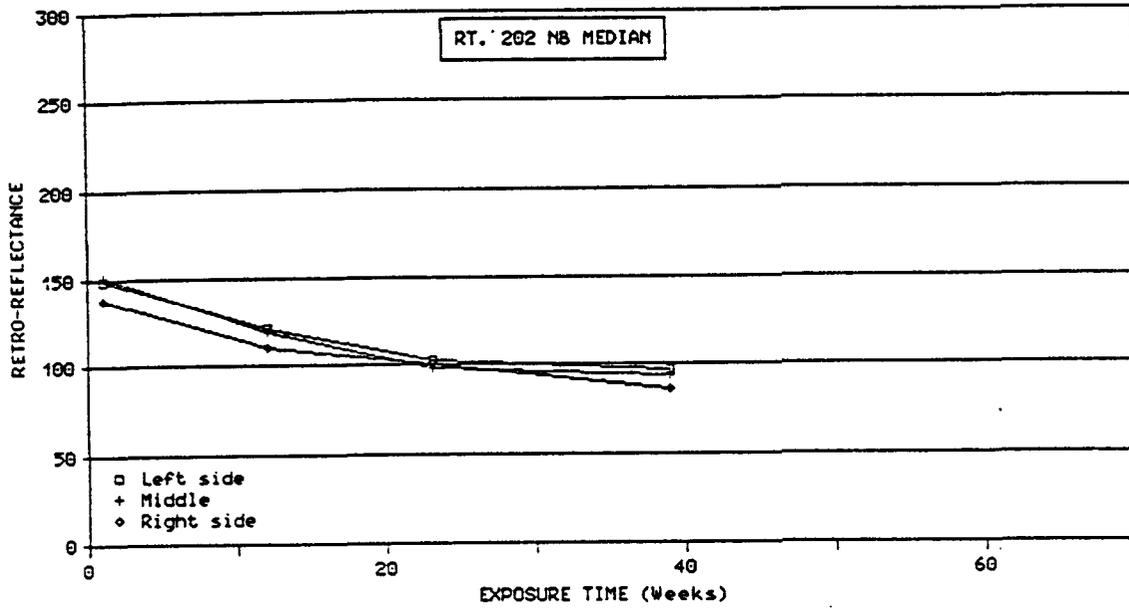
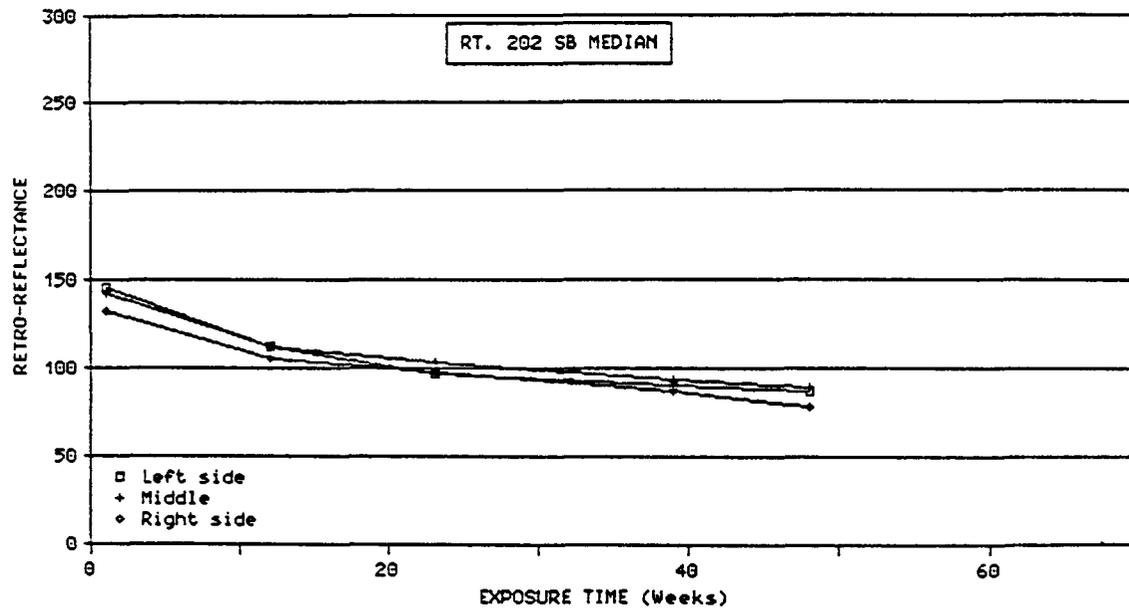
Figure 11c  
Wear Pattern of 8" Wide Lines

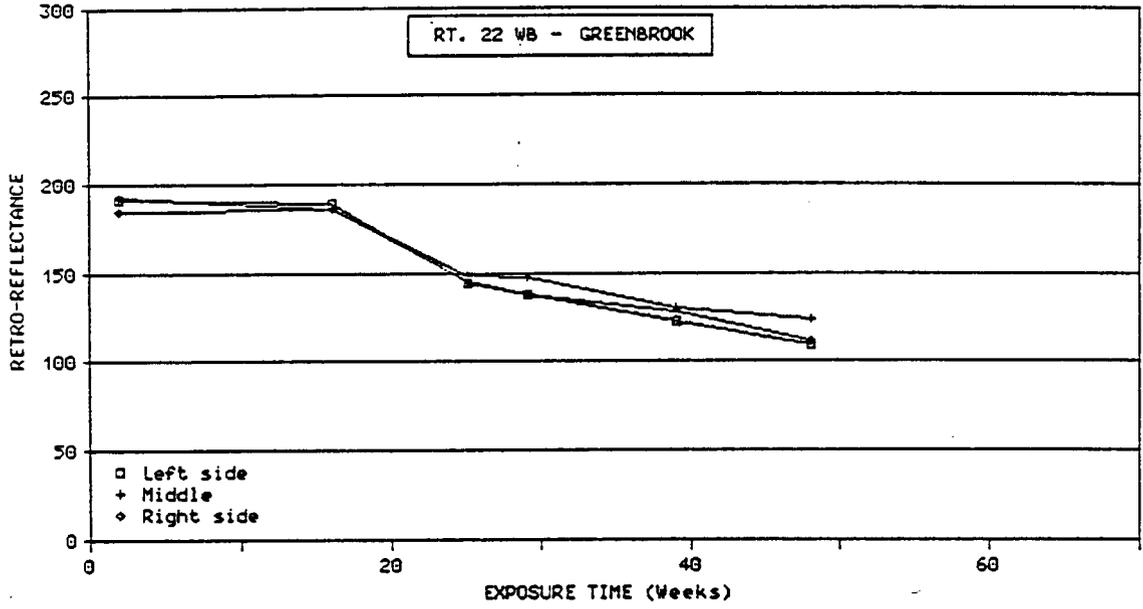
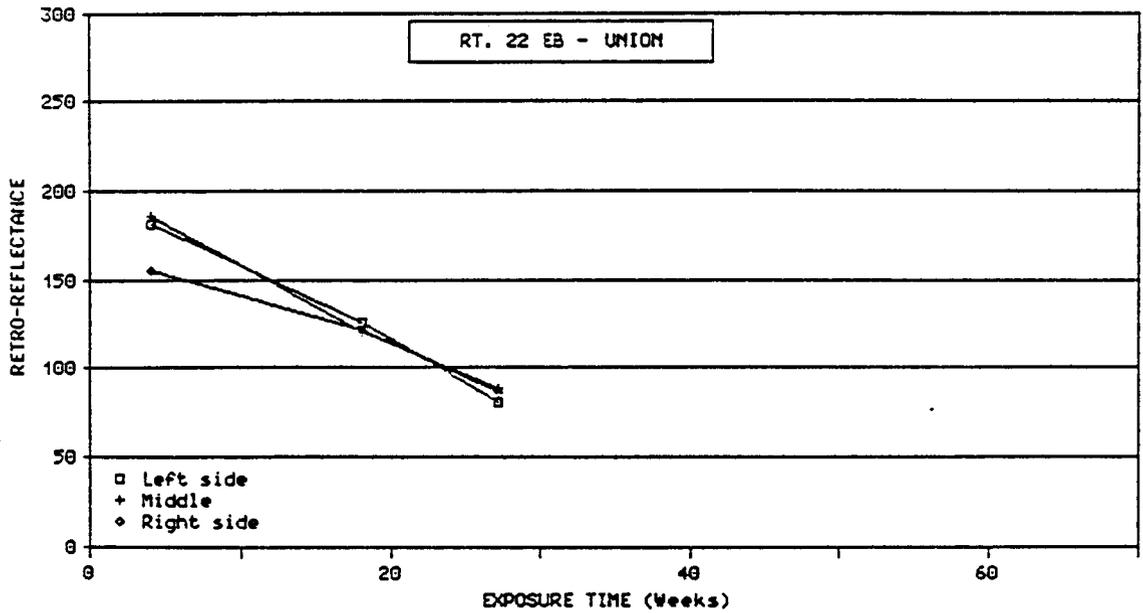
Figure 11d  
Wear Pattern of 8" Wide Lines
