# **SIGNS ON BREAKAWAY BARRICADES WIND AND CRASH TESTS**

**FINAL REPORT**

1. Report No. FHWA NJ 90-007		2. Government Accession No.		3. Recipient's Catalog No.	
4. Title and Subtitle Signs on Breakaway Barricades - Wind and Crash Tests				5. Report Date August 1990

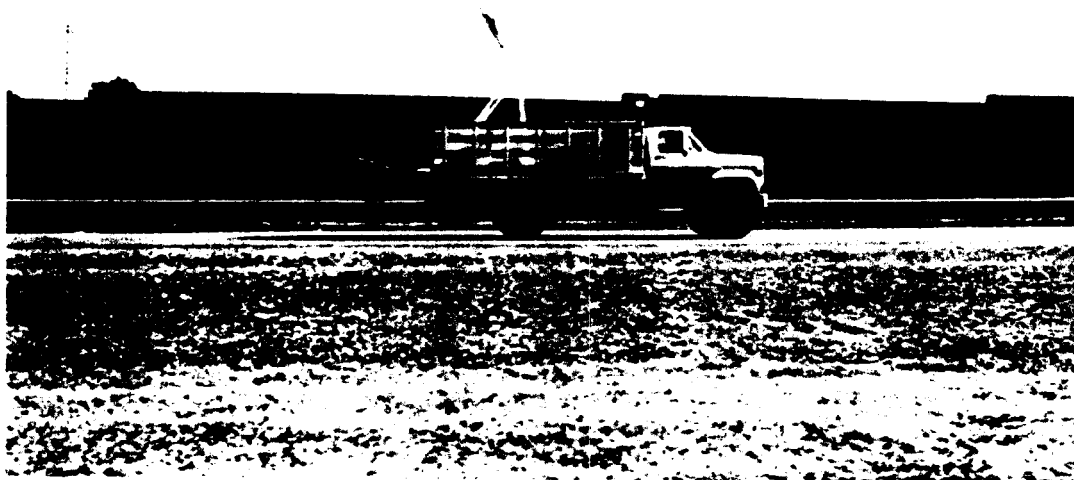
Figure 2. Phase 1 Wind Test with 7 ft. Clearance Vinyl Sign at 45 mph

Table 1 outlines the results of the phase 1 truck tests. There were no problems with the 1 ft. clearance signs. However, both aluminum and vinyl 5 ft. clearance and the vinyl 7 ft. clearance signs failed when the top extension broke free from the barricade. While the 0.024 in. aluminum sign flexed in the wind, it straightened out after the test.

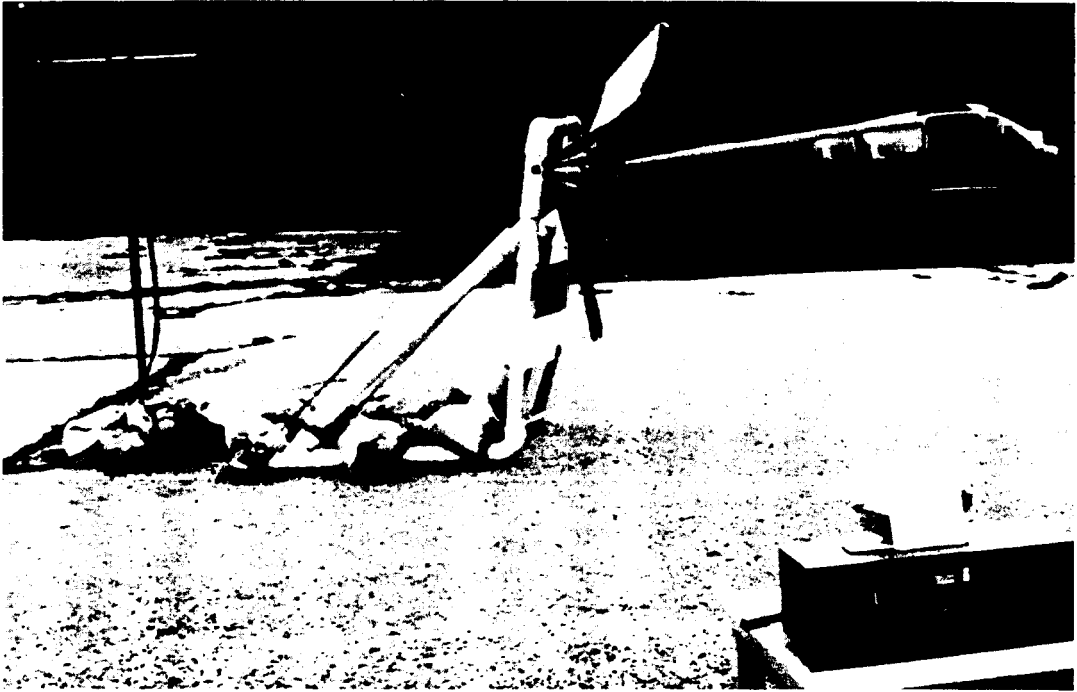
Figure 3. Phase 2 Wind Test with 1 ft. Clearance Vinyl Sign at 69 mph.

As Table 2 shows, the 1 ft. clearance vinyl sign passed this wind test as well. While the 5 ft. clearance vinyl sign endured the test, the aluminum sign failed when the frame separated with the wind into the sign. The 7 ft. clearance aluminum sign frame failed when the top "Y" fitting fractured.

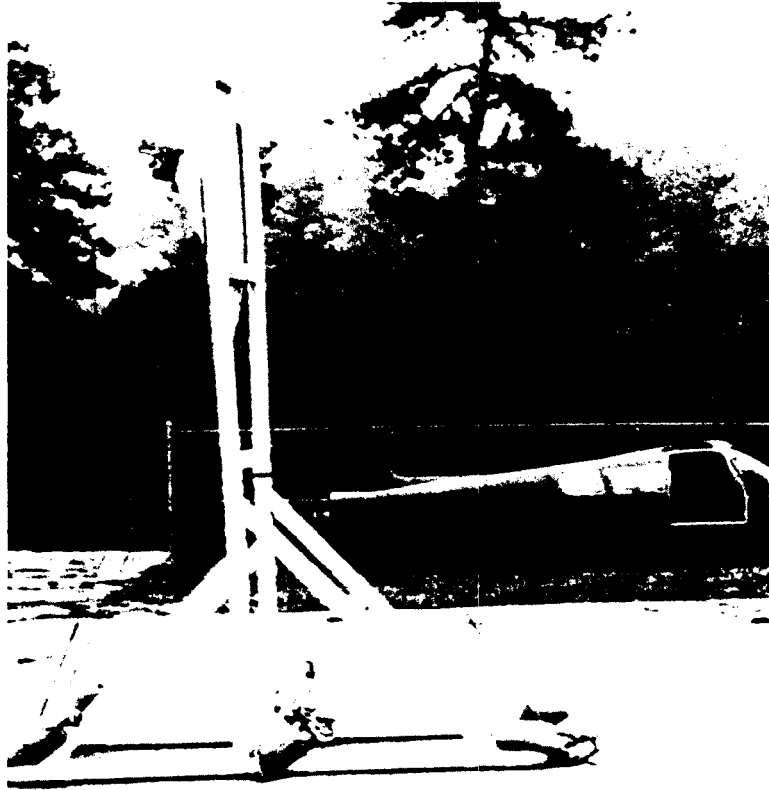
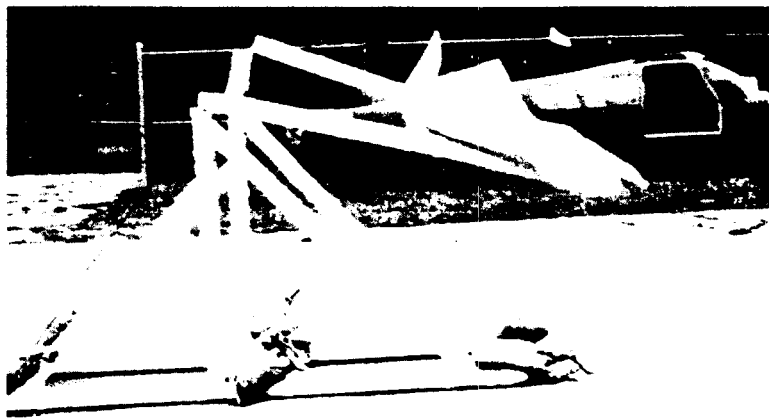
Figure 5. Phase 2 Wind Test with 7 ft. Clearance Aluminum Sign at 46 mph.

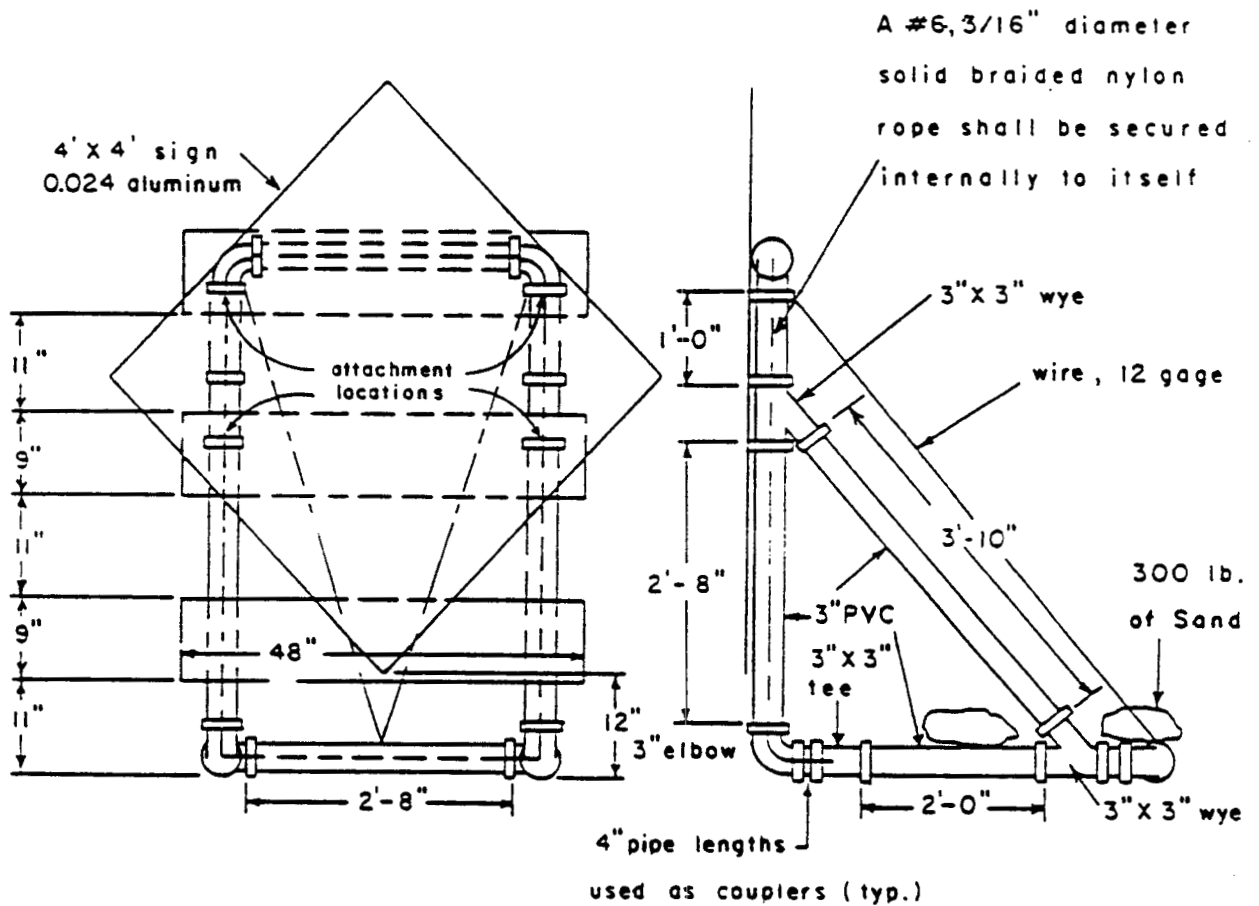
# FIGURE 8. ALUMINUM SIGN ON BARRICADE WITH 41" OF CLEARANCE

All dimensions on full pipe length.

Socket depth of fittings is 1 1/2".

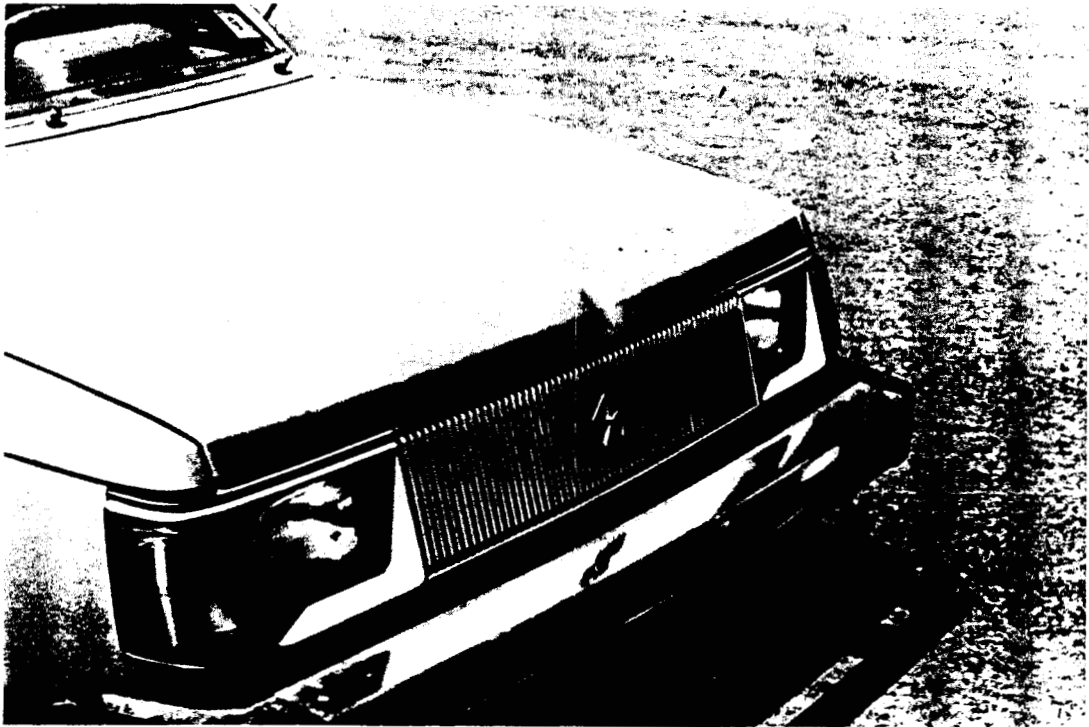
Figure 14. Typical Preliminary Crash Test Vehicle Damage.

As Table 4 shows, the six crashes, with the exception of one, did only cosmetic damage to the car. However, the 41 in. clearance aluminum sign did damage the windshield. The right post was hit and the upper right section of the barricade structure shattered the windshield. In this case, the internal rope failed to hold the vertical portion of the barricade together, permitting the debris to hit the windshield. The internal rope was used in the standard barricade to keep the top portion of the barricade away from the windshield. To minimize

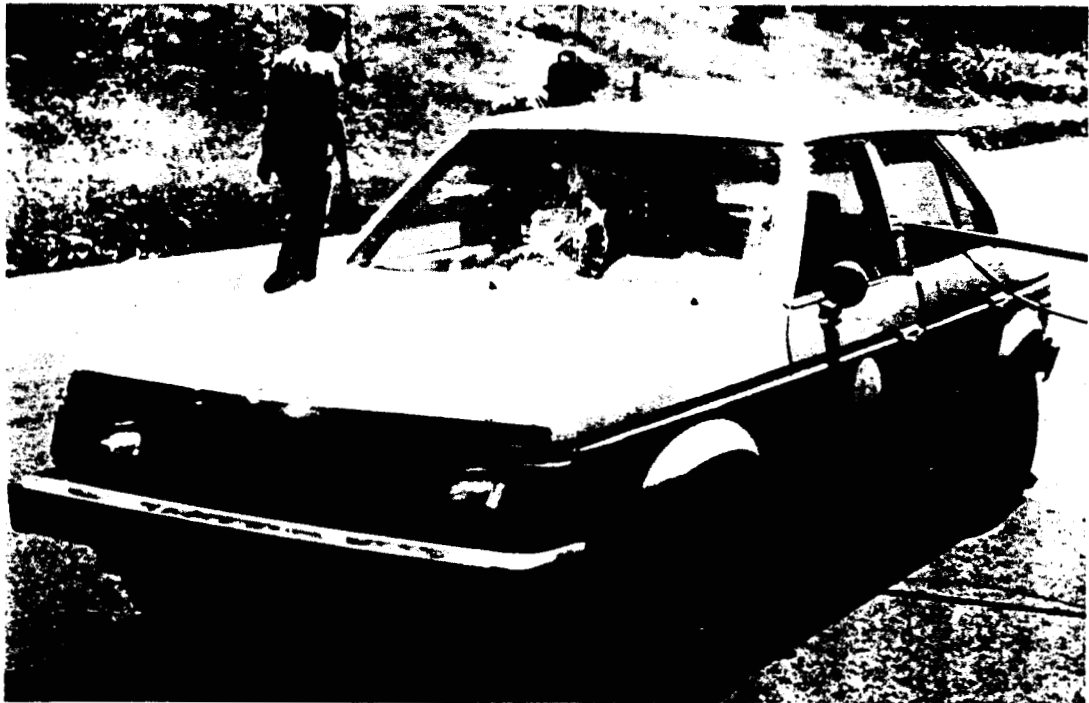
Figure 15. Preliminary Crash Test Windshield Damage from 41" Clearance Aluminum Sign.

this problem, the sign panel was attached above the top "T" fitting. Also, the two external tension wires were specified to be 12 gage (the original barricade wire gage was unspecified). In this way the sign and frame should separate above the "T" fitting and clear the top of the vehicle. The internal rope should keep the rest of the frame away from the windshield. In all of the tests the signs did not become missiles to harm other drivers or nearby workers. The sign either stayed with the vehicle or landed a few feet from the impact site. With these minor adjustments made, the signs were ready for the final crash tests.
