**AN EVALUATION OF THORMA JOINT
A FLEXIBLE BRIDGE EXPANSION JOINT SYSTEM**

Construction Report

By
Gerald J. Kauffman
and
Victor Mottola

Prepared By
New Jersey Department of Transportation
Bureau of Transportation Structures Research

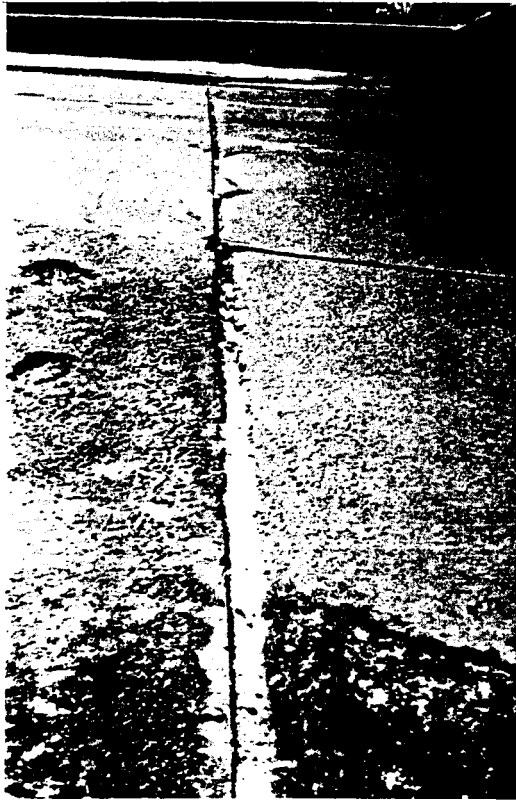
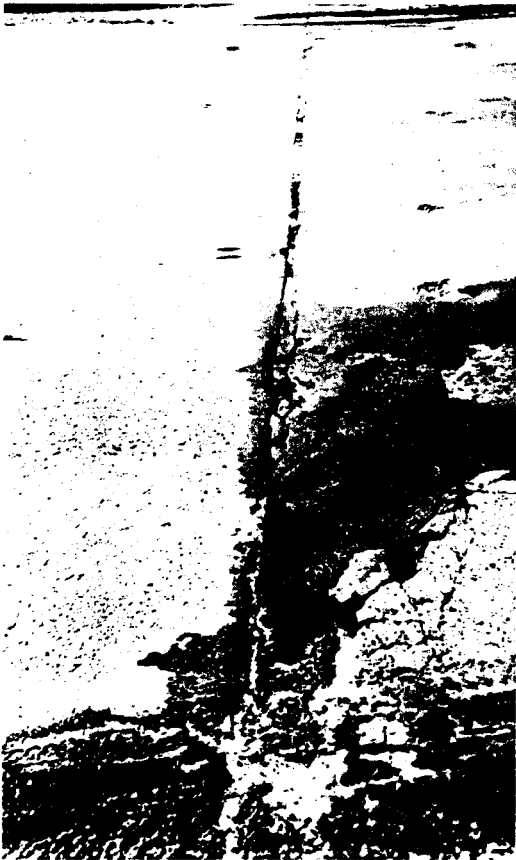
A pre-construction survey of the 6 bridges along Route 3 was conducted on January 5, 1988. The weather was overcast and the air temperature was 17 deg. F. The bridge deck joints were expanded at maximum width due to the cold temperatures. Joint openings ranged from 1-in to 2-in wide. The non-armored expansion joints were spalled and in poor condition. Armored expansion joints were in good condition. The concrete bridge decks exhibited severe spalls and potholes and certainly required resurfacing (Figure 5).

Figure 5. Typical Pre-construction Condition of Bridge deck Joints.

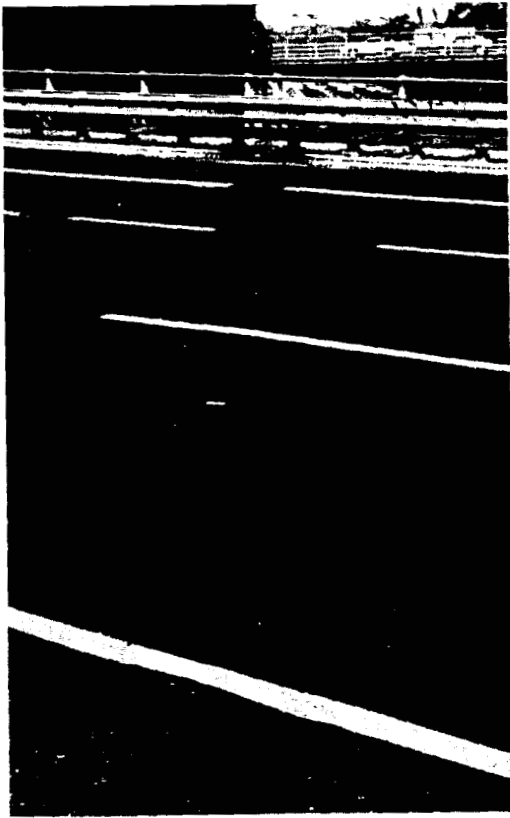
In September, 1988, about 2 months after installation of the Thorma-Joint, a post-construction evaluation was conducted. The Thorma-joints were in fair to average condition (Figure 7). The rubber asphalt surface exhibited no signs of cracking. The visual inspection of the underside of the bridge decks indicated that there was no deck joint leakage and that the Thorma-joints seem to provide an impermeable and waterproof barrier to joint infiltration.

The overall appearance of the completed Thorma-joints was, however, less than desirable. Most of the Thorma-joints were not compacted flush with the surrounding overlay and a slight hump was left which caused noticeable traffic noise as vehicles passed over. At some locations, the Thorma-joints were rutting, shoving, and delaminated. This could be attributed to the record breaking hot temperatures (20 days over 90 deg F during July, 1988) and the passage of frequent and heavy traffic (AADT, 2 way = 124,000 vpd). There is some concern that the rubber asphalt B200 binder may not have the necessary stability to withstand the high summer temperatures in New Jersey.

Figure 7. Typical Two-month Condition of the Thorma-Joints.

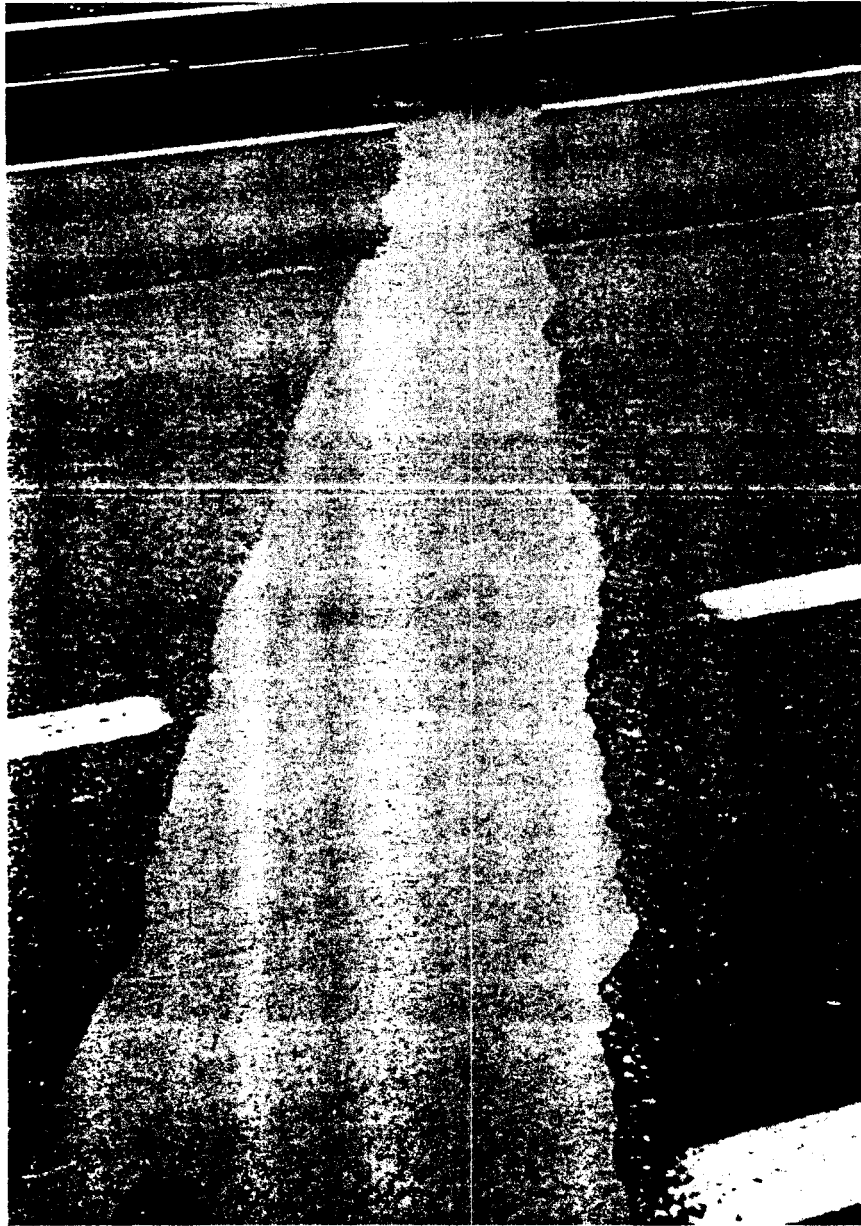
Inspection of the bridges indicates that the Thorma Joint has performed well after 2 to 3 years under traffic. The hot poured rubber asphalt surface has remained resilient and waterproof. Informal tests in the field indicate that the rubber asphalt will stretch about 1½" to 2" before breaking apart. This indicates that the Thorma Joint will accommodate up to 2" of joint movement before ripping apart. Inspection of the underside of the bridges shows no evidence of salt staining or water spots that would indicate leakage of the Thorma Joint.

The passage of traffic has compacted the Thorma Joint so that the material is flush with the adjacent pavement. The Thorma Joint does cause an audible increase in traffic noise, however, the increase is not significant when compared to the overall high noise levels of Parkway traffic.

Figure A. Typical Condition of 2-3 Year old Thorma-Joint on The Garden State Parkway.

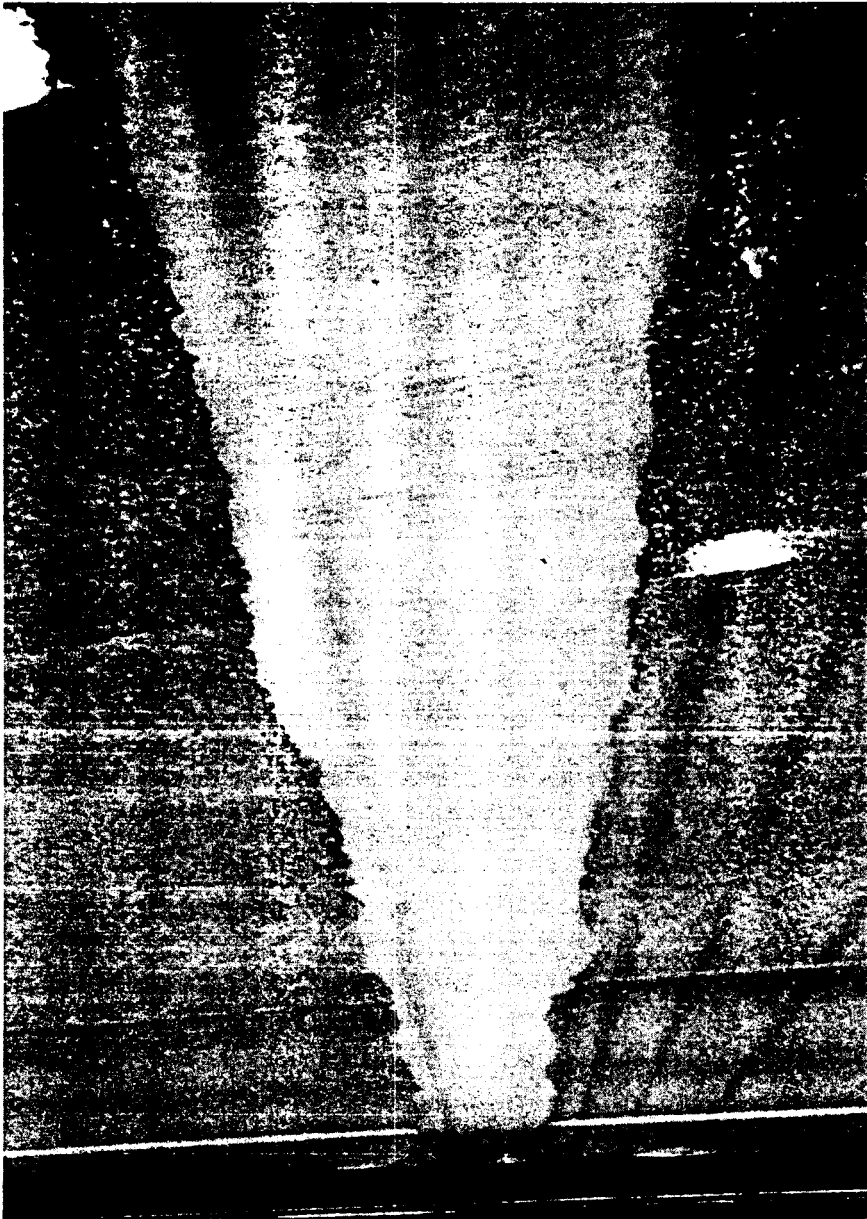
Figure B. Typical Condition of 2-3 Year Old Thorma-Joint on the Garden State Parkway
