COLD RECYCLING OF BITUMINOUS PAVEMENTS
BUCKSHUTEM ROAD, COUNTY ROUTE 670
CUMBERLAND COUNTY, NEW JERSEY

CONSTRUCTION AND FINAL
REPORT
BY
VICTOR MOTTOLA
AND
ANTHONY CHMIEL
RESEARCH ENGINEERS

THE NEW JERSEY DEPARTMENT OF TRANSPORTATION
BUREAU OF TRANSPORTATION STRUCTURES RESEARCH

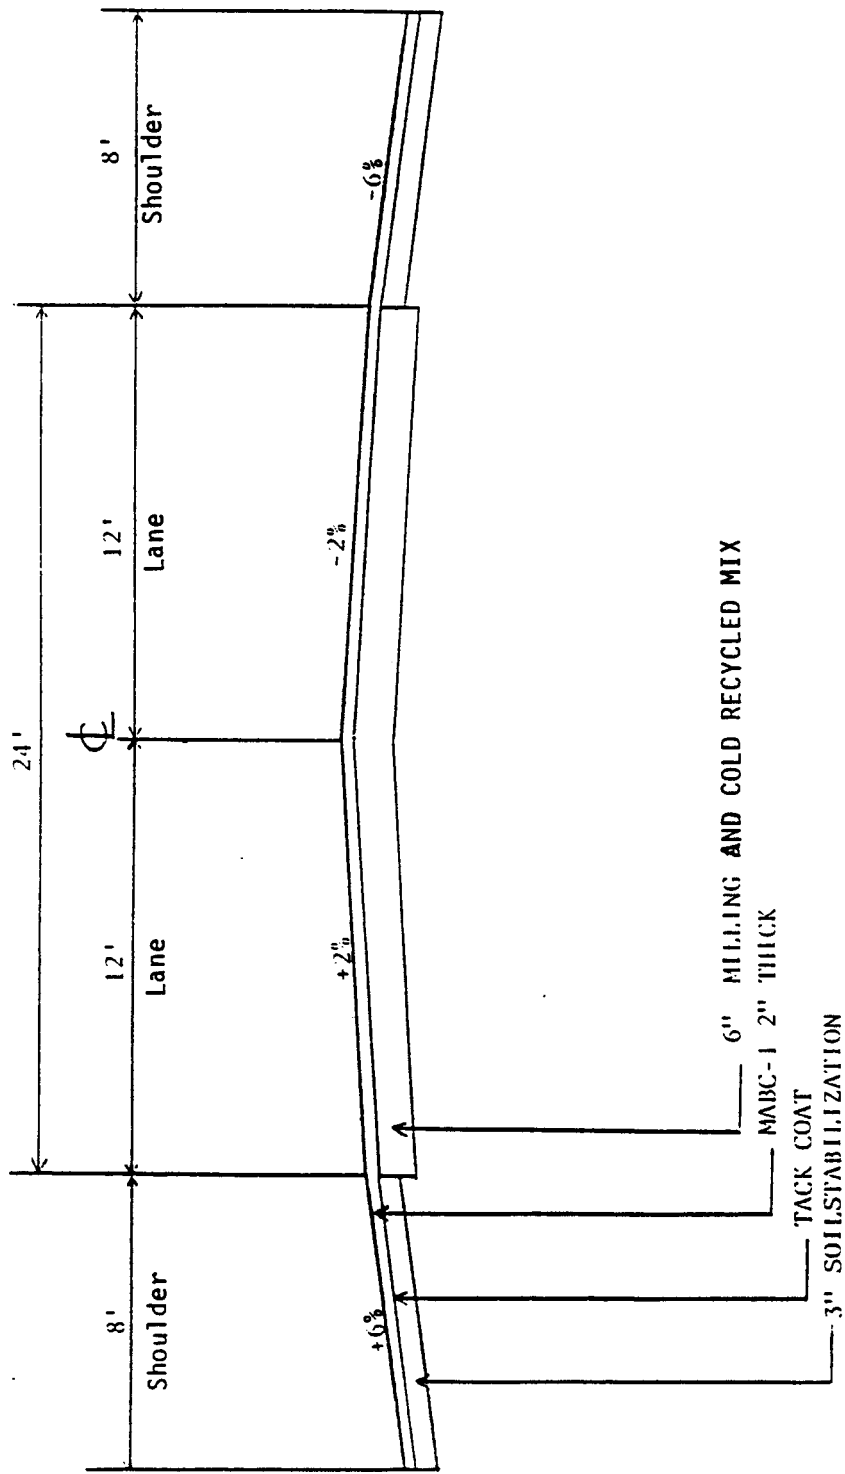
FIGURE-2

The reconstructed roadway was designed to include a 12 foot lane in each direction with 8 foot outside shoulders. The cross-section shown in Figure 2 consists of a six inch cold recycled bituminous stabilized base course topped by a two inch bituminous concrete wearing course on a gravel base. The control section shown in Figure 3 consists of three inches of bituminous stabilized base course and a two inch bituminous concrete wearing course on a gravel base.

COLD RECYCLED SECTION

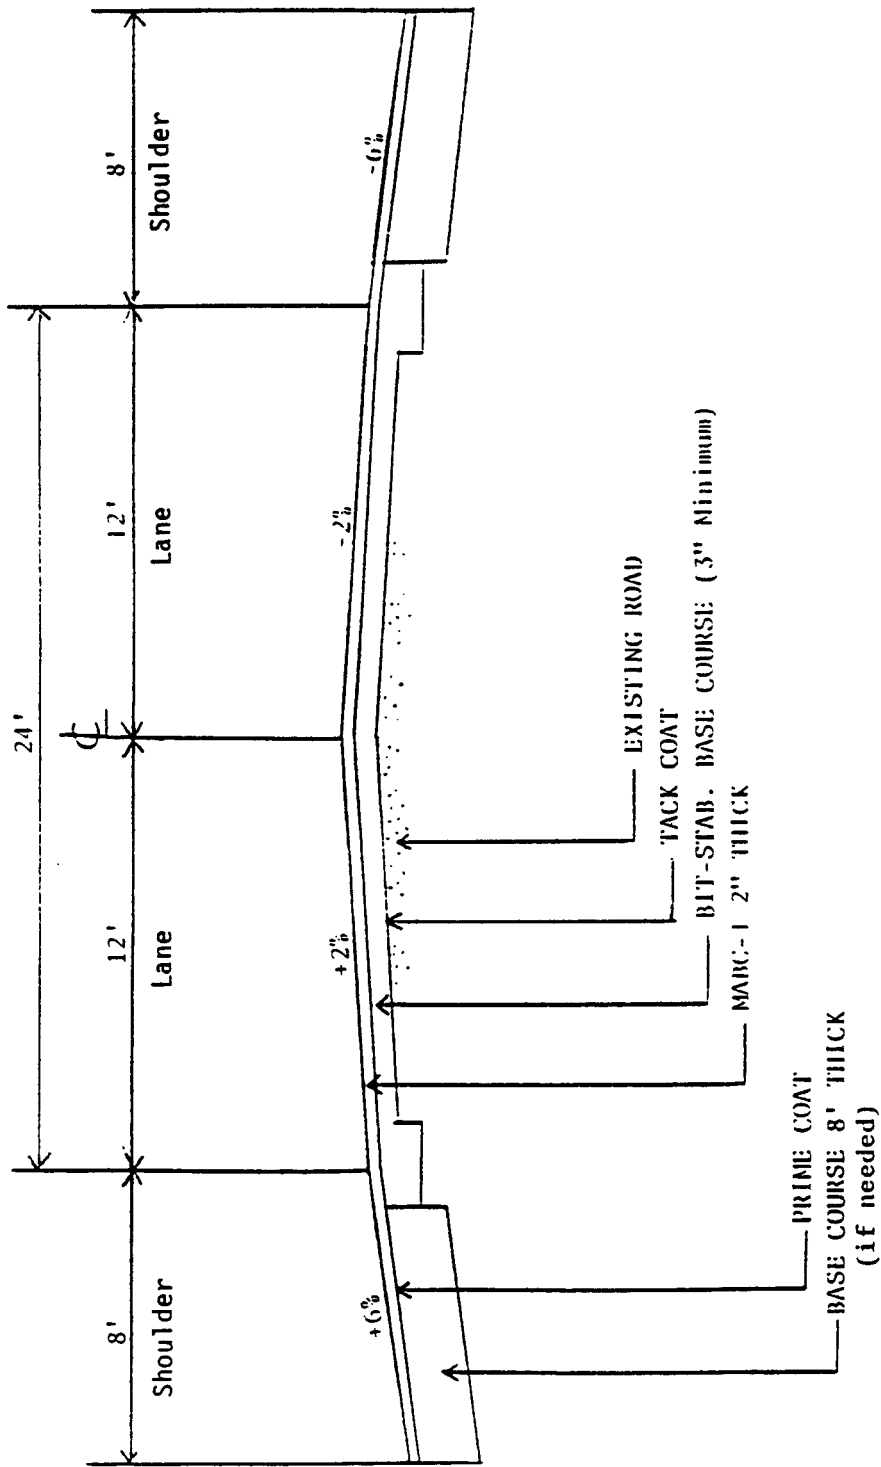
FIGURE 3
CONTROL CROSS-SECTION

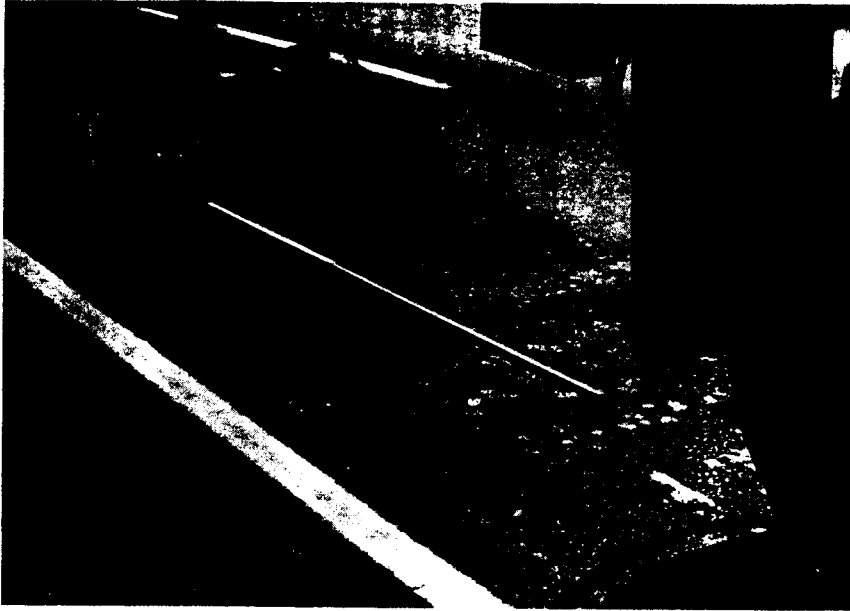
Deflections were determined from the weight of a dump truck loaded with 18,000 pounds on the rear axle at locations 0, 20, and 40 inches from the apparatus probe.

Photo #4 Benkelmen Beam Measurement

These readings established a representative deflection basin of the pavement and subgrade.

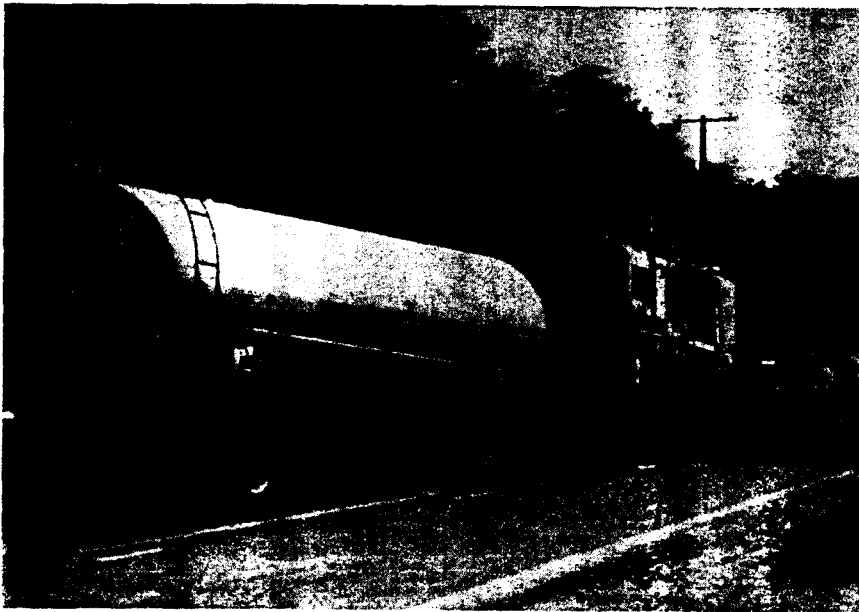
The rejuvenating oil (Asphalt Emulsion CSS-1), which was kept in a tanker with a capacity of 4,000 gallons was added to the milled material.

Photo #6 Emulsion Storage Tanker in Recycling Train

The tanker had the capability of metering the emulsion up to a 5% deviation from the required specification. The recycled material was placed by a Blowknox paver and rolled with a Dynapac static/vibrating roller to 95% compaction.

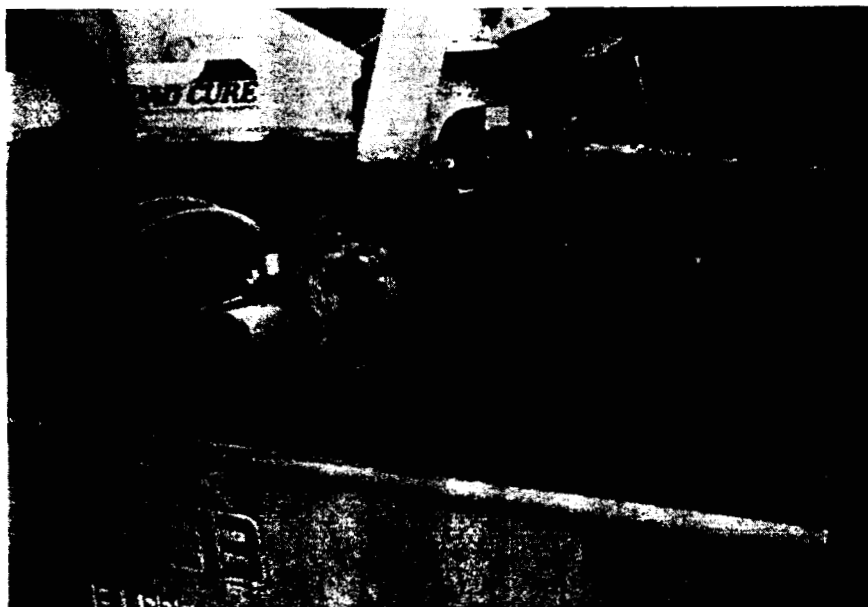
- * the mixed material then travels by means of a conveyer to the paver where it is laid back to its original position.

Photo #9 Conveying Blended Material to Paver

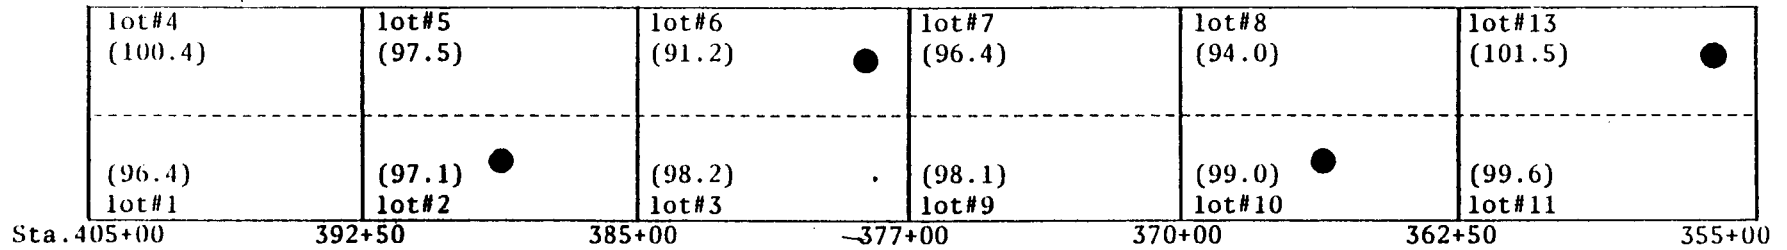
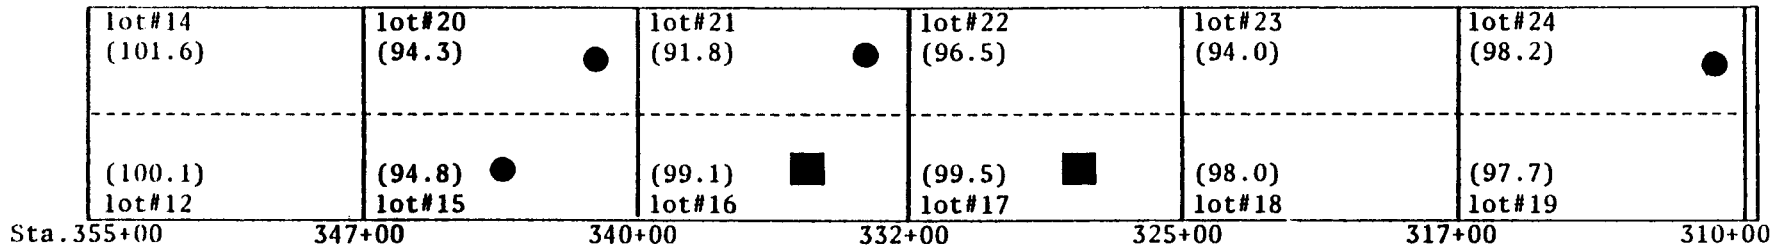
● Sample Taken for Extraction and Marshall Plugs

■ Sample Taken for Extraction Only

|| End of Construction

Densities of each lot in Parenthesis

FIGURE 4 - SAMPLE LOCATION DIAGRAM

In addition two extra samples were taken for extractions only (Figure 4). An average was computed of the eight regular samples. Two of these eight samples (Lot #15 & 20) were from excavation areas (areas where no recycled asphalt pavement material was mixed with base material).

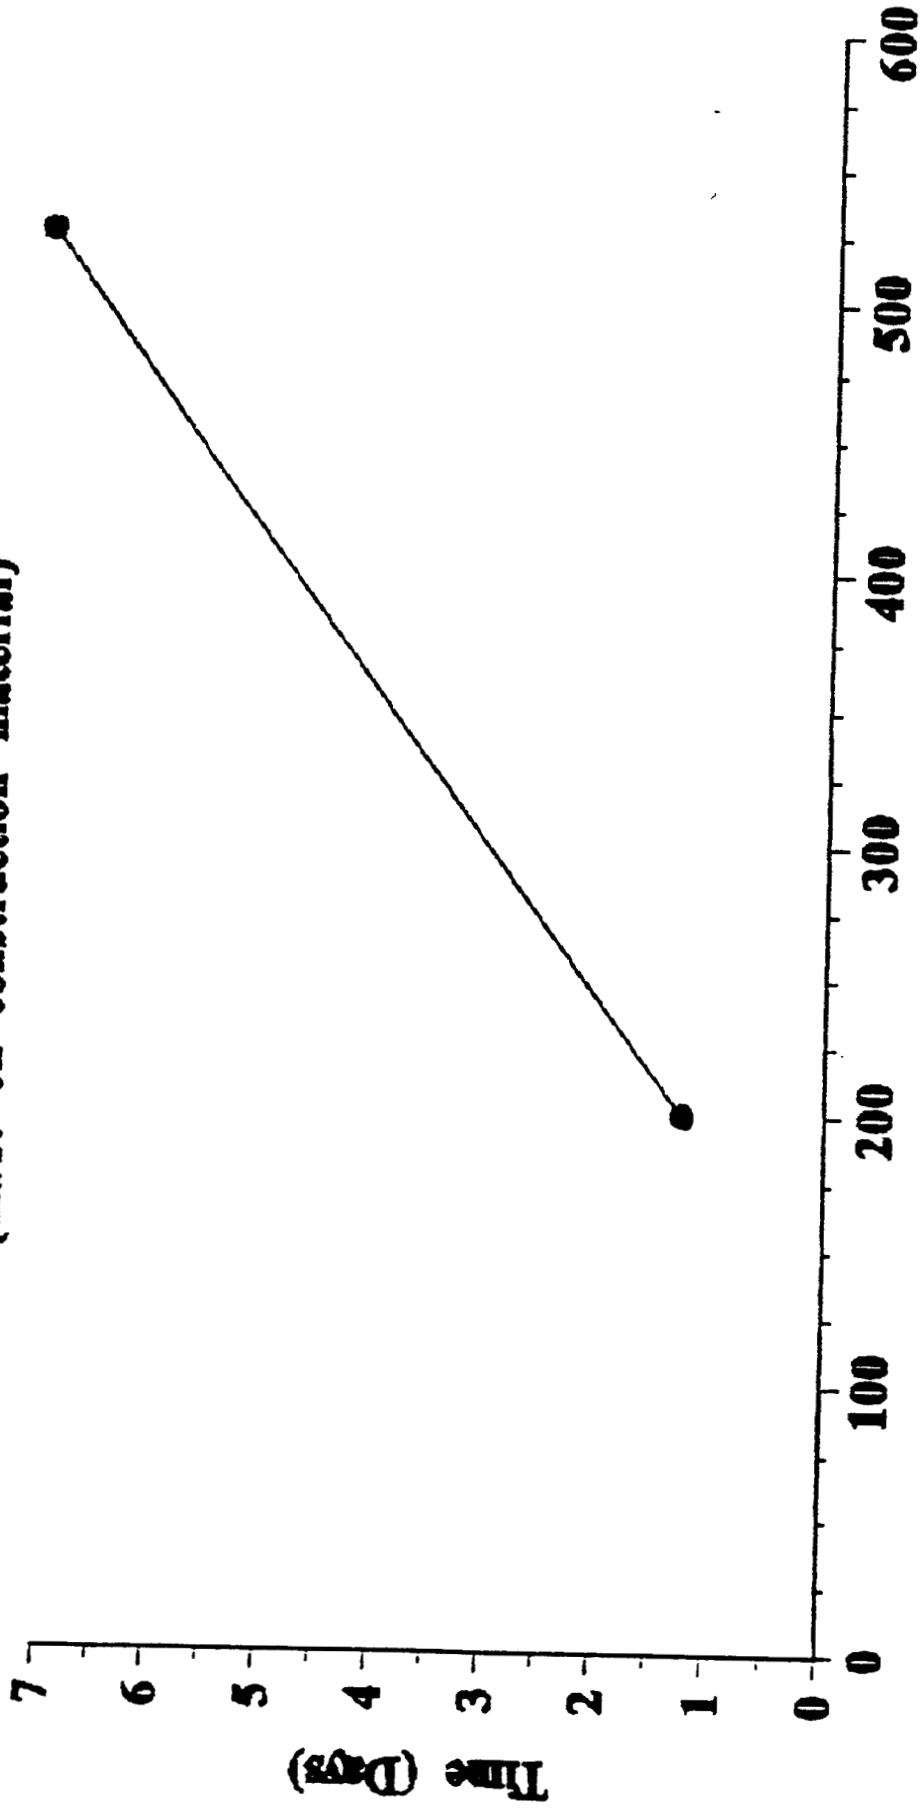
MR. (in thousands)
Figure 5

The average values obtained on the Marshall plugs made during construction were 200,000 PSI in one day and 525,000 PSI in 7 days. (Typical MR value for Bituminous Concrete is 350,000 to 400,000 psi).

Marshall Plugs (made on construction material)

Approximately one month after construction the six cores taken yielded an average 250,000 PSI, at ten months averaged 457,000 PSI, and at one and one-half years averaged 777,000 PSI. These results were averaged and are graphically depicted in Figure 5 which shows the Marshall plugs and Figure 6 which shows the core data.

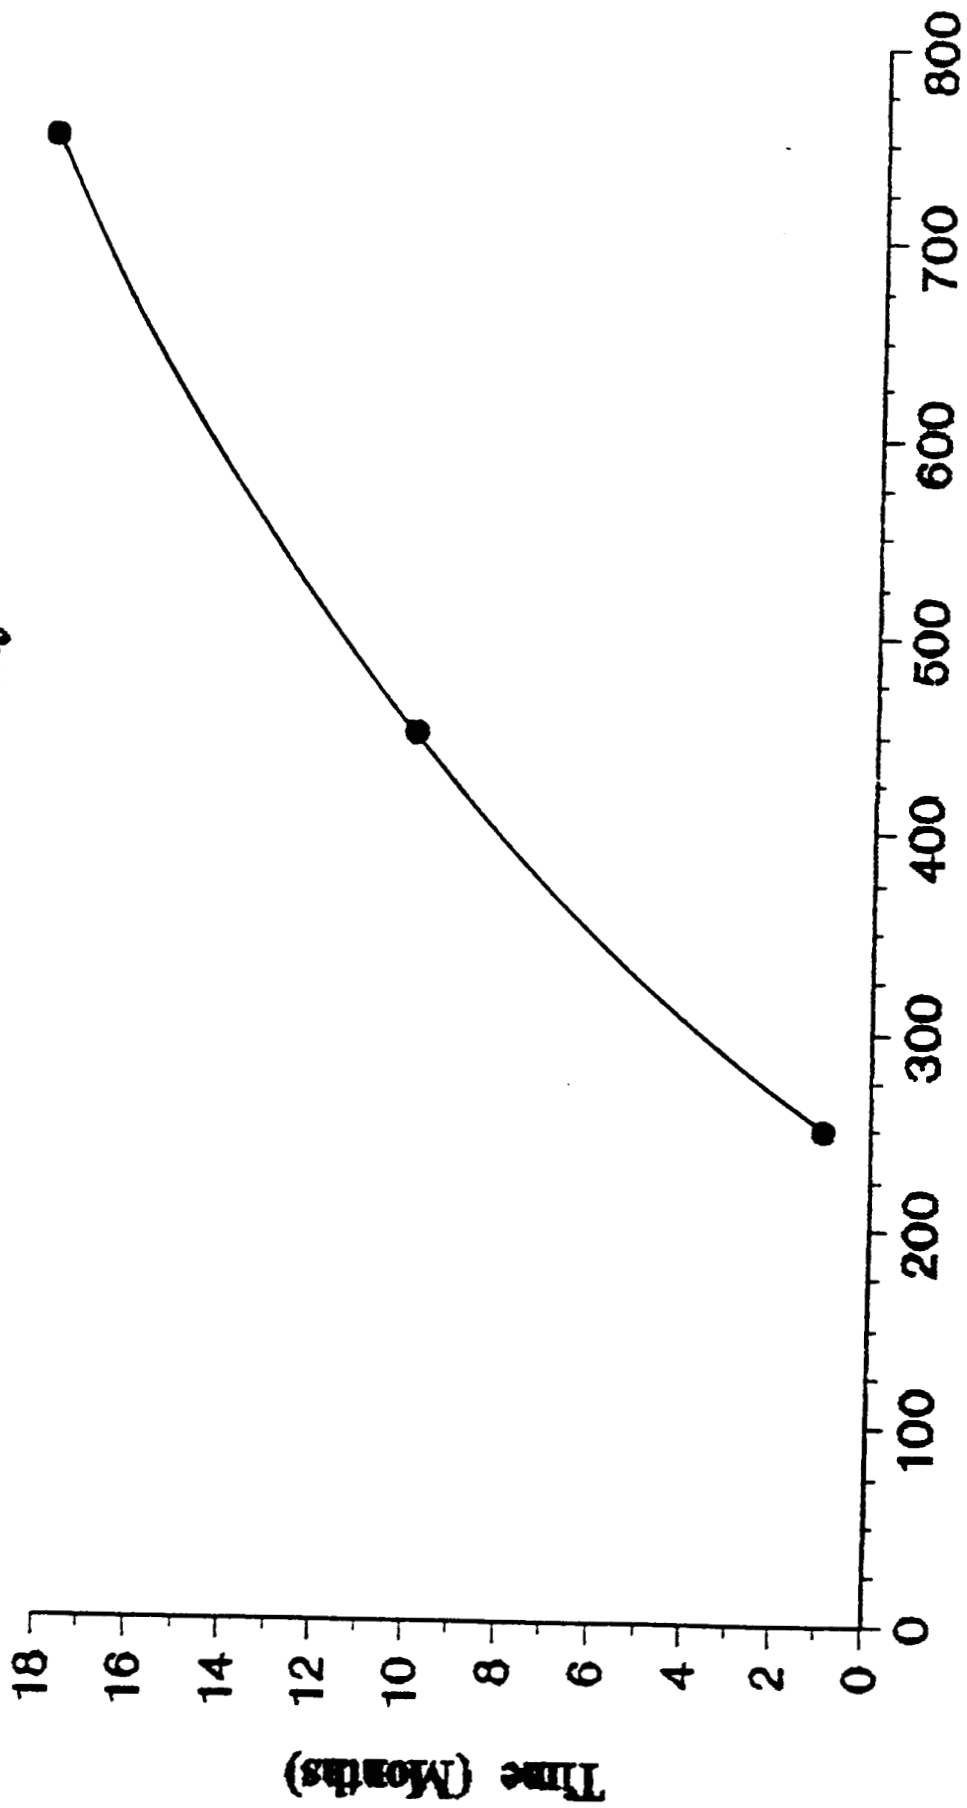
Figure 6

Cores of Roadway

MR. (In Thousands)
