GUIDE SIGN VIEW SURVEY
IN NEW JERSEY

BUREAU OF TRANSPORTATION TECHNOLOGY RESEARCH
DIVISION OF RESEARCH AND DEMONSTRATION
NEW JERSEY DEPARTMENT OF TRANSPORTATION

April, 1991

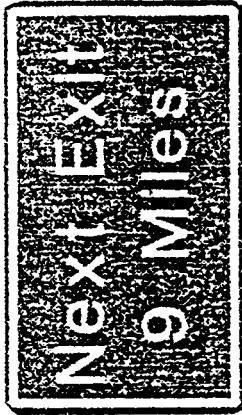
FIG. 1
SIGN TYPES

AGS - Advance Guide Sign with Exit Number Panel

IEDS - Interchange Exit Directional Sign

PULL - Pull Through Sign

1. Advance;
2. Supplemental advance;
3. Exit direction;
4. Gore; and
5. Pull through, including both ground mounted and overhead signs.

The following sign types were surveyed (Figure 1).

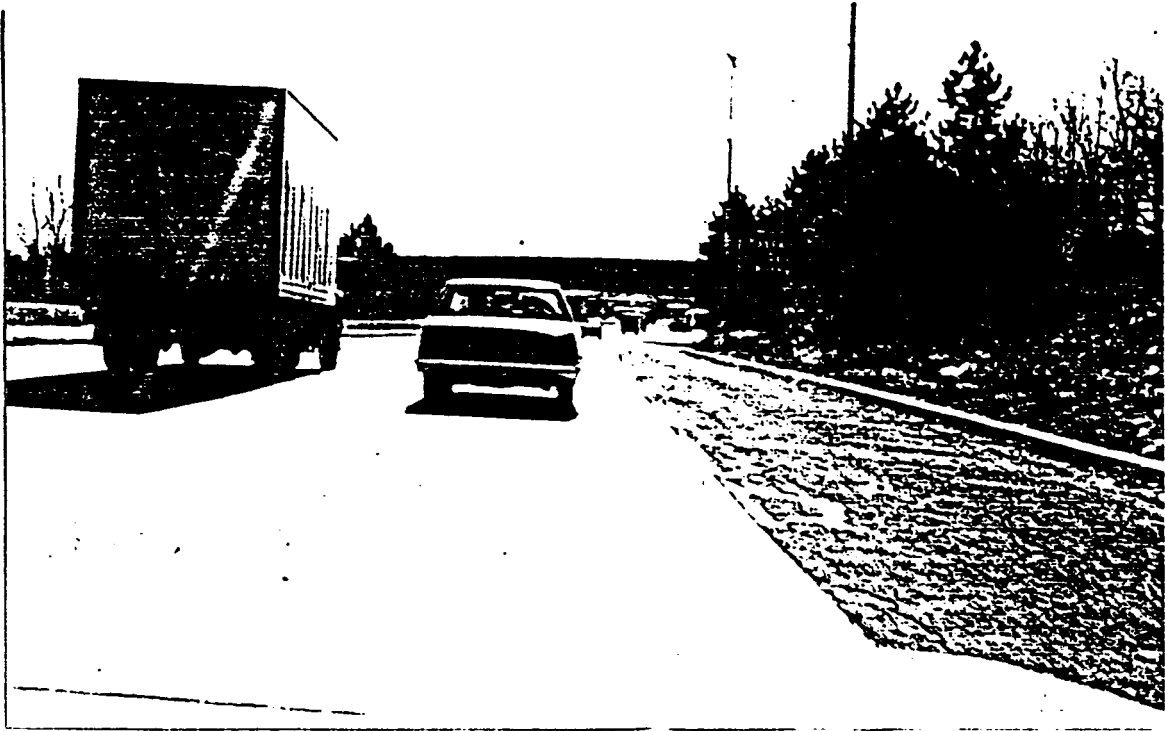
Figure 2: Tree Blockage, Rt. 21 North at Passaic Park

We found that a little more than half of the blockages were caused by trees. The maintenance of landscaping is normally an annual event when there are sufficient funds. Trees and shrubs are relatively inexpensive to modify. Apparently, when they were originally located in the design phase, the impact of this growth process was often not foreseen. They can be cut back or removed to correct the interferences at relatively low cost.

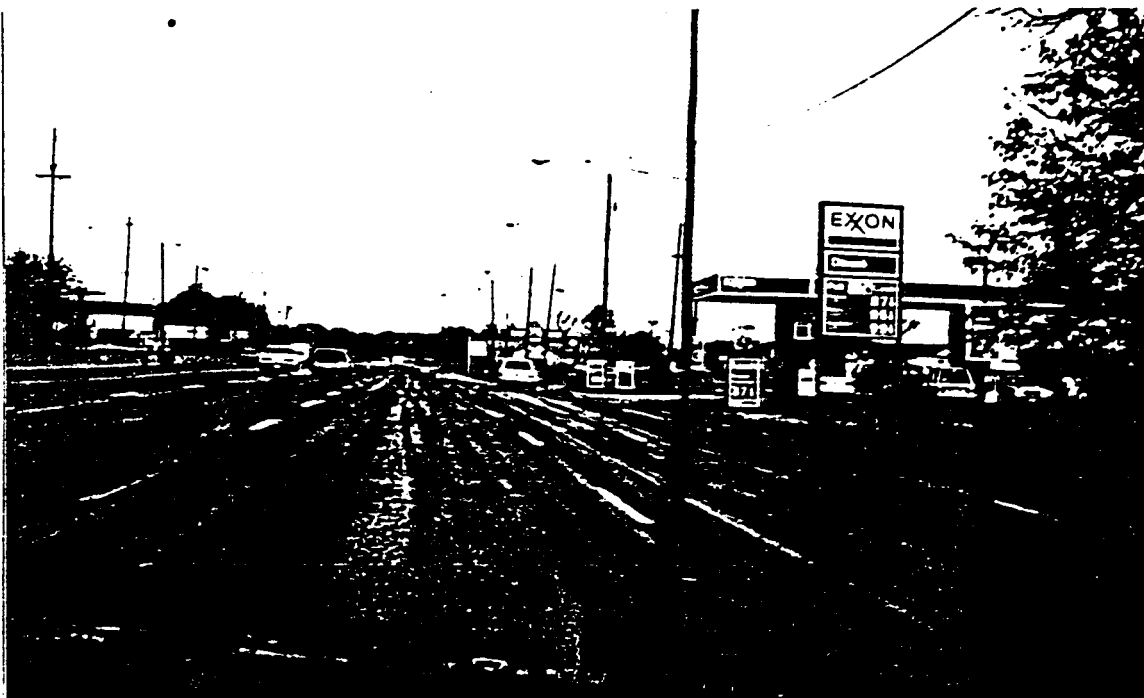
Figure 5: Complex Environment, Rt. 1 North at Rt. 18
