FATIGUE PERFORMANCE OF VARIABLE MESSAGE SIGN & LUMINAIRE SUPPORT STRUCTURES

Volume I – Fatigue Related Wind Loads on Highway Support Structures

FINAL REPORT
April 1998

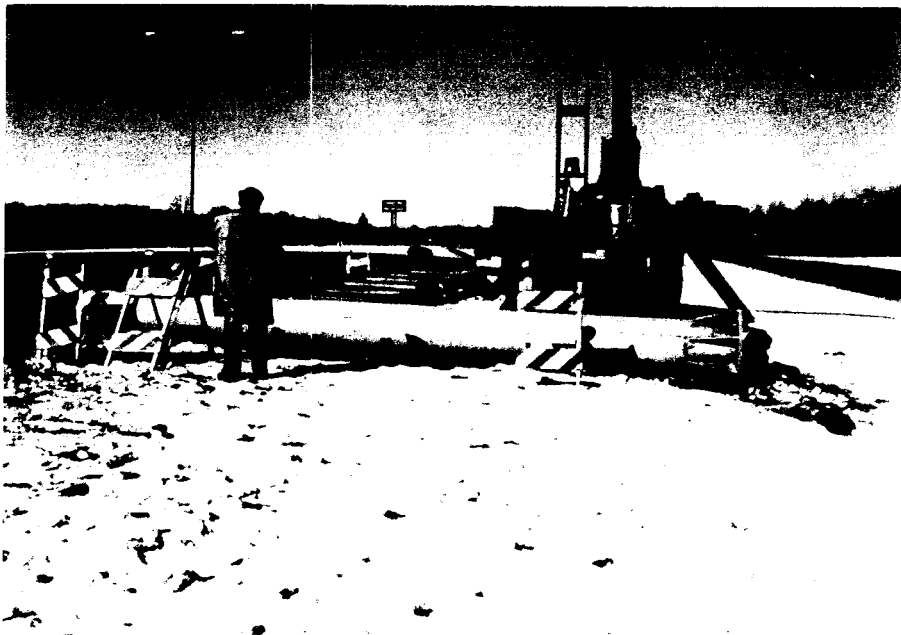
Figure 2-2 Failed VMS Support Structure Due to Anchor Bolt Fatigue

The VMS are particularly susceptible to truck-induced wind gusts. These signs have a relatively large width (up to approximately 1.2 m or 4 ft) in the direction parallel to traffic flow. Figure 2-2 is a VMS structure that failed due to anchor bolt fatigue. Figure 2-3 shows a closer view of the fractured anchor bolts. Prior to failure, VMS structures in Virginia and California were observed to be vibrating in the vertical plane. Therefore, it is believed to be the vertical pressure acting on the horizontal area that caused these vibrations.

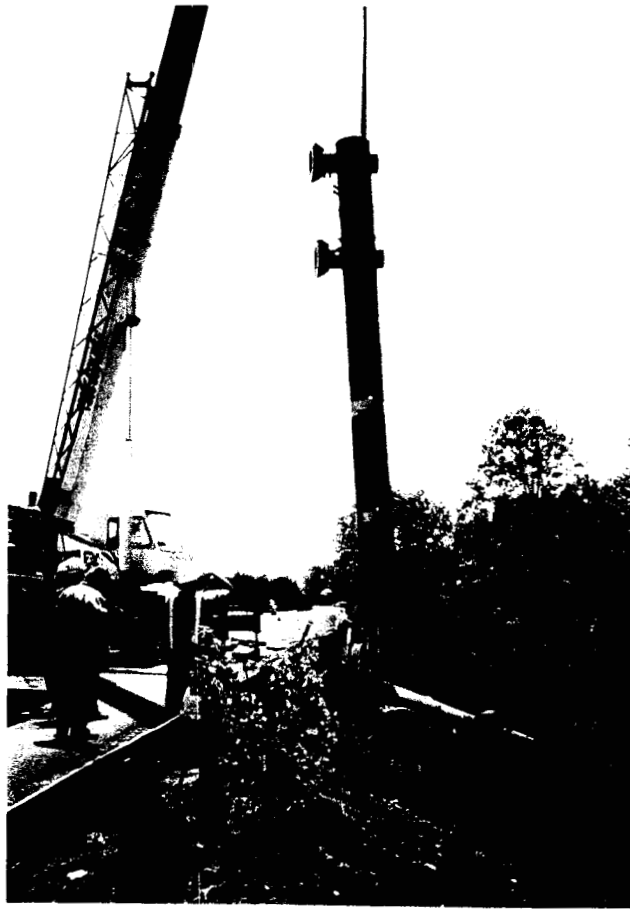
Figure 3-1 VMS Column Erection on Interstate 80.

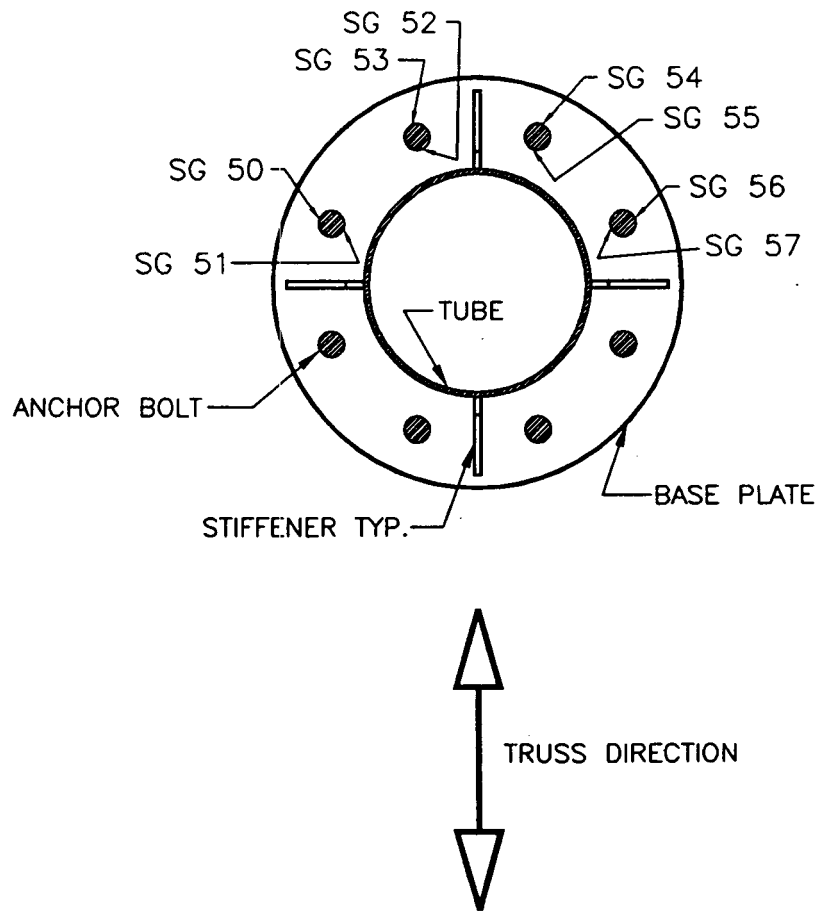
Figure 3-12 Strain Gage Locations on Anchor Bolts.
