# **FATIGUE PERFORMANCE OF VARIABLE MESSAGE SIGN & LUMINAIRE SUPPORT STRUCTURES**

## **Volume II – Fatigue Testing and Failure Analysis of Aluminum Luminaire Support Structures**

FINAL REPORT  
May 1998

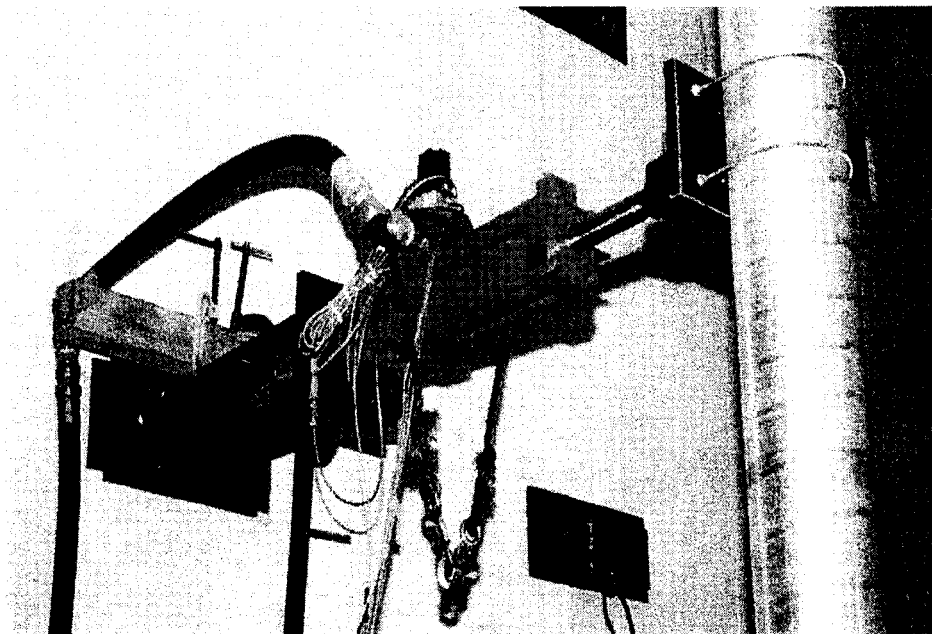
Figure 3-12 Actuator used in Fatigue Test

A fatigue test was performed on six cantilevered support standards and six straight support standards. A cantilevered and straight support standard was both bolted to the concrete foundation. The two support standards were connected together with a pinned linkage (Figure 3-11). This enabled the two support standards to be cycled at the same time. A hydraulic actuator was connected to the support standard closest to the reaction wall (Figure 3-12).

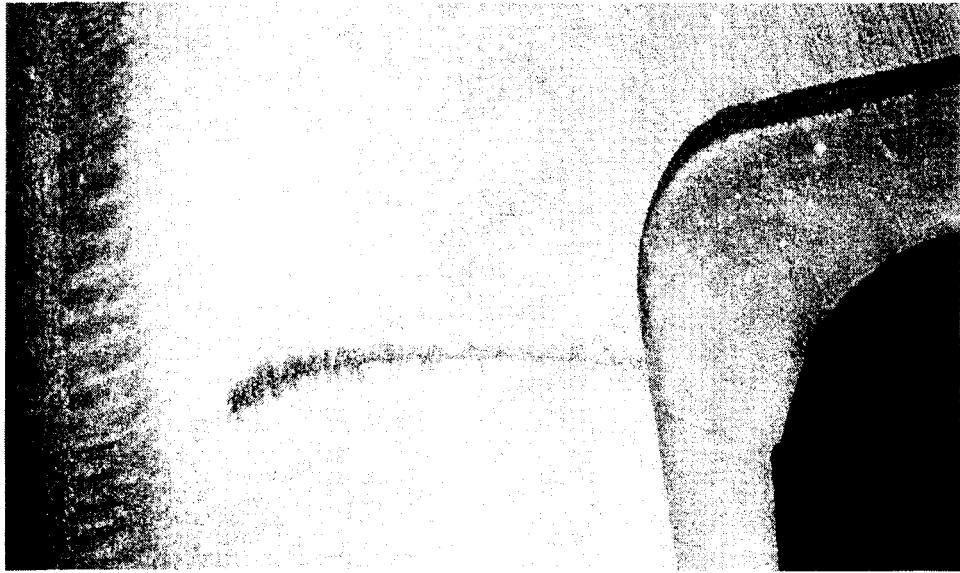
Figure 3-13 Fatigue Crack in Transformer Base of Specimen S-3

Three of the seven transformer bases included in the fatigue test developed cracks at various locations. Specimen S-3 developed a crack at the top corner of the access hole (Figure 3-13). There was a small notch that was noticeable at the origin of the crack. There appeared to be grinding marks going in two directions in the area of the crack that helped to form a point on the edge of the access hole. This combination of a sharp edge with a notch initiated the fatigue crack.

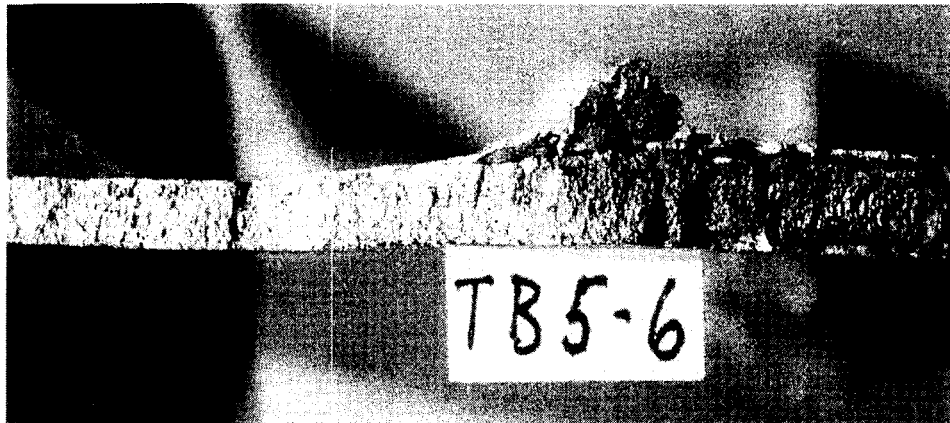
Figure 3-15 Cross Section of Transformer Base Wall of Specimen S-6

Specimen S-6 developed cracks in two places. The first crack started to form in the side of the transformer base wall opposite the access hole (Figure 3-14). After the test this crack was cut out and a definite change in thickness was noticed in the transformer base wall (Figure 3-15). The thinner wall was caused by excess grinding on the side of this transformer base. There may have also been an attempt at a weld repair in the base metal of this transformer base. Apparently there was a surface defect in this base. Instead of discarding it a repair was attempted and this was the origin of the first fatigue crack. The second crack in this base originated at the back of the finger tabs that are used to bolt the structure to its foundation (Figure 3-16). This crack appeared to originate out of the radius at the back of the finger tabs.
