# Evaluation of Pothole Patching Materials

FINAL REPORT

February 2001

Dept. of Civil & Environmental Engineering  
Center for Advanced Infrastructure & Transportation (CAIT)  
Rutgers, The State University  
Piscataway, NJ 08854-8014

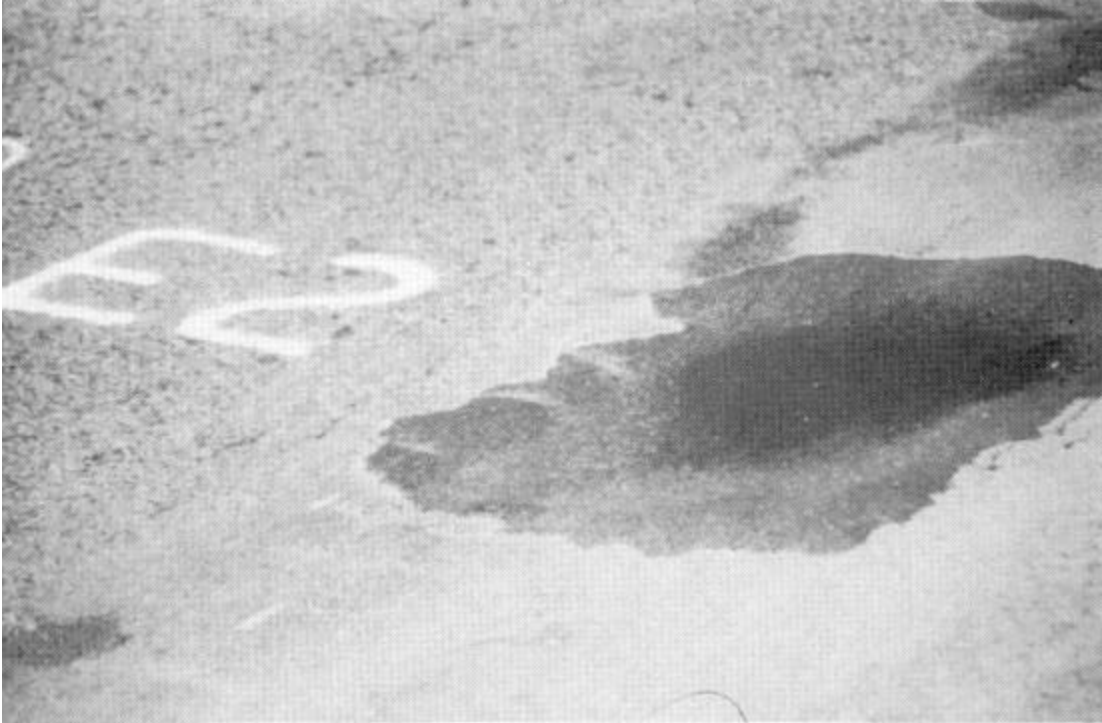
**Figure 1. Bleeding Distress** <sup>(3)</sup>

In Table 4 <sup>(2)</sup>, in-service problems and failure mechanisms in cold-mix patching materials are presented. Some examples of distress types are shown in Figures 1-5 <sup>(3)</sup>.

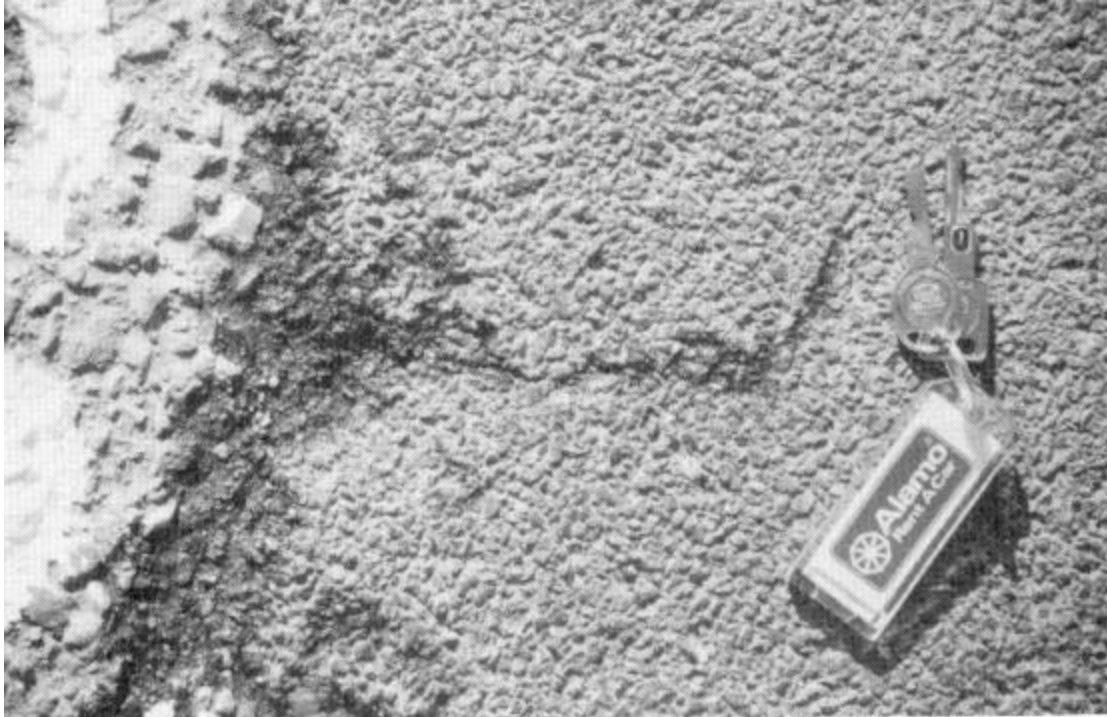
**Figure 2. Cracking Distress** <sup>(3)</sup>

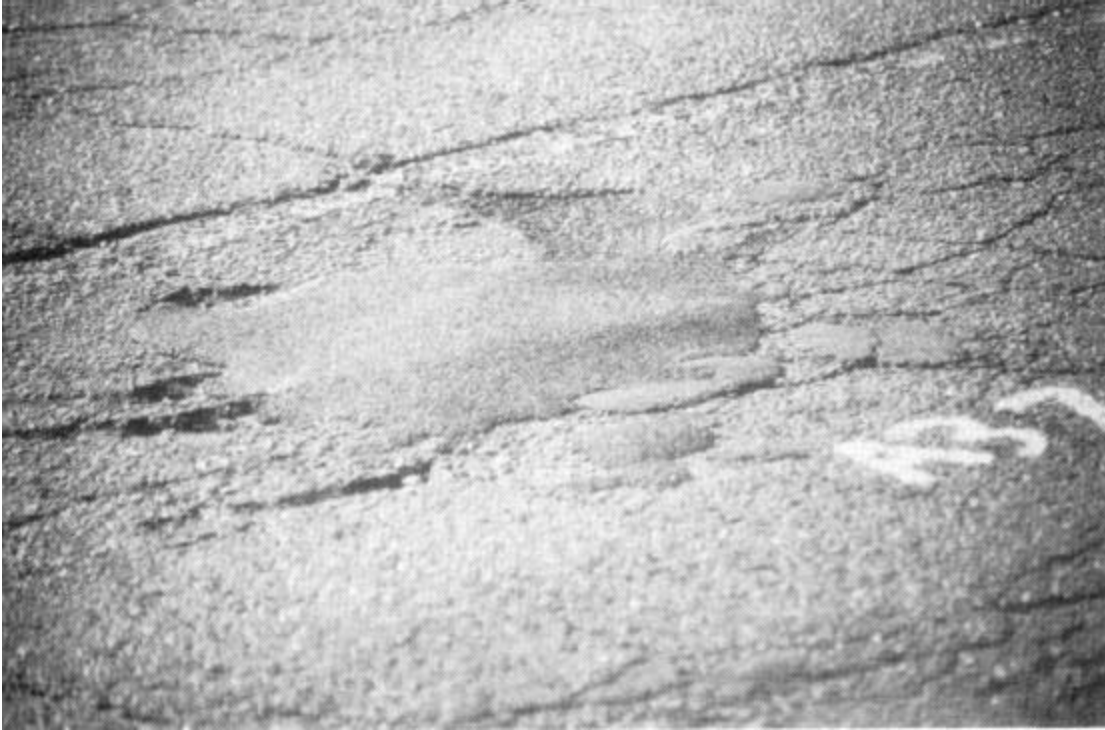
**Figure 3. Edge Disintegration Distress <sup>(3)</sup>**

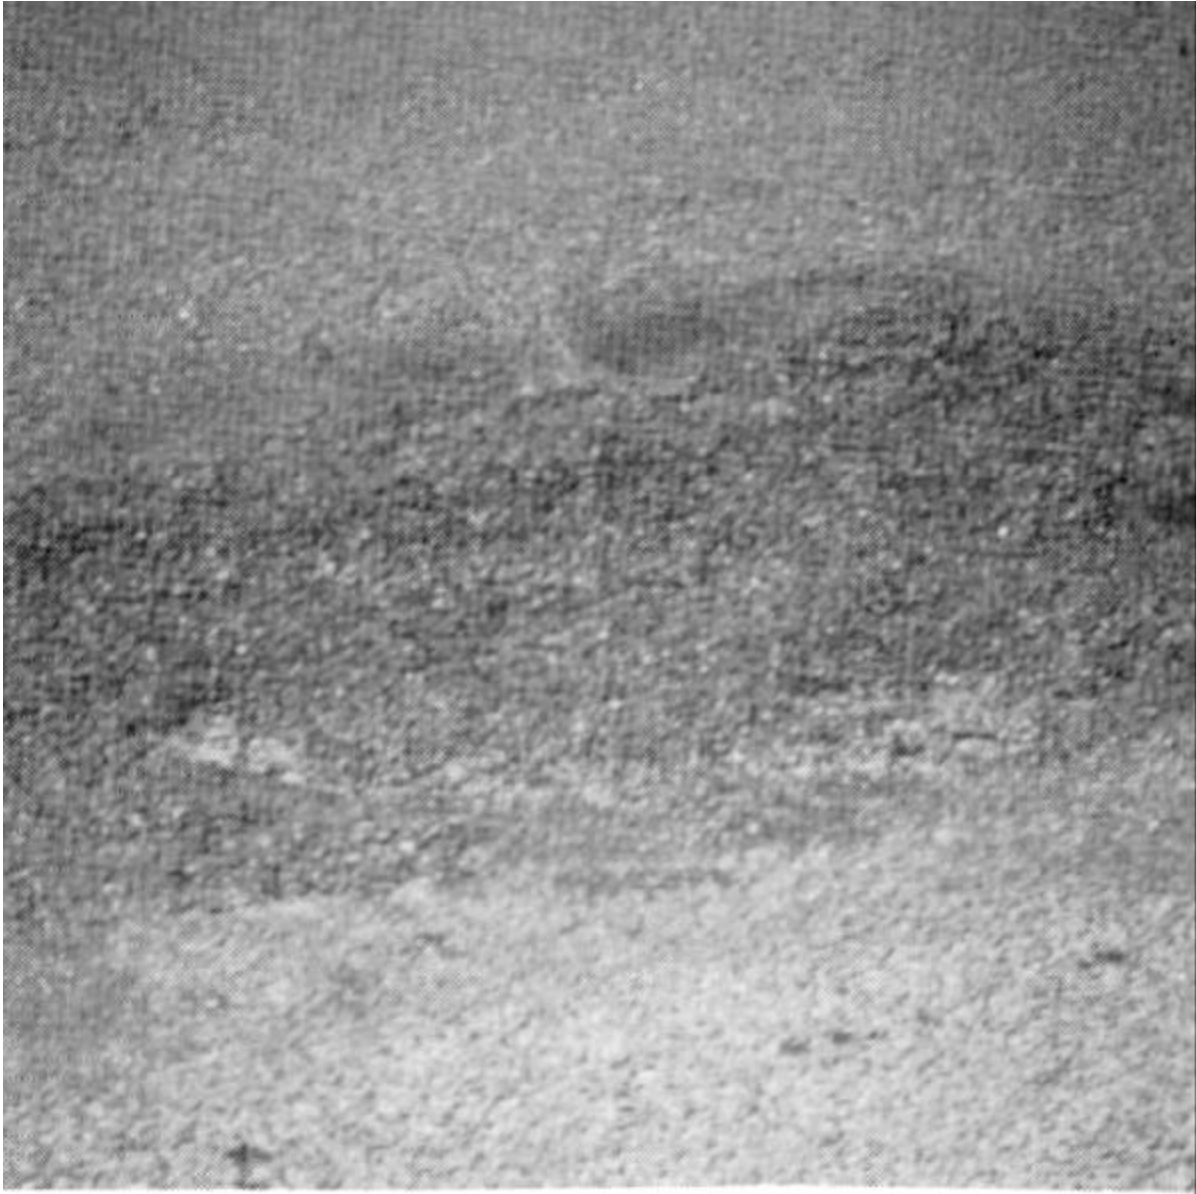
**Figure 4. Raveling Distress** <sup>(3)</sup>

3. *Raveling* can be described as a progressive loss of aggregate from the surface of the repair. It is basically the product of poor aggregate interlock and inadequate cohesion within the mix. Poor compaction may also contribute to raveling as it reduces cohesion. Most factors that cause shoving may also contribute to raveling.

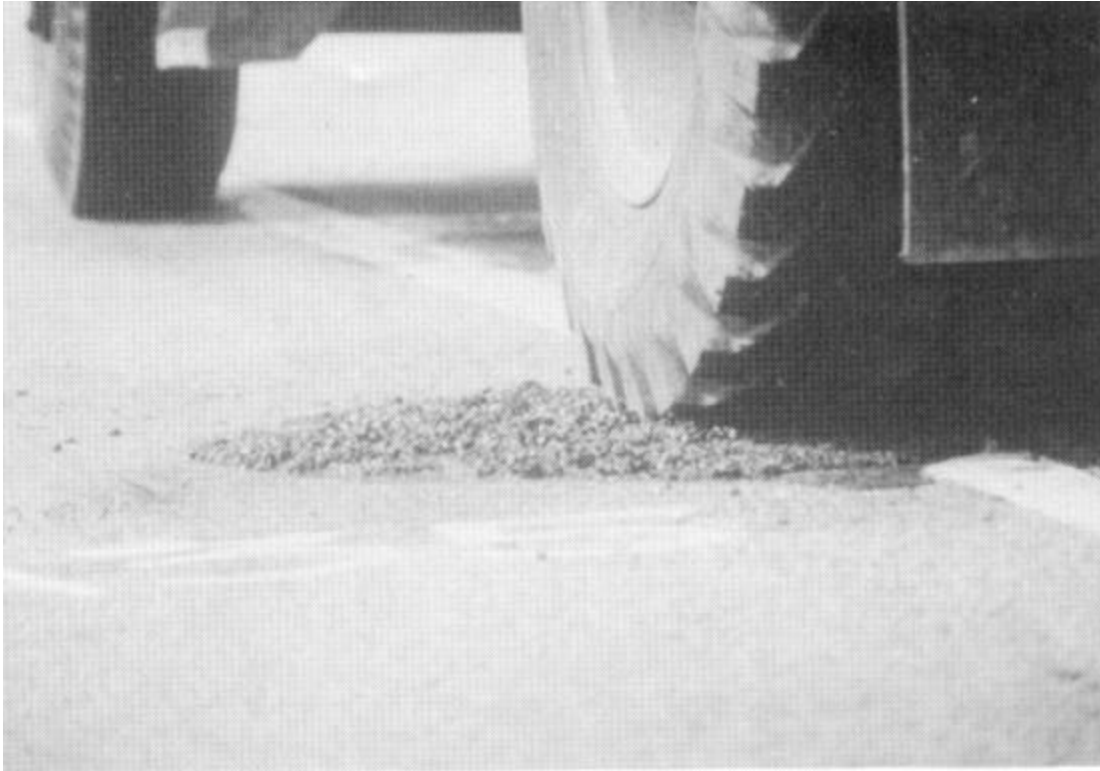
**Figure 7. Throw-and-Roll Repair Method: Compaction of Material Using the Wheels of a Truck on Site<sup>(5)</sup>**

In the "throw and roll" method the material is first placed into the pothole (which may or may not be filled with water or debris). The material is then compacted using track tires to allow for a tighter patch for traffic. The remaining is crown between 3 and 6 mm (0.125 and 0.25 in). The maintenance crew moves to the next pothole and the repair is open to traffic as soon as maintenance workers and equipment are clear.

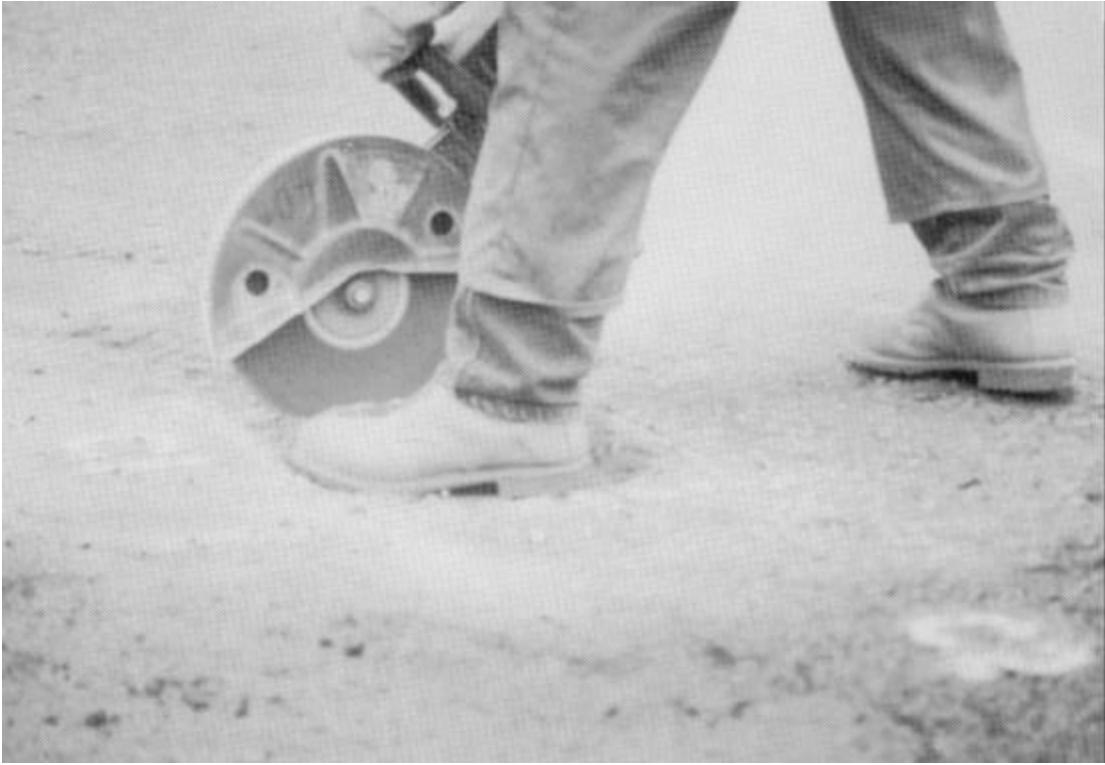
**Figure 8. Semi-permanent Method of Pothole Repair: Saw-Cutting of Edges <sup>(5)</sup>**

In the semi-permanent method, the water and debris are first removed from the pothole. The sides of the patch area are then squared up until vertical sides exist in reasonably sound pavement and the mixed is placed. The patch is then compacted by using a device smaller than the patching area and the repair is opened to traffic as soon as the maintenance workers and equipment are clear.

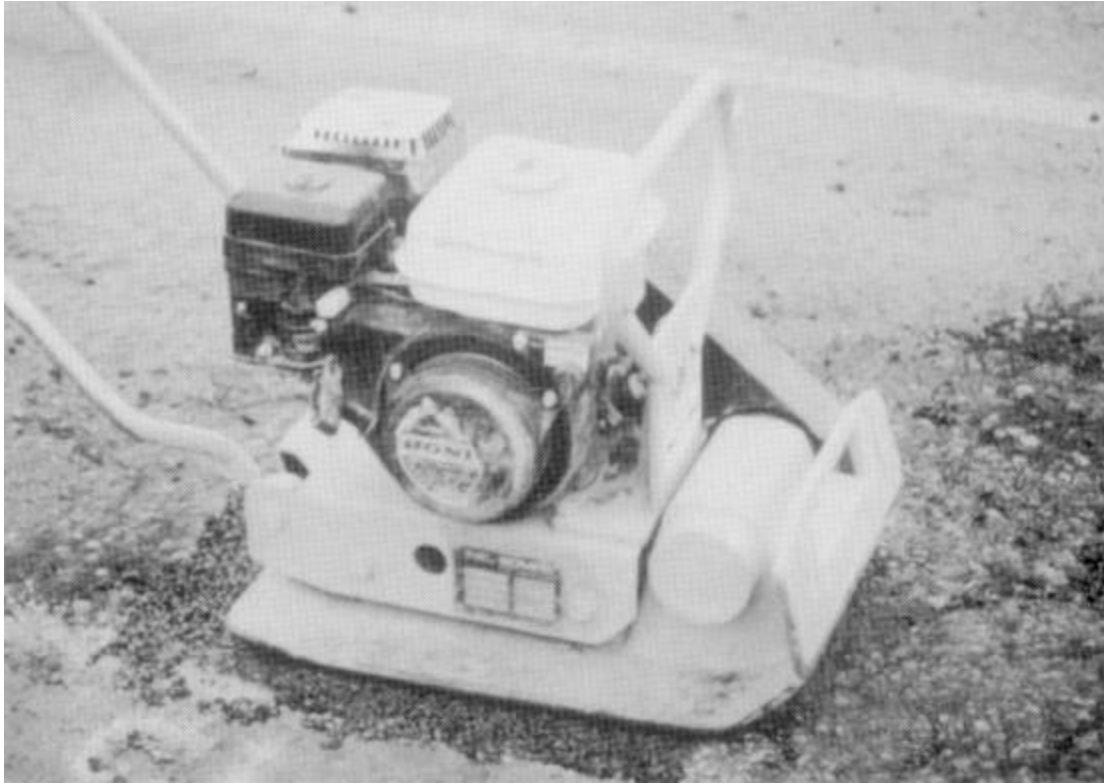
**Figure 9. Semi-permanent Method of Pothole Repair:  
Compaction Using a Mobile Vibratory Plate Compactor <sup>(5)</sup>**

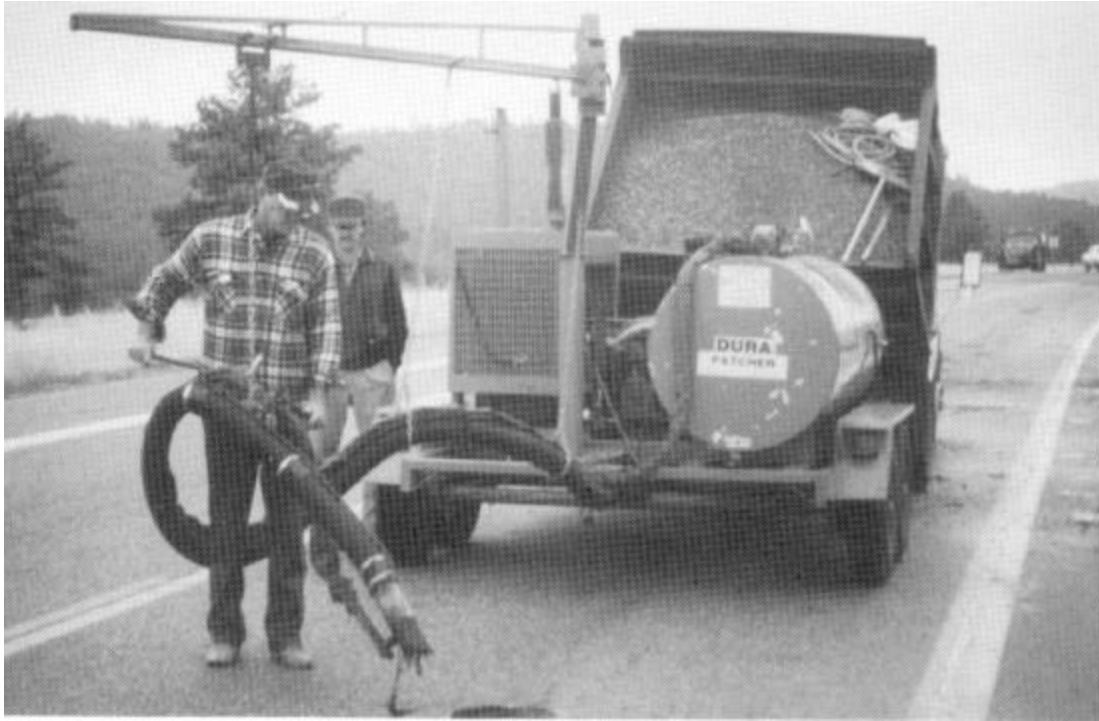
**Figure 10. Spray Injection Method of Pothole Repair <sup>(5)</sup>**

In the spray injection method the water and debris are first removed from the pothole and a tack coat of binder is sprayed into the pothole on the sides and bottom. The asphalt and aggregate are then blown into the pothole and the patched area is then covered by an aggregate layer. The repair is finally opened to traffic as soon as the maintenance workers and the equipment are clear.

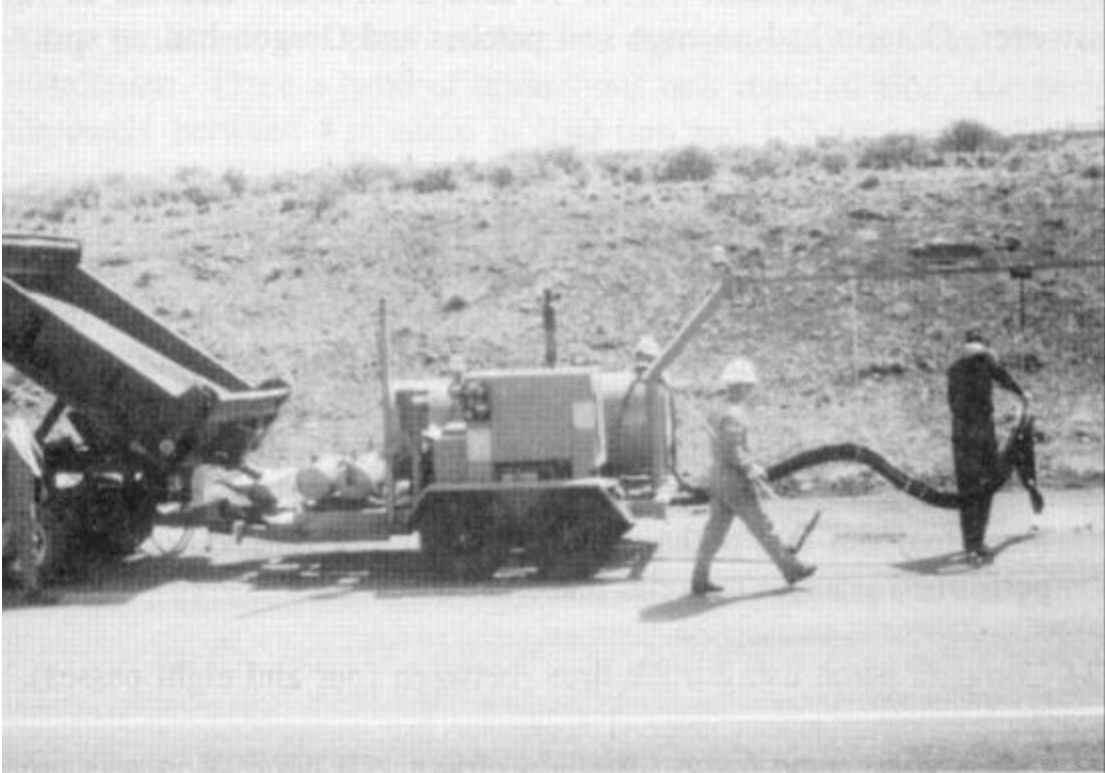
**Figure 11. Spray Injection Method of Pothole Repair <sup>(5)</sup>**
