# Evaluation of Corrosion Inhibitors

FINAL REPORT  
October 1999

Submitted by  
Dr. P. Balaguru  
Professor

NJDOT Research Project Managers  
Mr. Carey Younger & Mr. Robert Baker

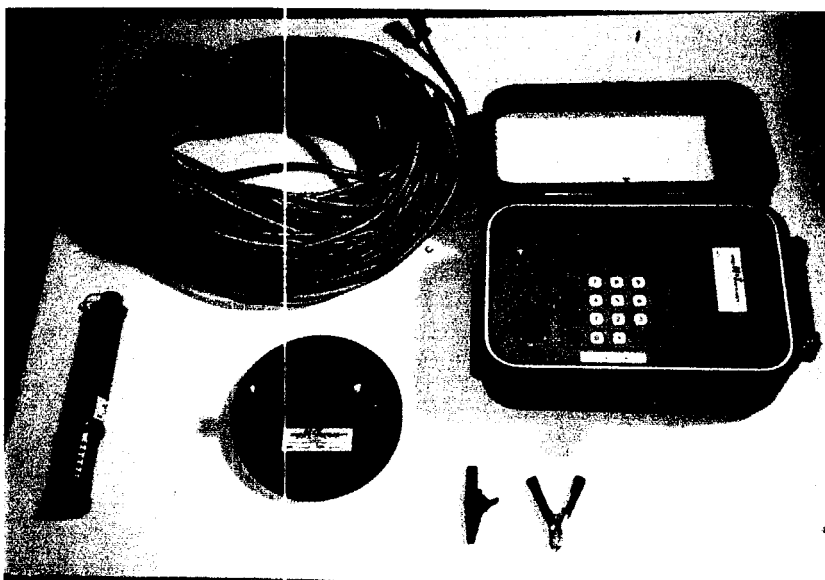
Fig. 3.1: Components of the GECOR 6 Corrosion Rate Meter

The GECOR 6 Corrosion Rate Meter has three major components, the rate meter and two separate sensors. Only the larger sensor was used during this project. The sensor is filled with a saturated Cu/CuSO<sub>4</sub> solution for the test for half cell potential. The main components of this device can be seen in Fig. 3.1. A wet sponge is used between the probe and the concrete surface as seen in Fig. 3.2. Long lengths of wire are also provided to connect the sensor to the rate meter and to connect the rate meter to the reinforcing bar mat of the bridge deck, a necessary step for the operation of the meter.
