# **Cause and Control of Transverse Cracking in Concrete Bridge Decks**

Final Report  
December 2002

Department of Civil and Environmental Engineering  
New Jersey Institute of Technology  
Newark, NJ 07102

New Jersey  
Department of Transportation  
Division of Research and Technology  
and  
U.S. Department of Transportation  
Federal Highway Administration

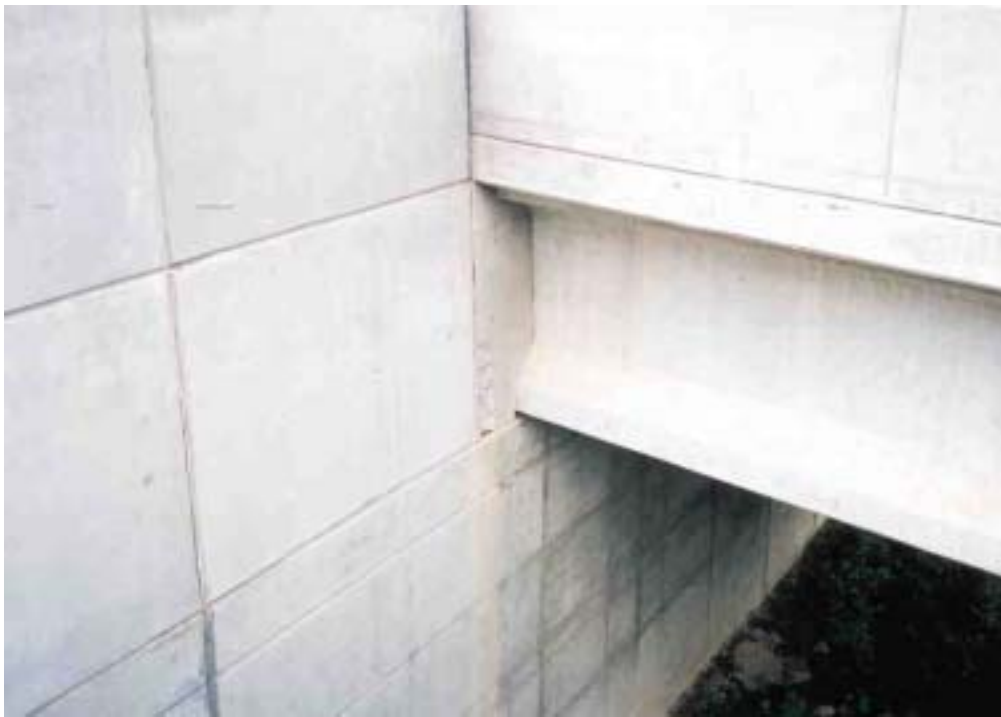
Figure 10. Boundary condition: girders are bounded.

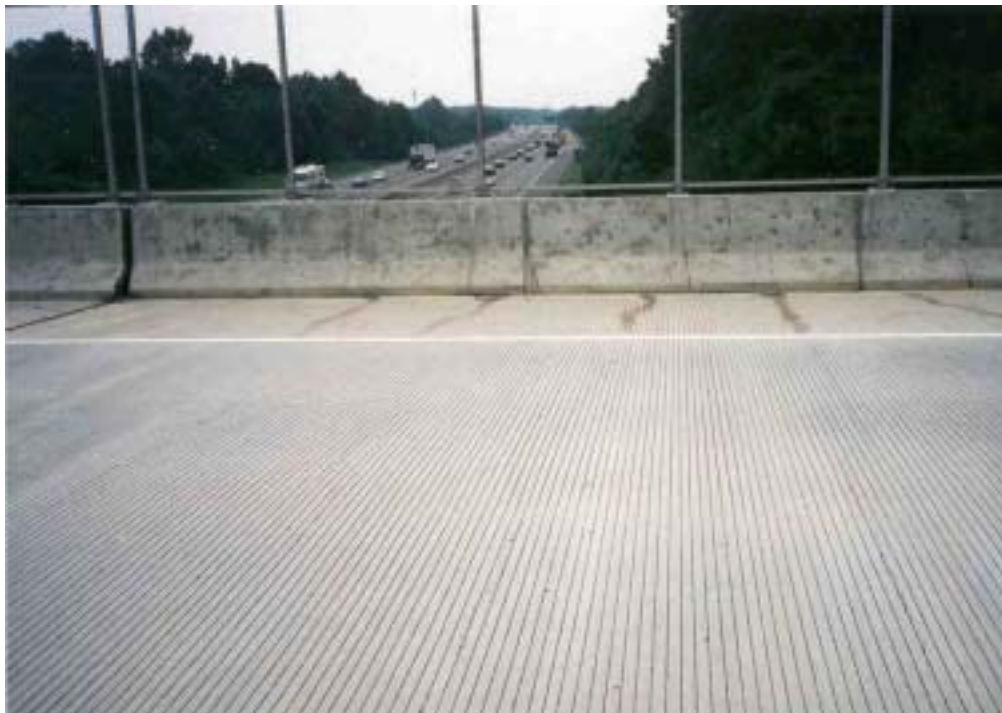
Figure 16. Rt. 133 bridge deck crack.

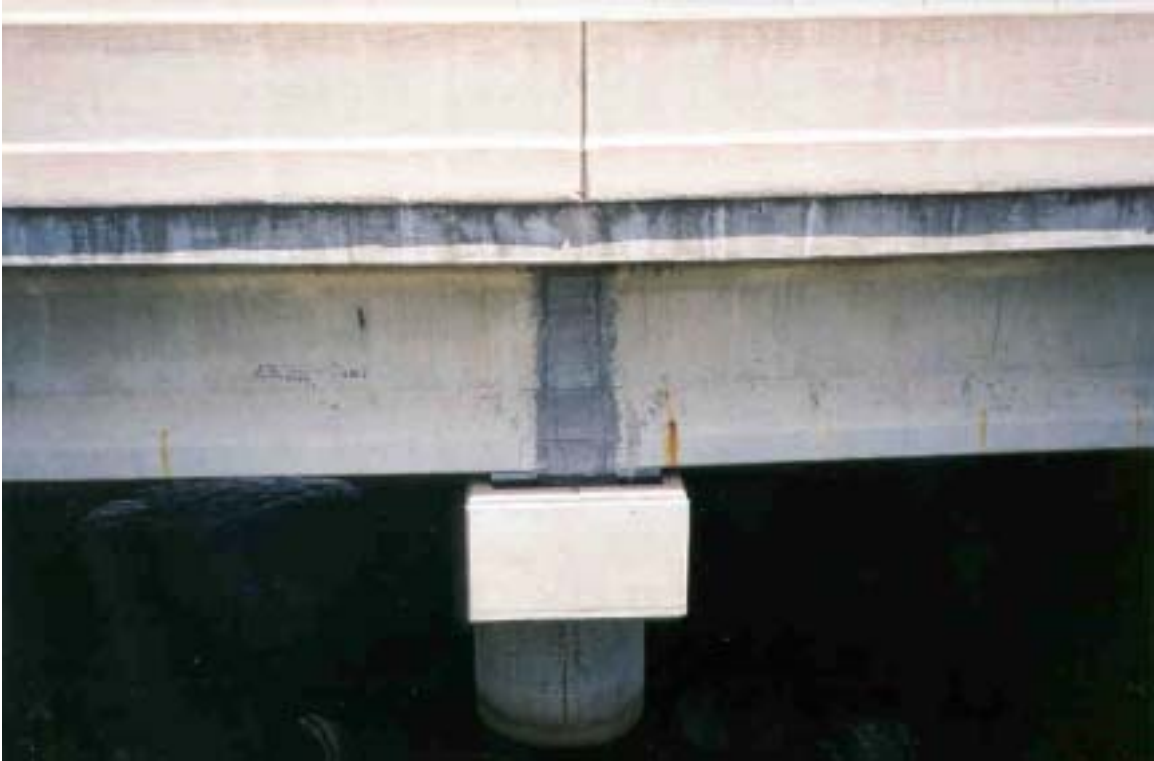
Figure 17. Watson Creek Bridge (West Bound): Cracked continuity joints (bridge No.1130-152).

were intact (see figure 17 and 18). That is, the bridge with cracked joint (less rigidity/constraint) did not develop any cracking in the deck, while the one with uncracked joint (more rigid/restraint) did develop transverse deck cracking. These observations point to the role of structural design factors in deck cracking and the need for further research to enhance our knowledge on these factors.

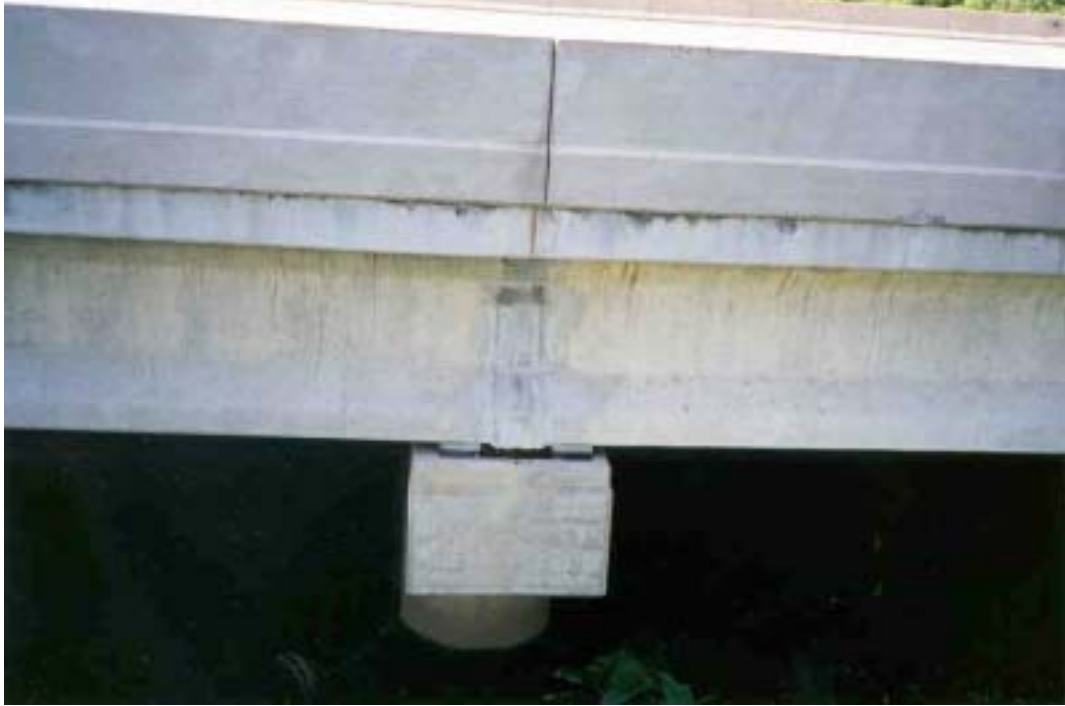
Figure 18. Watson Creek Bridge (East Bound): Un-cracked continuity joints (bridge No.1130-153).

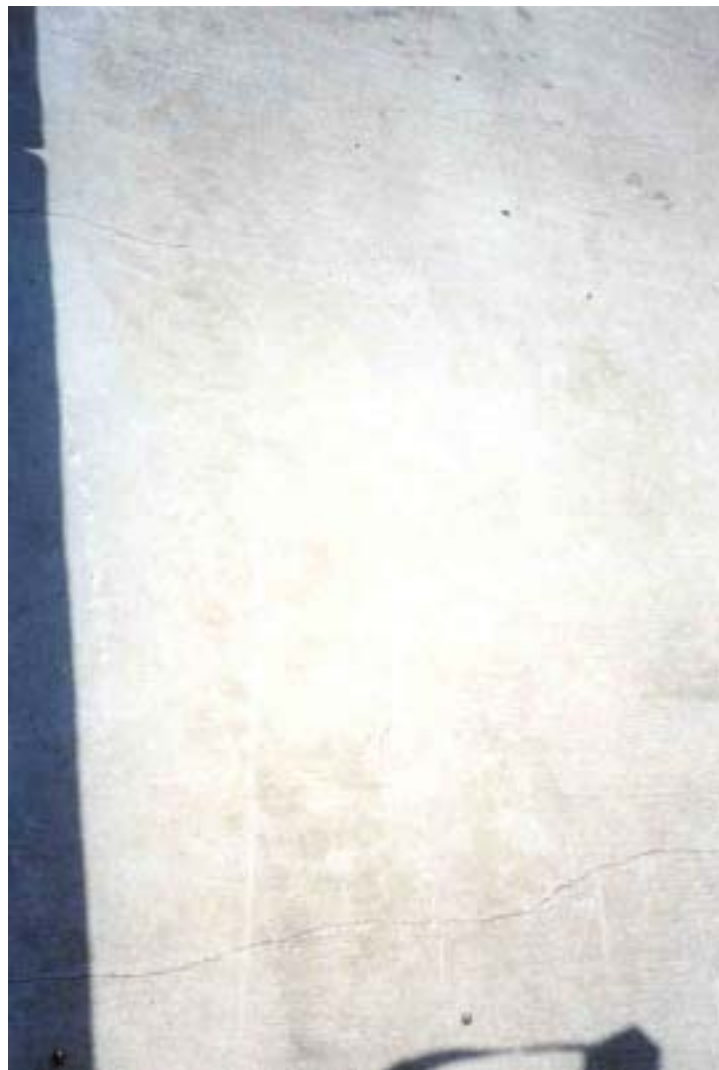
Figure 90. Crack on the deck (Bridge No 0713-151).

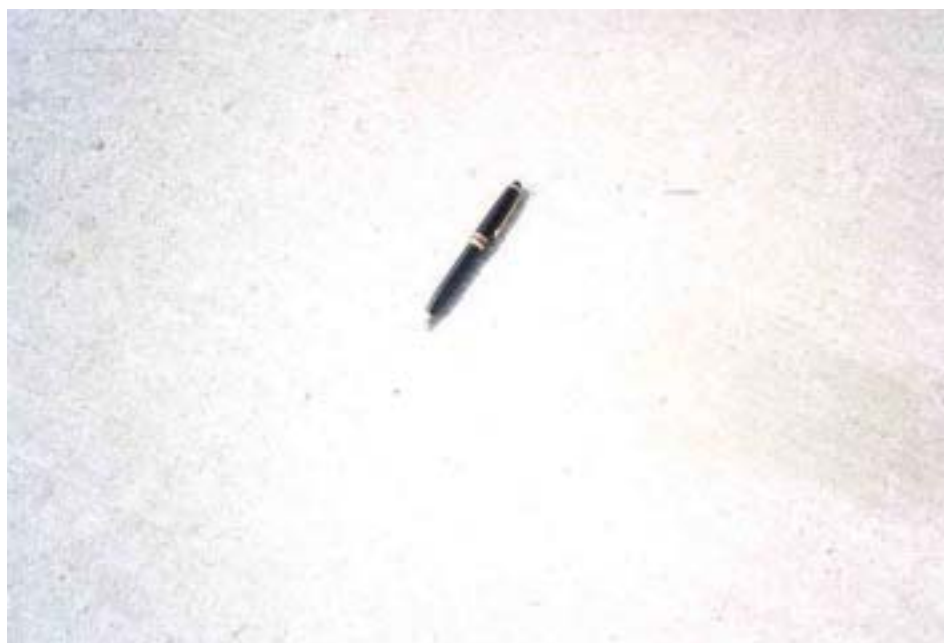
Figure 92. Crack on the deck (Bridge No. 0713-151).

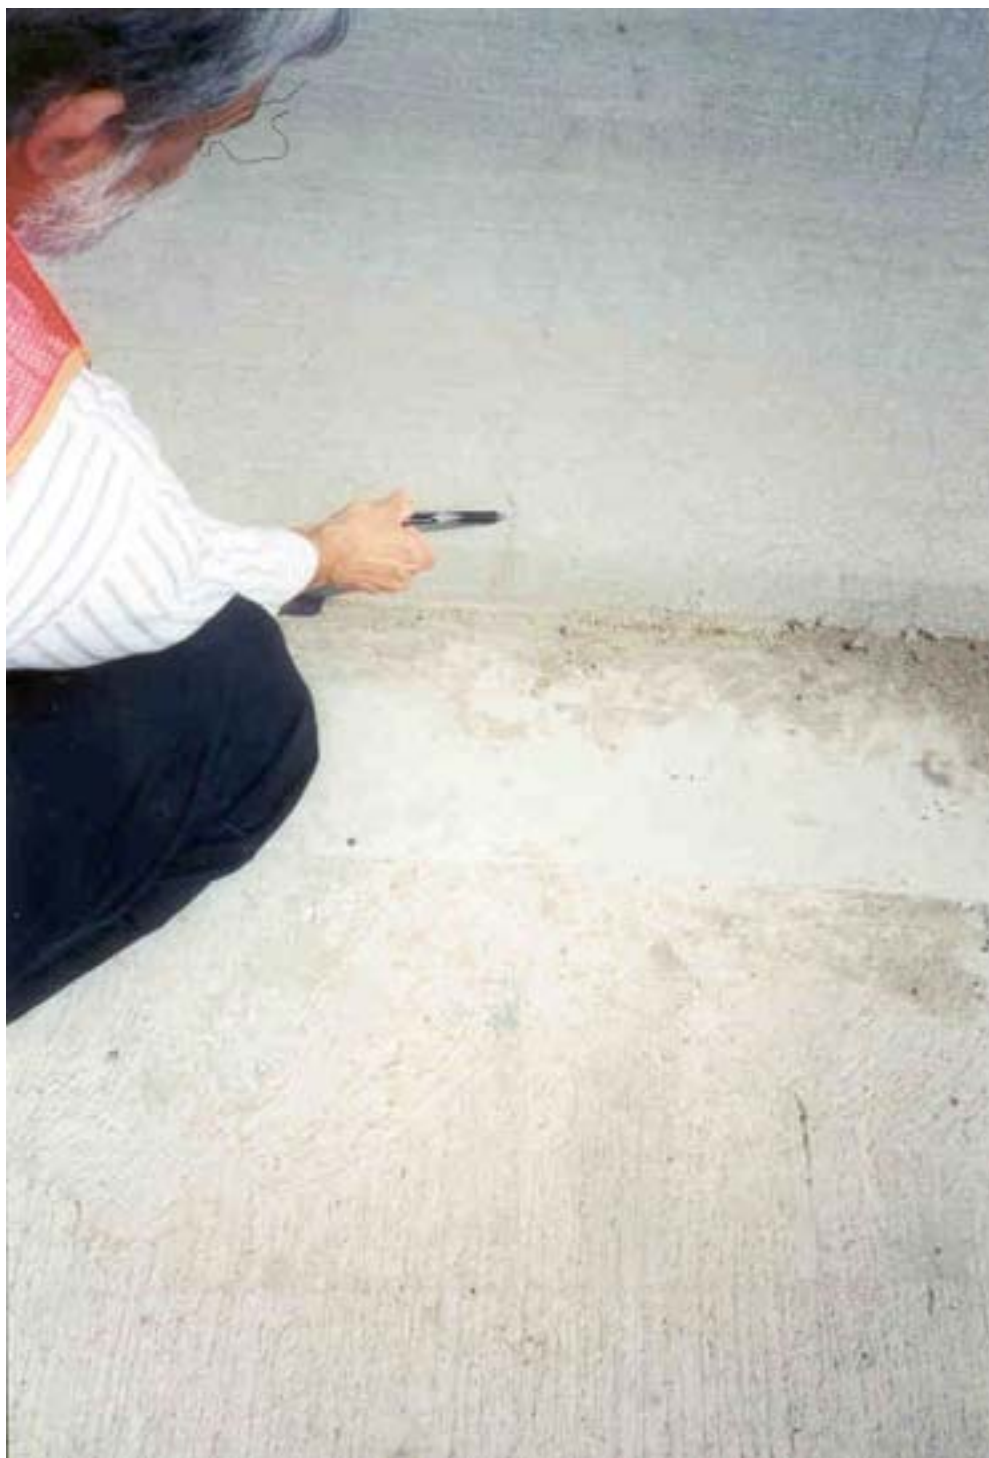
Figure 93. Crack extending into the parapet (Bridge No. 0713-151).

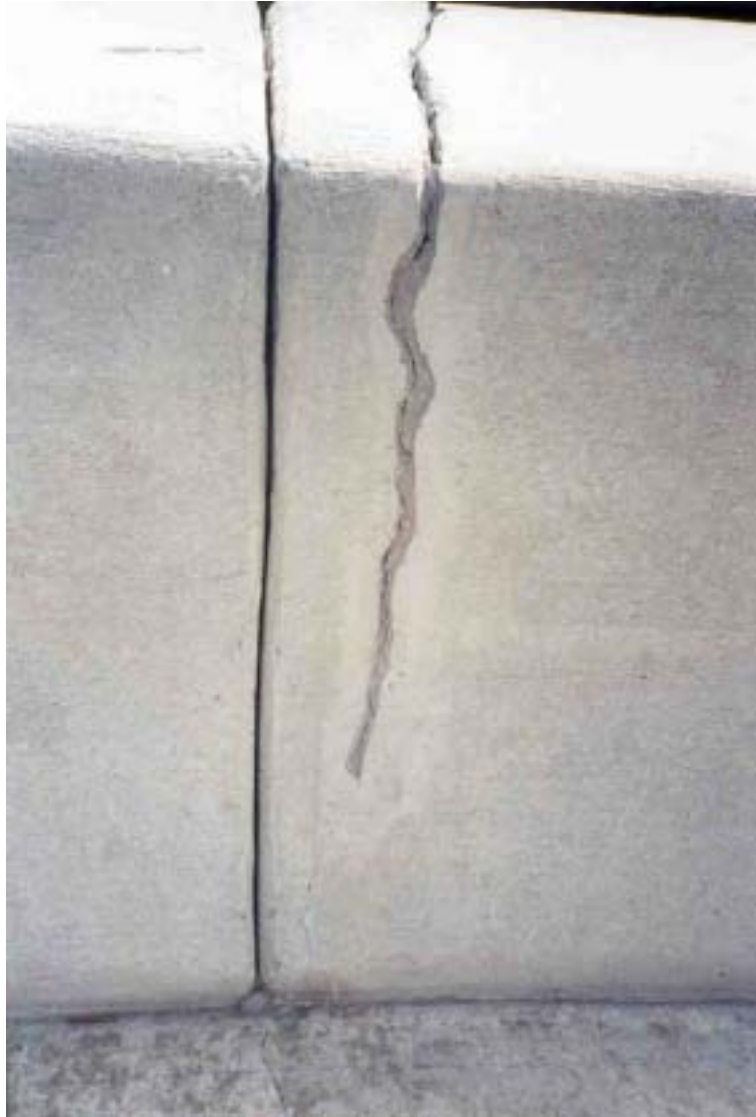
Figure 94. Crack on deck and parapet (Bridge No. 0173-151).

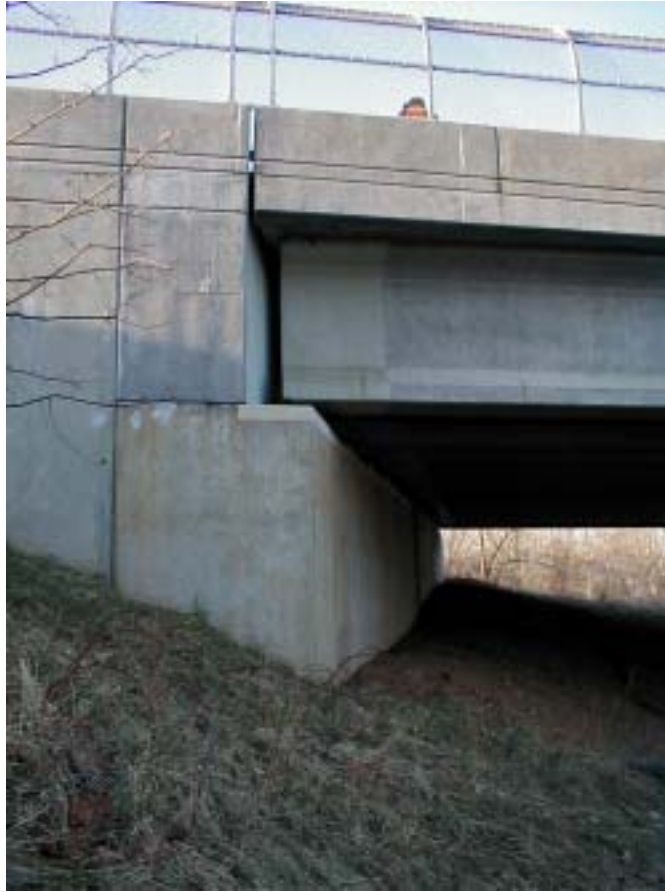
Figure 96. Girder end condition at the abutment (Bridge No. 1013-151).

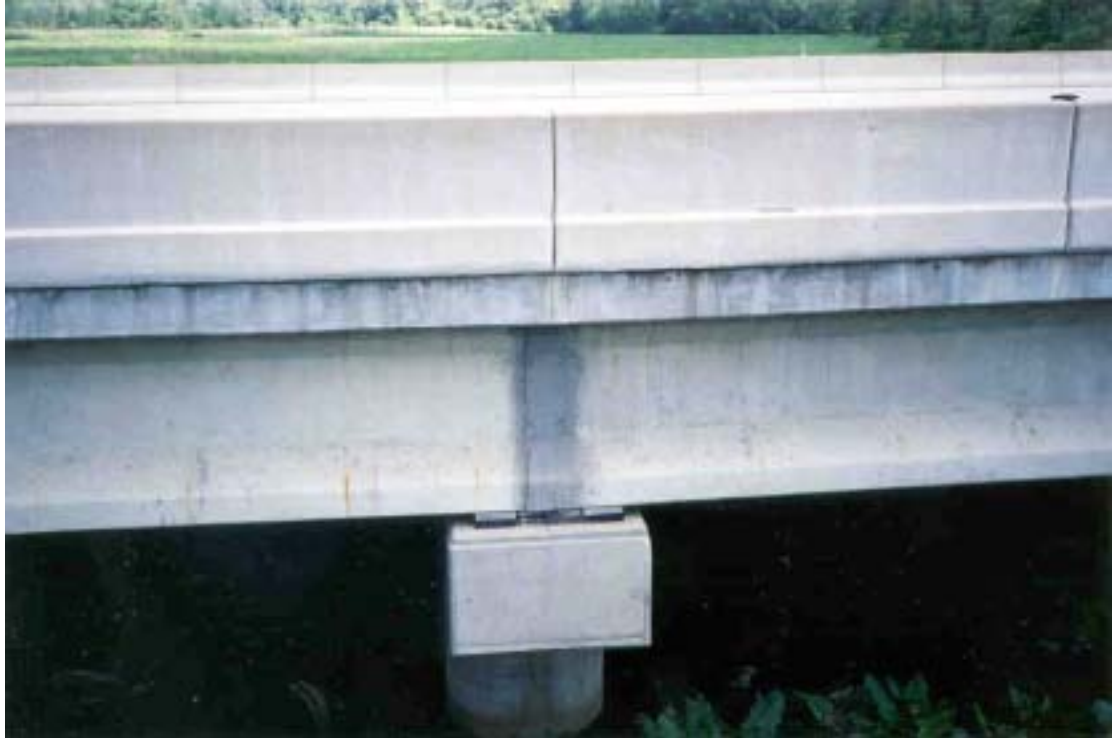
Figure 97. Cracked continuity joint (Bridge No. 1130-152).

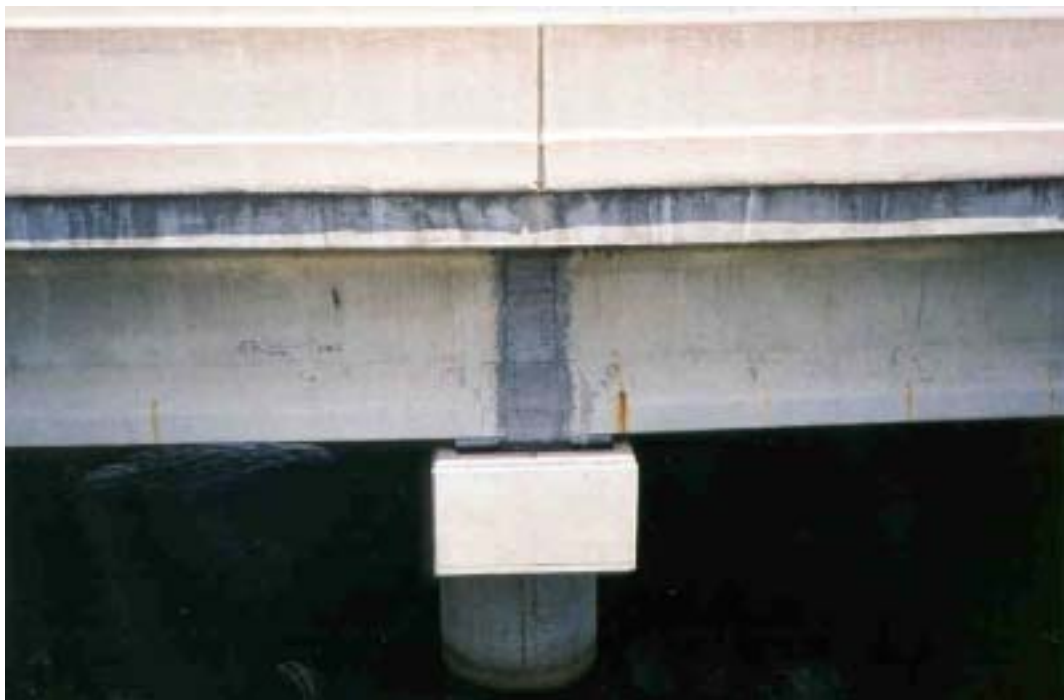
Figure 98. Another cracked continuity joint (Bridge No.1130-152).

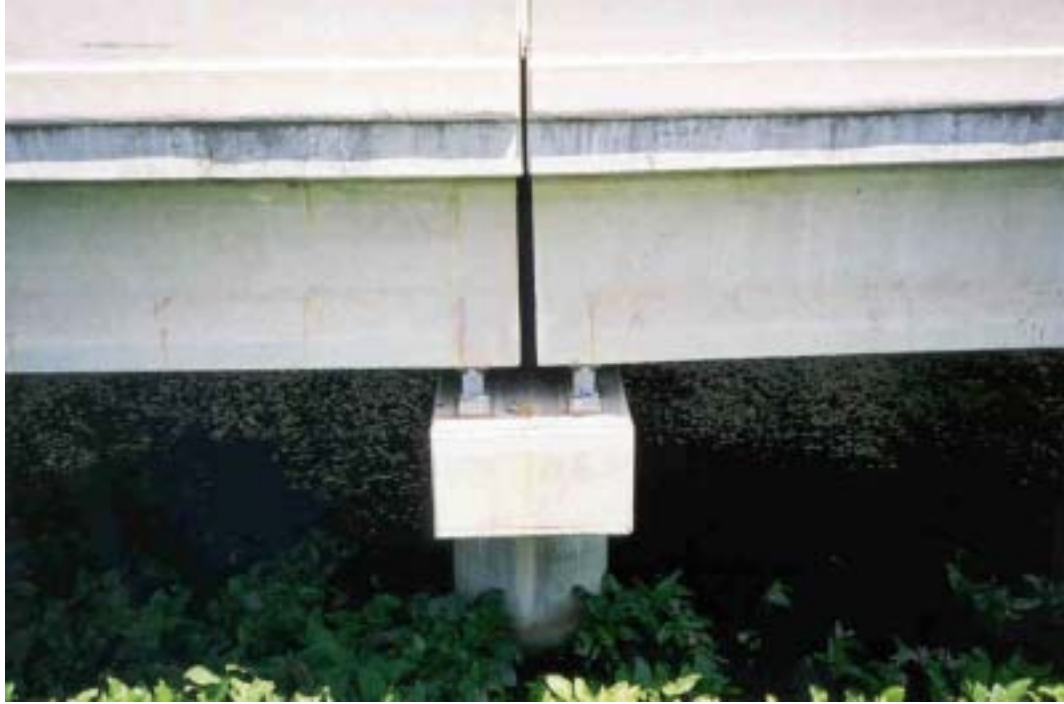
Figure 99. End condition in simply supported spans (Bridge No 1130-152).

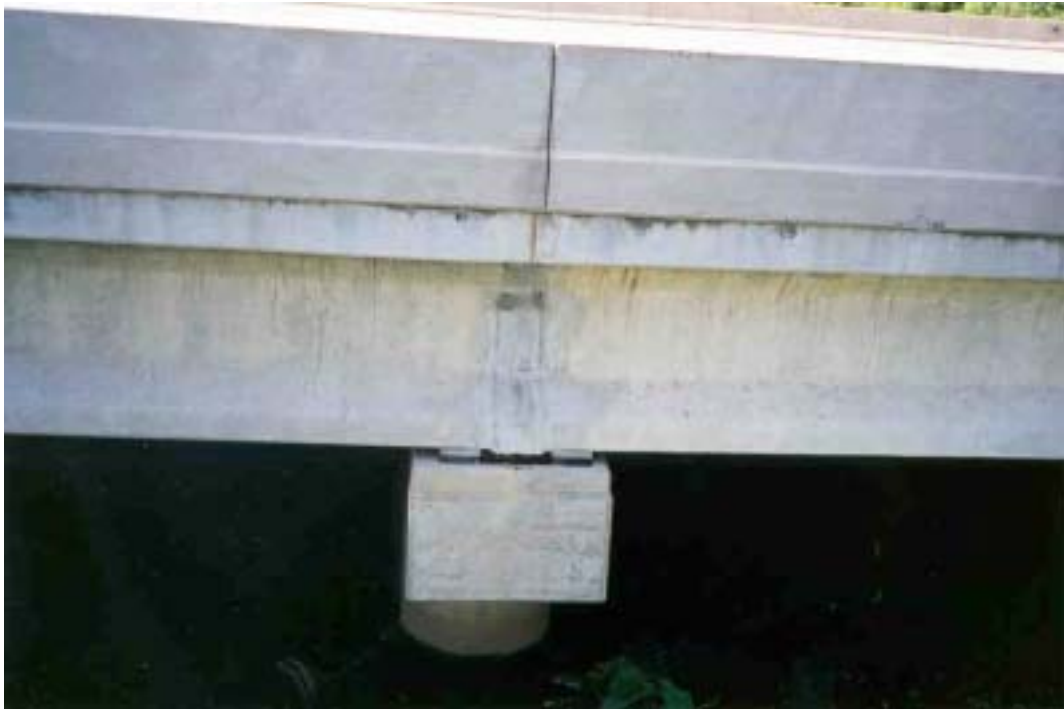
Figure 101. Un-cracked continuity joint (Bridge No.1130-153).

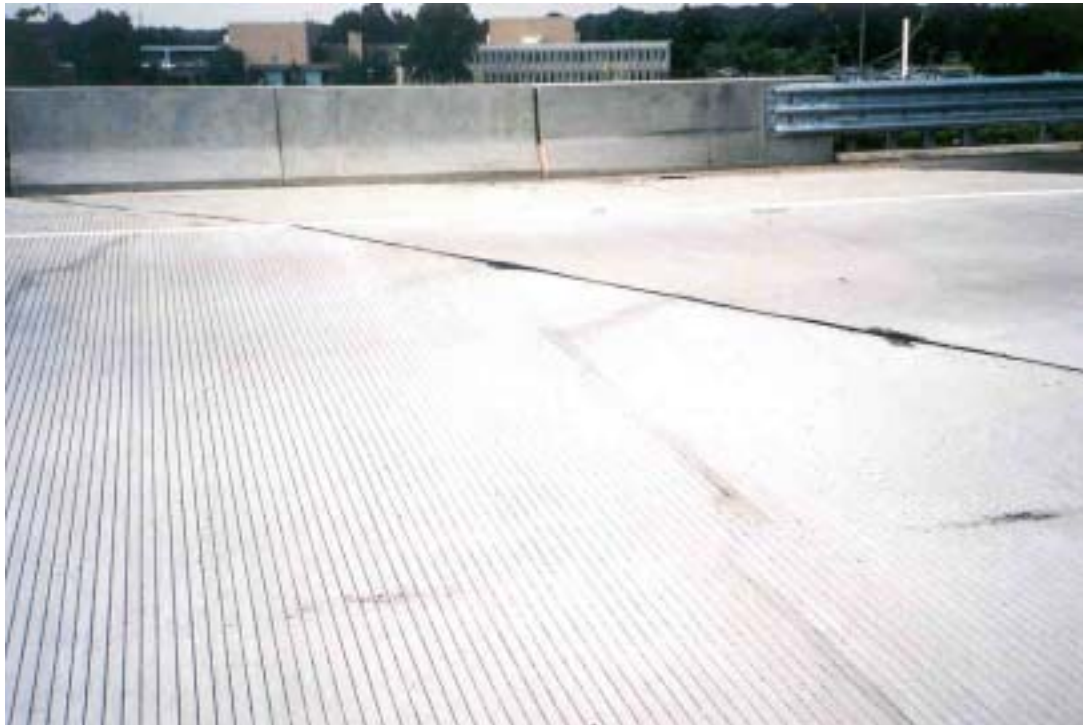
Figure 102. Deck cracks at the bridge end (Bridge No. 1143-466).

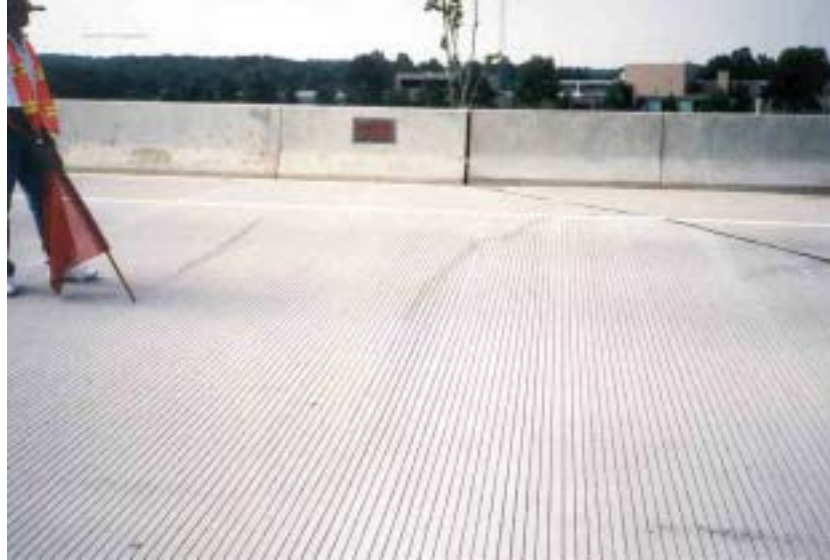
Figure 103. Wide view of deck cracks at the bridge end (Bridge No. 1143-466).

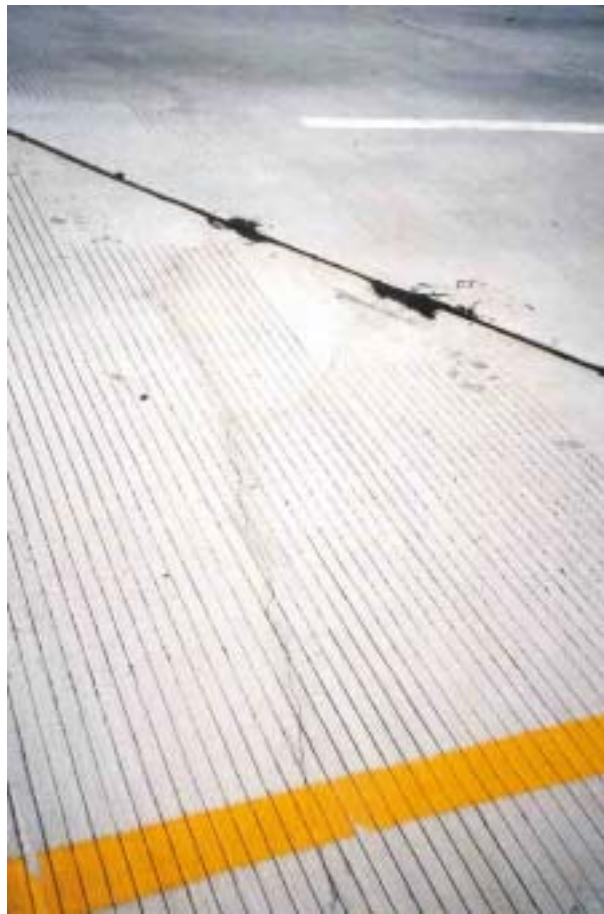
Figure 104. Close view of a crack (Bridge No. 1143-166).

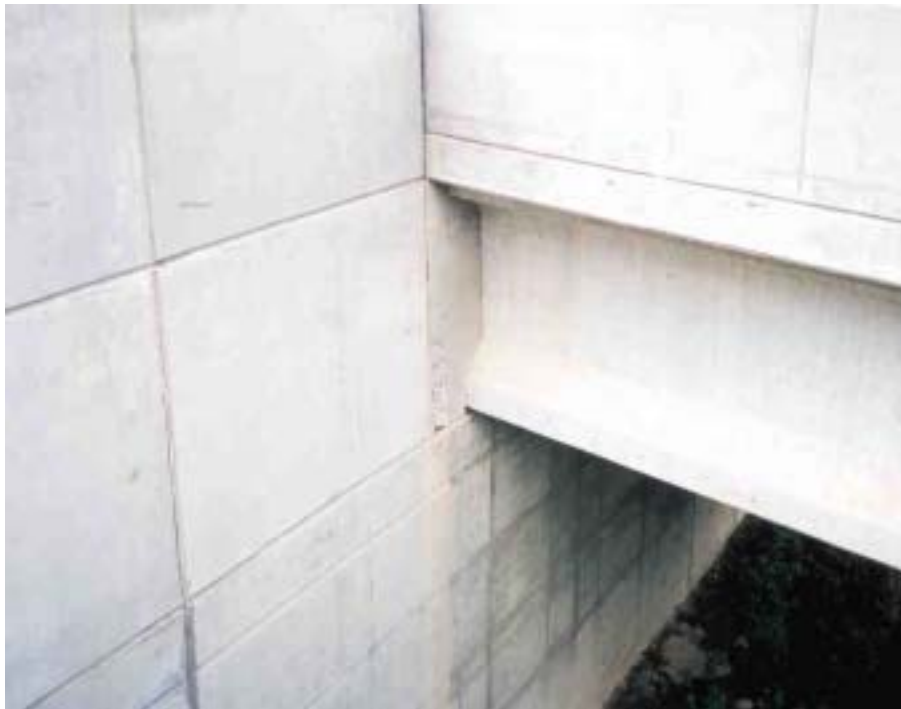
Figure 105. Girders embedded in end diaphragm (Bridge No.1143-168).

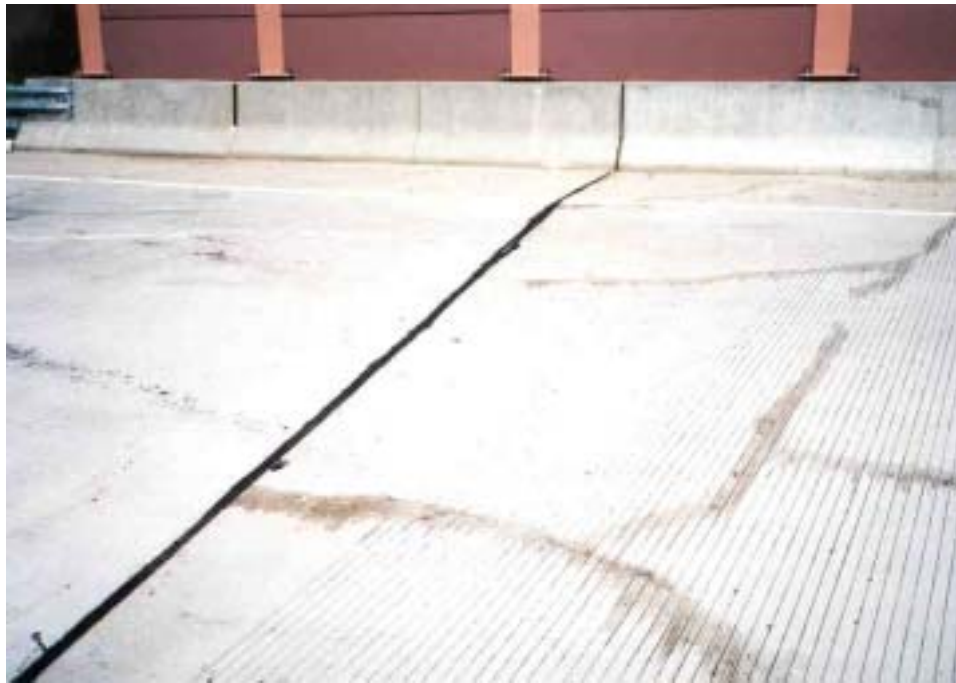
Figure 107. Transverse cracks on bridge deck (Bridge No. 1143-169).

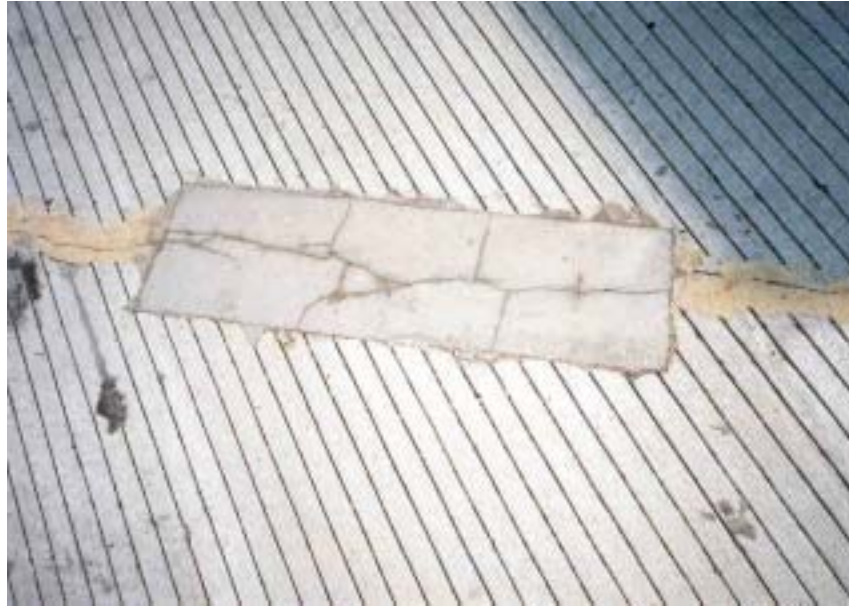
Figure 109. Close up view of repair patch (Bridge No. 1143-170).

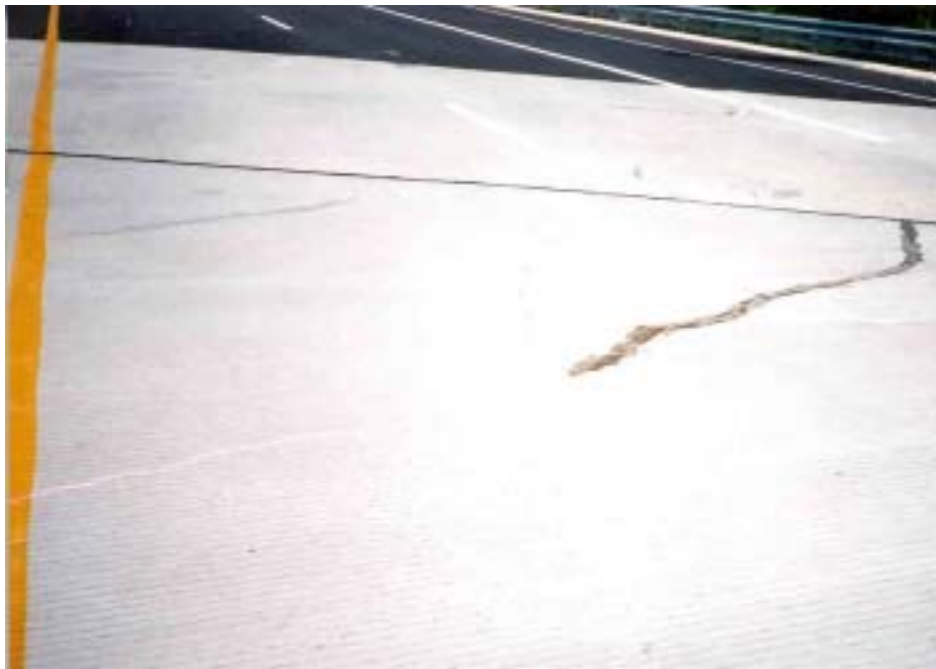
Figure 110. Cracks on the deck (Bridge No.1143-171).

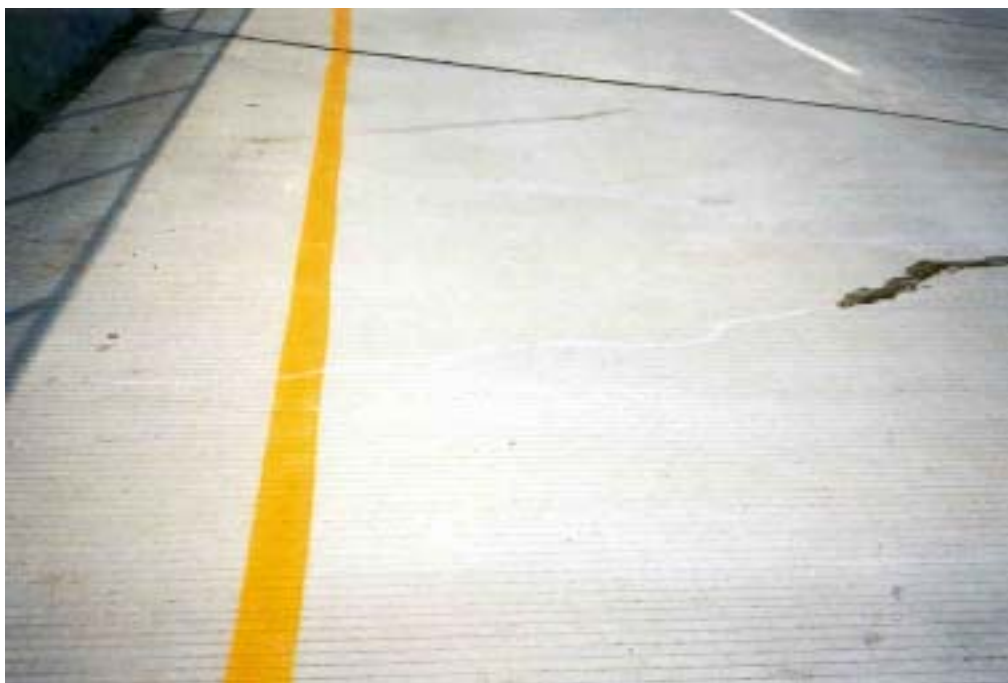
Figure 111. Another marked crack on the deck (Bridge No.1143-171).

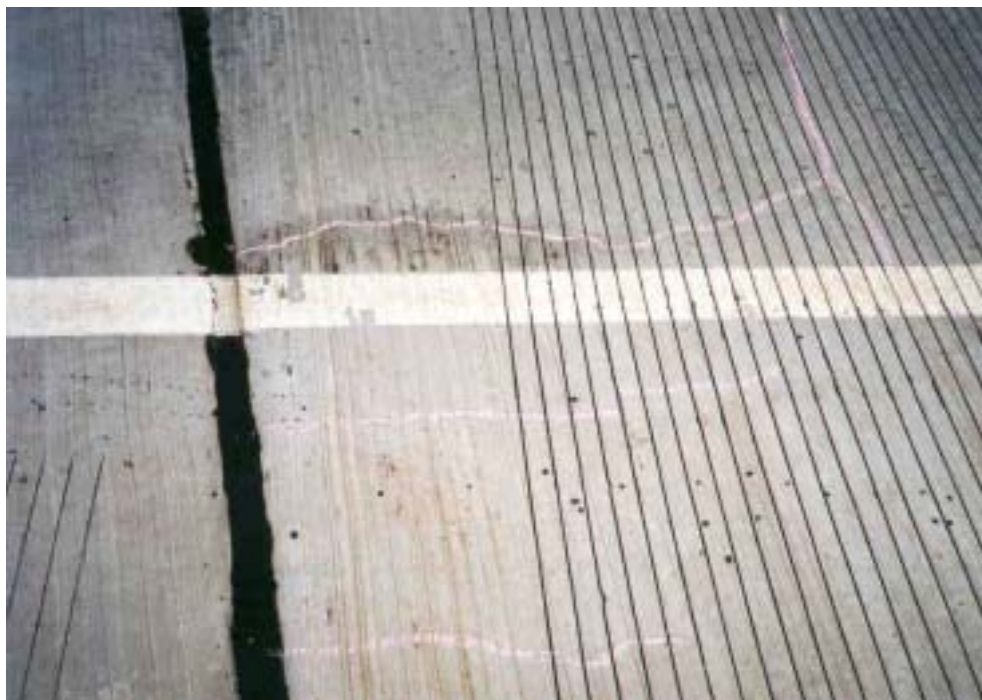
Figure 112. Close up view of deck cracks at the ends (Bridge No.1143-172).

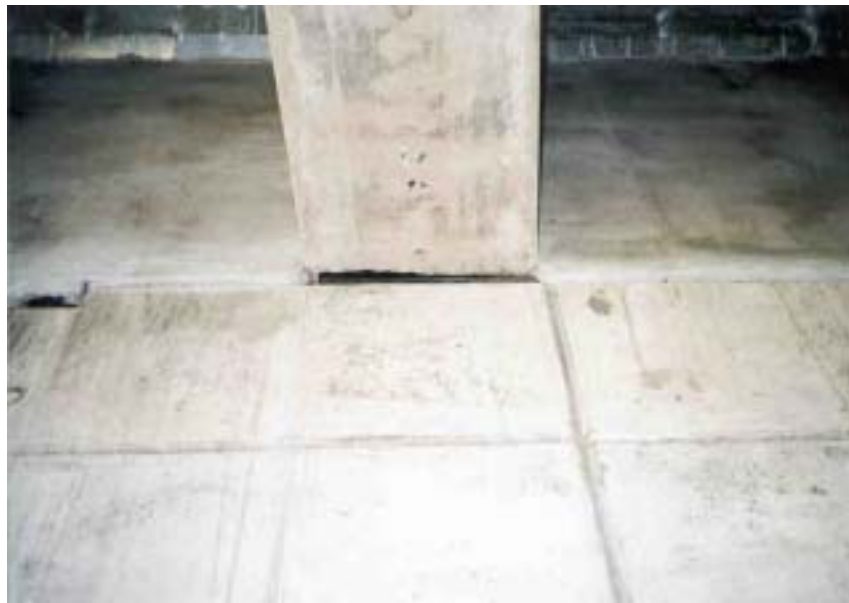
Figure 113. End diaphragm (Bridge No.1143-176).

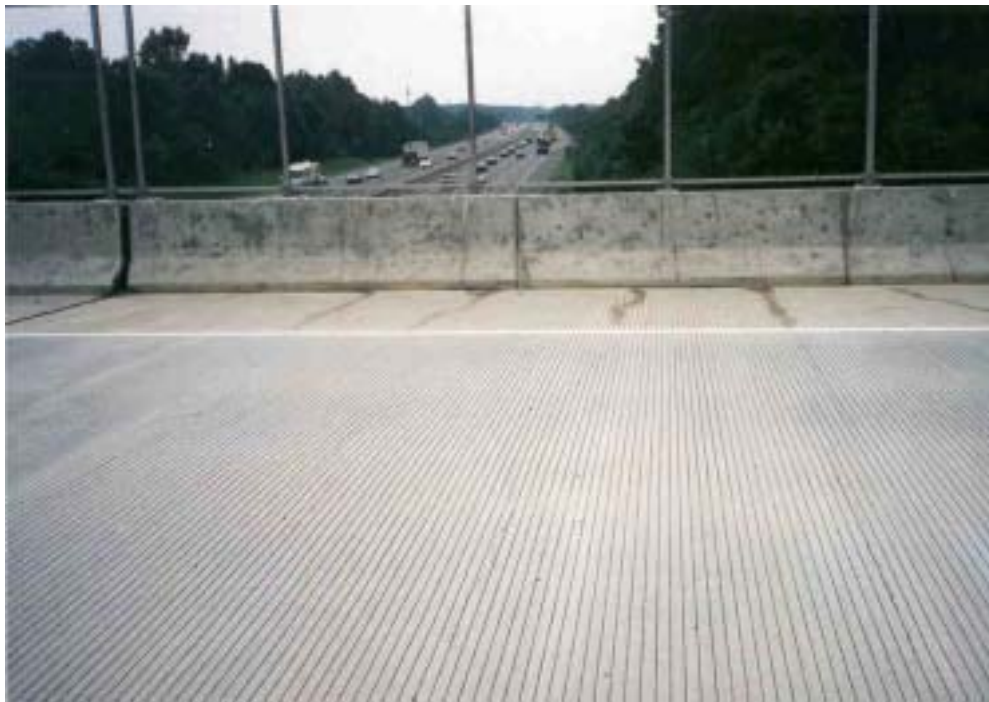
Figure 115. Transverse deck cracks on Bridge No.1143-176 (NJ Turnpike in the background).

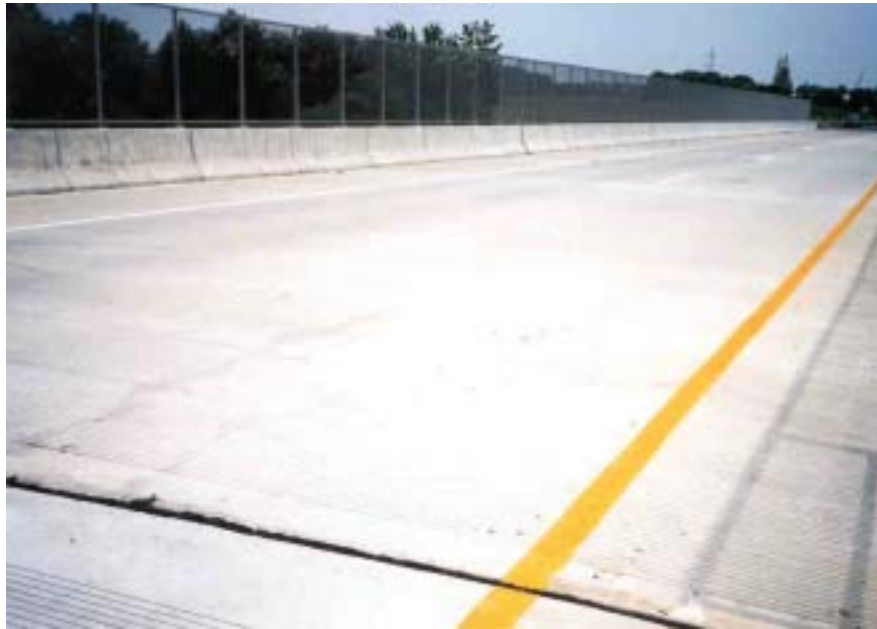
Figure 116. Transverse (and longitudinal) cracks on deck (Bridge No.1143-177).
