Tech Brief

Pedestrian Safety and Mobility Aids for Crossings at Bus Stops

FHWA-NJ-2003-013

September 2003

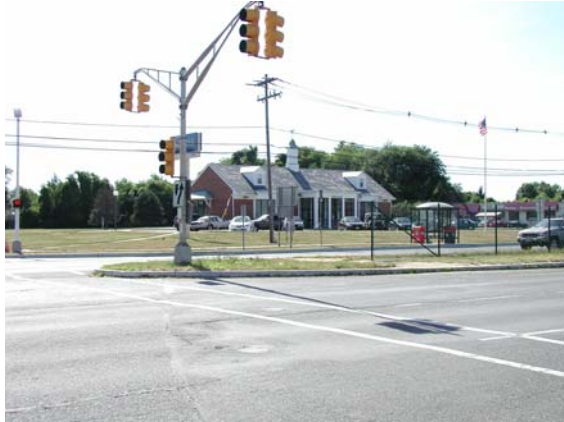
Existing chain link fence in the median.

The research team conducted a number of field observations both under favorable and inclement weather conditions. A number of interesting crossing behaviors were observed and are documented in the report, but overall we found that pedestrians crossing the highway to access bus stops paid little of no heed to existing traffic control devices. Even the presence of a high chain link fence installed in the median

at one location was ineffective in forcing pedestrians to cross at the appropriate crossing location.

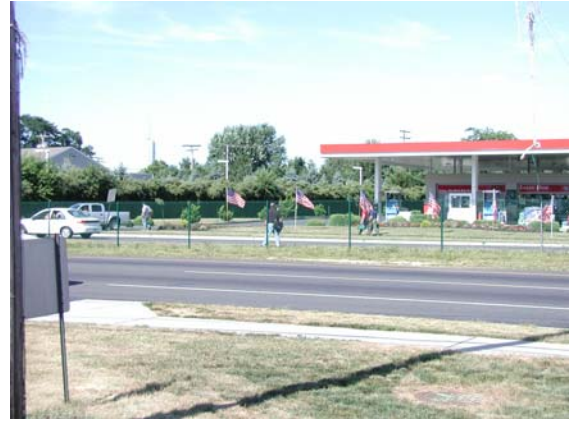
Pedestrians walking along fence in the median waiting to cross northbound Route 9.
