## Tech Brief

### Implementation of Weigh-in-Motion (WIM) Systems

FHWA-NJ-2009-001

February 2009

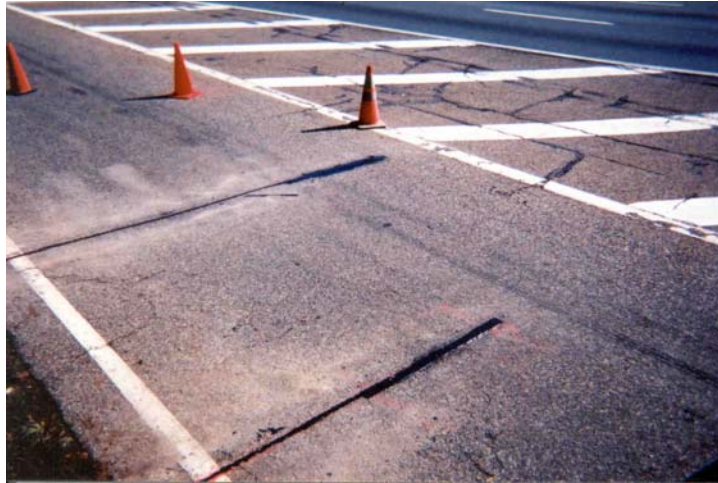
**Photograph of the completed WIM installation at the Route 287 weigh station.**

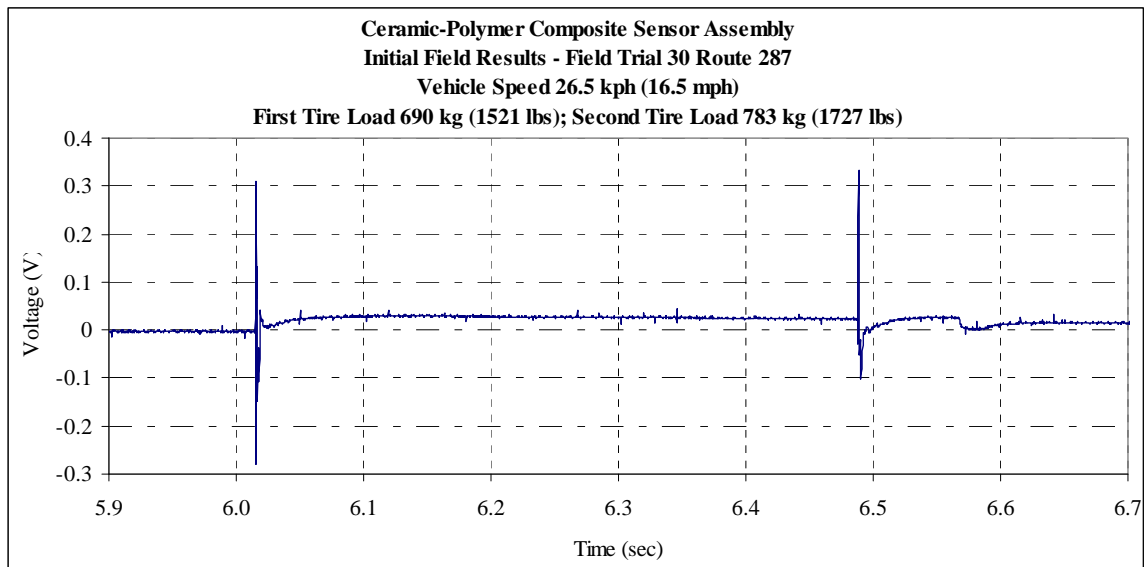
**Ceramic-polymer composite sensor assembly initial field trial Rt. 287 results at 26.5 kph (16.5 mph).**

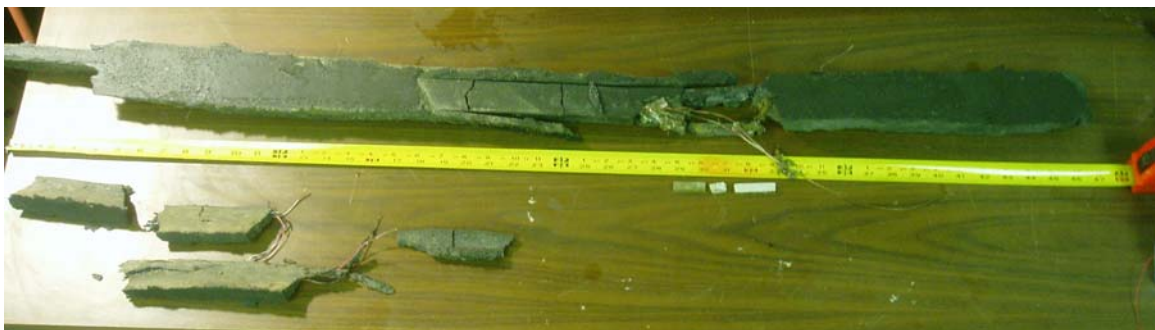
The entire ceramic-polymer composite sensor assembly from the inside lane was recovered. A portion of the outside lane sensor was also recovered, pieces of that sensor were found strewn throughout the roadway. A significant portion of these pieces, many of them being chunks of PZT composite, were also recovered. The recovered sensor assemblies were removed from the roadway by hand, simply by pulling up on the epoxy; thus demonstrating how weak the bond between the sensor and the roadway had degraded to. Since the inside lane sensor assembly was recovered largely intact it can be assumed that all sensor degradation would have been as a result of the damage experienced while installed on the roadway and not during the removal process. The entire sensor as removed from the field can be seen below.

**Recovered sensor assembly from Rt. 287 field installation**
