### Evaluation of Automated Distress Survey Equipment

FHWA/NJ-2009-007

September 2009

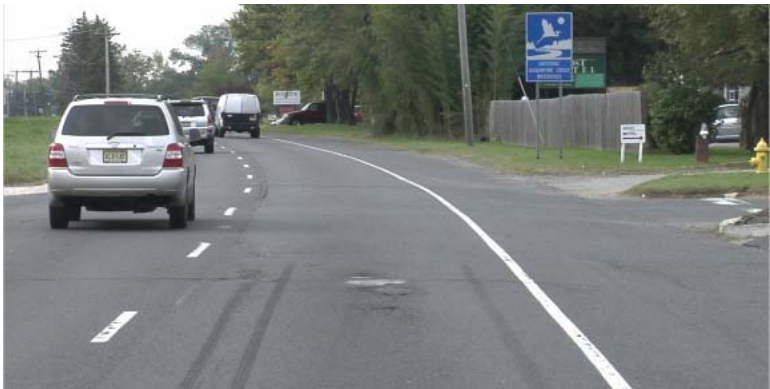
Morning Image

The NJDOT current visual distress assessment program is dependent on visual image quality to rate pavement distress severity and extent.

The lighting and direction affect the manual rating.

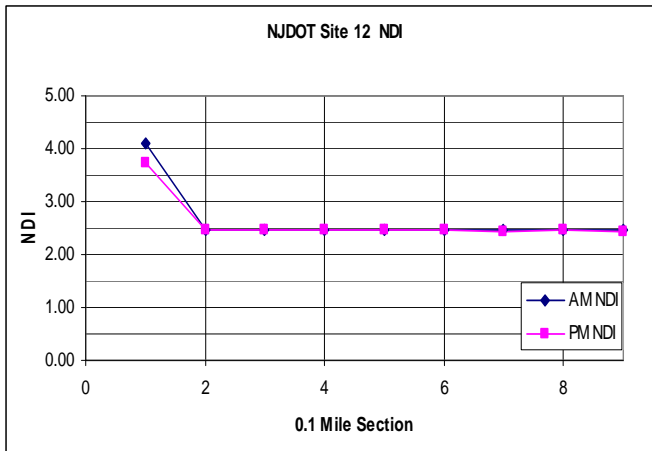
Repeatability of the analysis for different sites, distresses, and severity levels was assessed on a visual and statistical basis for the fully automated, semi-automated, and fully manual procedures.

The statistical assessment of repeatability of NDI used T-Test of Differences to determine the effects of lighting, imaging equipment, and analysis software.

<u>Dynatest (Fully Automated)</u>		
Ho	17	47%
H1	19	53%
 <u>Roadware (Semi-Automated)</u>		
Ho	23	64%
H1	13	36%
 <u>NJDOT (Manual)</u>		
Ho	9	75%
H1	3	25%
 <b>Overall</b>		
<b>Ho</b>	<b>59</b>	<b>55%</b>
<b>H1</b>	<b>49</b>	<b>45%</b>
