# Elimination of Weight Restriction on Amtrak, NJ Transit, and Conrail Lines

REPORT  
May 2012

1. Report No. FHWA-NJ-2012-003		2. Government Accession No.		3. Recipient's Catalog No.	
4. Title and Subtitle Elimination of Weight Restriction on Amtrak, NJ Transit, and Conrail Lines				5. Report Date May 2012

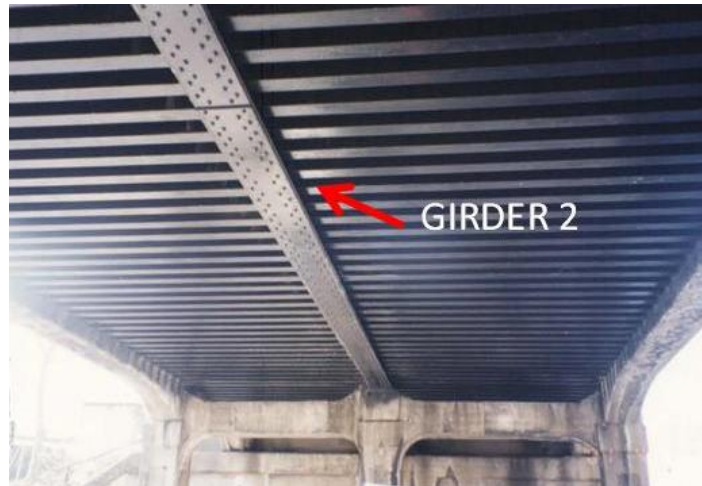
Figure 22. General view of Span 2 superstructure and underside of Girder 2 of the Main Line MP 15.95 Bridge<sup>(25)</sup>

As shown in Figure 22, the controlling superstructure member was designated as Girder 2, Span 2, as noted in the Inspection Report Cycle 2.<sup>(25)</sup> Span length is 44.8 feet. Girder 2 is a riveted plate girder with three cover plates on top and bottom. The angles on top and bottom are riveted into the web plate, and the flanges are riveted into the angles. It has a depth of 69 in. and a width of 15 in. Figure 23 shows the cutoff points and the location of maximum moment where the methodology for load-rating checks and calculations covered in the inspection reports was applied.

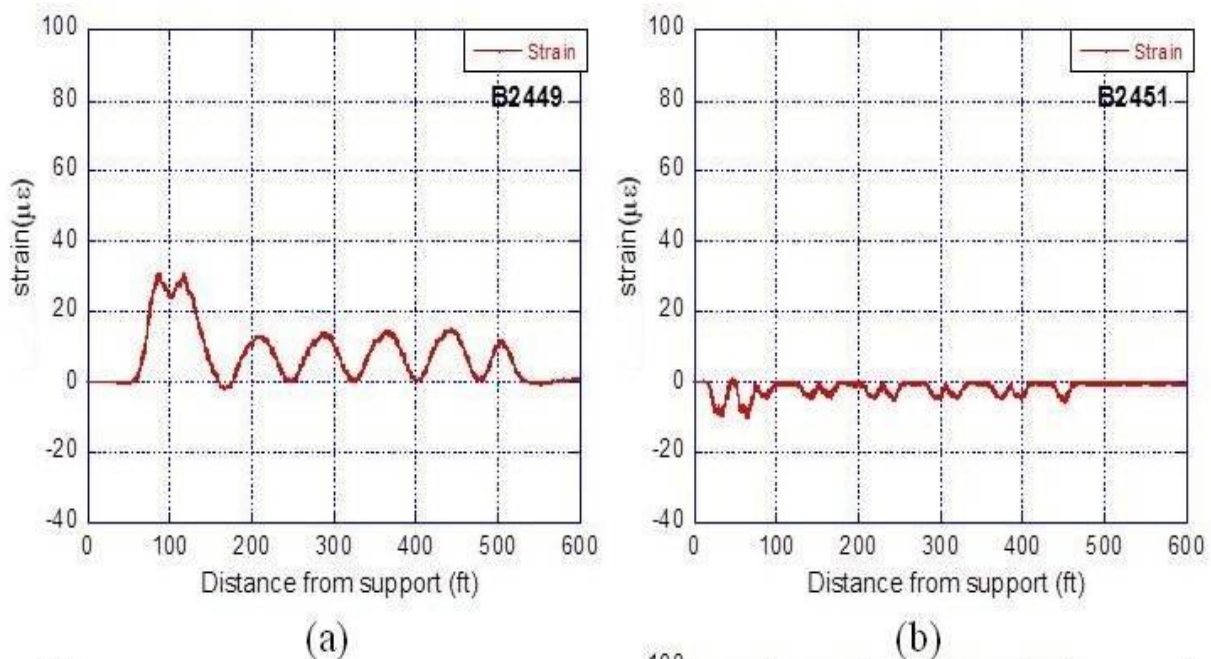
Figure 33. Typical strain data collected for Main Line MP 15.14

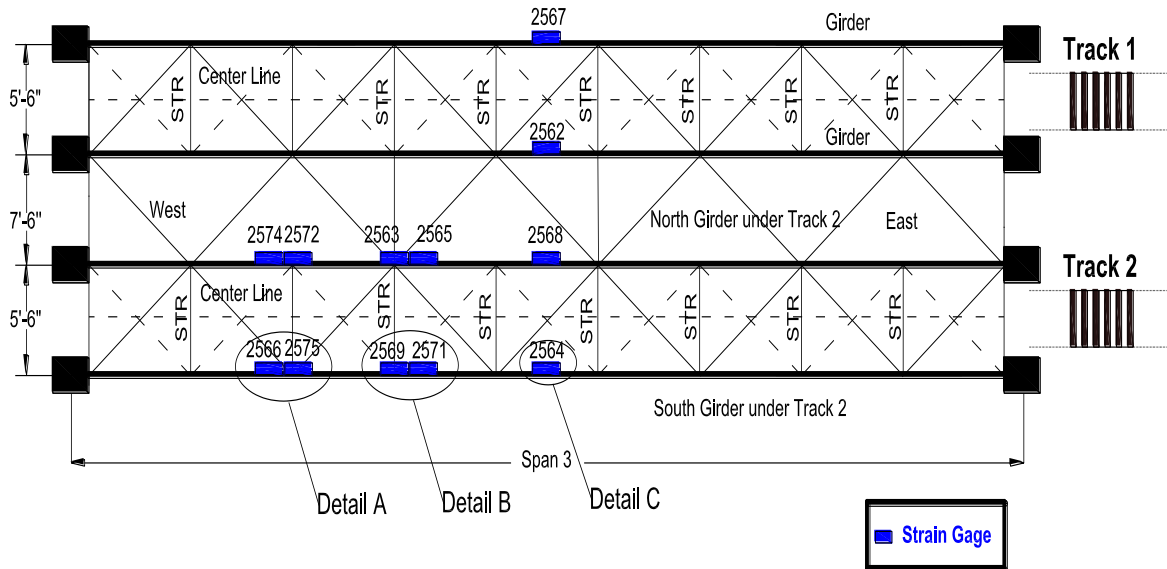
Figure 35. Layout of the strain transducers installed in Span 3 of the *Bergen County Line MP 5.48 (HX Draw) Bridge*

The sensor instrumentation at this structure was mainly focused on the north girder in Span No. 3 (approach span) below Track 2. This girder has the lowest as-inspected rating, which are E27 at normal level and E43 at the maximum level. Strain transducers were also installed on the south girder under Track 2, the girders under Track 1, and the girders in Span No. 2, to gain a thorough understanding of the structural response and load distribution of the bridge. Moreover, based on the preliminary calculation performed by NJ Transit, the end floor beam of Span No. 9 (approach span) and stringers in Span 12 (tower span) were also selected for testing. Figure 34 through Figure 38 show the locations of sensors on the desired spans specified by the sensor number.

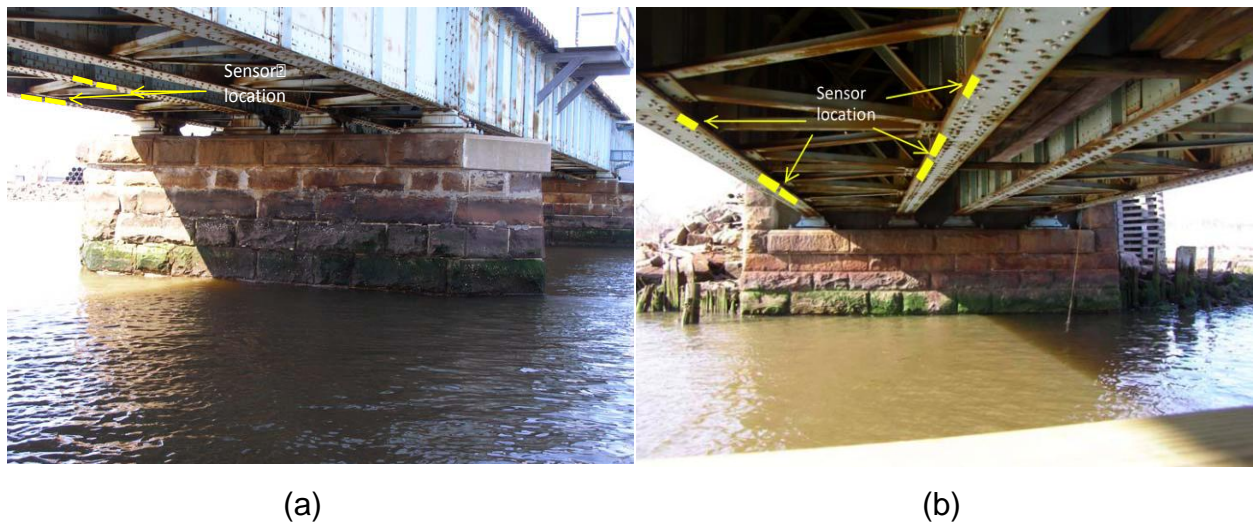
Figure 44. Elevation view (a) and bottom view (b) of a typical approach span (span length = 88 ft) of the North Jersey Coast Line MP 0.39 (River Draw) Bridge

The sensor instrumentation at this structure focused mainly on Girder 5 through Girder 8 in Span 26 (one of typical 88 ft approach span), since these members rated lowest as inspected (E47 at normal level and E70 at maximum level). Figure 44 shows the elevation and bottom views of a typical approach span (span length is 88 ft). Sensors were also instrumented on the end floorbeam of Span 20. Figure 45 and Figure 46 show the locations of the strain transducers installed on Span 26 and Span 20, respectively. Please note that sensor 3236 is located at the midspan of the end floorbeam, while sensors 3228, 3217, and 3229 are located at the cutoff point.
