**ENGINEERING INVESTIGATION & ANALYSIS  
GEOTECHNICAL & STRUCTURAL  
ASSESSMENT REPORT**

**47 RIVEREDGE DRIVE  
FAIRFIELD, NEW JERSEY 08203**

Matrix No. 20-1052

August 2021

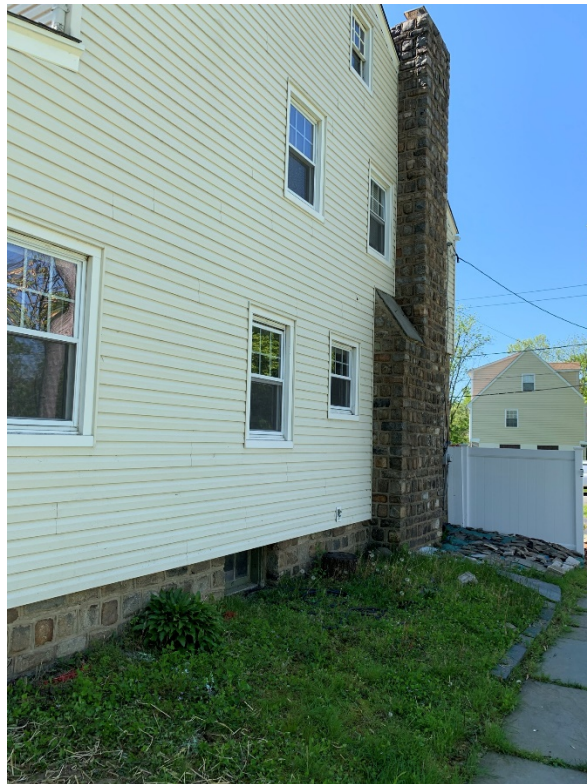
A brick chimney was observed along the building west exterior wall, covered in the same stone façade as detailed above. The bottom of the chimney was visible in the ceiling of the basement, its arched bottom supported by the basement foundation walls on the west edge and timber planks/studs along the east edge. The exhaust pipes of the water heater and boiler run through the west wall of the basement and into the chimney.

**Photo 3. West Wall of Building with Chimney**

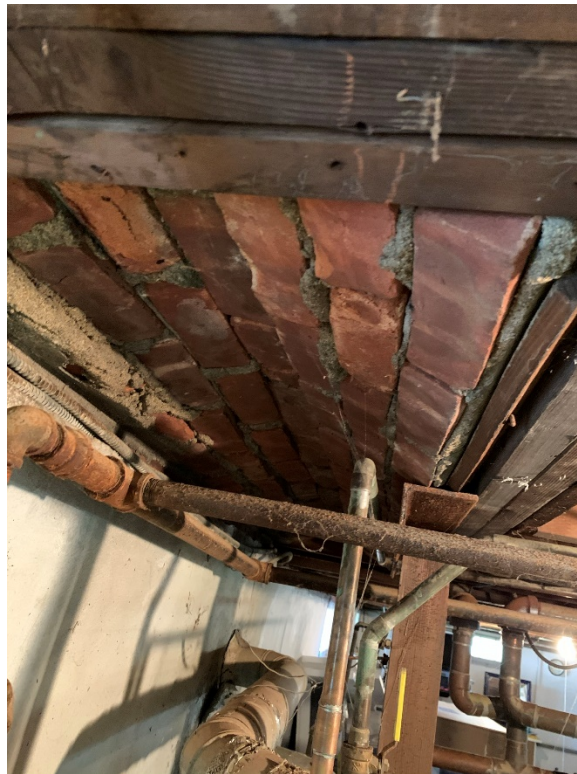
**Photo 4. Bottom of Chimney in Basement (Along West Wall – Looking North)**

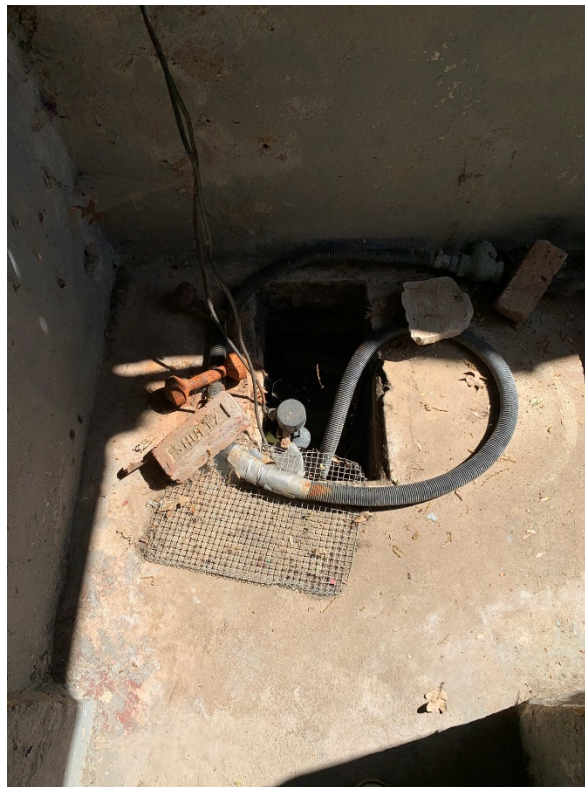
The only machinery not in the basement area was a sump pit observed within the rear stair enclosure, located at the basement floor level.

**Photo 6. Sump Pit in Rear Stair Enclosure**

Additionally, any service equipment, whether outside or in the basement, such as air conditioning, heat pump compressors, gas meters, electric meters, and hot water heaters, must be elevated 3 feet above the BFE. For interior elements, this may include relocation to an upper floor and thus less usable living space. For this residence, the hot water heater, boiler, gas meter, and electrical panel in the basement would require elevating 3 feet above the BFE onto the raised first floor.

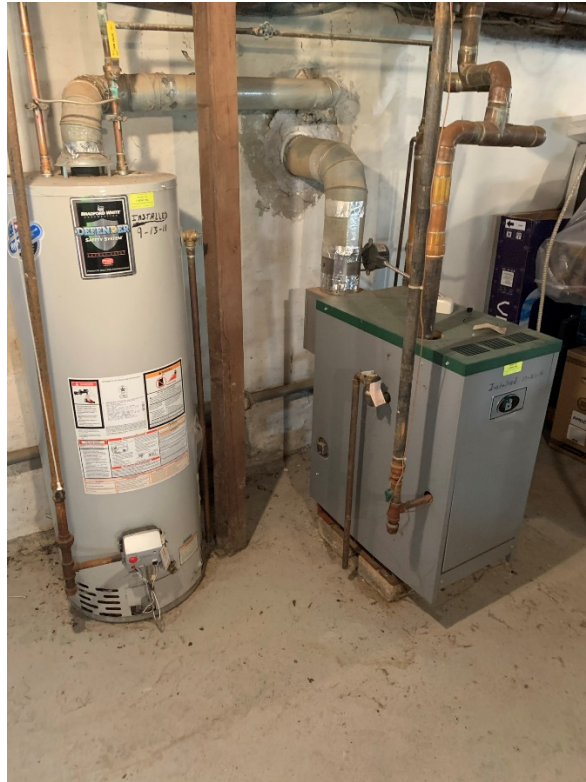
According to the resident, all equipment and machinery for the building is located within the basement level. Within this area, a boiler and water heater were observed in the southwest corner. The boiler was elevated approximately 6.5” above the basement floor surface with concrete block and metal skids, while the water heater was situated on the floor. Also in the southwest corner was a gas meter (53” above the floor), electrical panel (56” above the floor), and a sump pit within the ground. In the northeast corner of the basement, a washer and dryer were observed on a 6” high concrete slab. Various PVC and metal pipes were also seen running along the perimeter walls of the basement, at varying elevation.

**Photo 7. Water Heater & Boiler in Basement (West Wall)**

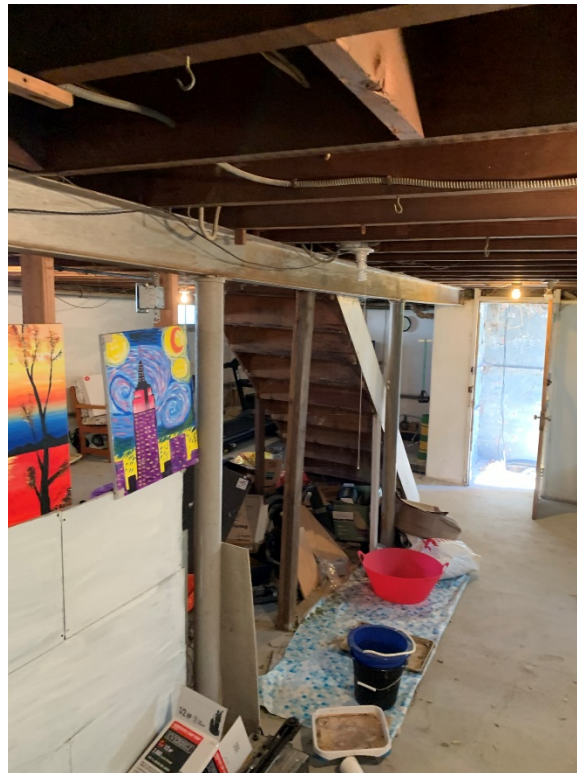
The steel girder observed in the basement did not represent a standard W or S-shape beam, as per the American Institute of Steel Construction Manual. The 7" deep, 3.5" wide member appears to have been a custom section.

**Photo 8. Steel Girder Supporting First Floor Joists (Looking North)**

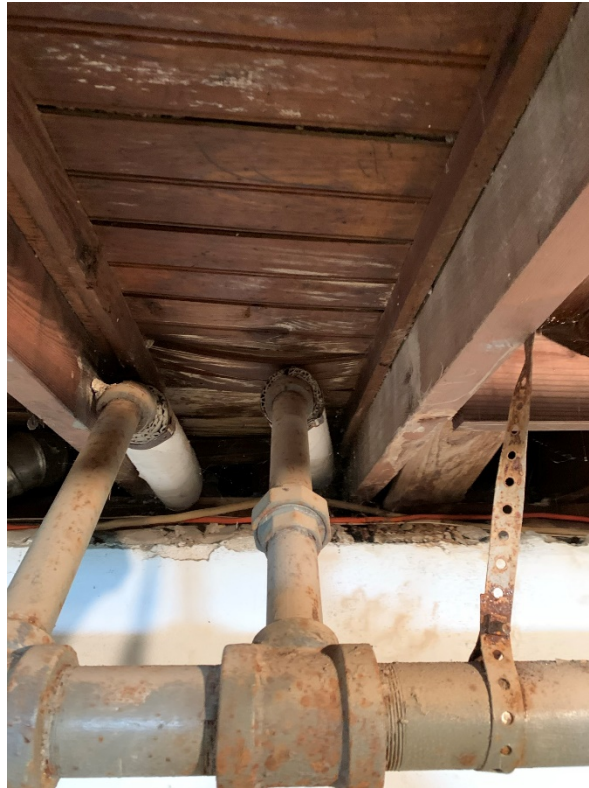
**Photo 9. Typical First Floor Subfloor in Basement**

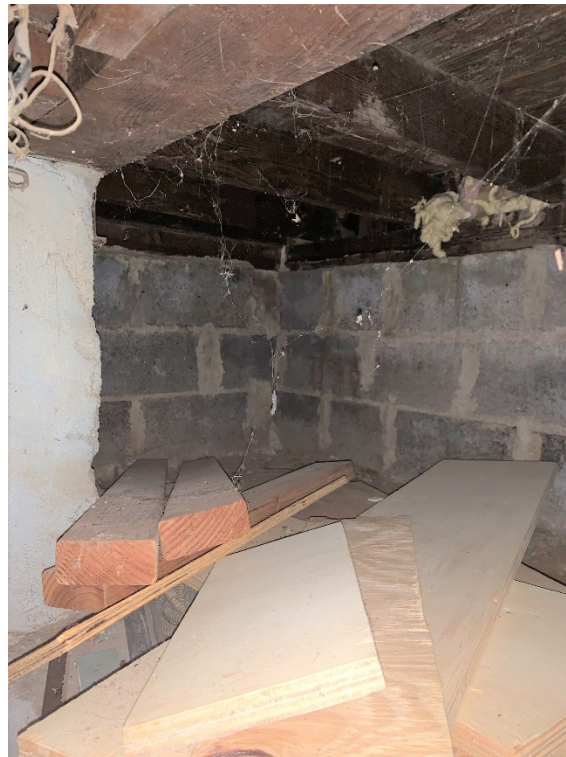
Adjacent to the south (front) wall of the basement, a small crawl space was observed supporting the first-floor entrance vestibule. An opening in the basement wall allows for access to the crawl space. This space measures approximately 3’-2” long x 8’-0” wide, and contains CMU foundation walls (thickness could not be determined at time of inspection). The joists above the crawl space run north to south (perpendicular to the floor joists observed in the basement), spanning the shorter distance between foundation walls.

**Photo 10. Front Crawl Space with CMU Walls (Looking South)**

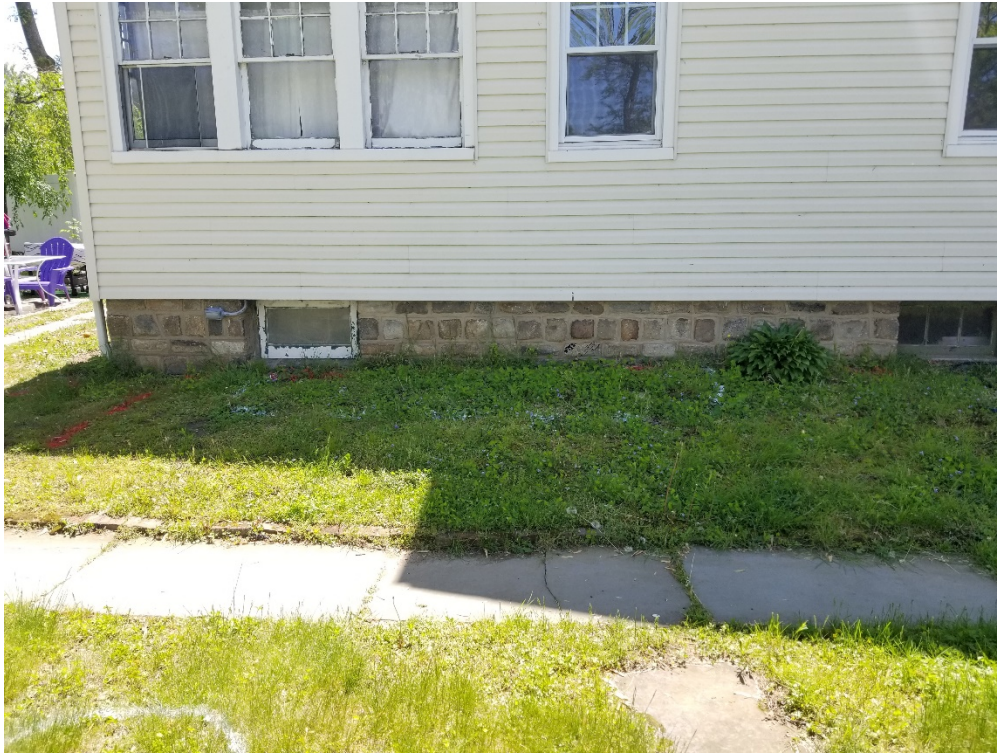
Two test pits were excavated along the exterior walls of the building, adjacent to the west and north walls of the basement. An approximately 18” wide (minimum) concrete spread footing was revealed during the test pit excavation program, with bottoms ranging from 64” to 68” below the exterior ground surface. Based on our findings within the test pits and from conventional foundation construction, Matrix utilized an 18” wide footing as a minimum value for analysis, but believes the actual footings for the building to likely range from 18” to 24” in width. Prior to raising the house, Matrix recommends that the contractor confirm the foundation size and bearing adequacy with multiple test pits around the building perimeter.

**Photo 11. Test Pit TP-1 Location (West Wall of Building – Basement)**

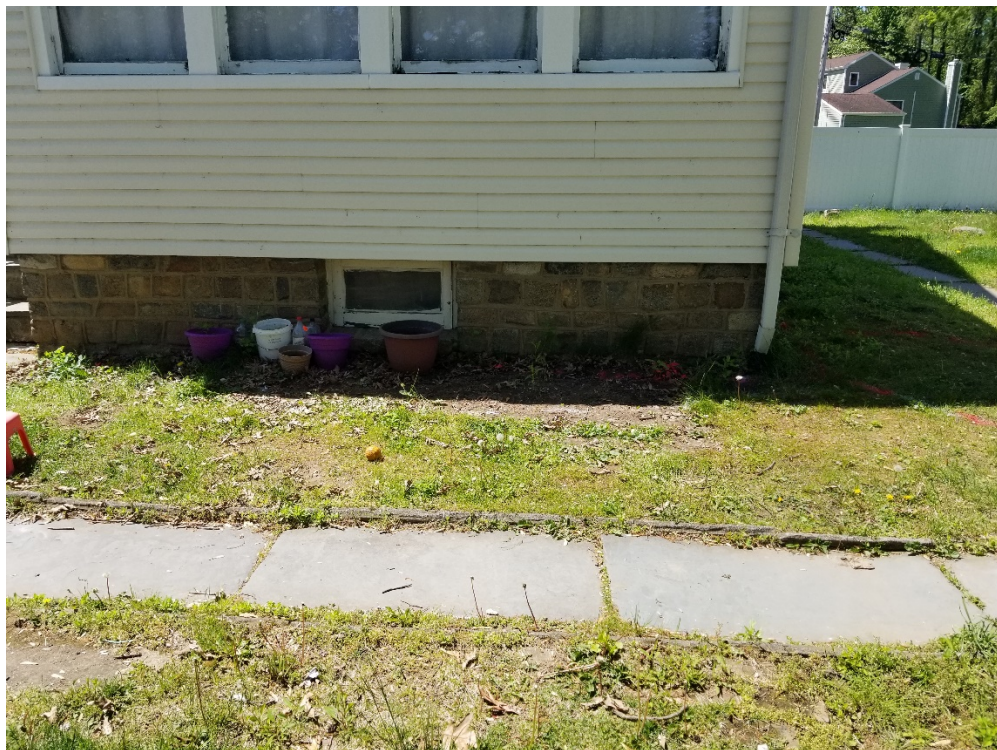
**Photo 12. Test Pit TP-2 Location (North Wall of Building – Basement)**

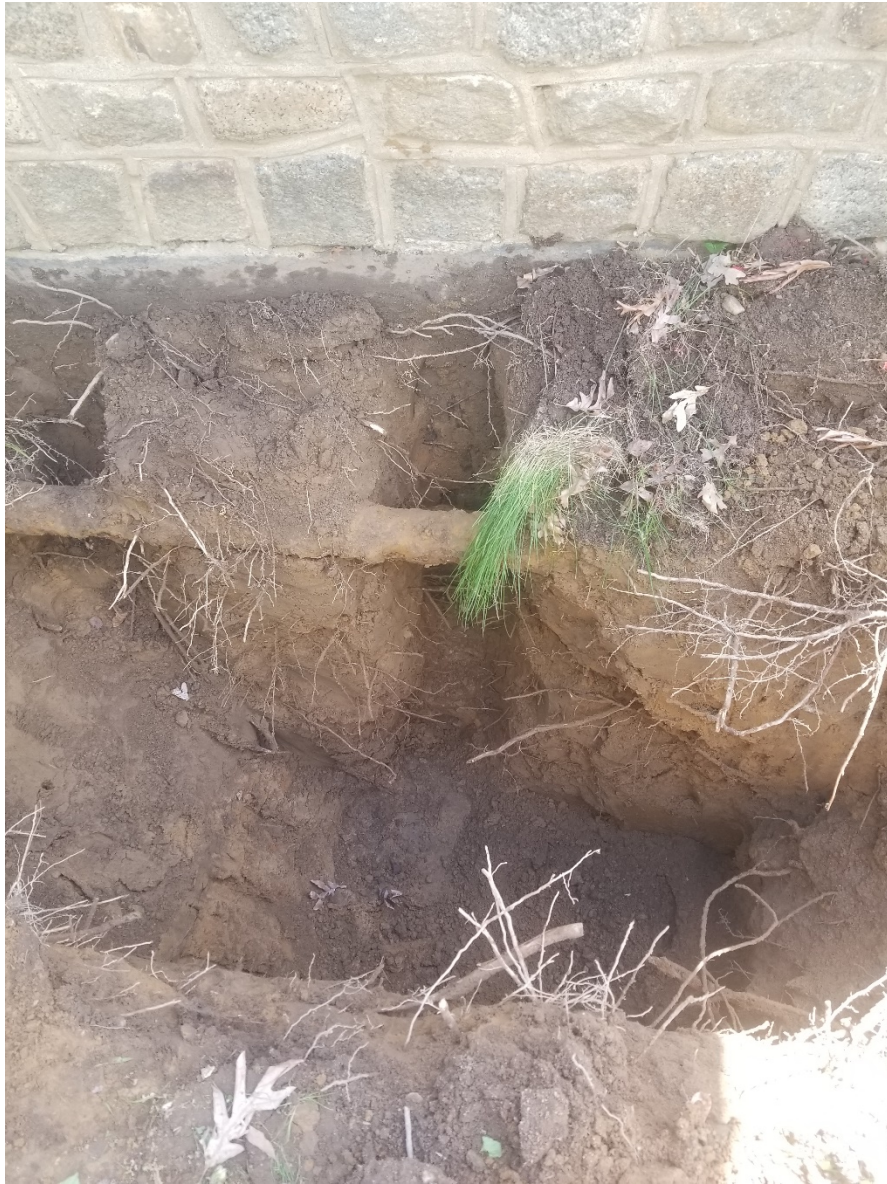
In TP-2, located along the north (rear) wall of the building, concrete was uncovered at 58” bgs and protrudes 8” from the wall and extends 6” deep. It was noted in TP-1 the existence of an abandoned copper pipe at 30” bgs. Groundwater was observed below the footing in TP-1.

**Photo 13. Test Pit TP-2 Conditions**

Brown SILT and mf Sand, some fine Gravel, moist-wet (ML)	
58-64		58-64		Top of concrete encountered at 58" bgs, protrudes 8" from the face of the wall and extends 6" downward.	
				Bottom of Test pit @ 64 in. Test Pit Backfilled.

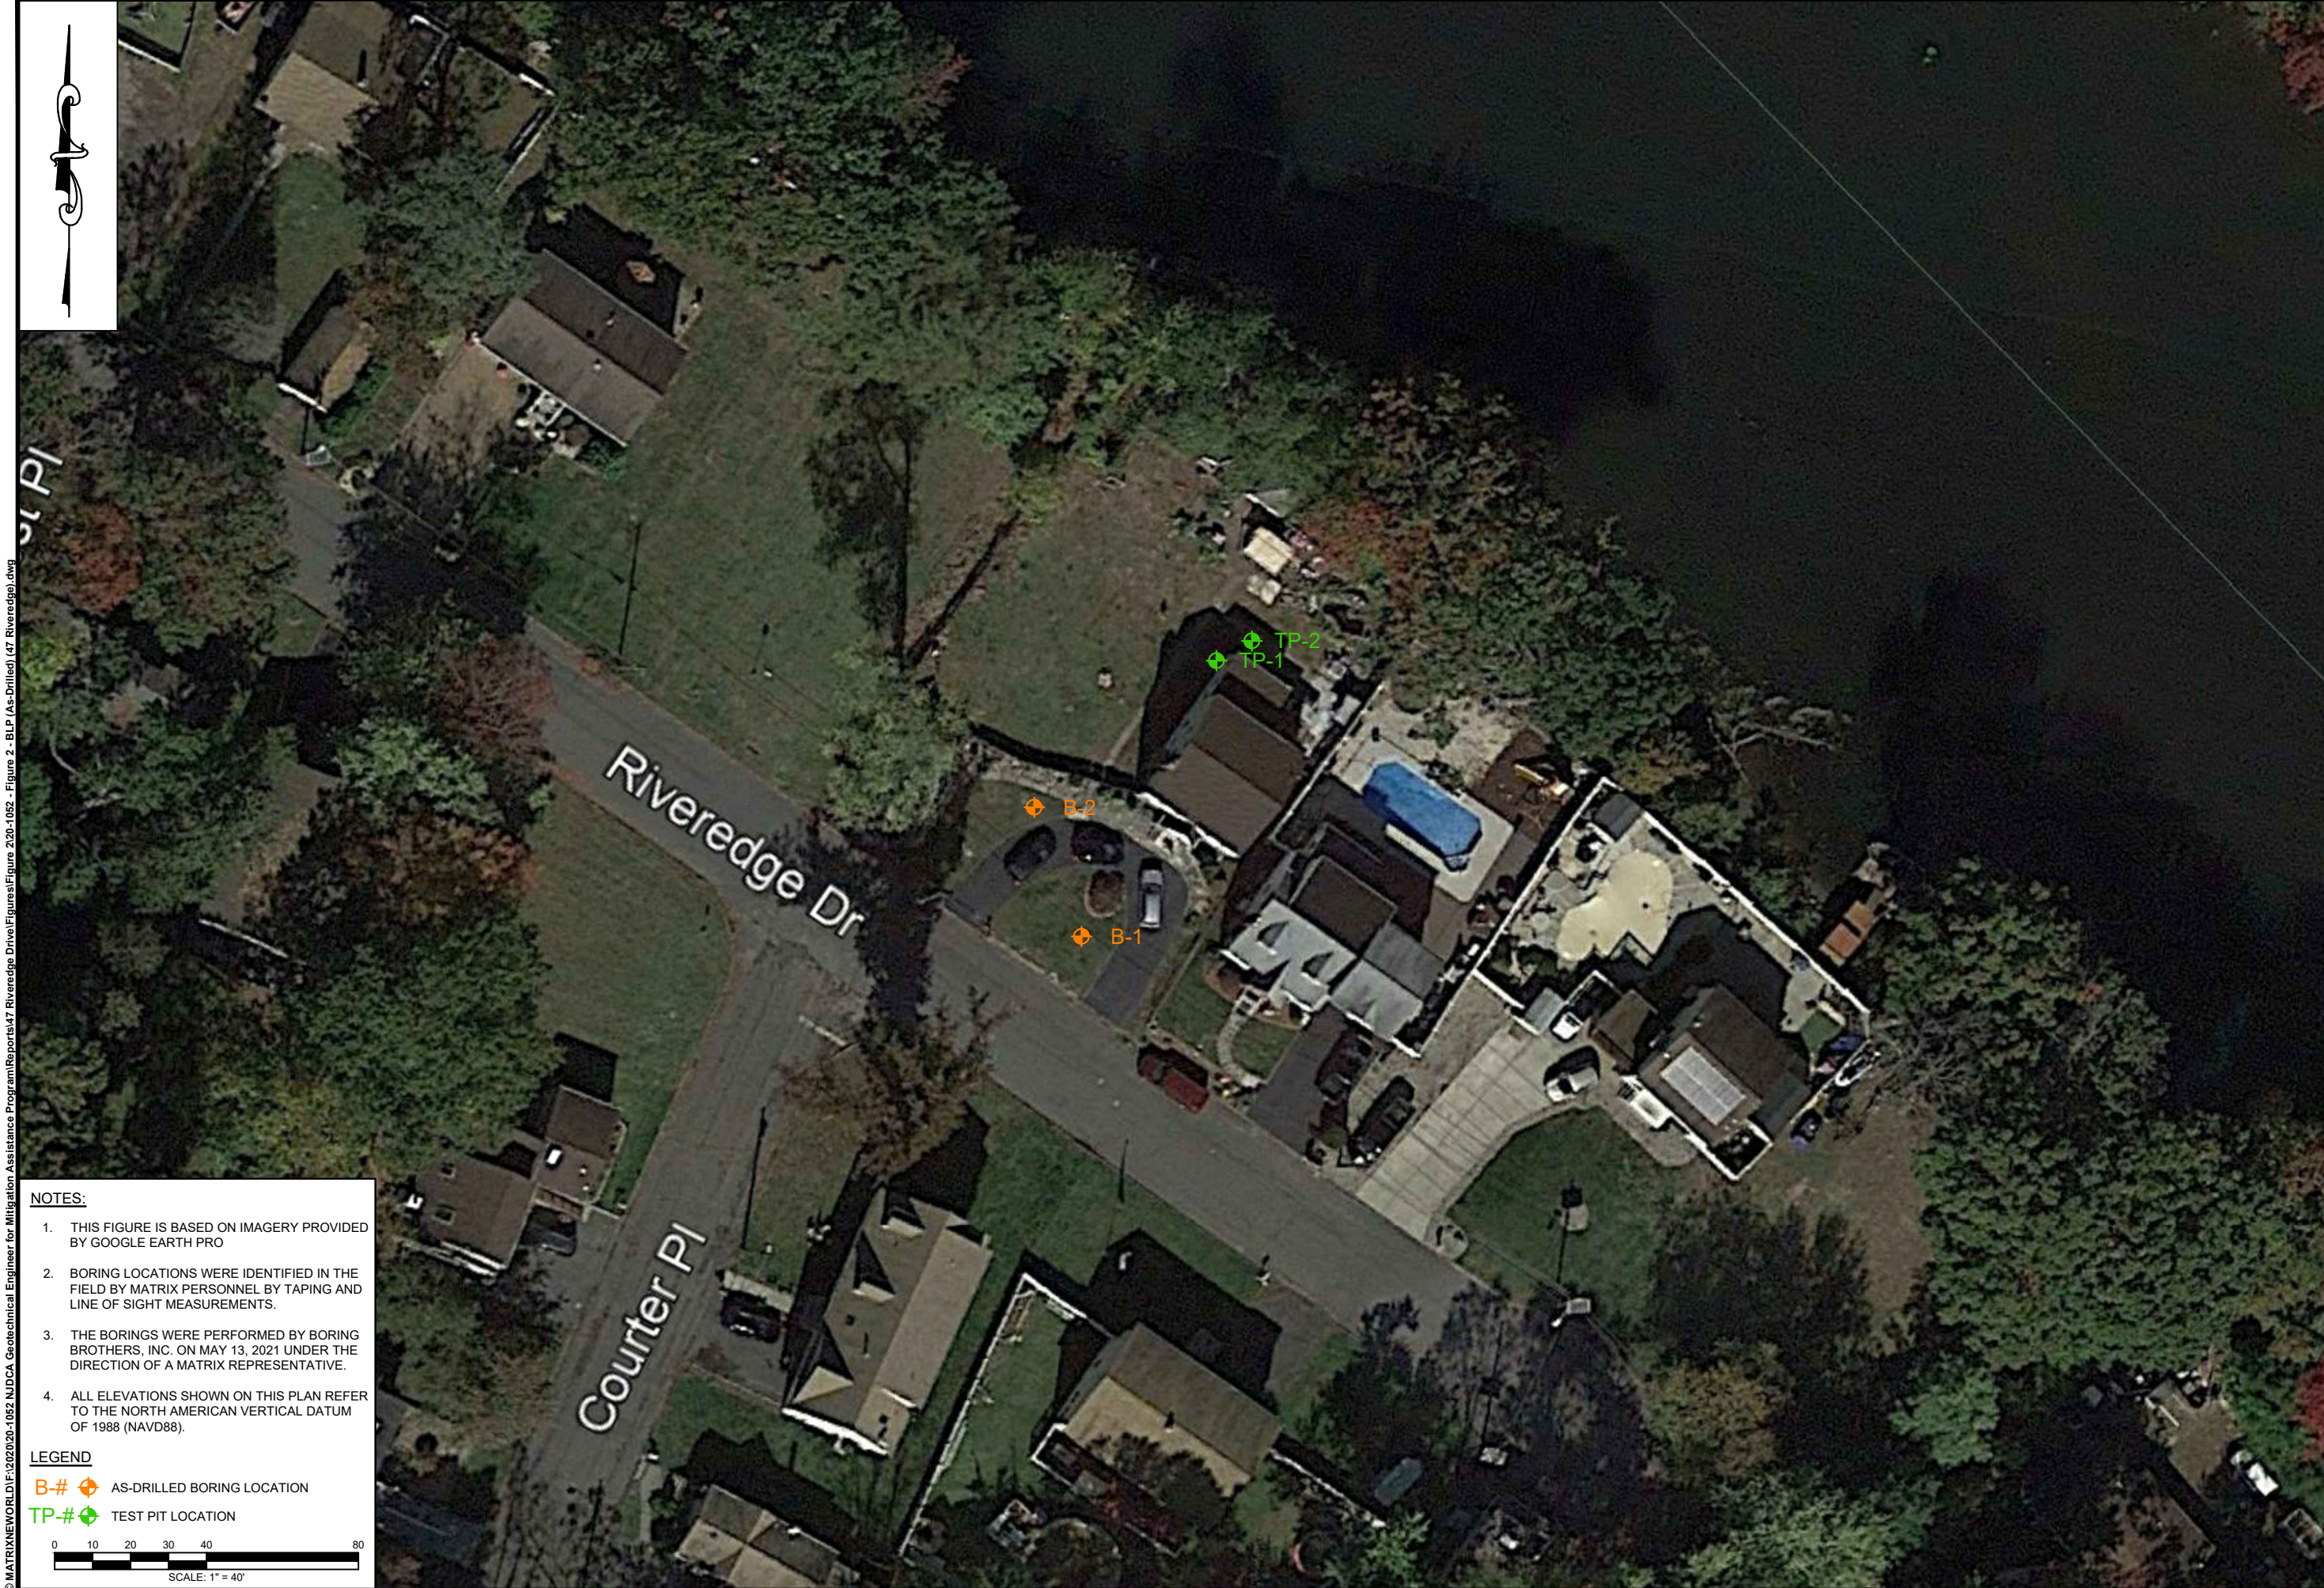
FIGURE NO.:  
 1

The purpose of the engineering study was to compile comprehensive data regarding the existing building's foundations and overall structural composition and condition at the Site. The information obtained will be further utilized to determine the feasibility and proposed design of raising the existing residence 3 feet above the base flood elevation (BFE) as determined by FEMA. A team of Matrix engineers and surveyors performed the evaluation, consisting of a geotechnical soil inspection, test pits to reveal the existing building foundations, an interior inspection of the building's visible foundation walls and frame, and topographic surveying for the development of a flood elevation certificate. A total of 2 test pits, (TP-1 and TP-2) were completed to depths of 68 and 64 inches, respectively, below the ground surface (bgs) and 2 geotechnical borings (B-1 and B-2) were completed to a depth of 27 feet bgs (see Figure 2).

To assist with the geotechnical and structural evaluation, test pits and geotechnical borings were advanced in areas around the residence to obtain information regarding the soil's structural properties and building's existing foundation. The 2 test pits and 2 borings were located to provide the most useful information about the subsurface conditions. Refer to Figure 2 of this report for a map of the test pit and boring locations.

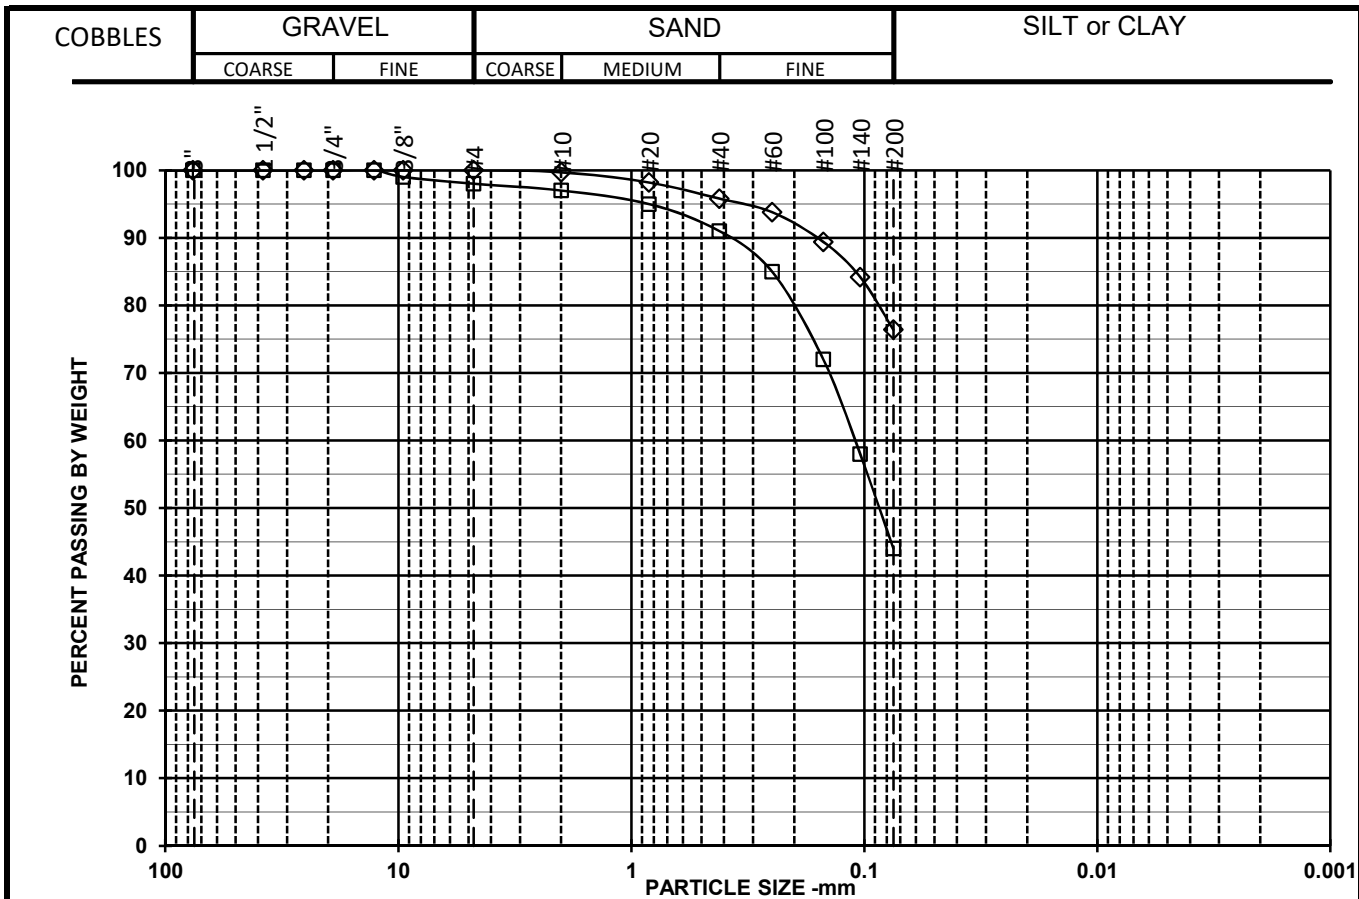
Open Symbols: Sieve analysis by ASTM D6913  
 Filled symbols: Hydrometer analysis by ASTM D7928 corrected for complete sample

Symbol	□	◇	○
Boring	B-1	B-2	
Sample	S-6	S-3	
Depth	10-12	4-6	
% +3"	0	0	
% Gravel	2	0	
% SAND	54	23.6	
%C SAND	1	0.3	
%M SAND	6	3.9	
%F SAND	47	19.4	
% FINES	44	76.4	
D <sub>100</sub> (mm)	12.7	4.75	
D <sub>60</sub> (mm)	0.11		
D <sub>30</sub> (mm)			
D <sub>10</sub> (mm)			
Cc			
Cu
