# Vehicle Tampering

May 4, 2022

# Meet Our Staff - Diesel Enforcement Team

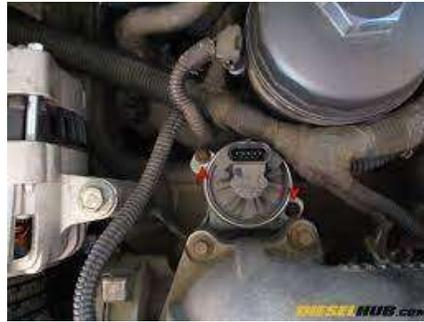
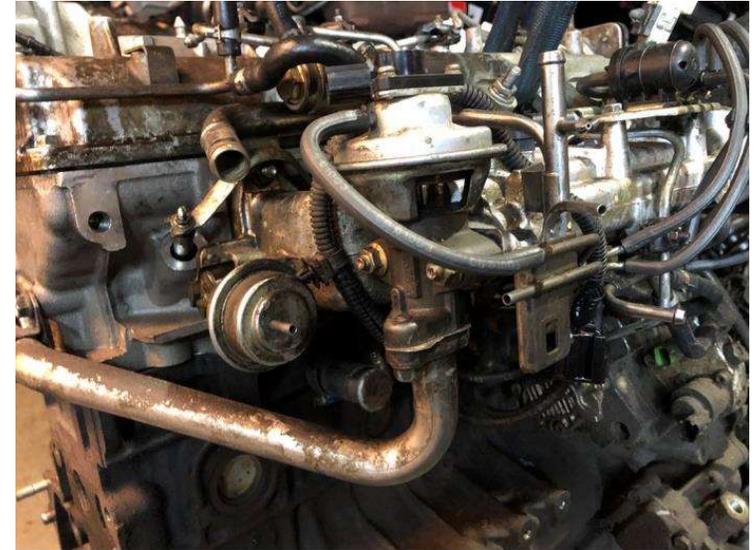
EGR Valve

The EGR system works by returning a small portion of exhaust gas to the engine's combustion chambers through the intake manifold, lowering combustion temperatures and therefore reducing the amount of NOx emitted. This control is located in the engine compartment

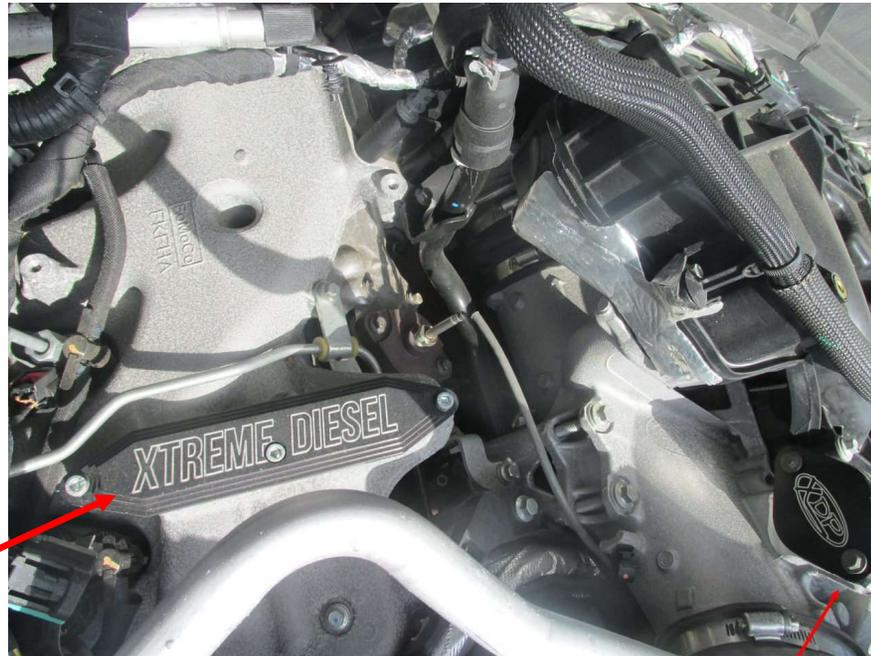
# Exhaust Gas Recirculation Delete

- EGR Cooler location

- EGR Valve location

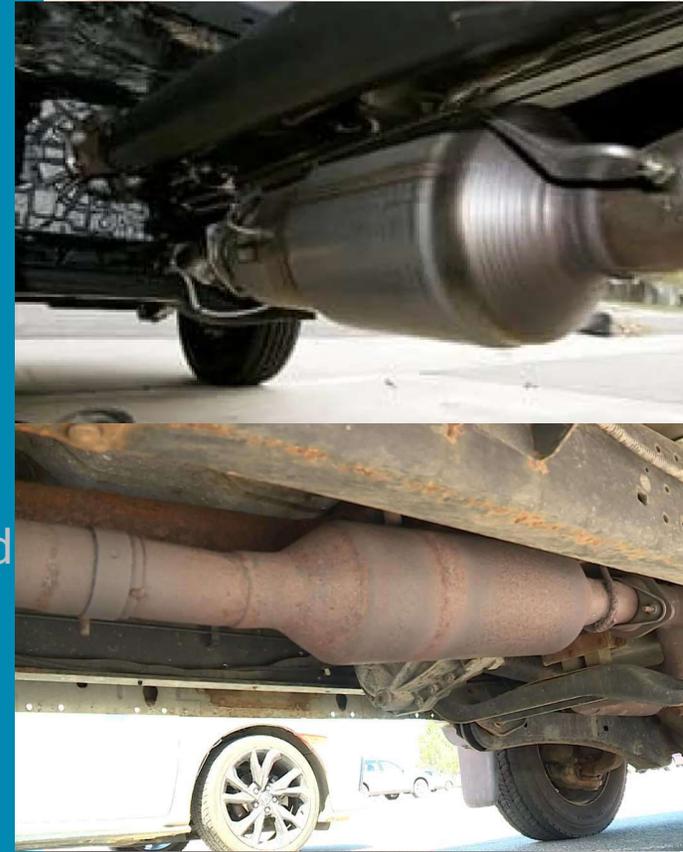
# Diesel Oxidation Catalyst (DOC)

Diesel Oxidation Catalysts (DOC) are **catalytic converters** designed specifically for diesel engines and equipment to reduce Carbon Monoxide (CO), Hydrocarbons (HC) and Particulate Matter (PM) emissions. DOC's are simple, inexpensive, maintenance-free and suitable for all types and applications of diesel engines.

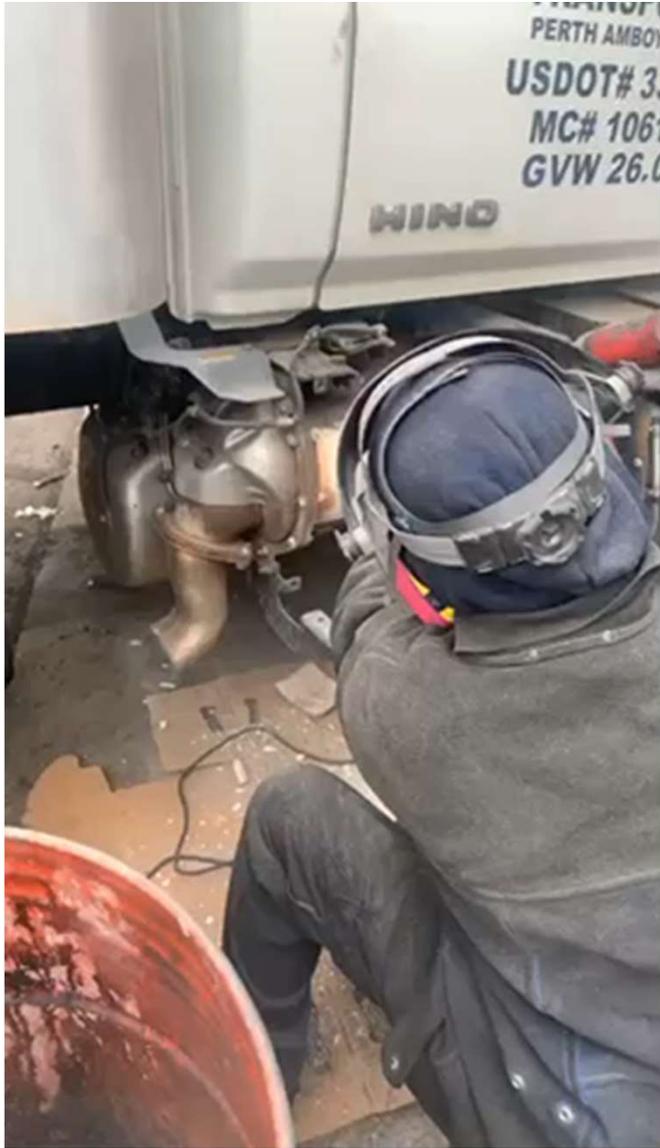
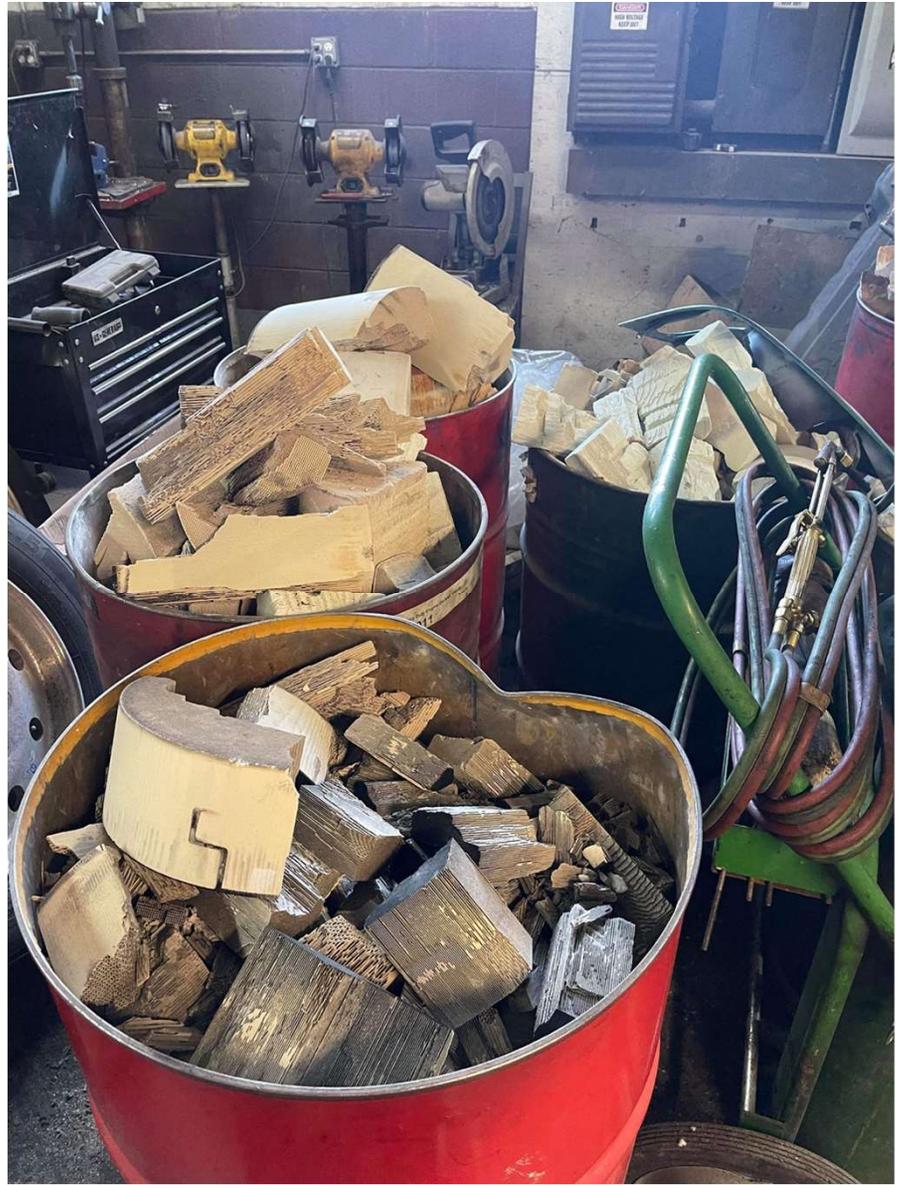
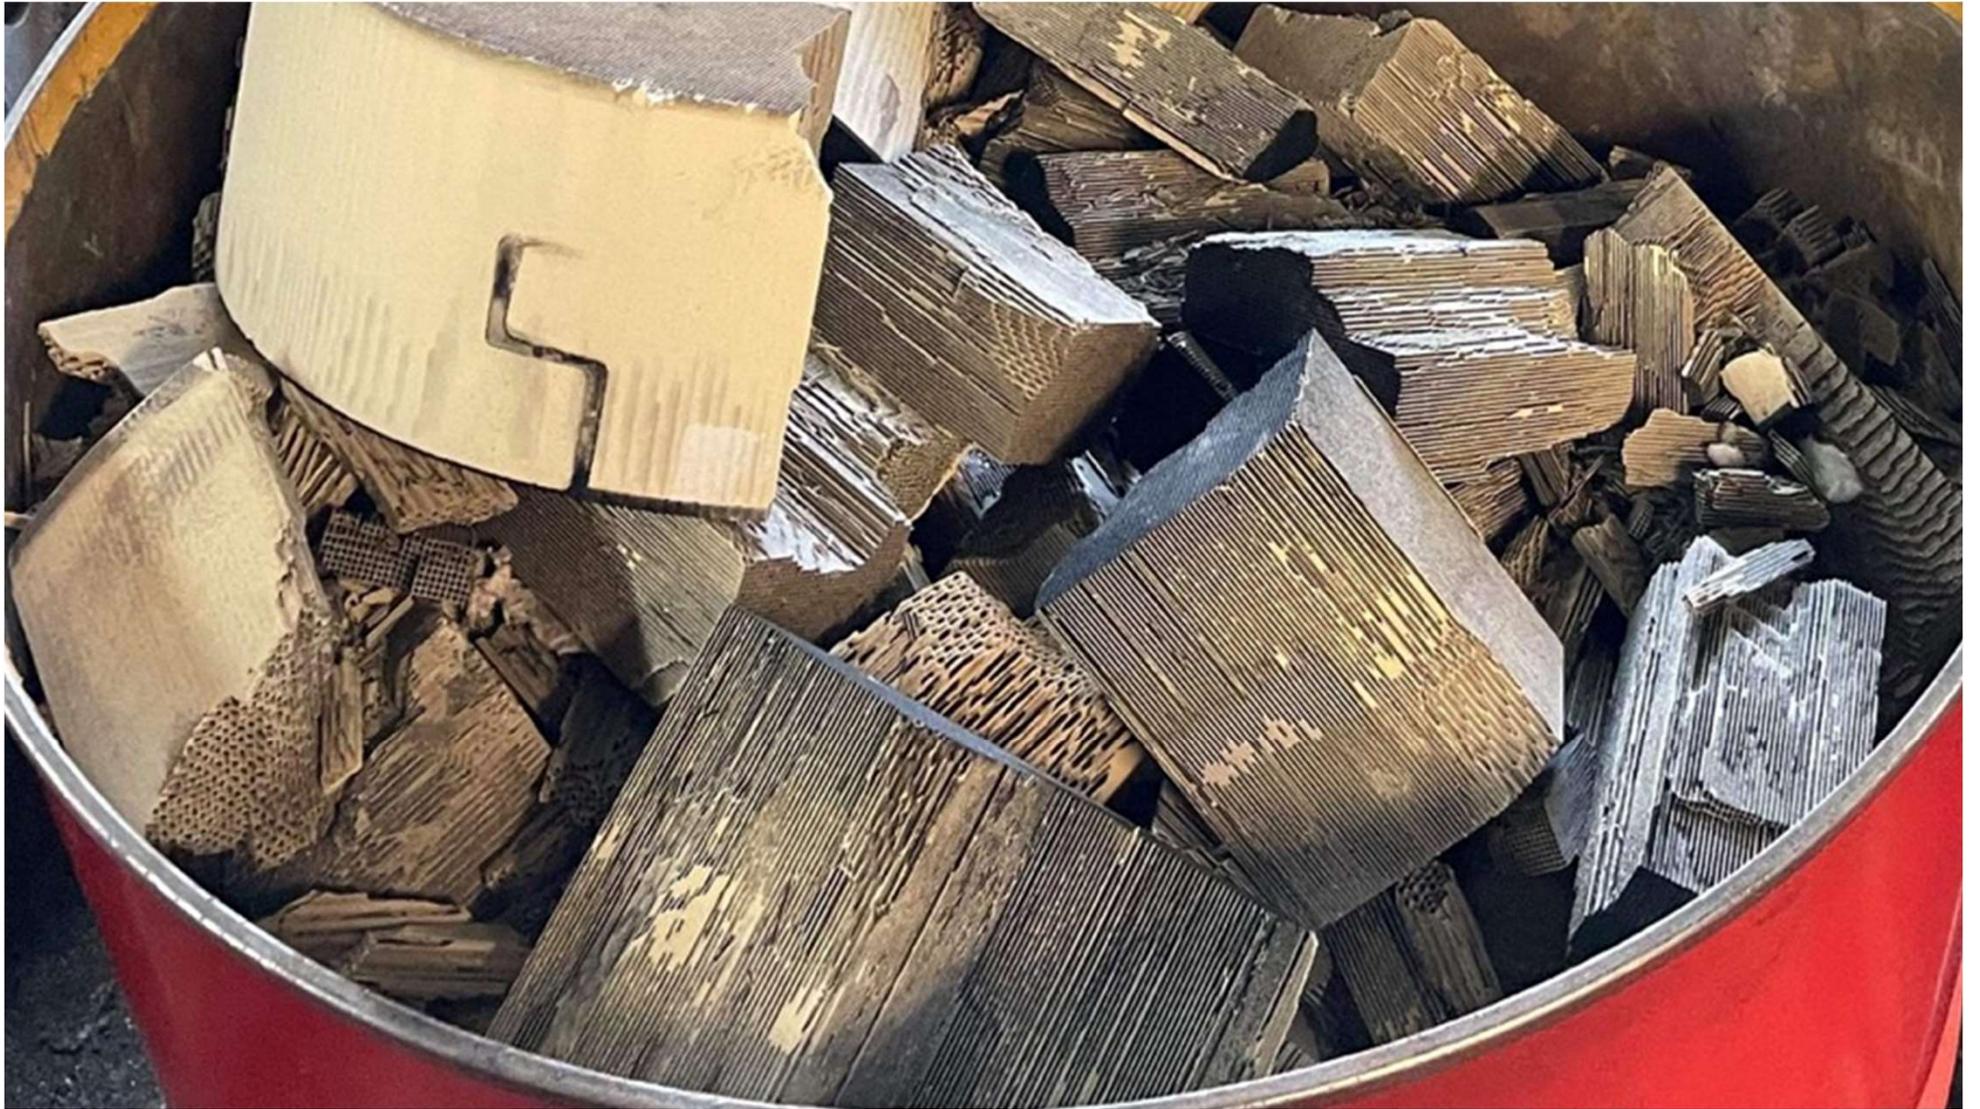
## Diesel Particulate Filter (DPF or Ptox)

A diesel particulate filter, or DPF, is an exhaust aftertreatment device that traps particulate matter such as soot and ash. A DPF typically uses a substrate made of a ceramic material that is formed into a honeycomb structure.

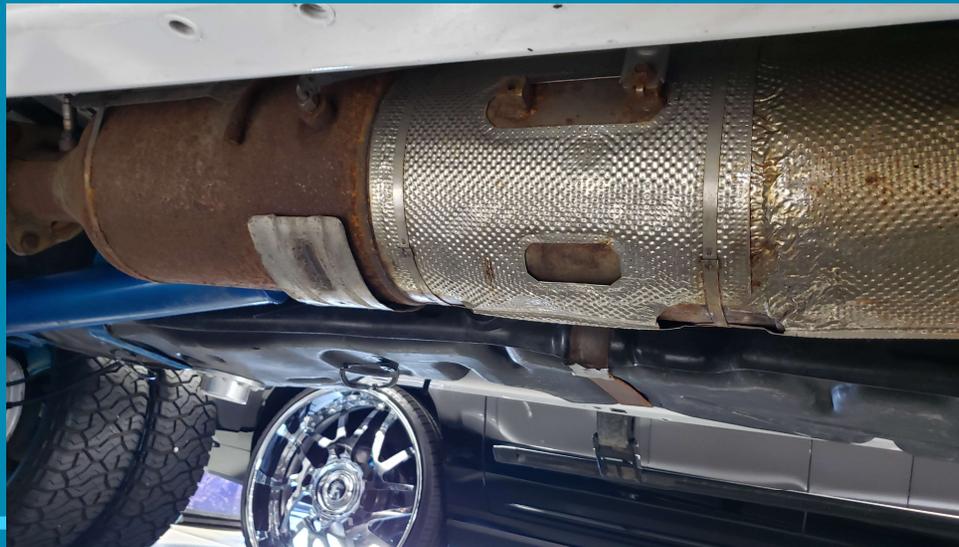
# Selective Catalytic Reduction (SCR)

This emission control device injects a liquid-reductant agent through a special catalyst into the exhaust stream of a diesel engine. The reductant source is usually automotive-grade urea, otherwise known as Diesel Exhaust Fluid (DEF). The DEF sets off a chemical reaction that converts nitrogen oxides into nitrogen, water and tiny amounts of carbon dioxide (CO<sub>2</sub>), natural components of the air we breathe, which is then expelled through the vehicle tailpipe.

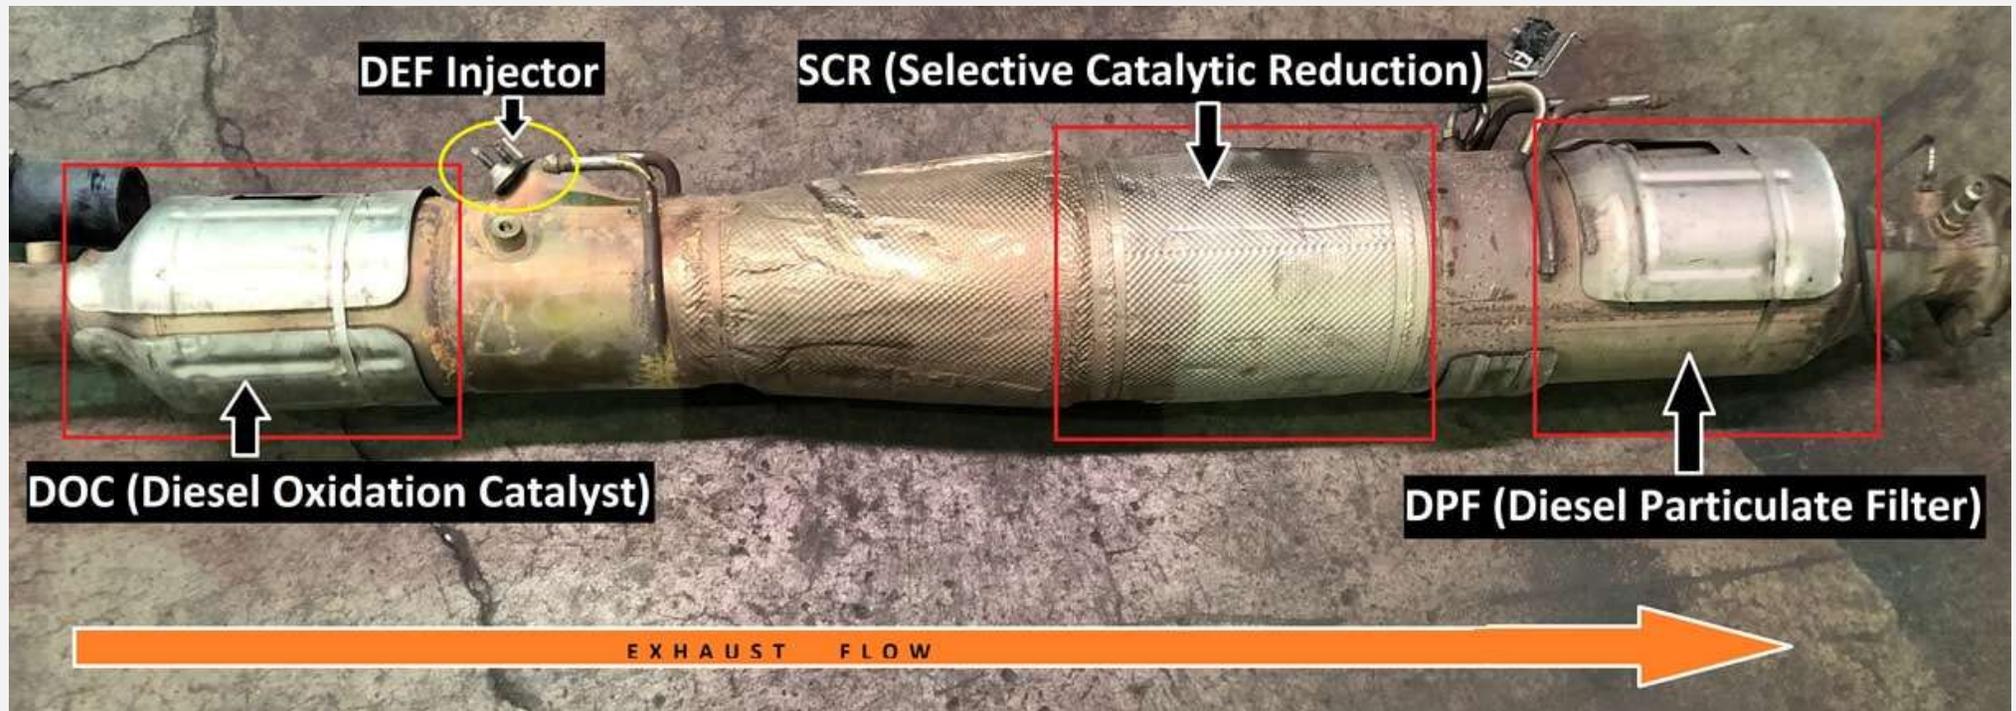
# Complete Exhaust System

Located Underside of Vehicle

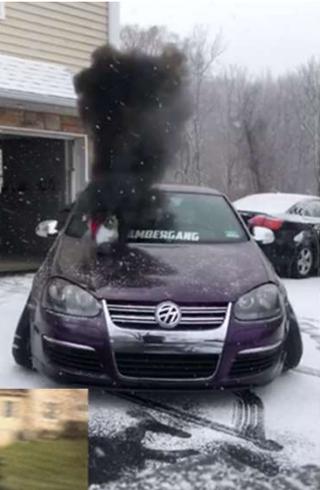
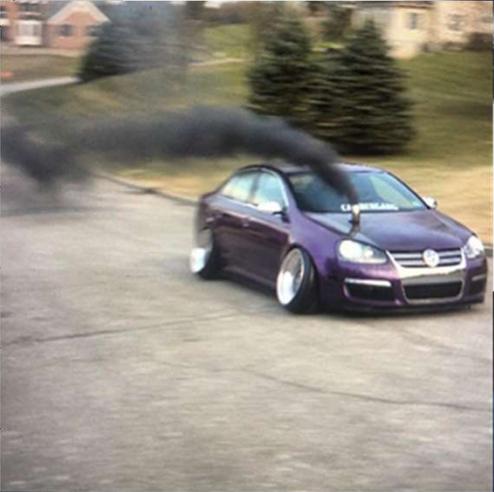
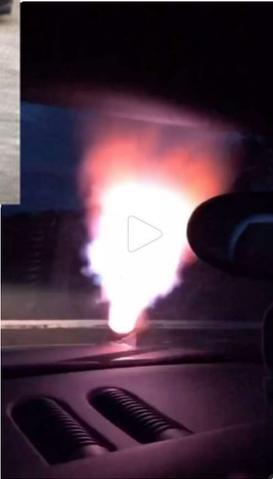
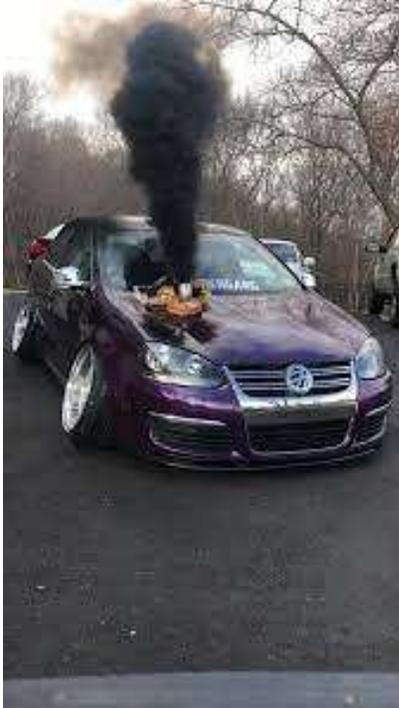
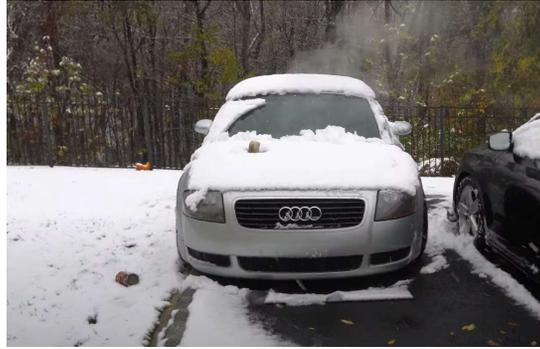
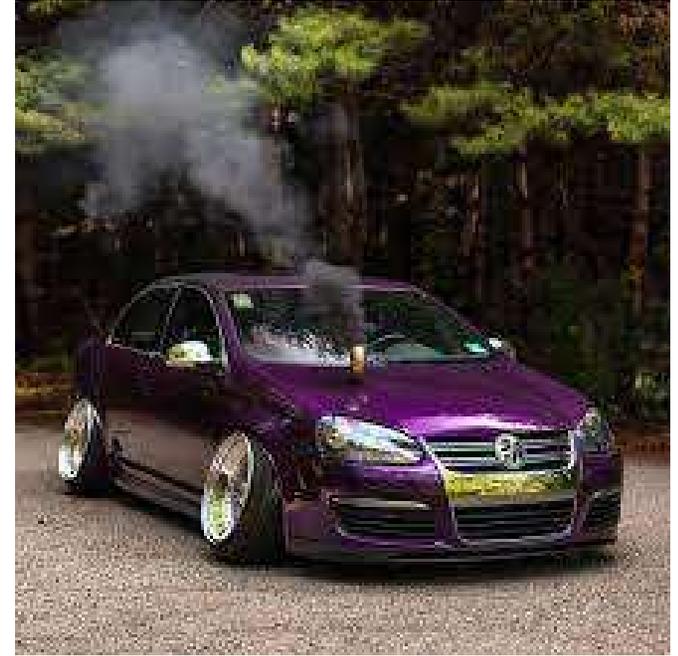
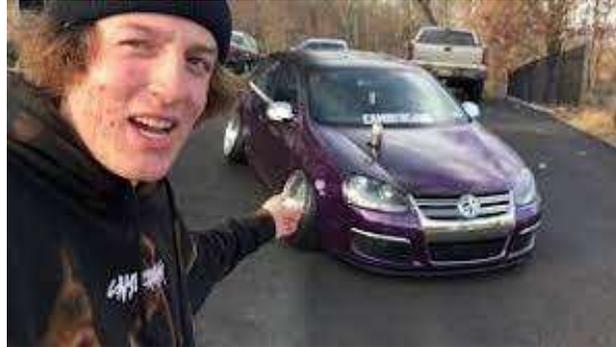
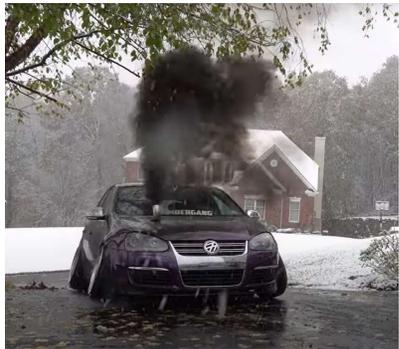
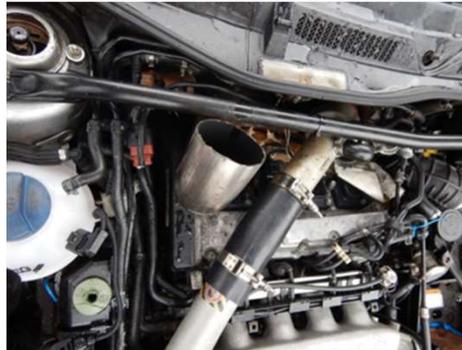
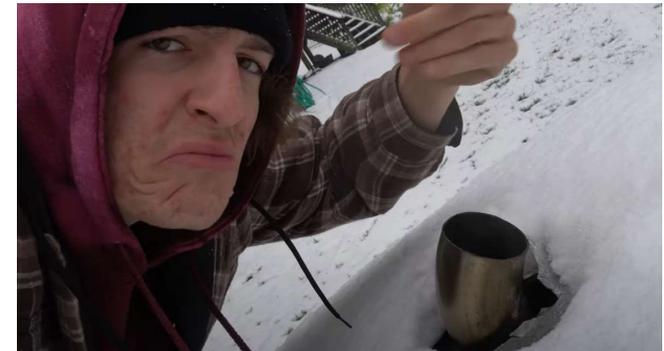
**CJ investigated for several months and eventually seized both of the vehicles in February 2021. We inspected the vehicles to verify that they were in fact tampered. Both vehicles had their catalyts removed and the VW had an EGR delete, and the oxygen sensors removed.**

A citizen complaint was reported on April 29, 2020. This incident was from the next-door neighbor who had dealt with this issue for too long.

**At the time we weren't dealing with Private citizens, but due to the blatant and public nature of these actions, the Commissioner wanted this case referred to Criminal Justice.**

**Owner entered into PTI and both vehicles were forfeited to the state.**

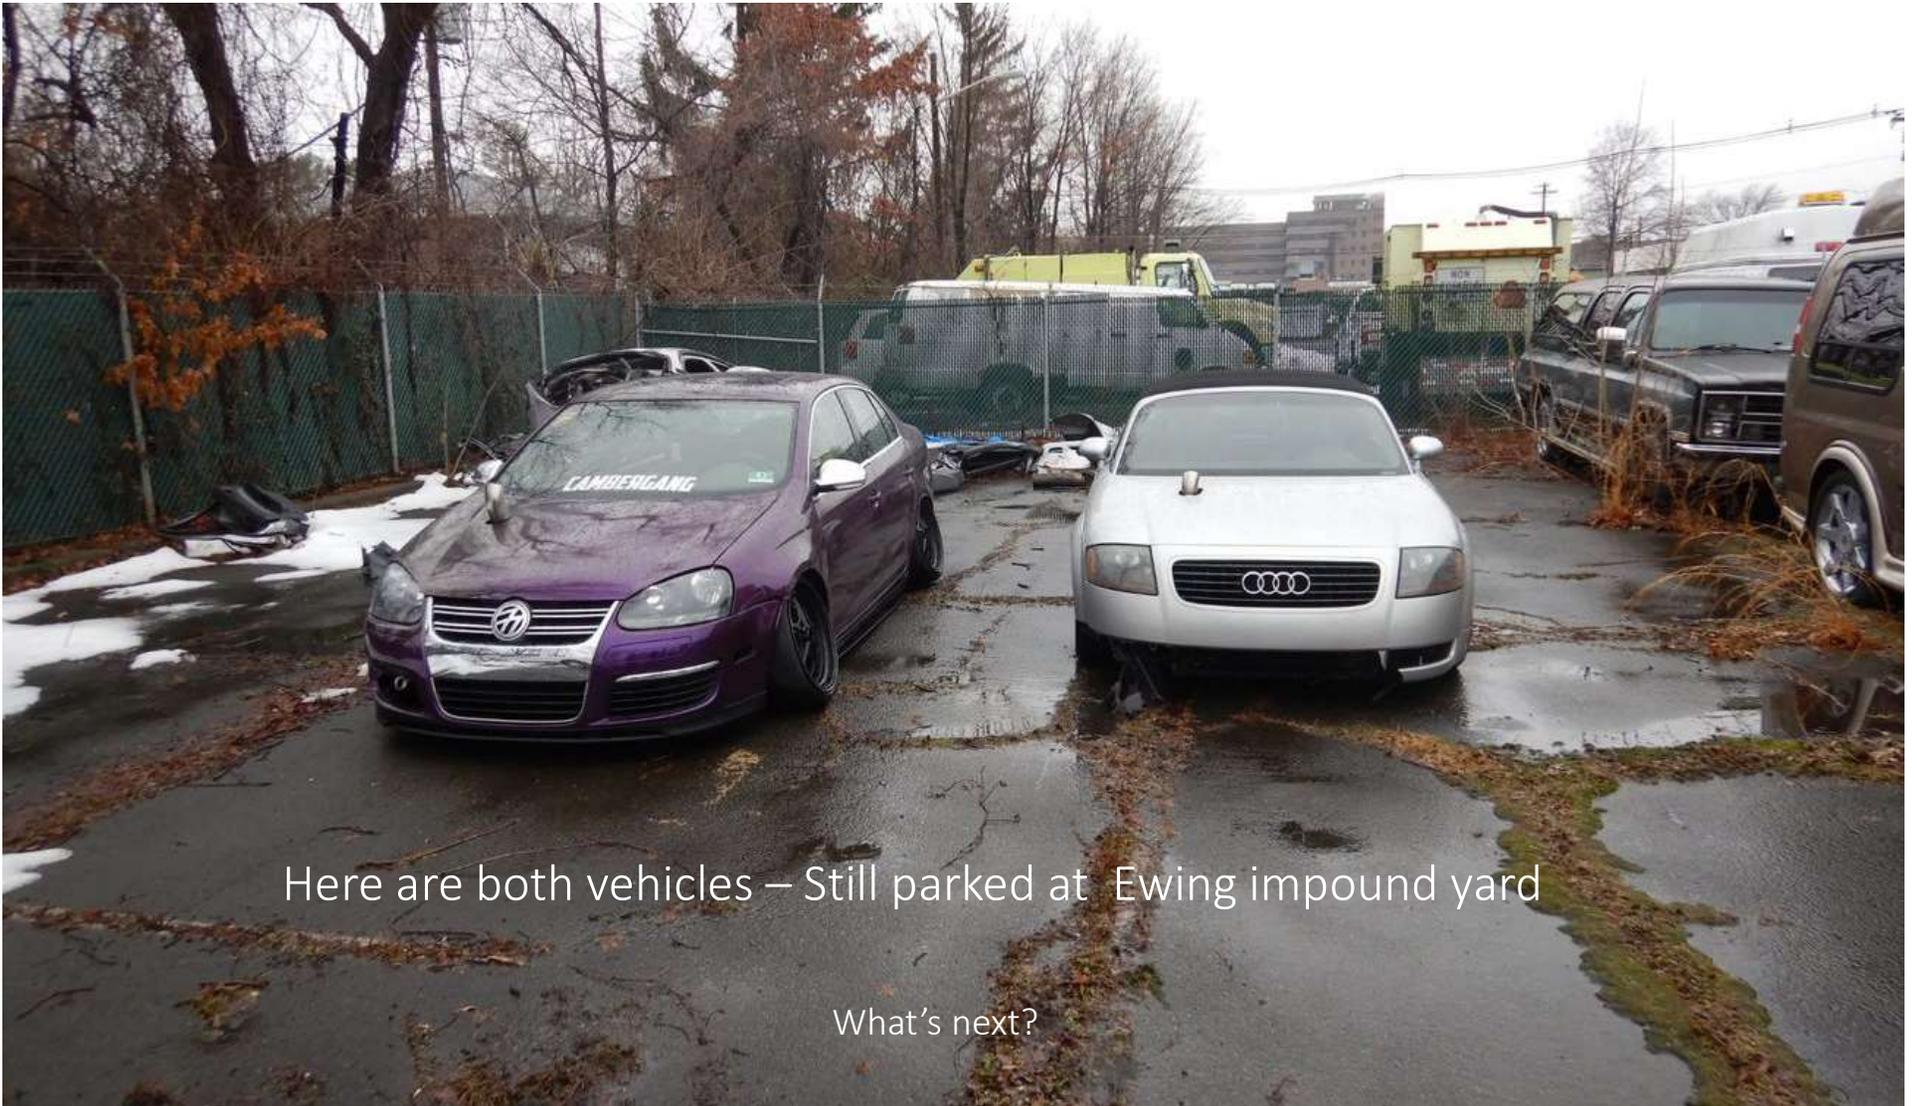
Here are both vehicles – Still parked at Ewing impound yard
