# Cyanobacterial Harmful Algal Bloom (HAB) Freshwater Response

## 2021 Summary Report

Division of Water Monitoring, Standards and Pesticide Control

**New Jersey Department of Environmental Protection**

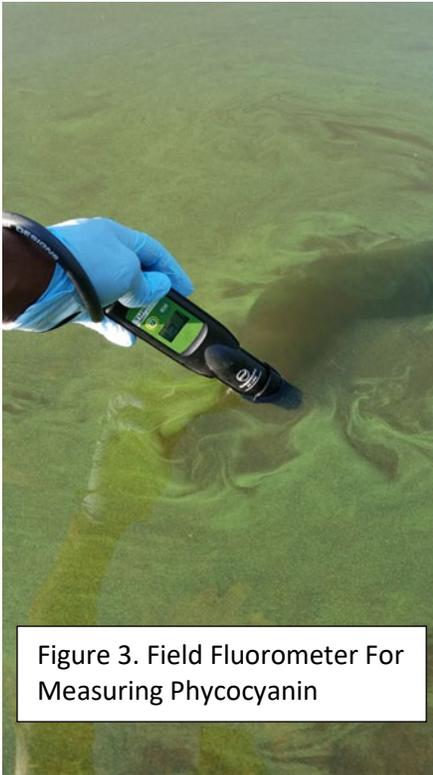
Figure 3. Field Fluorometer For Measuring Phycocyanin

Phycocyanin is a pigment unique to cyanobacteria, therefore the presence of a high concentration of phycocyanin is an indicator of a cyanobacteria bloom. Handheld field fluorometers measure the presence and relative concentration of phycocyanin and are used to qualitatively demonstrate whether cyanobacteria, if present, are in bloom densities. Phycocyanin measurements are used to approximate

cell concentration and cannot predict toxin production, toxin levels, identify taxa present, nor quantify cell density directly. However, these measurements can be used as a screening tool for suspected HABs and to monitor the status of confirmed HABs.

BFBM uses three types of fluorometers: a handheld field meter, laboratory meter, and a YSI data sonde. The YSI data sonde is used for real time continuous monitoring in conjunction with telemetry buoys (Figure 4), but units can also be used for discreet measurements by samplers.

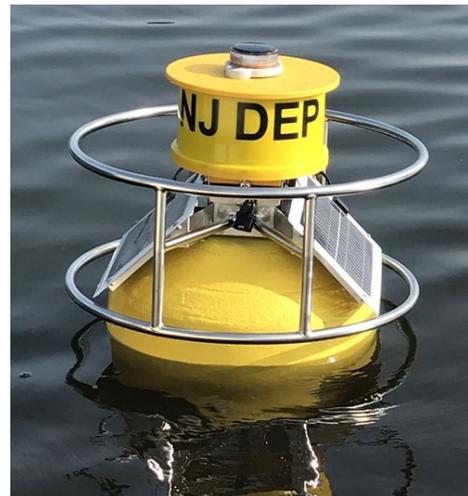
Figure 4. Continuous multi-parameter meter.

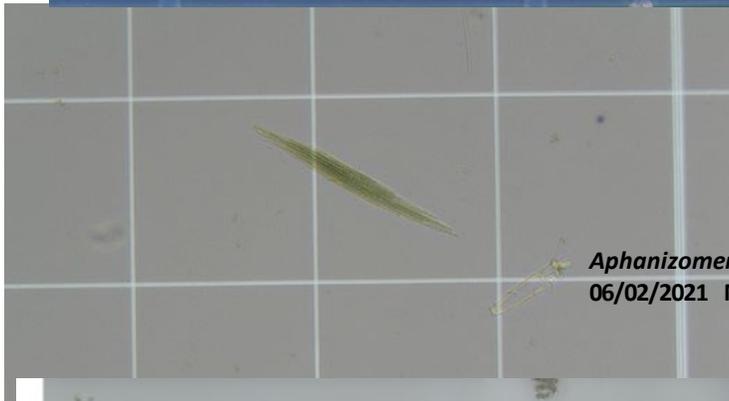
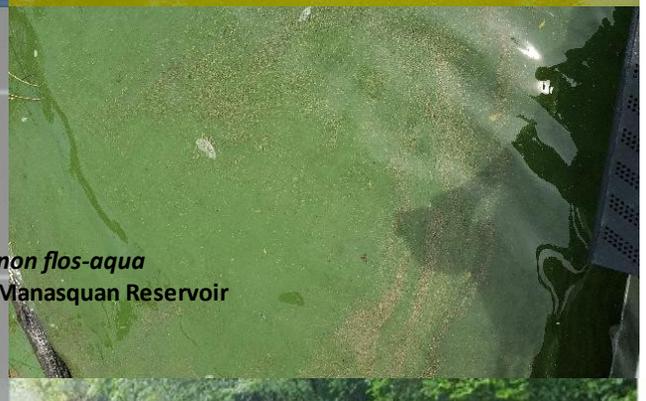
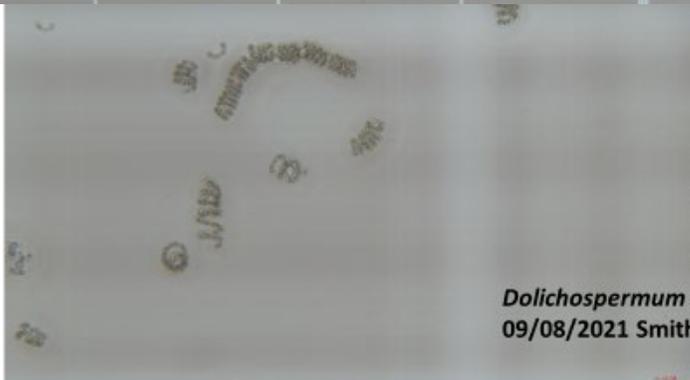
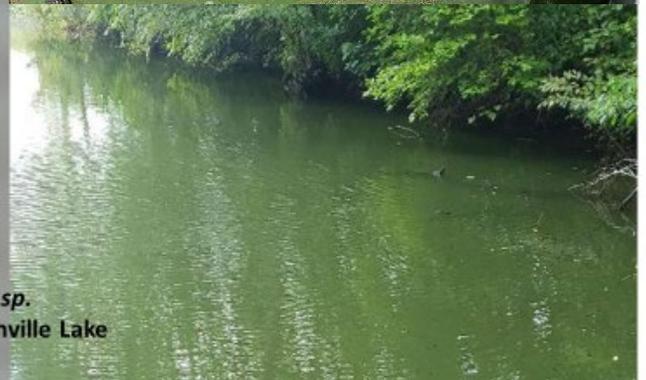
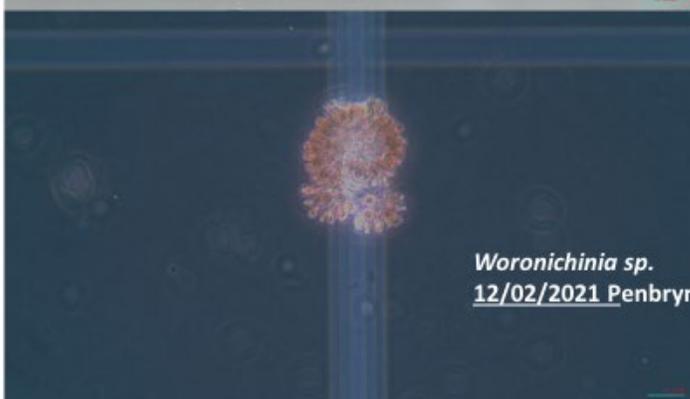
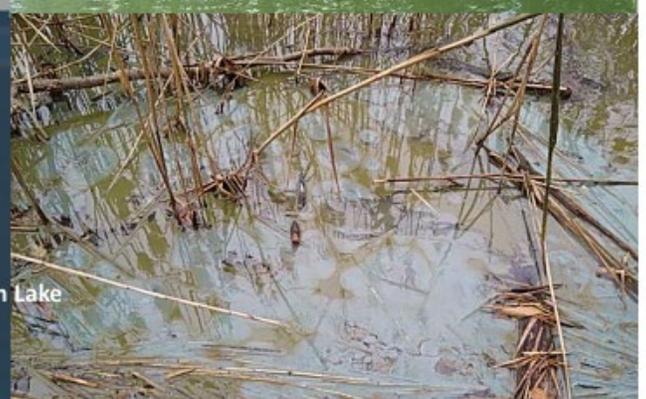
Figure 14. Examples of potential toxin producing cyanobacteria observed in samples with microcystins > 2.0 µg/L.

*Microcystis sp.*  
6/30/2021 Pemberton Lake

*Aphanizomenon flos-aqua*  
06/02/2021 Manasquan Reservoir

*Dolichospermum sp.*  
09/08/2021 Smithville Lake

*Woronichinia sp.*  
12/02/2021 Penbryn Lake

- Anatoxin-a (ATX) was detected in 46% of these samples. *Dolichospermum sp.*, *Microcystis sp.*, and *Woronichnia sp.* were frequently associated with these blooms. All of these are known anatoxin-a producers.
- Cylindrospermopsin (CYL) was detected in 47% of these samples. *Dolichospermum sp.*, *Microcystis sp.*, and *Woronichnia sp.* were associated with more than half of these blooms. Of these, only *Dolichospermum sp.* is a known cylindrospermopsin producer.
- Saxitoxin (STX) was detected in 92% of these samples. *Aphanizomenon sp.*, *Cuspidothrix sp.*, *Dolichospermum sp.*, *Microcystis sp.*, and *Woronichnia sp.* are associated with some of these blooms. Other than *Woronichnia sp.*, these are all known saxitoxin producers.

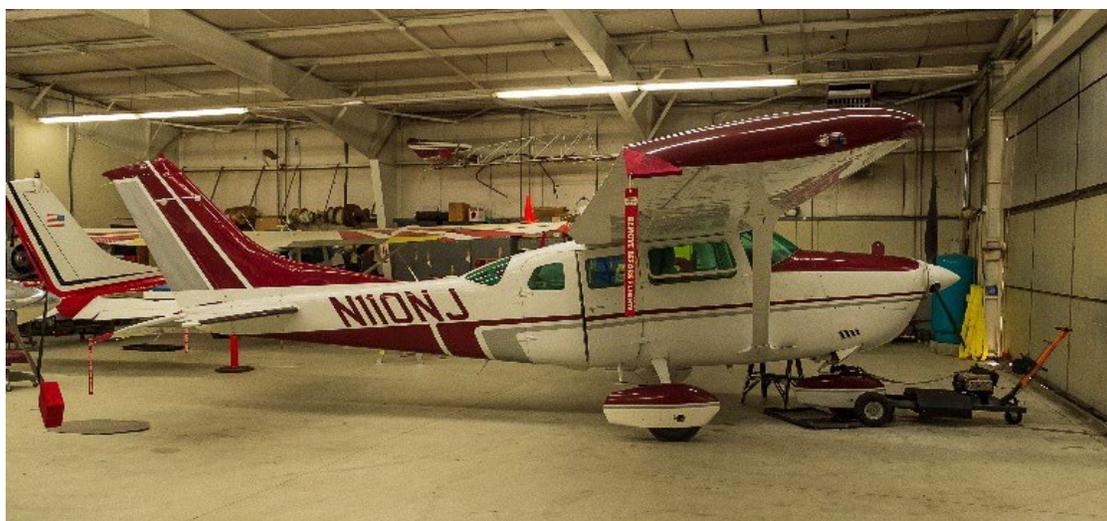
Figure 15. Forest Fire Service

NJ Forest Fire Service perform flight (Figure 15) surveillance at several larger Northern NJ lakes of concern. Visual observations are recorded as well as remote sensing of phycocyanin pigment. DWMSPC Bureau of Marine Water Monitoring developed a customized algorithm that can reliably detect and estimate phycocyanin concentrations in freshwaters through wavelength reflectance signatures. These measurements are not used as a replacement for confirmation analysis, but as a screening and status monitoring tool to detect relative increases and decreases in phycocyanin pigment concentrations. When levels change significantly i.e., indicate a change in Alert status, sampling staff are deployed for confirmation laboratory analysis.

Flights were performed once per week during the recreational season at the following lakes (weather permitting):

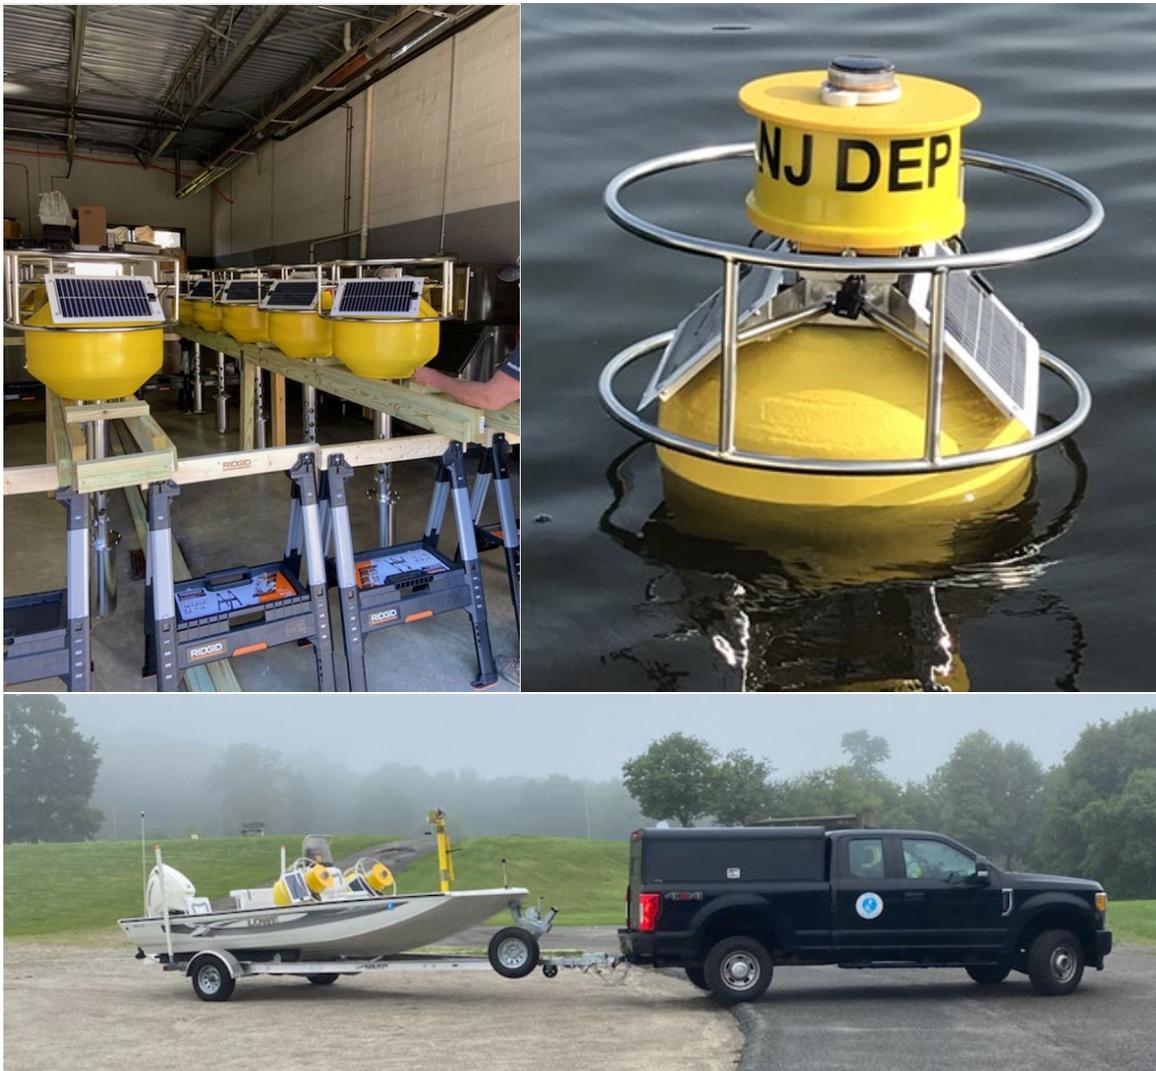
The Bureau of Marine Water Monitoring has also assisted in developing a program using buoys equipped with continuous monitoring meters and real-time telemetry technology (Figure 17). Nine (9) buoys were deployed at select waterbodies. The sites were chosen due to recreational and/or drinking water significance, repeated HAB occurrence, duration, and previous elevated levels of HABs at these waterbodies. The waterbodies had one or more remote monitoring devices to provide best feasible coverage for HAB status monitoring & response:

Figure 17. Real-Time Continuous Buoy Program
