United States Department of the Interior
National Park ServiceNational Register of Historic Places
Registration Form

1. Name of Propertyhistoric name Garritse/Doremus/Westervelt Houseother names/site number Vanderhoef House**2. Location**street & number Park Drive ☐ not for publicationcity or town Clifton City ☐ vicinitystate New Jersey code NJ County Passaic zip code 07011**3. State/Federal Agency Certification**

Garritse/Doremus/Westervelt House
Passaic County, New JerseySection number 7 Page 1

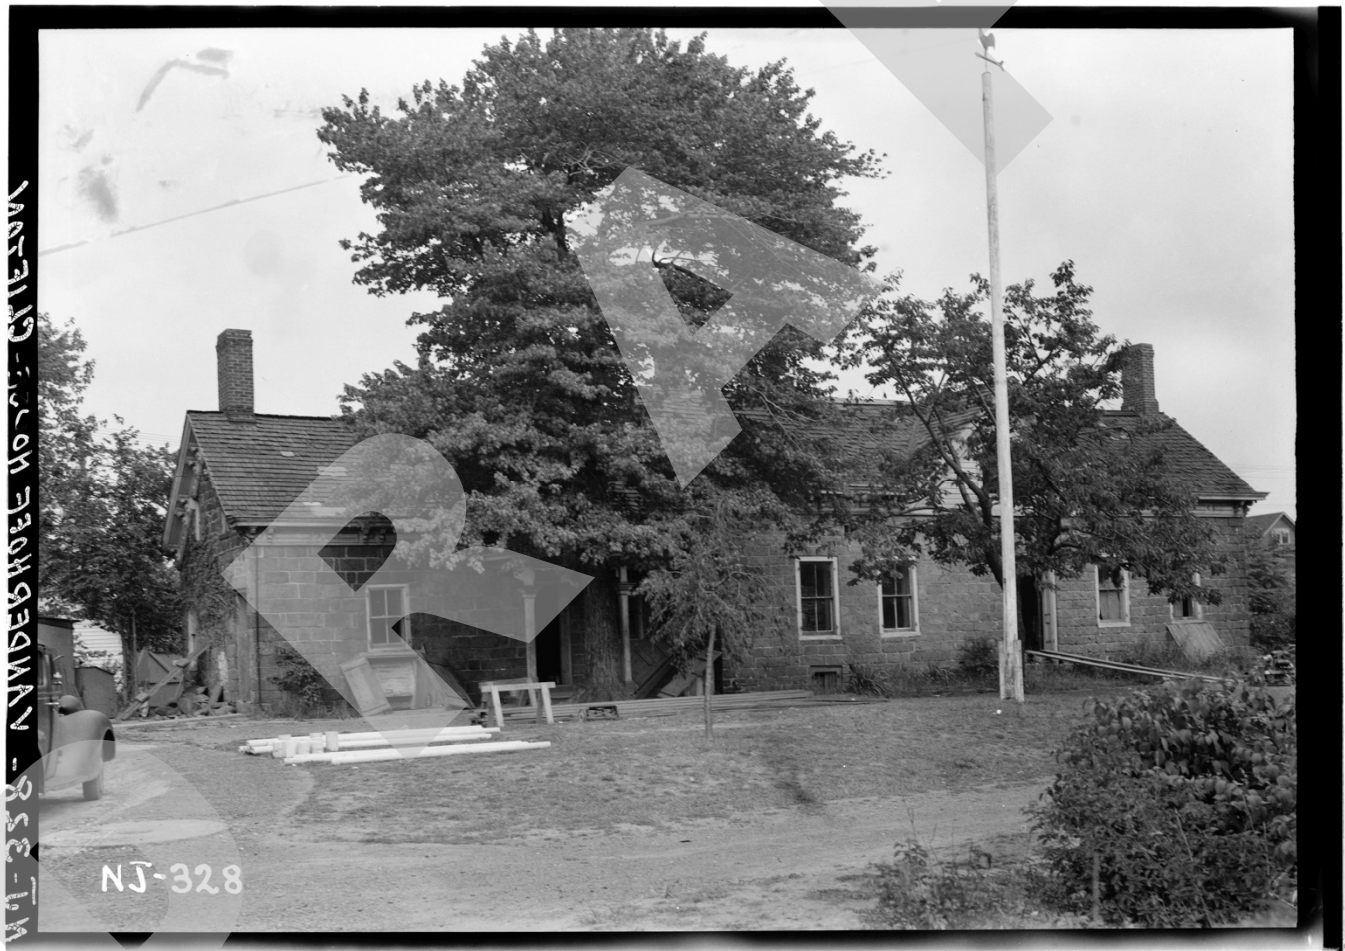
Figure 6. The front (southeast) elevation of the Garritse/Doremus/Westervelt House. August 18, 1939. Source: Historic American Buildings Survey.

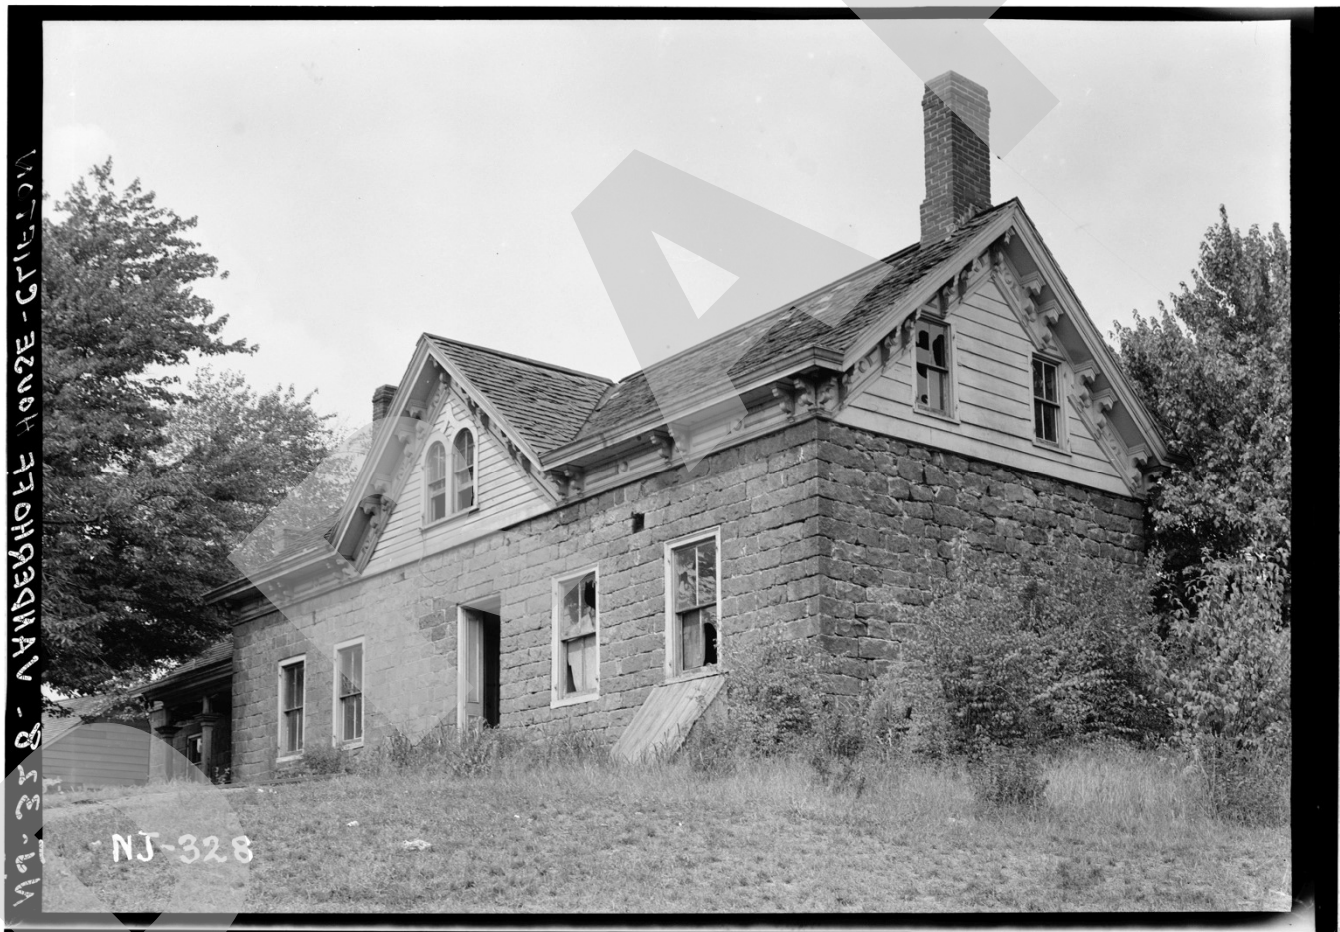
Figure 7. The front (southeast) and side (northeast) elevations of the Garritse/Doremus/Westervelt House. August 18, 1939. Source: Historic American Buildings Survey.

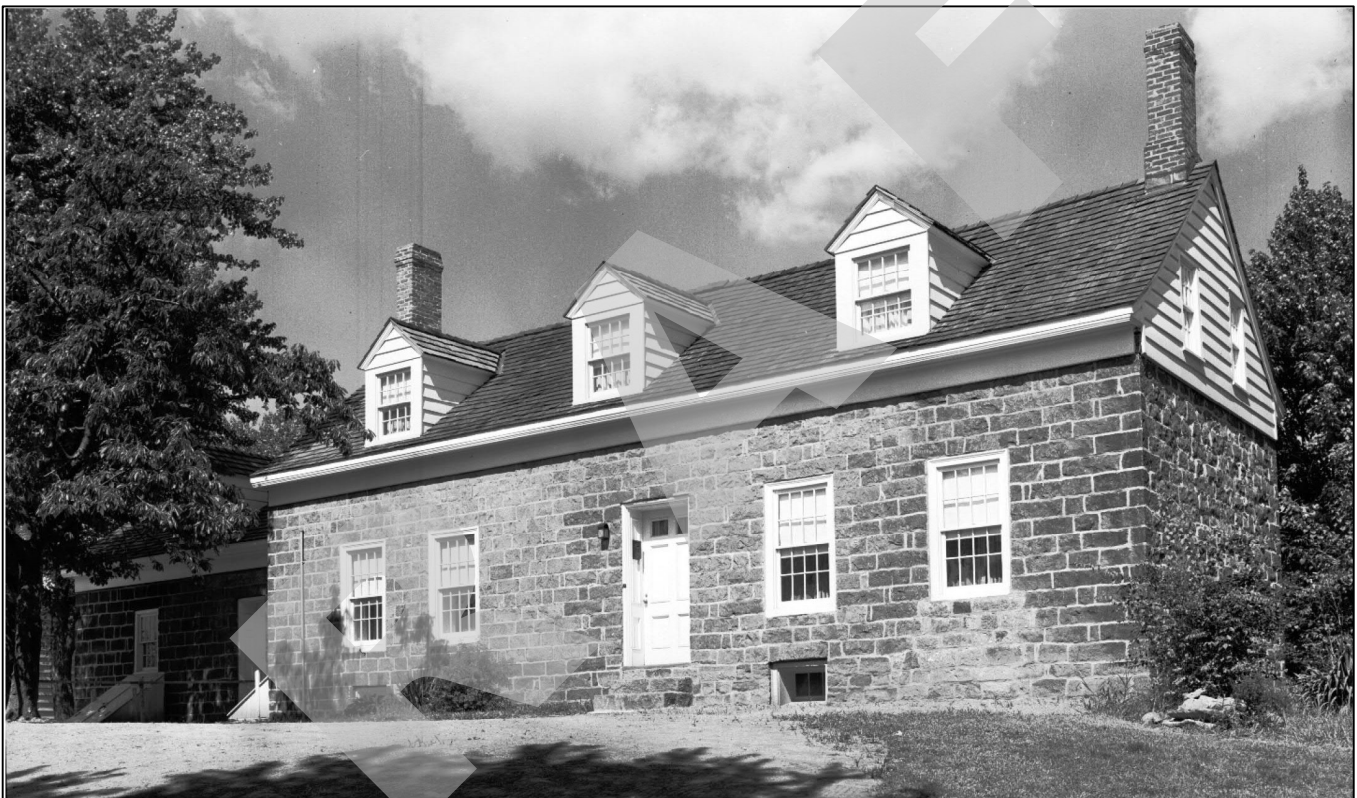
Figure 8. The Garritse/Doremus/Westervelt House following its first rehabilitation. *Circa 1940-41*. Source: New Jersey Historic Preservation Office 2019.

Jackson's specifications detailed the careful restoration of the exterior and interior of the building. He called for the repointing of stonework and the removal of the center cross gable to return the house's roof to its earlier form. The dwelling's original sashes had been replaced with two-over-two wood sashes and were replaced with eight-over-eight or six-over-six sashes compatible with an earlier period of development. Some areas of the dwelling's woodwork had rotted, particularly the exterior windowsills, and were replaced in-kind. The original floors were retained throughout the building with the exception of those in the *circa* 1830 kitchen wing, which were to be replaced with "asphaltic flooring."²⁷ According to the narrative description of the plans, "all doors and trim of each room [were] to conform to the oldest existing work in each room respectively or as drawn or directed."²⁸ This excluded the garret, however, as all woodwork was scheduled for replacement at the building's half story. Additional upgrades were made to heating, electrical, plumbing and gas systems. Not all of the work described in the plans was completed, however; Jackson called for the removal of the marble fireplace surrounds in the east parlor (Room 101) but these remain today. Plans included the repointing of the three fireplaces in the building; the plans did not indicate the removal of the kitchen wing hearth, however, the best evidence is that this removal was a decision made after construction began in late 1939. The project was finished and celebrated with a dedication ceremony in October 1940 (Figure 8).²⁹

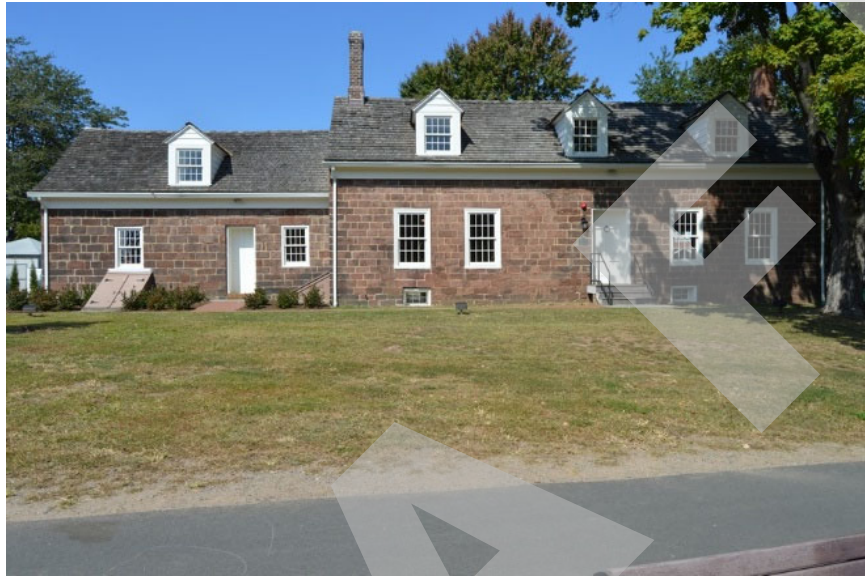
Photograph 3. The front (southeast) elevation of the Garritse/Doremus/Westervelt House, looking northwest.

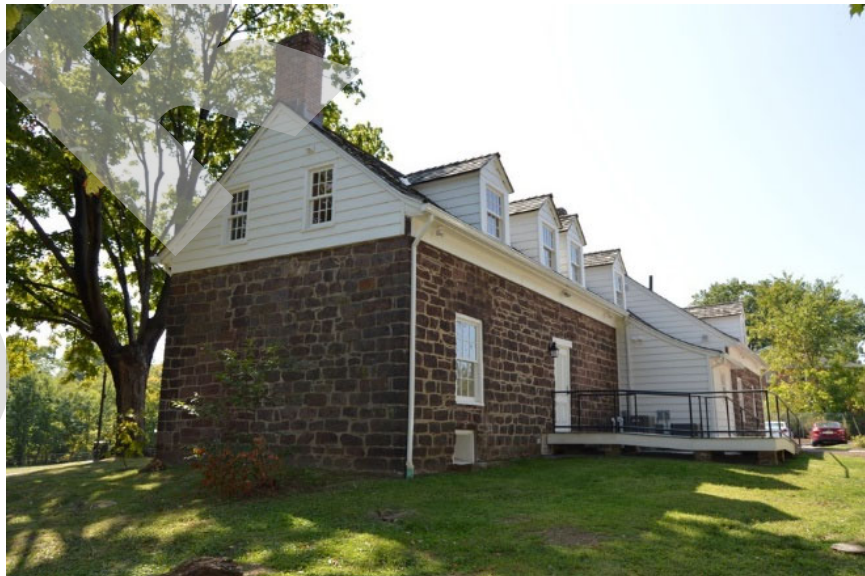
Photograph 4. Oblique view of the side (northeast) and rear (northwest) elevations of the Garritse/Doremus/Westervelt House, looking southwest.

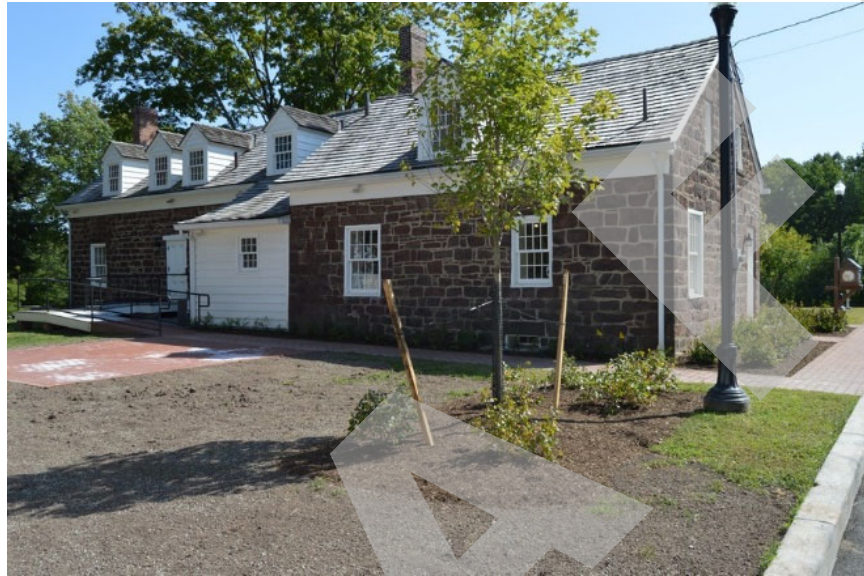
Photograph 5. Oblique view of the rear (northwest) and side (southwest) elevations of the Garritse/Doremus/Westervelt House, looking northeast.

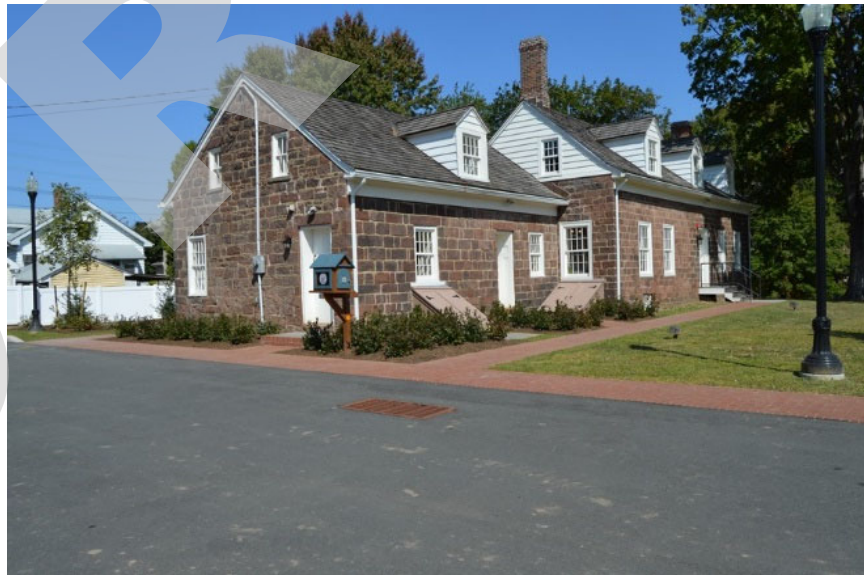
Photograph 6. Oblique view of the side (southeast) and front (southeast) elevations of the Garritse/Doremus/Westervelt House, looking north.

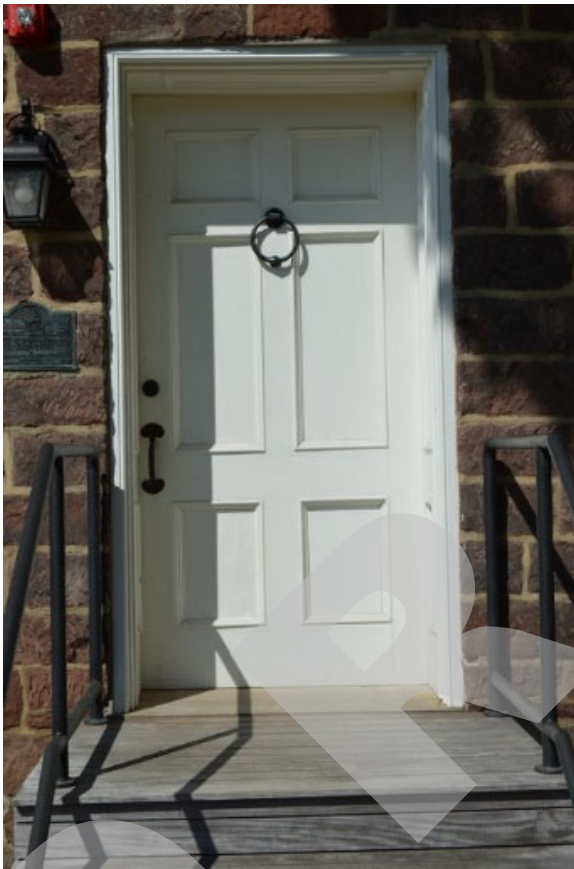
Photograph 7. The primary front entry, looking northwest.

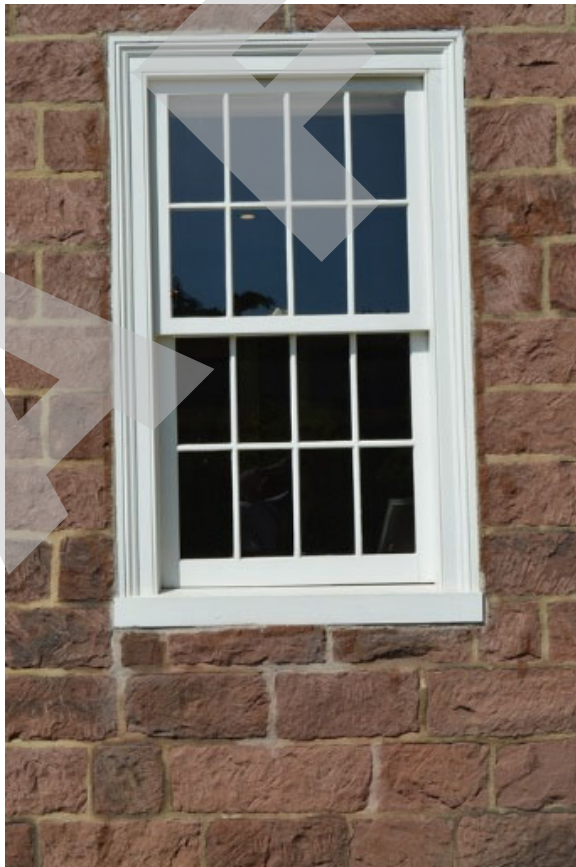
Photograph 8. The window to the left of the primary front entry, looking northwest.

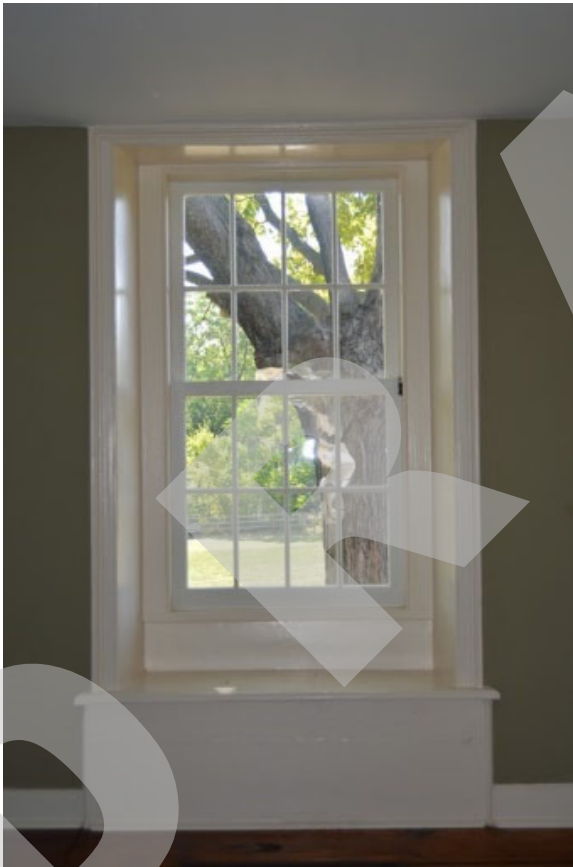
Photograph 14. A detailed view of front window in the east parlor (Room 101) of the building's main block, looking southeast.

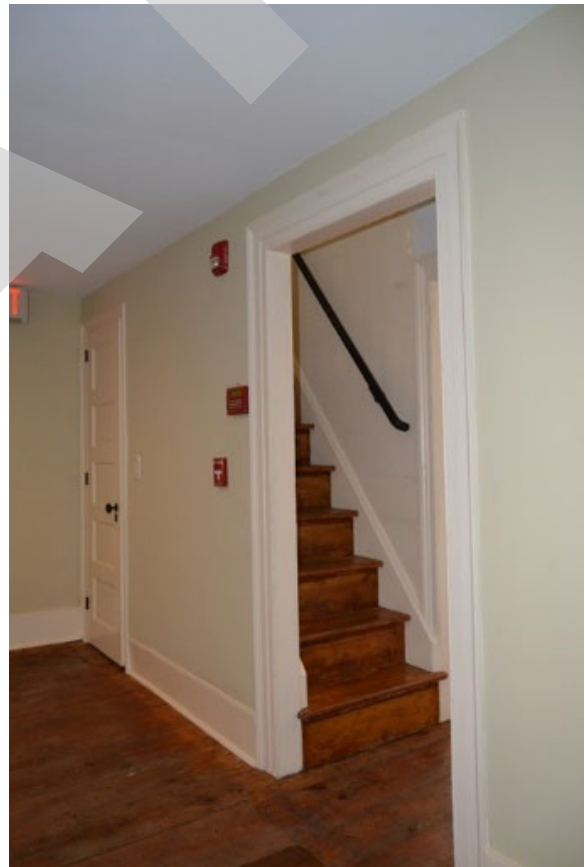
Photograph 15. The staircase situated between the center hall (Room 102) and west parlor (Room 103), looking southeast.

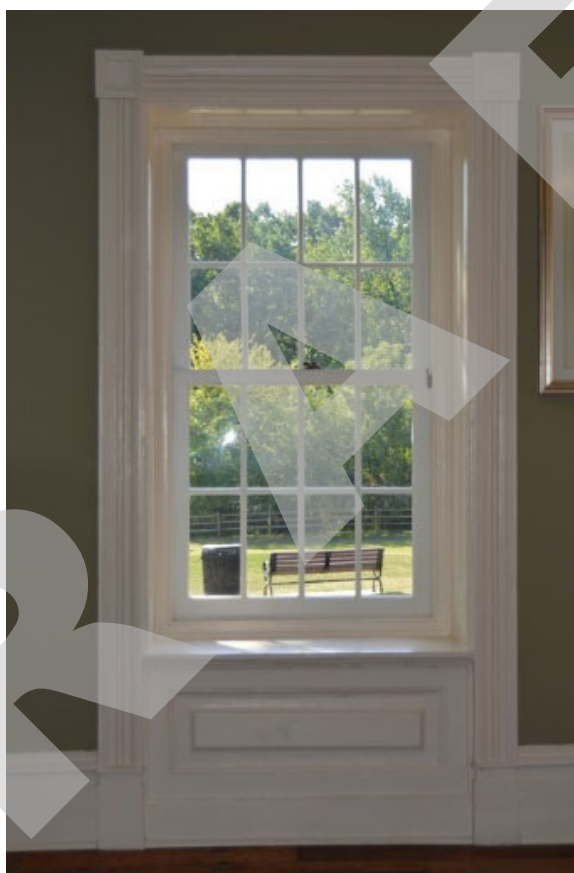
Photograph 17. A detailed view of a window in the west parlor (Room 103), looking southeast.

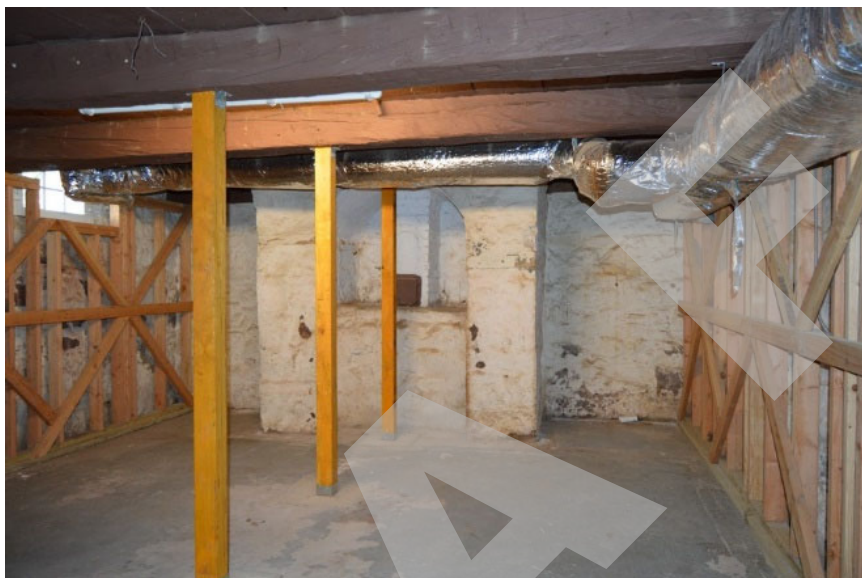
Photograph 20. The basement of the building's main block (Room 001), looking northeast.

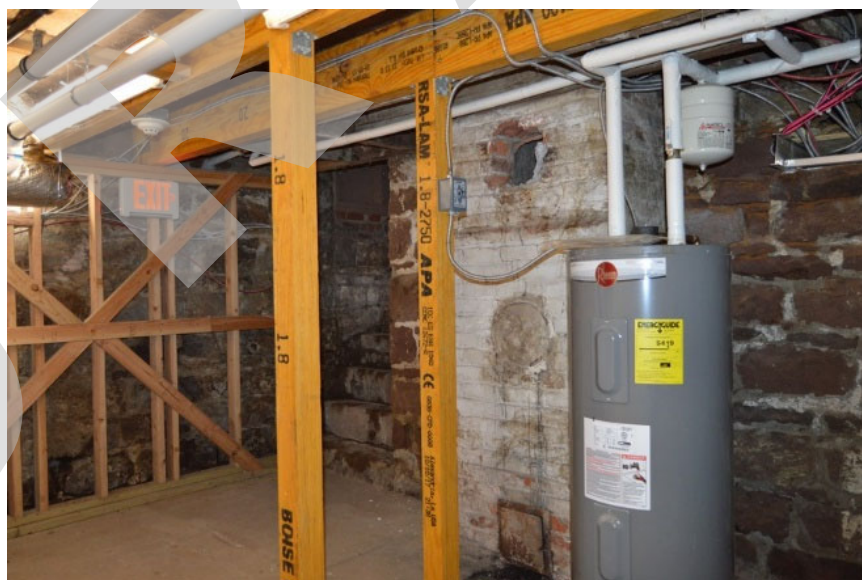
Photograph 21. The basement of the building's main block (Room 002), looking south.

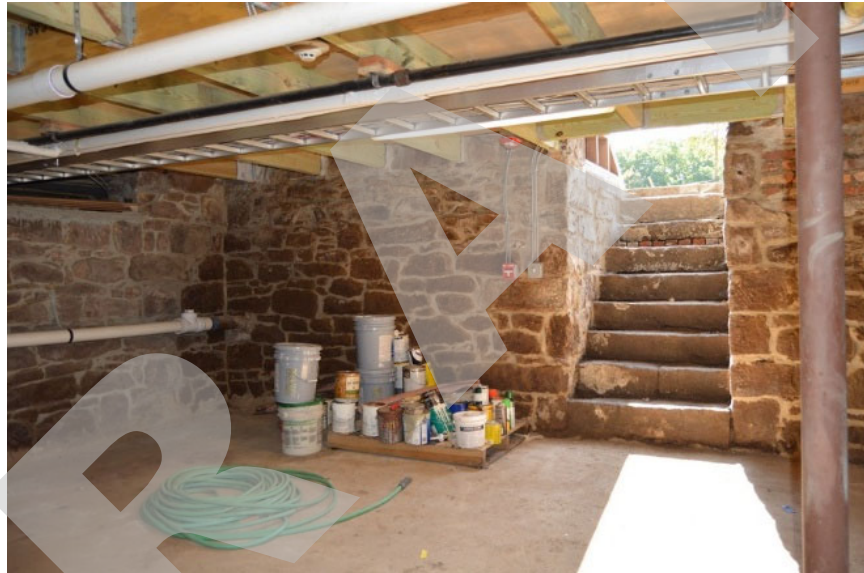
Photograph 22. The kitchen wing basement (Room 003), looking east.
