## National Register of Historic Places Registration Form

historic name Hinchman-Rickey Farm

street & number 435 and 442 Route 94

city or town Vernon

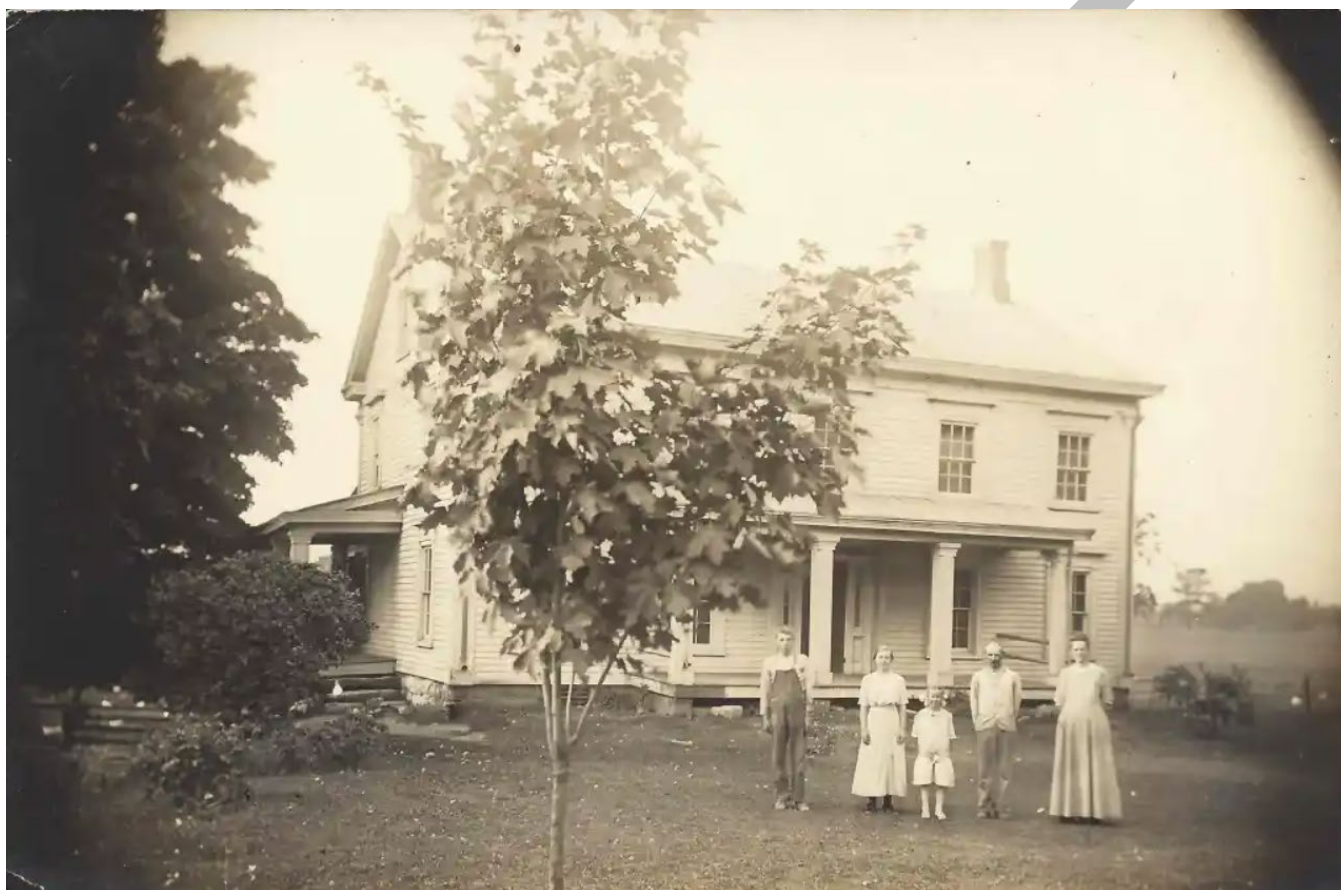
**Figure 4.** Circa 1912 view of the Rickey Farmhouse with the Rickey family.<sup>3</sup>

An enclosed one-bay wide by two-bay deep porch spans from the center of the house on its south side to a half bay over the rear extension (Photo 2). The porch is in poor condition but per the historic image (Figure 4) and the remaining material fabric, it has a low-slope hip roof with a built-in gutter and molded wood cornice, now partially covered by vinyl, that is supported by three turned posts. The east post is supported by a mixed stone and brick pier, the center post is unsupported, and the west post rests on a square wood post, which is replacement material. Under the porch is an access to the basement of the main core, which consists of a six-panel wood door with a five-light transom set in a molded wood surround. At the basement level of the extension and also located under the porch is a board-and-batten wood door with strap hinges set flush with the foundation. Concrete steps, set on a partial stone foundation, lead to a door opening on the east face of the porch. What remains at the first-floor level on the east side is the frame of a wood screen and vertical vinyl siding. On the south and west sides, there appears to have been a low vertical board wall with three grouped two-light sashes above in each porch bay. Based on the material fabric and the historic images (Figure 4), the porch roof overhang and possibly elements of the foundation are original, but the stairs, columns, and deck, which are wood, appear to be early-20<sup>th</sup> century material possibly taken from other buildings. The columns at the side porch appear to match the columns on the front porch, which are original.

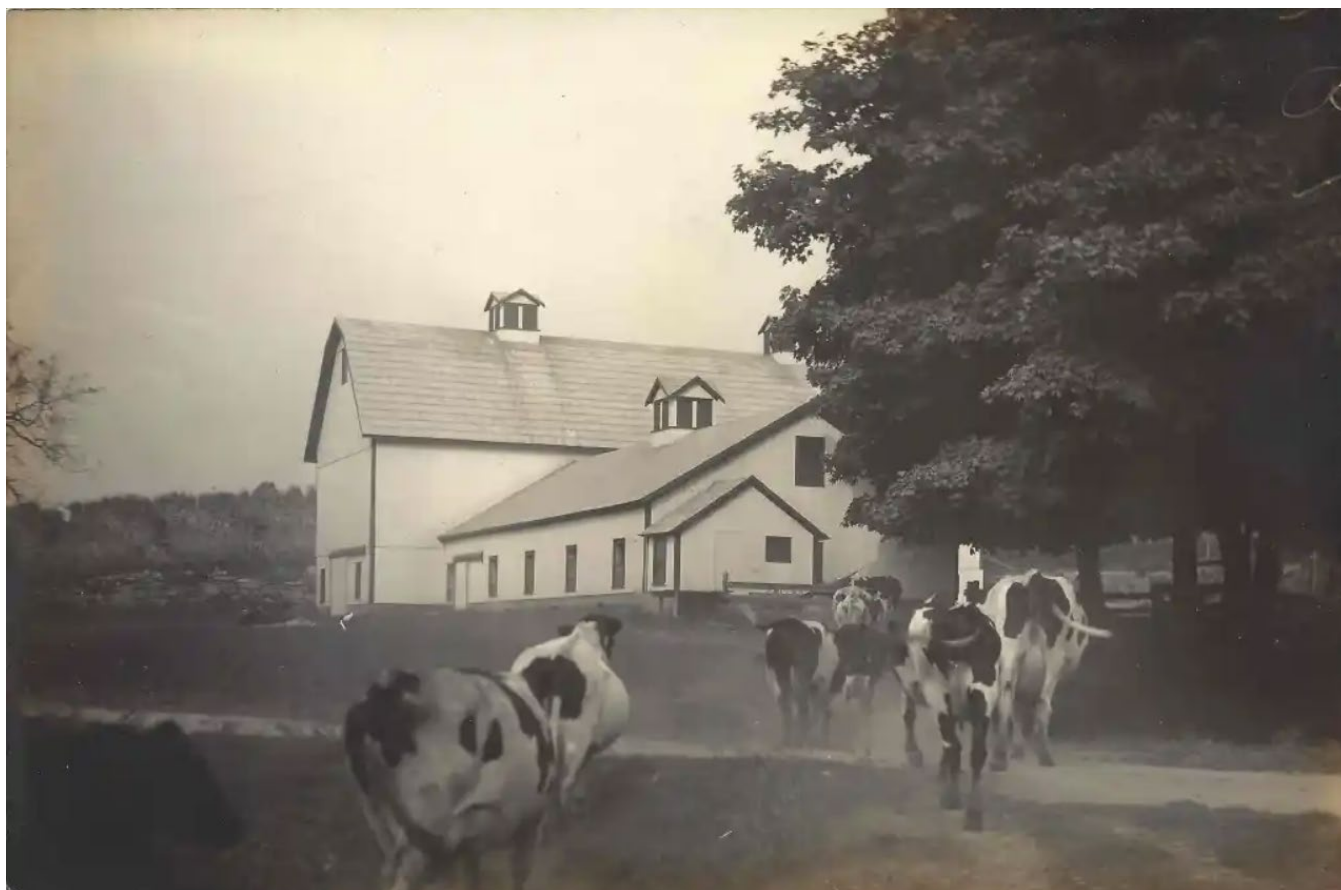
**Figure 5.** Circa 1912 view of the original dairy barn from the Rickey farmhouse.<sup>4</sup>

Dairy (cheese, butter, and liquid milk) at the Hinchman-Rickey Farm was the main agricultural product by the late-19<sup>th</sup> century and it appears that the property had at least three dairy barns. The first was struck by lightning in 1919 and the second was destroyed by fire in 1936. There is an historic image of the second barn (Figure 5) that shows a Dutch-style gambrel roof main barn and a smaller gable roof milk house attached to it. This style and form of the dairy barn was typical for the period and reflected changes in dairy operations that emphasized the issues of health and hygiene, which was critical due to the high incidents of cattle disease at the turn of the 20<sup>th</sup> century. These problems and the methods for addressing them were published in newspapers and agricultural journals as well as addressed by the federal and state government.<sup>75</sup> *Farm Buildings*, published by *The Breeder's Gazette* in 1911, notes of

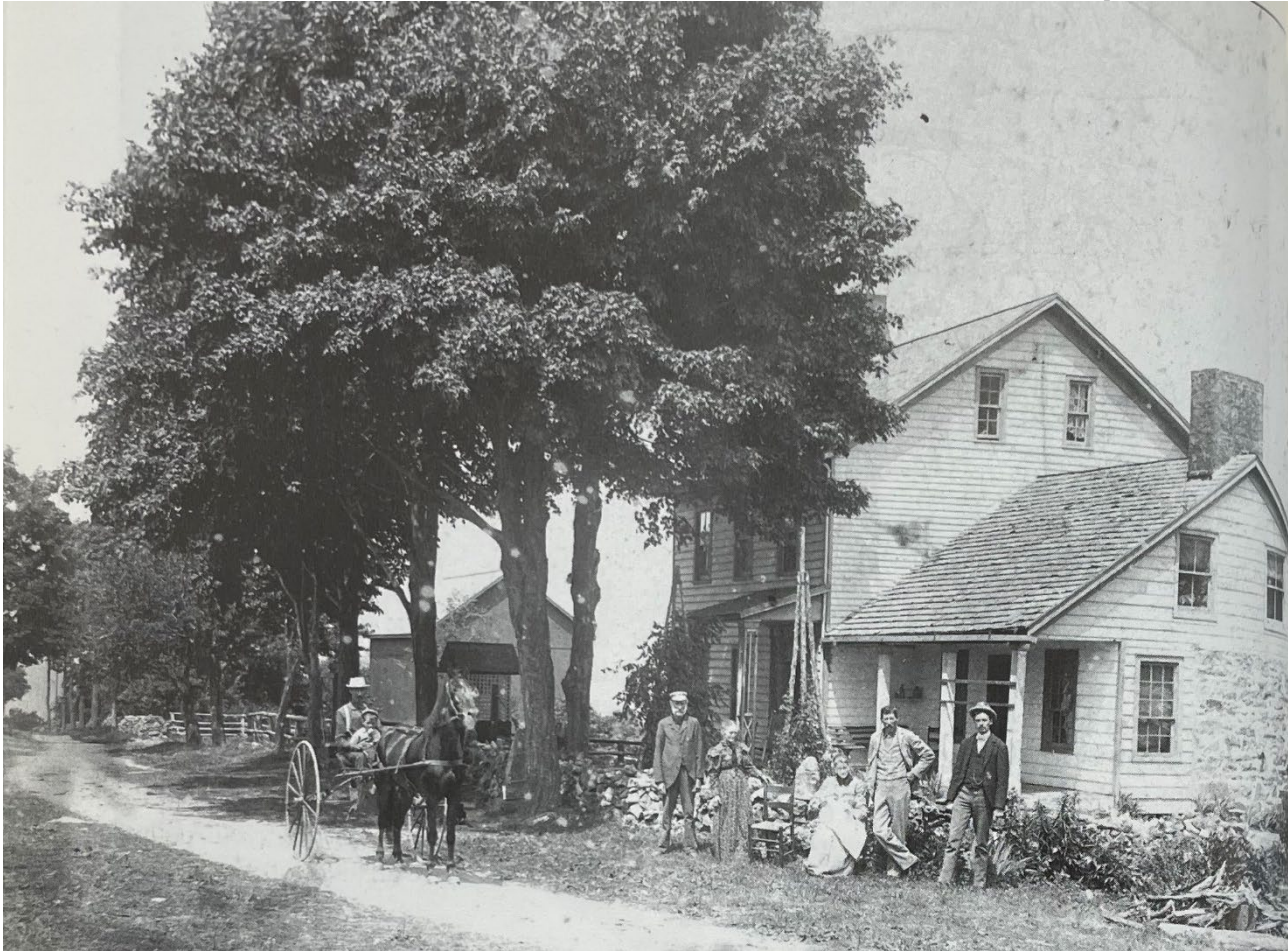
**Figure 7.** Historic image of High Breeze Farm, aka Barrett Farm, constructed c. 1828, showing simple Greek Revival detailing at the porch of the two-story section.<sup>6</sup> High Breeze Farm is located a few miles northwest of the Hinchman-Rickey farm within the Wawayanda Mountains.

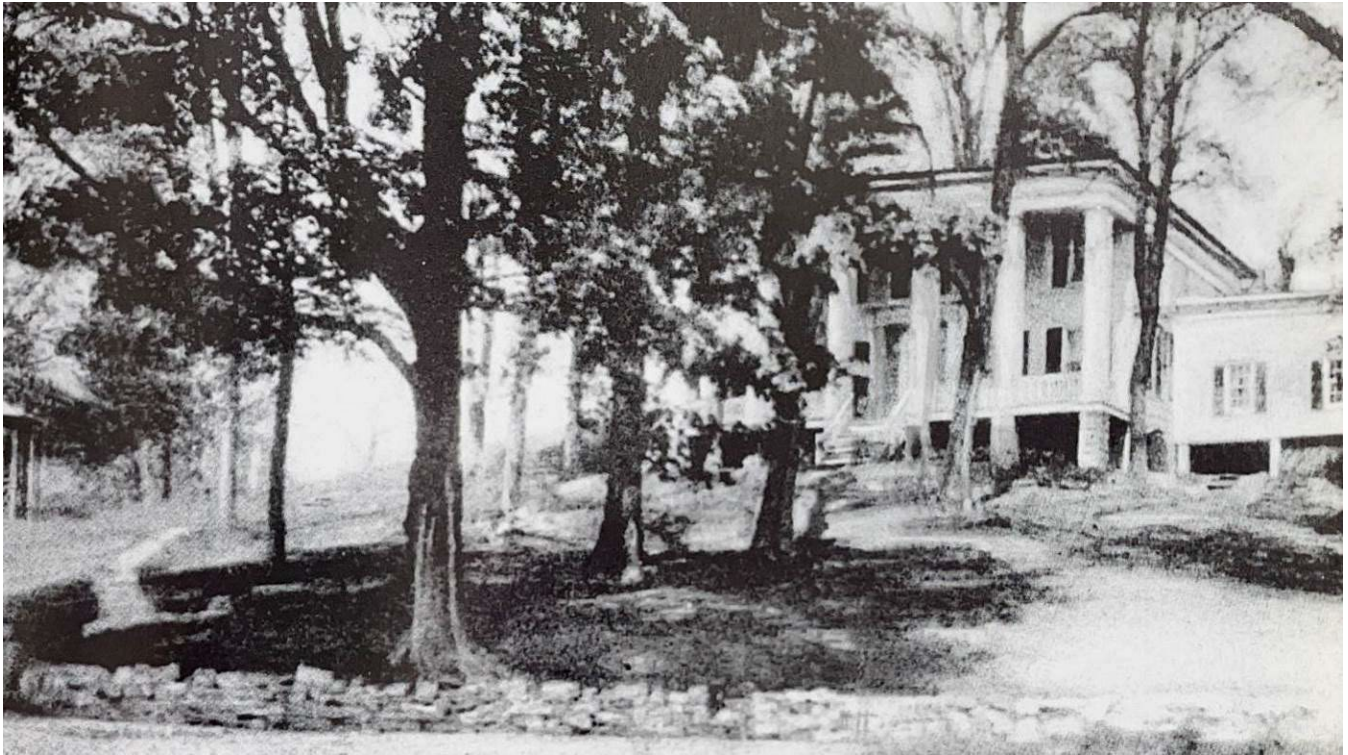
**Figure 8.** Historic image of the Claremont, constructed c. 1841, which is an example of a high-style Greek Revival residence constructed for the Lawrence family.<sup>7</sup> The house was located in Hamburg, a town a few miles south of the Hinchman-Rickey Farm.

*Lawrence Mansion (Hamburg, New Jersey):* Lawrence Mansion, also known as “Claremont,” (Figure 8) was constructed in 1841 and listed on the National Register in 1979. It is an excellent example of the Greek Revival style, with a full-façade porch. Like the Hinchman-Rickey Farmhouse, almost all of the original interior wood trim remains and exhibits a high degree of craftsmanship. This includes the entrance, which has a simple entablature and full transom light. While they both have the same general floor plan, five-bays wide, two-bays deep, and a center hall, the kitchen at Lawrence Mansion was historically located in the basement, and later in a since-demolished wing. Additionally, the staircase turns halfway up, whereas in the Hinchman-Rickey Farmhouse, it has a straight run. In the 1980s, Lawrence Mansion was restored and adapted for commercial use.<sup>61</sup>

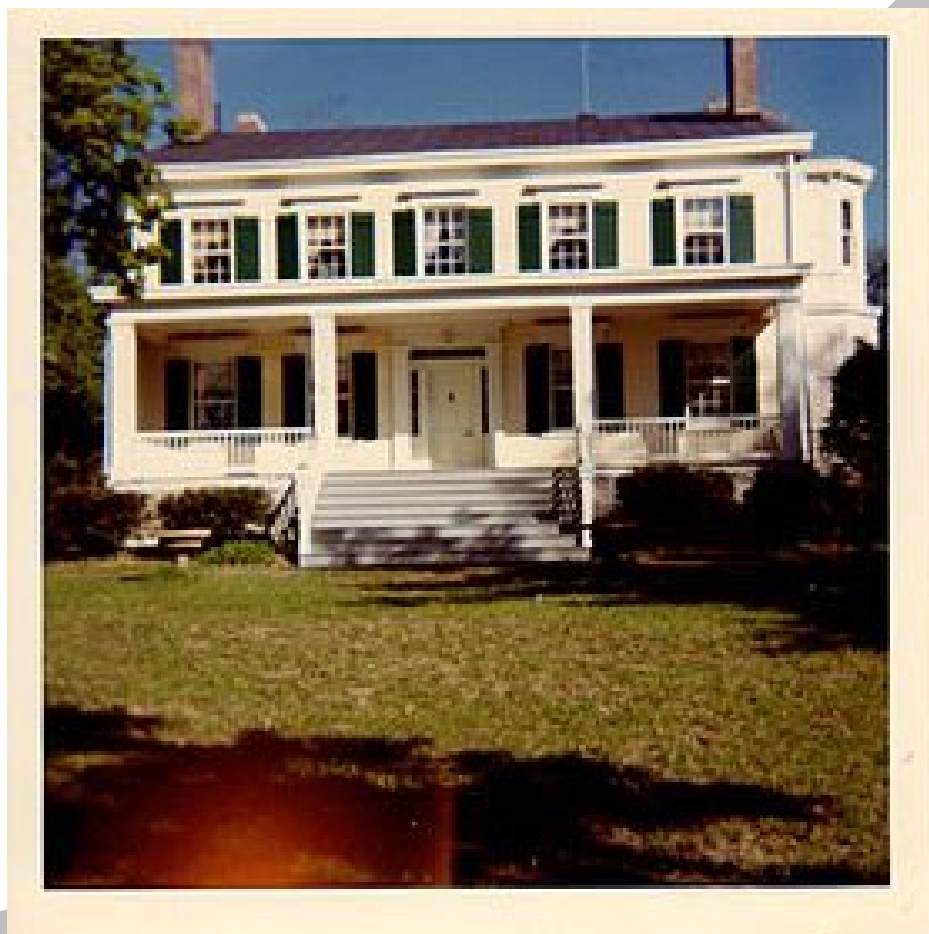
**Figure 9.** A 2004 image of the George T. Wisner House, Goshen, NY.<sup>8</sup>

*George T. Wisner House (Goshen, New York):* The George T. Wisner House (Figure 9), also known as “Oak Hill,” was constructed circa 1840 and listed on the National Register in 2005. It is similar to the Hinchman-Rickey Farmhouse in form and style, except it has a full-width porch, is four bays deep, as opposed to two, and has a large rear addition. The interior has a mixture of Greek Revival and Federal style elements, the latter of which can be seen in the mantels, doors and architrave moldings. Another difference between these two dwellings can be seen in the placement of the fireplaces. While in both, they are placed on the out walls, in the George T. Wisner House they are centered, but in the Hinchman-Rickey Farmhouse they are set to the east sides. Furthermore, the George T. Wisner House has wide plank floors, while the Hinchman-Rickey Farmhouse has – where exposed – narrow to medium width floorboards.<sup>62</sup>

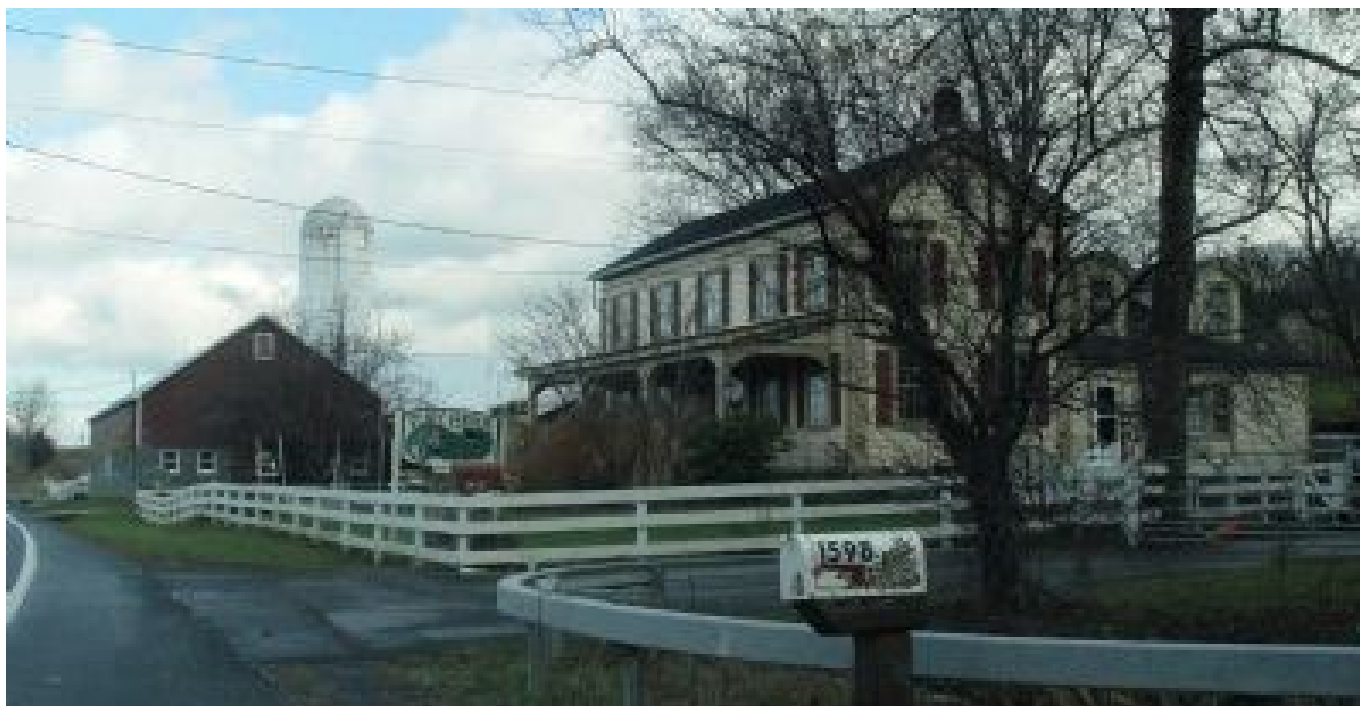
**Figure 10.** 2009 image of the farmhouse at Furybrook Farm in Chester, Orange County, New York.<sup>9</sup>

*Fury Brook Farm (Sugar Loaf, New York):* Fury Brook Farm (Figure 10), also known as “Bairdlea Farm,” was constructed circa 1856 and listed on the National Register in 2004. It is similar to the Hinchman-Rickey Farmhouse in its form and style, except it has a full-width porch. Additionally, it has a rear, one-story addition spanning the full width of the house that was historically used as a kitchen, like the Hinchman-Rickey Farmhouse. However, this rear addition is two-bays deep, as opposed to one. The Fury Brook Farm also has Greek Revival interior finishes, like those found at Hinchman-Rickey Farm, including its doors, mantels, stairway with turned newel post and balusters, plank floors, and use of plaster.<sup>63</sup>

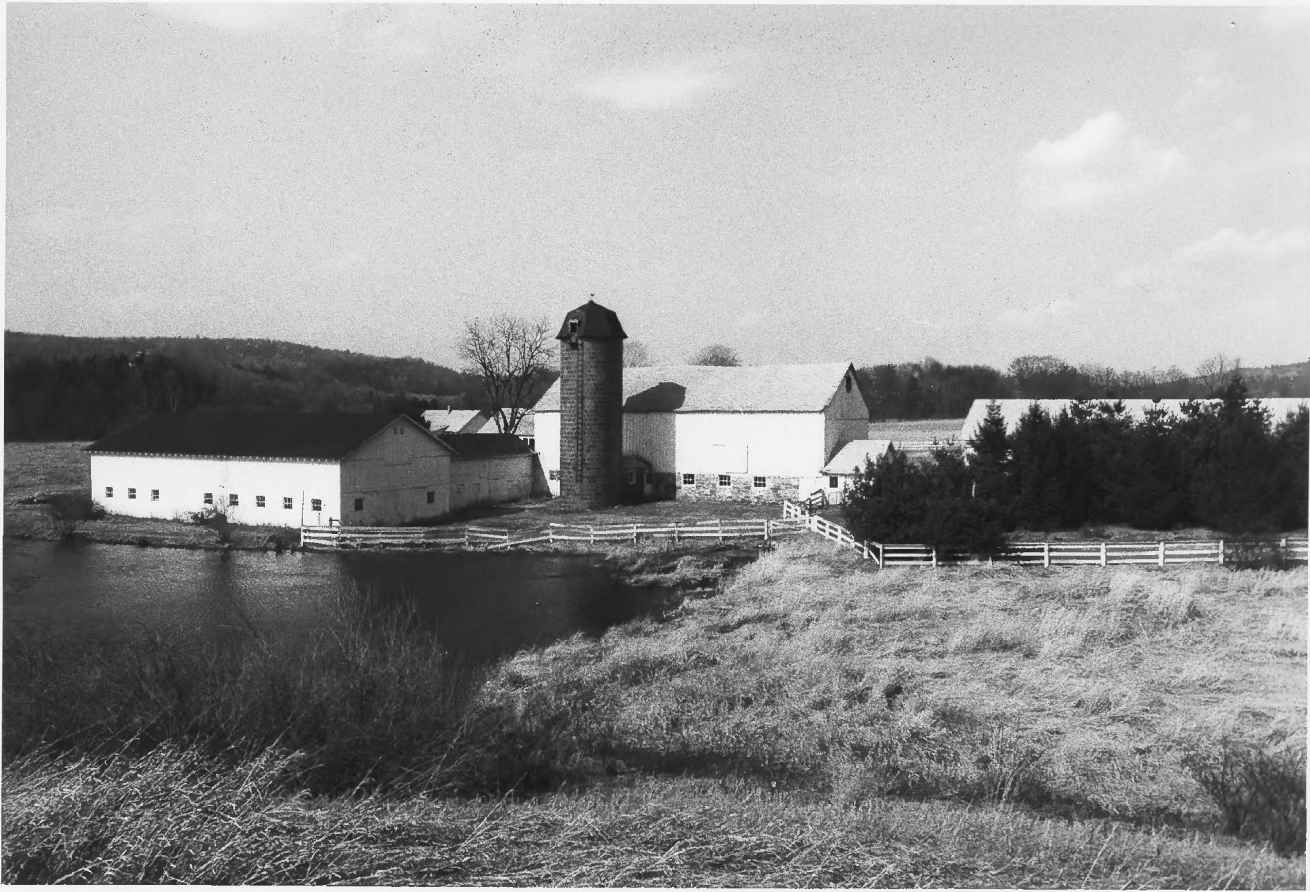
**Figure 11.** Late-20<sup>th</sup> century image of the barn and other outbuildings at the Shoemaker-Houck Farm in Walpack, New Jersey.<sup>10</sup>

*Shoemaker-Houck Farm (Walpack, New Jersey):* The Shoemaker-Houck Farm (Figure 11) was established in the early 19<sup>th</sup> century and listed on the National Register in 1979. A house and six outbuildings sit on a 145.39-acre property. Such outbuildings include a large, early 19<sup>th</sup> century barn with vertical wood siding; a tiled silo; a workshop; a connected icehouse and milkhouse, built c. 1829 and in 1854, respectively; and a storage building from c. 1948-1957. The town of Walpack was mostly abandoned in the 1960s for the Tock Island Dam project, which never came to fruition. Today, the abandoned farm is part of the Delaware Water Gap National Recreation Area.<sup>85</sup>

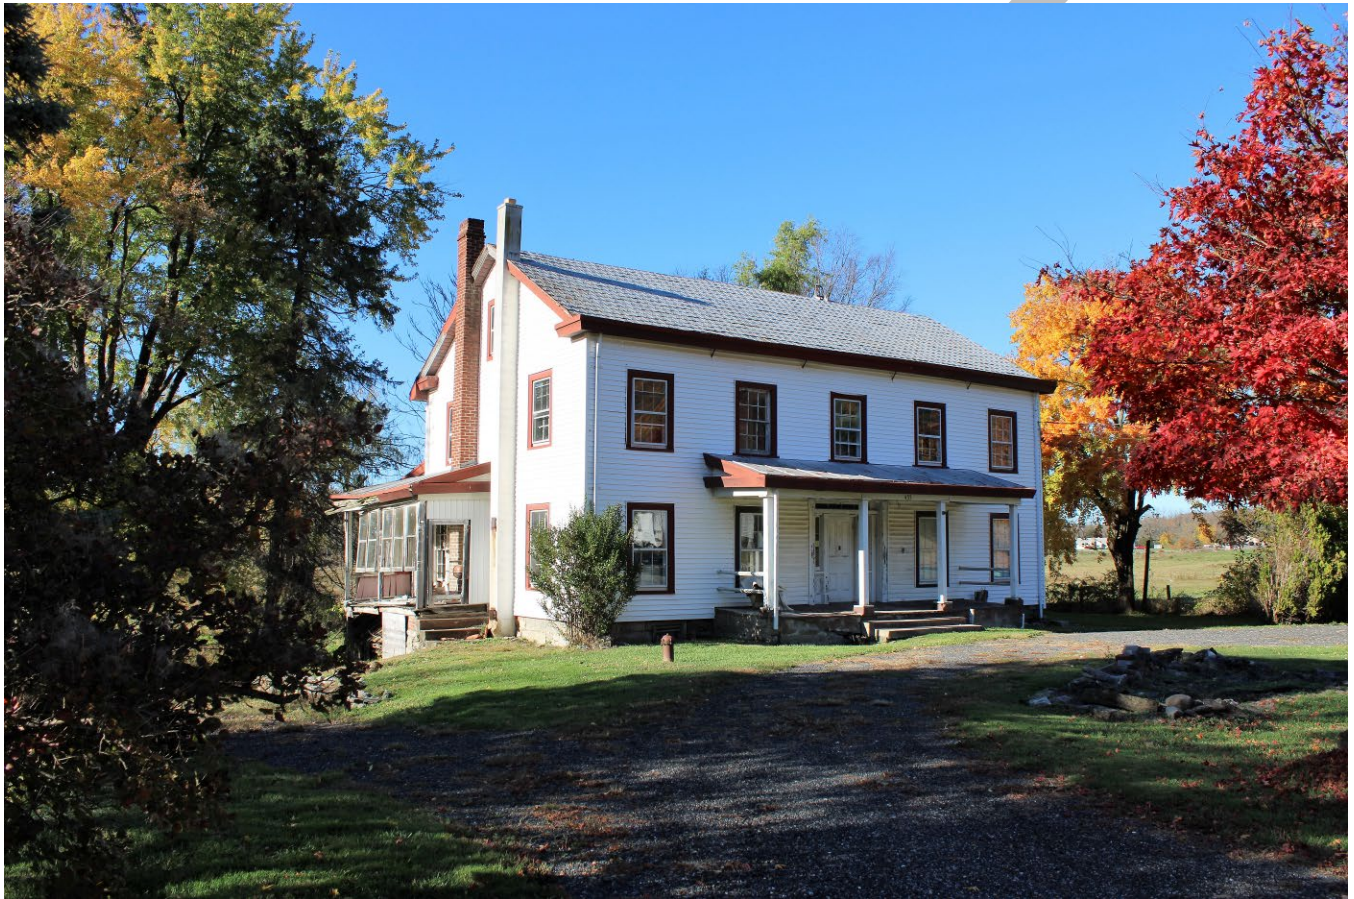
**Photo 0001:** View of the front (east) elevation of the farmhouse, camera facing north.

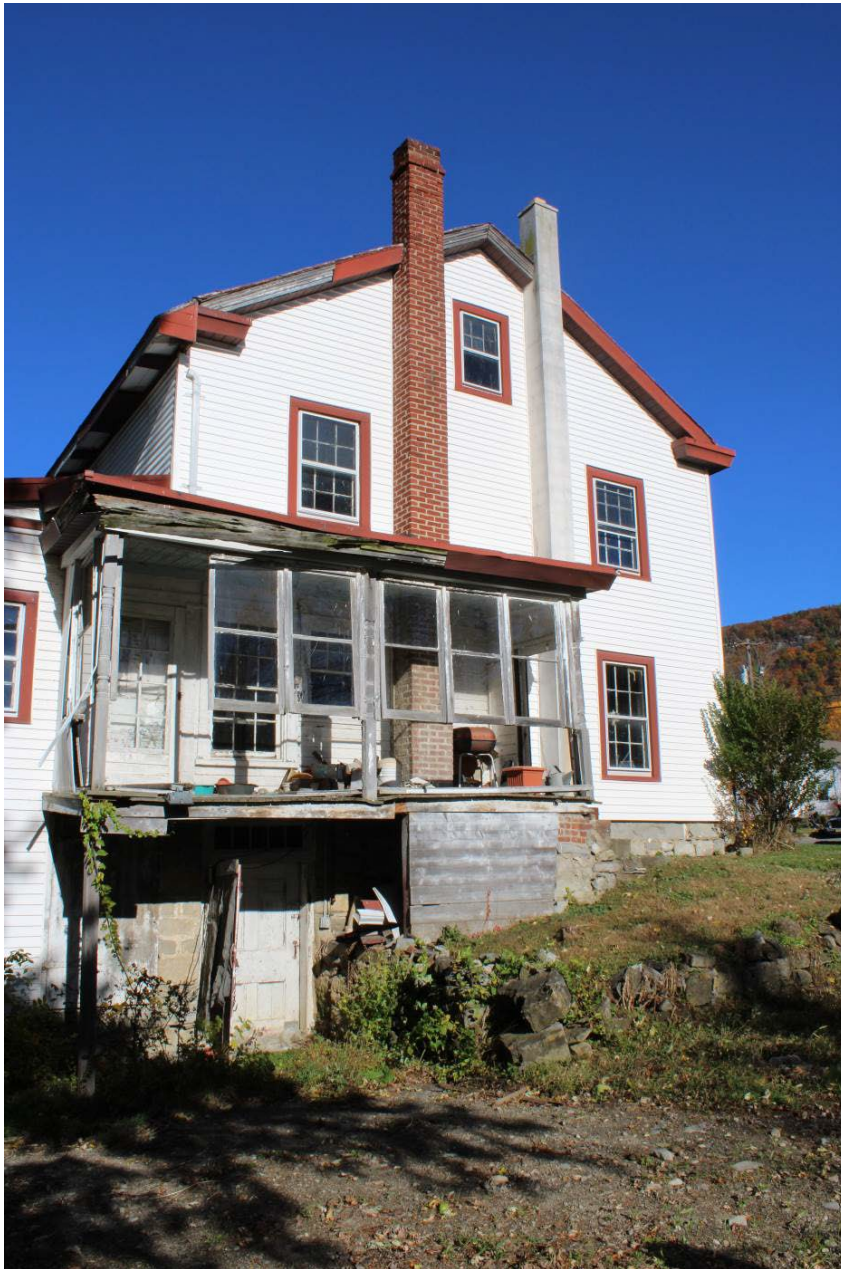
**Photo 0002:** View of the south elevation of the farmhouse showing the side porch, camera facing northeast.

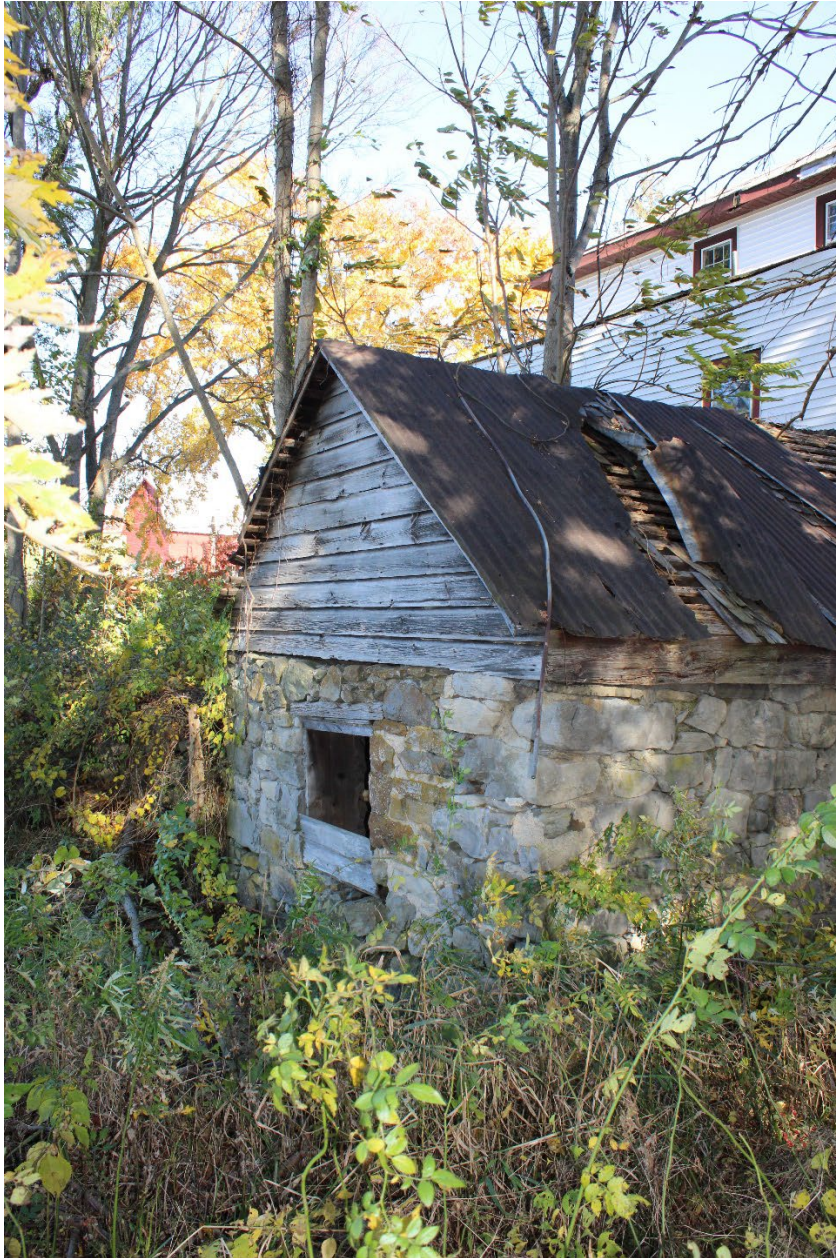
**Photo 0003:** View of the west side of the farmhouse showing the partial elevation of the main house and its fenestration, camera facing northeast.

A one-story extension spans the entirety of the rear (west) elevation; it is one-bay deep, has a shed roof, and is finished similarly to the farmhouse with the vinyl siding cladding from just above grade to the underside of the roof. The foundation, where exposed, is rough uncoursed limestone. This extension served as an out kitchen and includes a stone spring box enclosing a natural spring on the south end and is partitioned off from the rest of the rear cellar. The masonry separating the main core and rear extension shows two distinct phases of construction, but both were possibly constructed within a few years of each other given the first-floor framing at the extension is mostly composed of hand-hewn timbers. The fenestration at the west elevation consists of three equally-spaced six-over-six wood-hung windows at the first floor of the rear extension. At the second floor of the main core are single six-over-six wood-hung windows in the two center bays (Photo 3).

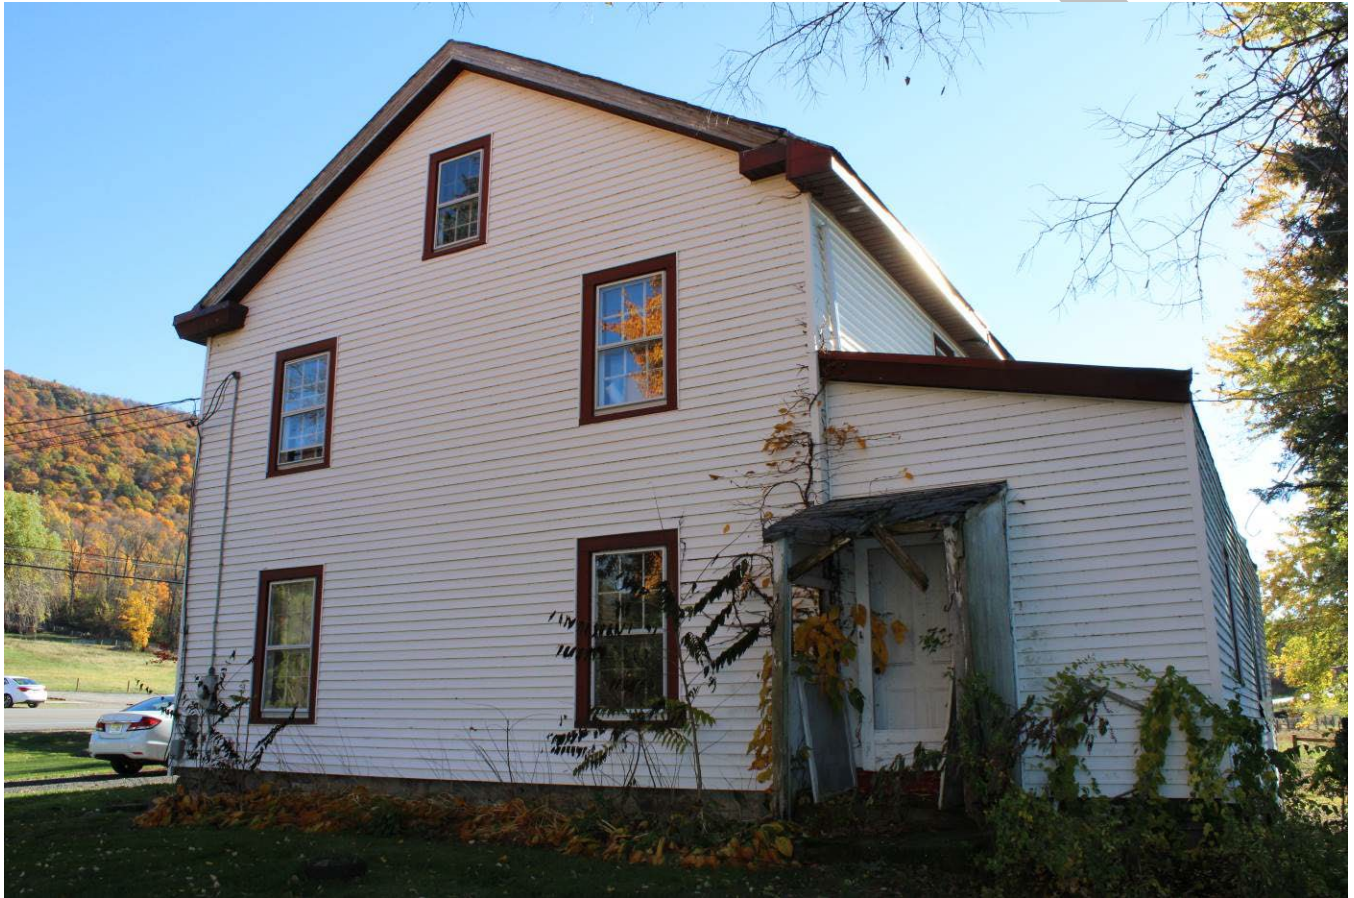
**Photo 0004:** View of the north elevation of the farmhouse, camera facing south.

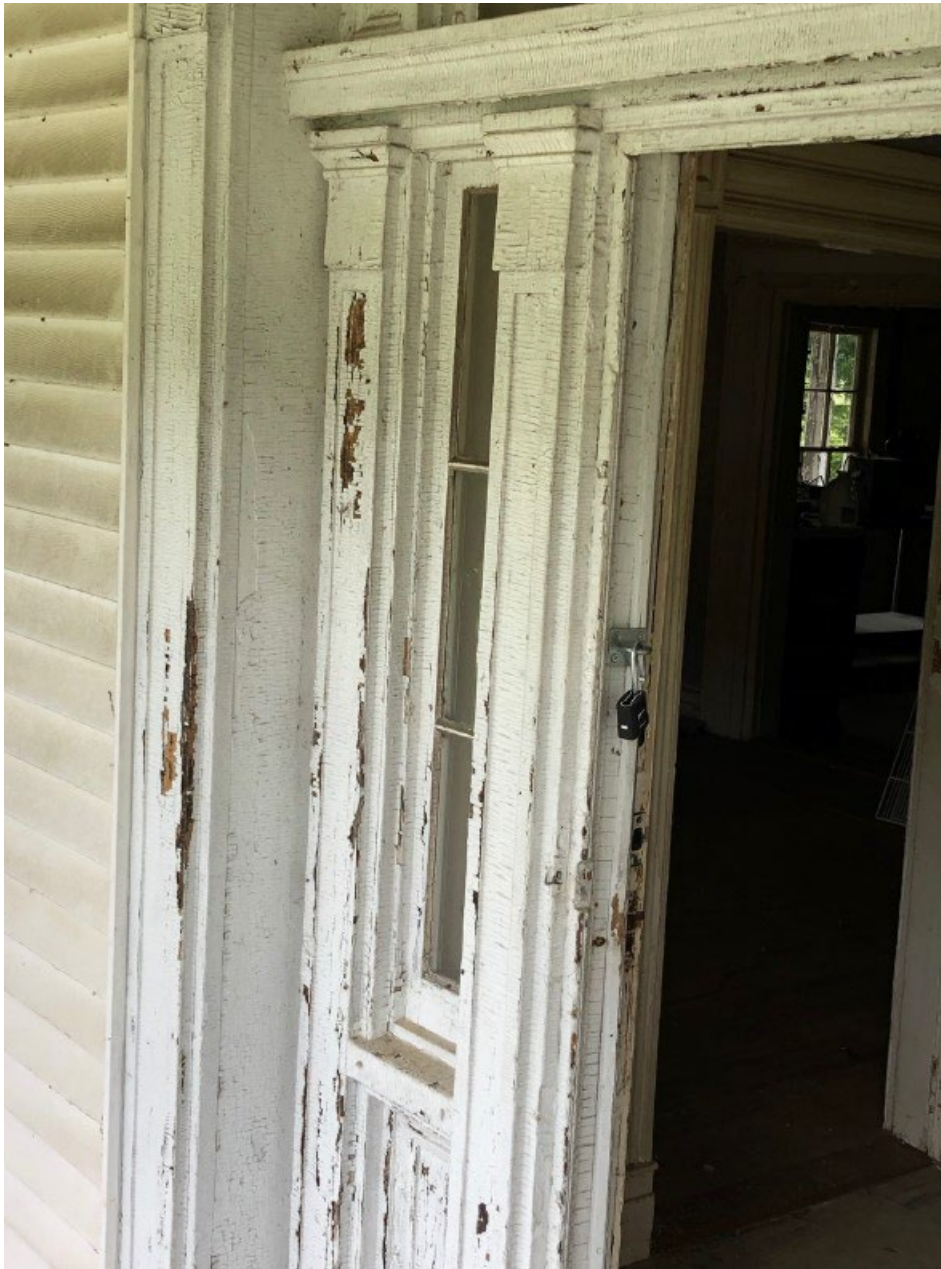
**Photo 0005:** Detail view of the front entrance surround from the exterior at the farmhouse, camera facing southwest.

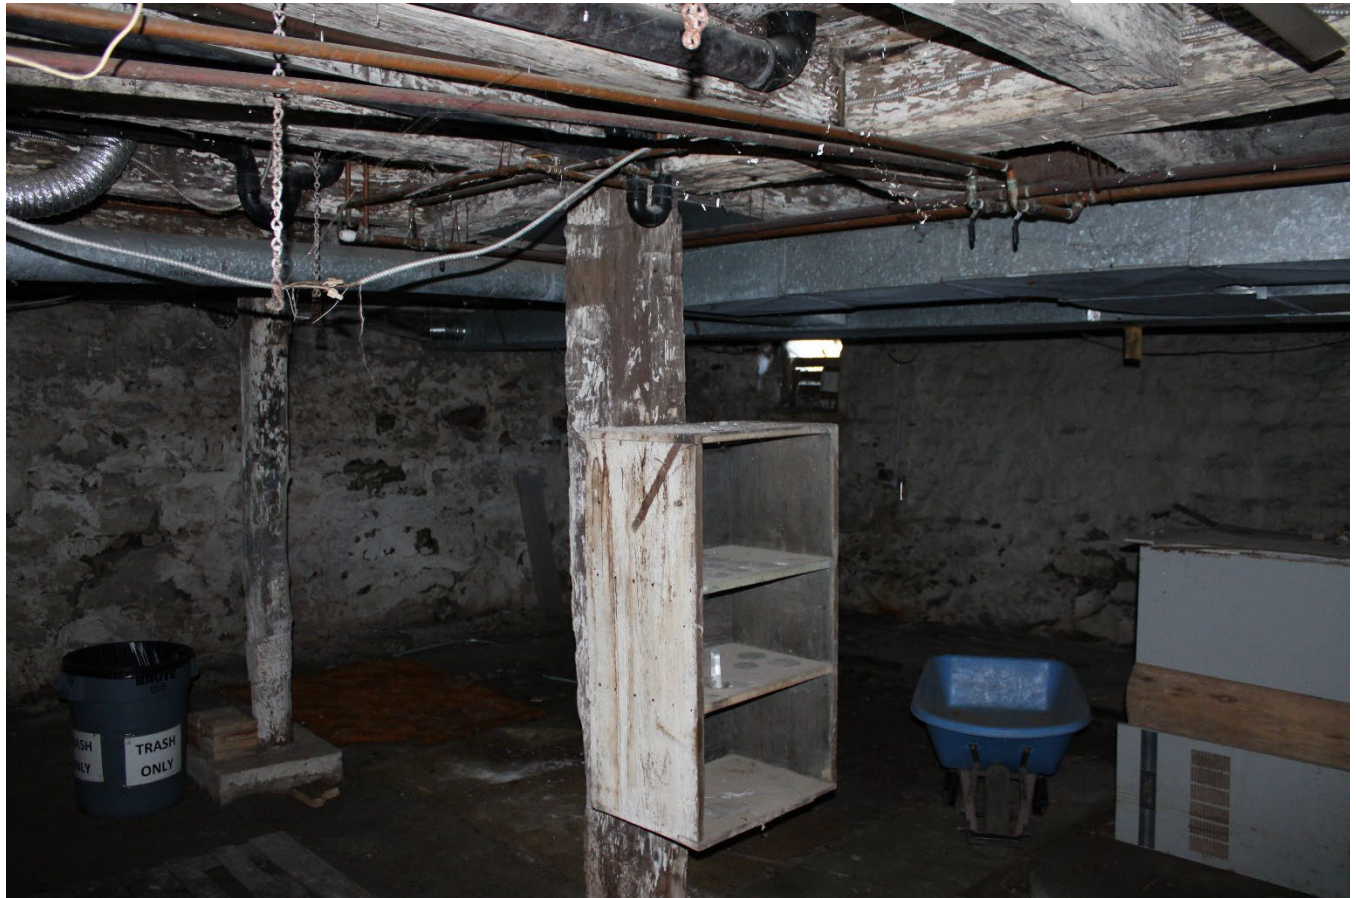
**Photo 0006:** Overall view of the basement within the farmhouse, camera facing northeast.

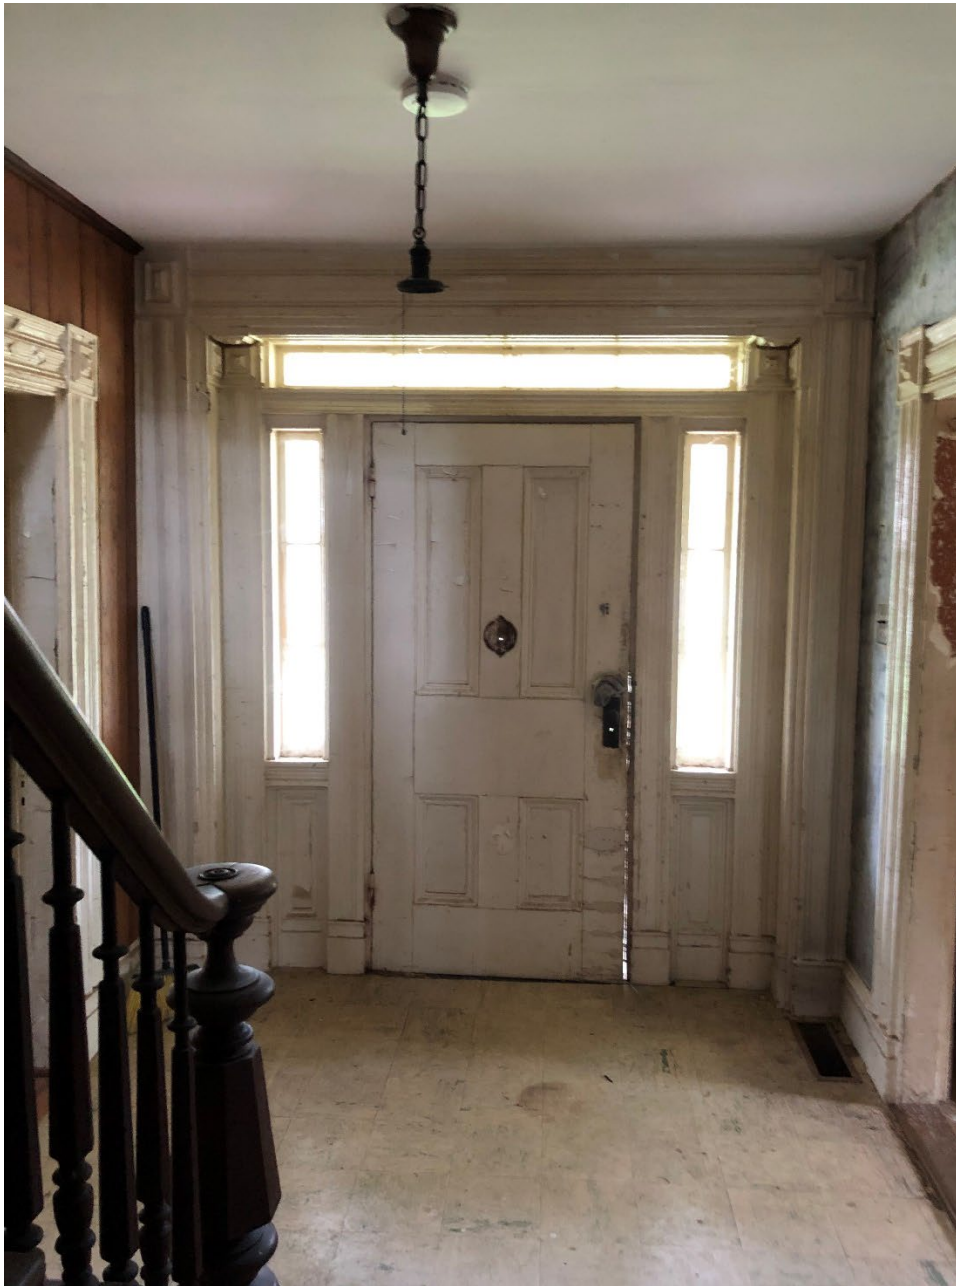
**Photo 0007:** View looking at the front entrance door assembly within the farmhouse, camera facing east.

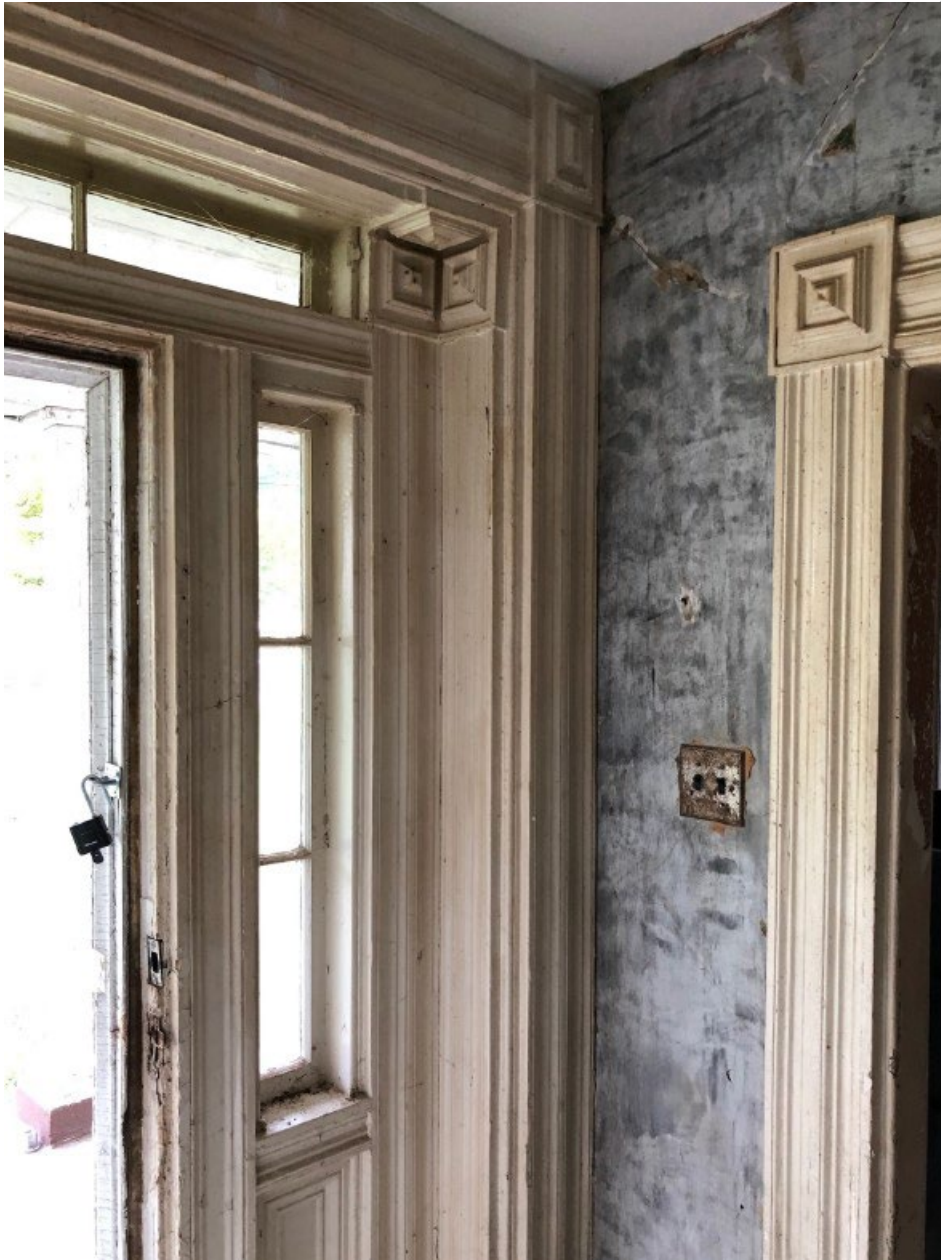
**Photo 0008:** Detail view of the front entrance trim and moldings, camera facing south.

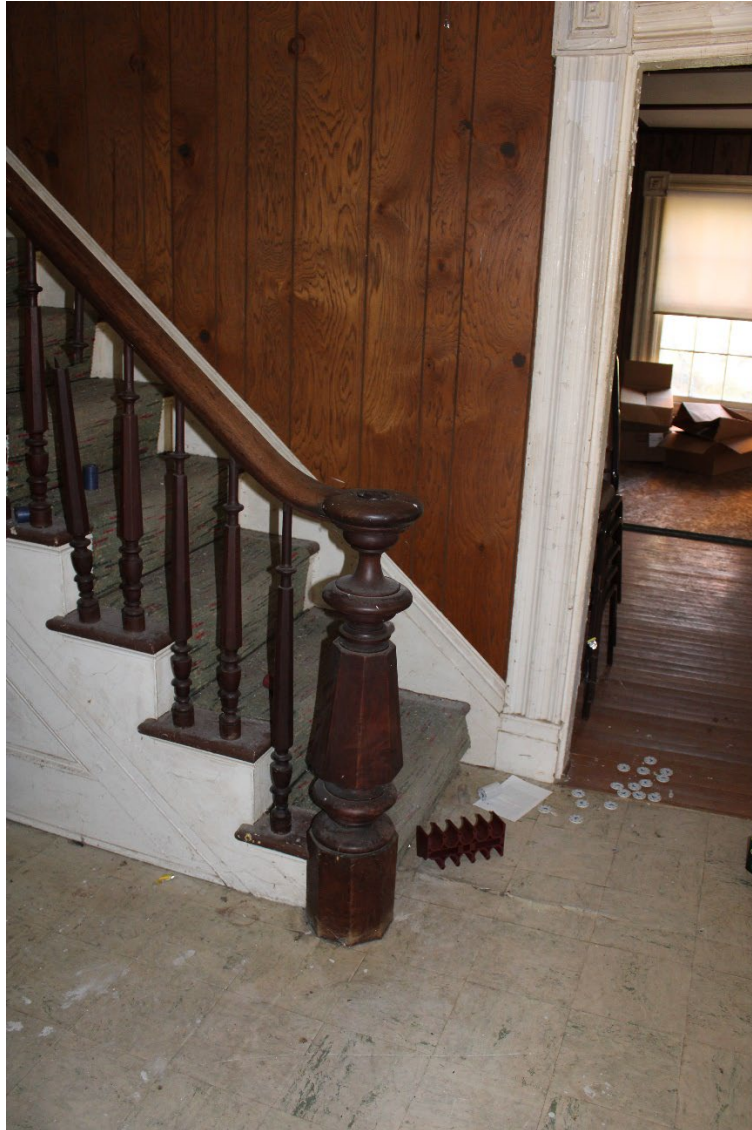
**Photo 0009:** Detail view of the stair including newel post and balusters beyond, camera facing north.

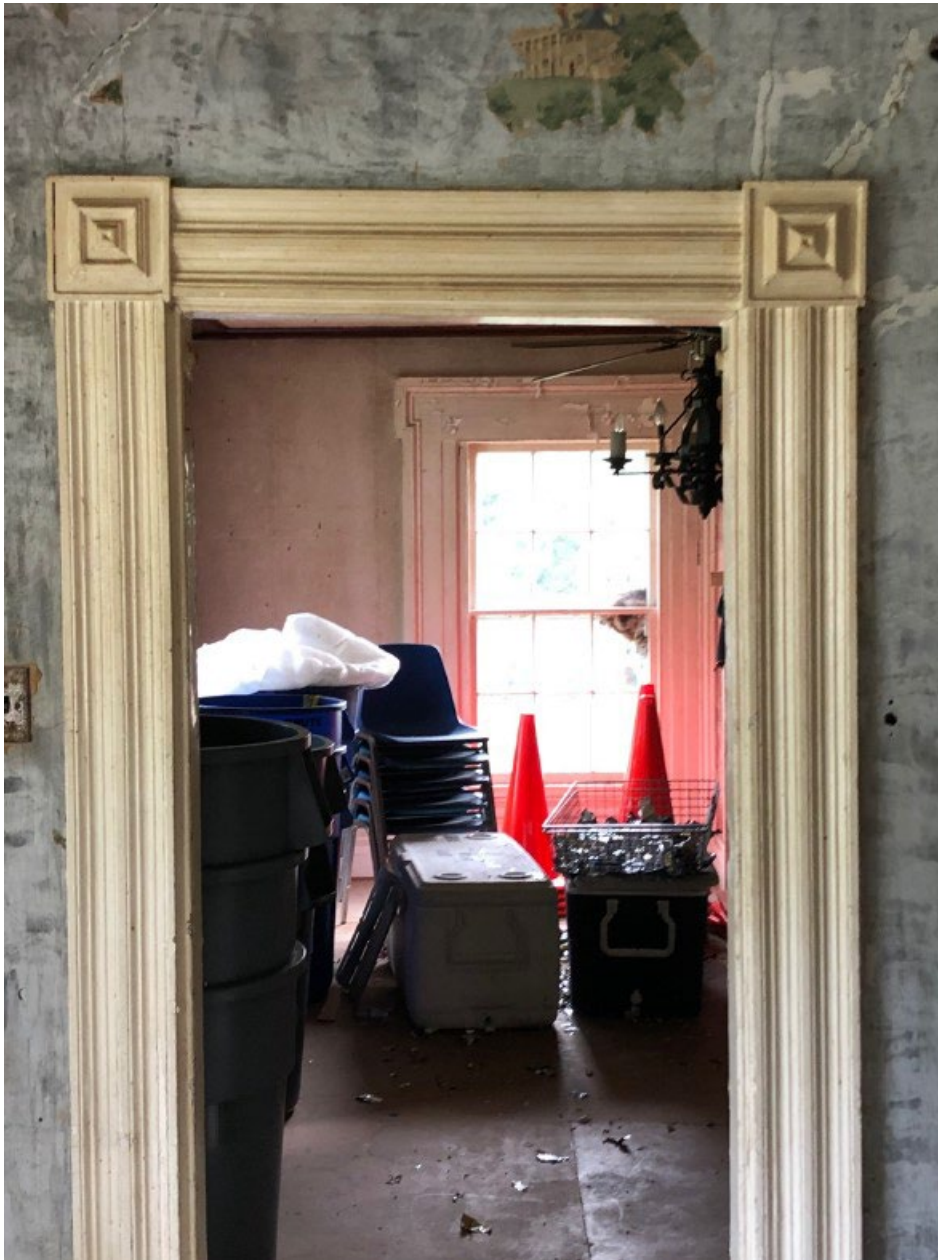
**Photo 0010:** View of typical fluted door molding, camera facing southwest towards Room 102.

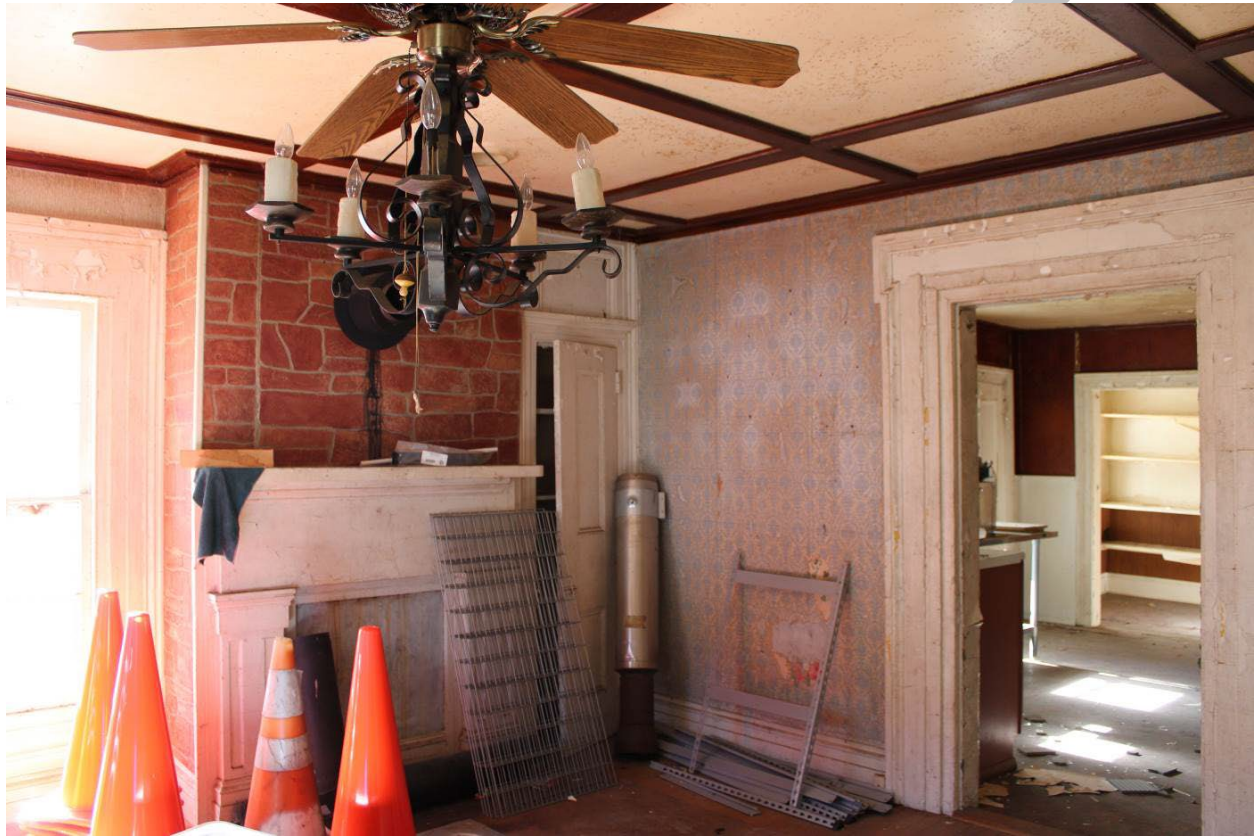
**Photo 0011:** View of Room 102 showing simpler eared moldings, camera facing west.
