## National Register of Historic Places Registration Form

historic name Hinchman-Rickey Farm

street & number 435 and 442 Route 94

city or town Vernon

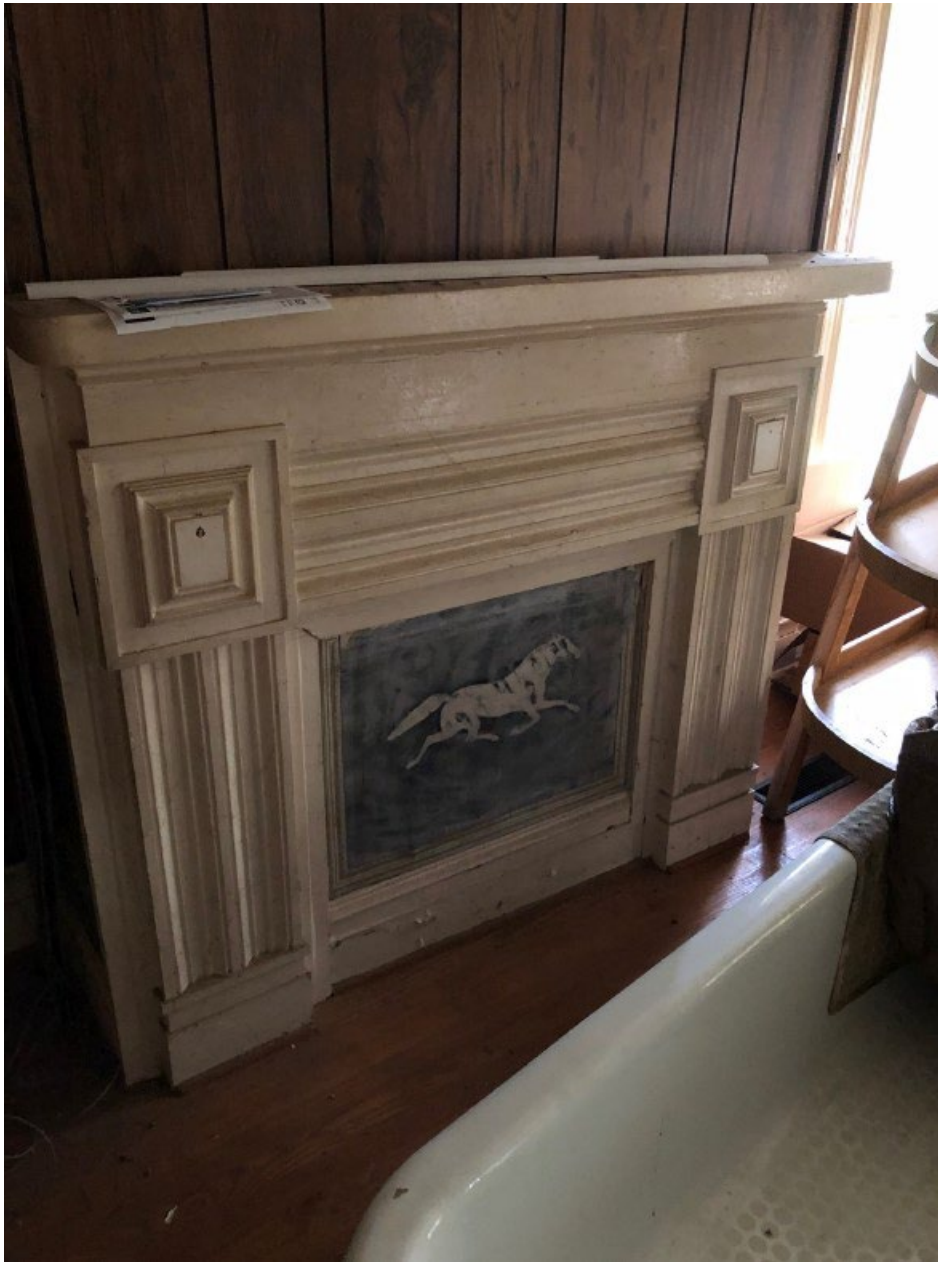
**Photo 0012:** View of the fireplace in Room 106, camera facing east.

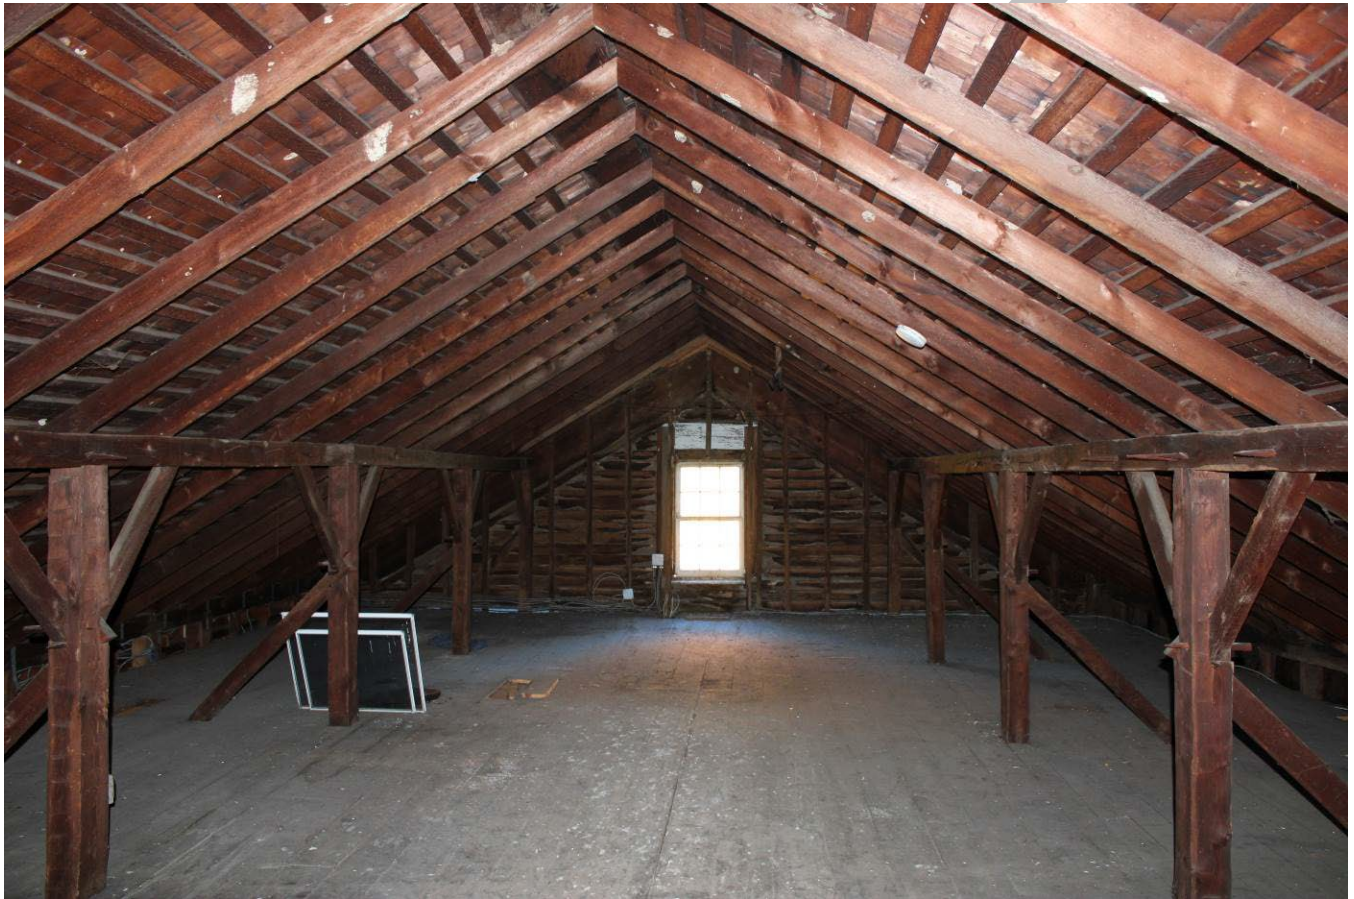
**Photo 0014:** View of the attic showing the exposed framing and earlier wood roof shingles, camera facing north.

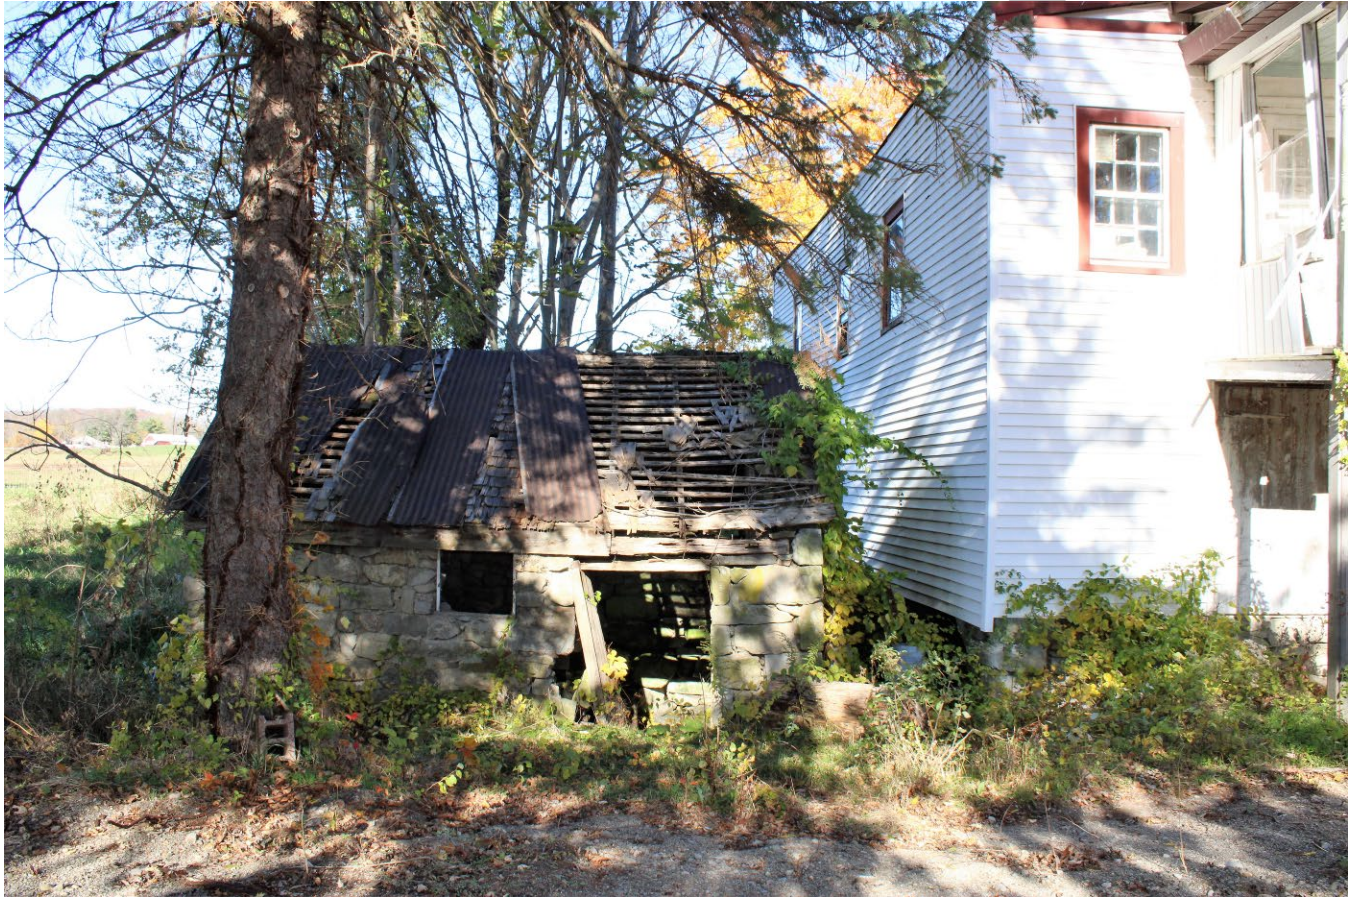
**Photo 0015:** View of the south elevation of the spring house, camera facing northeast.

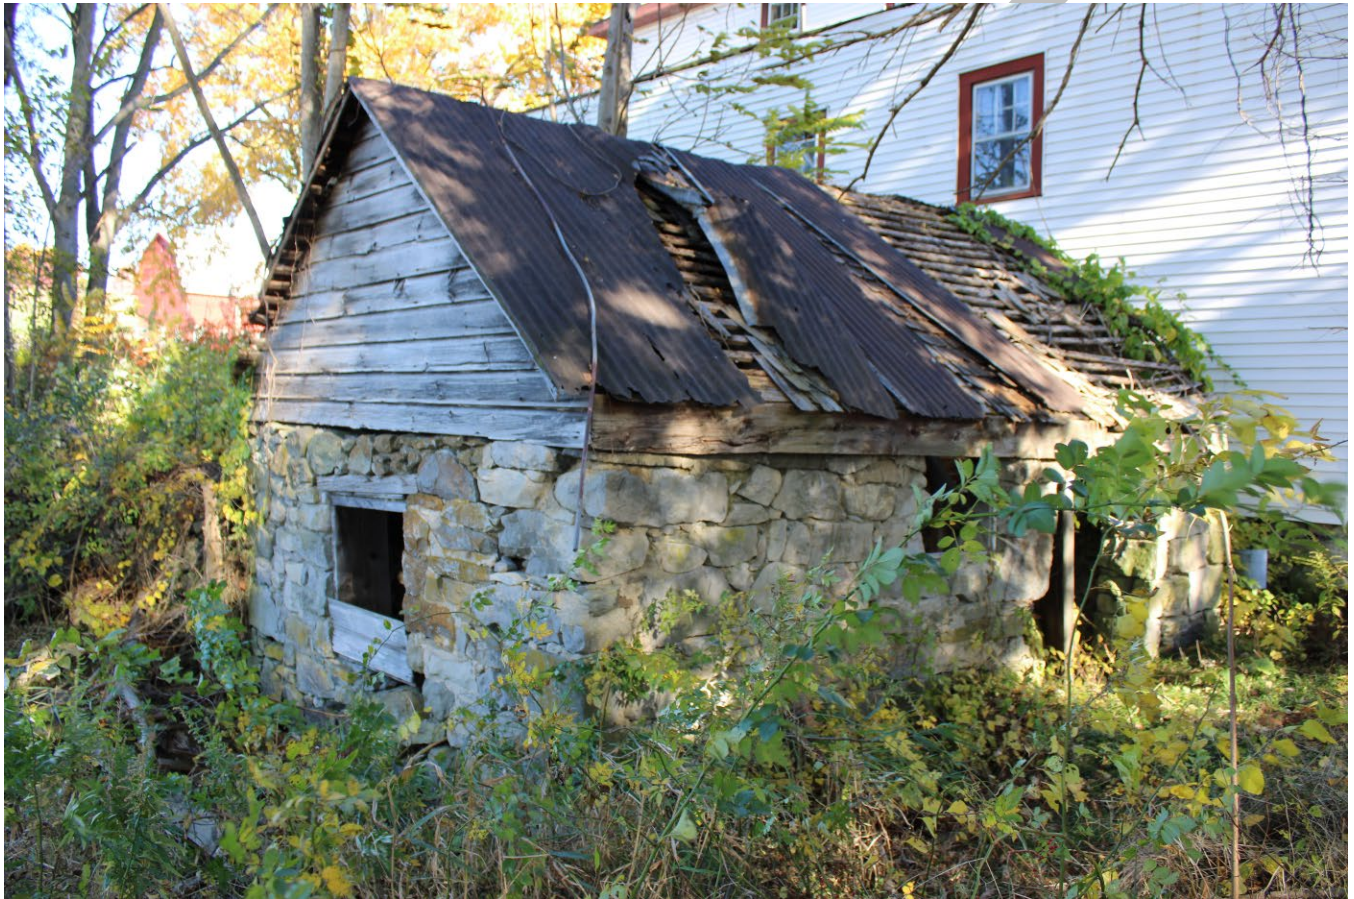
**Photo 0016:** View of the west and south elevations of the spring house with the west elevation of the farmhouse beyond, camera facing east.

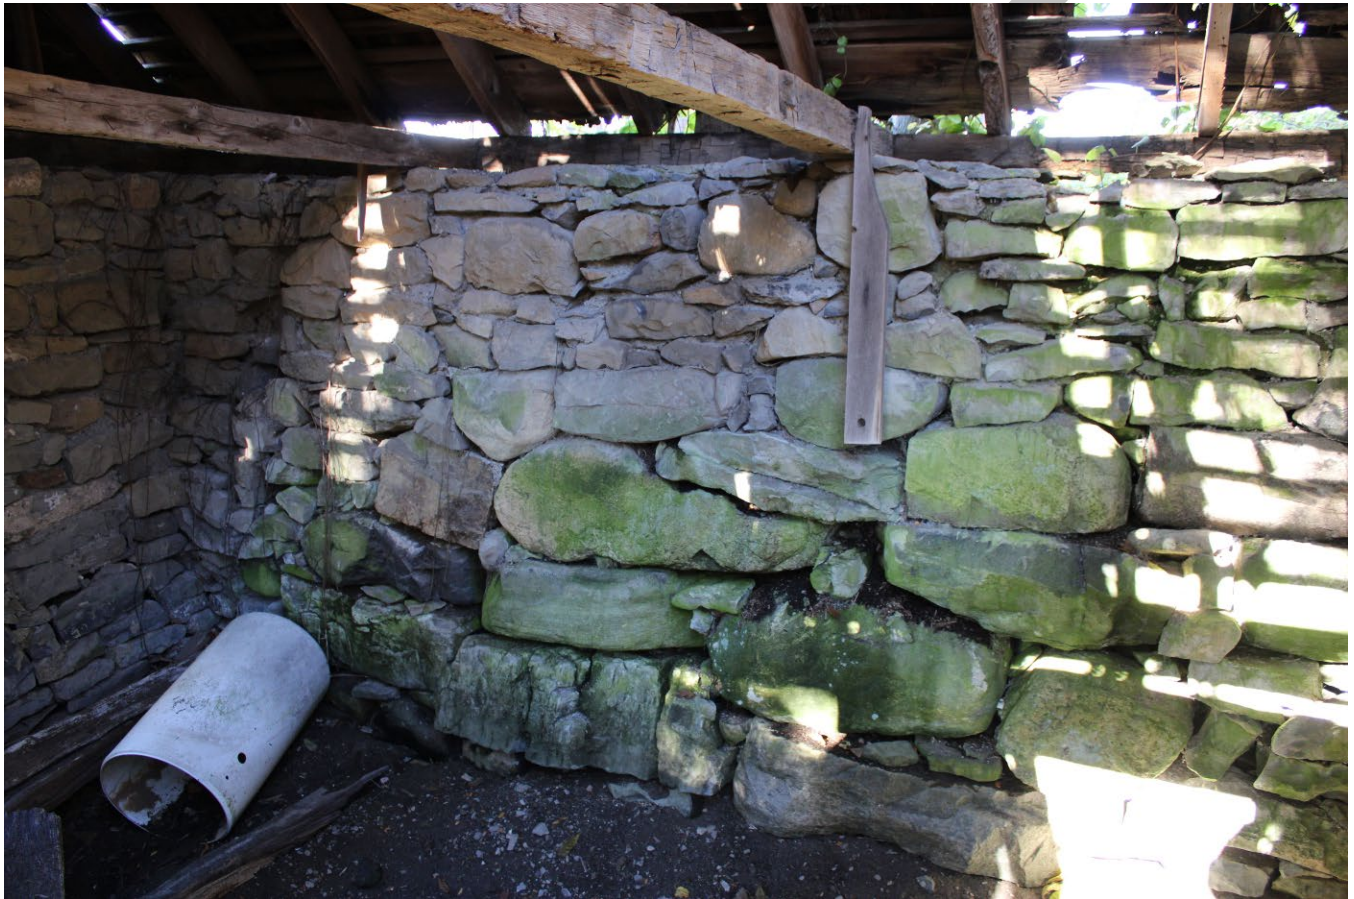
**Photo 0017:** View of the interior of the spring house, camera facing north.

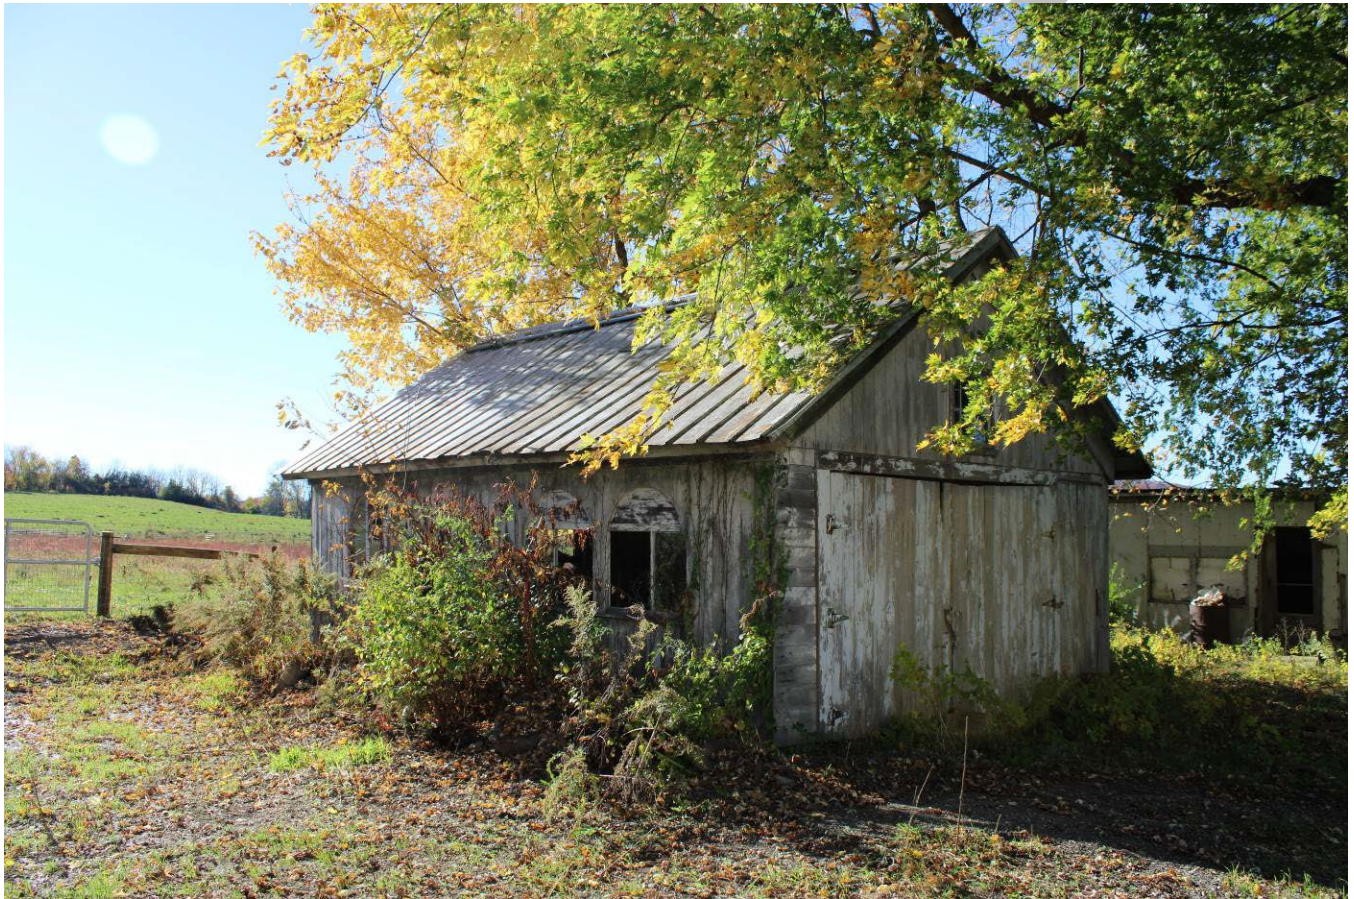
**Photo 0018:** View of the north and east elevations of the "old" chicken house, camera facing west.

The dairy barn, including the milk house and machinery shed, was constructed c. 1937 on the foundations of earlier dairy barns. It was constructed utilizing a popular form of dairy barn produced by the James Manufacturing Co. of Fort Atkins, Wisconsin; the barn is banked, uses the Shawver truss system (Figures 13 and 14), and at one time incorporated the James Way milking system at the ground level, where the cows were milked. Its reuse of the earlier dairy barn foundations reflects an economy often employed in rural environments, which is also seen in the reused timbers of the old chicken house.

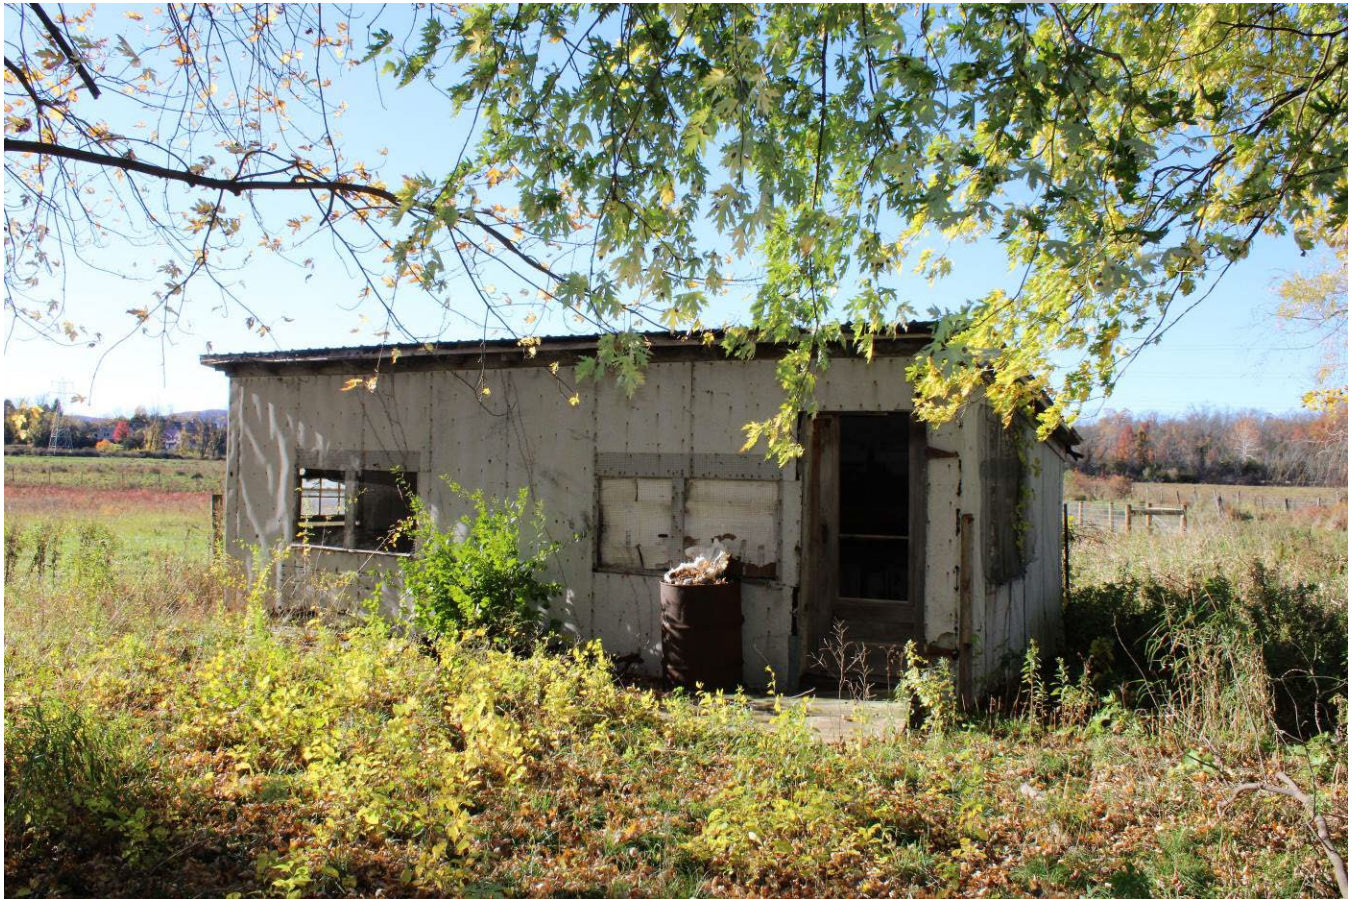
**Photo 0019:** View of the east elevation of the “new” chicken house, camera facing west.

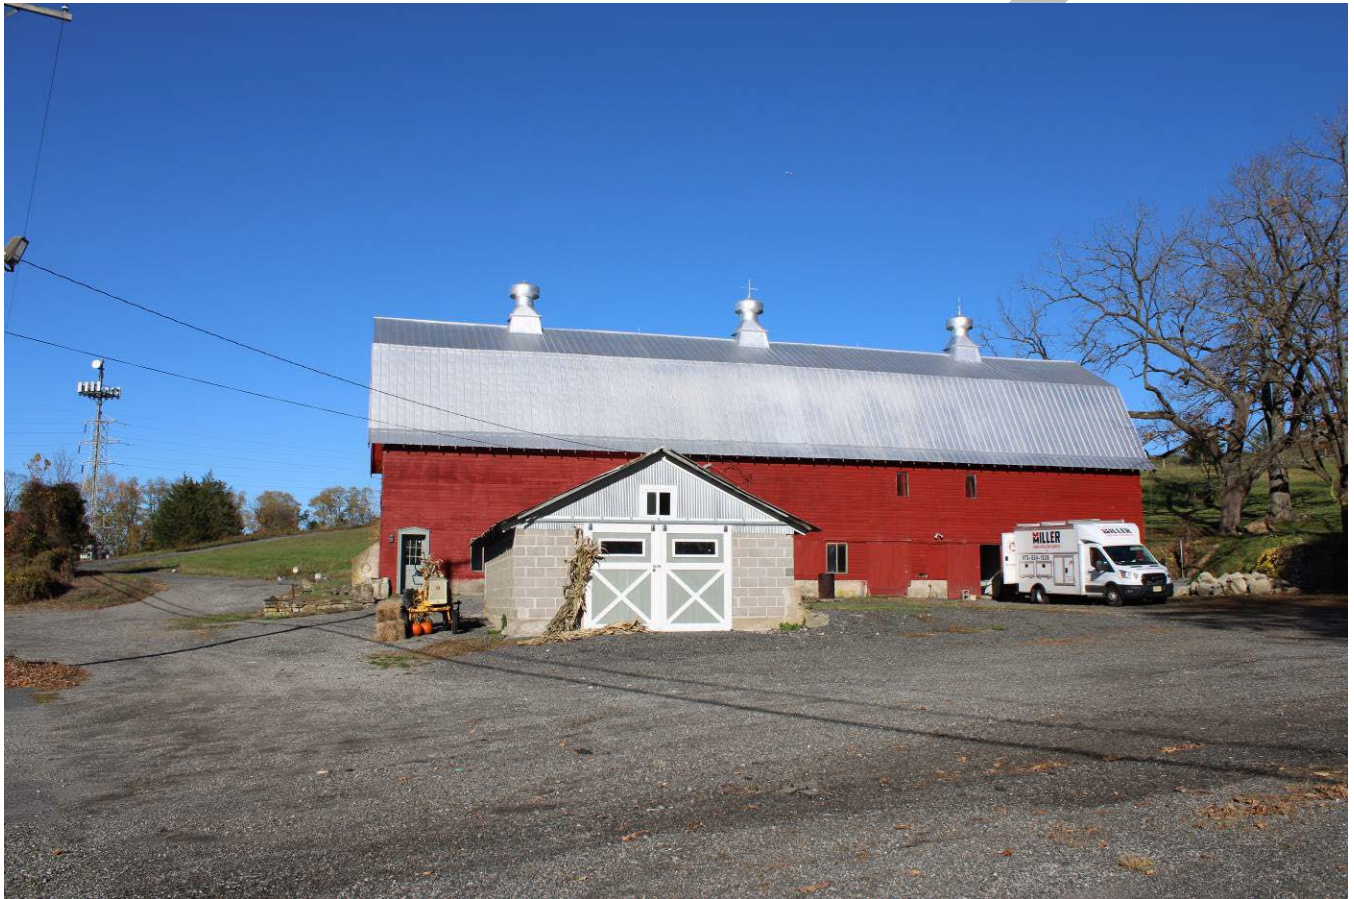
**Photo 0020:** View of the south elevation of the dairy barn and machine shed, camera facing northeast.

The Wisconsin style barn became common in dairy farming areas of New Jersey and New York beginning during the Great Depression.<sup>83</sup> The Rickey family having lost a barn not yet 20 years old, would have been looking for an economical way to rebuild, which included both reusing the foundations from the earlier barn and employing the latest in construction technologies.

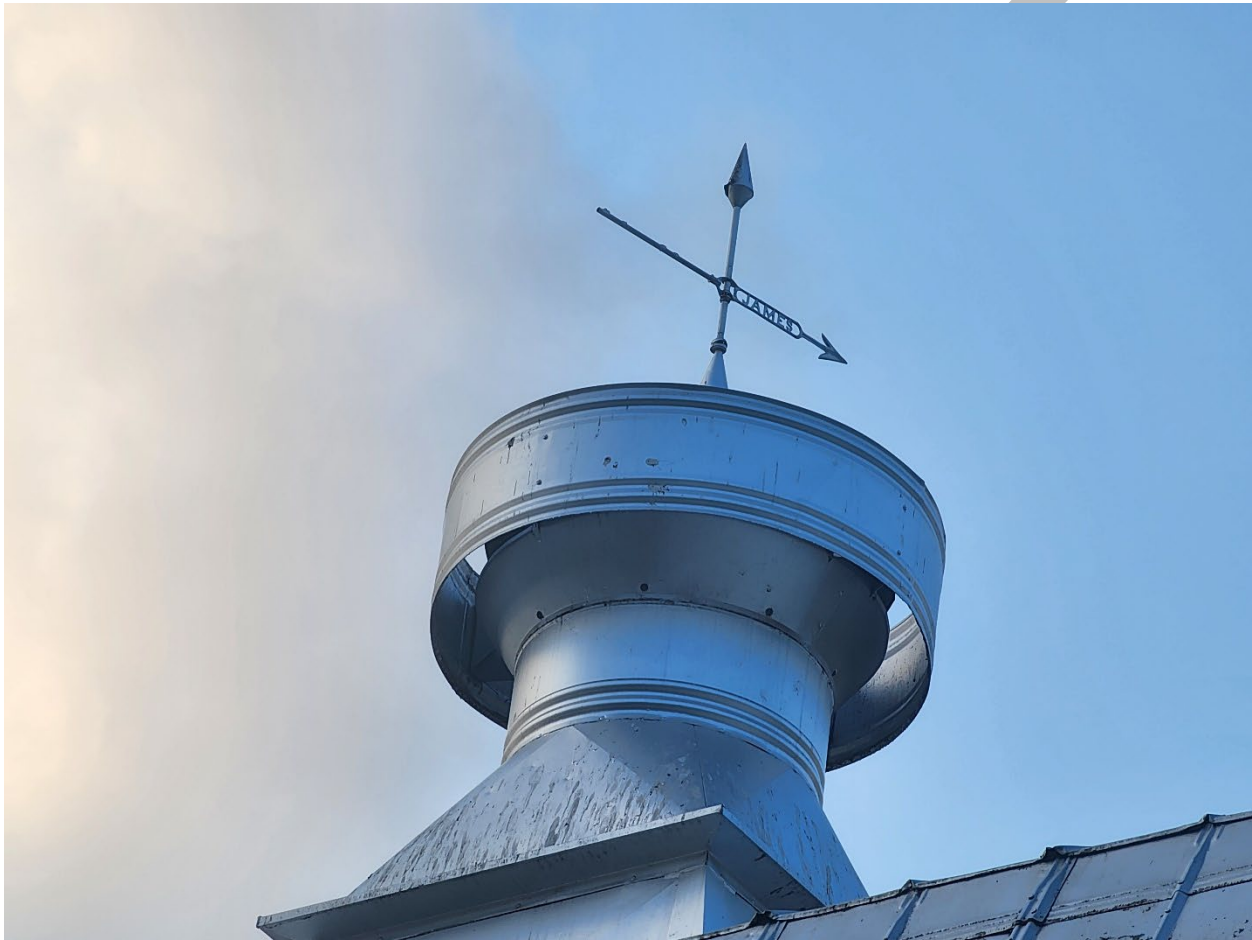
**Photo 0021:** View of the James trademark on the weathervane of a ventilator at the dairy barn; camera facing northwest.

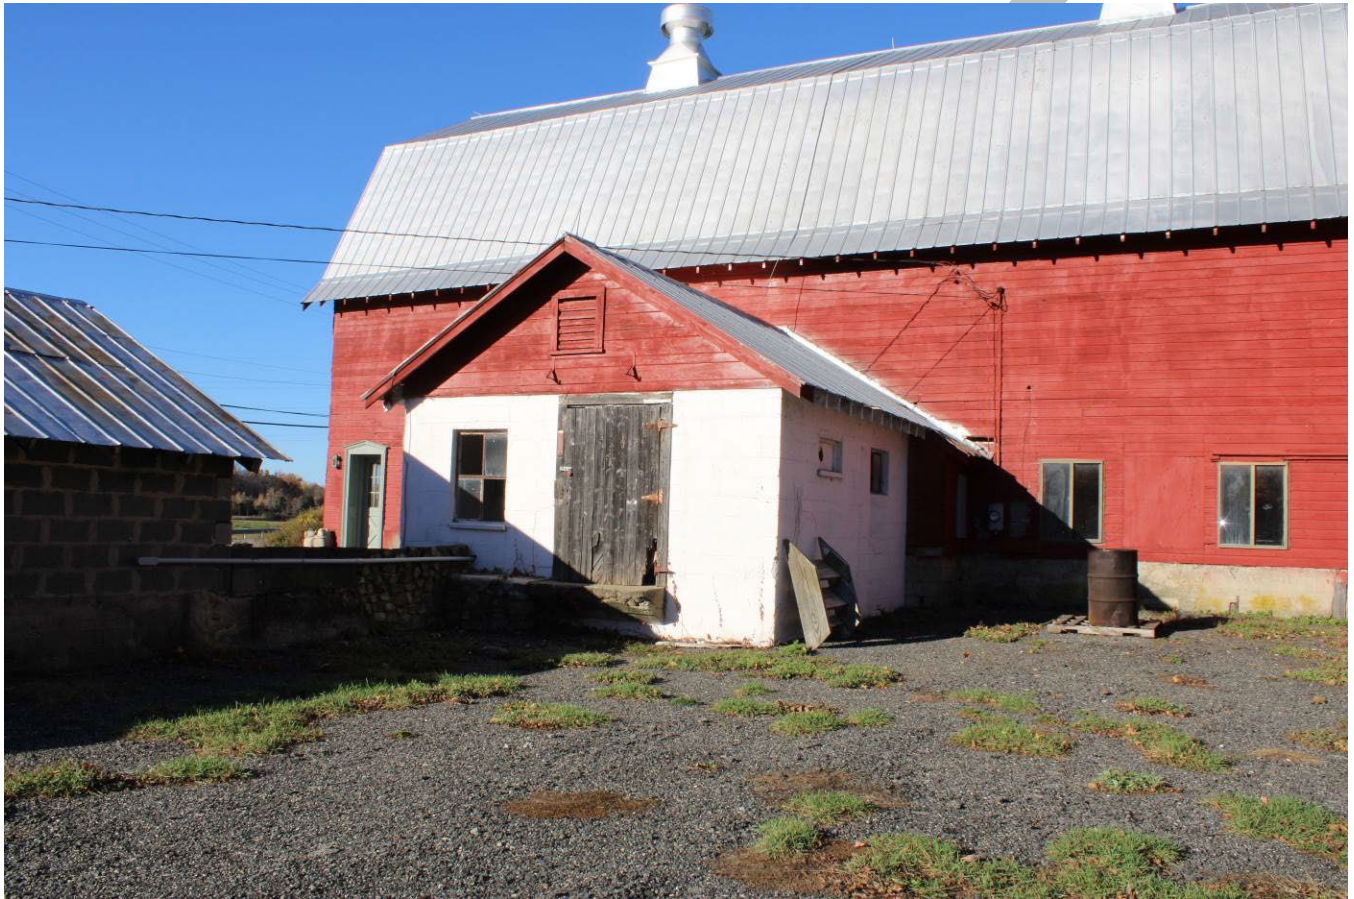
**Photo 0022:** View of the milk shed on the south elevation of the dairy barn, camera facing north.

The milk room could have also been part of the plans provided by the James Manufacturing Company as their publication notes the ability to customize plans for the Owner’s needs and to accommodate site conditions. The machine shed would have been a common building on site as well and could have held any amount of equipment from seeders and cultivators to wagons and manure spreaders. According to the *Farm Building* publication of 1911, the gabled form of either one or two bays deep with large openings on one side would have been a typical arrangement.<sup>84</sup> Concrete block, of which both buildings are constructed, was readily available beginning in the 1920s, has fire-rated capabilities, and were an economical building material. Utilitarian in form and function, they are each subservient to the larger

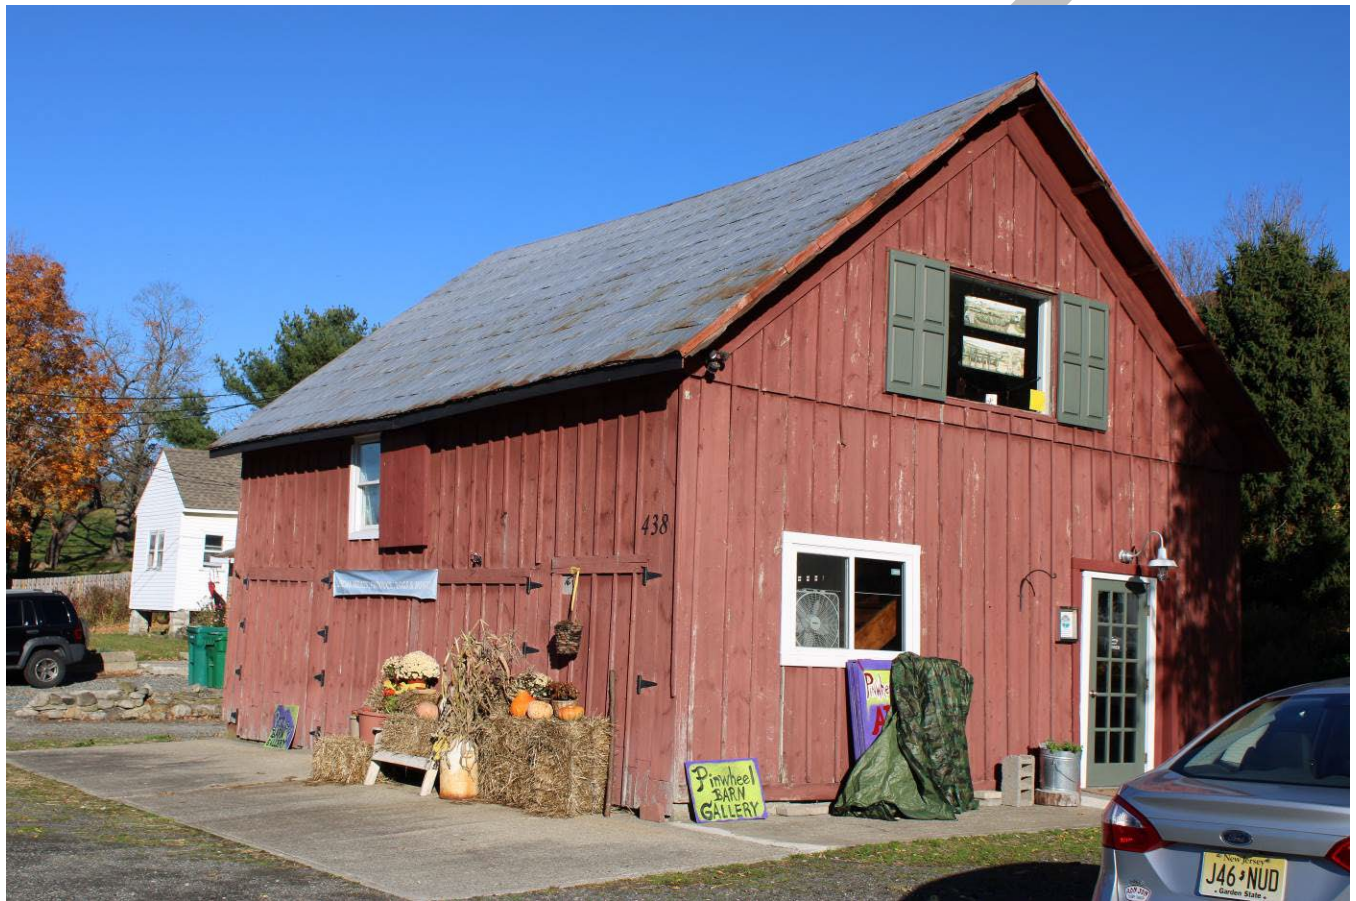
**Photo 0025:** View of the west and south elevations of the carriage house, camera facing northeast.

**5. Carriage House.** The Carriage House is a three-bay wide by two-bay deep, one-and-one-half story, side-gable structure that faces northwest (west) towards Vernon-Warwick Road (Route 94). The building is of heavy hand-hewn-timber construction<sup>8</sup> set on a limestone foundation, is clad with vertical board-and-batten siding, and has a pressed tin roof (Photo 24). On the front elevation, the center bay contains a pair of large board-and-batten carriage doors with strap hinges and a one-over-one vinyl-hung window set in wood trim above it, just under the gable eave. A sliding panel constructed of wood boards hangs from the eave and can slide across the window. Flanking the carriage doors is a large board-and-batten door in the northern-most bay and a narrower board-and-batten door in the southern-most bay; both doors are affixed with strap hinges (Photo 25).
