National Register of Historic Places Registration Form

Historic name: Acorn Hall (Additional Documentation)

Street & number: 68 Lafayette Avenue (formerly 68 Morris Avenue)

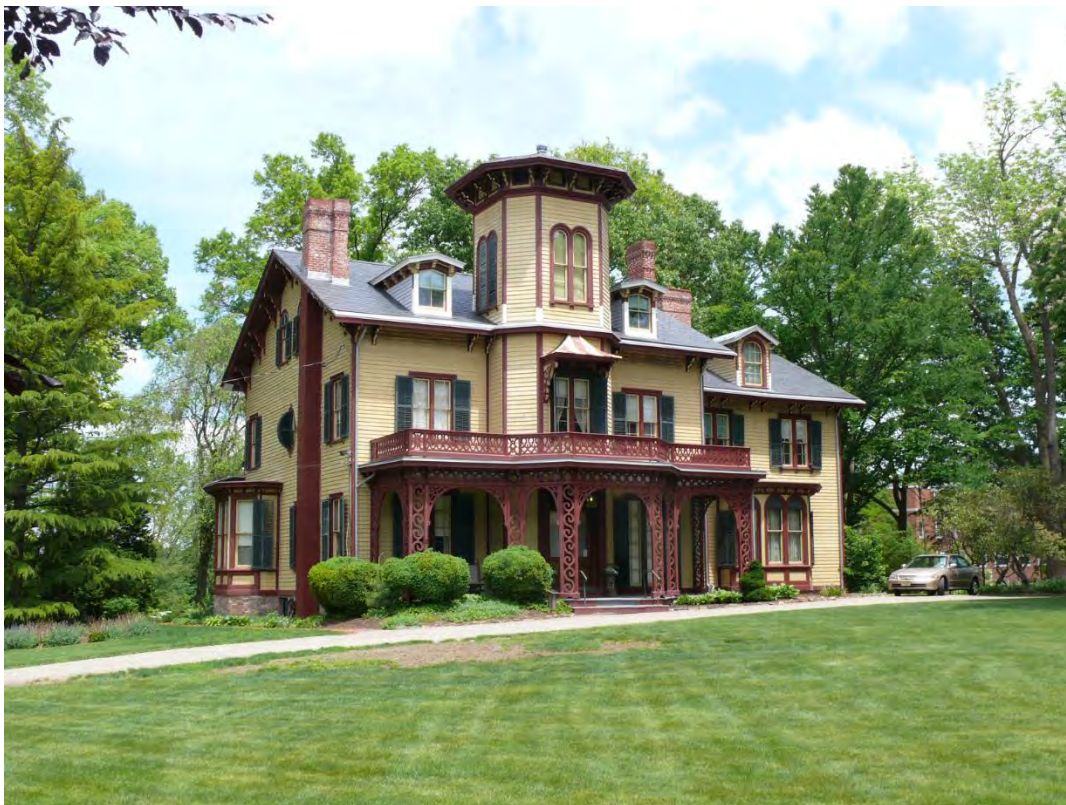
Acorn Hall (Additional Documentation), Morristown, Morris County
Photo #6

South Elevation (Photo 0006)

The south elevation serves as the primary façade and displays symmetry through its fenestration pattern, ornamentation, and overall massing. All of the windows on the south elevation at the first and second floor levels have shutters. The main section of the house has a full-width front verandah and a grand entry at the projecting octagonal tower (c.1860-1870). The verandah has thick, flat, scroll-cut wood trim supports; spandrels; and an oval-cut trim frieze. Above the verandah is a detailed balustrade with similar thick, flat decorative trim in place of balusters. The shape of the porch mimics that of the house, projecting in a bay shape at the center. The verandah is three bays wide. At the entry are tall paired doors with large-pane glazing, a transom, and elaborate surround above and around them. In the outer bays at the first floor are tall paired French doors (Photo 0007). The doors have decorative asymmetrical glazing where the glass is divided into twelve panes of different sizes.

At the second floor above the French doors are tall paired windows. All of the windows at the second floor level are atypical four-over-four hung wood sashes with decorative asymmetrical glazing reflective of the French doors below. Centered at the second floor are paired, arched windows with an individual bracketed roof. The scroll-sawn brackets that support this small roof are the largest and most ornate of the building.

At the third floor level of the center projecting bay of the main building is a tall eight-sided tower (c.1860-1870). At the center bay is a set of tall paired one-over-one hung wood sash round-arched windows. The hipped tower roof is octagonal in shape with wide overhanging eaves supported by decorative scroll-sawn brackets; this fenestration pattern continues onto the east and west sides of the tower. Beneath the eaves of the tower roof, in between each bracket, are decorative panels with single-pane fixed windows at each corner instead of panels. To either side of the tower at the third-floor level is a small gable dormer with decorative brackets and two-over-two pointed-arch hung wood windows; the dormers were likely added c.1860-1870.

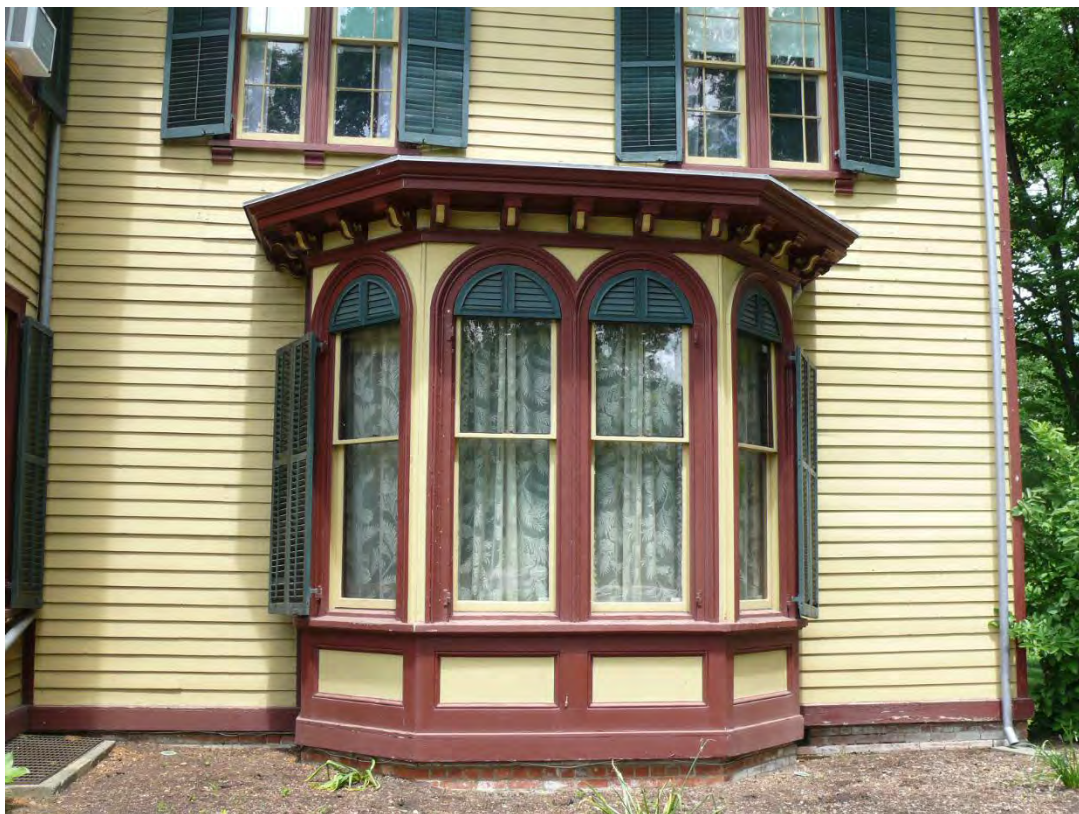
Acorn Hall (Additional Documentation), Morristown, Morris County
Photo #8

Centered on the first floor level of the east wing is a projecting five-sided bay with tall, round-arched windows on three of the five sides (Photo 0008). The central bay wall is the widest side and features paired one-over-one hung wood sashes; these are the only windows that do not have shutters. The other two windows on either side of the center bay wall are single one-over-one hung wood sashes. In the round-arched top of each window are small half-round top shutters. Below each bay window are panels and thick surrounds. At the second floor of the wing are a set of tall paired windows in each bay reflective of those on the main section. A single central dormer with an arched six-over-six hung wood window and less distinctive brackets punctuate the roof.

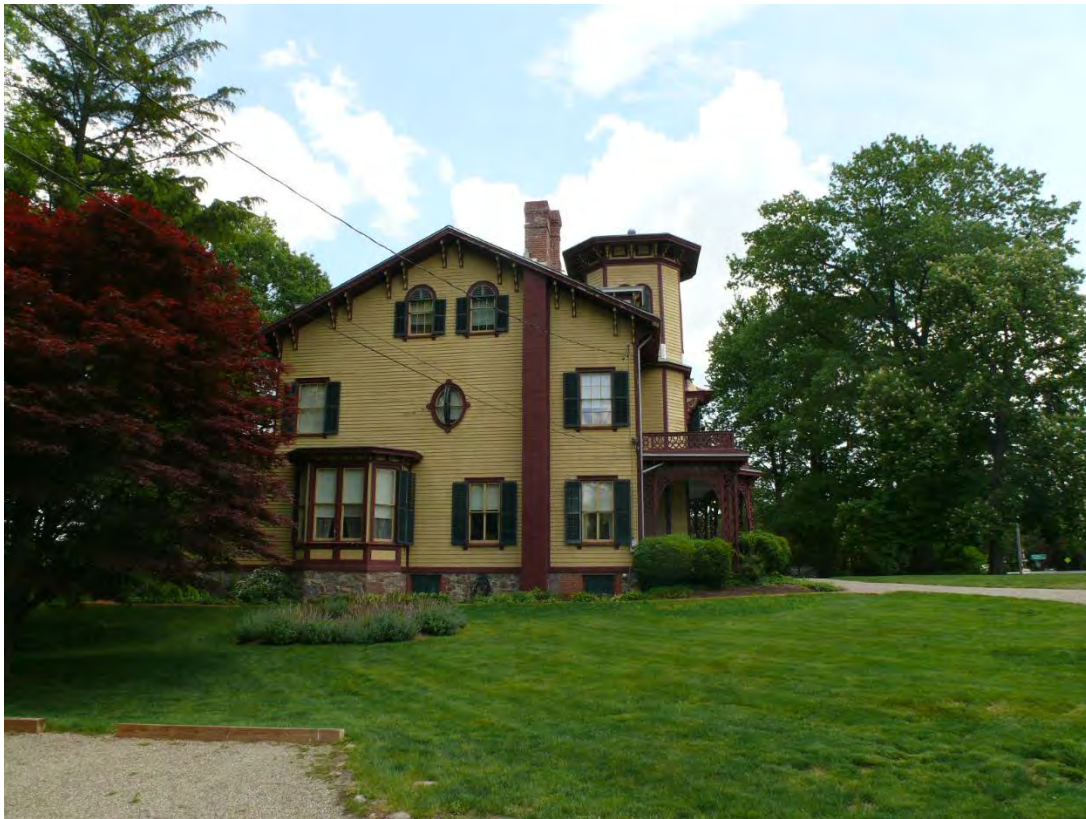
Acorn Hall (Additional Documentation), Morristown, Morris County
Photo #9

West Elevation (Photo 0009)

The fenestration on the west elevation is irregular. At the foundation in the south and center bays is a rectangular basement window (Photo 0010). At the first-floor level the

two southern bays contain a wider, shorter, two-over-two hung sash window; centered between them is a brick chimney. At the north bay is a five-sided projecting bay with detail and a fenestration pattern reflective of that on the five-sided bay at the south elevation (c.1860-1870). The windows of this bay are tall, rectangular one-over-one hung wood sashes with shoulder heads. In the single bay at the north block addition (c.1860-1870) there is a small over window with decorative trim and an oval shutter.

The outer bays at the second floor each contain a six-over-six hung wood sash window. In the center bay is a large oval with decorative trim and a shutter. Centered at the attic level are two small, round-arched, six-over-six hung wood sash windows. In the arched top of the windows are small half-round top shutters.

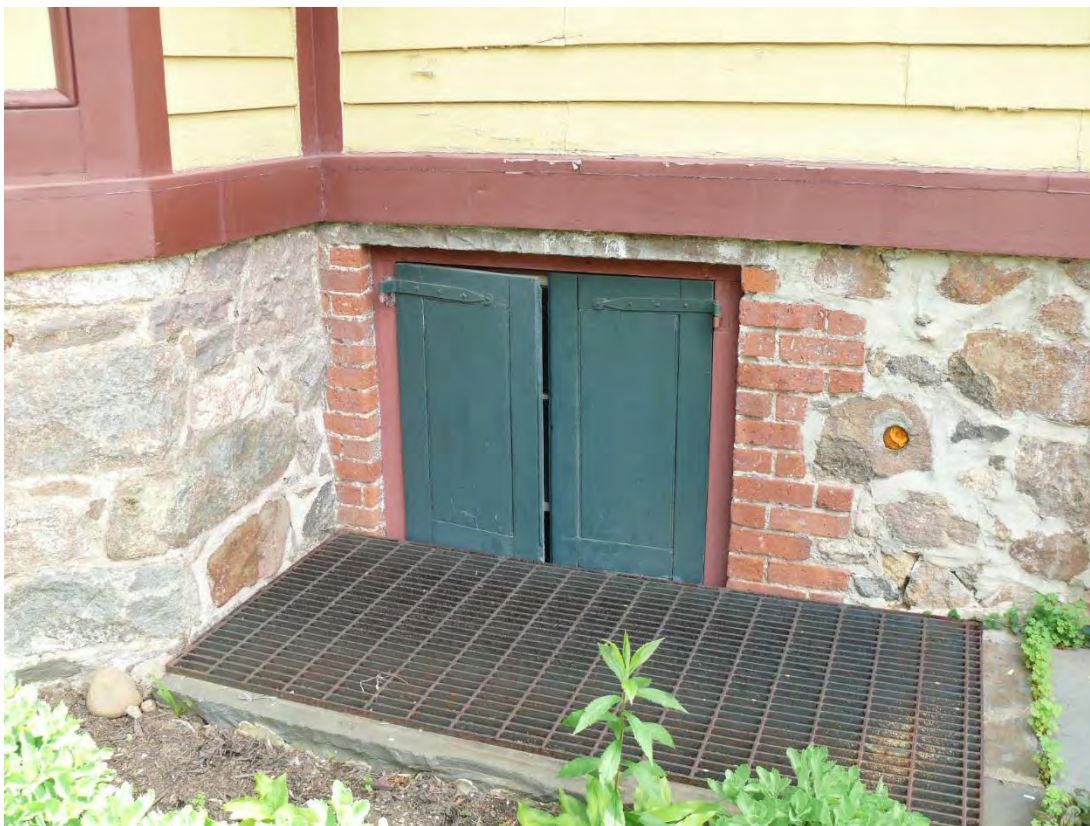
Acorn Hall (Additional Documentation), Morristown, Morris County
Photo #10

Close-up view of the stone foundation showing a basement-level window at the west elevation.

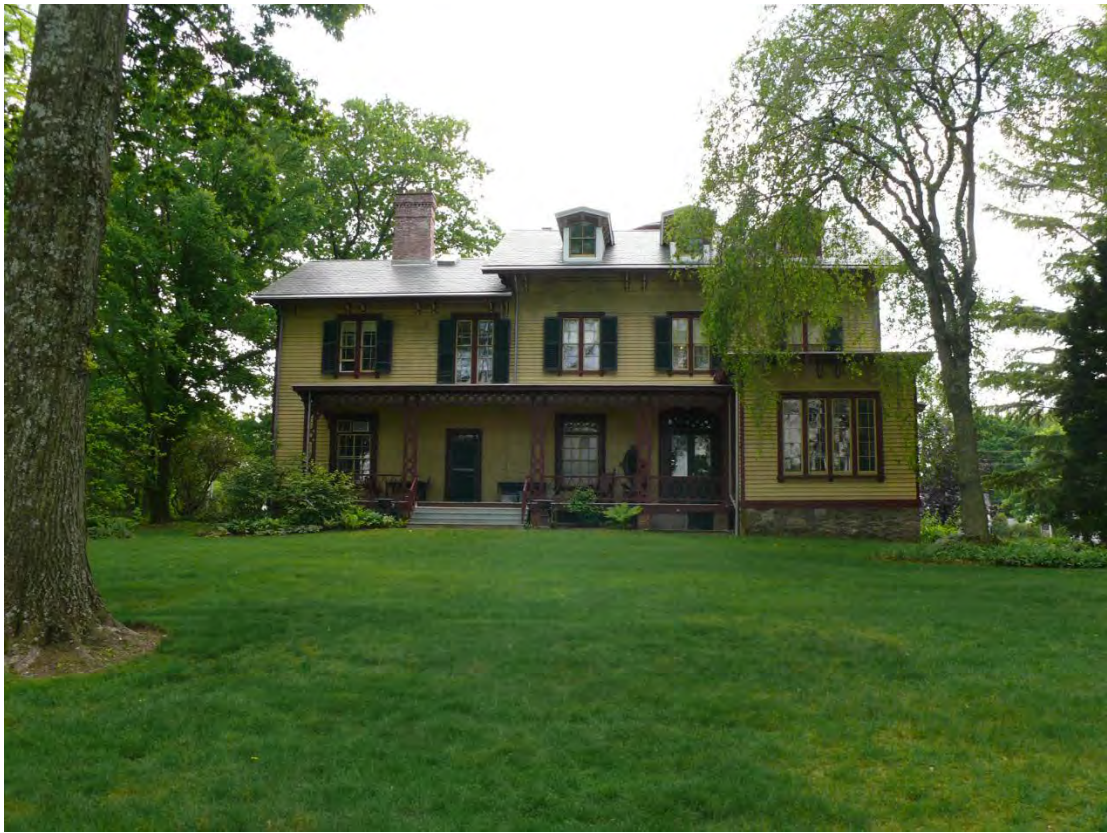
Acorn Hall (Additional Documentation), Morristown, Morris County
Photo #11

North Elevation (Photo 0011)

Extending east from the north block addition (c.1860-1870) is a one-story, four-bay-wide porch. The ornate detailing of the porch echoes that of the south (front) verandah (modified c.1860-1870). The porch wood railing has diamond-cut thin trim in place of balusters. Unlike the verandah openings, the porch openings are not arched, but have scroll-sawn spandrels. Wide wood steps access the porch off-centered towards the east. West of the stairs below the porch is a long, narrow, multi-lite wood basement window, while east of the stairs is a wood lattice vent covering the basement level opening. At the west end of the porch, stone steps lead down underneath the porch to access the basement level.

Centered at the north block addition (c.1860-1870) is a set of four tall, narrow casement windows with the decorative glazing exhibited on the paired windows on the south elevation. In the center bay of the main section is a pair of doors reflective of the main, front entry. East of the doors is a low oval window with decorative trim and a shutter. In the east bay of the main section is a wide eight-over-eight hung wood sash window with a transom. The west bay of the wing contains a single four-paneled wood door with a transom. East of this is another wide eight-over-eight hung wood sash window with a transom.

At the second floor level, there are paired hung wood sashes in each bay of the main section and wing. The paired windows in the west bay of the wing are taller than the rest of the second floor windows. The decorative glazing of the paired windows at the second floor level reflects that of that paired windows on the south elevation. Projecting from the main gable roof, centered above the paired second-floor windows, are three symmetrically placed gable dormers reflective of those at the south elevation.

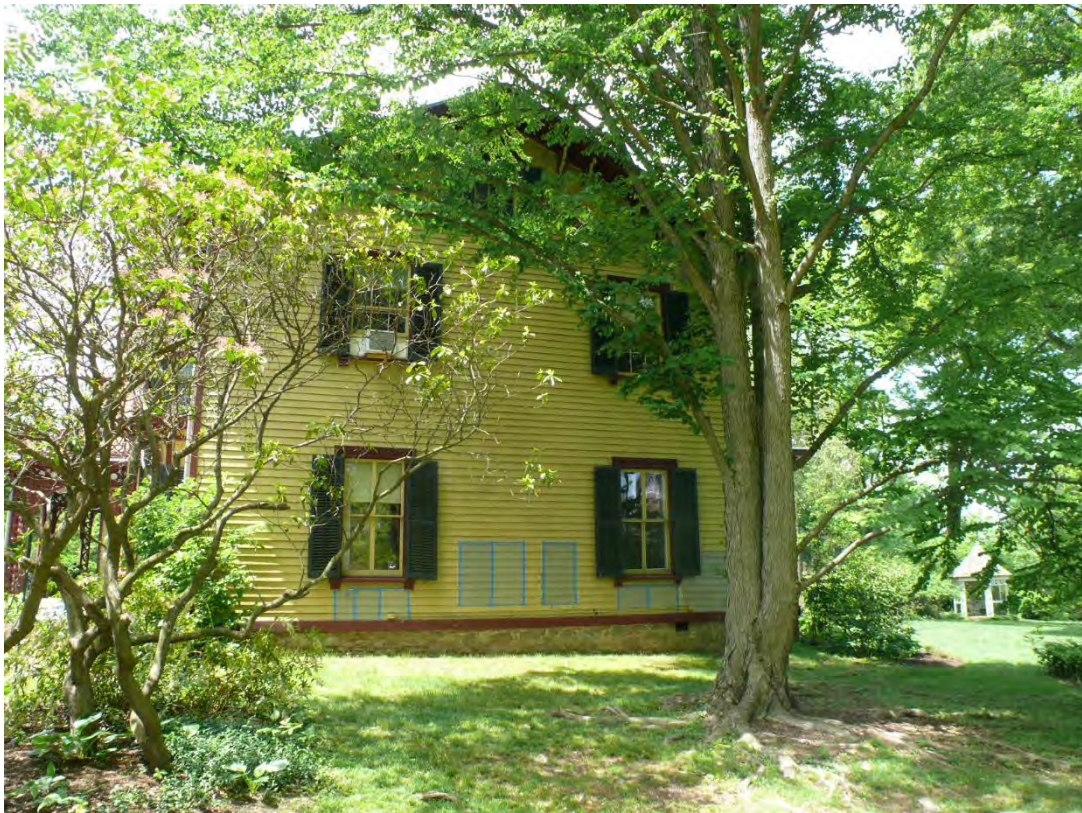
Acorn Hall (Additional Documentation), Morristown, Morris County
Photo #12

East Elevation (Photo 0012)

There are two symmetrical bays at the east wing. The north and south bays at the first floor each contain a single two-over-two hung wood sash windows. At the second floor level of the wing are two six-over-six hung wood sash windows set above the first floor

windows. Centered in the gable end of the wing is a single round-arched, six-over-six hung wood sash window with half-round top shutters.

In the one visible bay at the south end of the main section is a single two-over-two hung wood sash window at the first floor. At the second floor above is a six-over-six hung wood sash window.

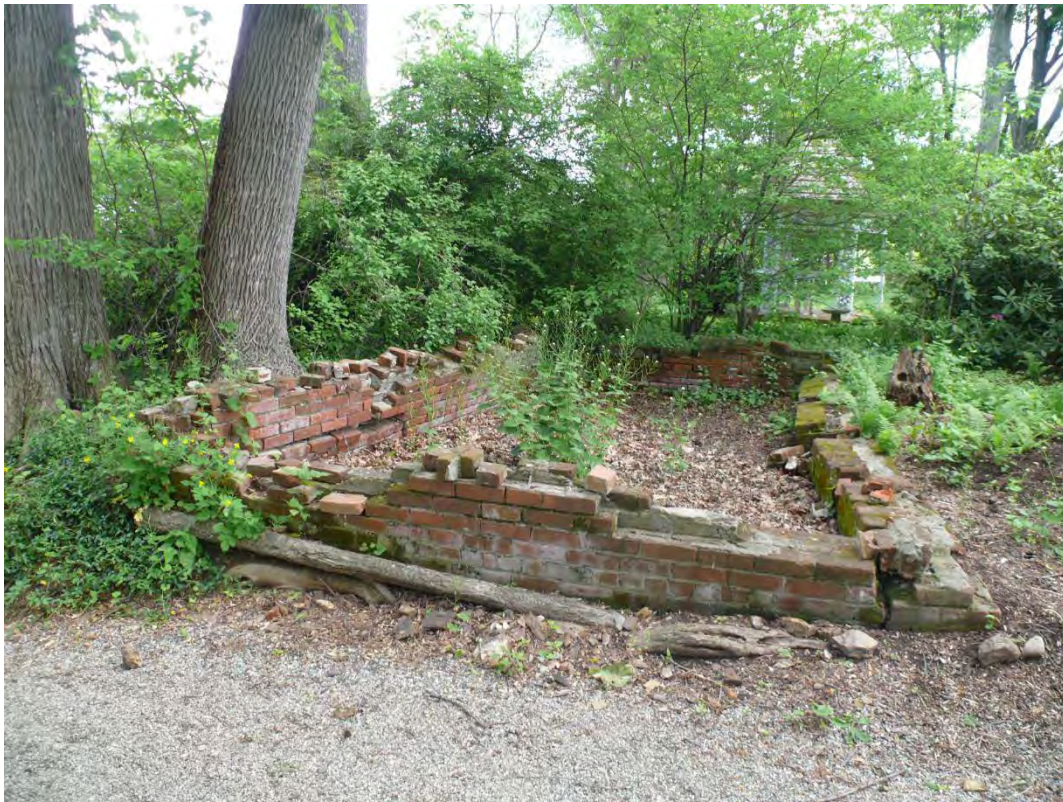
Acorn Hall (Additional Documentation), Morristown, Morris County
Photo #25

Foundation from Greenhouse (Contributing) (Photo 0025)

Ruins of brick foundation from a former greenhouse are located east of the Carriage House.

View of the remnants of the brick foundation from the former Greenhouse.
