National Register of Historic Places Registration Form

historic name Cole Landing Tavern

other names/site number Upton Log Cabin

street & number 500 Cole Landing Road not for publication

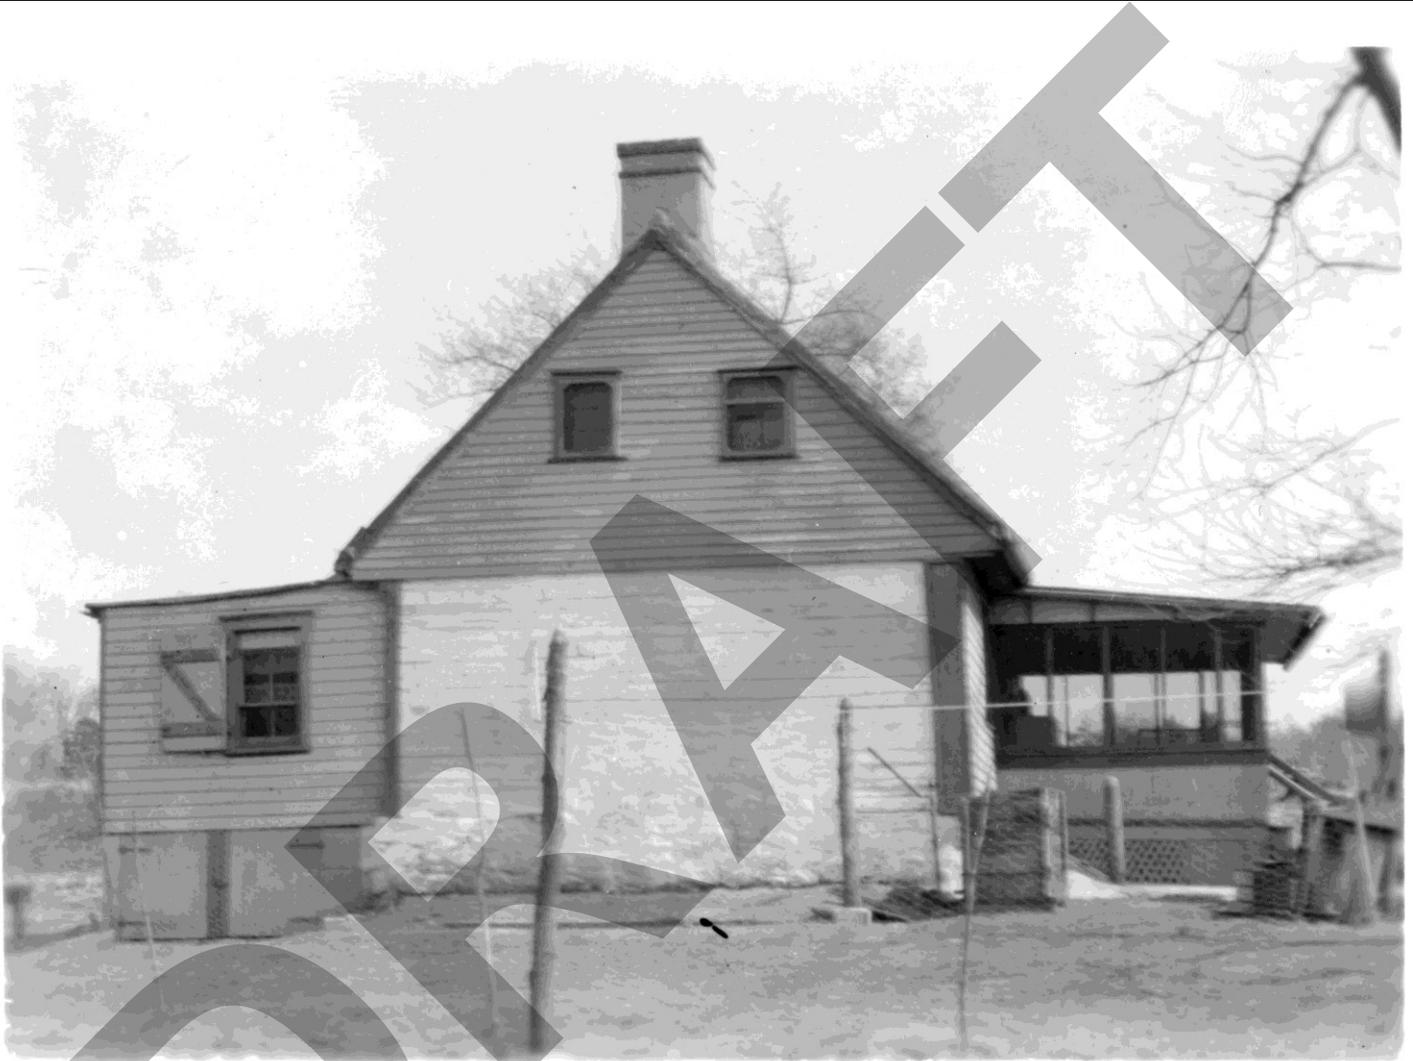
Historic Photograph #1: West elevation of the Cole Landing Tavern (c. 1930) from the files of the Camden County Historical Society. Note opening to north addition's cellar with two door leaves on strap hinges, and screened front porch with lattice panel at base and wood steps without stoop.

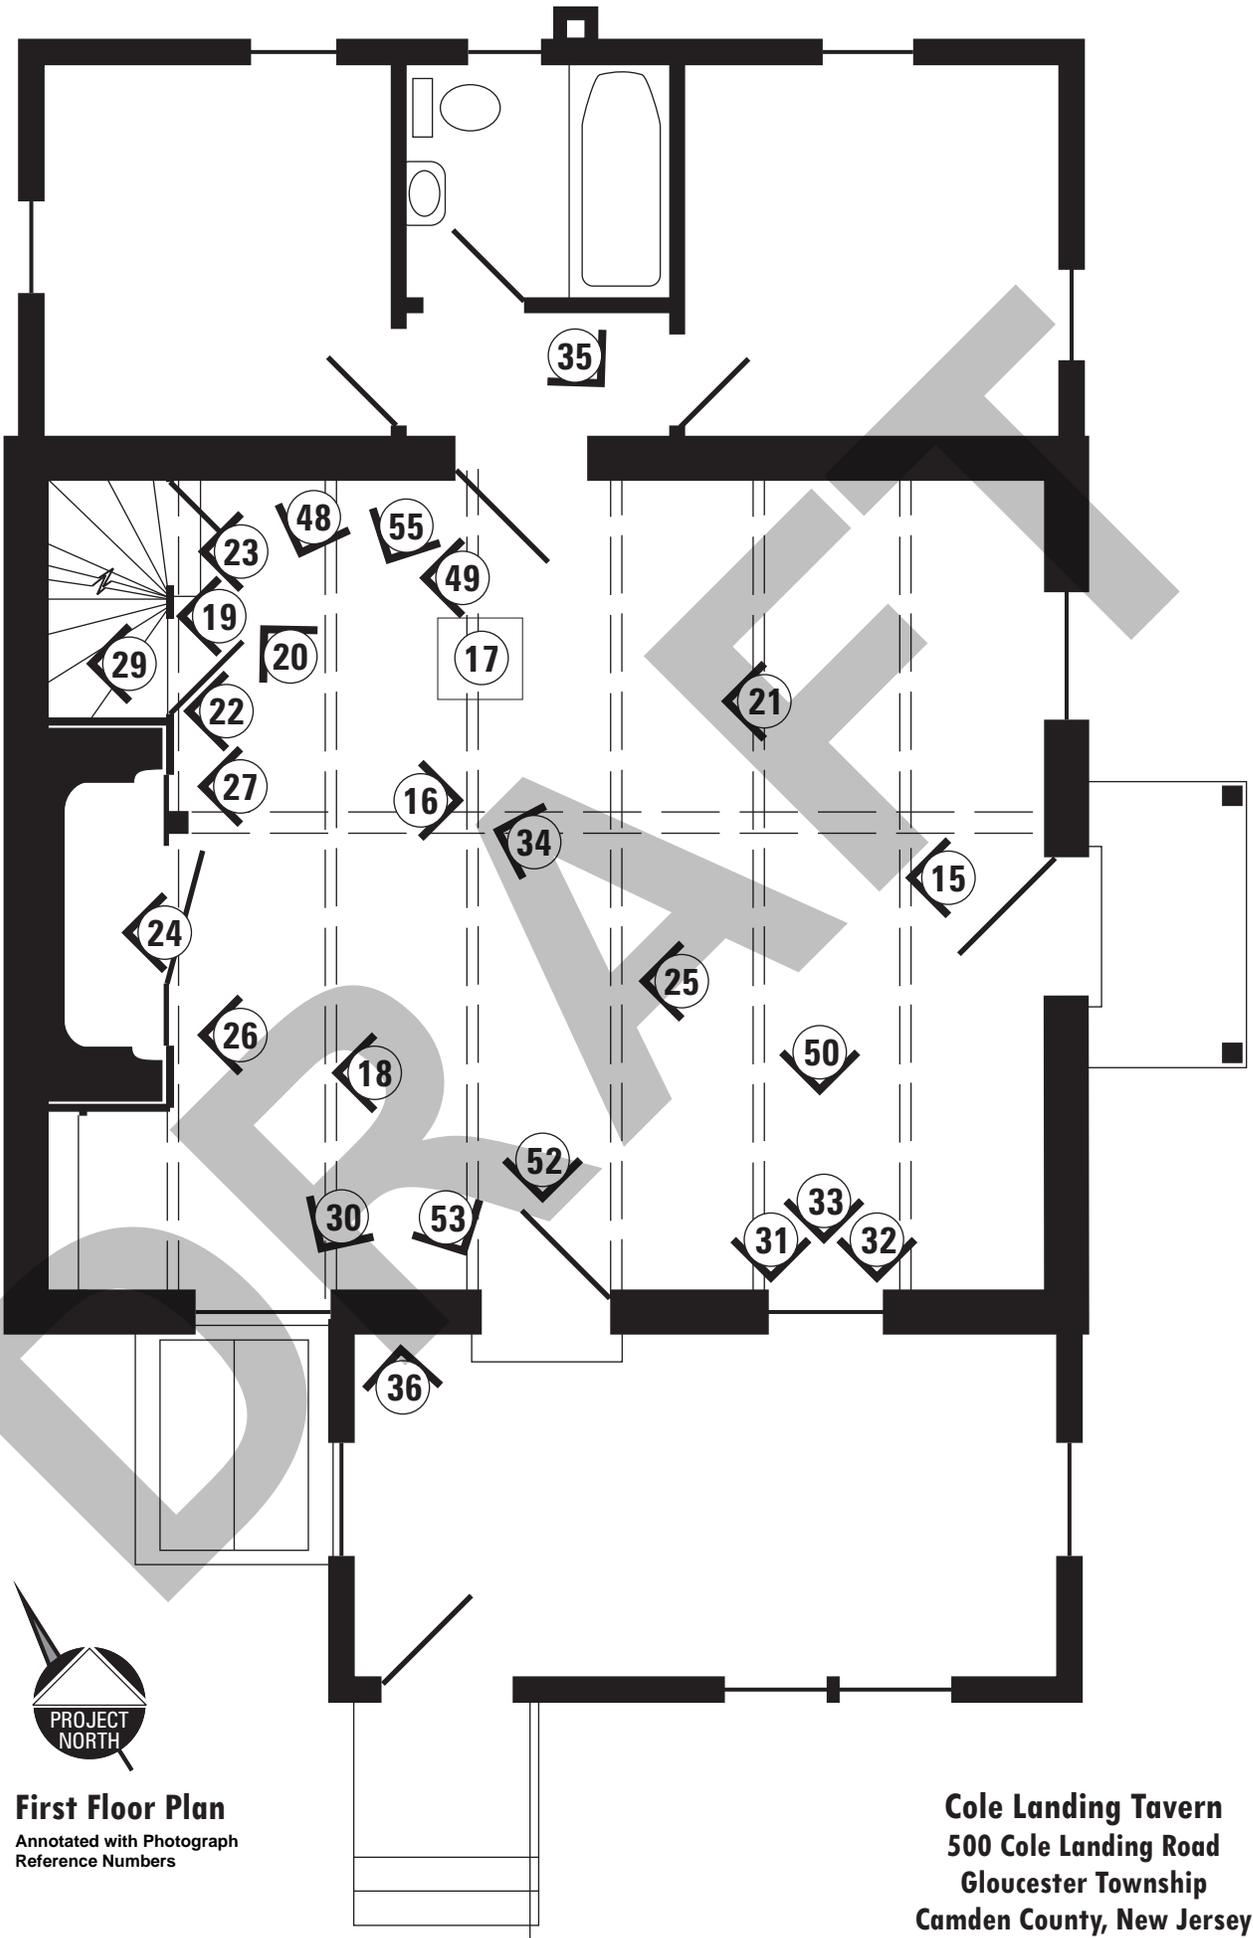
First Floor Plan

Annotated with Photograph Reference Numbers

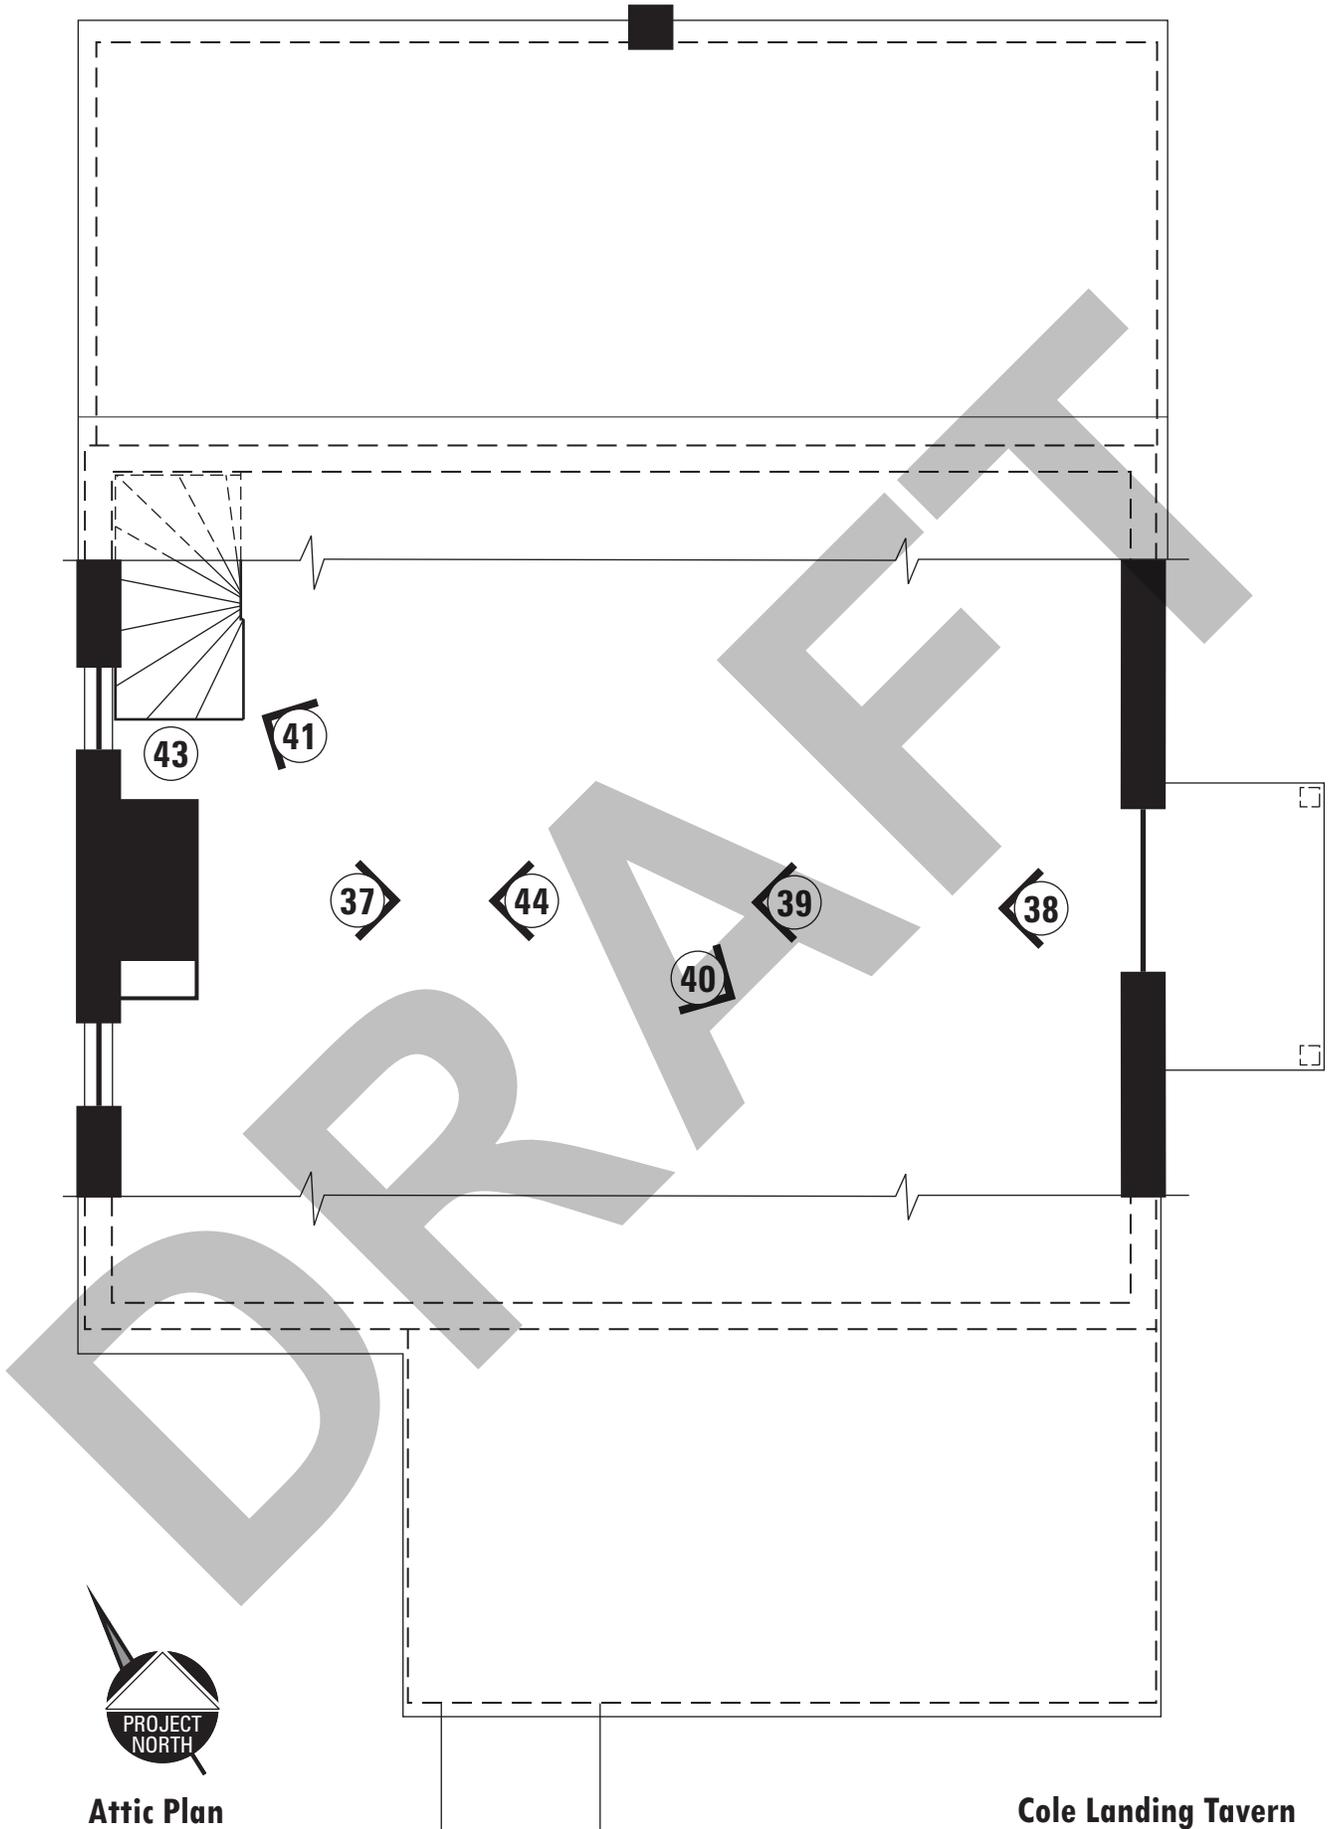
Attic Plan

Annotated with Photograph
Reference Numbers

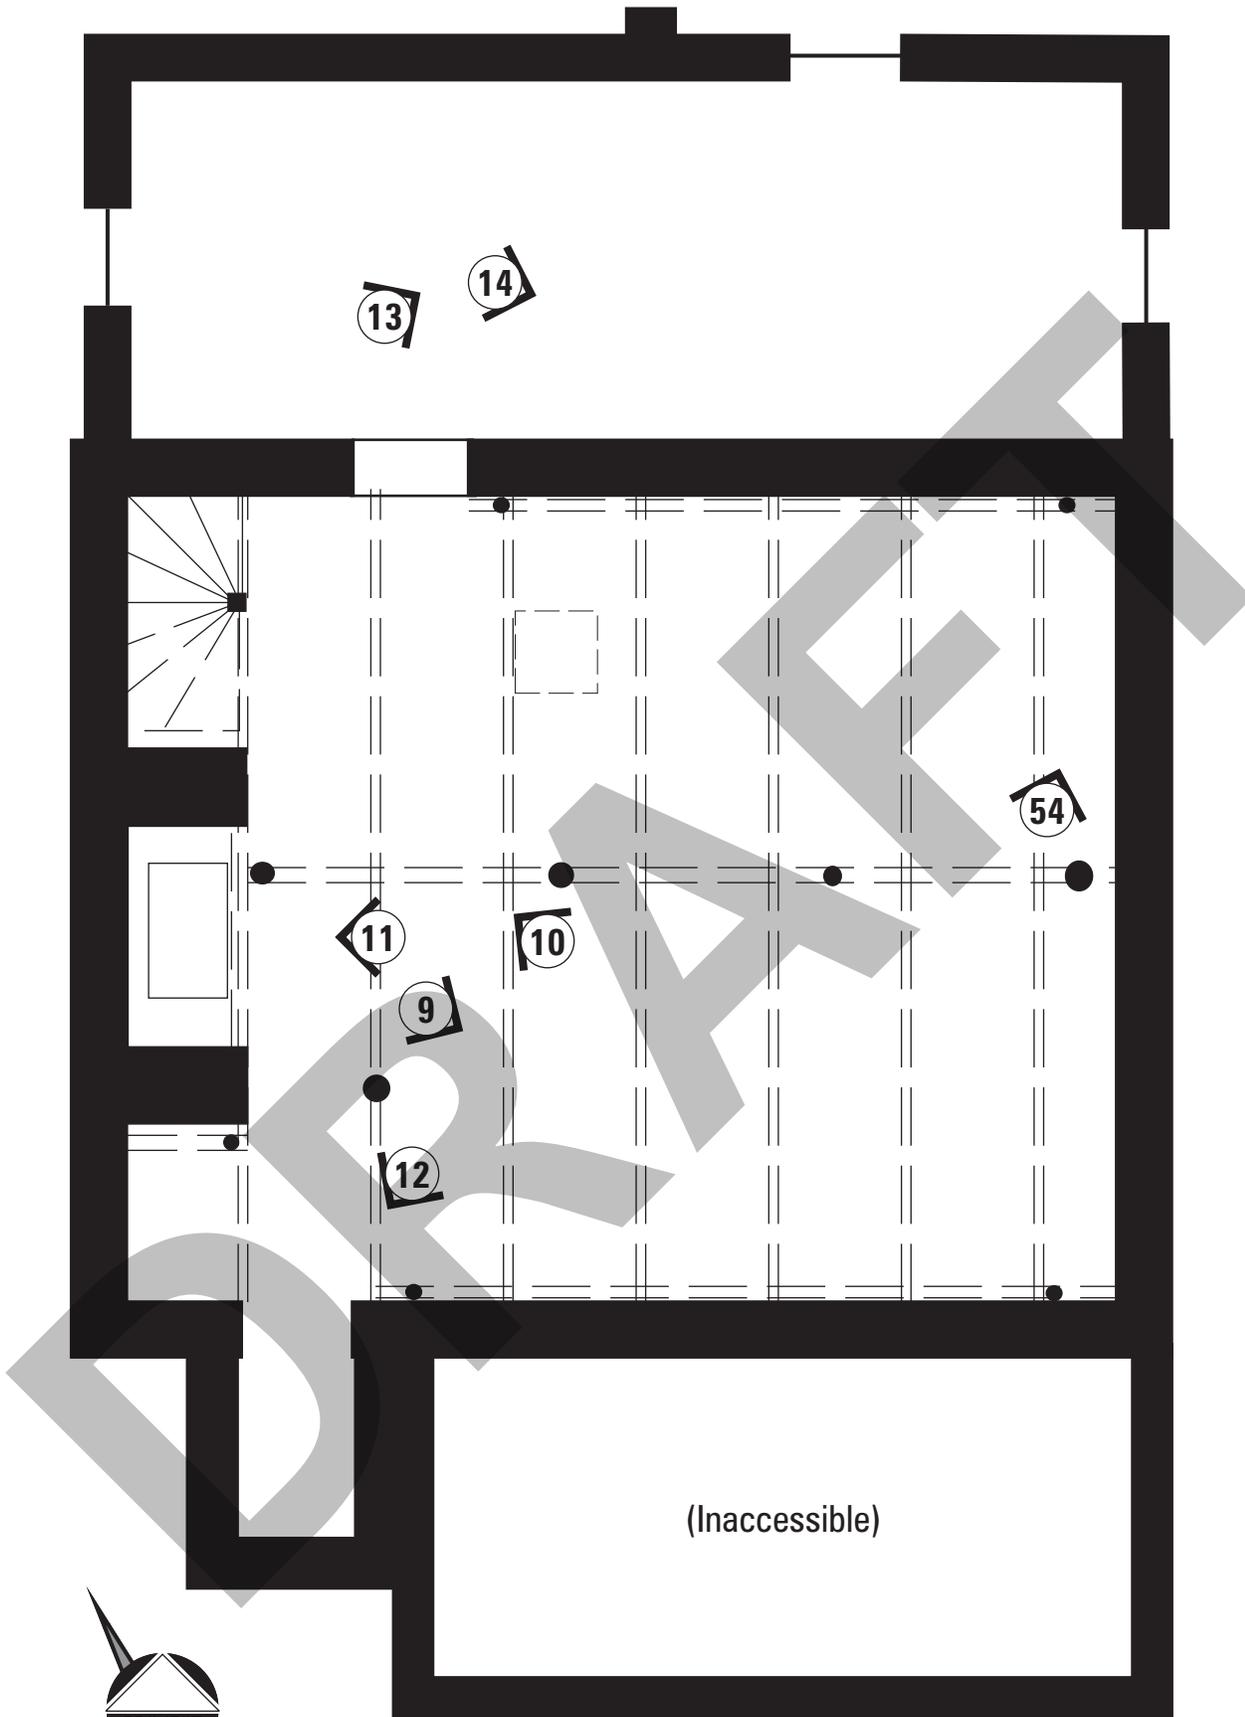
Basement Plan
Annotated with Photograph Reference Numbers

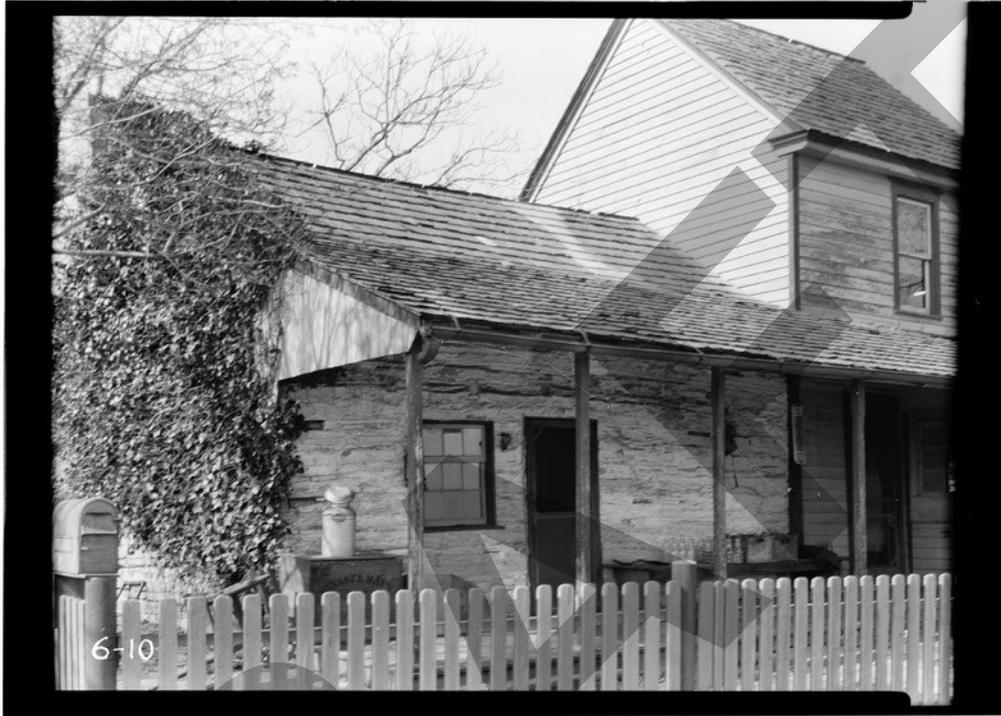
Nothnagle Log Cabin (c.1685?), Paulsboro, Gloucester County.
Historic American Buildings Survey, 1936.

The Nothnagle Cabin, which is attributed a seventeenth-century construction date, is a small cabin, 16' x 20', bearing several similarities to the Cole Landing Tavern, including planked logs with full dovetail notching, an exposed-log exterior, a one-room floor plan with entrances on eaves elevation, and an open-joint ceiling. This cabin does not appear to have ever been covered with clapboards, instead showing heavy layers of whitewash and paint in historic photographs. This may reflect the same condition as the early state of the Cole Landing tavern exterior. Likewise it appears the interior may not have been originally finished with plaster, being whitewashed instead, as seems to have been the case at the tavern. The Nothnagle cabin also has a corner fireplace, however, with no paneling, and lacks a cellar and exposed chimney back. The Nothnagle cabin's corner fireplace is more generally associated with Swedish log cabin construction, although there are few apparent examples remaining to confirm that connection.⁴⁵ It also appears to originally have had a ladder stair near the fireplace up to the loft.

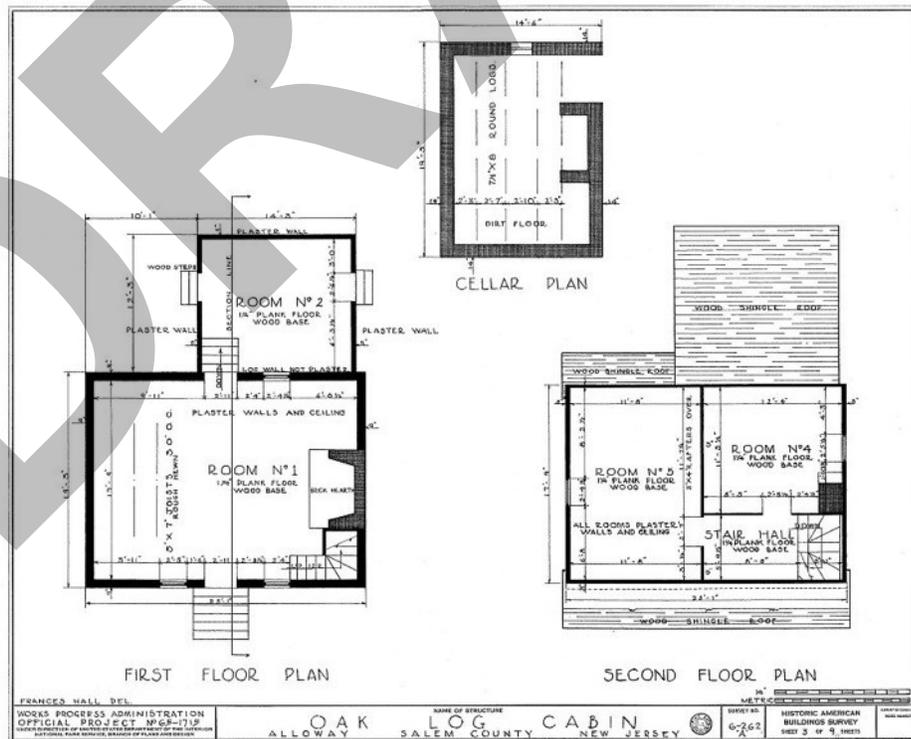
Holme-Reeves Log House (c. 1775), Alloway, Salem County.
Historic American Buildings Survey, 1936.

The Holme-Reeves House, which is ascribed a construction date in the second half of the eighteenth century but may be earlier, was larger than the tavern at 19' x 25'. The roof, unusually steep and cantilevered out from the log walls, may have been a later alteration. It shared many other characteristics with the tavern, however, including a stone foundation with a partial cellar, planked logs with full dovetail notching, a single first floor room with a main entrance on an eaves elevation and a brick hearth in a gable end wall, a two-panel door, and a winder staircase. It appears that this

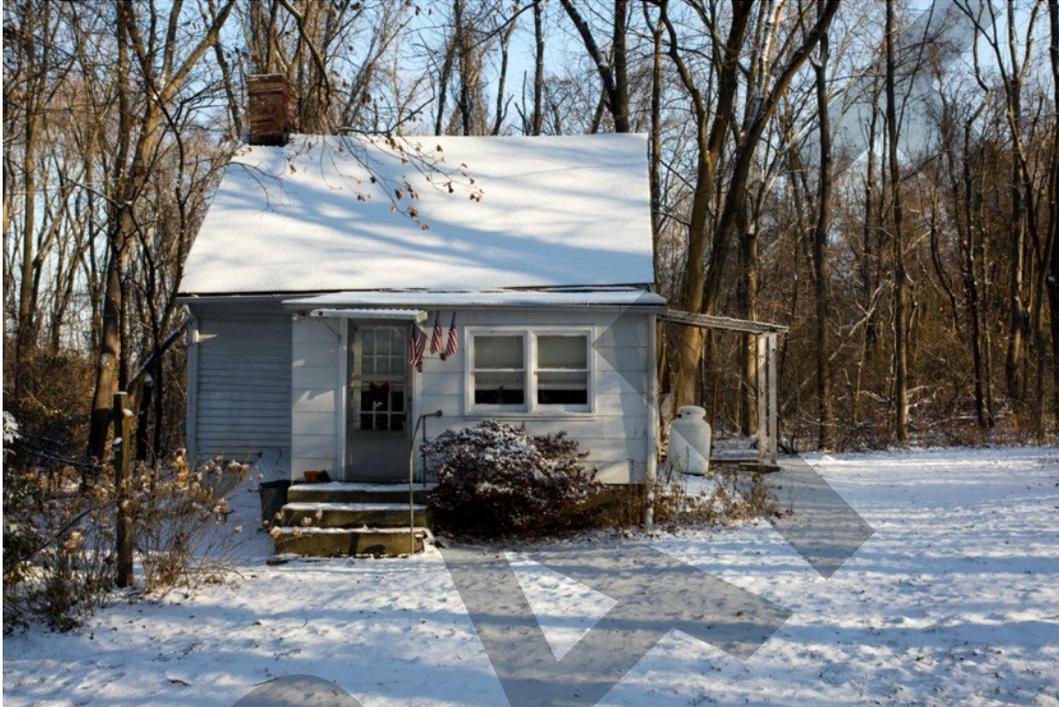
Photograph 0003: View of the south facade.
(21 February 2018 by Adin Mickle)

The south elevation, facing the waterway, is the façade of the building (Photograph 3). Asymmetrical, it is three bays wide, with the two eastern bays of the original cabin enclosed within a mid-twentieth century porch. The exposed western bay of the south wall has a rubblestone foundation, clapboard covering the original planked logs, and a plain box cornice where the wall meets the steep slope of the asphalt-shingled roof. The clapboard is attached with wire nails, which together with a generally uniform appearance, suggest they were installed in the twentieth century or possibly the late nineteenth-century. A bulkhead with stone cheek walls and wood board-and-batten doors cuts into the foundation adjacent to the enclosed porch. A six-over-six sash window with Georgian muntins and flat, unmolded trim is located above the bulkhead at the first-floor level (Photograph 4).

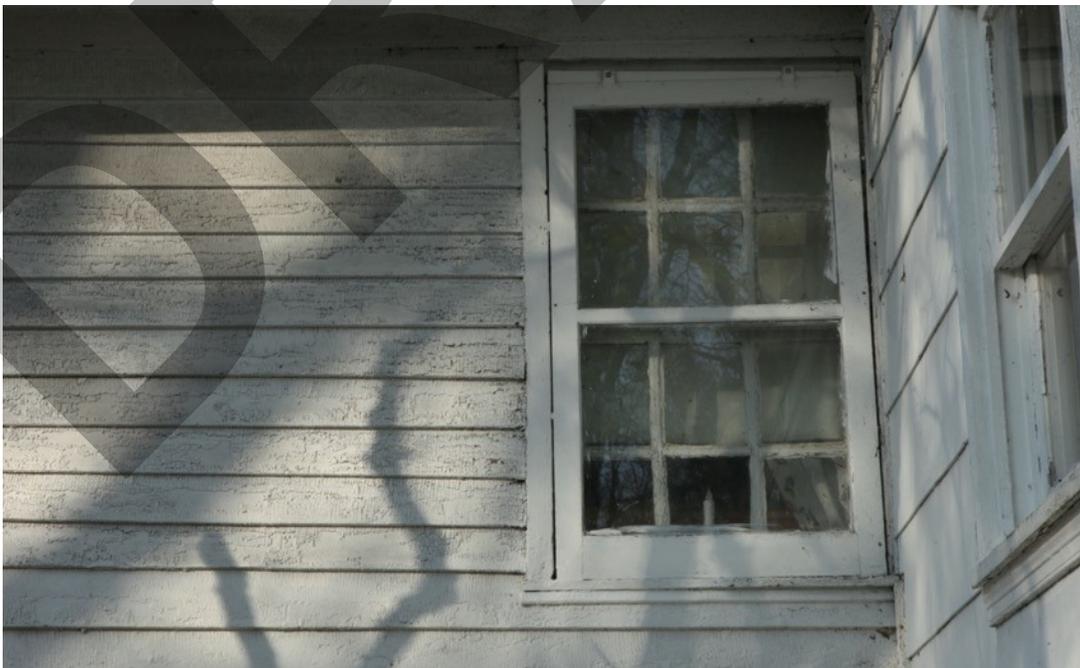
Photograph 0004: Detail of the west window on the south facade.
(21 February 2018 by Adin Mickle)

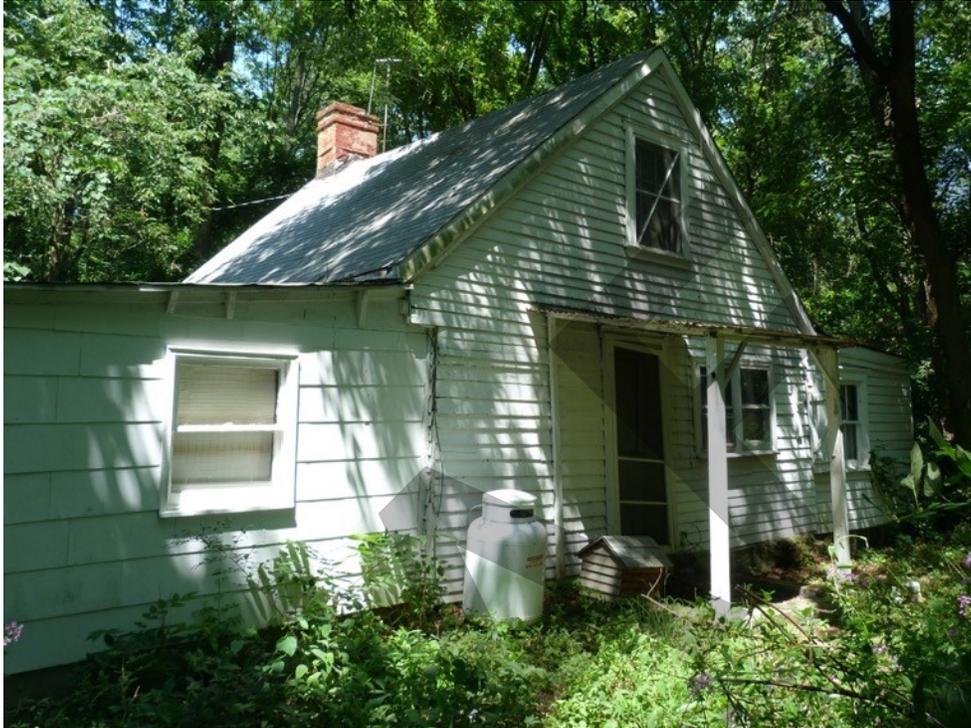
Photograph 0005: View of the east (side) elevation, camera facing northwest.
(4 August 2015 by Margaret Westfield)

The east elevation is asymmetrical, with four bays across the three sections (Photograph 5). The original cabin gable end wall comprises the center two bays. Clapboard covers this section beneath a plain box raking cornice. A short length of rubblestone foundation is exposed north of the door. An entrance with unmolded trim, a sash door, and a screen door is roughly centered on the wall. The entrance is sheltered by a mid-twentieth-century porch consisting of 4x4 posts with interior 2x2 brackets supporting a 2x4 beam, on which rests 2x2 framing that is attached to the wall and covered by corrugated metal. A pair of one-over-one sash windows is located to the north of the door. Centered above, a nine-light, casement window pierces the gable end. The trim around the window is unmolded, with a drip cap, projecting sill, and an applied apron with angled edges.

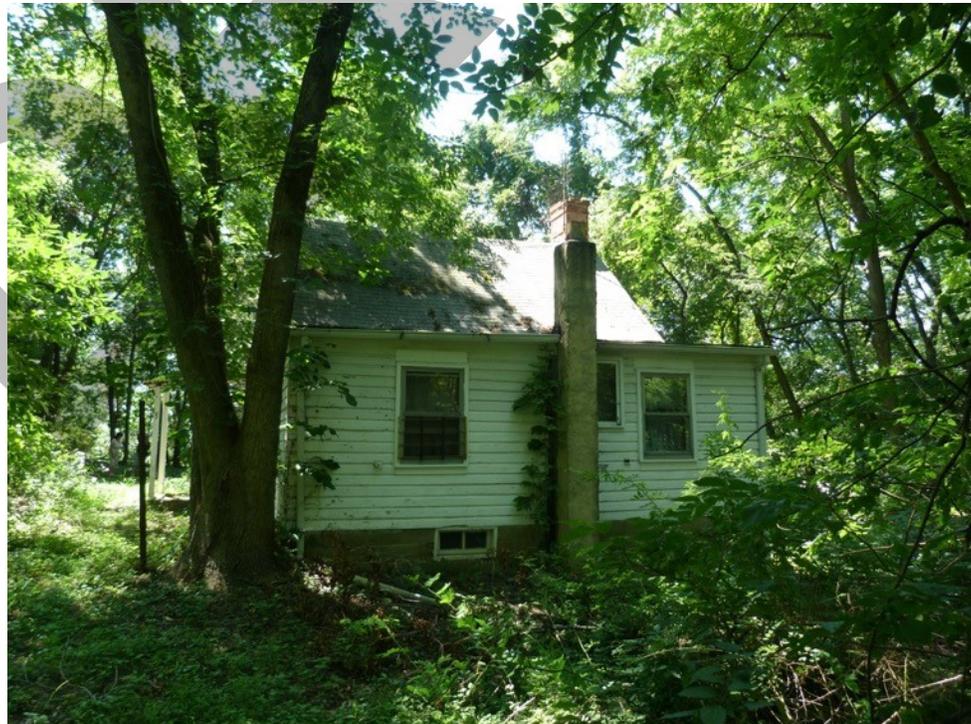
Photograph 0006: View of the north (rear) elevation, camera facing southwest.
(4 August 2015 by Margaret Westfield)

The north elevation consists of the north wall of the nineteenth-century addition (Photograph 6). This asymmetrical elevation features a concrete block foundation, drop siding, and a plain cornice. One two-light window pierces the foundation, while two twentieth-century one-over-one sash windows with a single-light fixed window in between are spaced along the first-floor level. An added modern chimney was constructed just west of center on the elevation.

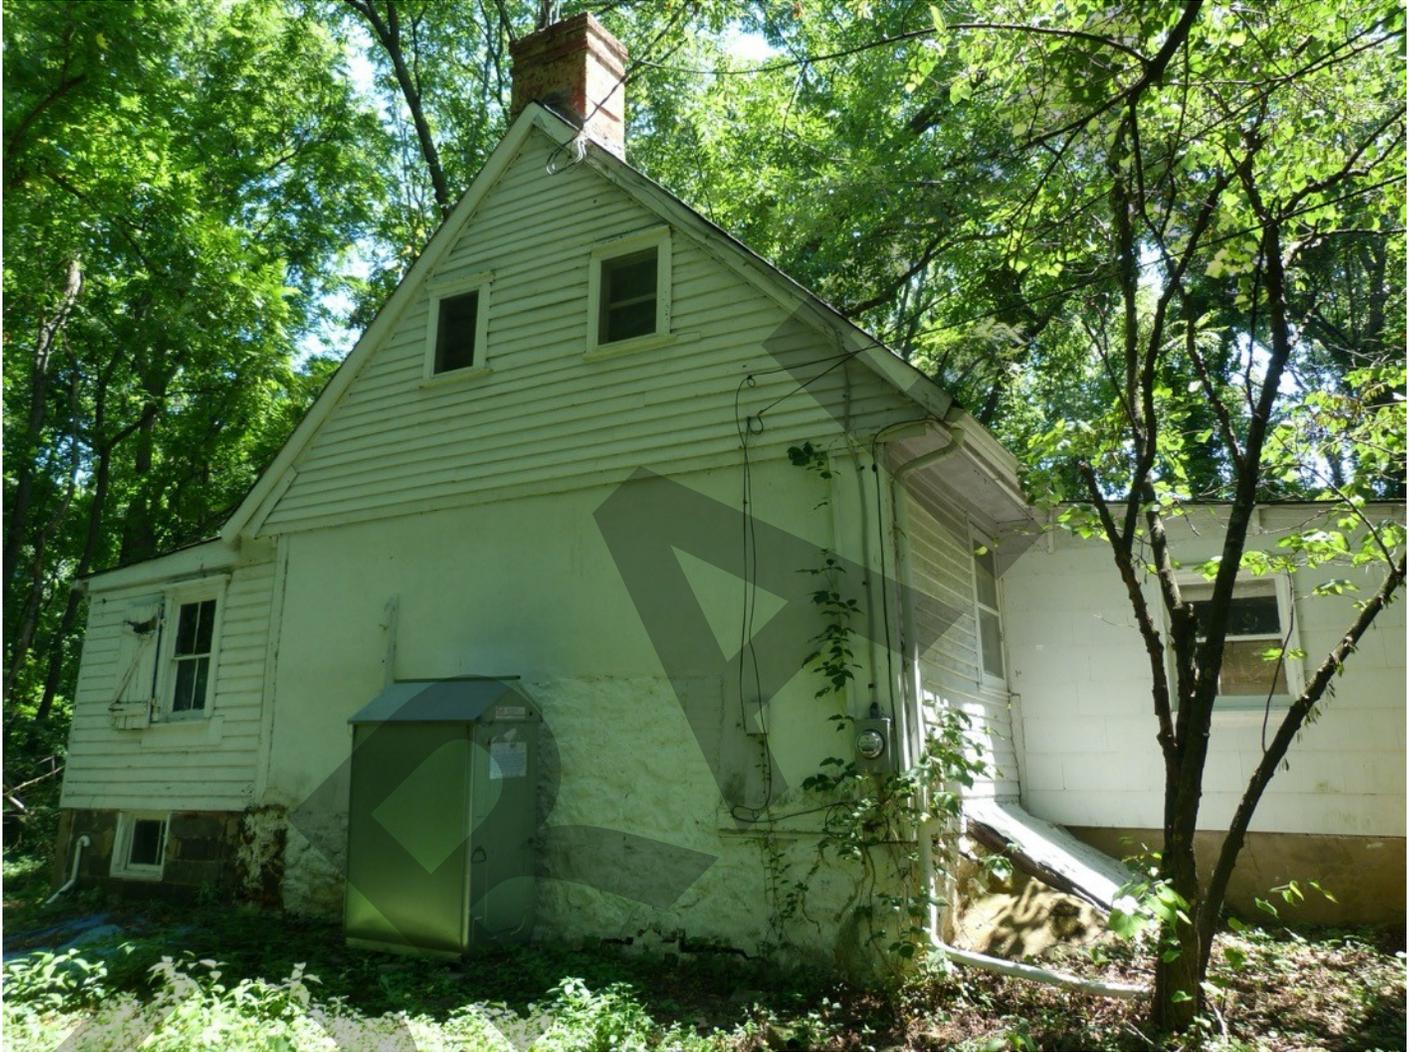
Photograph 0007: View of the west side elevation, camera facing northeast.
(4 August 2015 by Margaret Westfield)

The west elevation, like the east elevation, is composed of three sections, including the original cabin in the center, the addition to the north, and the porch, which is recessed from the faces of the other two sections, to the south (Photograph 7). The west elevation of the cabin consists of exposed stone foundation and chimney back, along with modern stucco over the original plank logs at the first-floor level and clapboard in the gable end. A pilaster, likely of early twentieth-century construction, runs up the south end of the wall, visually supporting the gable end. Two casement windows are symmetrically placed in the gable end: a two-horizontal-light sash in the south end and a six-light sash, both of which appear to have been reused from other locations and rotated 90 degrees for installation in the vertical openings. The trim on both windows is plain, with a drip cap and projecting sill and appears to have been installed over the clapboard, suggesting it is not original. The raking cornice, which has been added, based on historic photographs, is a thick, unmolded board. The previous rakeboard was also a plain board applied directly over the clapboard. The interior end chimney breaks through the roofline at the ridge. The original northwest corner of the cabin is exposed since the north addition is not flush, but it is covered by a vertical board except at the eaves, where a single quarter-log end is exposed. (Photograph 8). This would appear to be the notched end of the top log on the west wall and may have been cut that way due to the framing of the gable end.

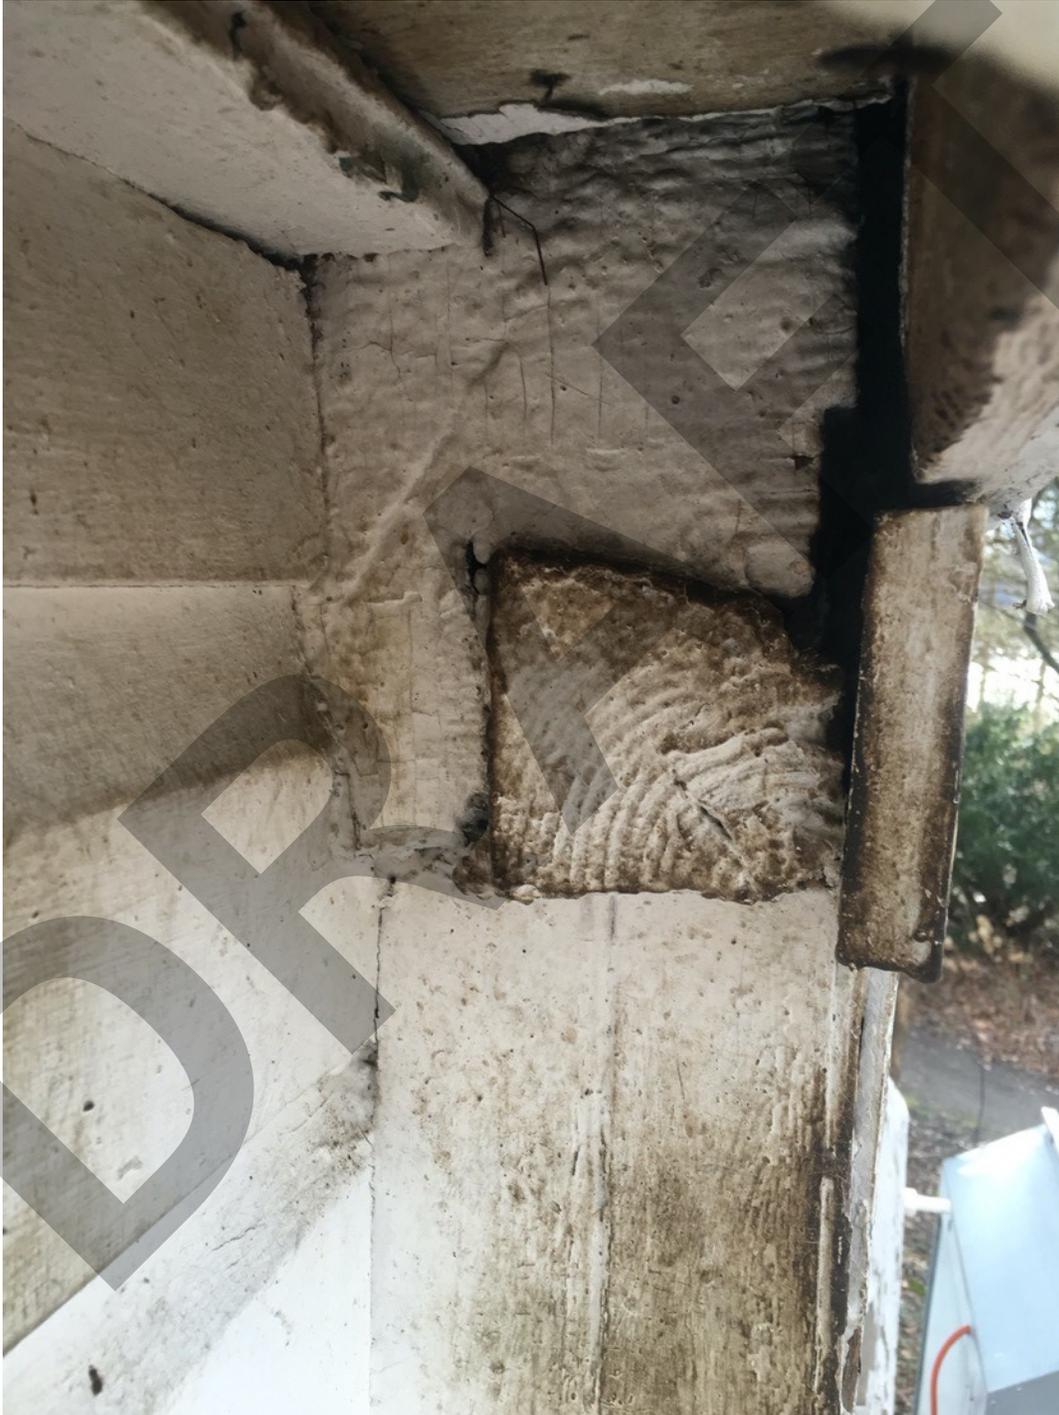
Photograph 0008: Detail of dovetail joint exposed on original northwest corner.
(4 August 2015 by Margaret Westfield)

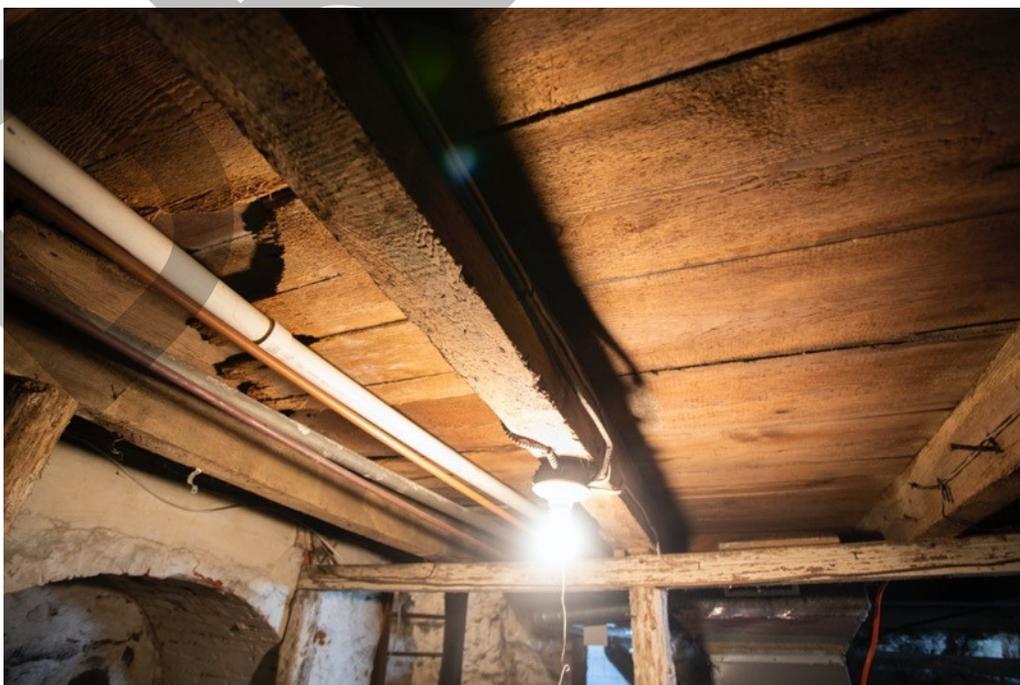
Photograph 0010: Detail of cellar framing, camera facing northwest, looking up.
(21 February 2018 by Adin Mickle)

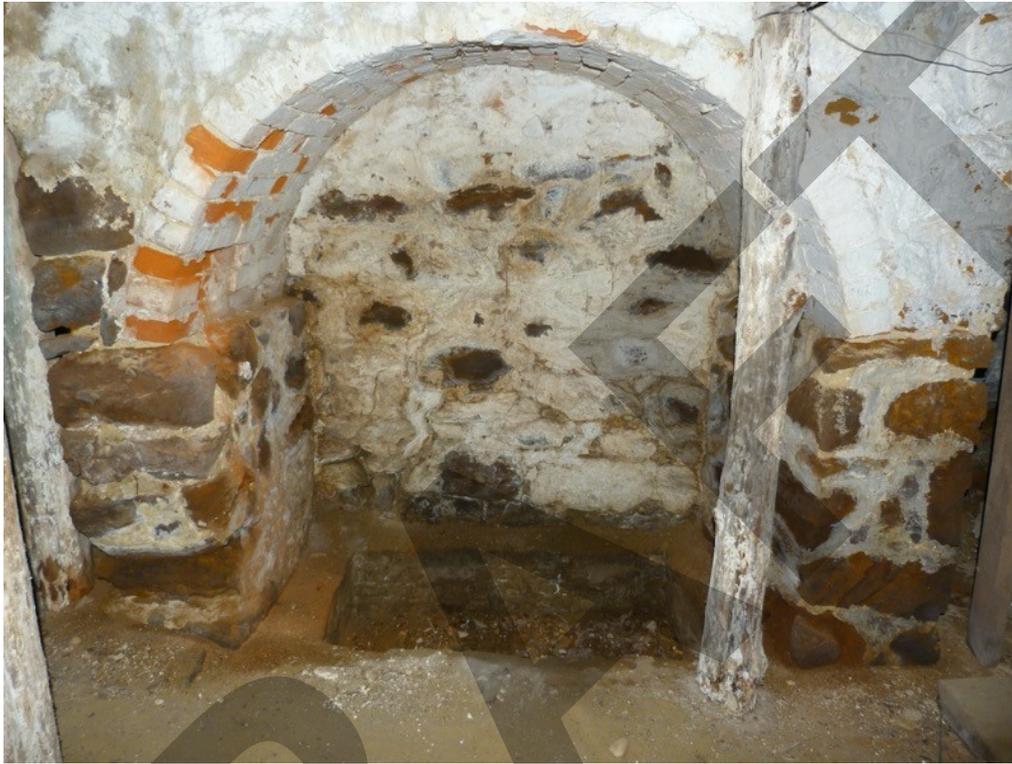
Photograph 0011: Detail of cellar fireplace vault, camera facing west.
(4 August 2015 by Margaret Westfield)

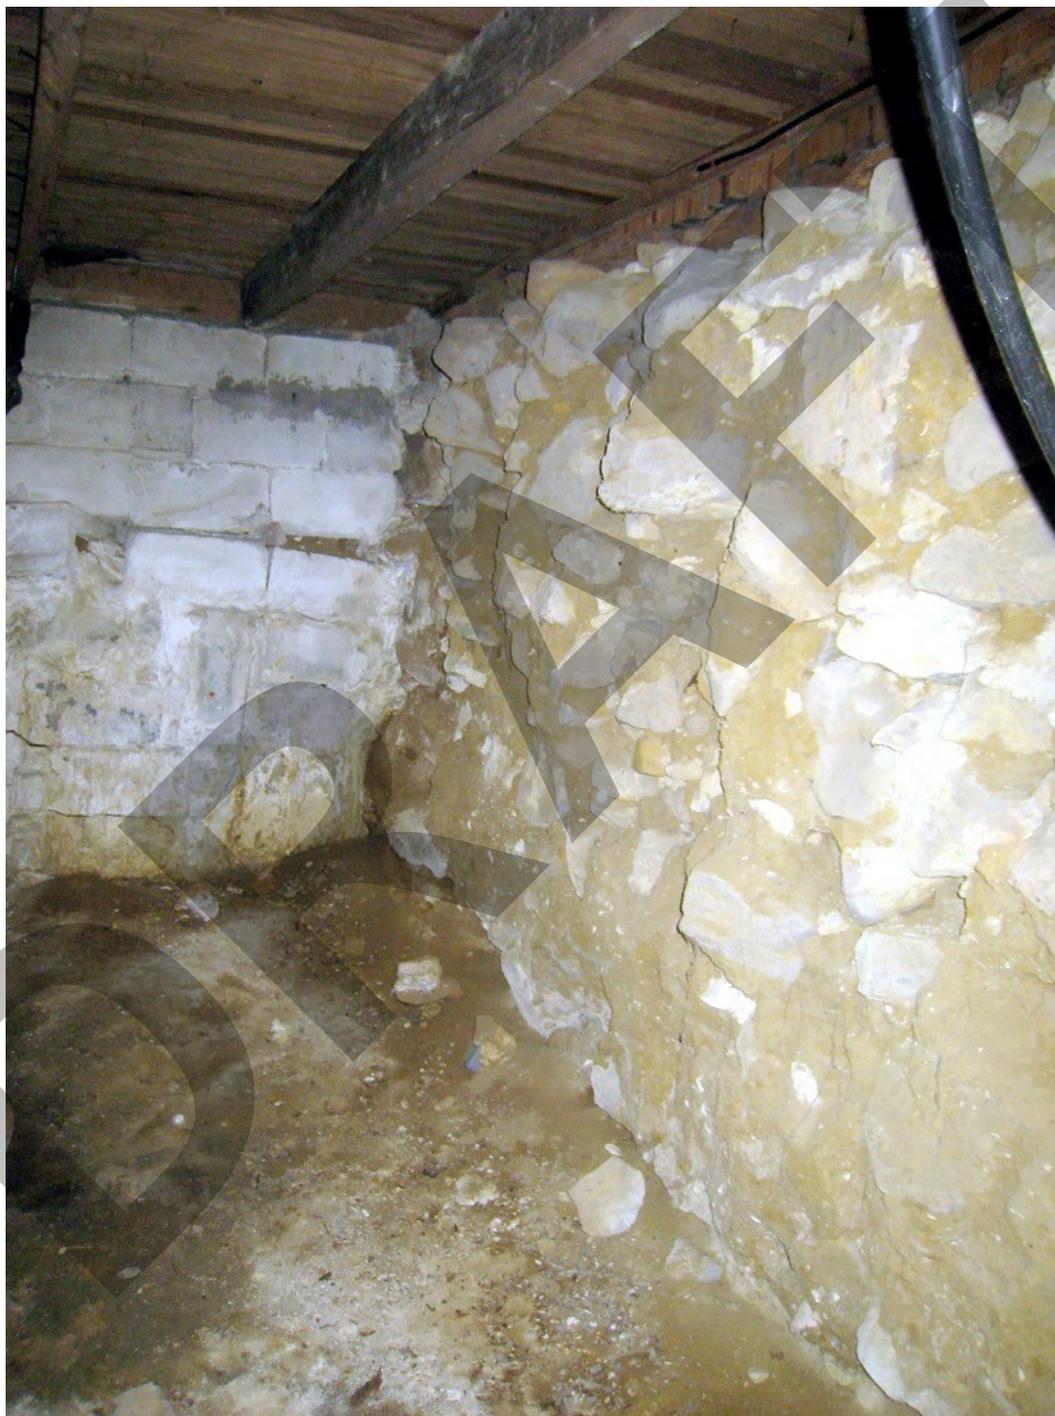
Photograph 0014: Interior view of outside surface of the original north foundation wall from addition cellar, camera facing east.
(21 February 2018 by Adin Mickle)

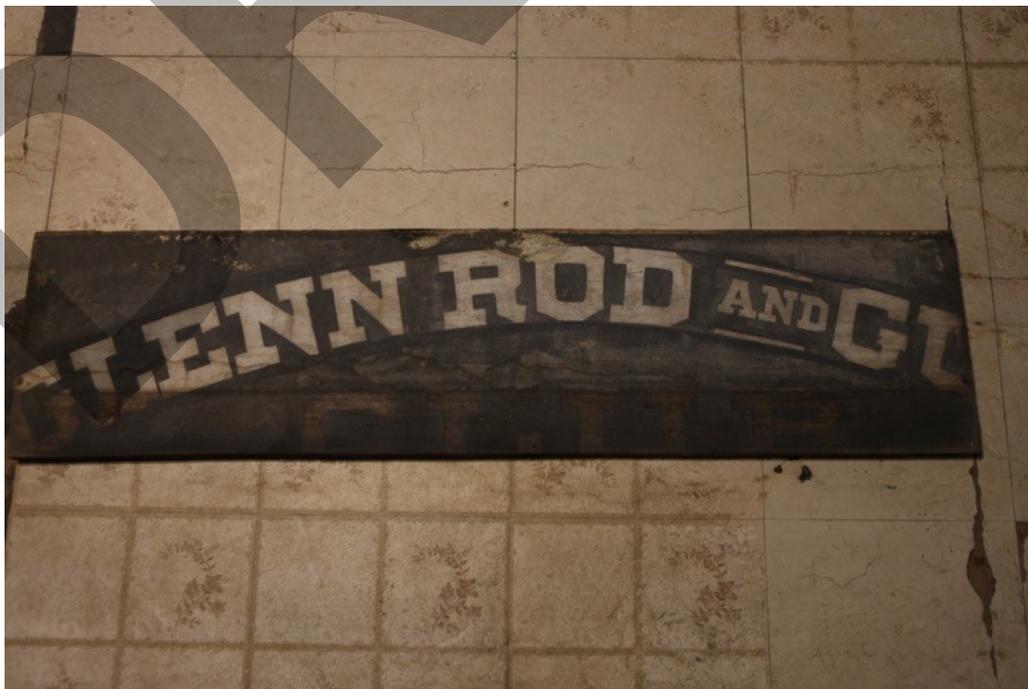
Photograph 0028: Detail of sign reused as cupboard shelf.
(21 February 2018 by Adin Mickle)

³² The name of the sporting club was found on the underside of a shelf in the cupboard (to the left of the fireplace) on the west wall by Adin Mickle. This shelf was made from a reused portion of the Club's sign. See Photograph 28.

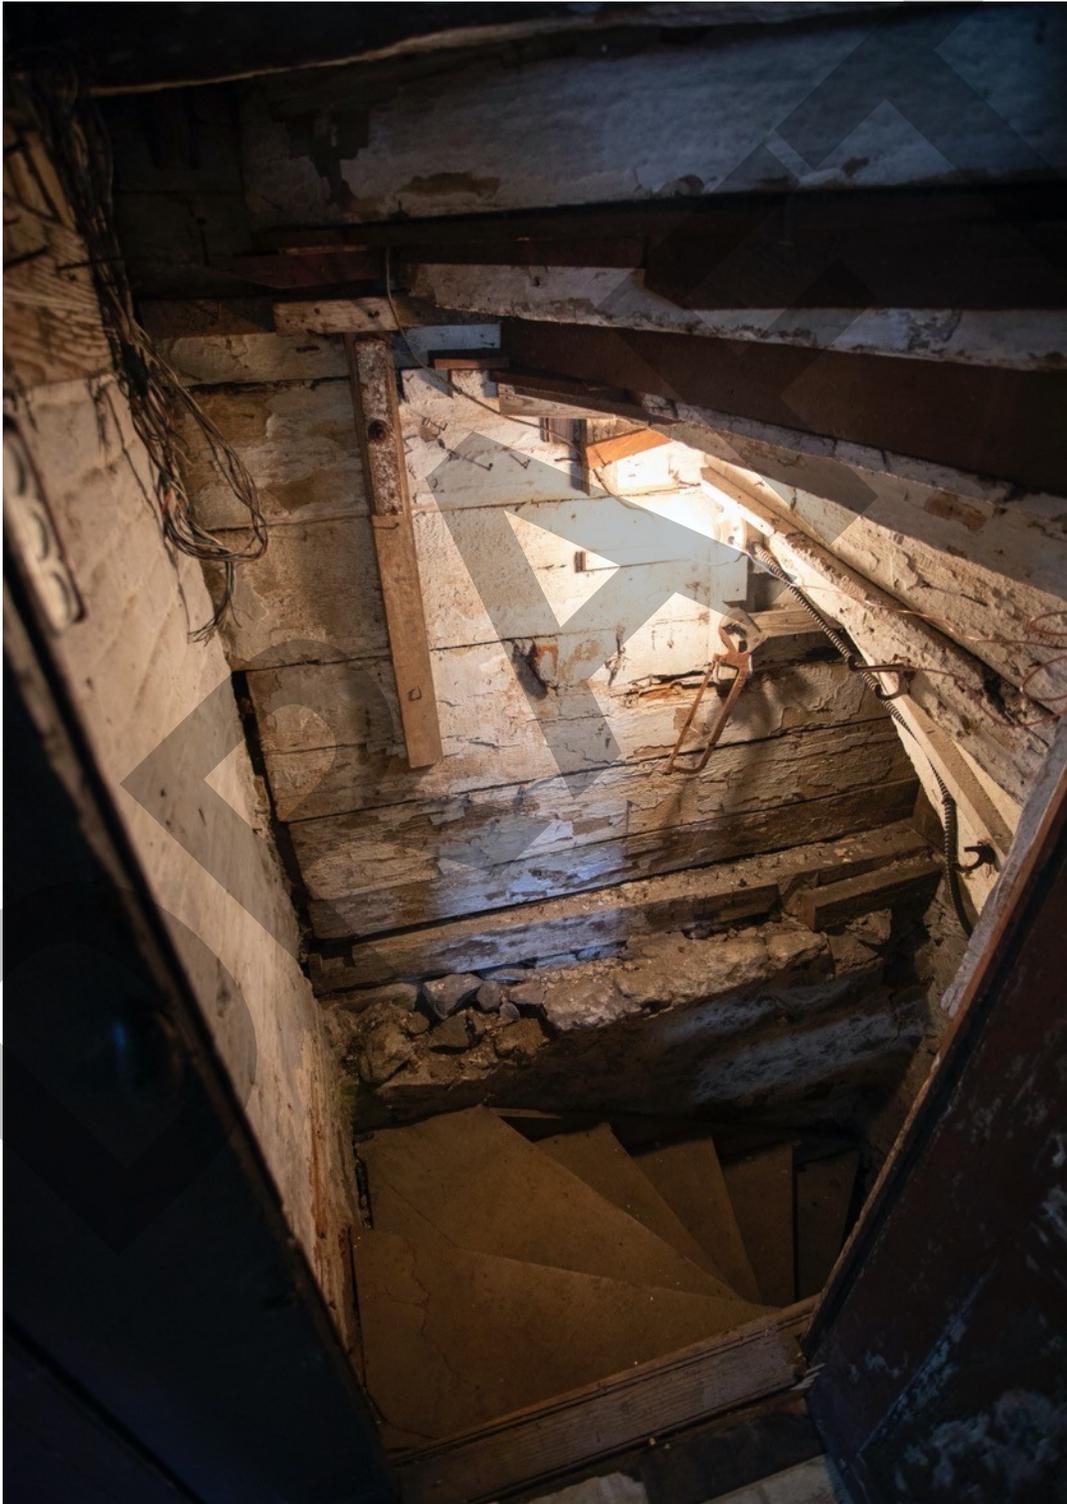
Photograph 0029: Detail of log wall construction within cellar stairway.
(21 February 2018 by Adin Mickle)
