National Register of Historic Places Registration Form

historic name Cole Landing Tavern

other names/site number Upton Log Cabin

street & number 500 Cole Landing Road not for publication

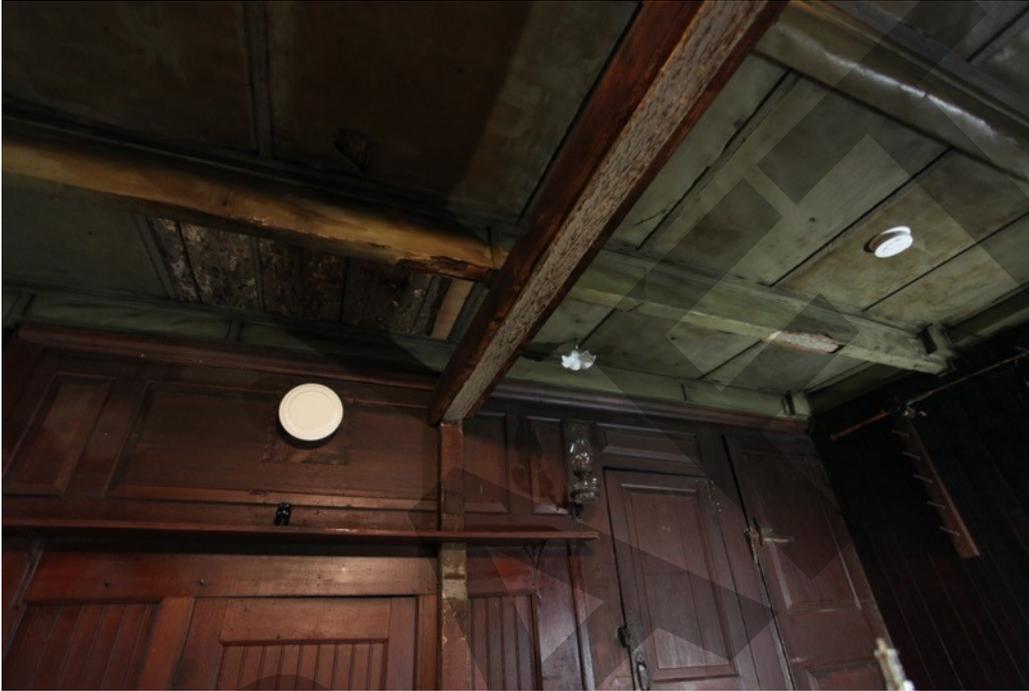
Photograph 0034: Ceiling detail showing second floor framing with added mid-span beam.
(21 February 2018 by Adin Mickle)

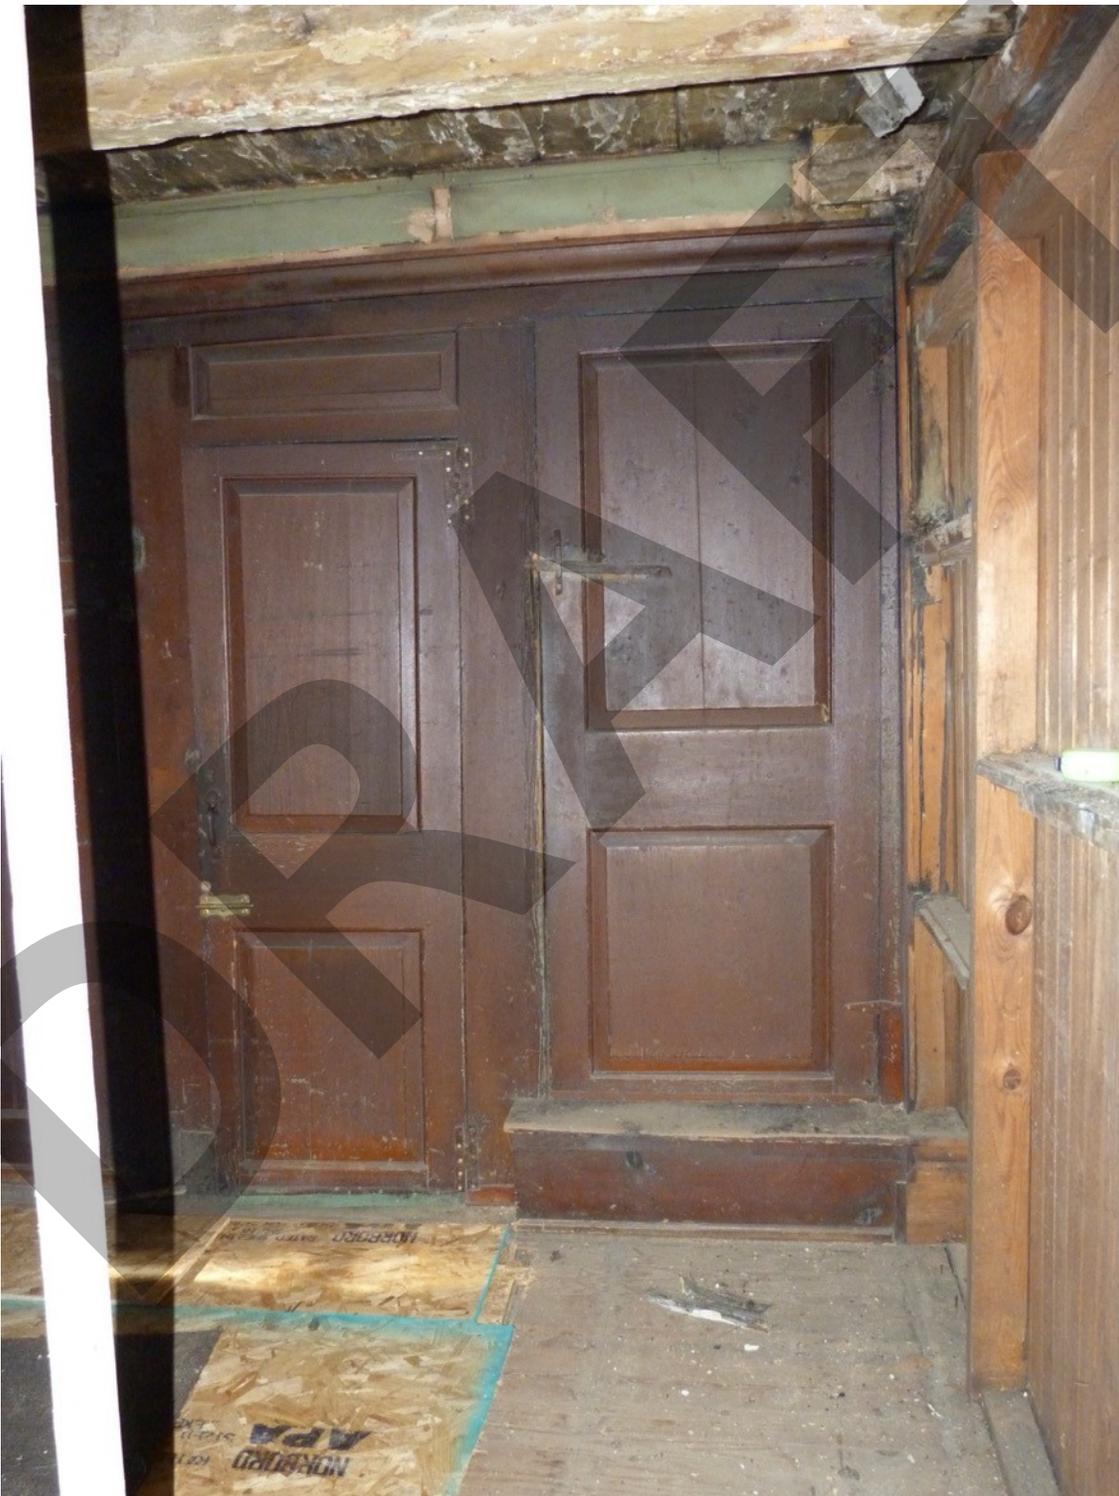
Photograph 0049: Detail of first floor door to attic and stud wall found under 1908 vertical-board paneling during construction.
(December 7, 2018 by Margaret Westfield)

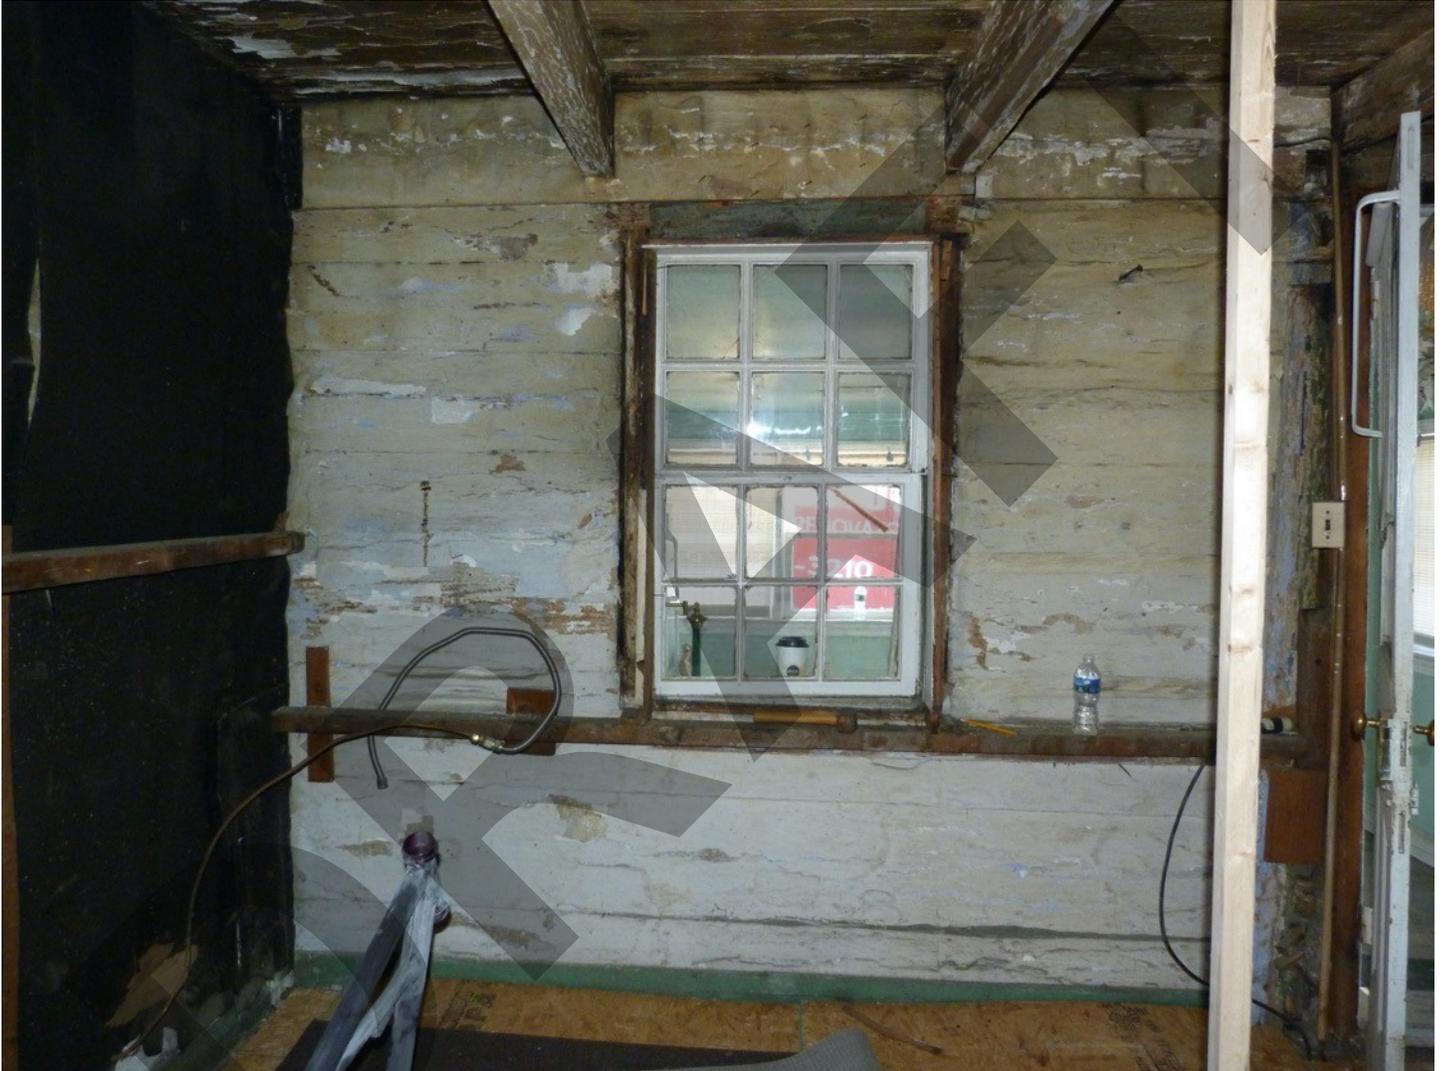
Photograph 0050: Interior south log wall exposed during construction.
(December 7, 2018 by Margaret Westfield).

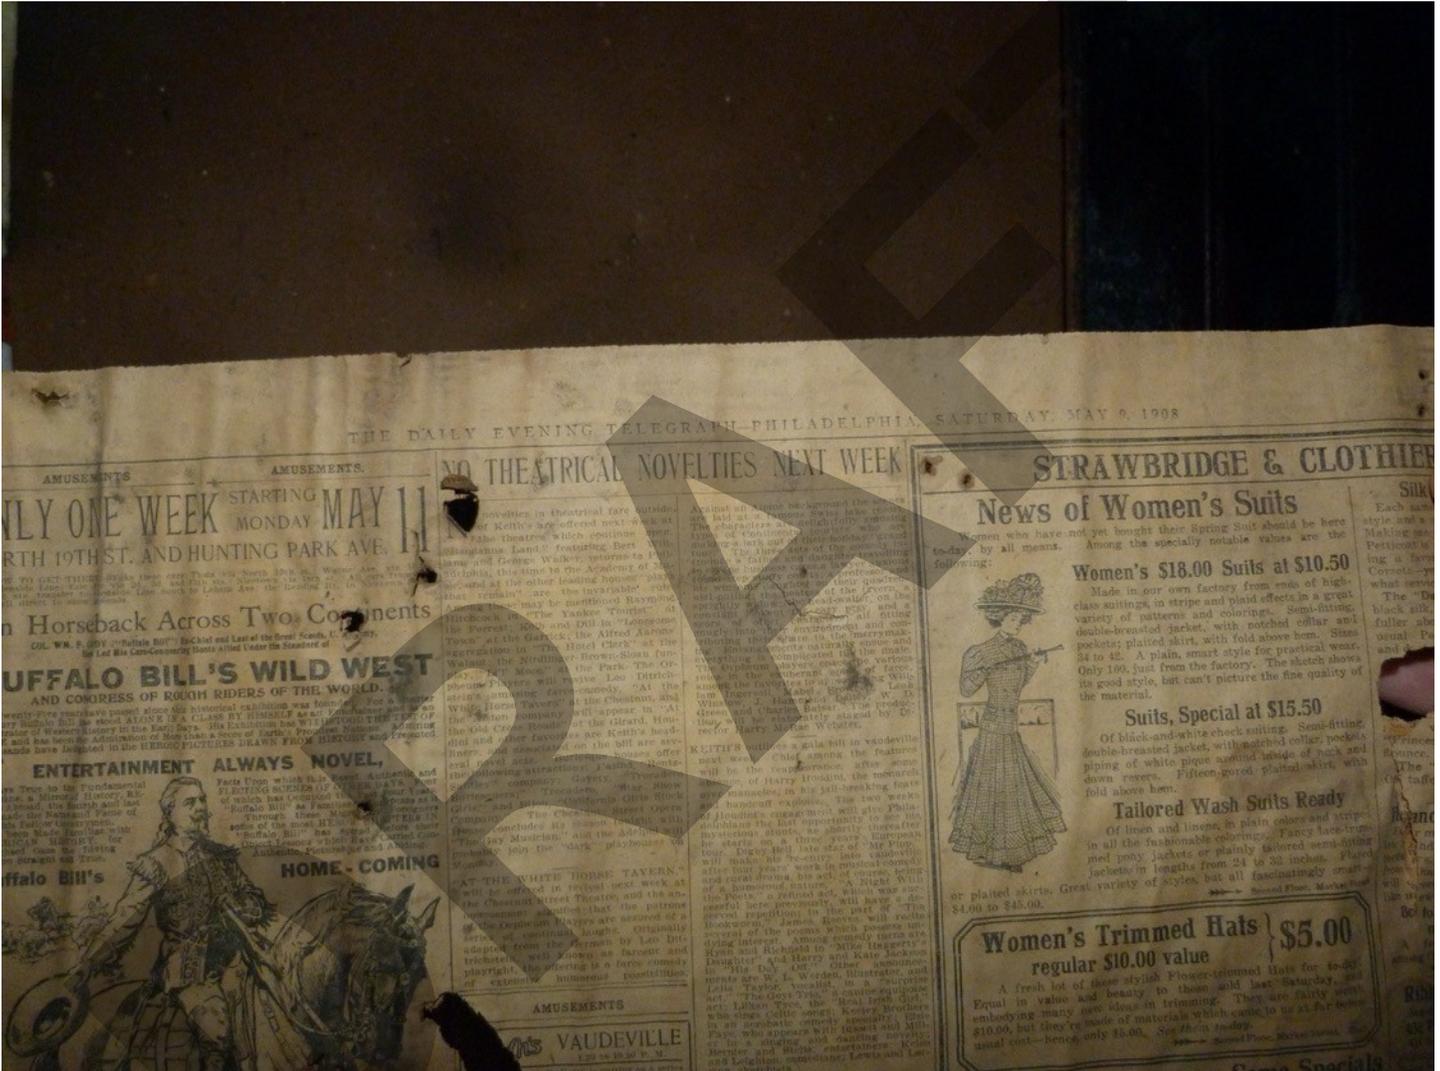
Photograph 0051: Detail showing one of May 1908 newspapers found during demolition of added board siding. (December 7, 2018 by Margaret Westfield)

⁴ This date is based on the dates on newspapers found behind the added vertical-board paneling during renovations in 2018-2019.

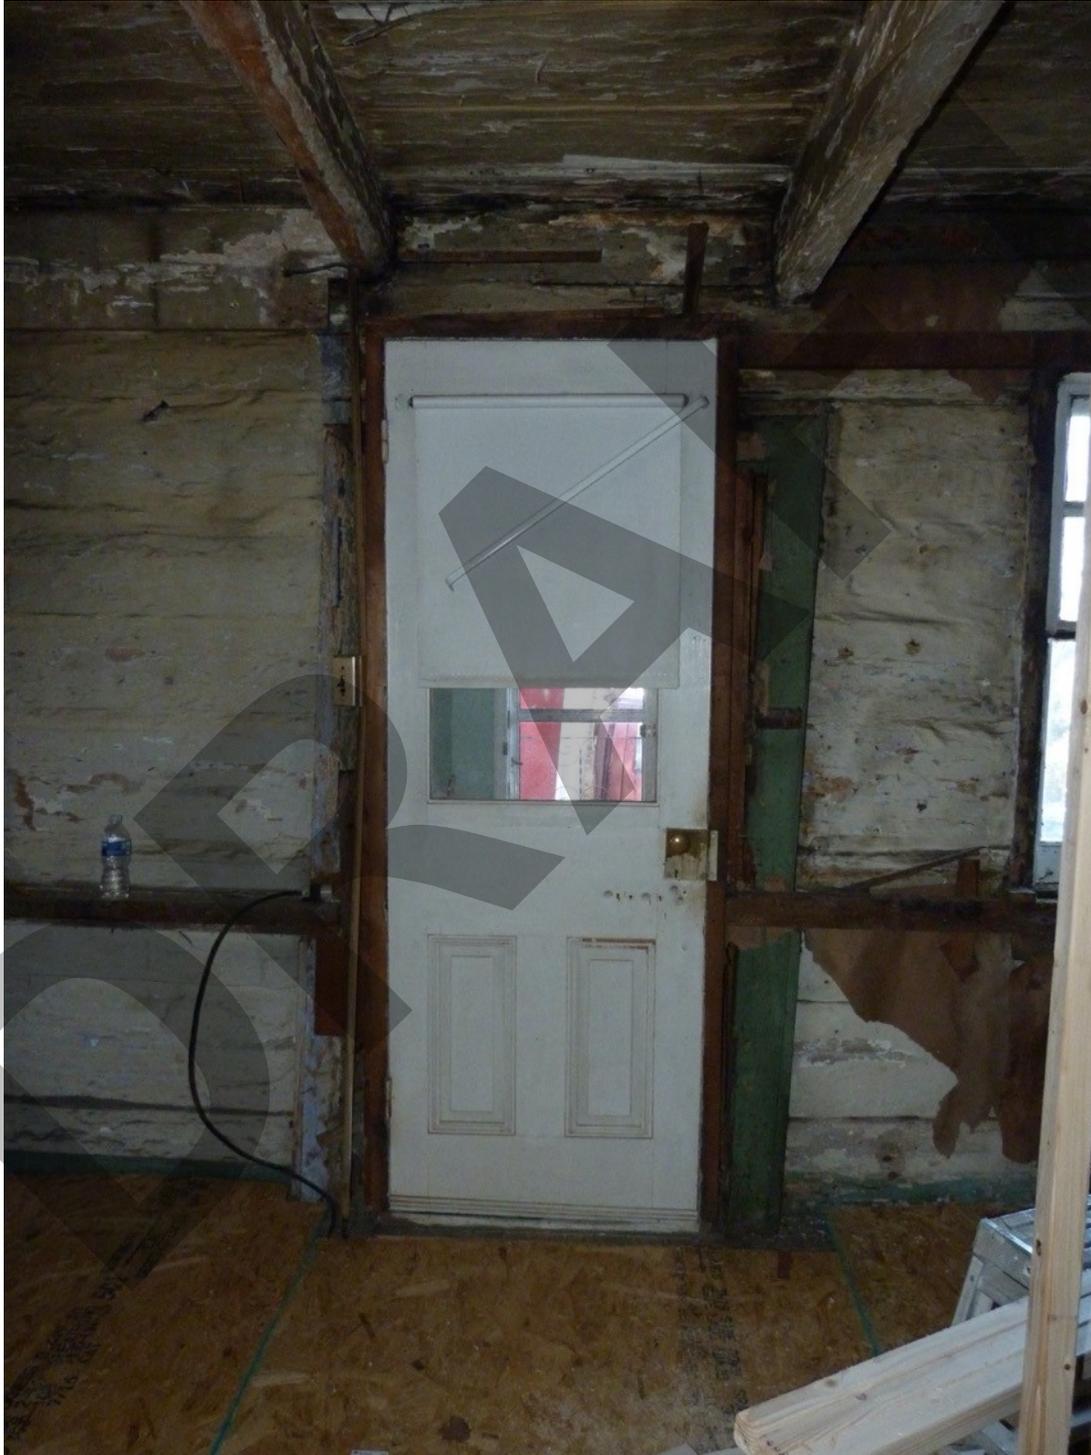
Photograph 0052: Interior view of replacement door in wider, shorter original door opening during construction. (December 7, 2018 by Margaret Westfield)

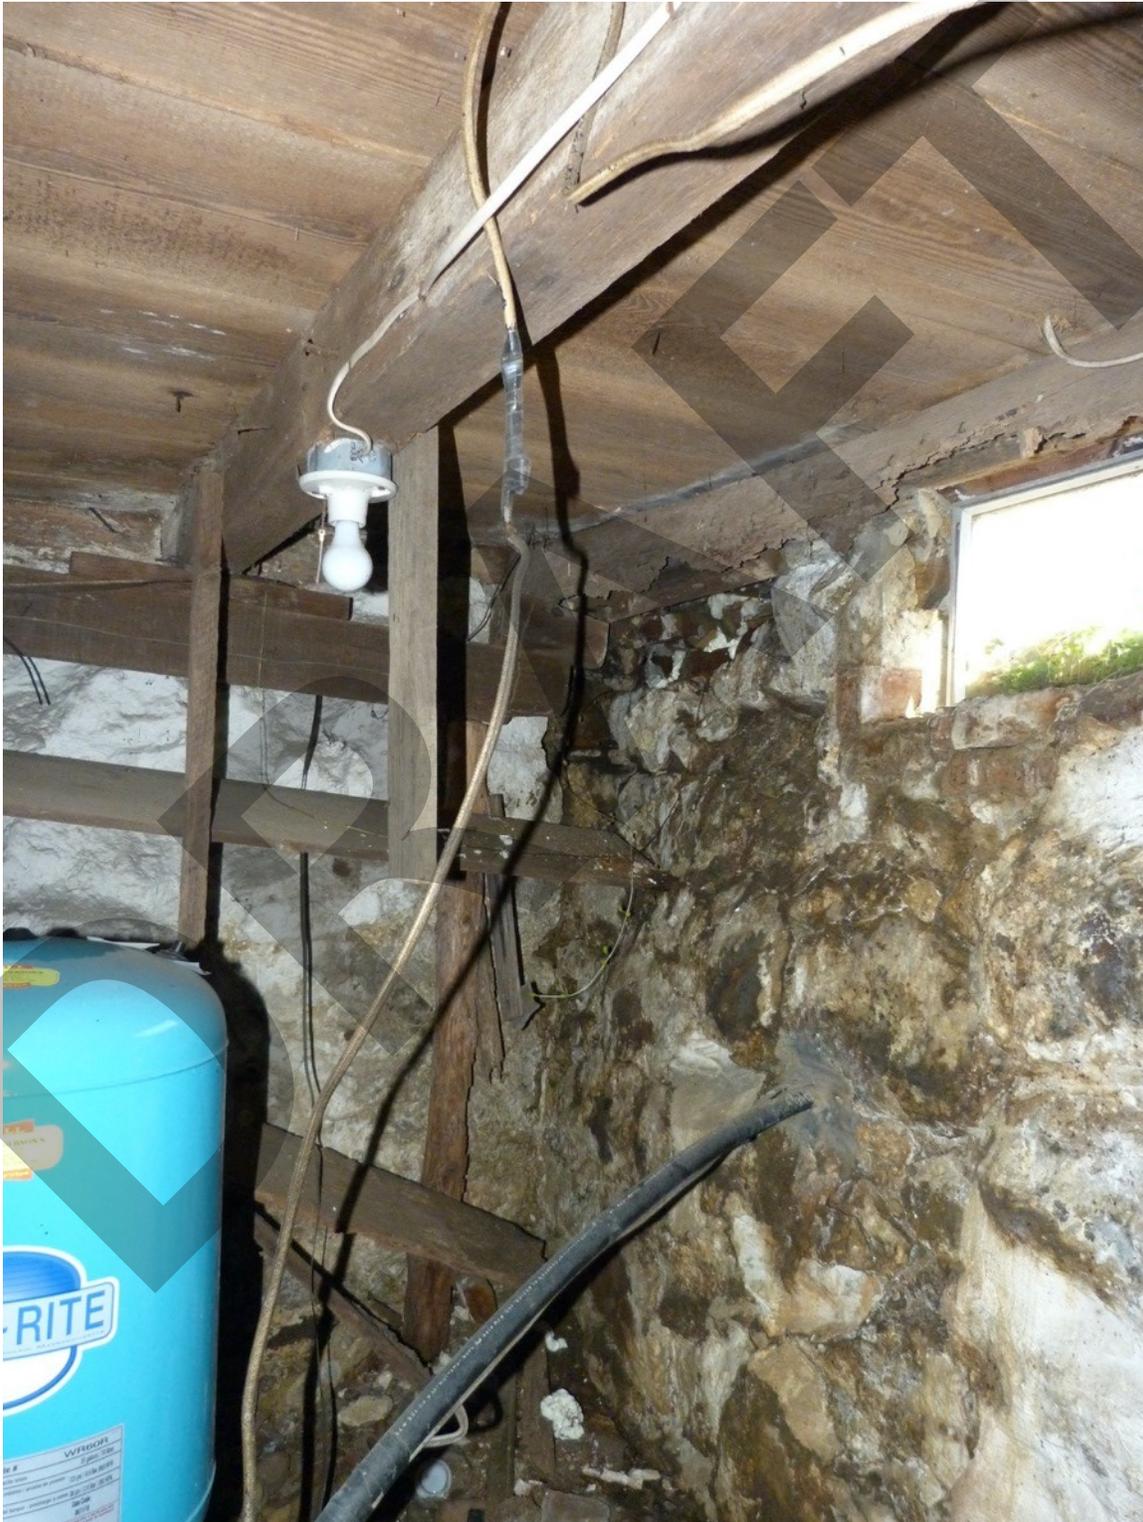
Photograph 0054: Detail of structural deterioration in northeast corner of cellar during construction. (December 7, 2018 by Margaret Westfield)

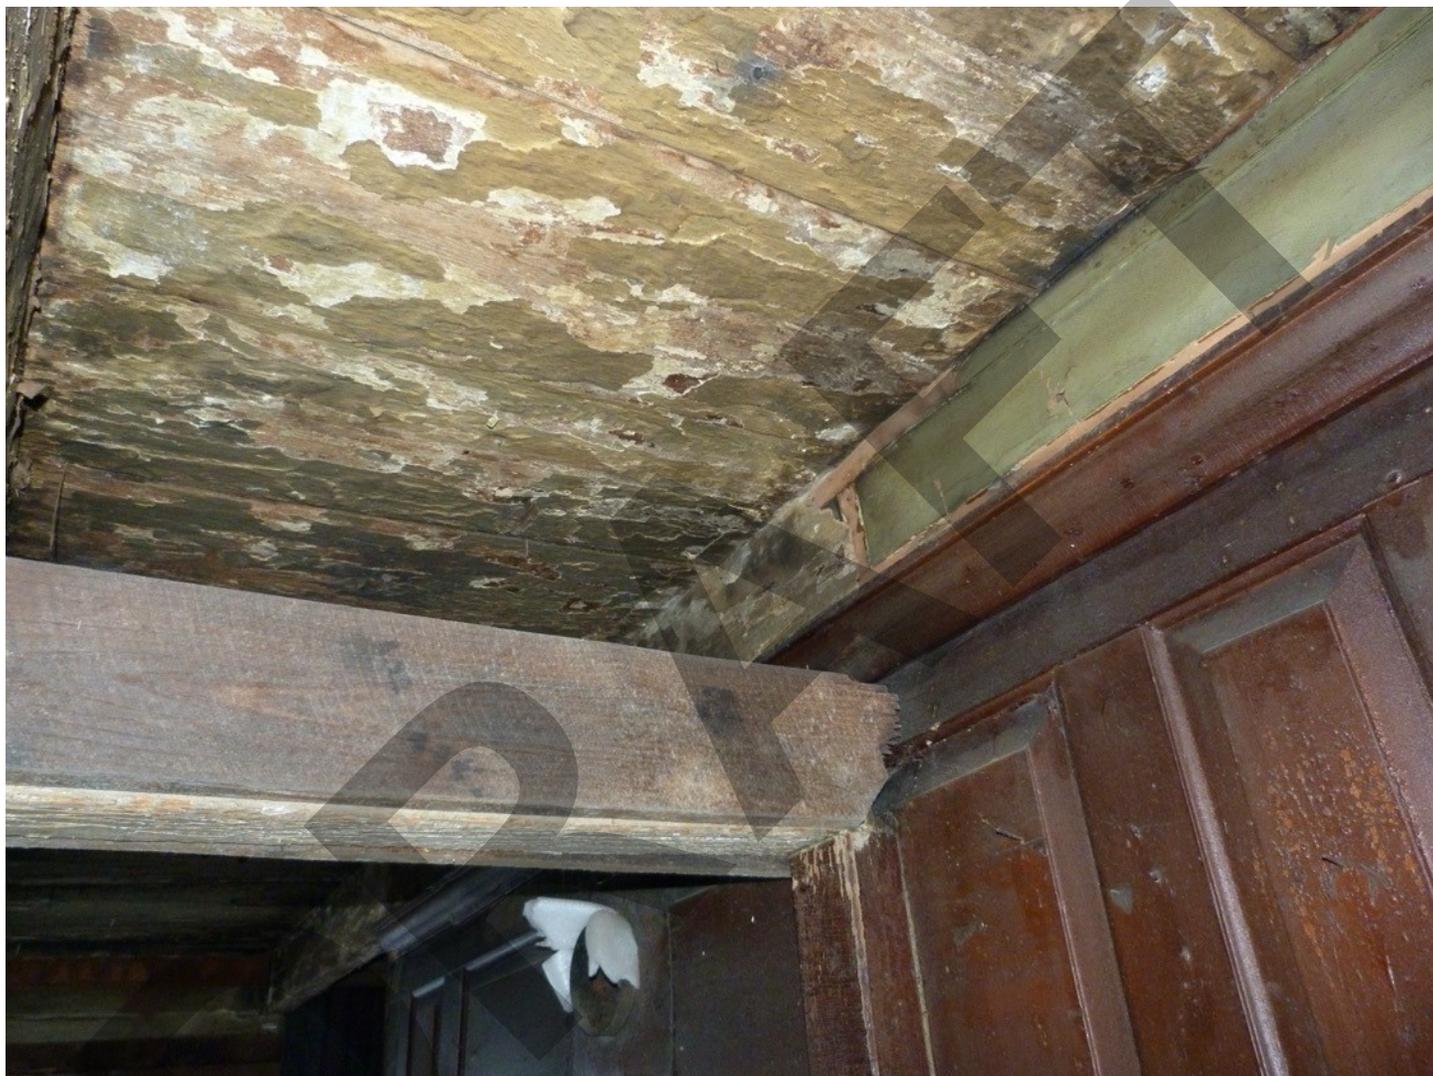
Photograph 0055: Detail of the underside of attic floor boards above added beam against west wall during construction. (December 7, 2018 by Margaret Westfield)
