EAGLESWOOD

EAGLESWOOD TOWNSHIP

Eagleswood Township
Municipal Code 1508
— Survey Form Site

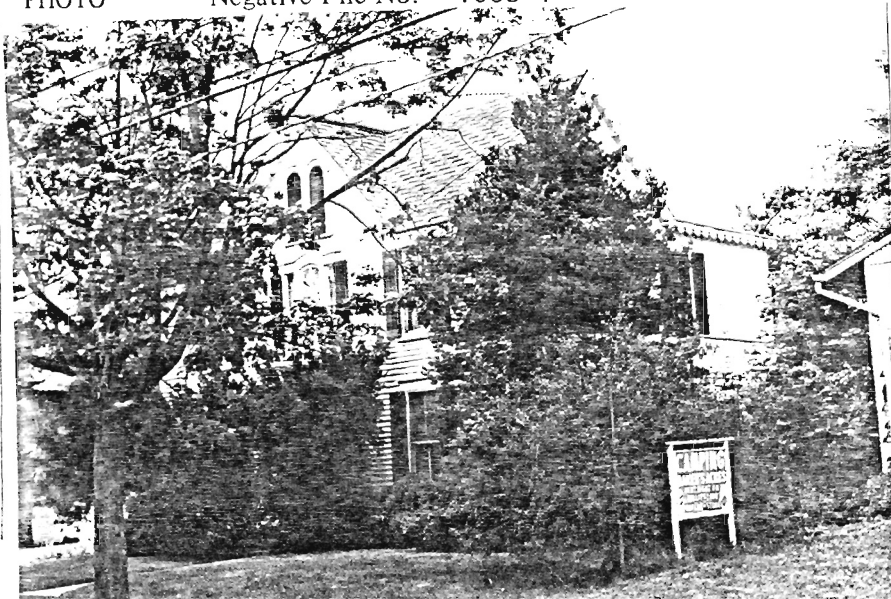
Negative File No. 1508-1

A center door contains a fanlight and sidelight. All windows are 2/2 with louvered shutters. A Palladian-like window is located above the door on the second floor. Paired Roman arch attic windows are found in the gable ends. Staggered-butt shingles are also located in the gable peaks as is vergeboard.

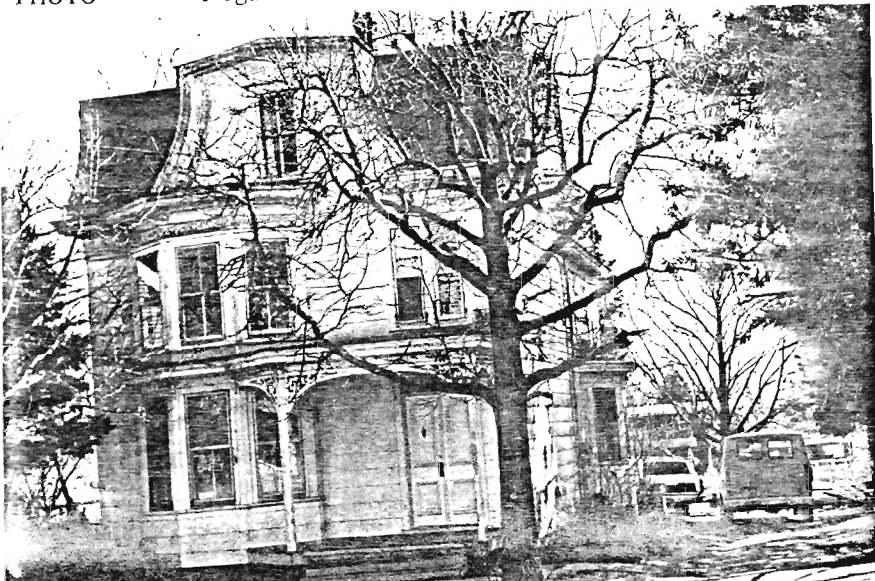
PHOTO Negative File No. 1508-2

Construction Date: c. 1852
Architect:
Style: Vernacular / Second Empire
Number of Stories: 2½
Foundation: low, brick
Exterior Wall Fabric:
Fenestration: 2 bay
Roof/Chimneys: Dutch mansard, returns
Additional Architectural Description:

Two/two windows are employed throughout. A 2 story bay window is found across the facade and contains brackets and an elaborate band. A double door with round top panels and transom is located south of the bay window. A small front porch has square posts, and vergeboard brackets.

The structure is located on a narrow lot near the road. A similar building is found at the northern edge of town.

The house is a good example of Second Empire / vernacular architecture. Few buildings of this kind are found in the township, however one structure along Route 9 contains similar elements including a mansard roof, small porch and decorative bands.

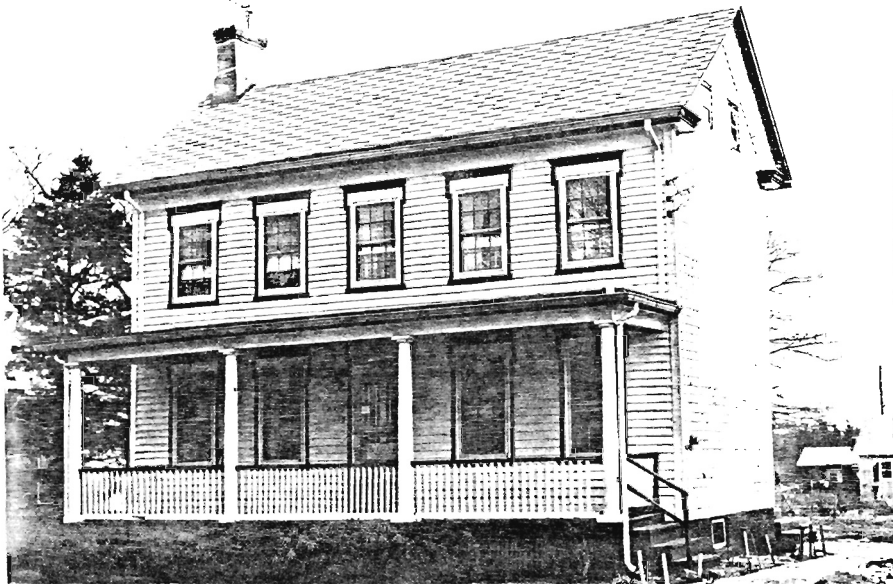
Negative File No. 1508-3

An open porch with Doric columns and a standard railing is found across the facade. Six/six windows are employed throughout and have shouldered architrave trim. The center door has an enclosed transom.

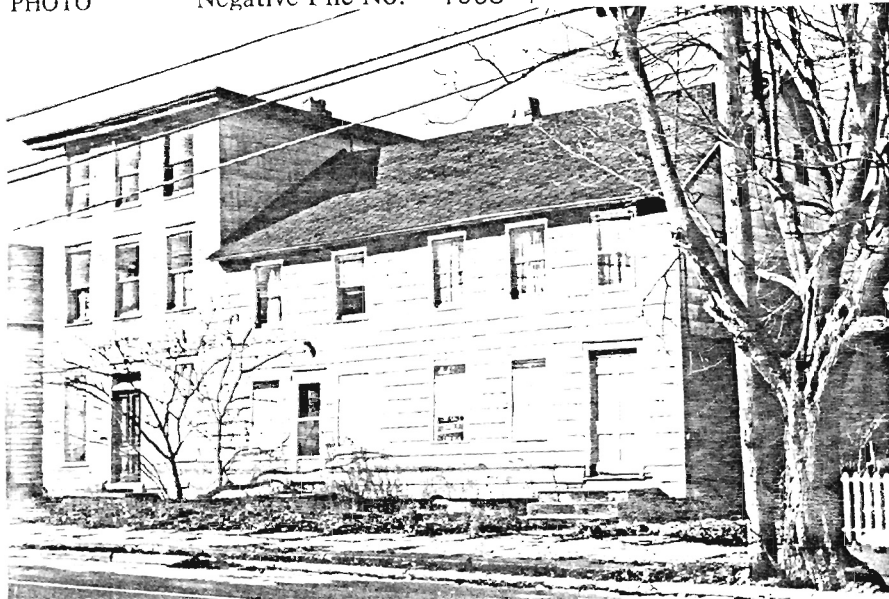
Negative File No. 1508-4

The hotel was built in three sections, a 3 story, 3 bay late 19th century section with parapet roof, molded cornice to the south, and two 2 story, 3 bay, gable roof sections to the north. The south section contains a paneled door with transom. A 6 panelled door is found on the extreme north section. Windows are 2/2 or boarded.

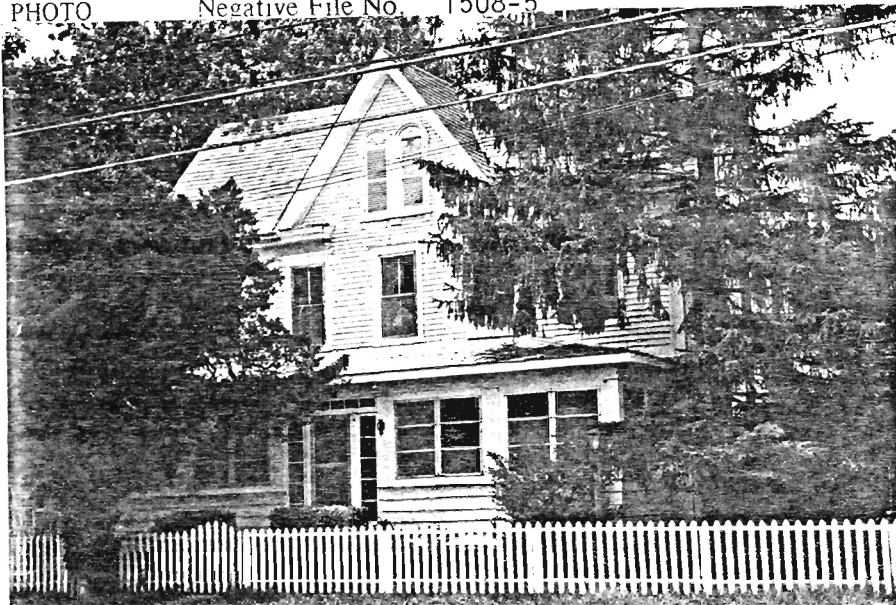
PHOTO Negative File No. 1508-5

An enclosed porch is found across the facade. Windows are 2/2. Double round arched attic windows are located in the gable peaks. A center door contains side-lights and transom. Molded (panelled) corner posts and molded window surrounds are found. A molded cornice runs around the perimeter of the building. A 19th century outbuilding contains a decorative rake board.

The house is located on a corner lot on the main road. Small out-buildings are found in the rear yard. Similar buildings are found along Route 9.

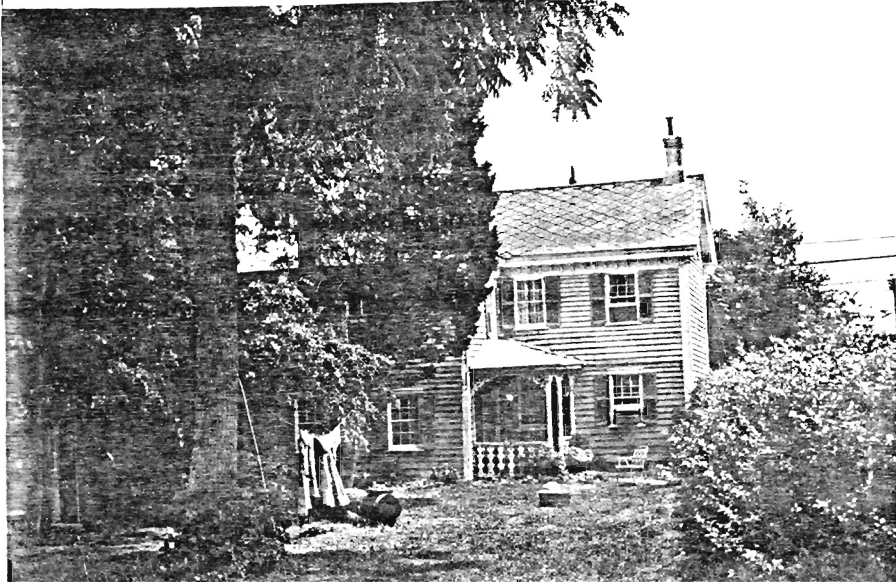
PHOTO Negative File No. 1508-6

The structure has 6/6 windows with louvered shutters. A center panelled door contains sidelights and a transom. A screened porch with blind balustrade runs across the facade. Sawn brackets are located below a molded cornice. Decorative rake boards are found on either end. A low 1 story addition is found on the north end. Two small outbuildings can be found in the rear yard. The barn is small and has a flaring gable roof with a decorative rake board, clapboard exterior, and lean-to additions.

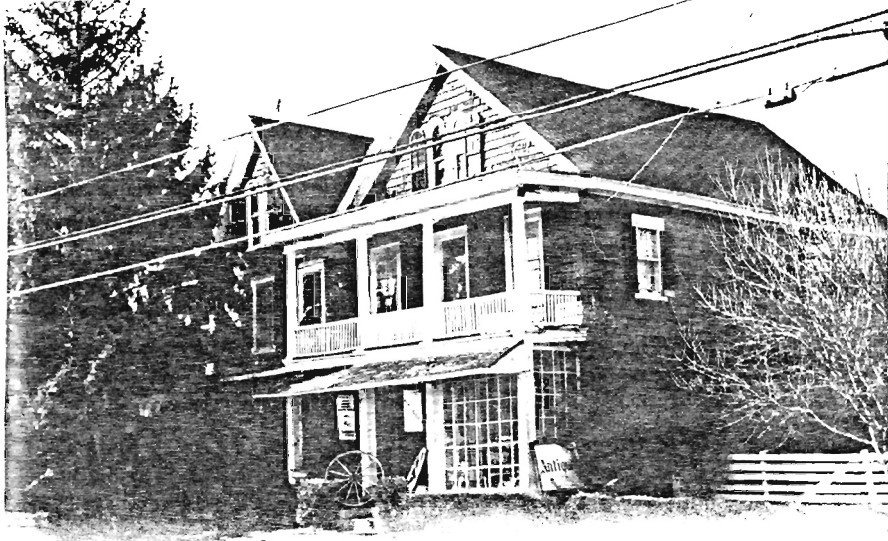
Negative File No. 1508-7

The structure was originally a 5 bay house. A 3 bay store was built separately but connected to the house in the 1870s by the center 3 bay section. The oldest section is found to the south. It is 2 stories and contains 6/6 windows, gable roof with returns, molded cornice and a screened front porch. The northern sections have cross gable roofs, 2/2 windows and paired Roman arch attic windows. All windows have louvered shutters. The store contains a 2 tiered porch with a standard railing and Doric columns. A large rear addition is found at the north end.

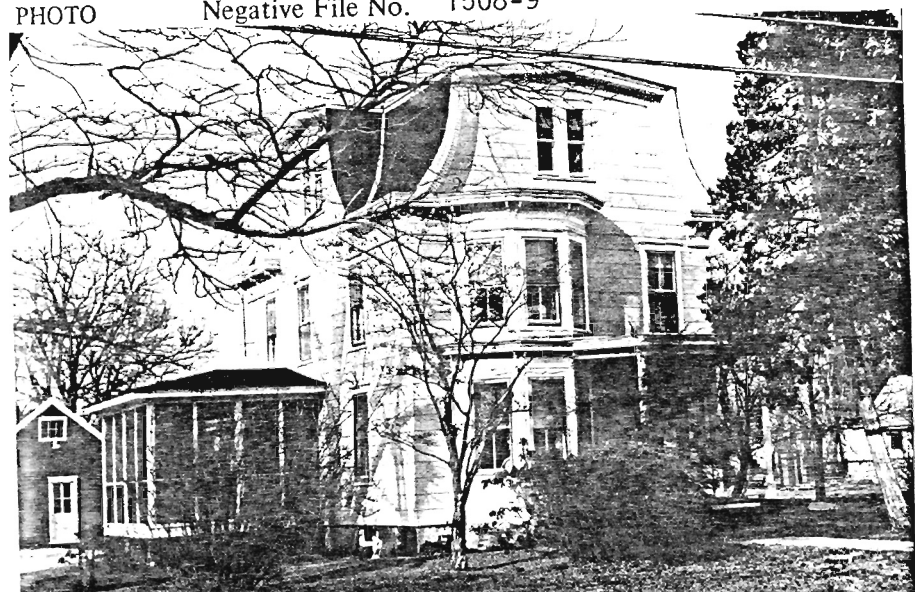
PHOTO Negative File No. 1508-9

Construction Date: late 19th century
Architect:
Style: Vernacular / Second Empire
Number of Stories: 2½
Foundation: low
Exterior Wall Fabric: asbestos siding
Fenestration: 2 bay
Roof/Chimneys: Dutch mansard roof
Additional Architectural Description:

A two story bay window is found on the facade and contains brackets and decorative bands. A bracketed cornice and decorative bands run along the perimeter of the building. 2/2 windows are found throughout. A double-leaf door with transom is found on the facade. A screened porch is located on the south end and has square posts and vergeboard brackets.

The structure is located on the main street (Route 9), back from the road on a large lot. Smaller, older structures are found nearby. To the south are early 20th century buildings.

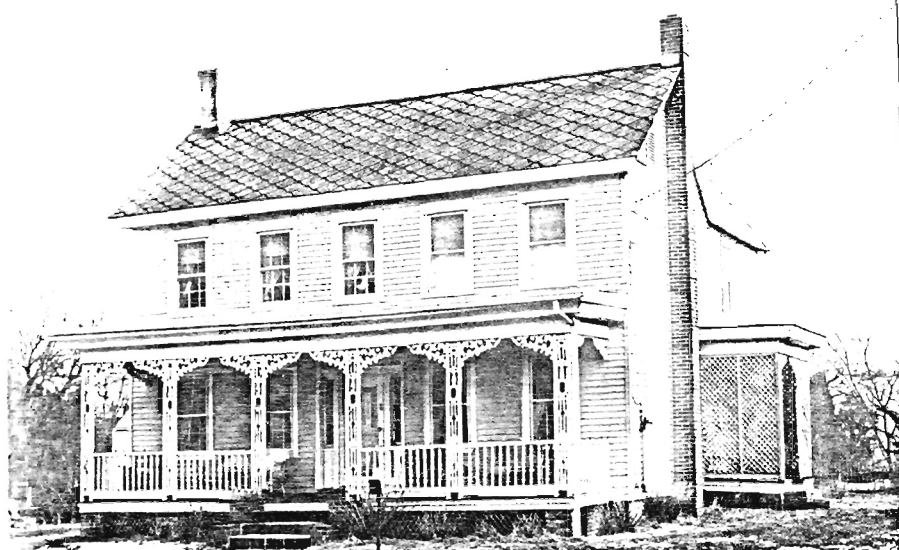
PHOTO Negative File No. 1508-13

Six by six windows are found throughout. A center door has sidelights and a transom. An elaborate front porch contains a standard balustrade, carved posts with cut out designs, and vergeboard brackets. A south porch contains lattice work and vergeboard brackets.

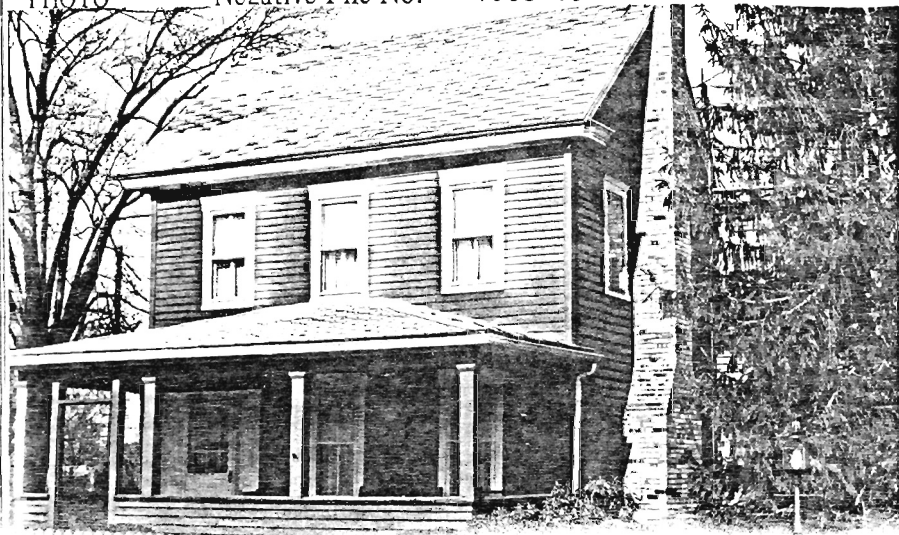
PHOTO Negative File No. 1508-19

An open porch has square posts and a blind balustrade. A side porch is located on the west elevation. 2/2 windows with louvered shutters are found throughout. An end doorway has an enclosed transom and sidelights. Staggered butt and fishscale shingles are located in the gable peaks.

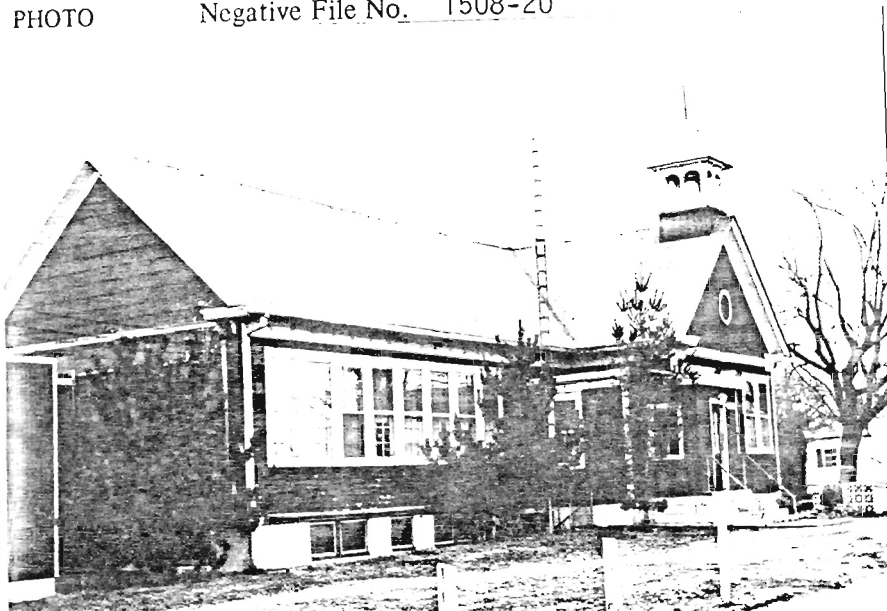
PHOTO Negative File No. 1508-20

A cupola rests on the roof, below which is a bracketed cornice. A flush board runs across the gable ends at the roofline. 9/9 windows are paired or single on the main section of the school. The west wing was added later, but contains the same elements. A continuous band of eight windows is found on the wing.

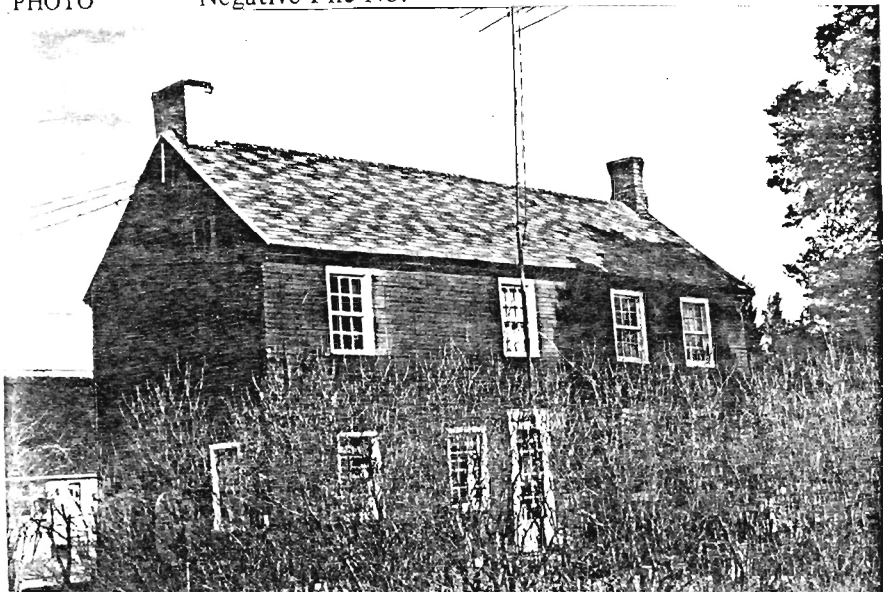
PHOTO Negative File No. 1508-21

This early 18th century structure was built in two sections (3 bay, 2 bay)
The exterior has been altered over the years, but the original 6/6 windows and
panelled doors are intact.

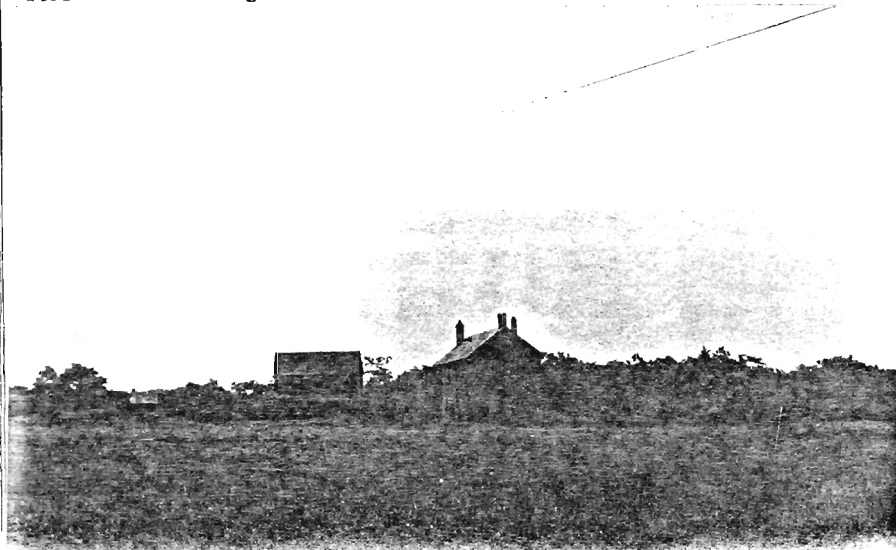
Negative File No. 1508-26

Construction Date: late 19th century Source of Date: style
Architect: Builder:
Style: Form/Plan Type: rectangular
Number of Stories: 2
Foundation: low
Exterior Wall Fabric: clapboard, weathered
Fenestration: 5 bay
Roof/Chimneys: gable roof with returns
Additional Architectural Description:

The structure has a 2 bay east wing with parapet roof. Windows are 2/2 and 6/6. A front porch has been enclosed but shaped brackets and turned posts are intact. Four large outbuildings are found east of the house. They are wood frame, clapboard structures with gable roofs and lean-to additions.

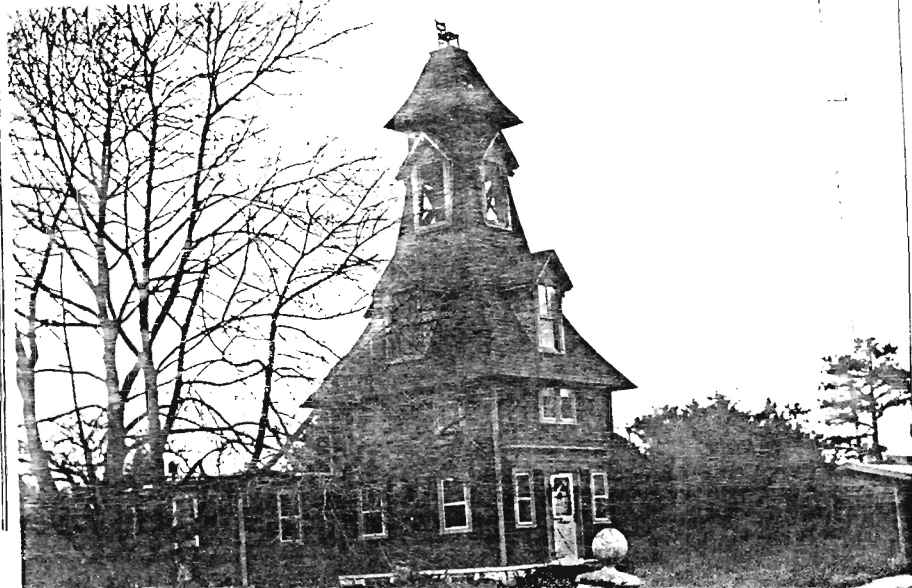
Negative File No. 1508-27

Construction Date: late 19th century Source of Date: style
Architect: Builder:
Style: Form/Plan Type: square
Number of Stories: 3½
Foundation: low
Exterior Wall Fabric: natural wood shingle
Fenestration: 3 bay
Roof/Chimneys: cupola roof
Additional Architectural Description:

The structure is located north of West Creek on a large lot along the main road. Small 20th century houses are located along the road, however large open fields are found to the east and west.

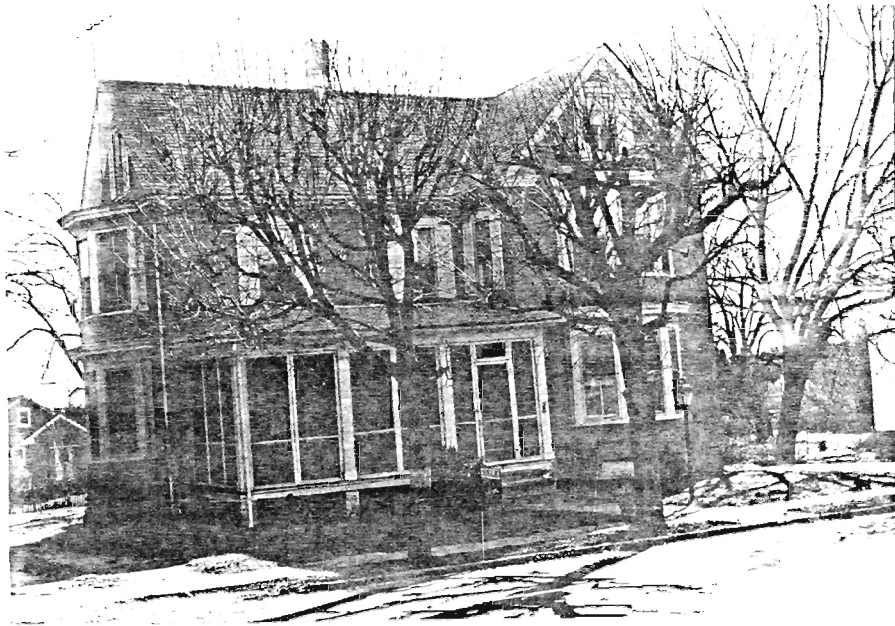
1508-L1

J. Sprague House / Main Street / Block 2 / Lot 11 West Creek

2½ story, 3 bay, asbestos siding, gable roof. 2/2 windows with louvered shutters are employed. A bracketed cornice with returns is found at the roofline. Like many of the houses along Main Street, this house was owned by a sea captain.

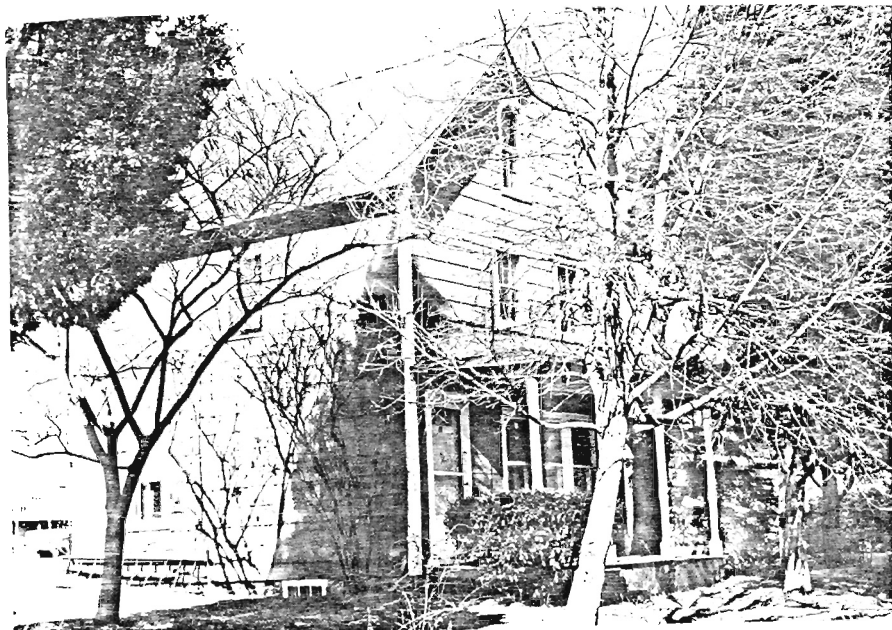
1508-L2

A.T. Willets House / Main Street / Block 16 / Lot 1 West Creek

2½ story, 3 bay, asbestos exterior, gable roof. A stone foundation, 6/6 windows and corner posts are among the structure's original elements. The building has been altered, but was once owned by the Willets family, one of the few large land holders of the area.

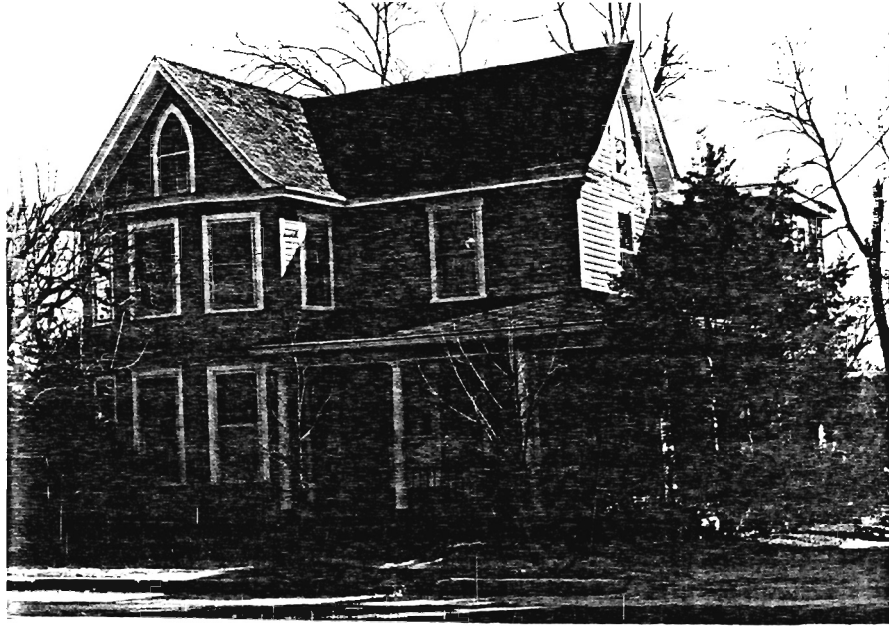
1508-L3

Captain S.P. Cranmer House / Main Street / Block 2 / Lot 9 West Creek

2½ story, 3 bay, clapboard and staggered butt shingle exterior, gable roof with flares. An open porch contains Doric columns. 1/1 windows and Gothic pointed arch windows are employed.

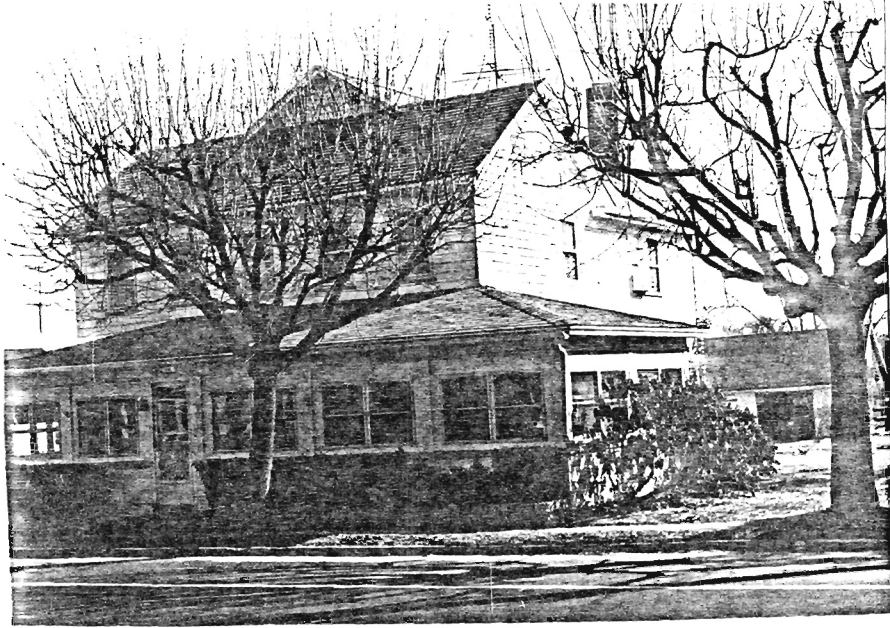
1508-L5

Captain John Crawford House / Main Street / Block 2 / Lot 6 West Creek

2 story, 5 bay, painted shingle exterior, gable roof with returns. An enclosed porch crosses the facade. This structure, built in c.1854 is typical of early houses owned by sea captains of West Creek.

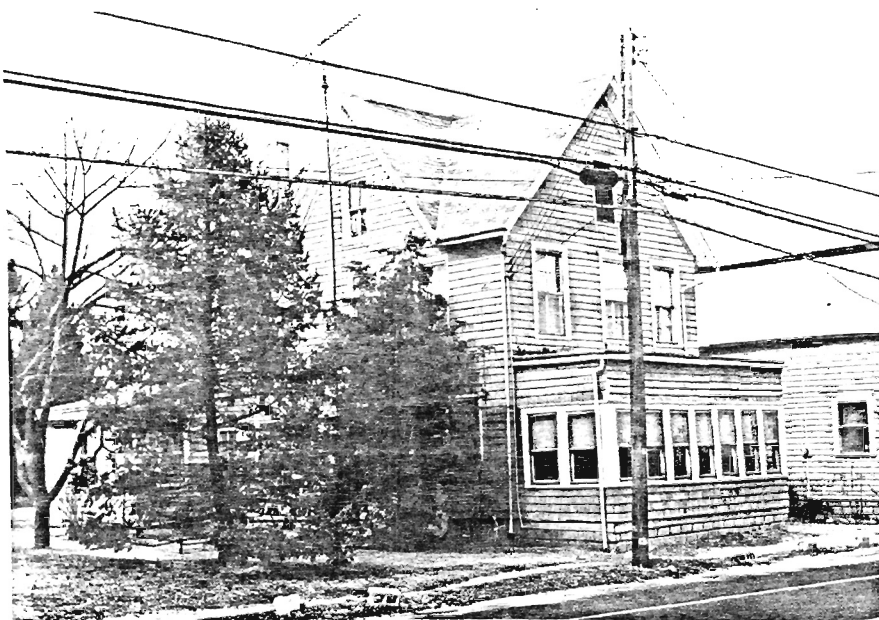
1508-L6

A.P. Willets House / Main Street / Block 16 / Lot 10 West Creek

2½ story, 3 bay, painted shingle exterior, cross gable roof. This building appears on maps of West Creek in the 1870s, however, its exterior has been altered. An enclosed porch is found across the facade.

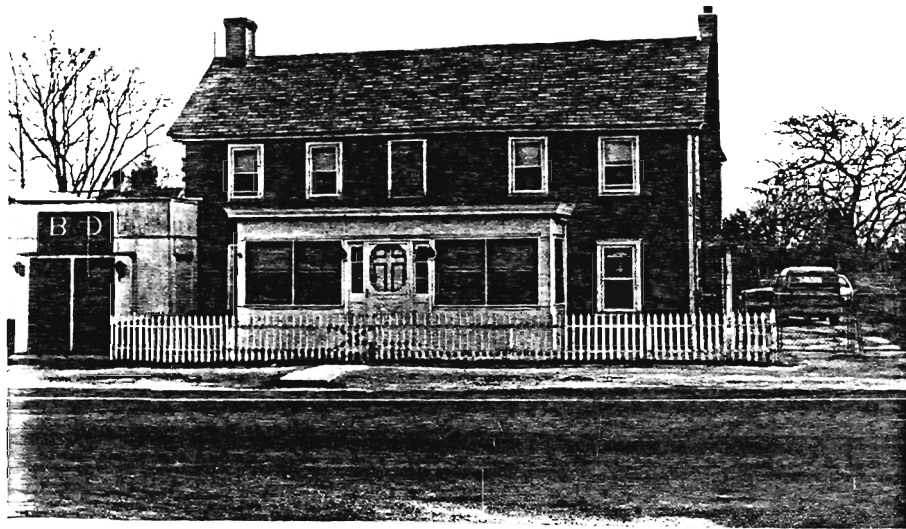
1508-L7

Kelley General Store / Main Street / Block 2 / Lot 2 West Creek

2½ story, 5 bay, clapboard exterior, gable roof with returns. A 20th century addition has been built across the facade. The store appears on the 1878 Woolman Map of West Creek.

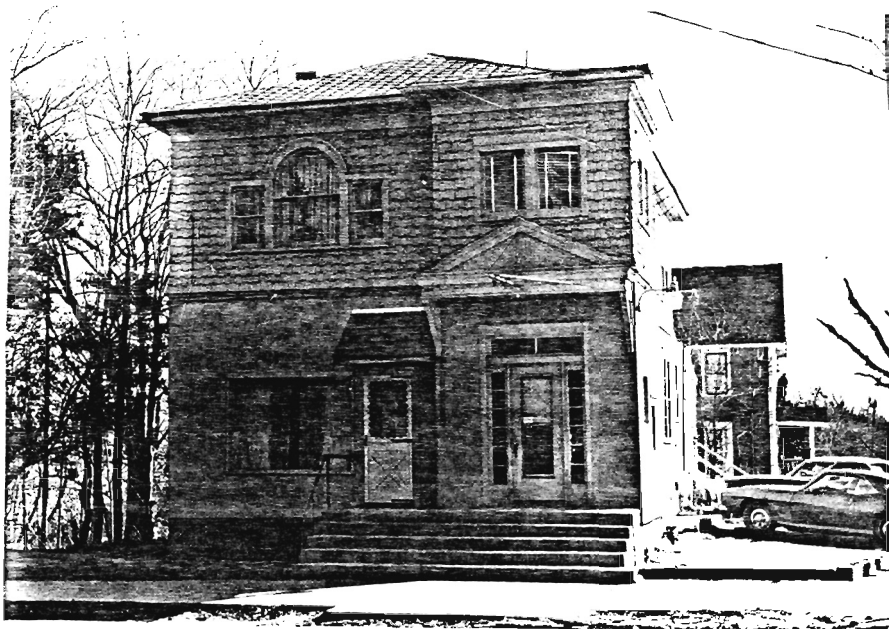
1508-L8

United American Mechanics Lodge Hall / N.E. corner of Main and Cox's Lane
Block 1 / Lot 131 West Creek

2 story, 2 bay, shingled exterior, parapet roof (altered). In 1899, the structure was built to house most of the social functions of West Creek. It still has its Palladian-like windows, dentil cornice and staggered butt shingle.

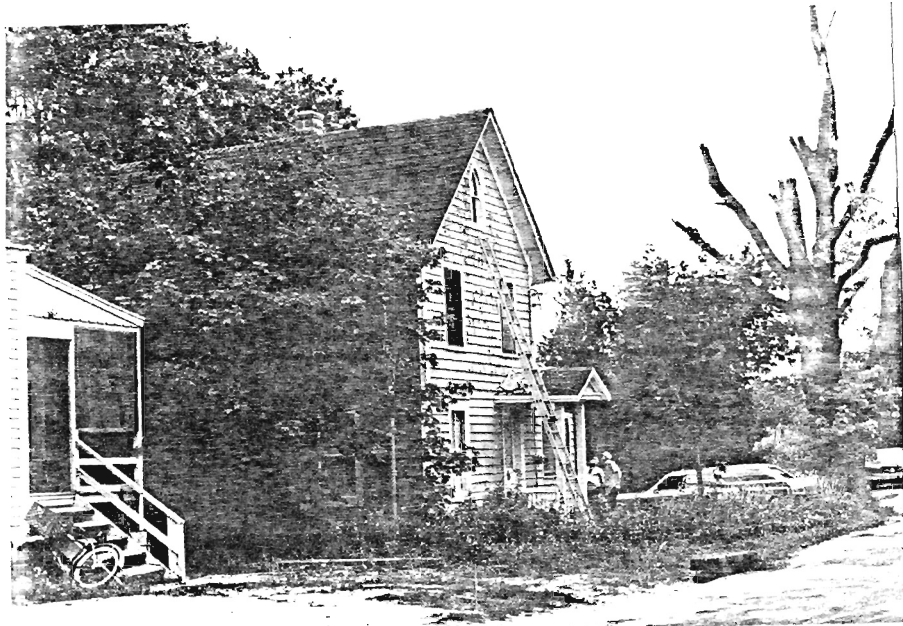
1508-L9

G.B. Cox House / Cox's Lane / Block 1 / Lot 128A West Creek

2½ story, 2 bay, clapboard exterior, gable roof. Corner posts, 2/2 windows and a Gothic pointed arch window are among the structure's original elements. This building was one of the many Cox structures found in the area. A small cranberry bog was located next to the building in the 1870s.

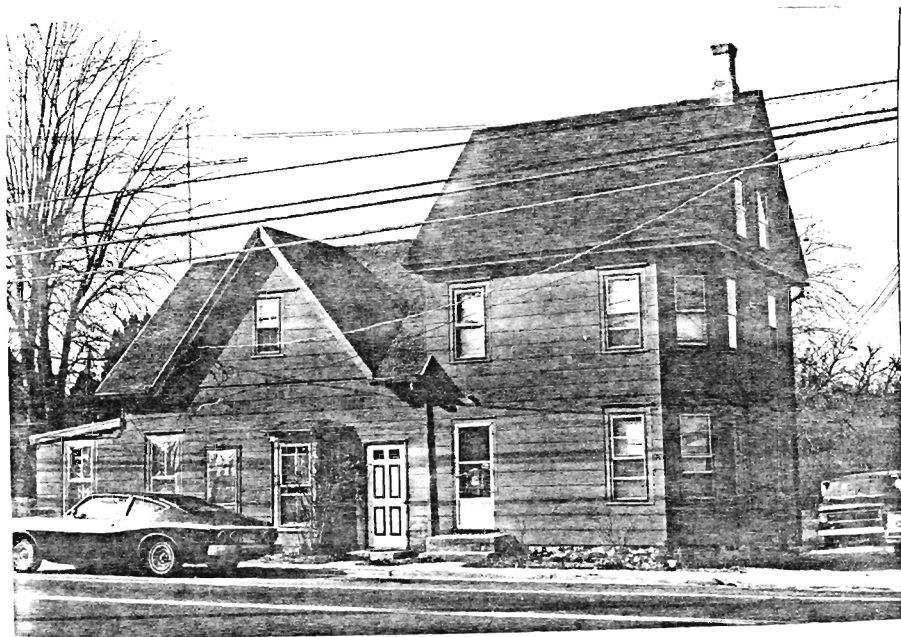
1508-L10

Main Street, across from Dock Road / Block 17 / Lot 16 West Creek

2½ story, 2 bay, asbestos siding, gable roof and full return. A south section is 1½ stories, 4 bays, with a cross gable roof. The structure, built in two sections has been altered, but is still an unusual combination of two late 19th century styles.

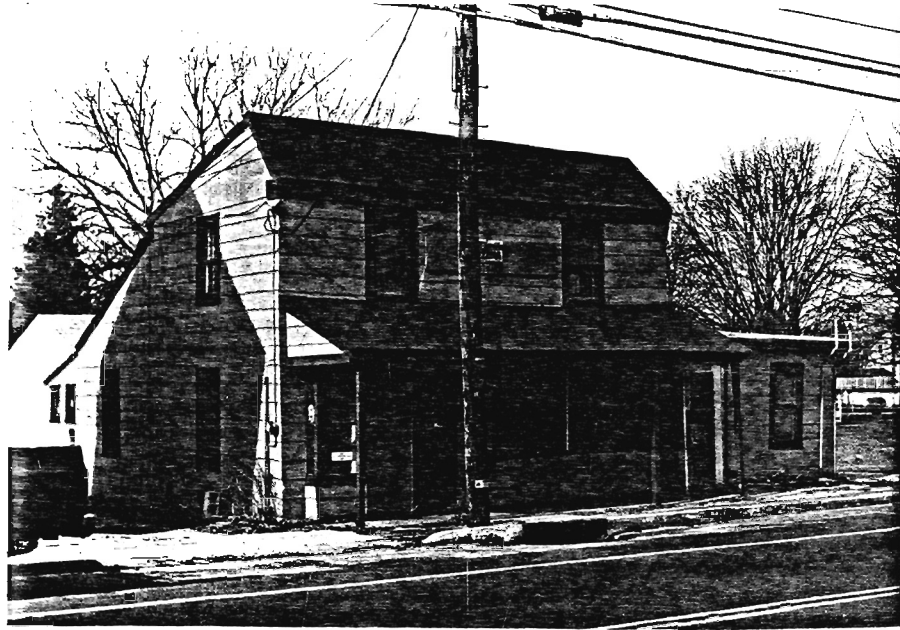
1508-L11

Main Street / Block 17 / Lot 15 West Creek

2 story, 2 bay, asbestos siding exterior, gable roof with small slope in front and large slope to rear. This late 19th century - early 20th century commercial structure has been changed over the years, but it is typical of many small commercial buildings along Route 9.

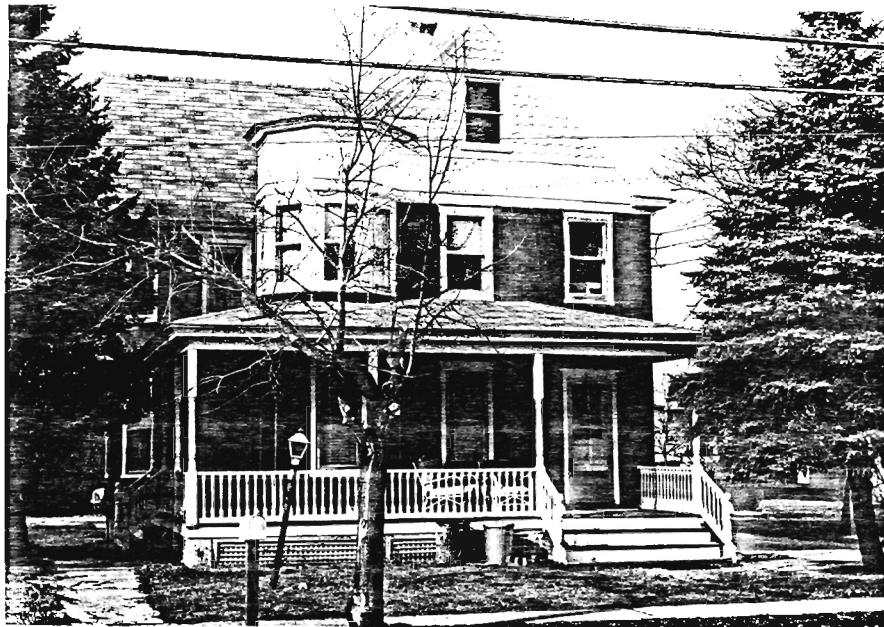
1508-L12

Main Street / west side / Block 17 / Lot 11 West Creek

2½ story, 3 bay, asbestos shingle and staggered butt and diamond shingle patterns, gable roof with returns. A flat topped tower is found in the southeast corner. Angled south walls are typical of Victorian Queen Anne elements found in the area.

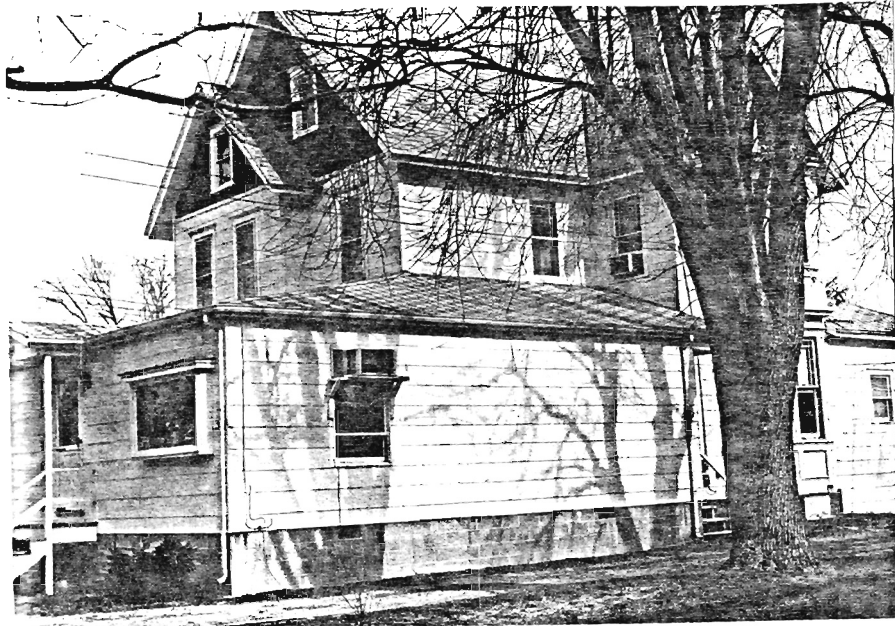
1508-L13

Main Street / east side / Block 4 / Lot 147 West Creek

2½ story, 3 bay, asbestos exterior, combination gable roof. Queen Anne windows and shingled gable ends are found on the upper levels of the building. The first floor has been extremely altered by an enclosed porch. The structure is one of the few Queen Anne buildings in the township.

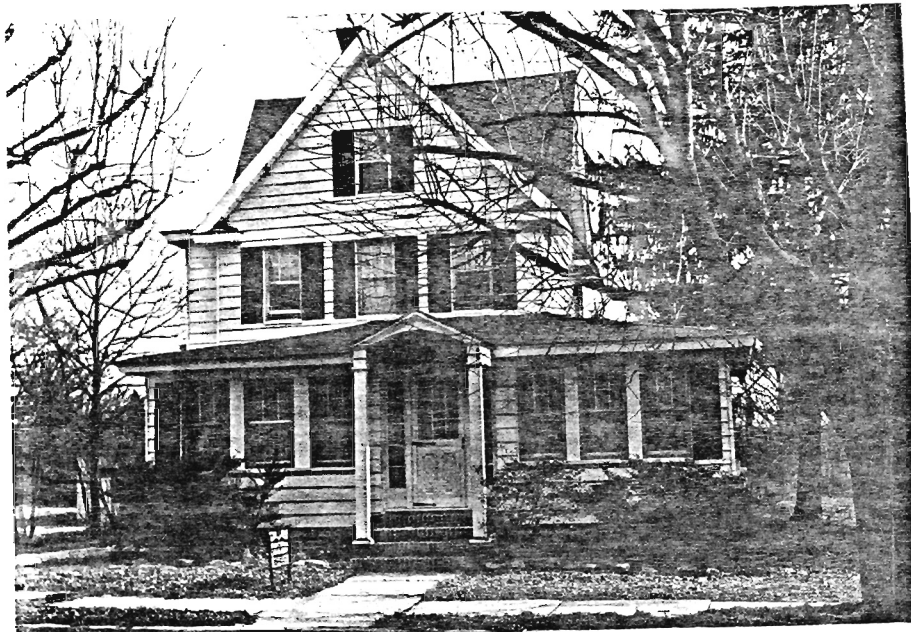
1508-L14

Main Street / east side / Block 4 / Lot 149 West Creek

2½ story, 3 bay, asbestos shingle exterior, cross gable roof with returns. 6/1 windows and the upper floor are all that remain of the late 19th century detailing. The first floor has been altered by an enclosed porch.

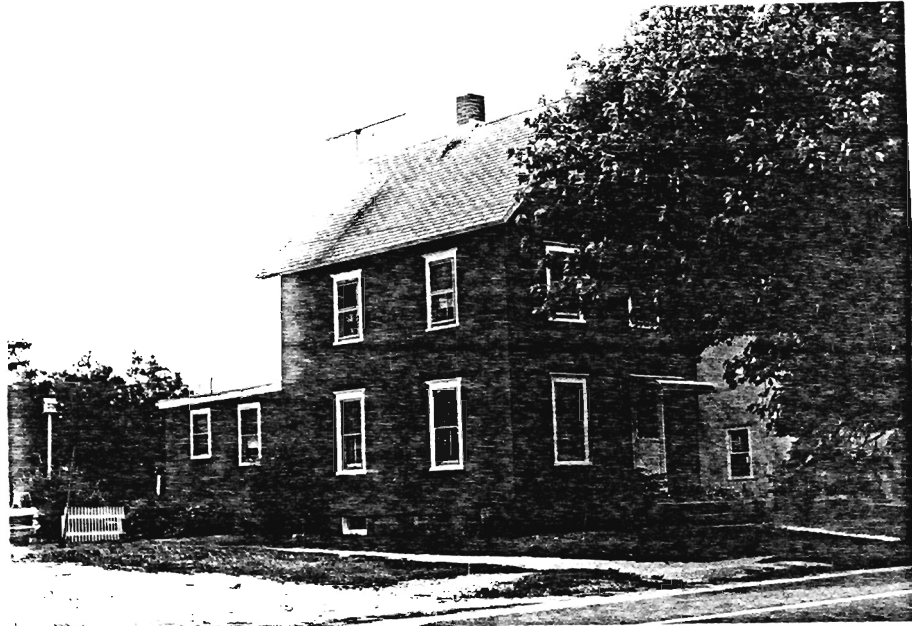
1508-L15

Main Street / east side / Block 4 / Lot 151 West Creek

2½ story, 2 bay, asbestos shingle exterior, gable roof. The gable peak faces the street and contains vergeboard elements. The structure is typical of late 19th century vernacular architecture, being 2½ stories high and 2 bays wide by 3 bays deep.

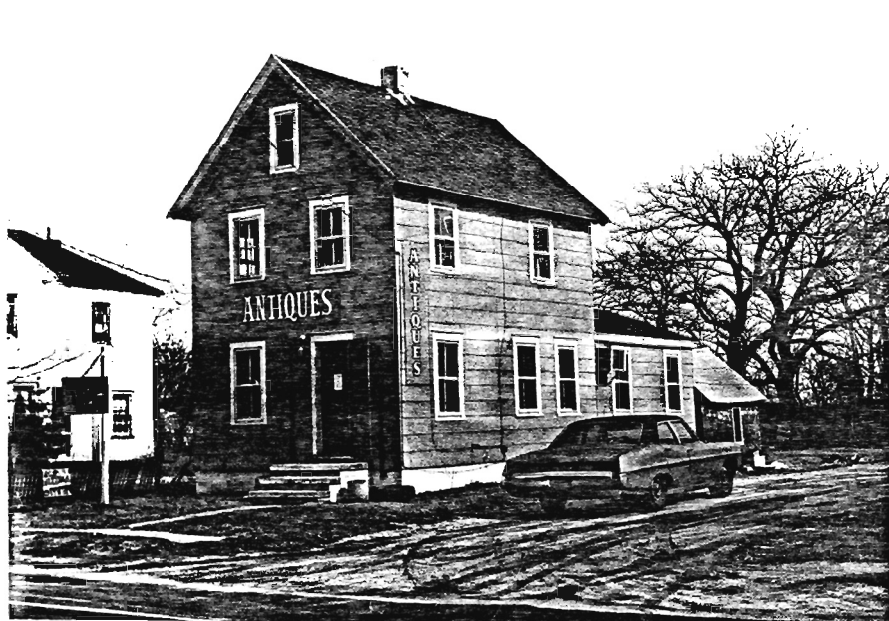
1508-L16

Main Street / east side / Block 4 / Lot 152 West Creek

2½ story, 2 bay, asbestos exterior, gable roof. The gable peak faces the street and has exposed shaped rafter tails. The building is typical of late 19th century construction. See # L15 above.

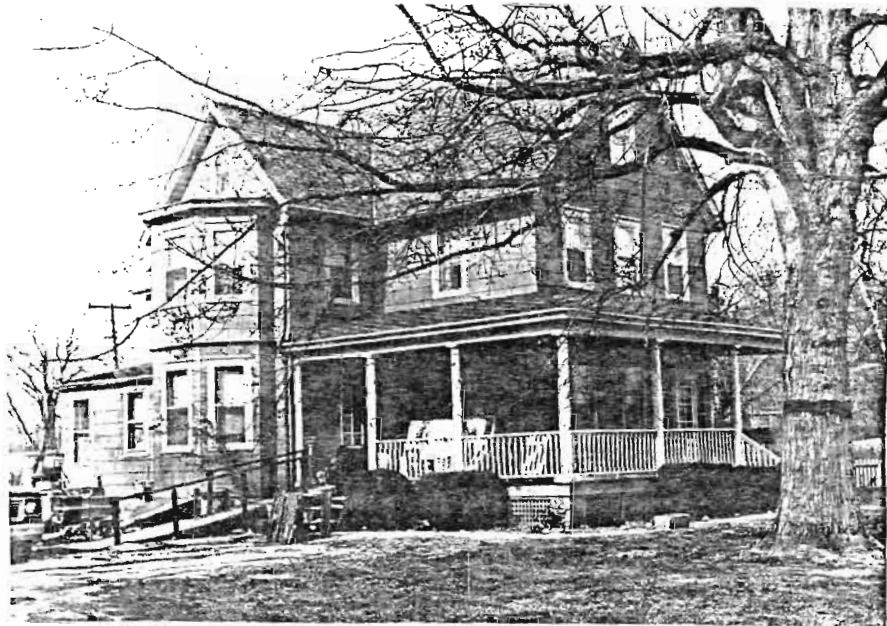
1508-L17

S.W. corner of Main and Mill / Block 17 / Lot 4 West Creek

2½ story, 3 bay, shingled exterior, cross gable roof. This L-shaped building employs Queen Anne features. An open porch has Doric columns and a standard rail. The house is one of the few structures in town built in this style at the turn of the century.

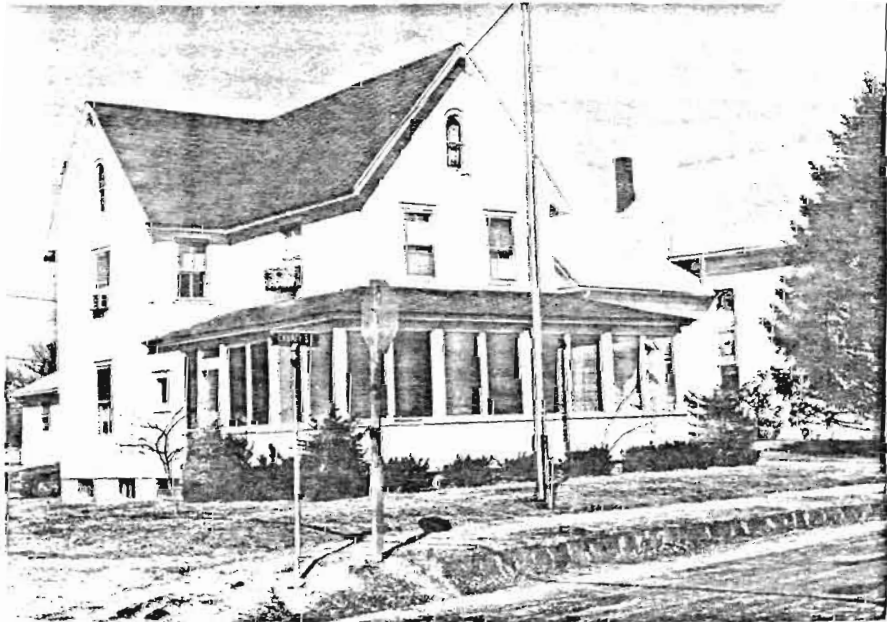
1508-L18

Methodist Parsonage / Thomas and Church Streets / Block 16 / Lot 3 West Creek

2½ story, 2 bay, asbestos shingle exterior, gable roof. This L-shaped building was built previous to 1878, since it appears on a map of that year. The structure is typical of vernacular 19th century houses, having minimal ornament. Round-arch attic windows and open porch are common elements of the late quarter of the 19th century.

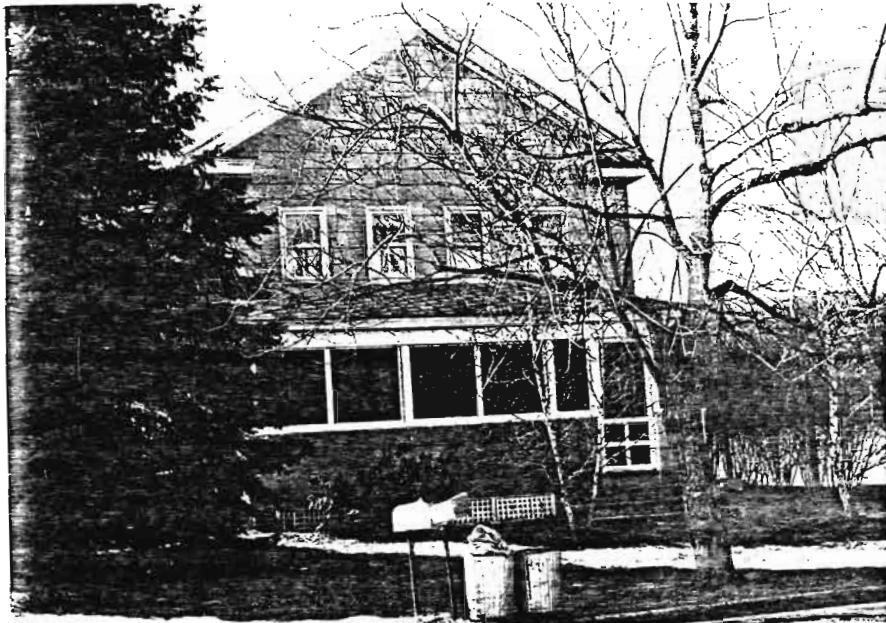
1508-L19

First Methodist Church / Thomas Avenue / Block 13 / Lot 2 West Creek

2 story, 4 bay, asbestos siding, gable roof. This building is said to be the first Methodist Church built at West Creek in the early 19th century. In 1858 the building was sold and moved by the Baptist congregation who used the building until 1901. In 1901 it was sold to Frank Shinn, at auction, for \$50.25. It has seen many changes over the last century.

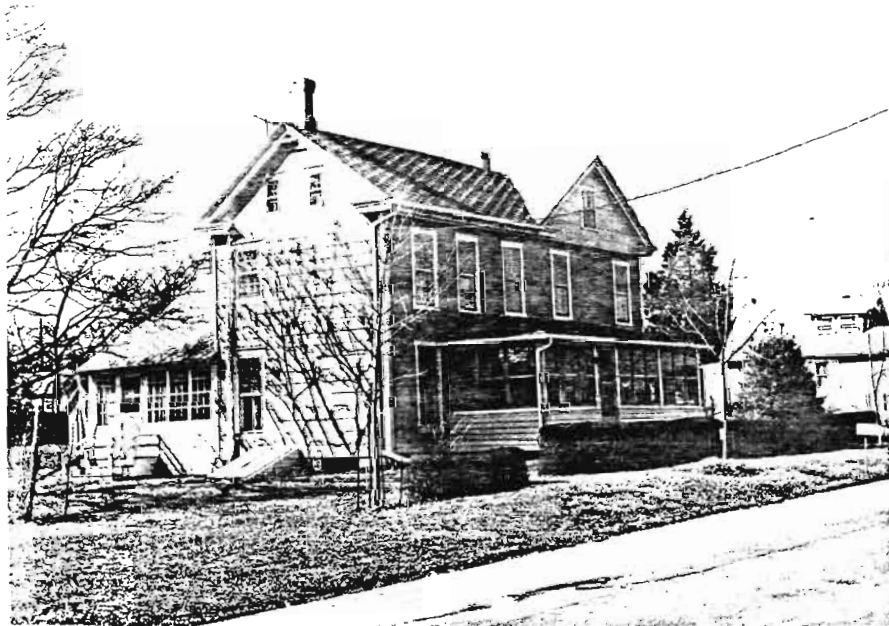
1508-L20

Major S. Barry House / Thomas Avenue / Block 13 / Lot 5 West Creek

2½ story, 3 bay, asbestos and shingle exterior, gable roof with returns. Although altered, the house was the only structure on the block in the mid 1870s. The house is believed to have originally been three houses which were put together.

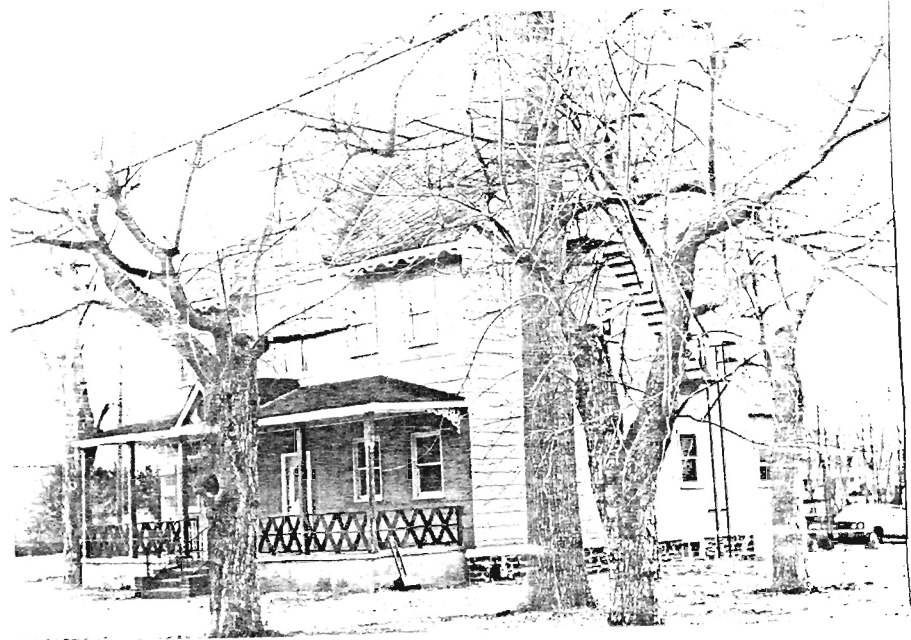
1508-L21

DeWitt Gale House / N.E. corner of West and Thomas / Block 15 / Lot 1 West Creek

2½ story, 5 bay, asbestos shingle exterior, cross gable roof. This large mid-19th century structure was a captain's house as were many of the large homes in the area. The building, now altered and used as an apartment house, still has a stone foundation, a curved rakeboard, pendants, and paired round-arch attic lights.

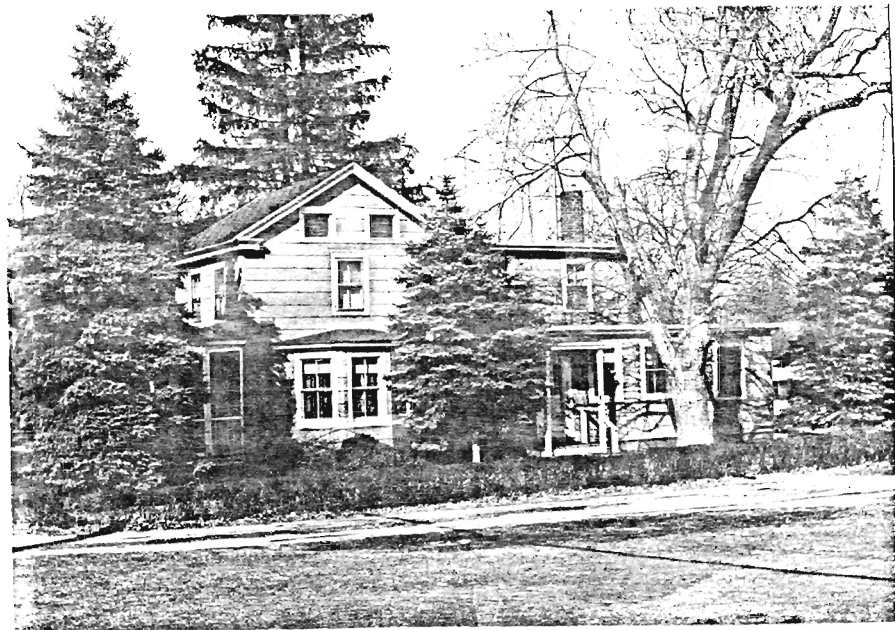
1508-L22

D. Gale House / Thomas Avenue / Block 15 / Lot 9 West Creek

2 story, 2 bay, asbestos siding exterior, gable roof with returns. This narrow mid 19th century structure appears on the 1878 West Creek map. It has 2/2 windows and a front porch with posts and vergeboard brackets.
