EAGLESWOOD

EAGLESWOOD TOWNSHIP

Eagleswood Township
Municipal Code 1508
— Survey Form Site

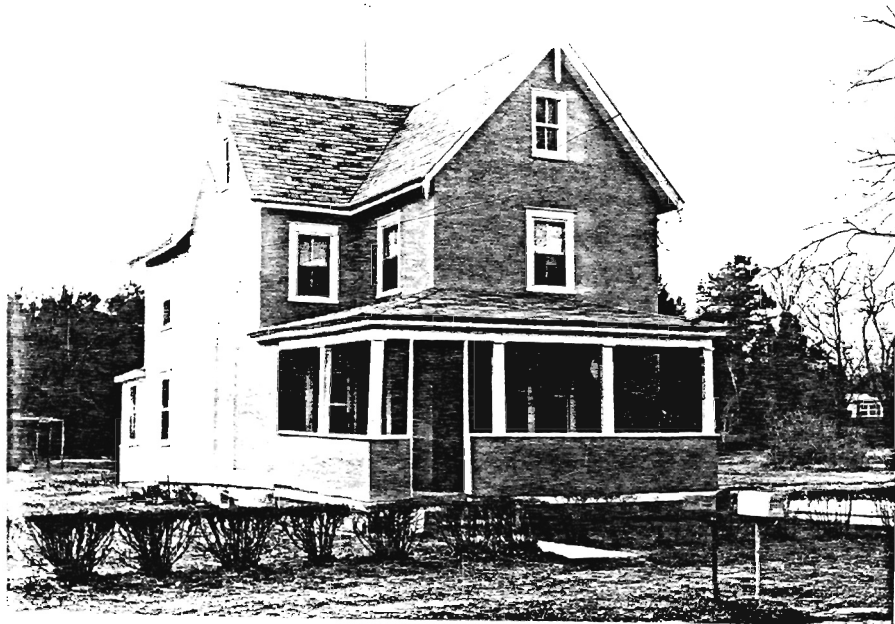
1508-L23

Thomas Avenue / Block 13 / Lot 4 West Creek

2 story, 2 bay, stucco exterior, cross gable roof. This late 19th century structure has an L-plan, 2/2 windows and pendants at the roof peaks and ends. The building is typical of late 19th century construction.

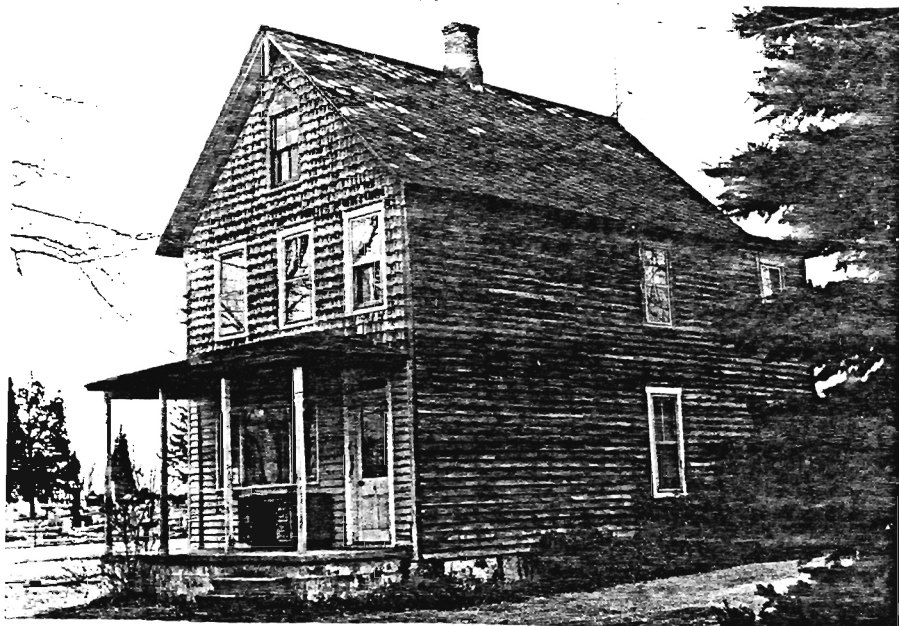
1508-L24

Corner of Thomas and Jones / Block 13 / Lot 1 West Creek

2 story, 2 bay, staggered butt shingle and clapboard exterior, gable roof, 2/2 windows and open porch with chamfered posts are typical elements found in late 19th, early 20th century architecture in the Route 9 area.

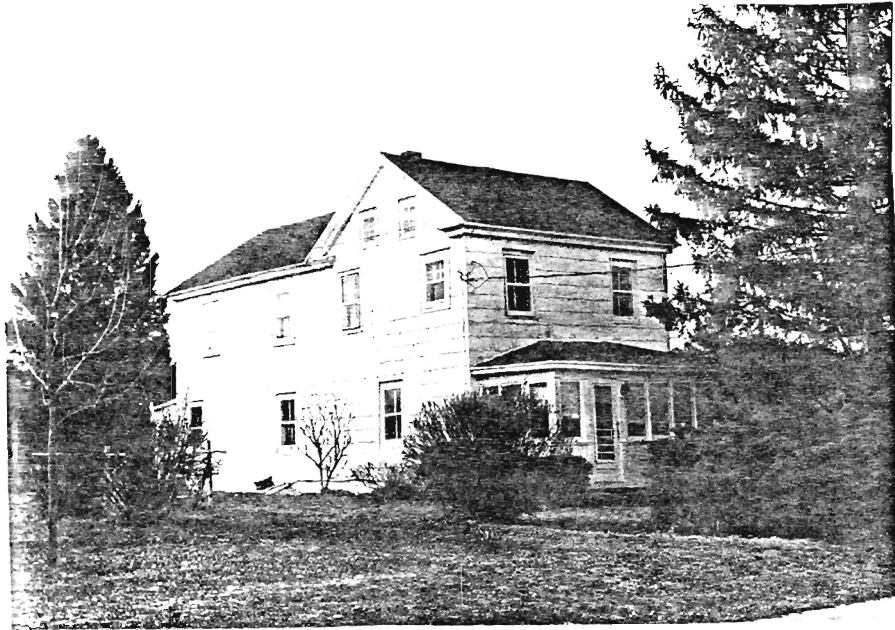
1508-L25

Corner of Railroad and Thomas Avenue / West Creek

2 story, 2 bay, asbestos siding, gable roof with returns. An enclosed front porch has altered the appearance of this late 19th century house, however, its 2/2 windows remain.

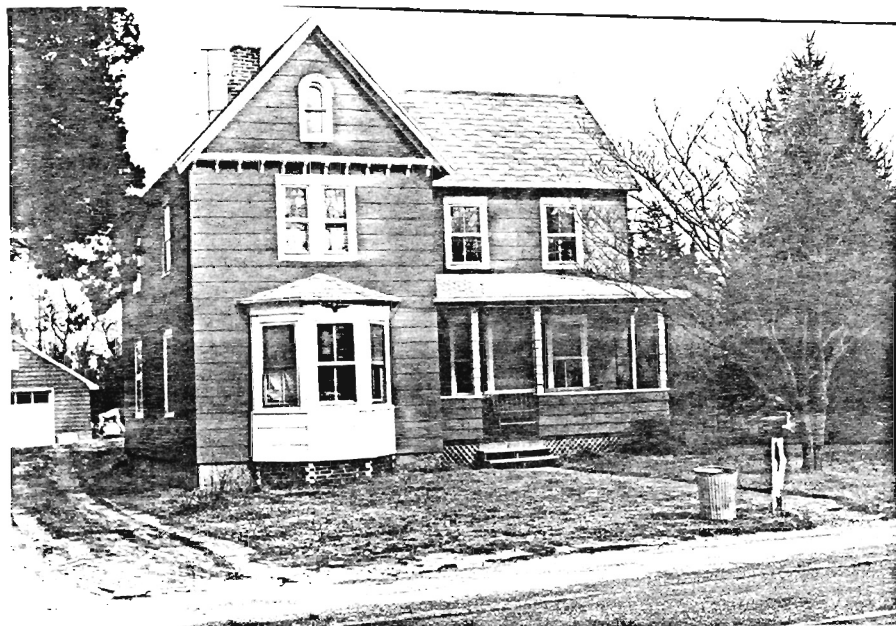
1508-L26

Thomas Avenue (near Railroad Avenue) / West Creek

2 story, 3 bay, asbestos siding, gable roof. This L-plan house has 2/2 windows and a bracketed cornice. The structure is typical of late 19th century construction in the area.

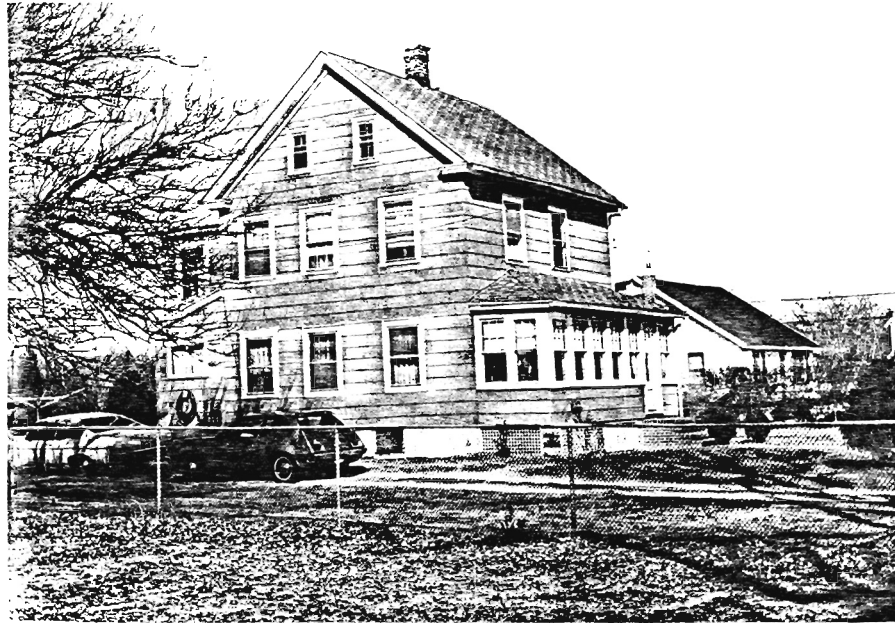
1508-L27

J.C. Johnson House / 2 West Street / Block 14 / Lot 3 West Creek

2½ story, 2 bay, asbestos shingle exterior, gable roof with returns. 6/6 windows are found on the facade even though the structure has been altered. The building has an unusually high foundation, and like most buildings in town appears on the 1878 map of West Creek.

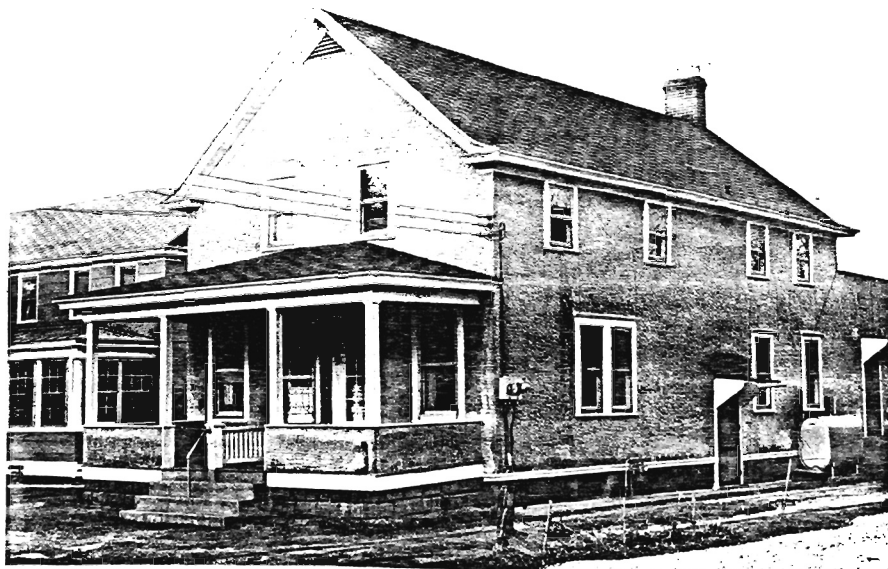
1508-L28

Captain Presgrove Cranmer General Store / Division (north side)
Block 17 / Lot 22 West Creek

2 story, 4 bay, stucco exterior, gable roof with returns. An open porch containing square posts extends across the facade. Although extremely altered, the structure is one of the few stores in West Creek of the late 19th century.

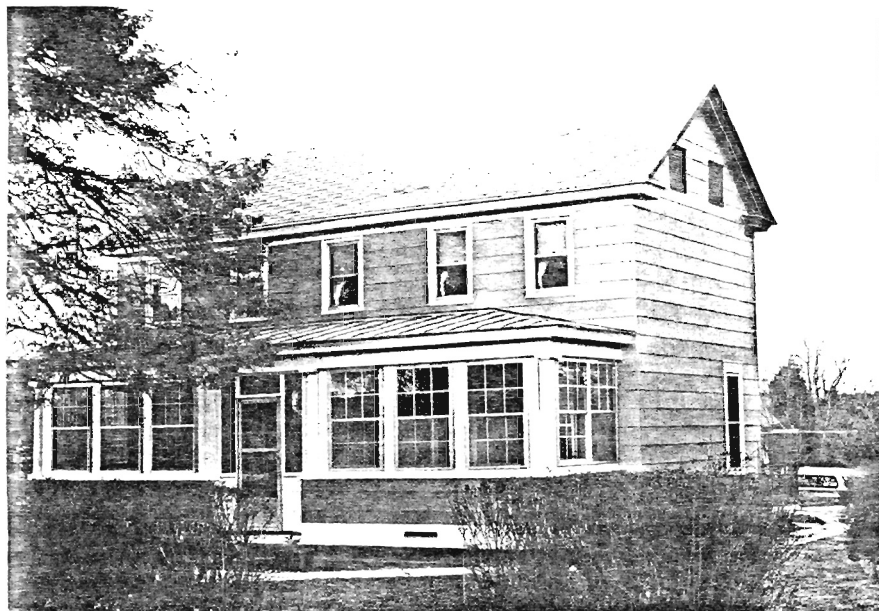
1508-L29

Captain Presgrove Cranmer House / Division Street (north side)
Block 17 / Lot 23 West Creek

2½ story, 5 bay, asbestos siding, gable roof with returns. A center door has a transom and sidelights. Few original exterior elements remain. The house was built for Presgrove Cranmer in the mid 19th century by his father, Captain Hazelton Cranmer who lived at the corner of Division and Main Street.

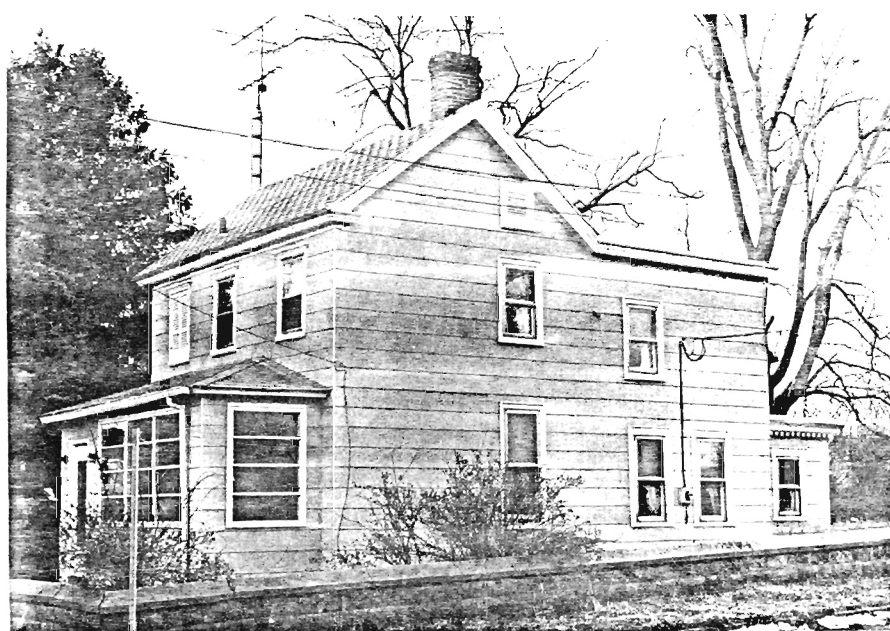
1508-L30

J. Willets House / Division Street (south side) at Church Street
Block 16 / Lot 7 West Creek

2½ story, 3 bay, asbestos siding, gable roof with returns. A dentil cornice is one of the most impressive elements of this house. An enclosed porch is found across the facade.

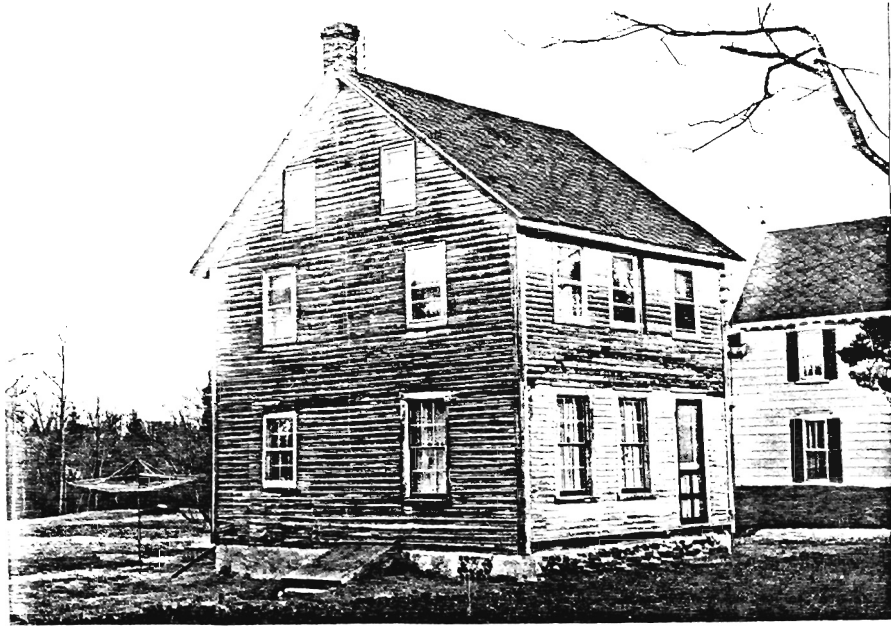
1508-L31

H. Seaman House / Division Street (north side) / Block 17 / Lot 25 West Creek

2½ story, 3 bay, weathered clapboard, gable roof. A stone foundation and 6/6 windows are still intact. The house is one of many built at mid century on Division Street. The Cranmer family encouraged settlement of their land and divided the family property in two at "Division Street." The street provided access for potential settlers.

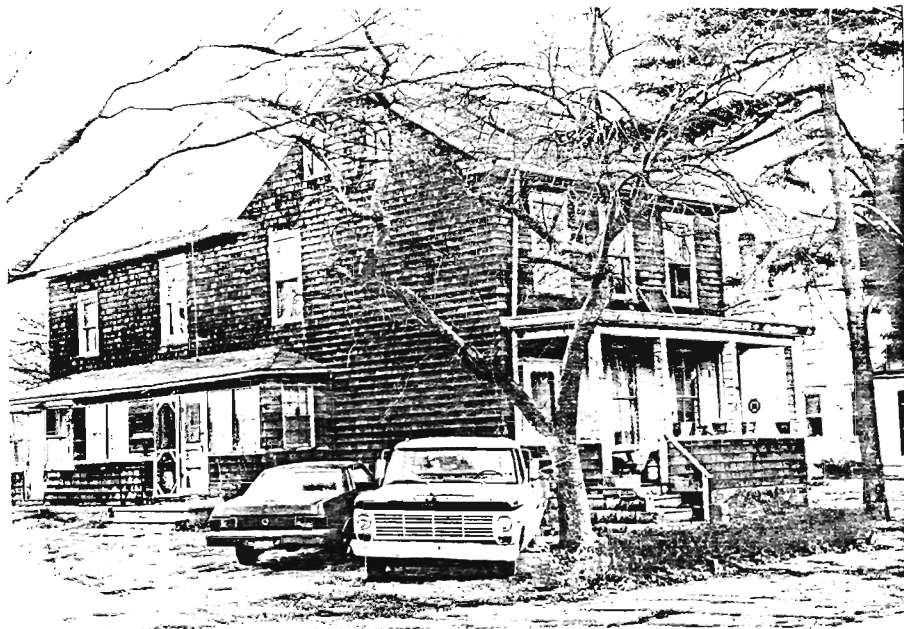
1508-L32

Division Street (south side) / Block 15 / Lot 5 West Creek

2½ story, 3 bay, natural wood shingle, gable roof with returns. A porch across the facade has a blind balustrade and shingled posts. An end doorway has a transom and sidelights. 2/2 windows are found throughout. The structure is one of the many homes built in the latter half of the 19th century.

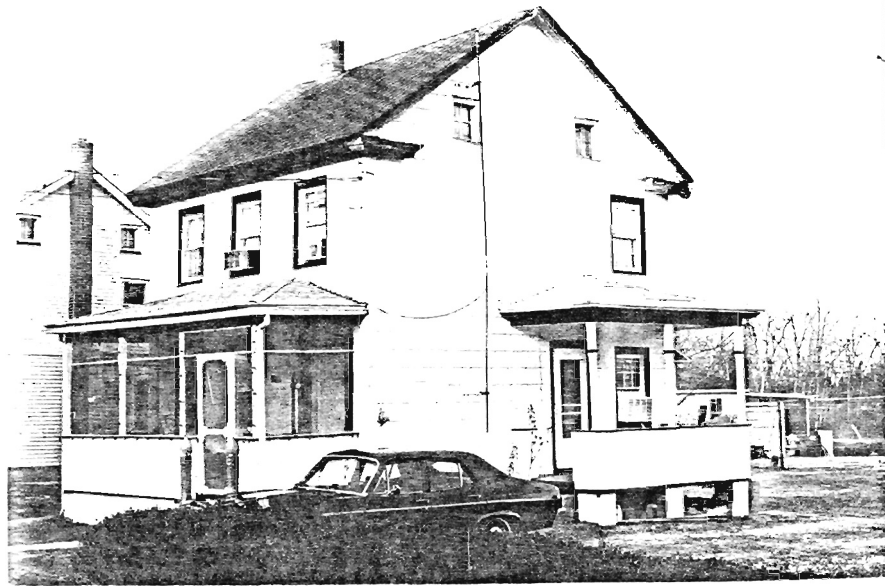
1508-L33

Mrs. Seamen's House / Division Street (north side) / Block 17 / Lot 26 West Creek

2½ story, 3 bay, asbestos exterior, gable roof with returns. A molded cornice runs along the perimeter of the house. A stone foundation and door with transom and sidelights are also original features. See # L31 for more information.

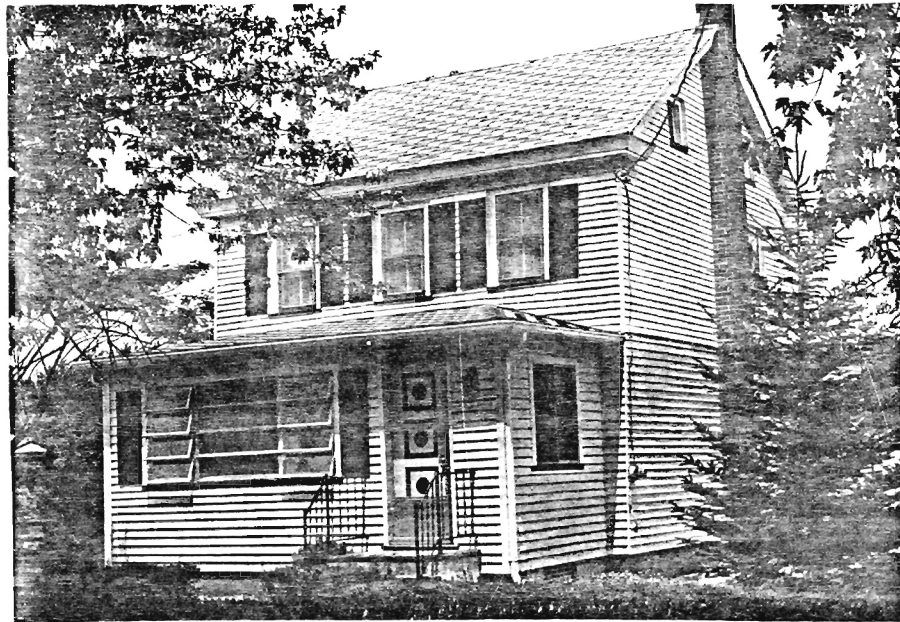
1508-L34

Seamen House / Division Street (north side) / Block 17 / Lot 27 West Creek

2½ story, 3 bay, aluminum siding, gable roof with returns. An enclosed porch is located across the facade. Although altered the house is similar to others on the street and was constructed at the same time. See # L31 for more information.

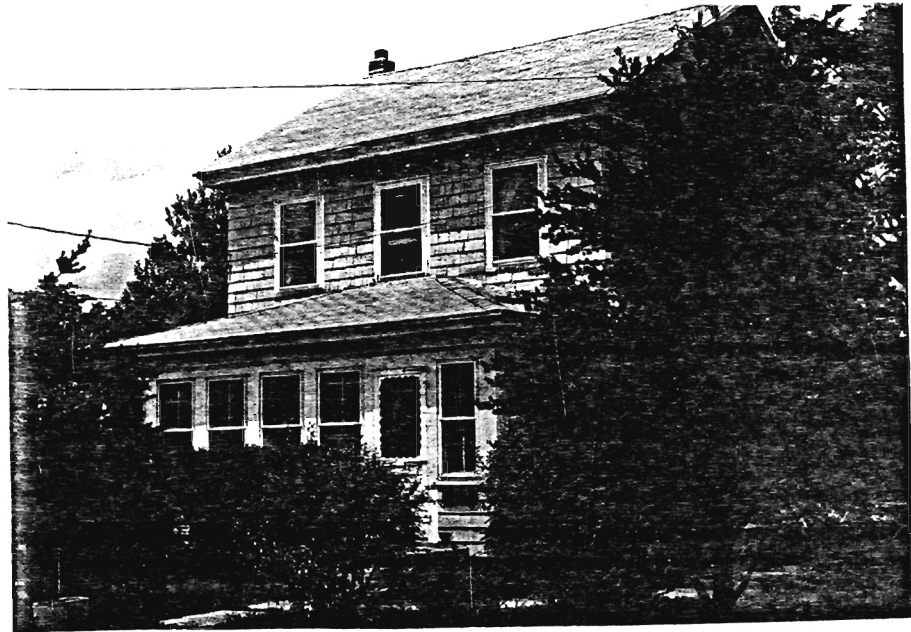
1508-L35

Mrs. E. Rutter House / Division Street (north side) / Block 17 / Lot 28 West Creek
2½ story, 3 bay, painted shingle exterior, gable roof with returns. See
L31 for more information.

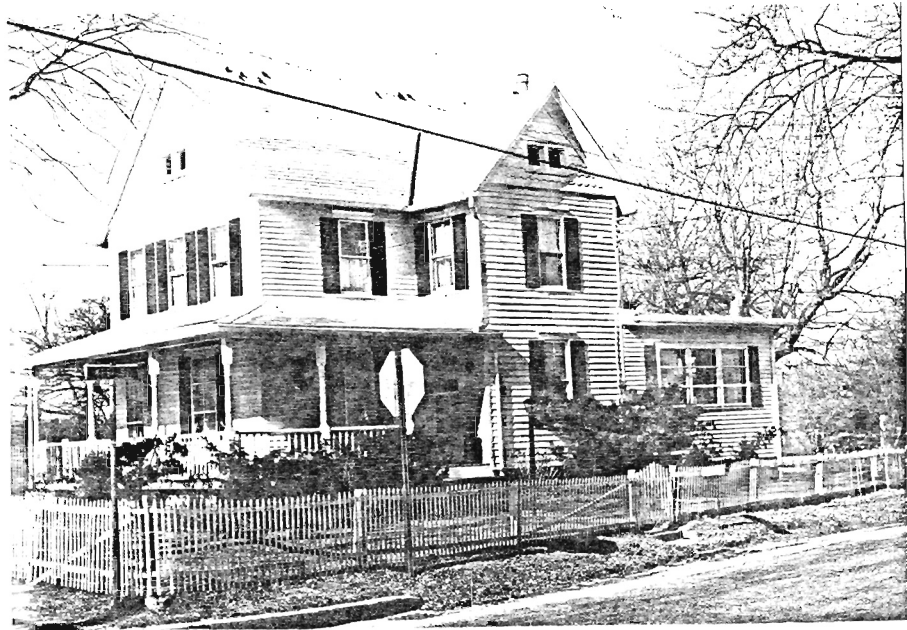
1508-L37

N.W. corner of Division Street / Block 18 / Lot 2 West Creek

2½ story, 3 bay, clapboard and staggered butt shingle exterior. 2/2 windows are employed throughout. An open porch contains turned posts and a standard balustrade. This late 19th century house is typical of many structures built at this time.

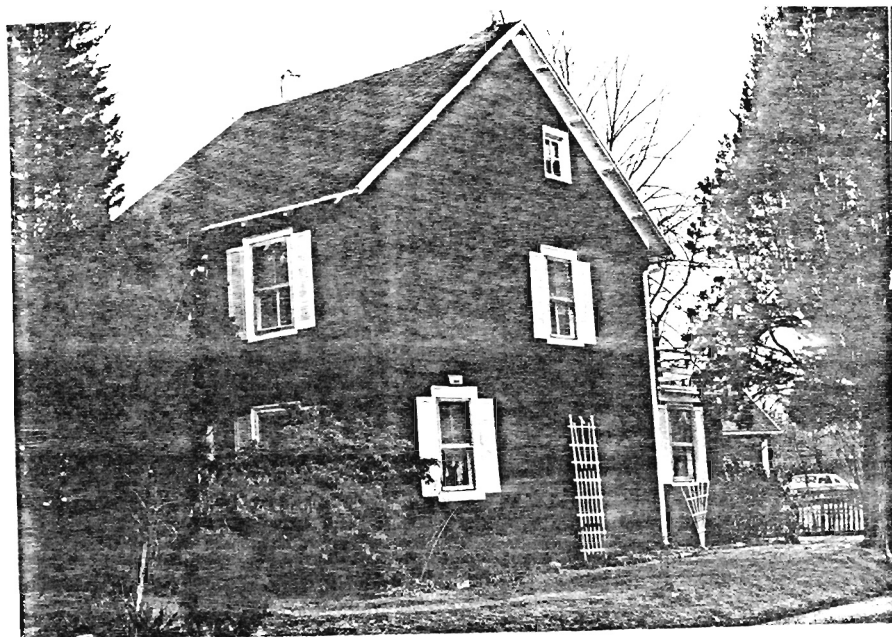
1508-L38

S. Pharo House / West Street / Block 17 / Lot 32 West Creek

2 story, 2 bay, natural wood shingle exterior, steep gable roof. The house is one of the earliest in the area. It is believed to date c.1800. The building has been altered by the construction of a one story front addition.

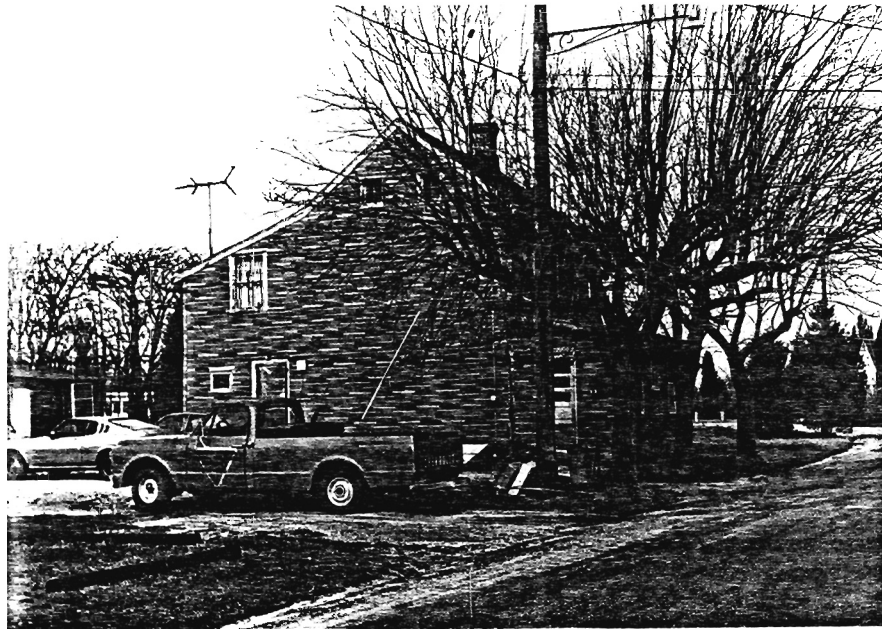
1508-L39

C.B. Pharo House / West Street / Block 17 / Lot 33 West Creek

2 story, 3 bay, asphalt shingle exterior, gable roof. A lean-to addition is located to the rear. 6/1 and 1/1 windows are employed. The structure has been extremely altered.

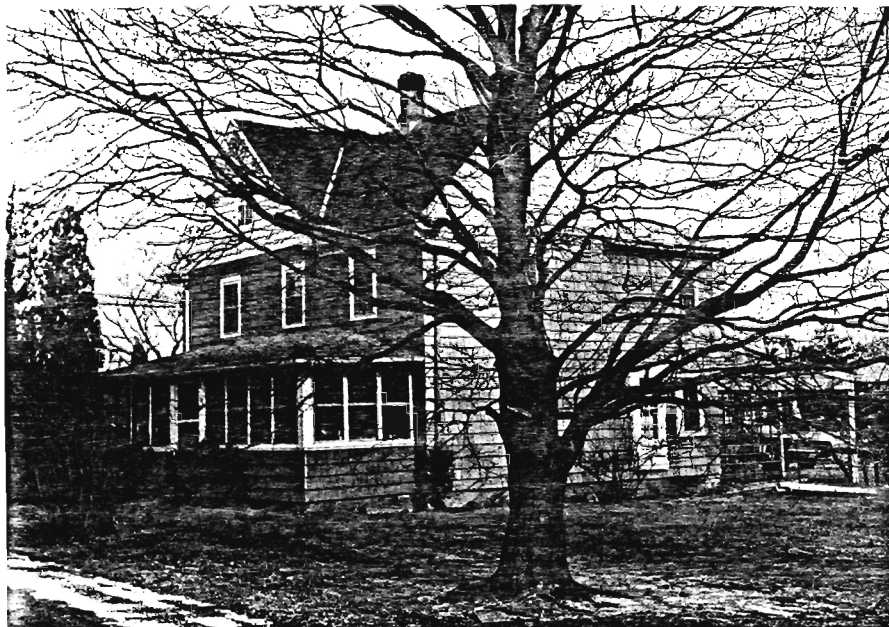
1508-L40

C.B. Pharo House / West Street / Block 18 / Lot 4 West Creek

2 story, 3 bay, shingle exterior, cross gable roof with returns. 2/2 windows and staggered butt shingle peaks are among its original elements. The building appears on the map of West Creek in 1878. An enclosed porch is located on the facade.

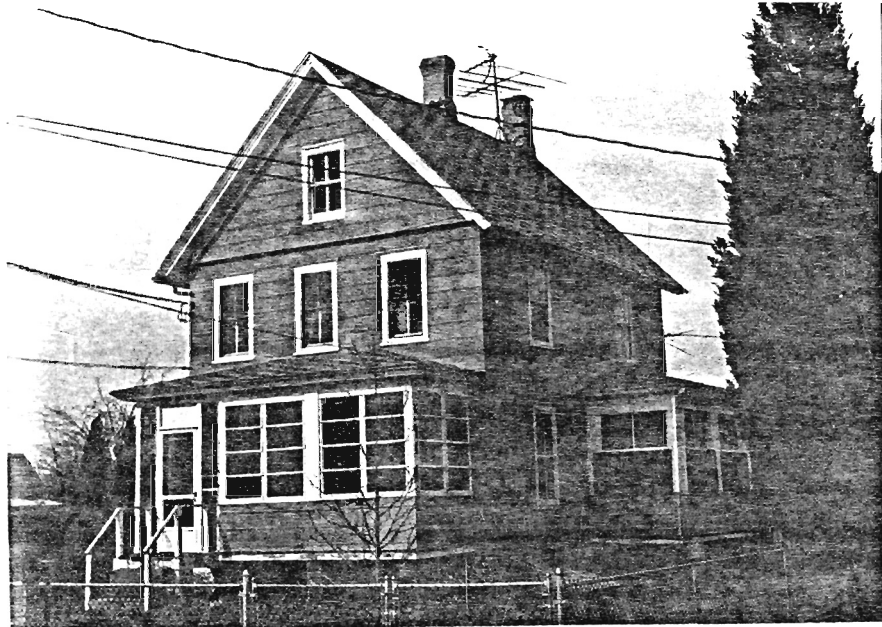
1508-L41

Kelly Avenue / Block 20 / Lot 4 West Creek

2½ story, 3 bay, asbestos shingle, gable roof faces street. 2/2 windows and a stone foundation. The structure is typical of vernacular late 19th century architecture found along Route 9, being 3 bays wide, 2 deep and 2½ stories tall.

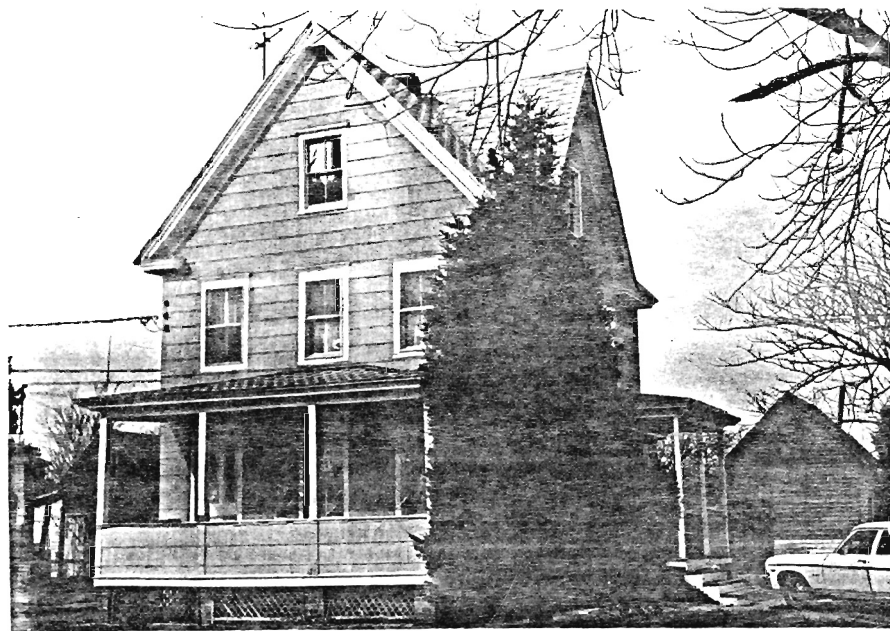
1508-L42

Kelly Avenue / Block 20 / Lot 3 West Creek

2½ story, 3 bay, asbestos shingle, cross gable roof with returns. Elongated first floor windows and paired Roman arch lights on the door are employed. The building is similar to others on the road and was built at the same time. See # L41 above.

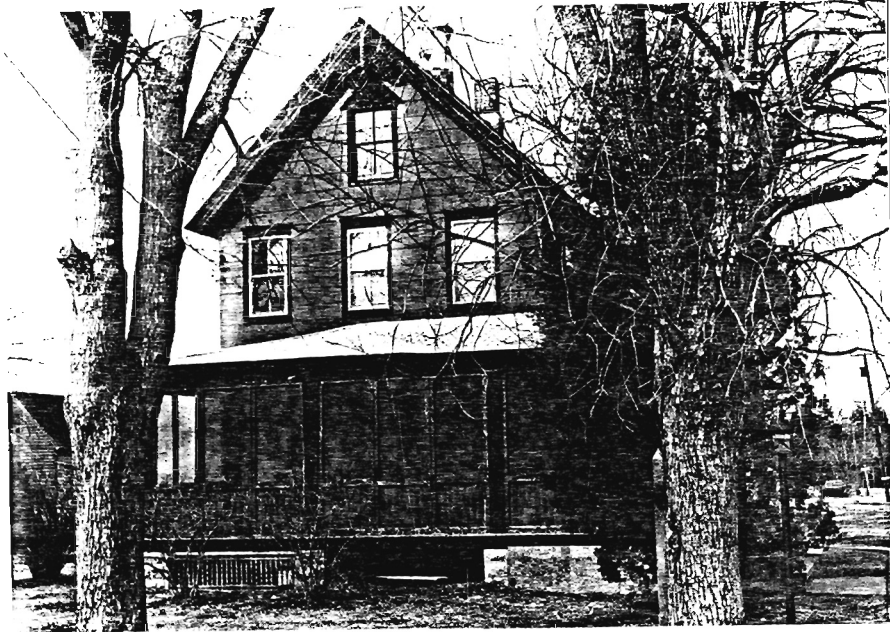
1508-L43

Kelly Avenue / Block 20 / Lot 2 West Creek

2½ story, 3 bay, asbestos shingle, gable roof faces street. A screened porch with square posts and a standard rail is found across the facade. Vergeboard is found on the gable peak. See above listings.

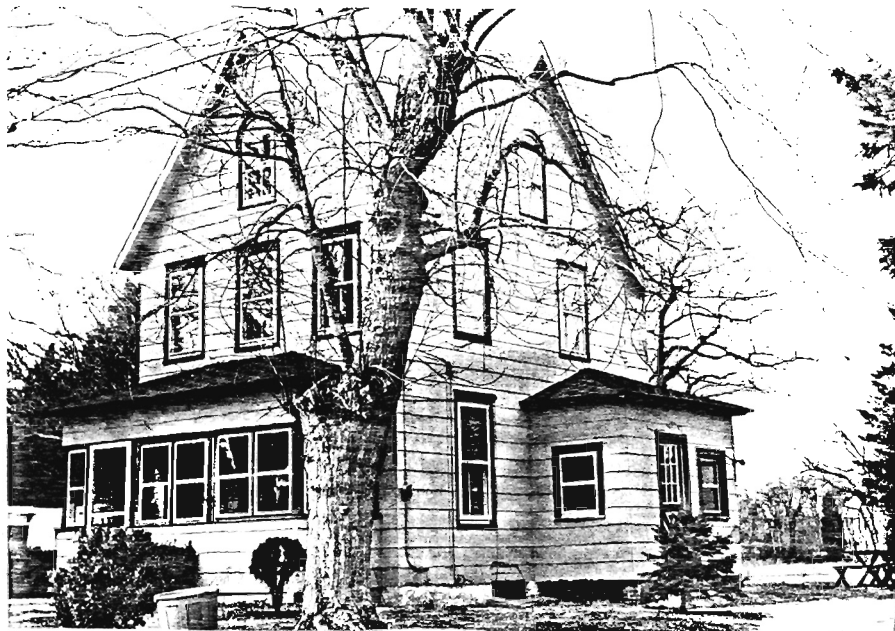
1508-L44

West Street / Block 21 / Lot 8 West Creek

2½ story, 3 bay, asbestos shingle, cross gable roof. Stone foundation and round arch attics are employed. Compare with above listings.

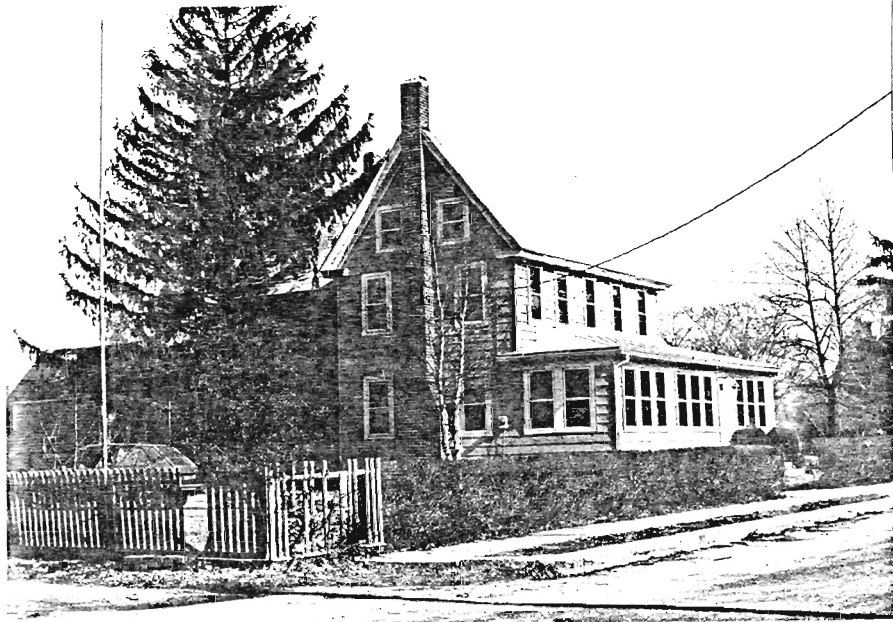
T508-L45

Kelly Farmhouse and Barn / Kelly Avenue/ Block 20 / Lot 1 & 1A West Creek

2 story, 5 bay, 20th century, metal siding, gable roof with cornice, returns. This late 19th century structure has been extremely altered over the years. It was once the farmhouse of the Kelly Cranberry Bog. A cedar shake barn with center entrance and lean-to addition is located in the rear yard along West Street. The barn was the storage and distribution center for the Kelly business until recent years.

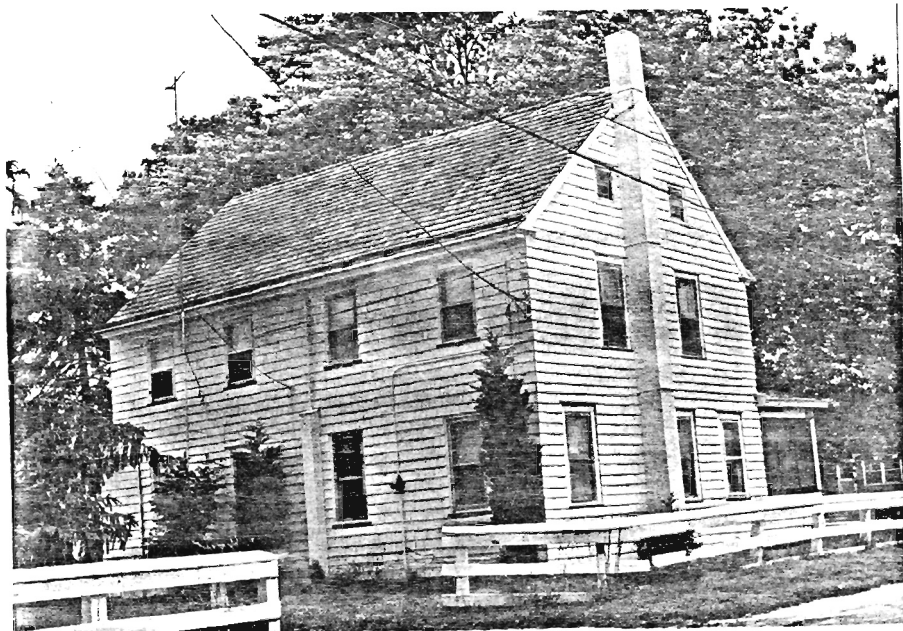
T508-L46

Shinn Farmhouse / Homestead Avenue / Block 22 / Lot 2 & 3 West Creek

2 story, 5 bay, shingle exterior, gable roof. This farmhouse, which dates from the mid 19th century, is one of the early farmhouses outside West Creek. The building has been altered over the years.

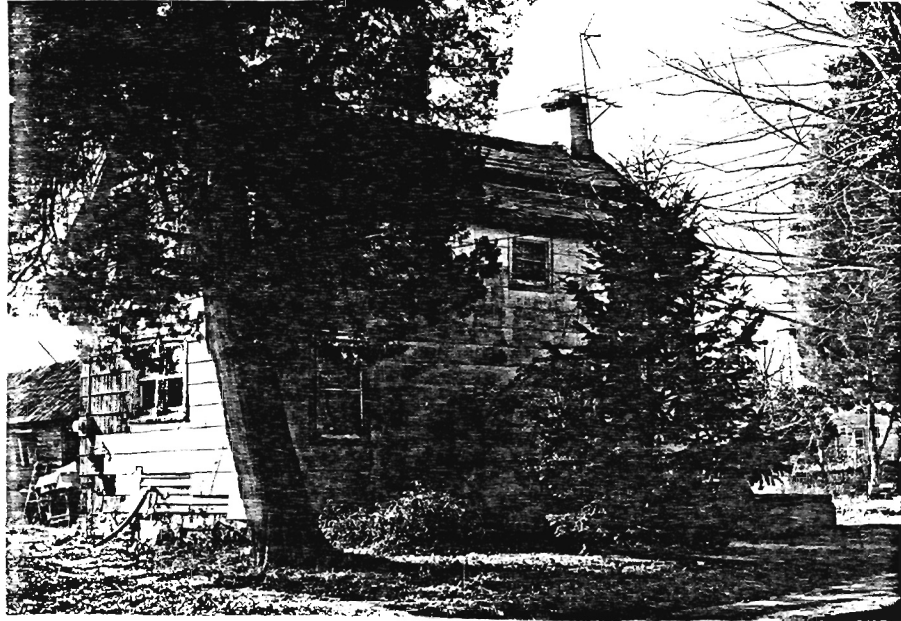
1508-L47

R.T. Pharo House / Mill Road / Block 22 / Lot 6 West Creek

1½ story, 3 bay, asbestos over clapboard, gable roof. Although altered, the scale and shape of the structure indicate the building dates from the early 19th century.

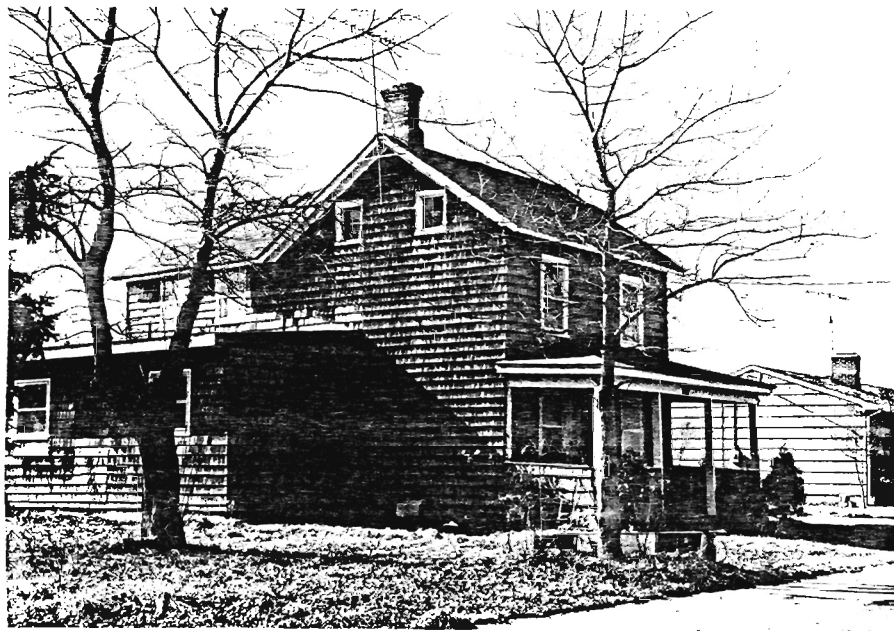
1508-L48

J. Mullen House / Mill Road / Block 22 / Lot 5 West Creek

2 story, 2 bay, natural wood shingle exterior, gable roof. This structure is said to date from the early 19th century. Many old structures can still be found along Mill Road and Silver Lake Drive.

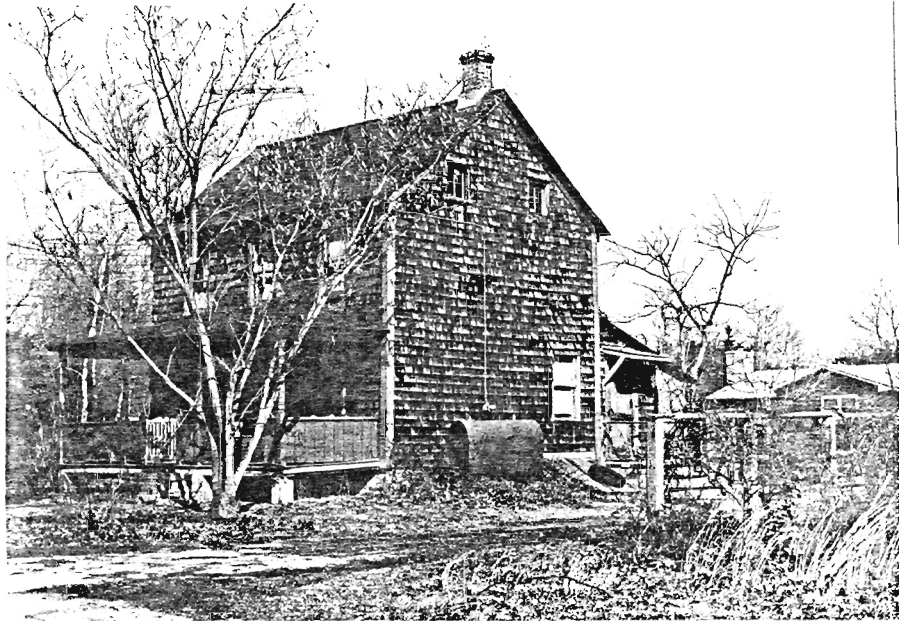
1508-L49

North Street / Block 39 / Lot 58 West Creek

2½ story, 3 bay, natural wood shingle exterior, gable roof. The structure has a center door with transom and an open front porch. It is typical of vernacular mid 19th century construction.

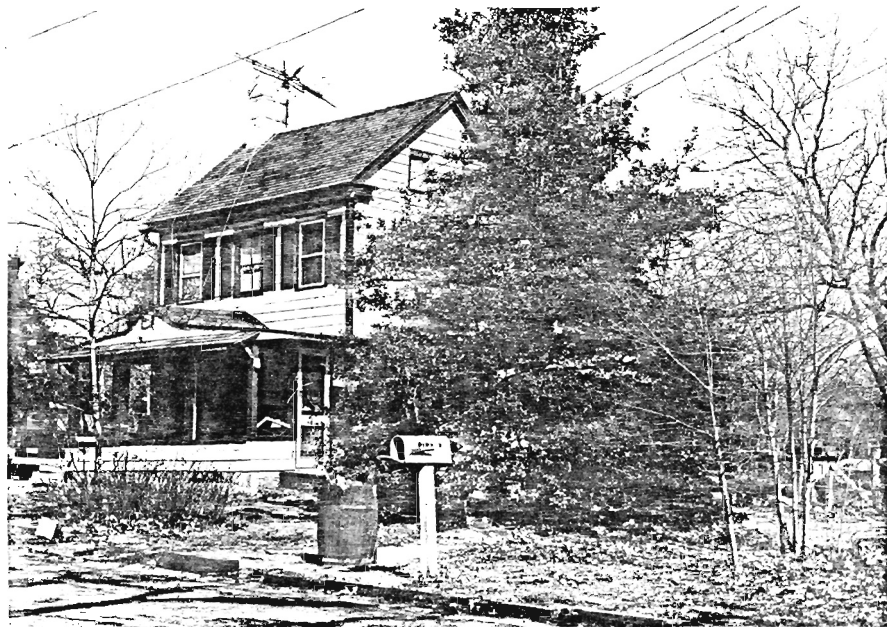
1508-L50

North Street / Block 39 / Lot 60 West Creek

2½ story, 3 bay, asbestos siding exterior, gable roof. This mid 19th century house is similar to other structures in the area. Lean-to additions have been added to the rear.

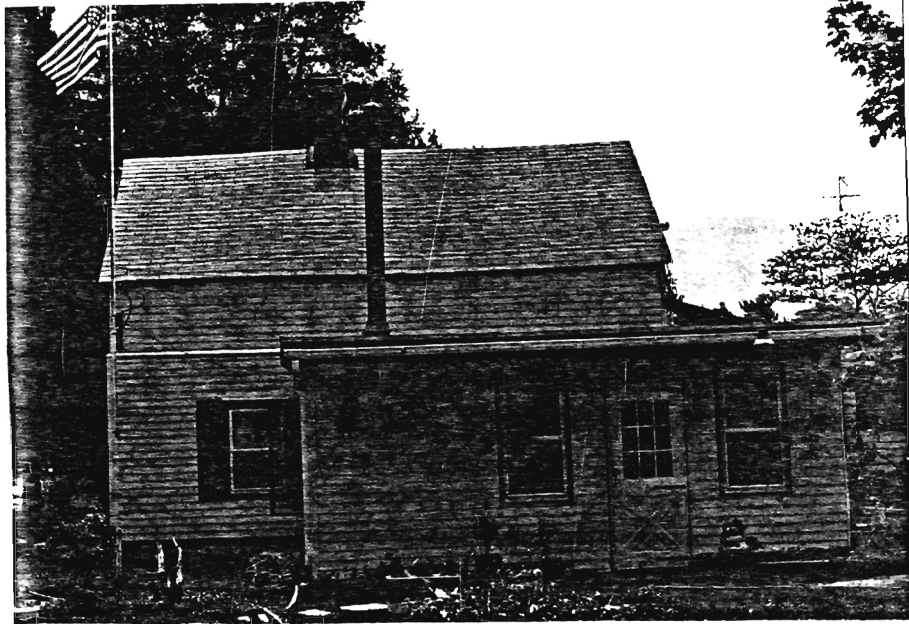
1508-L51

Floodgate House / Silver Lake Drive / Block 40 / Lot 5 West Creek

1 story, 2 bay, aluminum siding, gable roof. This building has been extremely altered by the construction of new additions, however, its original roof line and chimney indicate its early date of construction. Two similar structures are also found along the road. See below.

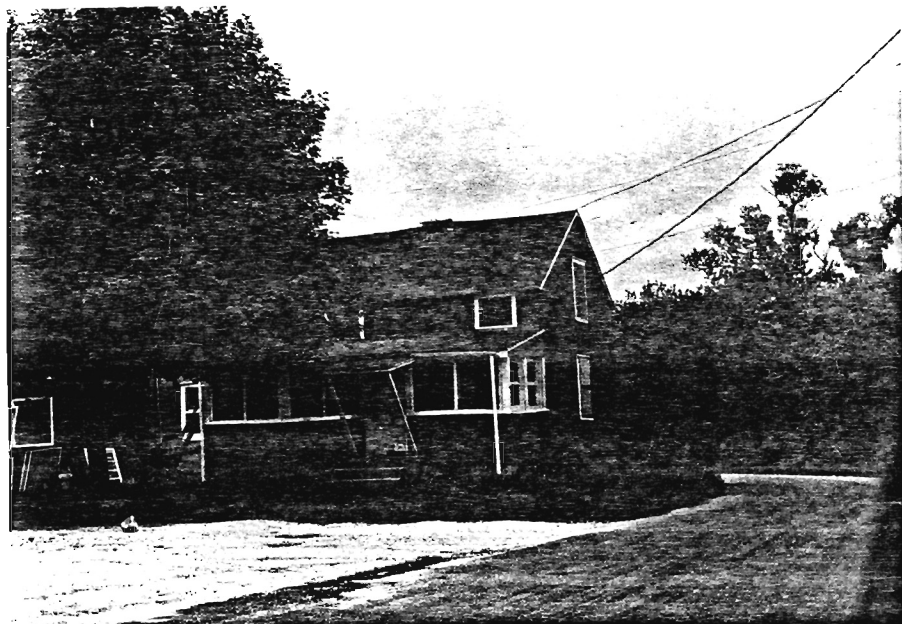
1508-L52

Silver Lake Drive / Block 40 / Lot 8 West Creek

2 story, 3 bay, asbestos shingle exterior, gable roof. Unusually narrow second floor windows are employed. The structure has a stone foundation and is oriented perpendicular to the road.

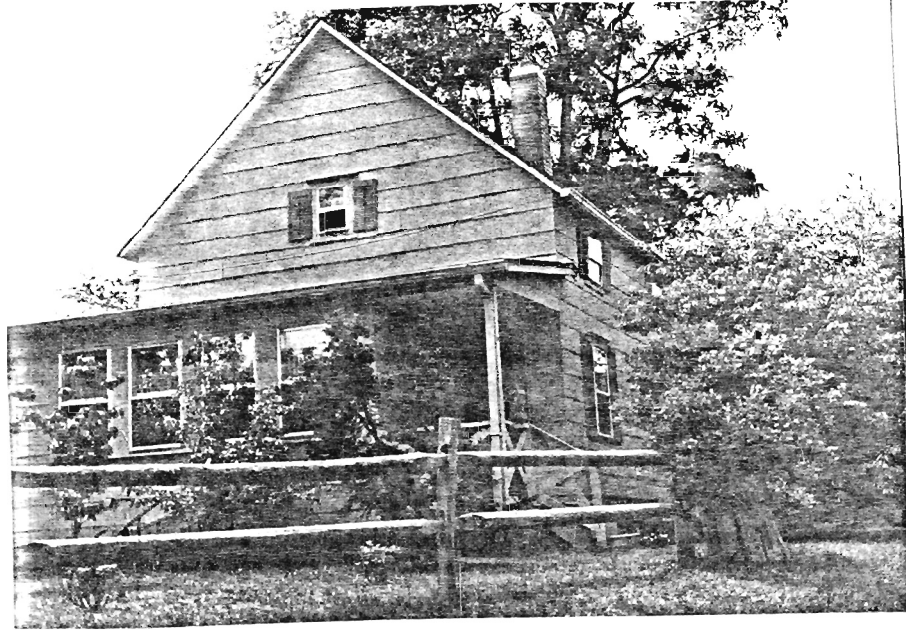
1508-L53

Silver Lake Drive / Block 40 / Lot 10 West Creek

2 story, 2 bay, asbestos siding, gable roof. Unusually narrow second floor windows and a stone foundation are employed. The structure has been altered over the years, however its original shape and plan remain.

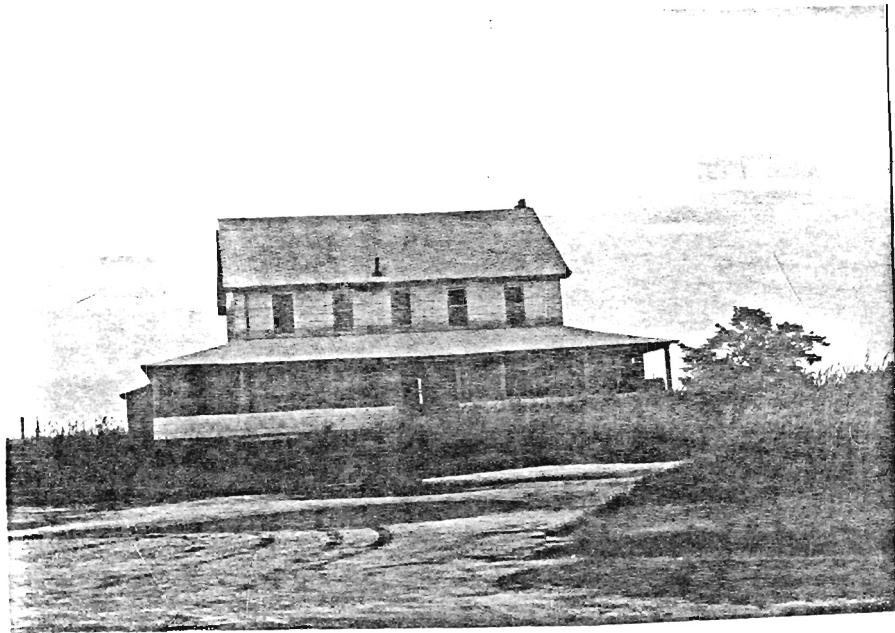
1508-L54

Gunning Club / Dock Road West Creek

2½ story, 5 bay, asbestos shingle exterior, gable roof with returns. A large open porch which is partially enclosed runs along all sides of the structure. The building has a high foundation and is located at the water's edge. The "hotel", circa 1900, was a popular place for hunters and fishermen in the early 20th century.

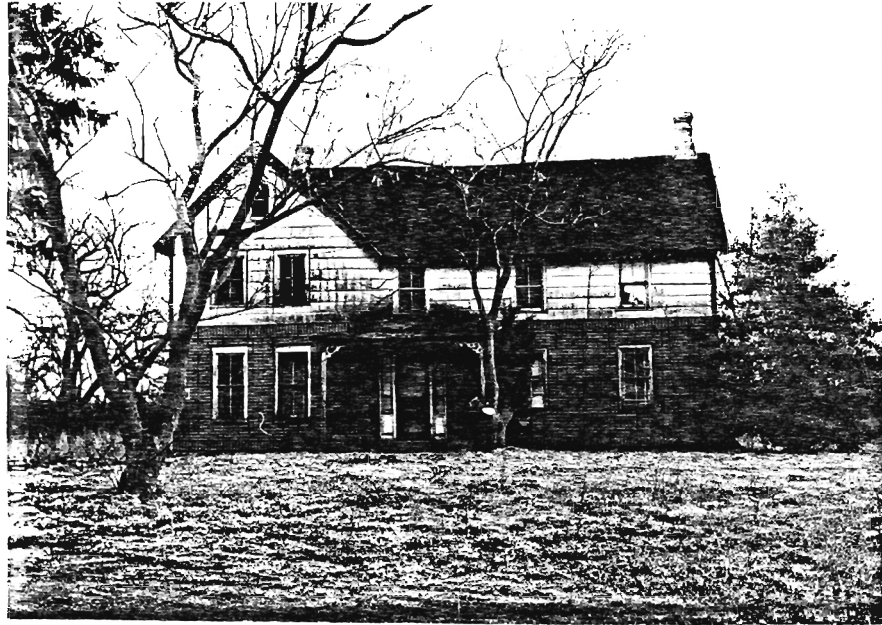
1508-L55

Main Street (east side near Bartlett Avenue) West Creek

2 story, 5 bay, asphalt and asbestos shingle, gable roof. A decorative rake-board is found along the roofline of the south section. 2/2 windows and door with transom and sidelights are employed. The north section is 2 bays and its gable end faces the road. The original structure is the south end. The structure is vacant and deteriorating.

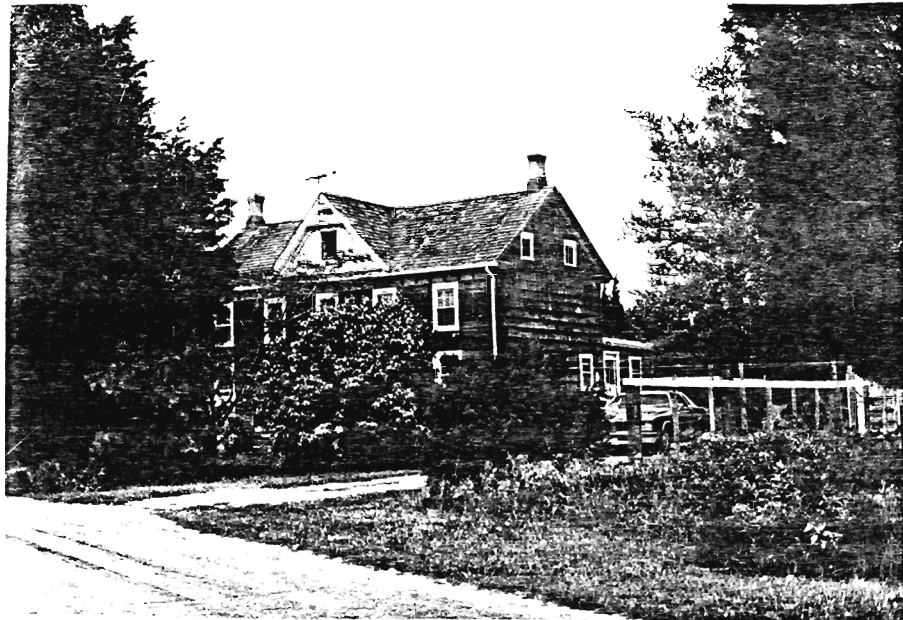
1508-L56

Sprague Avenue (north side) Block 27 / Lot 8 West Creek

2½ story, 5 bay, natural wood shingle exterior, cross gable roof. 6/6 window center door and a bracketed cornice are employed. The structure, which is set at an angle to the road, has been altered. A modern picture window is found on the facade.

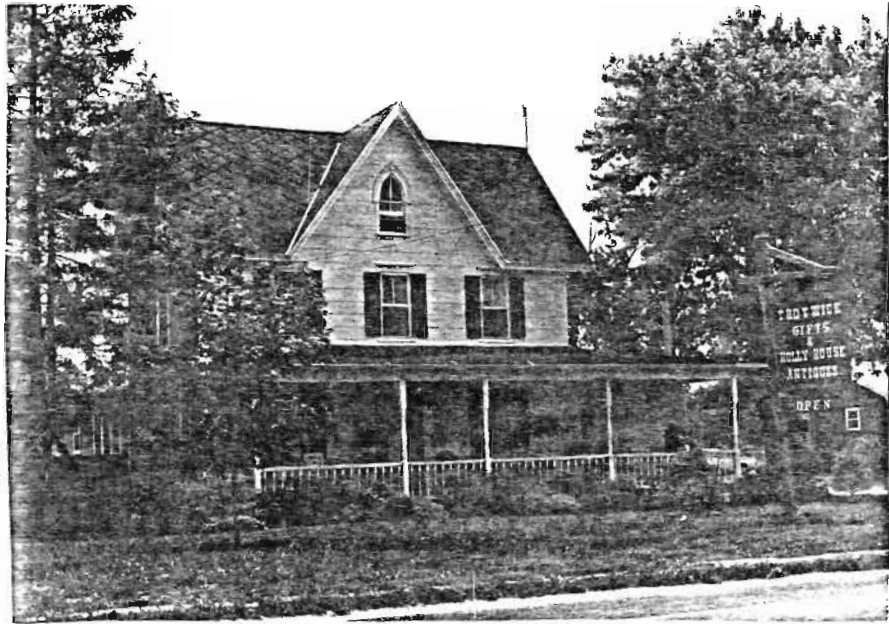
1508-L57

Giftshop / Main Street (east side) (across from Cox's Crossing) West Creek

2½ story, 3 bay, asbestos shingle and clapboard, cross gable roof. 2/2 windows and a Gothic pointed arch window are employed. The double leaf center door has a transom. The porch across the facade has turned posts and balustrade. The house is typical of late 19th century farmhouses along Route 9.

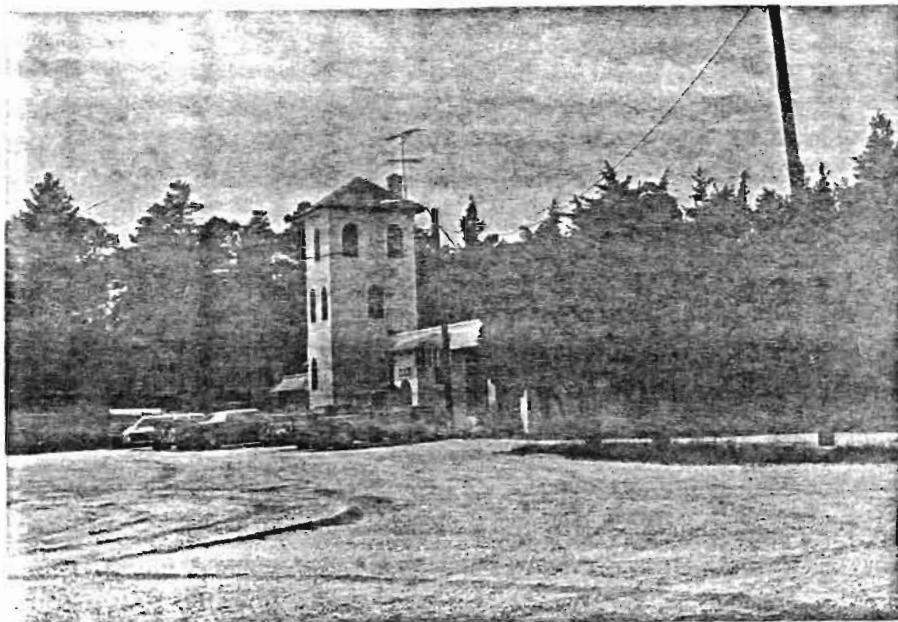
1508-L58

Tower Tavern / Main Street / West Creek

1 story, stucco exterior, parapet roof. This early 20th century structure has a three story tower with lancet windows. The building is typical of many early 20th century structures built in the Spanish Revival style, however, few examples of this style can be found in Ocean County.
